# Mount Thorley Warkworth 2020 Annual Review

Mount Thorley Warkworth (MTW) is an integrated operation of two open cut coal mines, Warkworth Mining Limited (WML) and Mount Thorley Operations (MTO). This Annual Review reports on the environmental performance of MTW for the period 1 January 2020 to 31 December 2020.

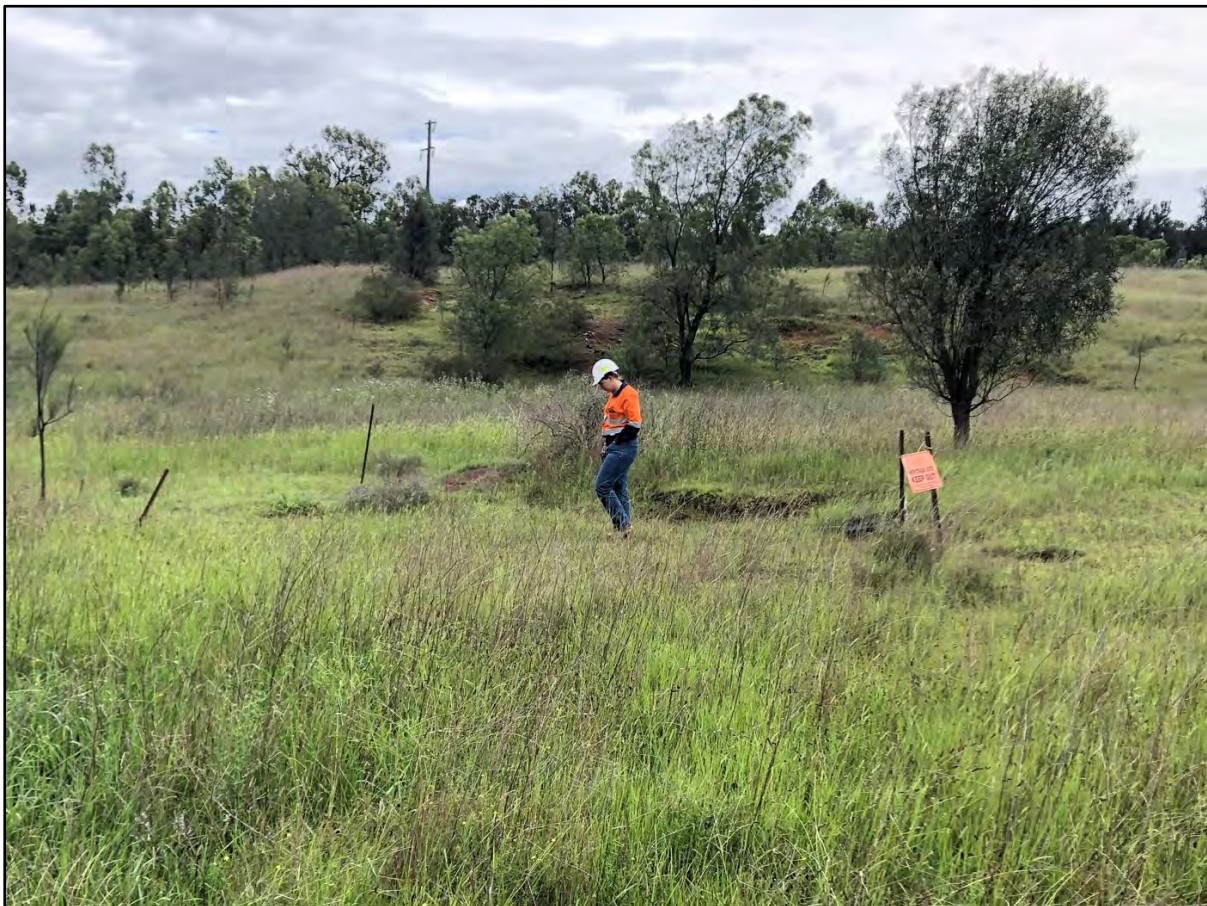
As a general observation, most of the barricading, where installed at ACH sites, was in a good state of repair. Some new barricading has been recommended as a protective measure for sites located in proximity to access or activity areas. Barricading should consist of hi-vis string line and signage delineating the area as an ACH site to be avoided.

***Example of dilapidated barricading (at MTW-506)***

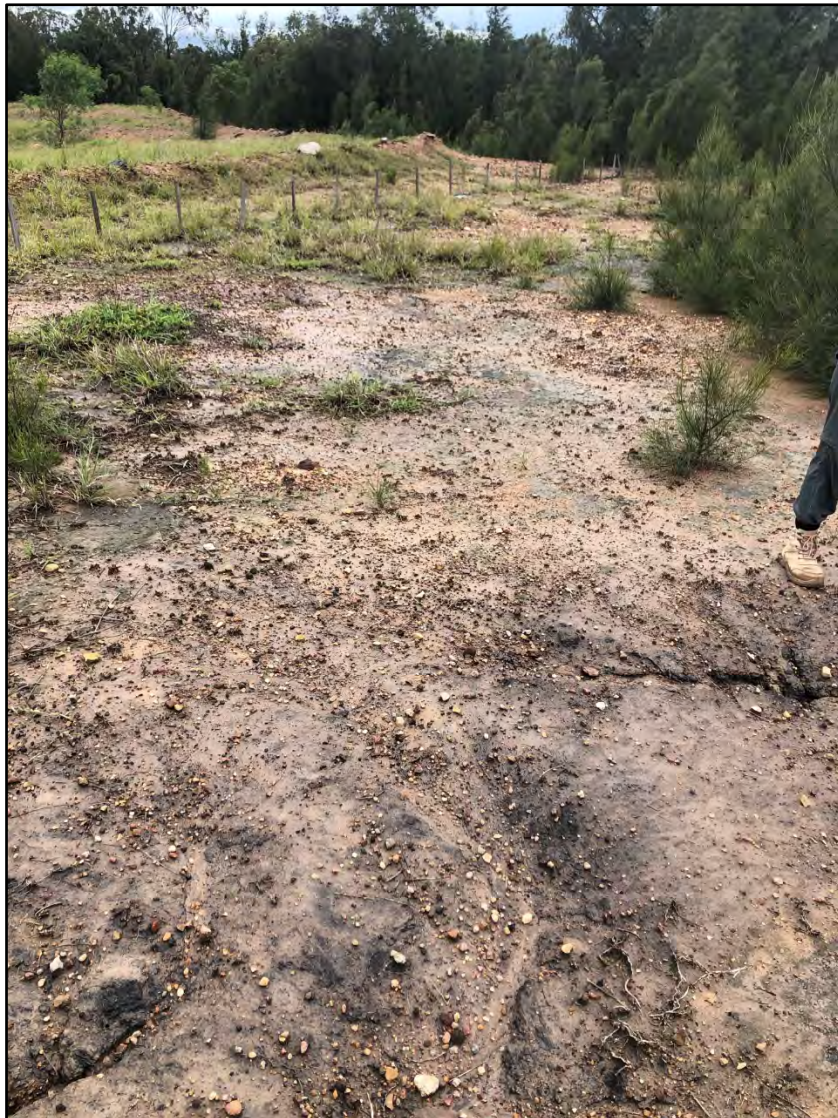
The two sites located at Mount Thorley (MTW-547 and 548) are located on the banks of Loders Creek and are at risk of being washed away by sheet wash and erosion. Their condition should be discussed with the CHWG with a view to salvaging them prior to them being lost to erosion.

**Sheet wash erosion at MTW-548**

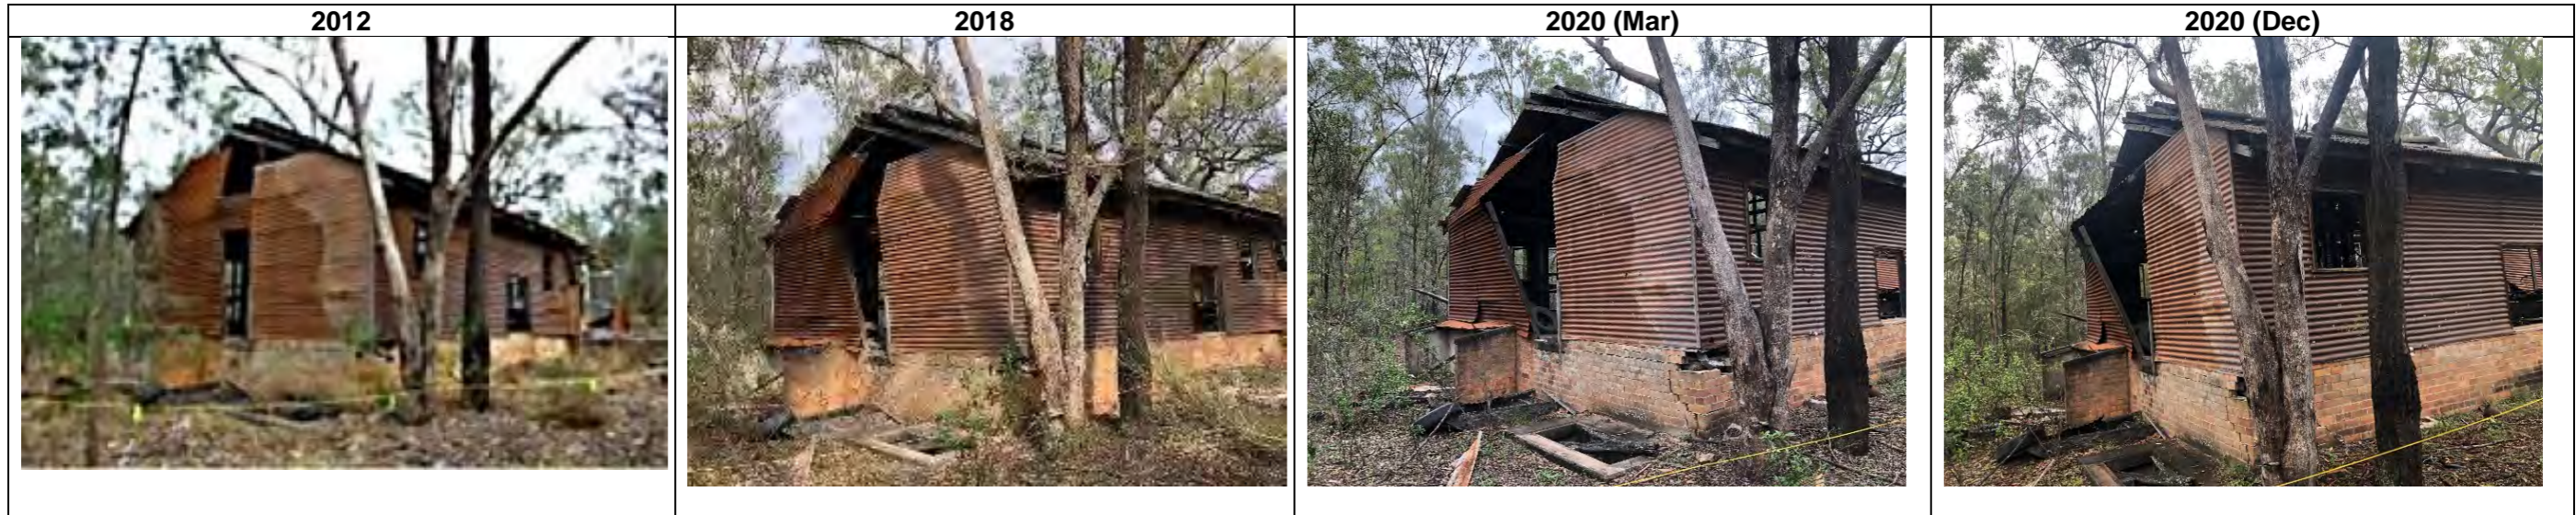
**South-east elevation**  
**2012-18:** evidence of increased bow to southern wall.  
**2018-20 (Mar):** bow in wall appears to have increased.  
**Mar 2020 – Dec 2020:** bow in wall continues to increase.

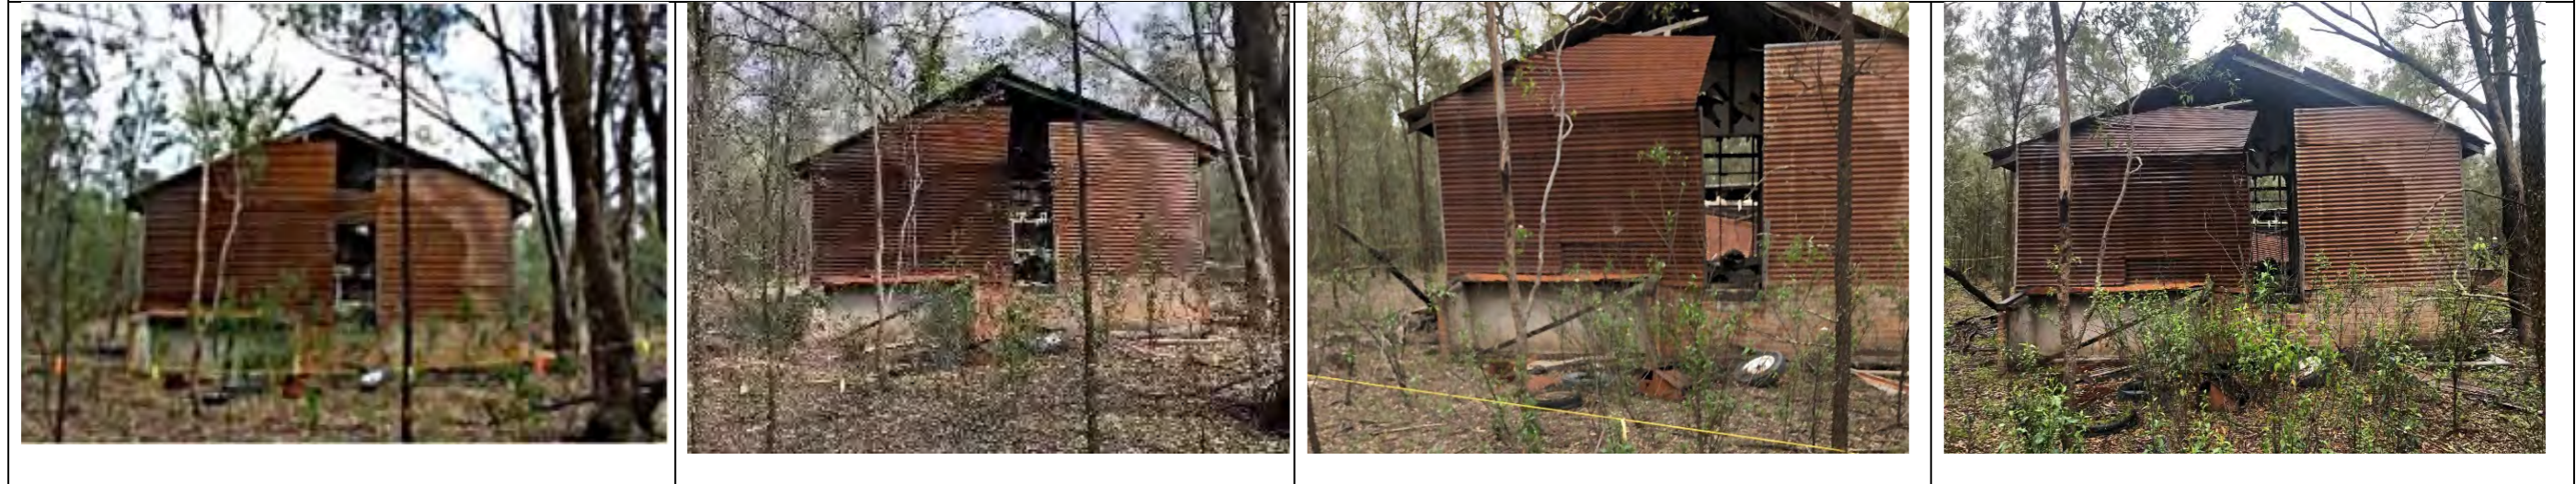
**South elevation**  
**2012-18:** evidence of increased bow to southern wall and missing panel above entry.  
**2018-20 (Mar):** increased bow to southern wall.  
**Mar 2020 – Dec 2020:** increased bowing on southern wall.

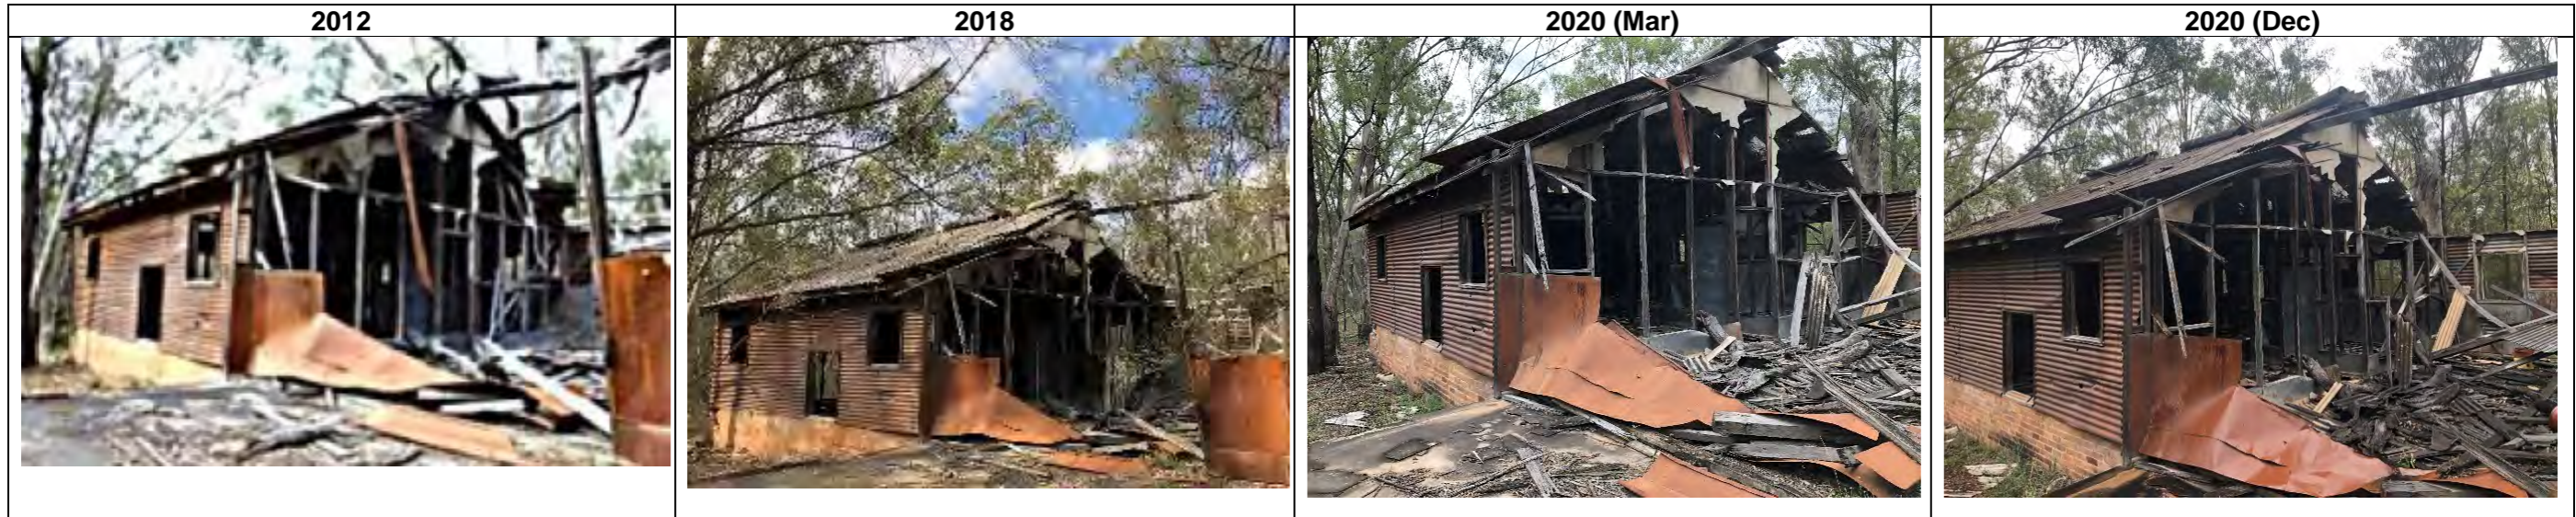
**View to building interior from north-east**  
**2012-18:** shows collapse of remnant roofing members above open kitchen area.  
**2018-20 (Mar):** further minor deterioration of asbestos sheeting panelling.  
**Mar 2020 – Dec 2020:** no discernible change.

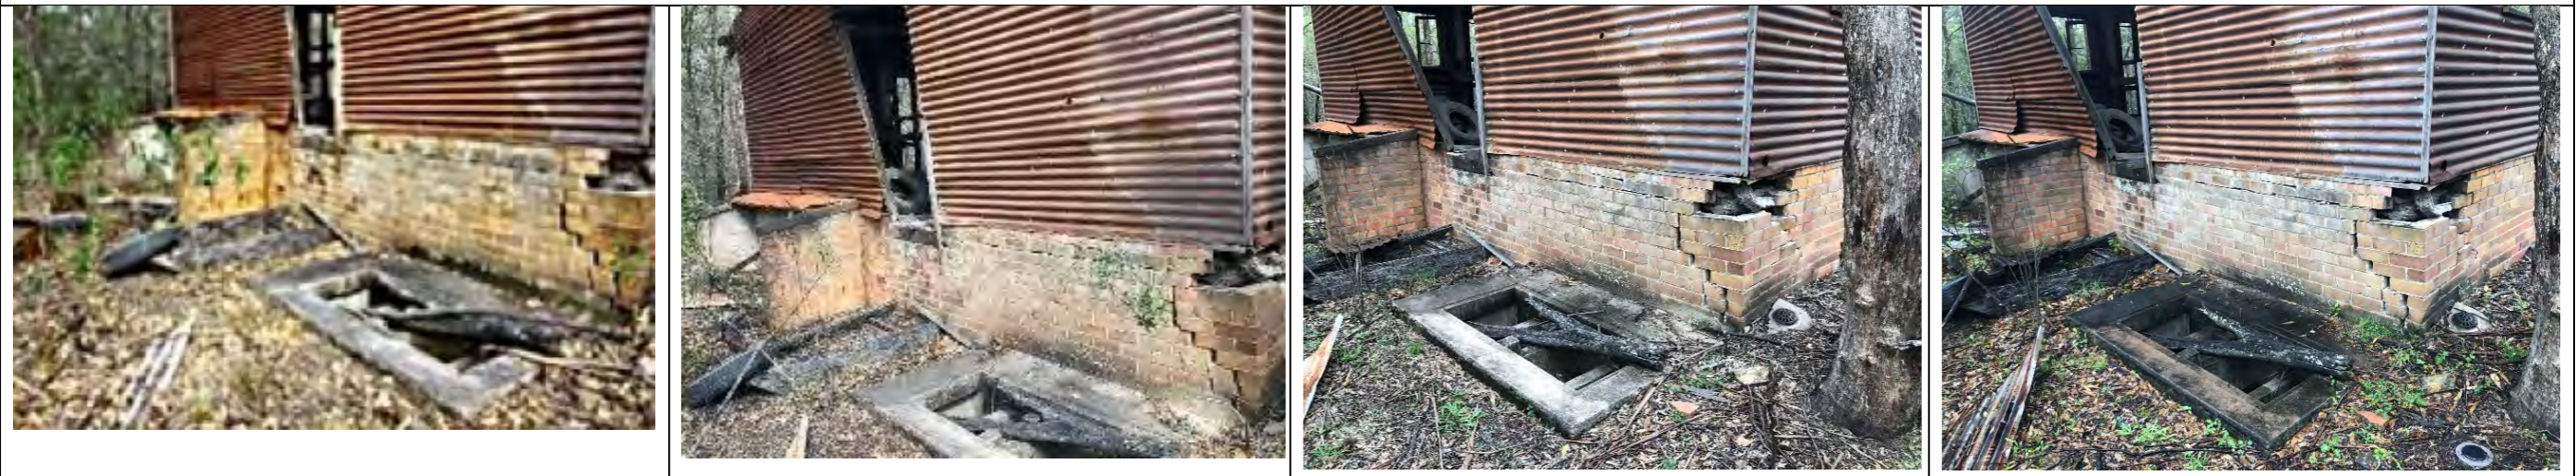
**Grease trap at south end of building**  
**2012-18:** shows bow to south wall.  
**2018-20 (Mar):** shows increased bow to south wall.  
**Mar 2020 – Dec 2020:** shows increasing bowing of south wall, and example of new termite monitoring system in bottom right of picture.

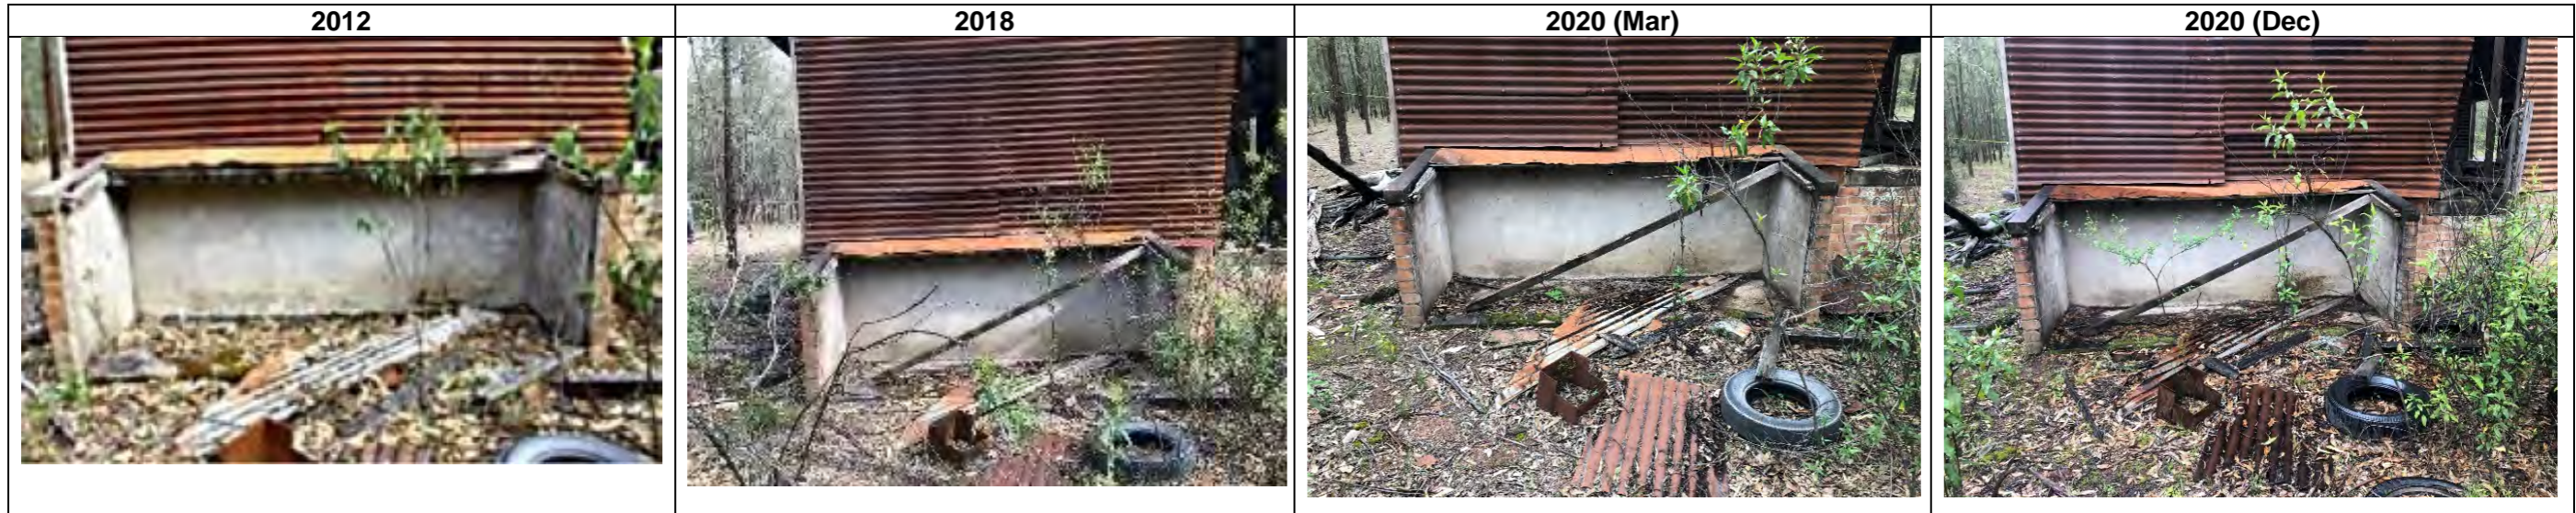
**Storage area at south end of building**  
**2012-18:** further slight collapse of storage area.  
**2018-20 (Mar):** shows loosening of corrugated iron wall sheeting due to bowing in wall.  
**Mar 2020 – Dec 2020:** no discernible change.

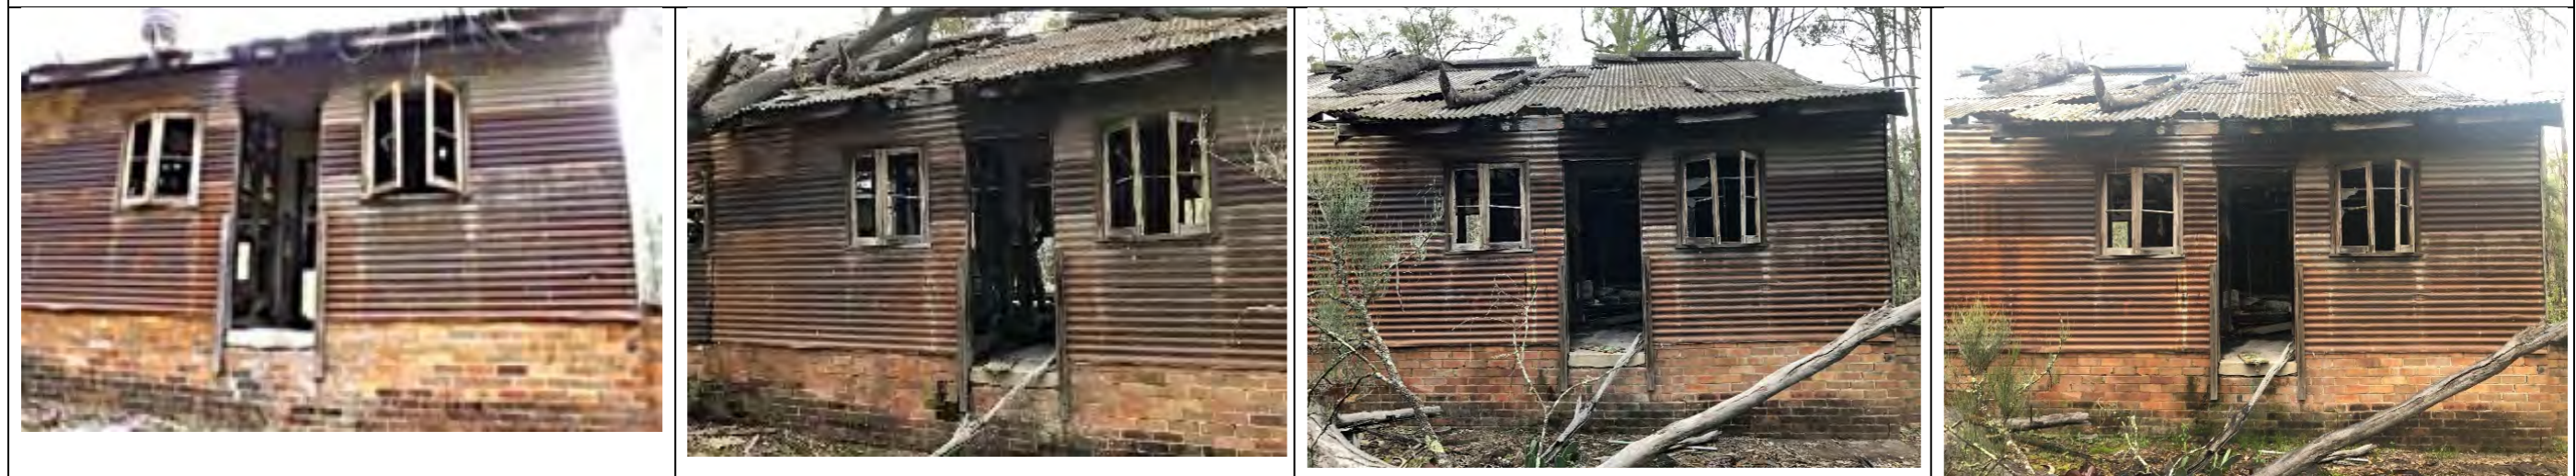
**Windows and entry at west elevation**  
**2012-18:** shows large trunk/branch portions of tree collapsed on roof, which has destroyed roof ventilator.  
**2018-20 (Mar):** shows majority of branches fallen from roof, leaving increased damage to sheeting.  
**Mar 2020 – Dec 2020:** no discernible change.

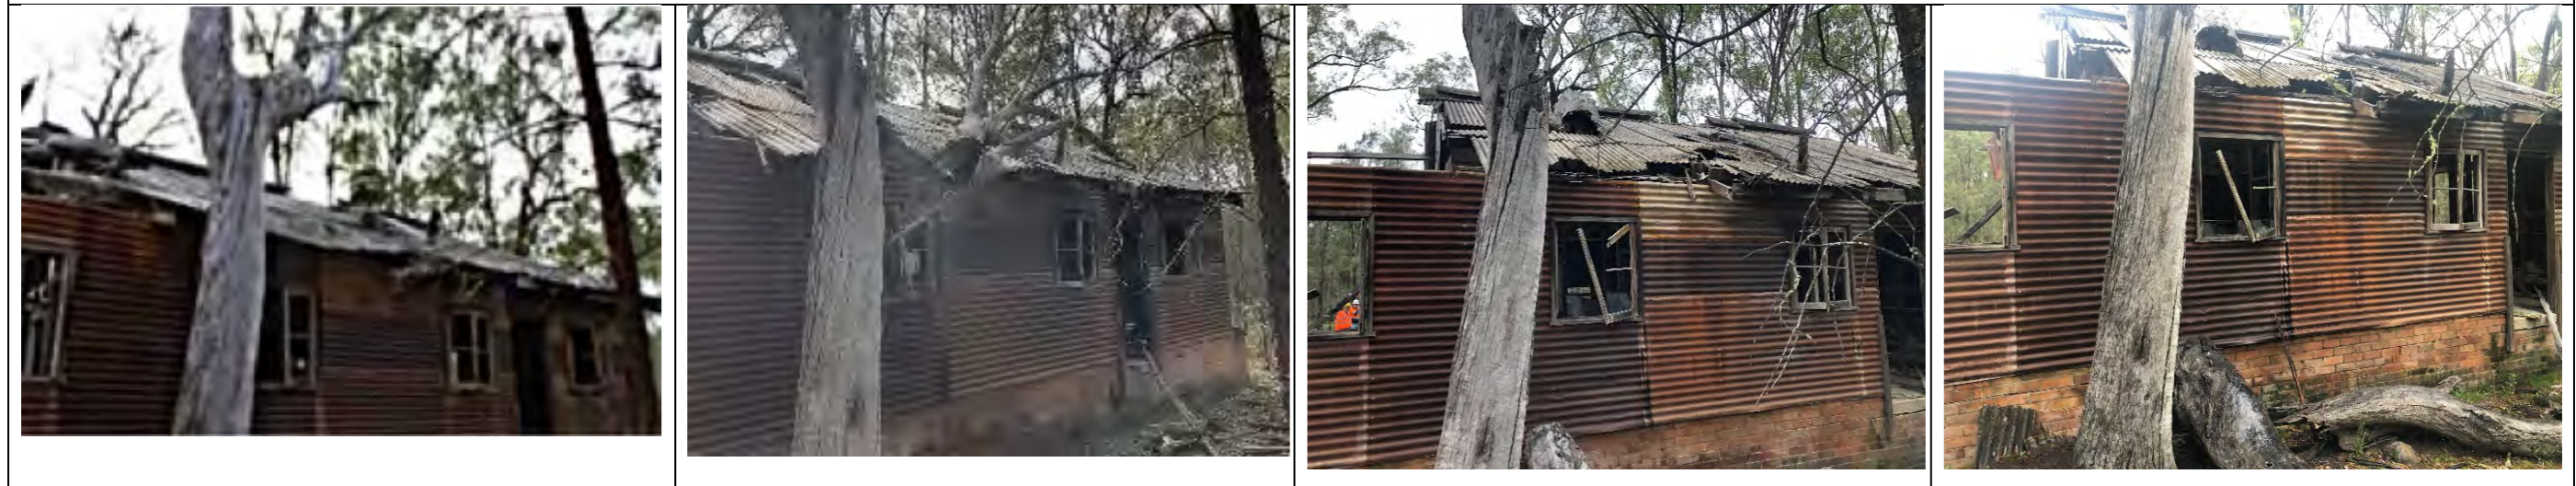
**Showing cylindrical ventilator and damage to roof, view from west**  
**2012-18:** shows significant roof damage from fallen dead tree, including to ventilator.  
**2018-20 (Mar):** shows increased damage to roof edge sheeting from fallen branch.  
**Mar 2020 – Dec 2020:** no discernible change.

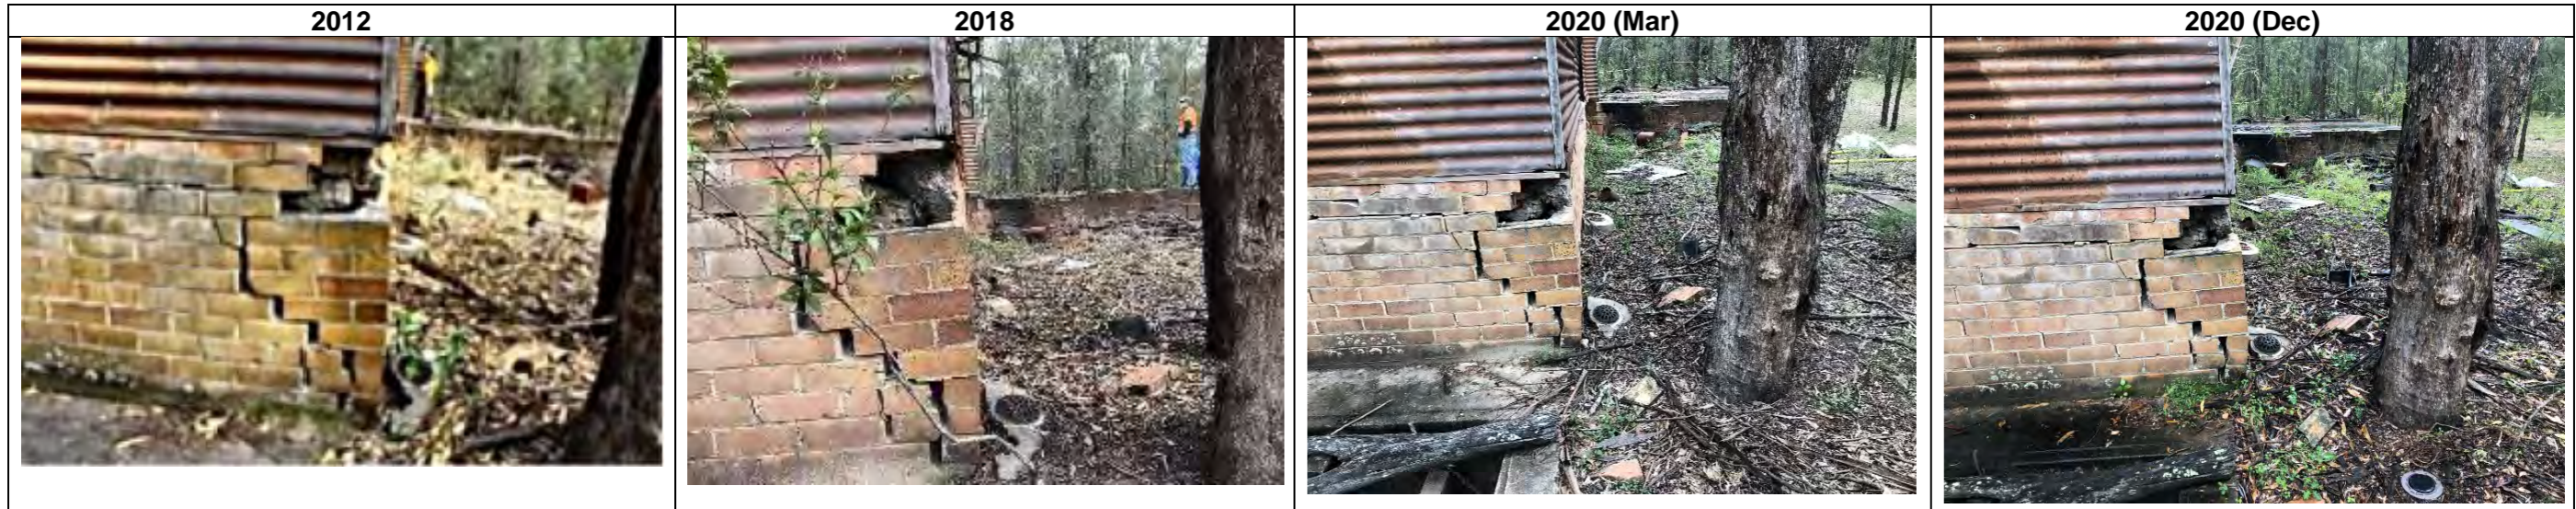
**Damaged brick foundation at south-east corner**  
**2012-18:** no discernible increase to cracked brick foundation.  
**2018-20 (Mar):** further cracking of foundation (to left of shot) and some slumping of corner bricks.  
**Mar 2020 – Dec 2020:** some slight potential further movement in cracked section (also note termite management system in bottom right hand corner of photograph).

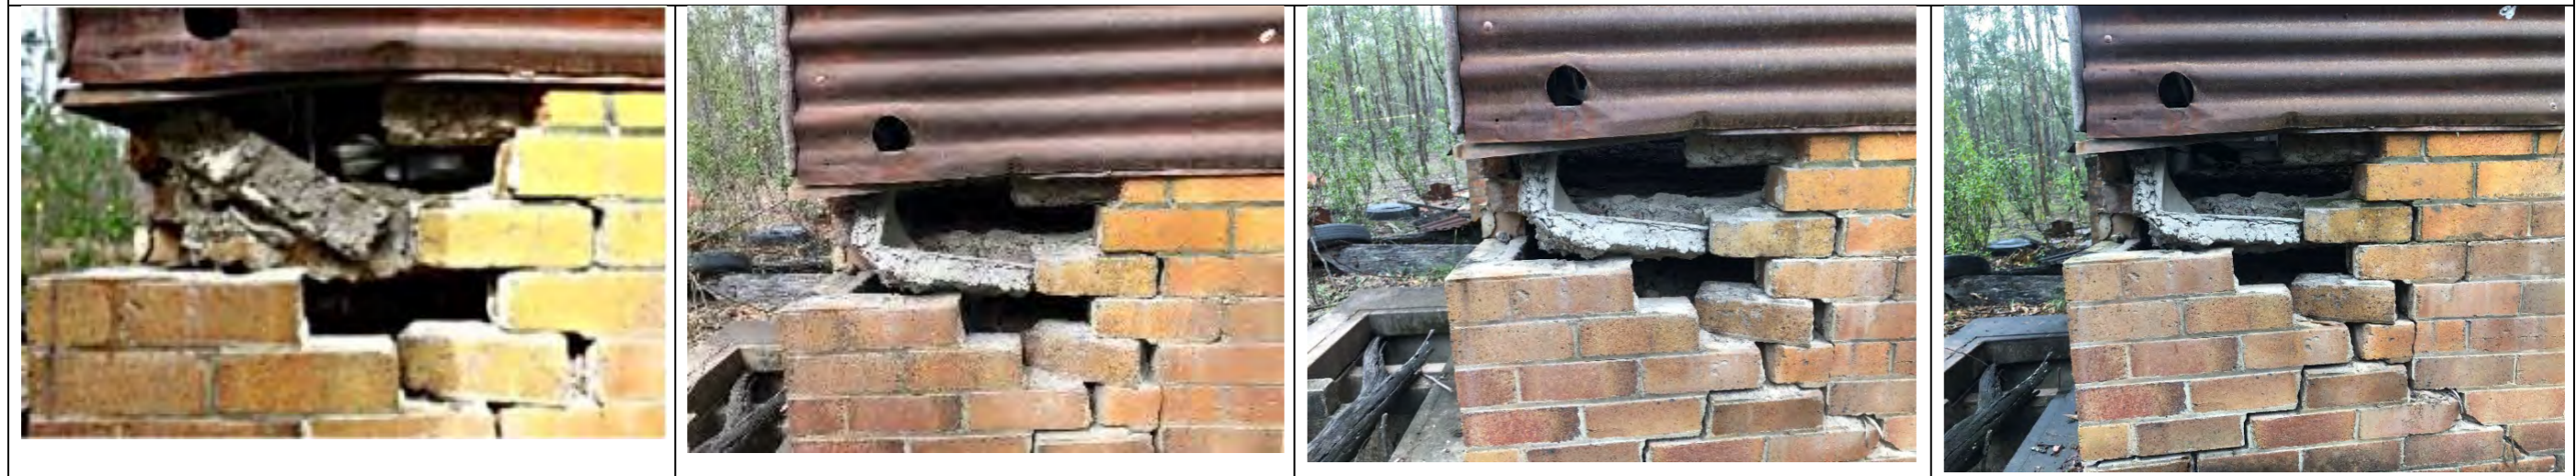
**Detail of damaged brick foundation**  
**2012-18:** some further collapse of concrete/cement above brick foundation.  
**2018-20 (Mar):** some slumping outwards of corner brick foundation.  
**Mar 2020 – Dec 2020:** no discernible change.

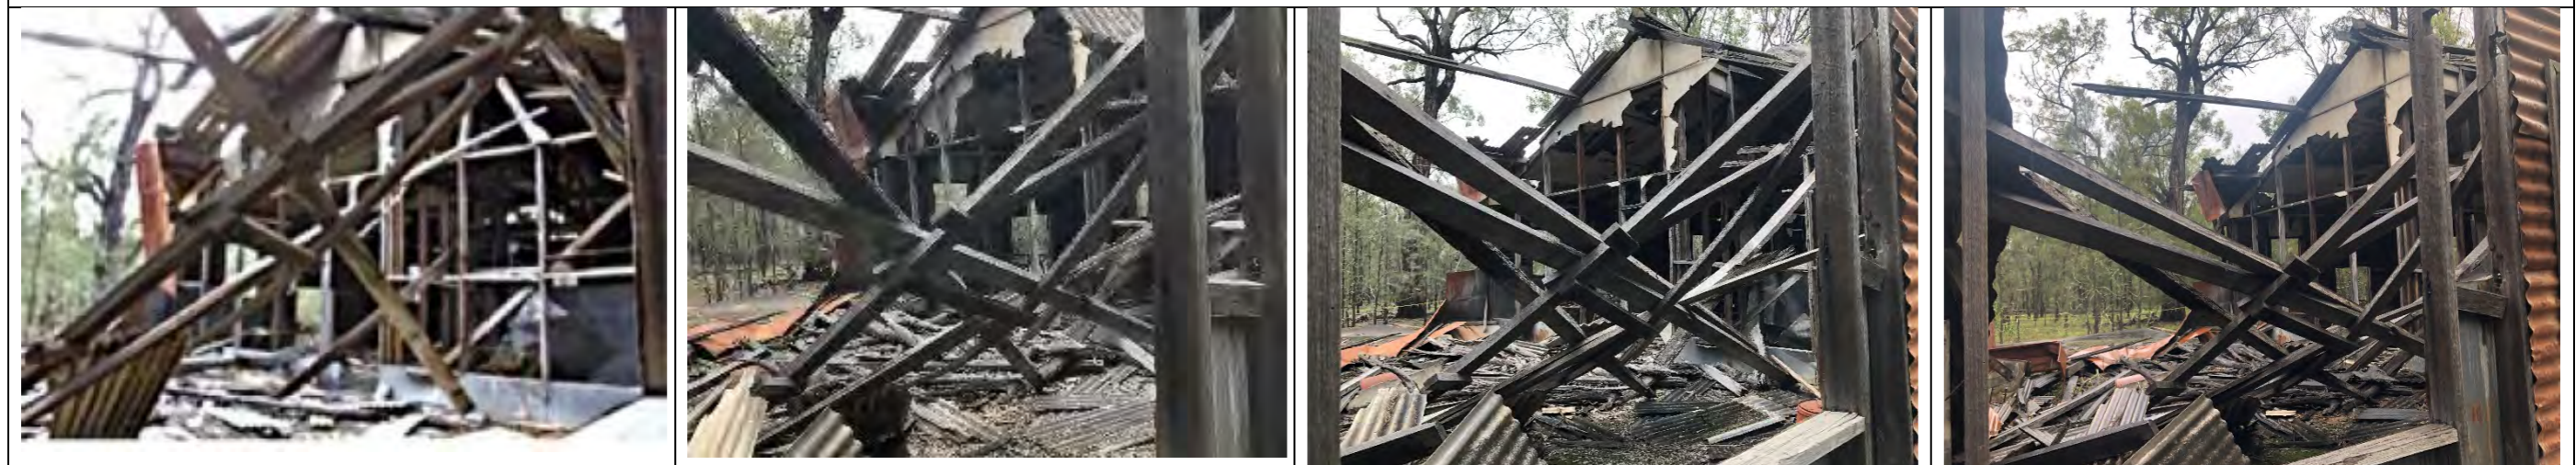
**Showing interior of building, viewed from north-west corner**  
**2012-18:** shows collapsed roofing members above open kitchen area and accumulation of debris.  
**2018-20 (Mar):** shows additional collapsed roofing member.  
**Mar 2020 – Dec 2020:** no discernible change.

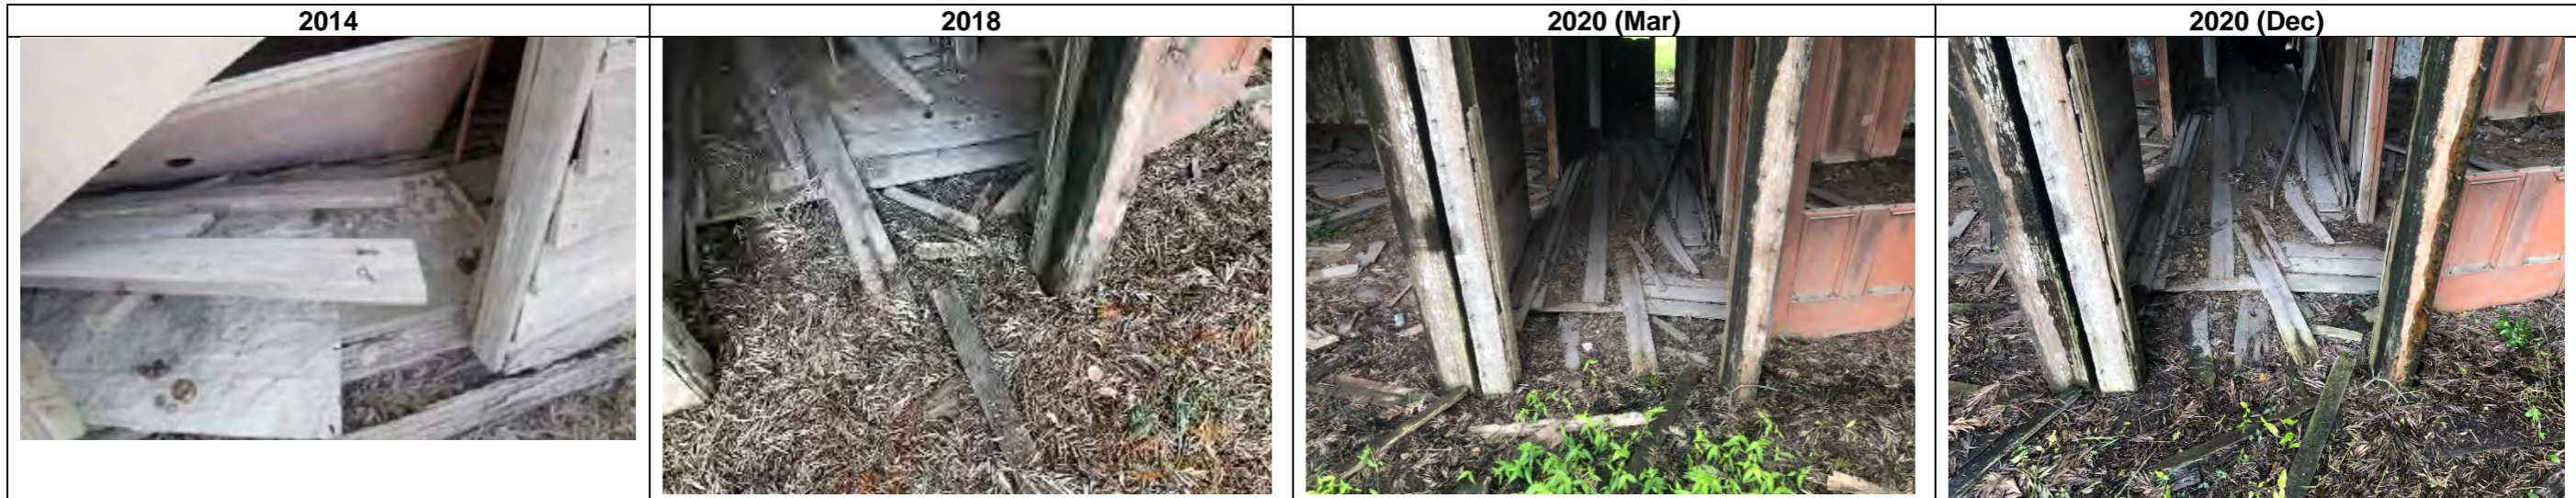
**Southern elevation doorway**  
**2014-8:** door has been removed.  
**2018-20 (Mar):** no discernible change.  
**Mar 2020-Dec 2020:** no discernible change.

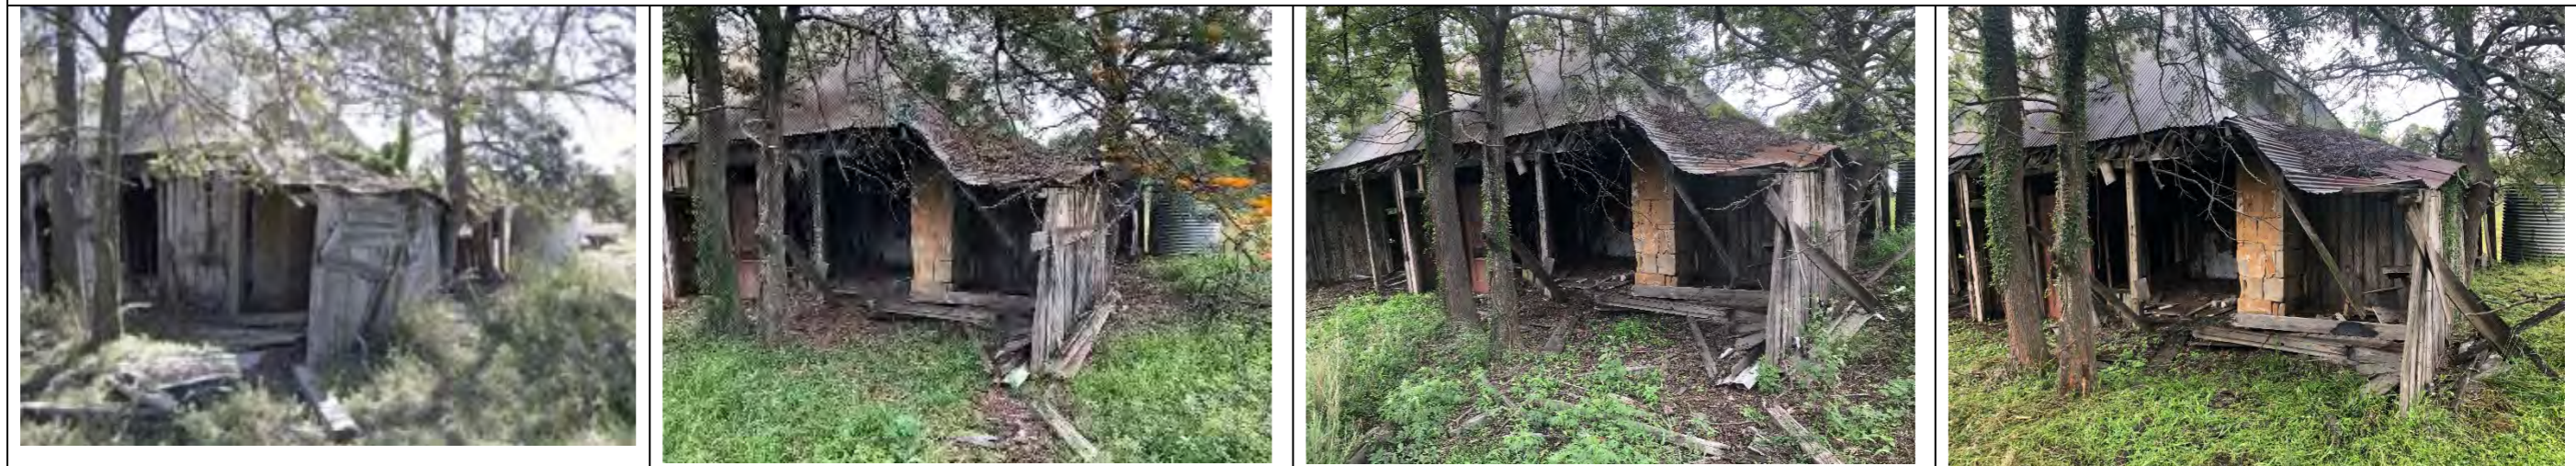
**South-eastern corner**  
**2014-8:** vertical slabs have been removed causing further collapse of roof.  
**2018-20 (Mar):** further deterioration of eastern wall.  
**Mar 2020-Dec 2020:** heavy leaf litter on roof persists.

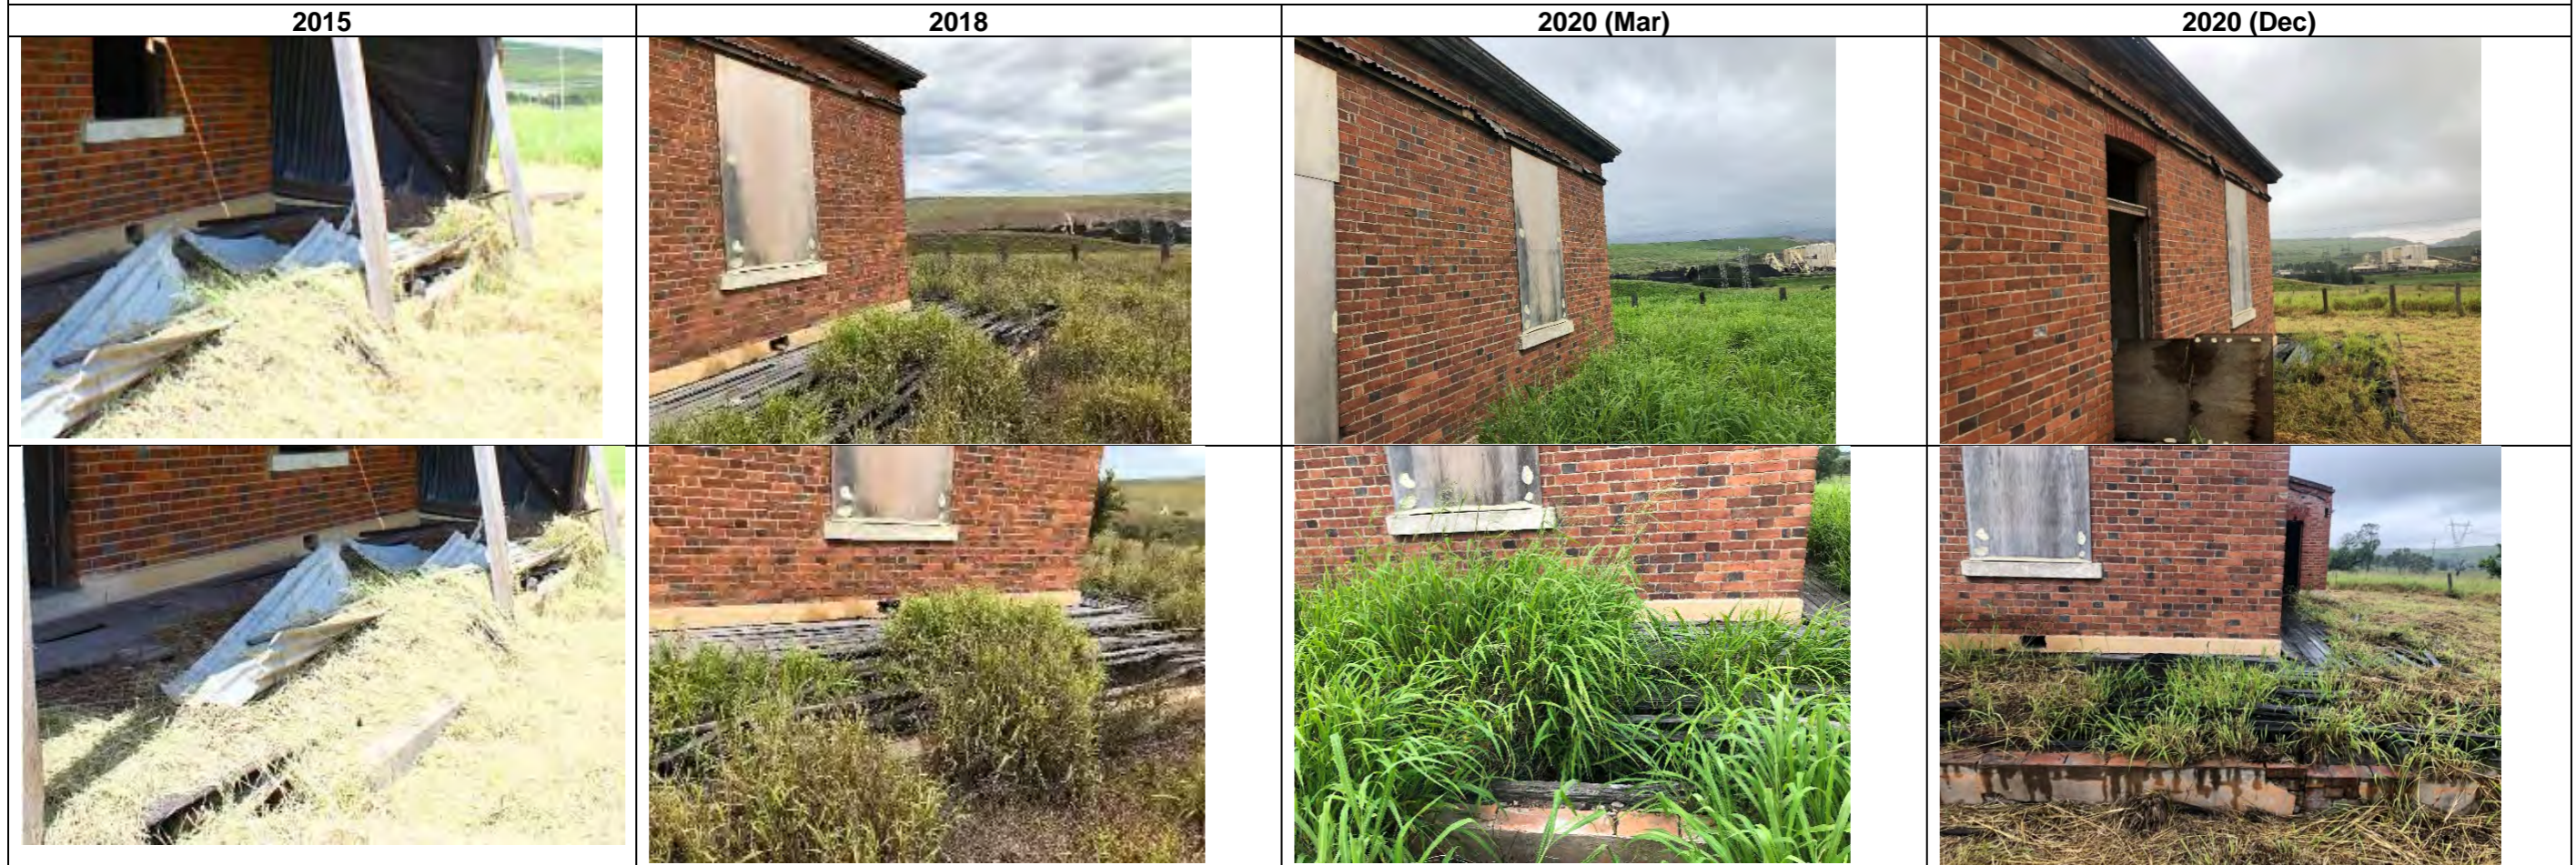
**View of eastern verandah (focus on verandah floor)**  
**2015-8:** posts and sheeting removed, damaged boards remain exposed  
**2018-20 (Mar):** damaged boards remain and vegetation growth throughout  
**Mar 2020-Dec 2020:** damaged boards remain and vegetation growth throughout

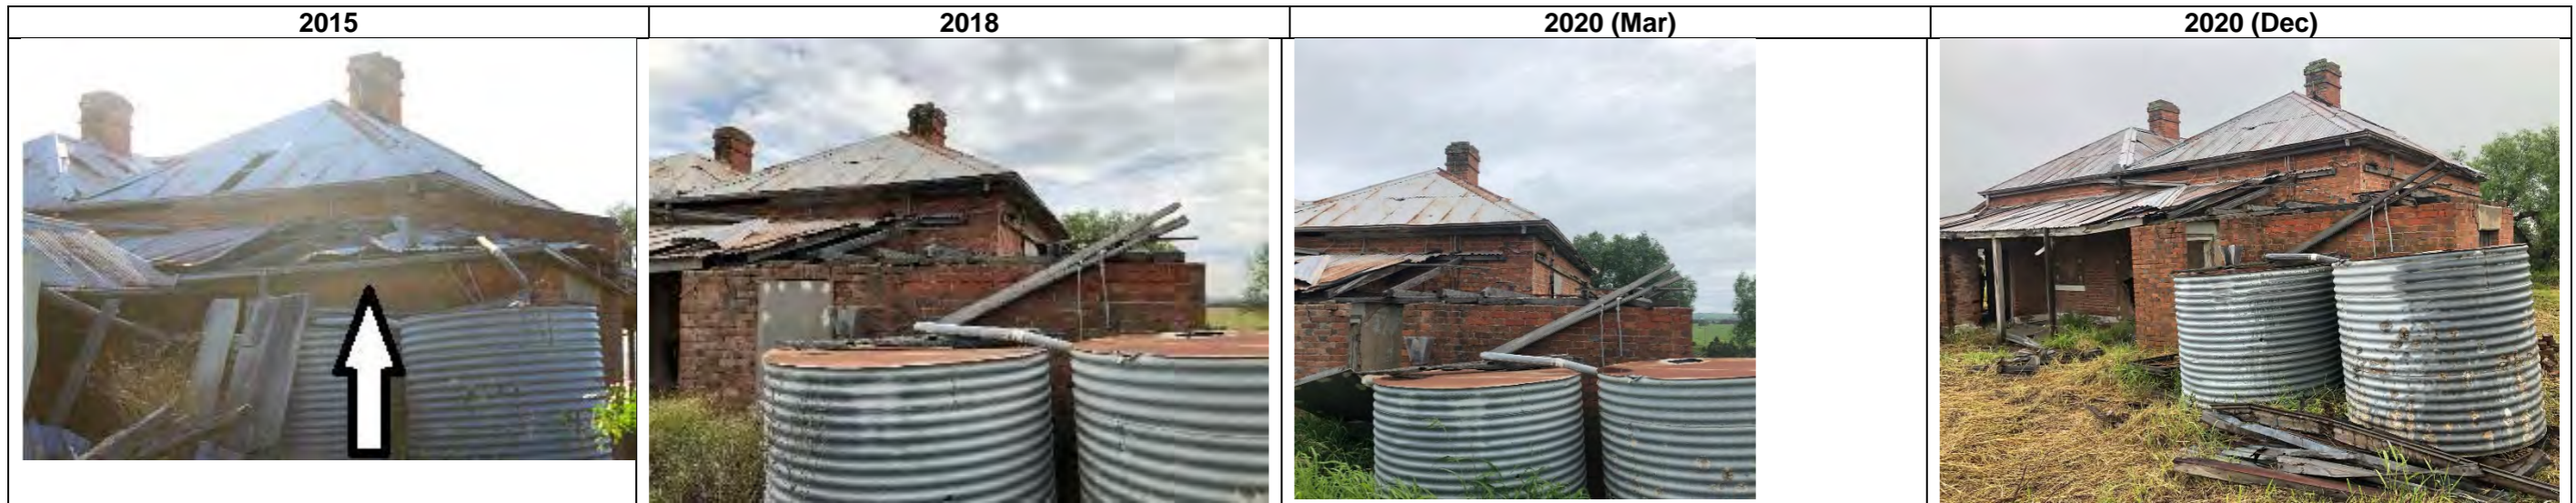
**View of rear of building (focus on roof)**  
**2015-8:** skillion roof, guttering and rafters have collapsed; main roof holes repaired  
**2018-20 (Mar):** no discernible change  
**Mar 2020-Dec 2020:** some minor holes in roofing require repair

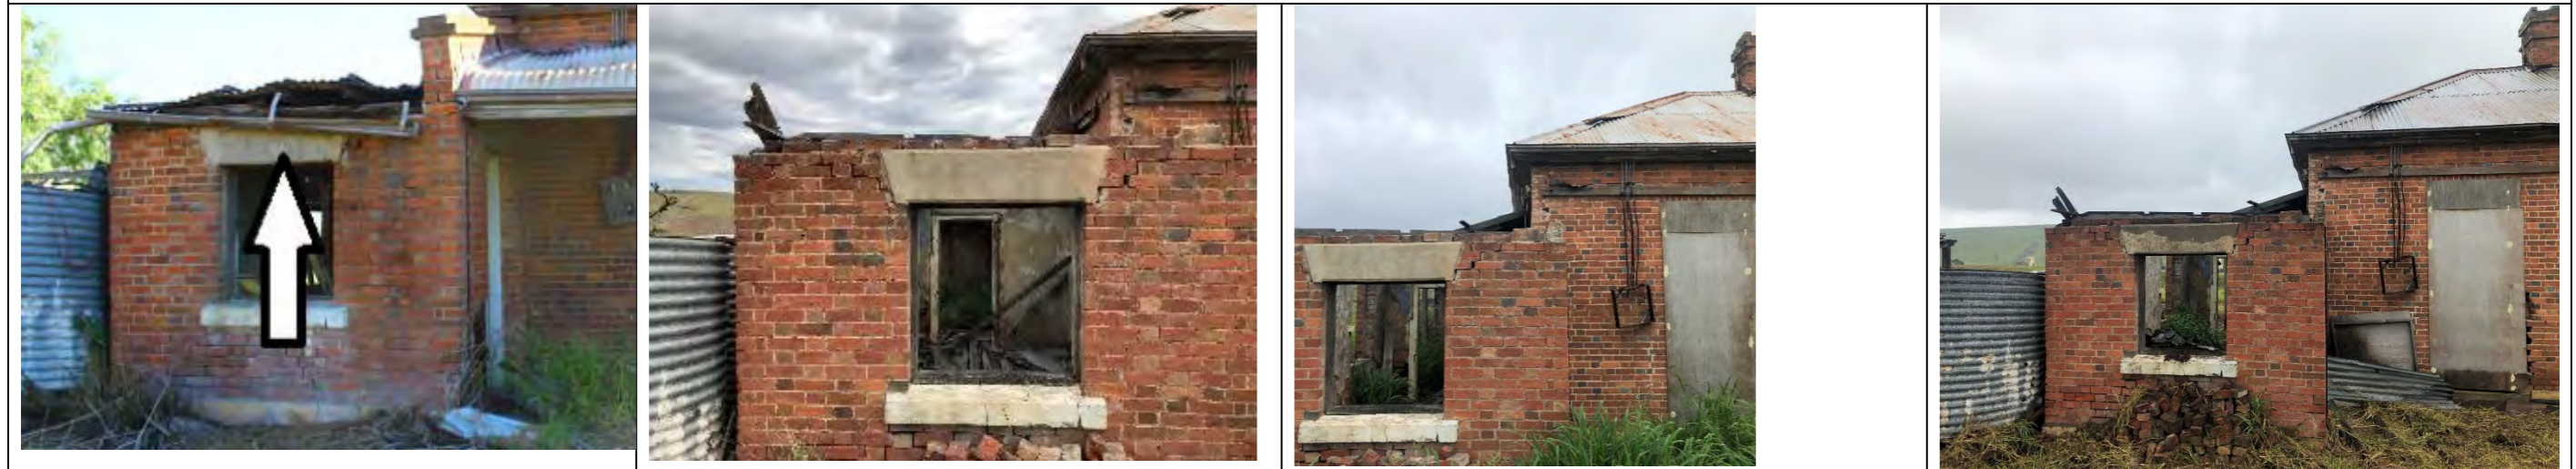
**View of north-east of building**  
**2015-8:** wall element has collapsed (bricks stacked under window); roof framing, sheeting and guttering has collapsed  
**2018-20 (Mar):** no discernible change  
**Mar 2020-Dec 2020:** no discernible change
