# Mount Thorley Warkworth 2020 Annual Review

Mount Thorley Warkworth (MTW) is an integrated operation of two open cut coal mines, Warkworth Mining Limited (WML) and Mount Thorley Operations (MTO). This Annual Review reports on the environmental performance of MTW for the period 1 January 2020 to 31 December 2020.

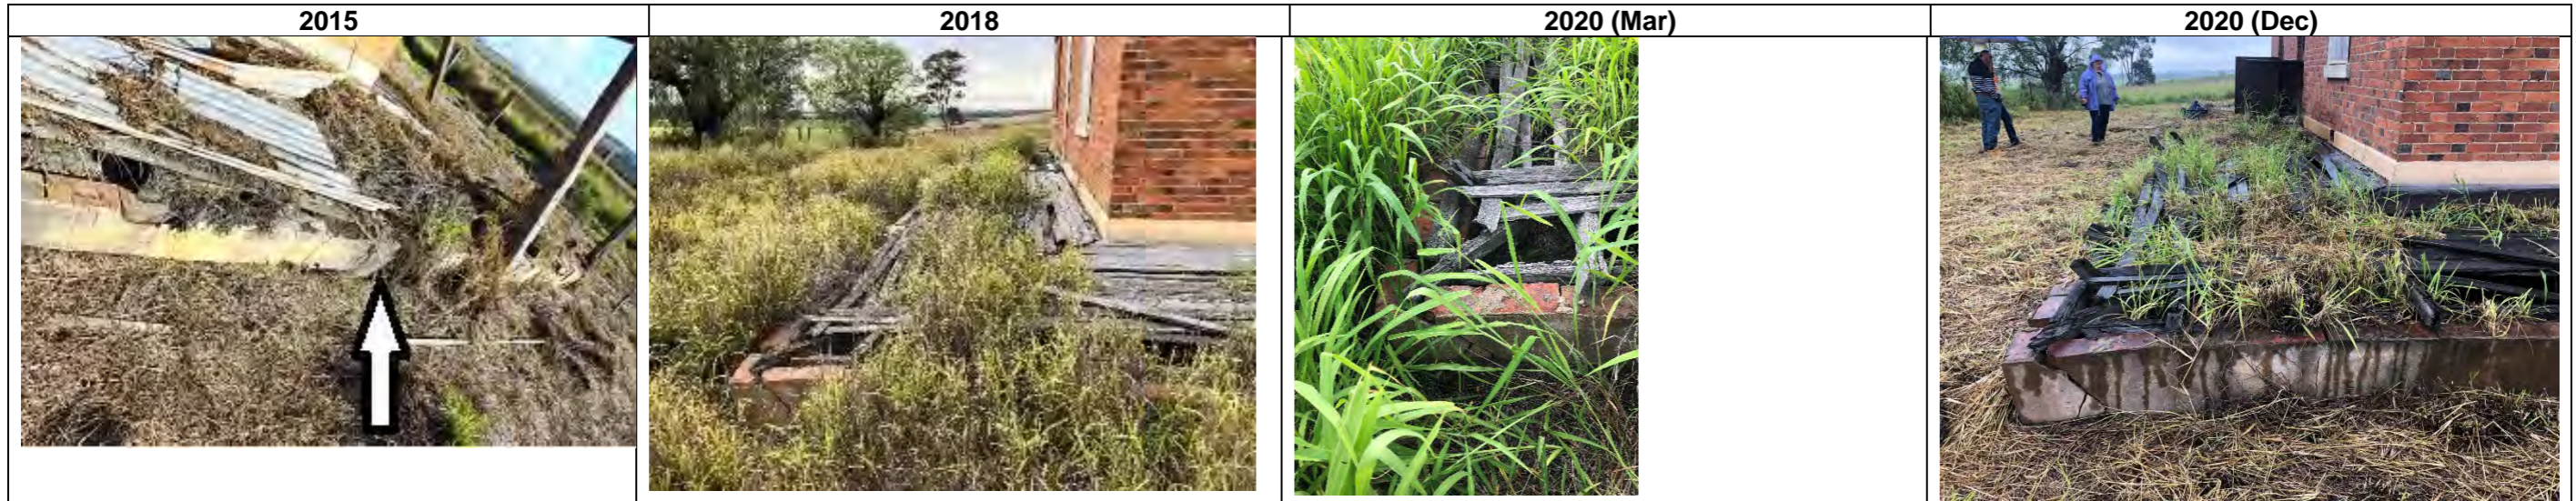
**View of eastern verandah (focus on dwarf wall wall)**  
**2015-8:** debris cleared from verandah, no change to dwarf wall  
**2018-20 (Mar):** no discernible change  
**Mar 2020-Dec 2020:** cracking to wall evident

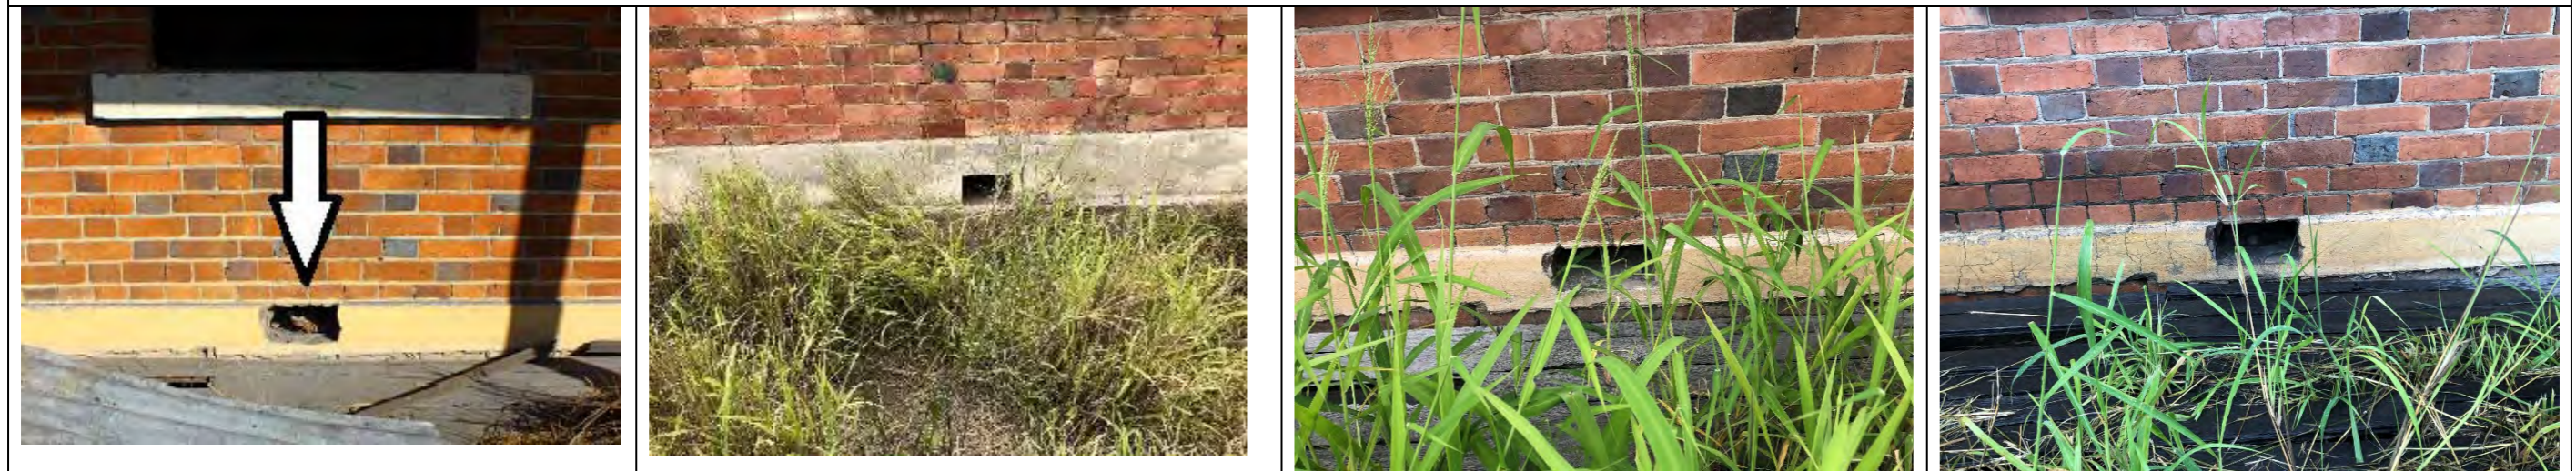
**View of ventilation grilles**  
**2015-8:** grilles not replaced  
**2018-20 (Mar):** no discernible change  
**Mar 2020-Dec 2020:** grilles remain open
