Mount Thorley Warkworth Aboriginal Heritage Management Plan 2019 Compliance Audit Inspection

Report prepared for
Yancoal Australia, Mount Thorley Warkworth

March 2020

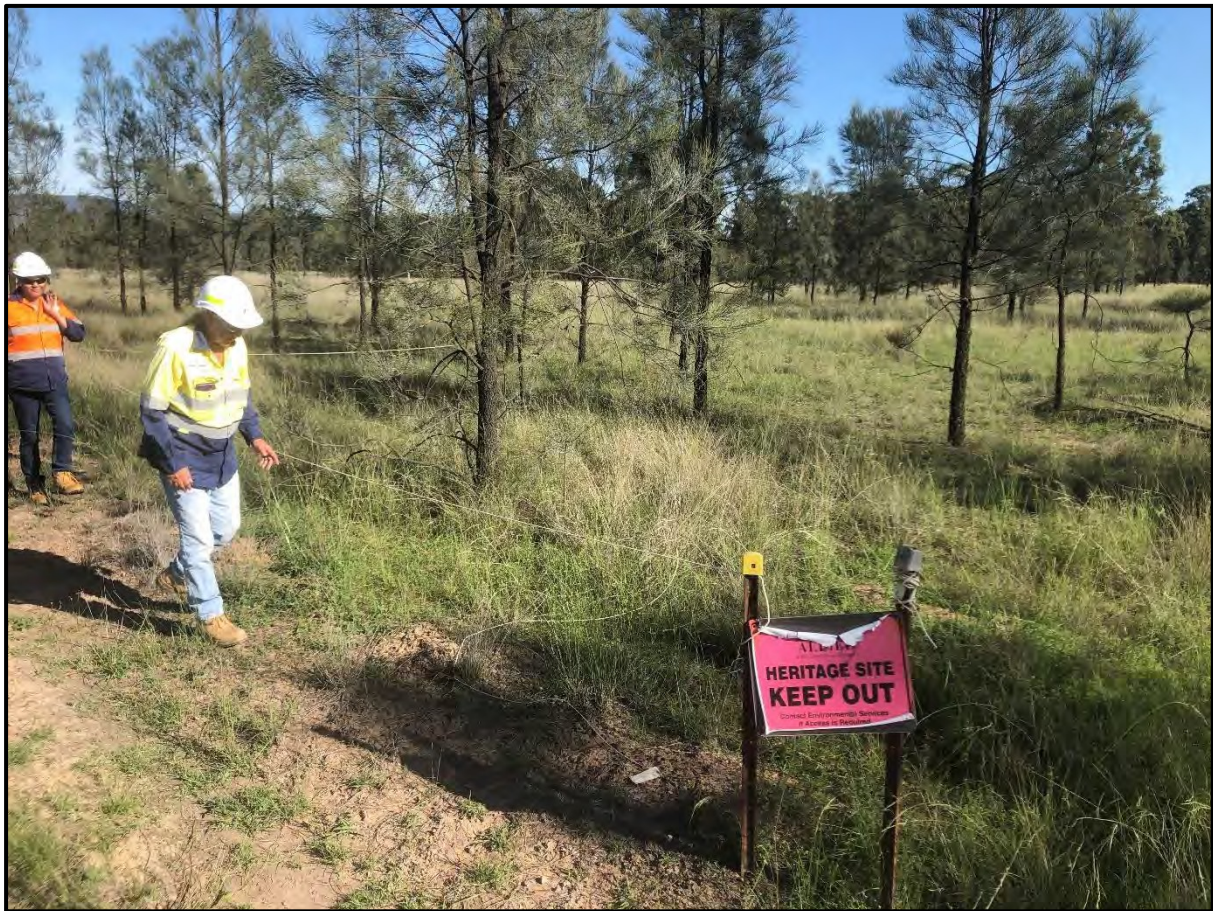
Example of dilapidated barricading

Consider rebarricading if activity increases in the area

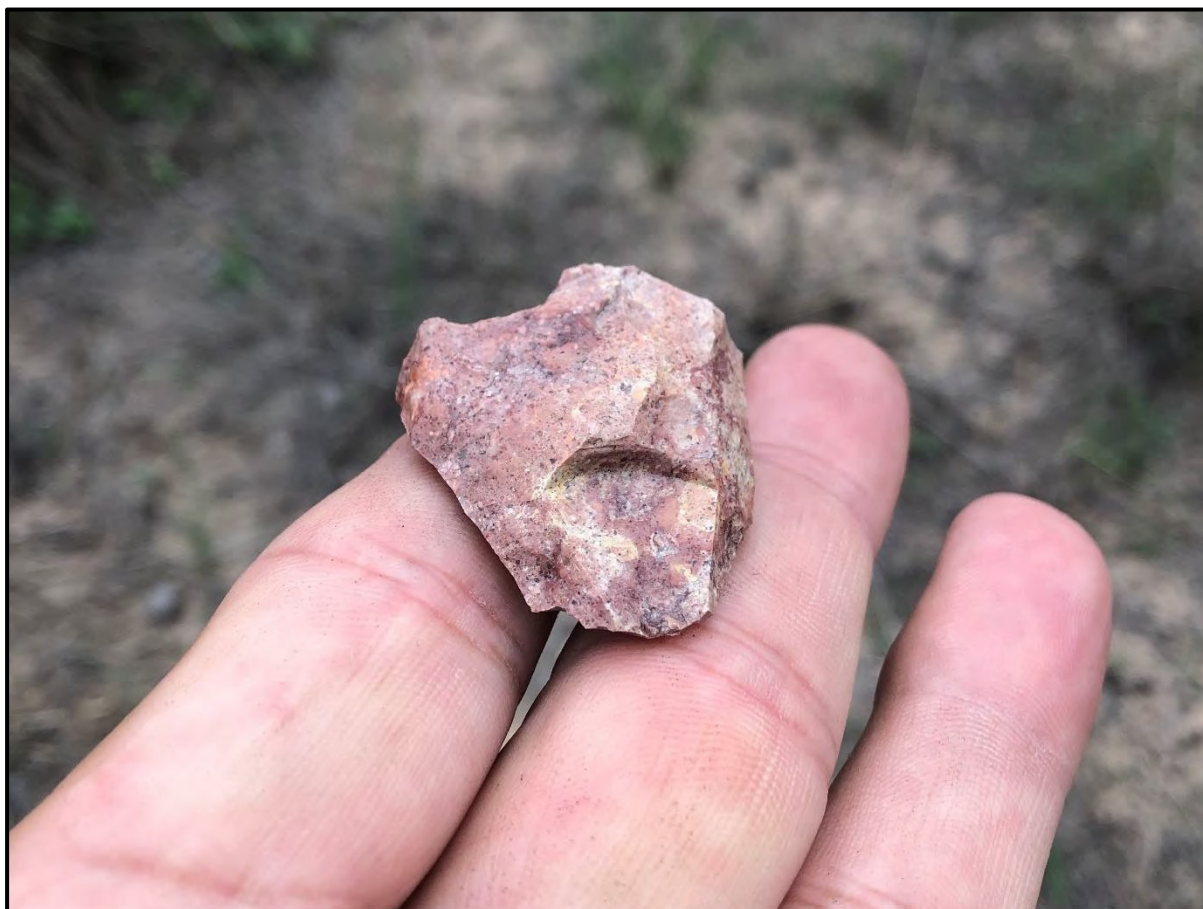
Silcrete flaked piece from WB3

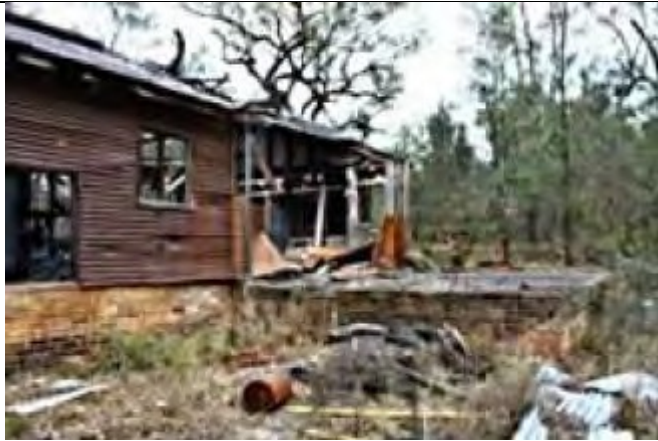
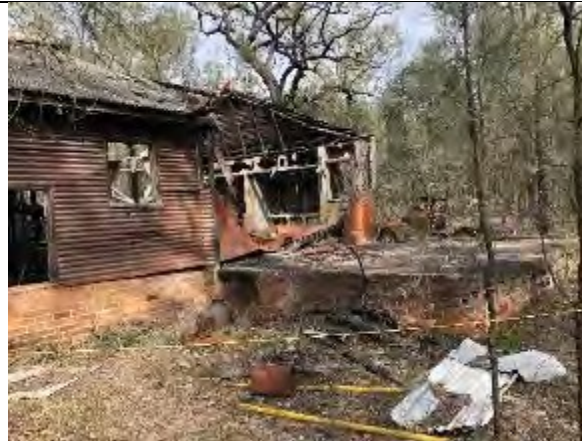
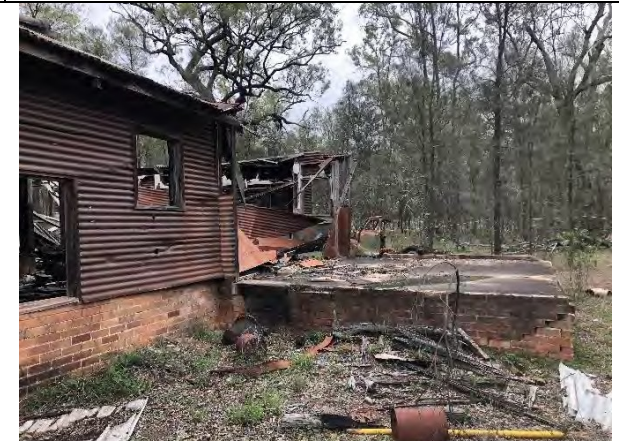
View to north-east elevation

2012-18: roof over open kitchen area has deteriorated, causing severe lean on far wall.

2018-20: top of far wall now collapsed.

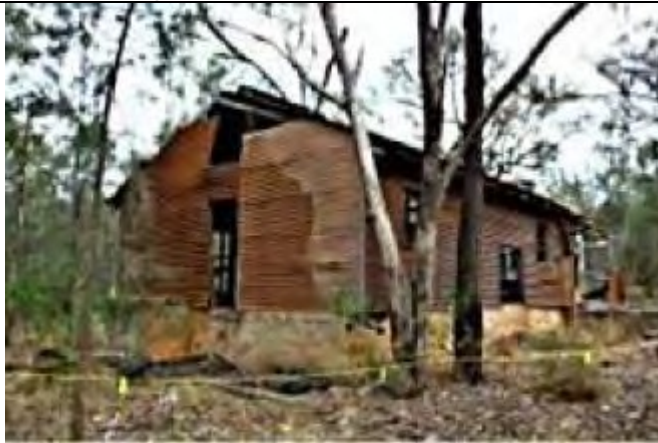
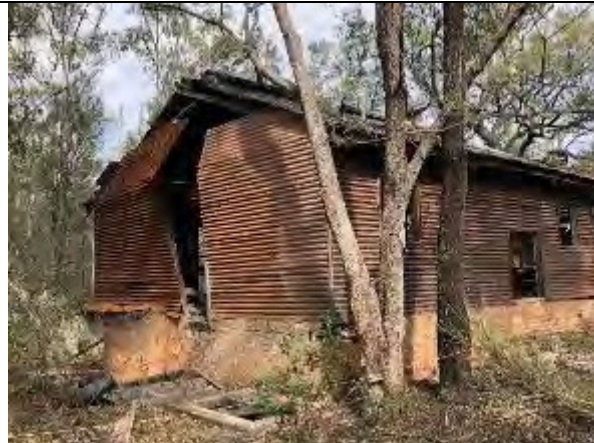
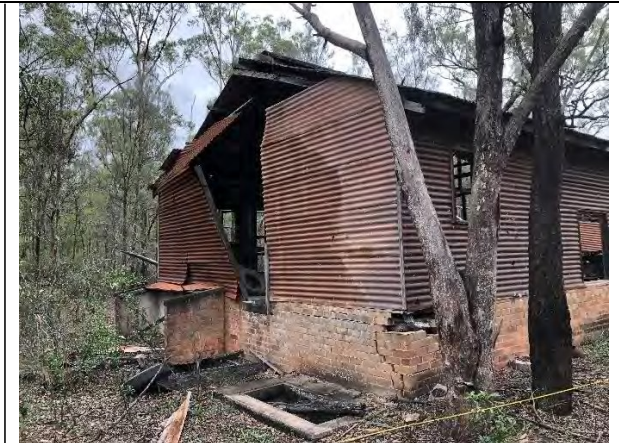
South-east elevation

2012-18: evidence of increased bow to southern wall.

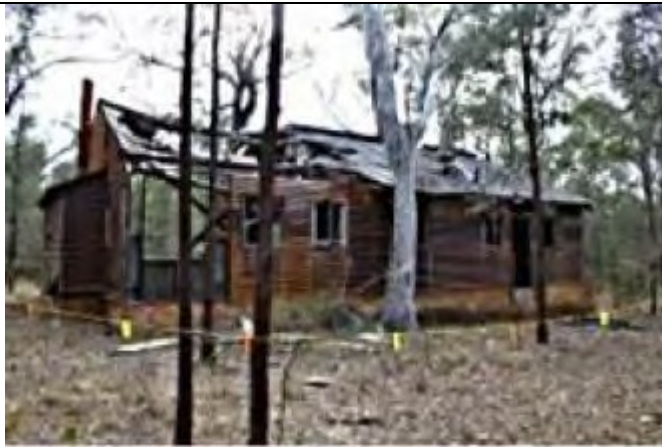
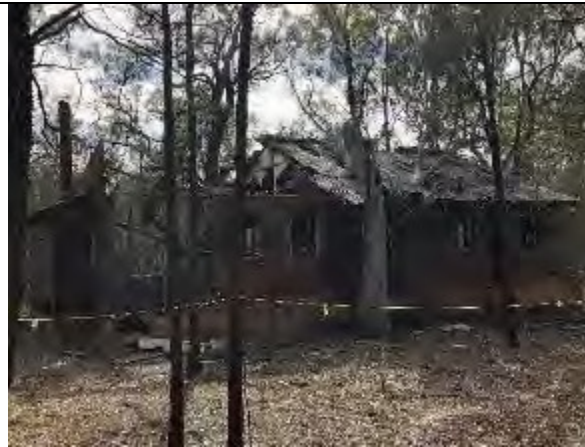
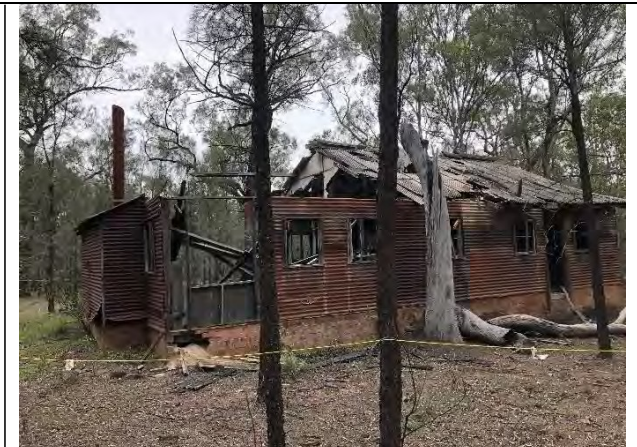
West elevation

2012-18: shows deterioration of roofing members above open kitchen area and leaning north wall, and further collapse of asbestos roof due to fallen dead tree.

2018-20: top of north wall now collapsed, further damage to roof with branch now fallen to ground.

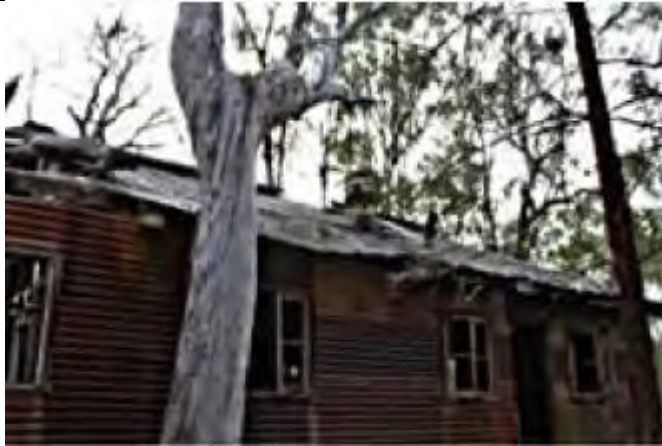
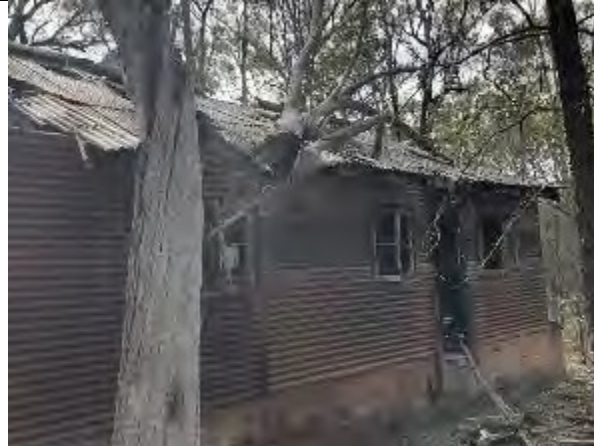
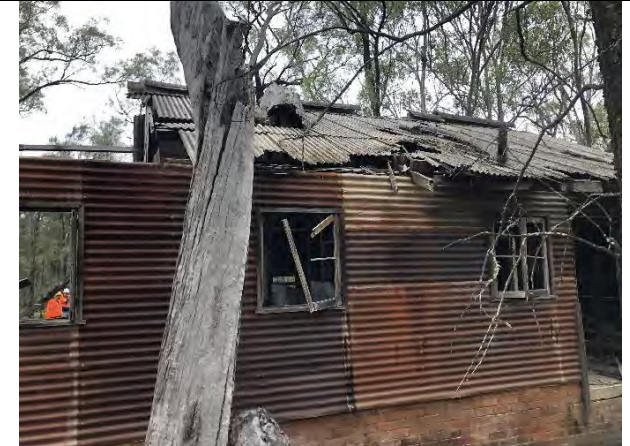
Showing cylindrical ventilator and damage to roof, view from west

2012-18: shows significant roof damage from fallen dead tree, including to ventilator.

2018-20: shows increased damage to roof sheeting from fallen branch.

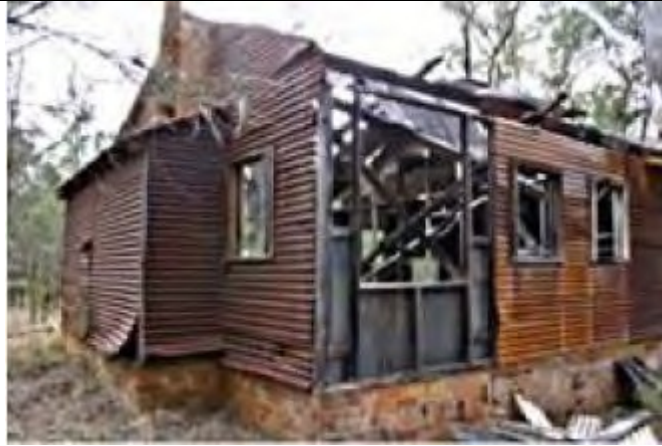
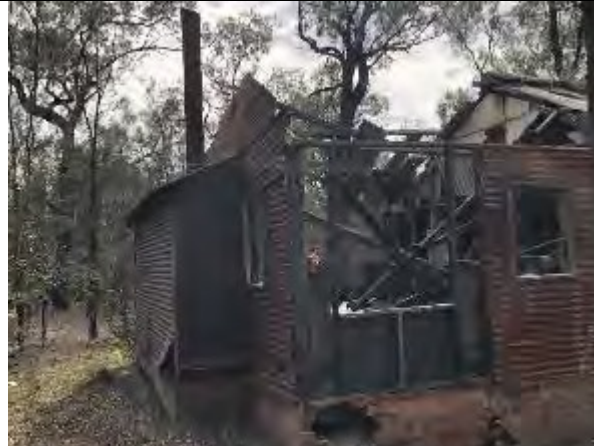
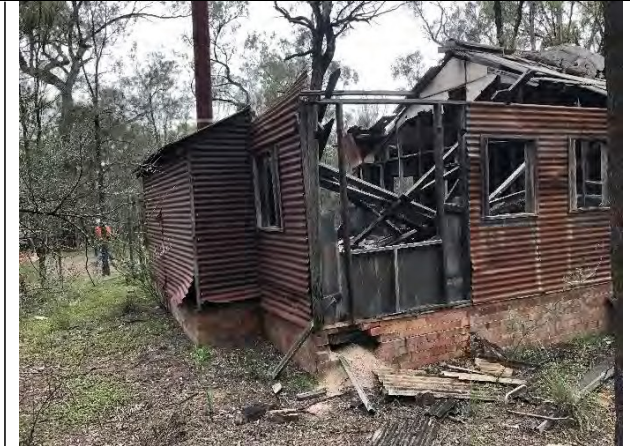
Detail of north-west elevation

2012-18: shows increased collapse over open kitchen area, as well as new damage to brick foundation at north-west corner.

2018-20: shows fallen top of north wall plus increased (animal?) damage to brick foundation at north-western corner.

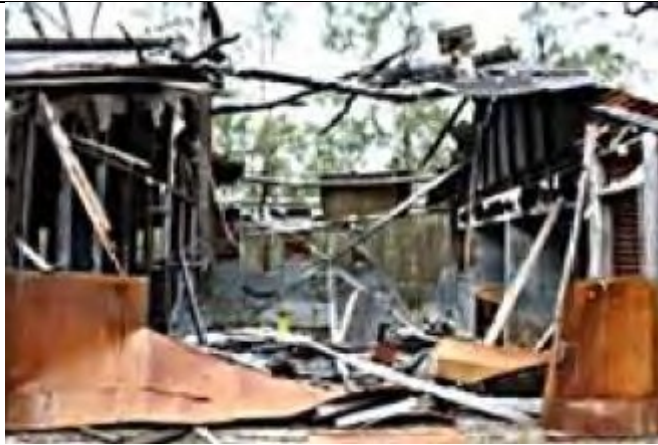
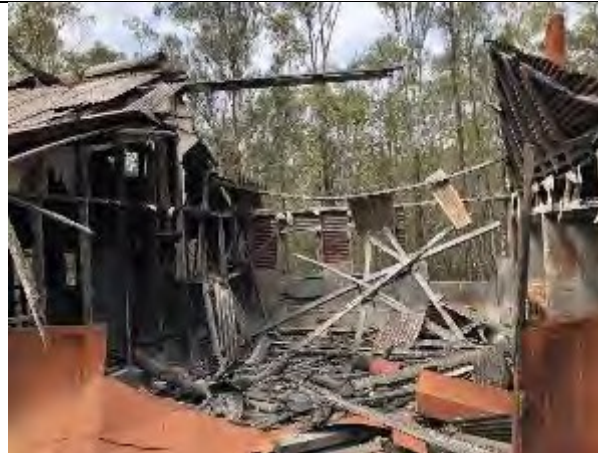
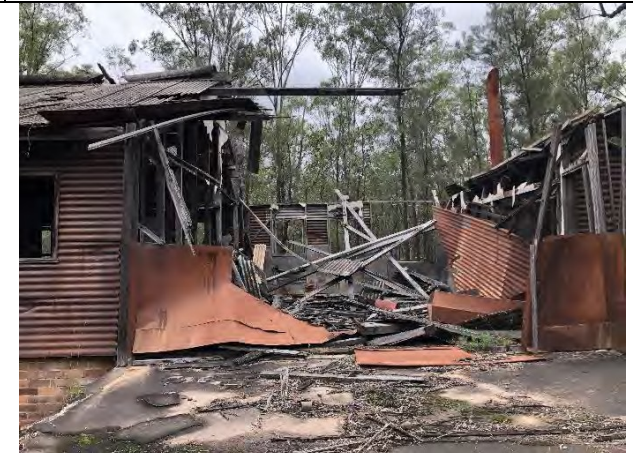
Showing interior damage at kitchen at north end of building

2012-18: shows increased collapse over and accumulation of debris within open kitchen area. Note also severe lean to north wall.

2018-20: shows collapsed top of north wall and collapse of remaining full cross-beam.

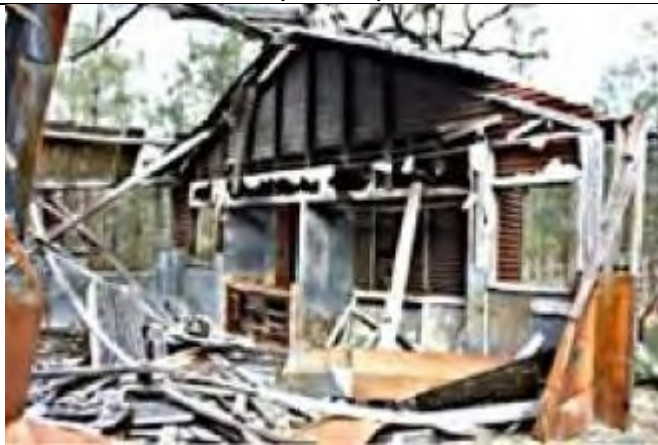
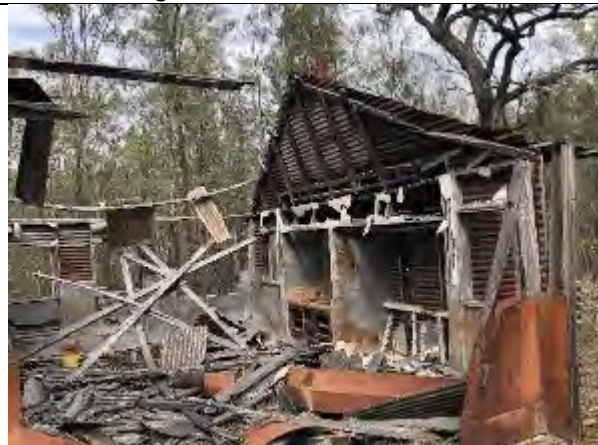
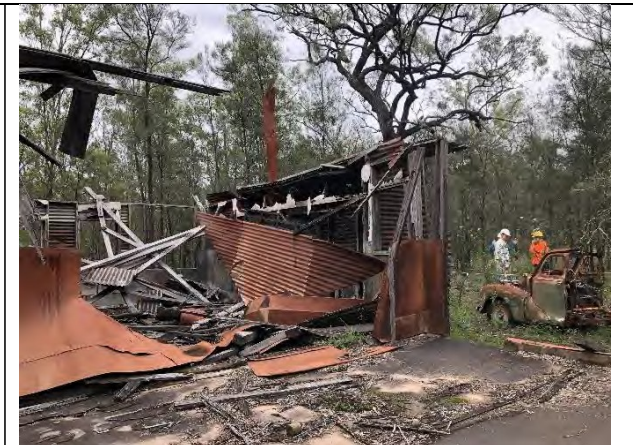
Showing interior damage at kitchen at north end of building

2012-18: shows increased collapse over and accumulation of debris within open kitchen area. Note also severe lean to north wall.

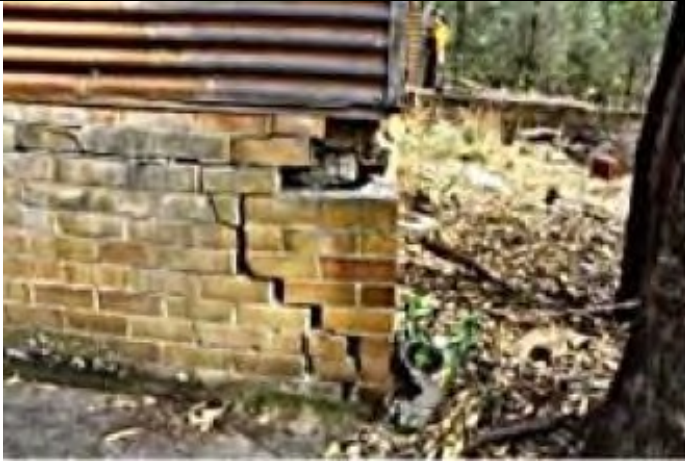
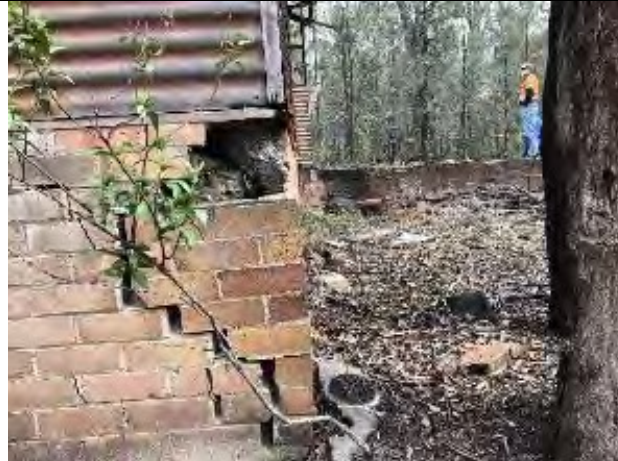
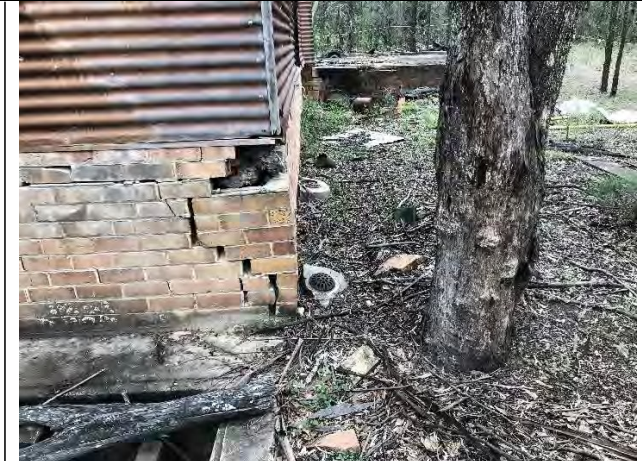
Damaged brick foundation at south-east corner
2012-18: no discernible increase to cracked brick foundation.
2018-20: further cracking of foundation (to left of shot) and some slumping of corner bricks.

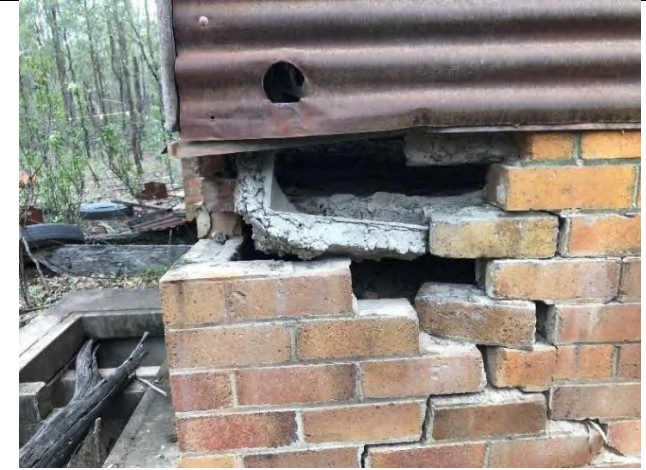
Detail of damaged brick foundation

2012-18: some further collapse of concrete/cement above brick foundation.

2018-20: some slumping outwards of corner brick foundation.

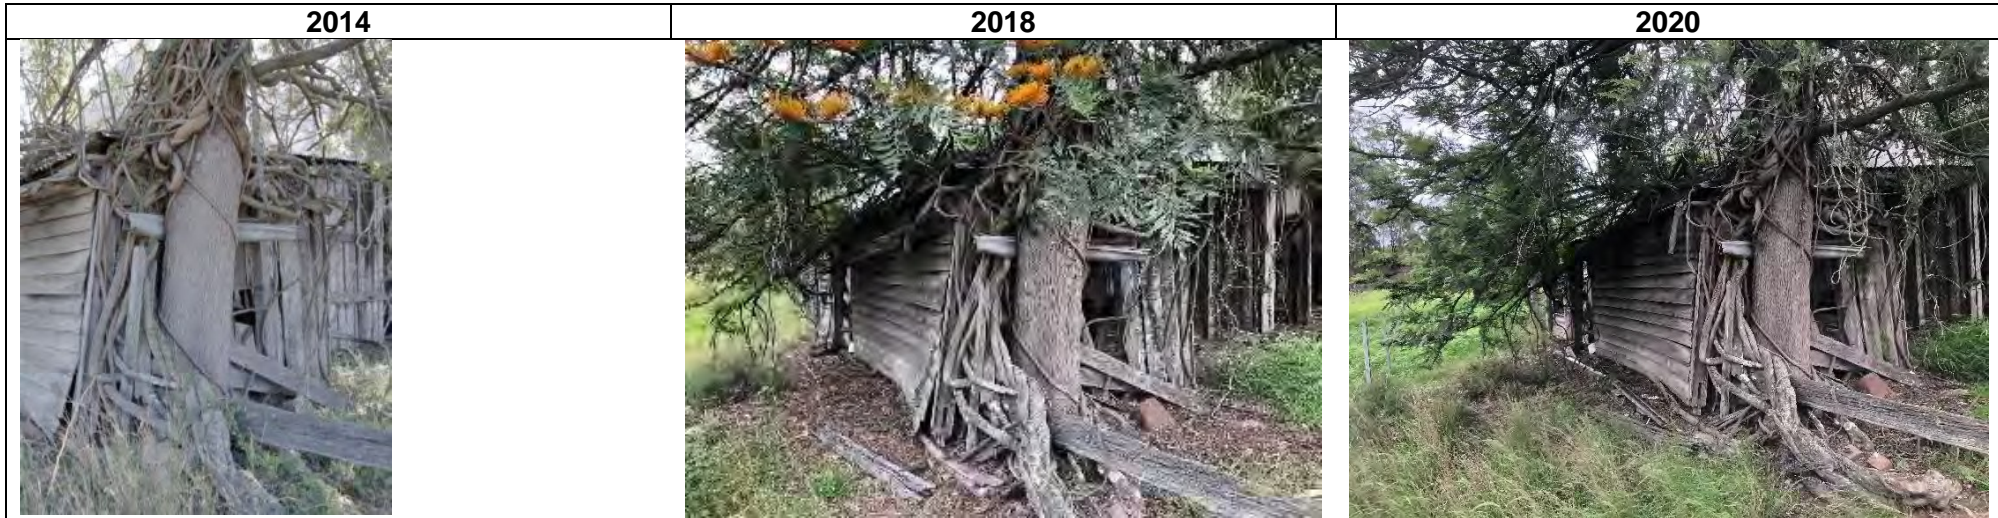
Looking towards south-west corner from south-west

2014-8: no discernible change to tree impact, but note missing vertical slabs from southern wall.

2018-20: no discernible change, but vine still growing.

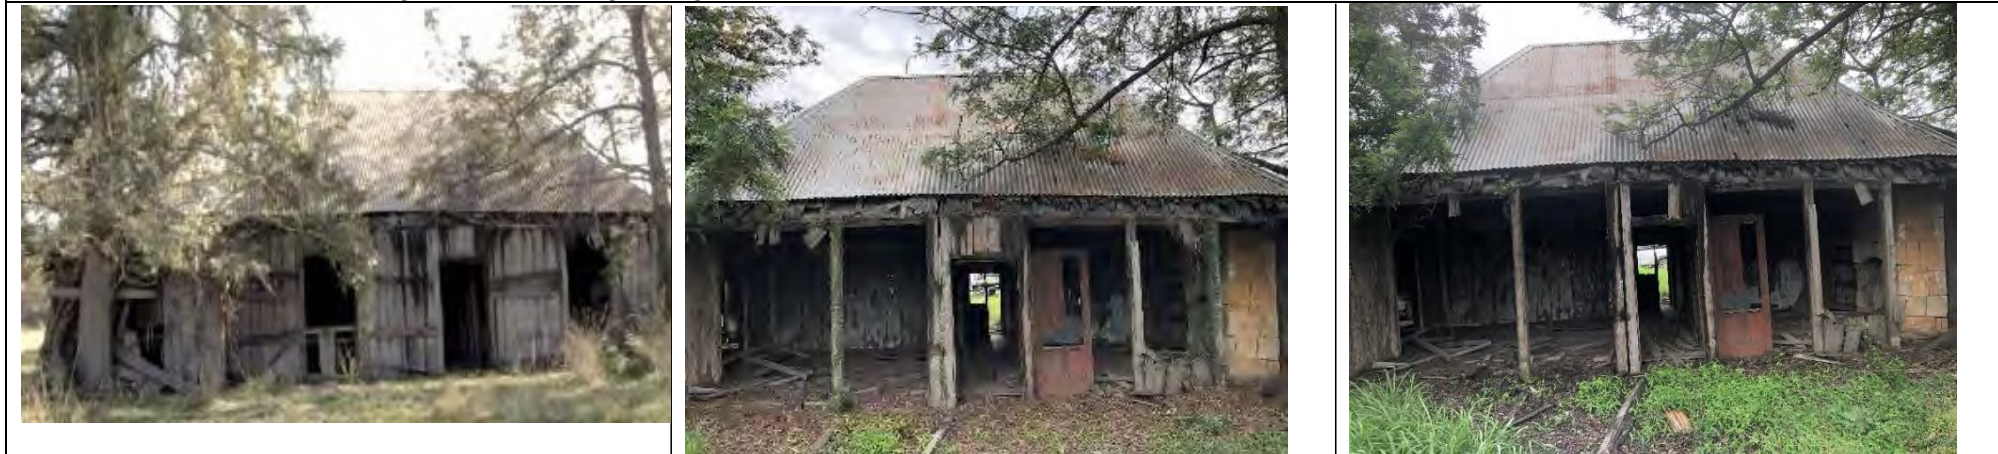
Southern elevation

2014-8: vertical timber slabs have been removed from southern wall.

2018-20: possible deterioration of shingles at roof edge, and missing panels from above back door.

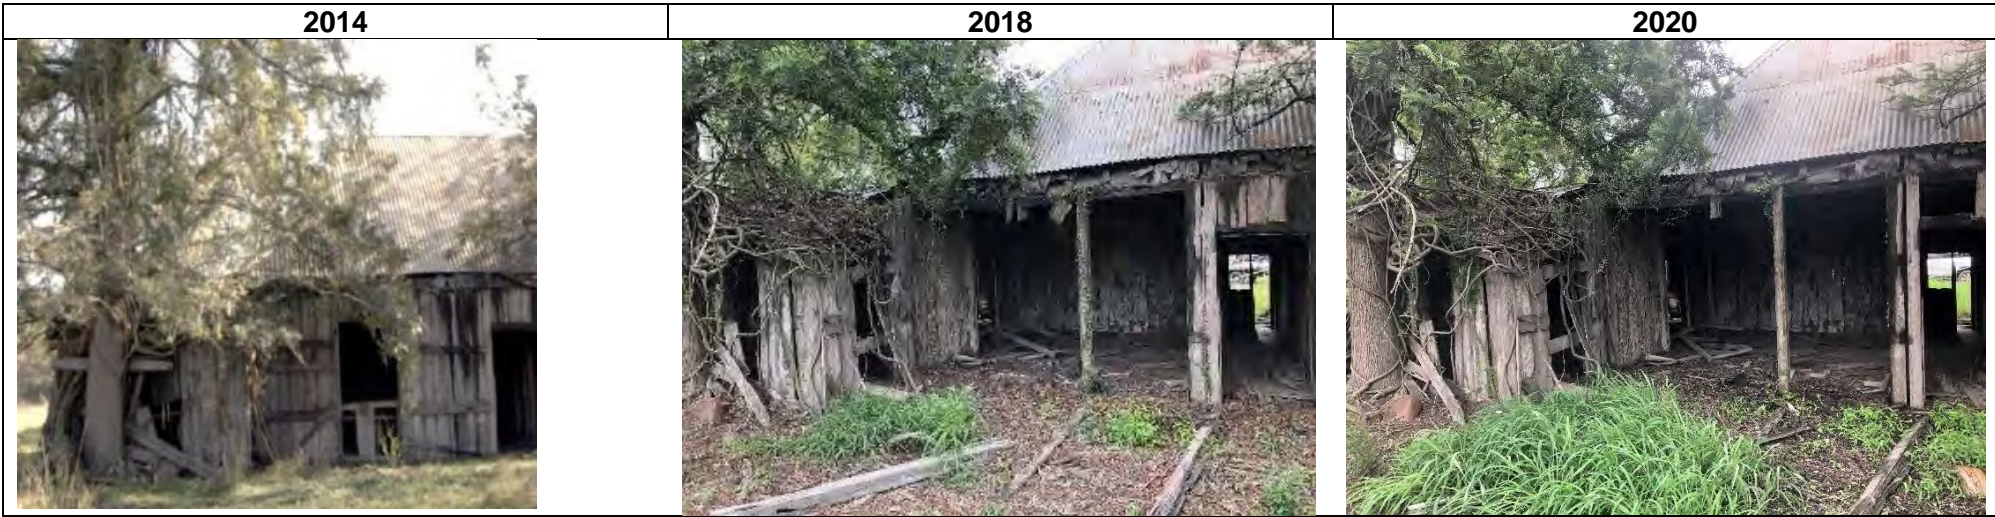
Southern elevation

2014-8: vertical timber slabs have been removed from southern wall.

2018-20: panels missing from above back door.

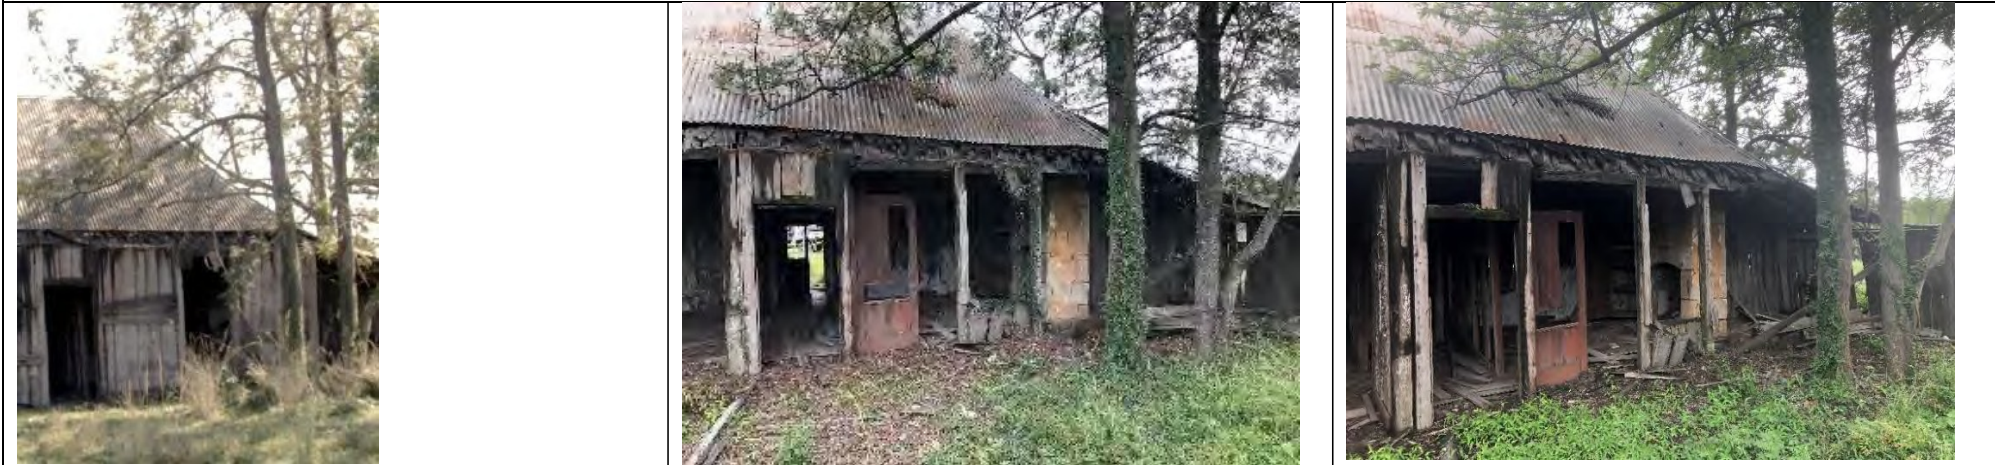
Southern elevation

2014-8: vertical timber slabs have been removed from southern wall.

2018-20: possible deterioration of shingles at roof edge, and missing panels from above back door.

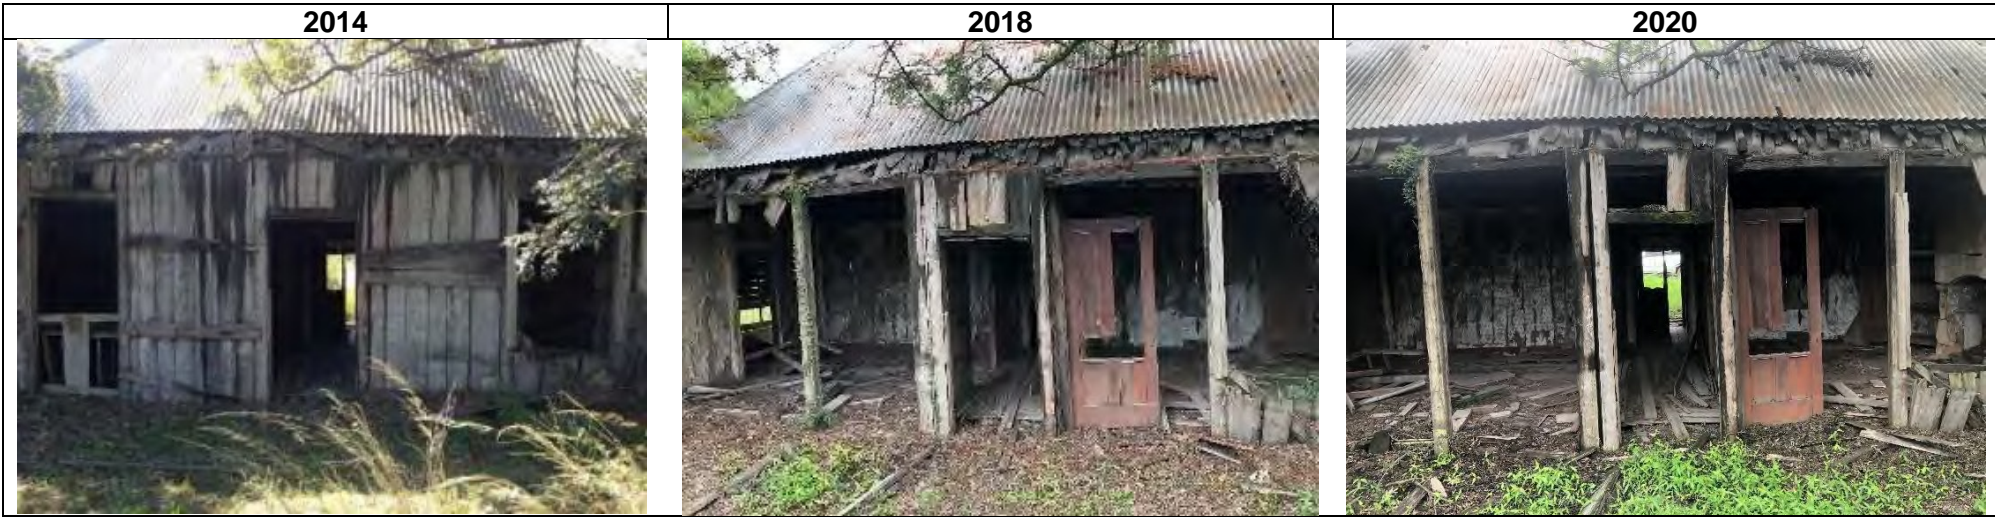
Southern elevation

2014-8: vertical timber slabs have been removed from southern wall.

2018-20: possible deterioration of shingles at roof edge, and missing panels from above back door.

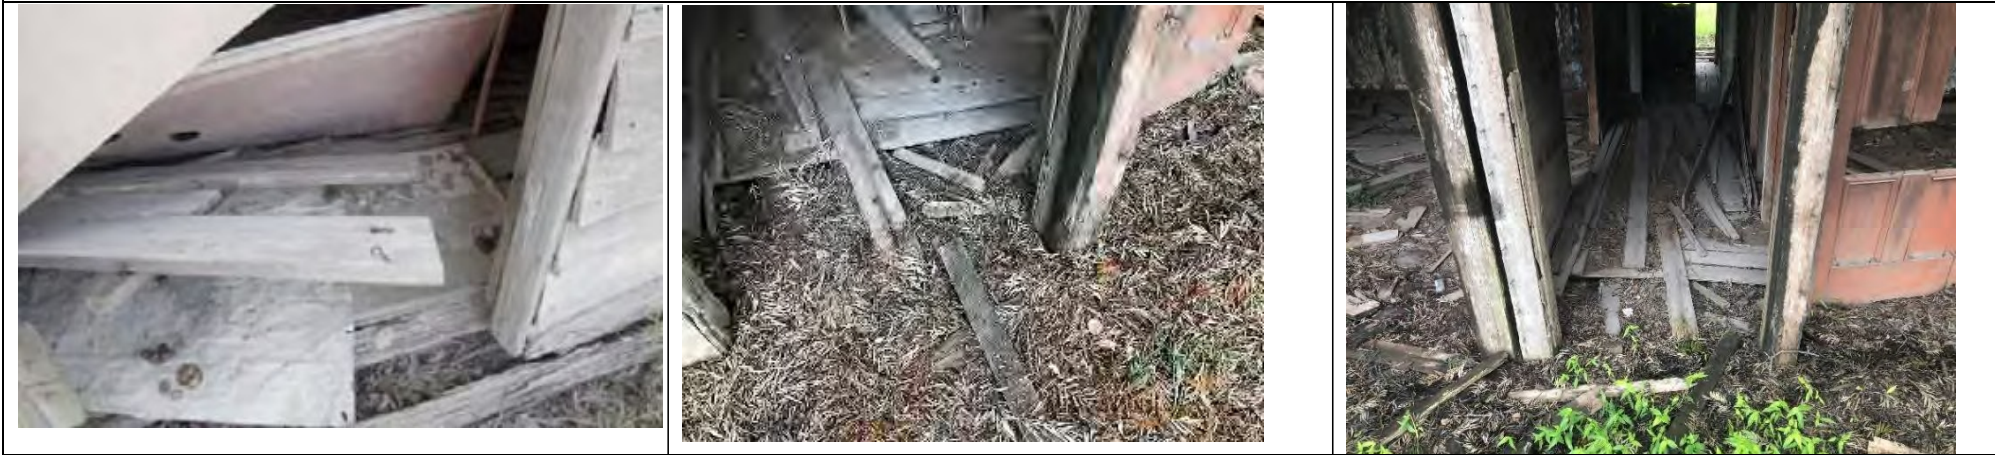
Southern elevation doorway

2014-8: door has been removed.

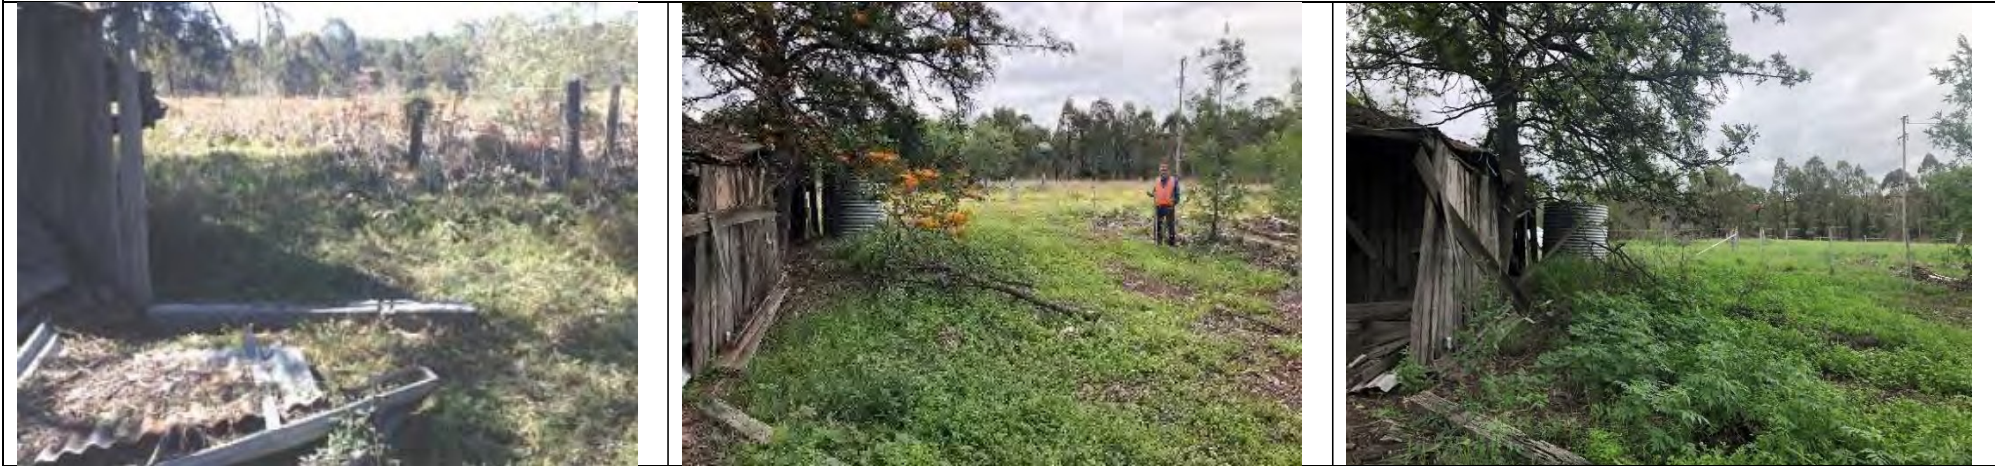
Eastern side

2014-8: debris has been cleaned and stored and a weed removal program conducted. The house area has also been fenced.

2018-20: further deterioration of eastern wall and regrowth of weeds.

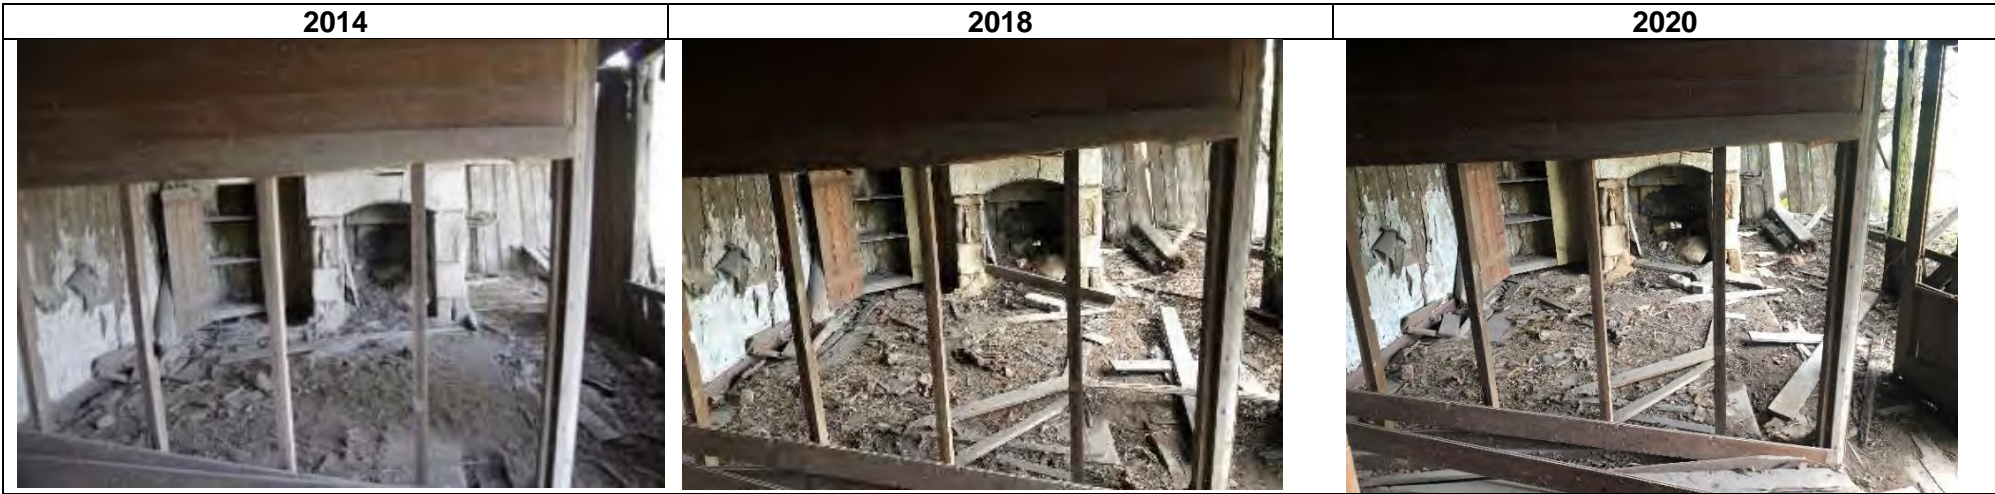
Room 2 interior

2014-8: increased debris caused by removal of southern wall.

2018-20: no discernible change.

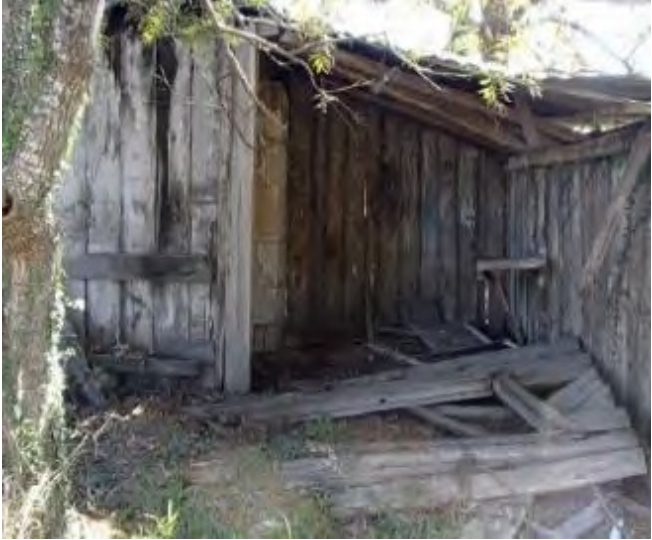
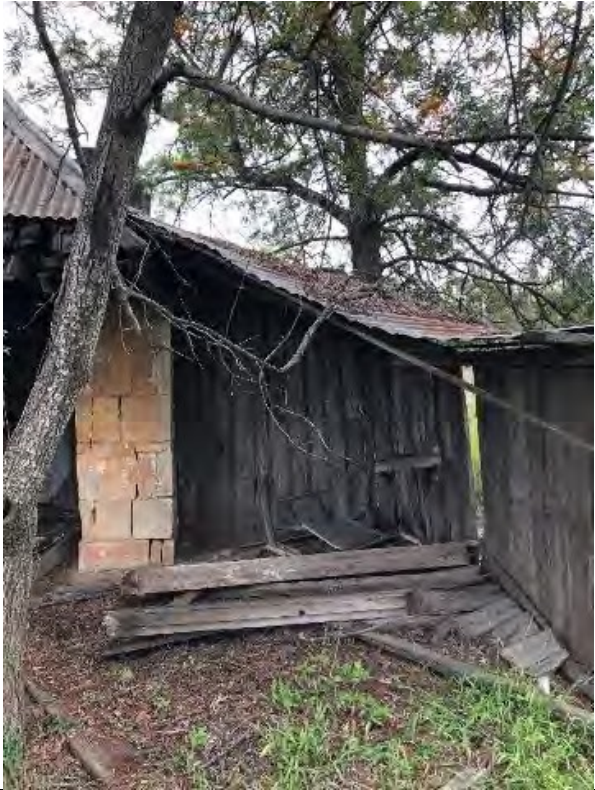
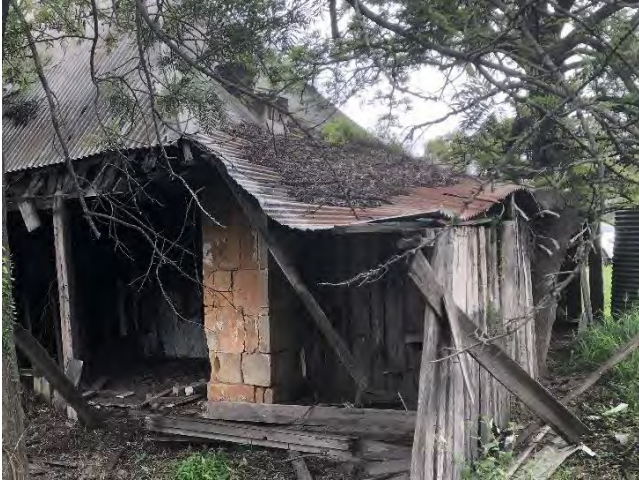
<p>South-east corner 2014-8: shows removal of vertical slabs from southern wall and further collapse of roof. 2018-20: further roof slumping and deterioration of eastern wall.</p>

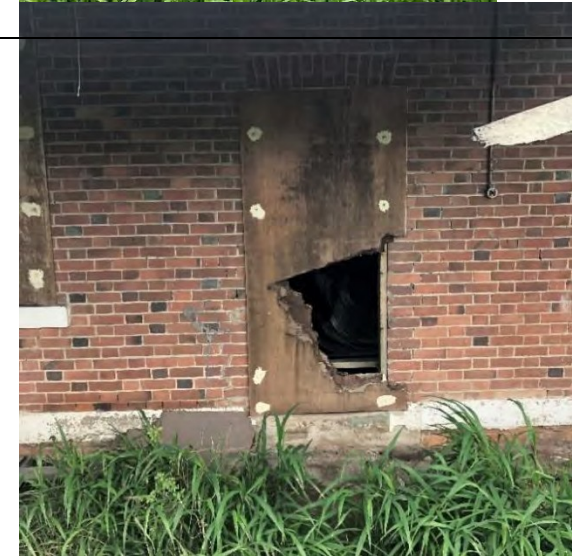
View of door and window panelling

2015-8: sheeting installed on all openings, however some repair required

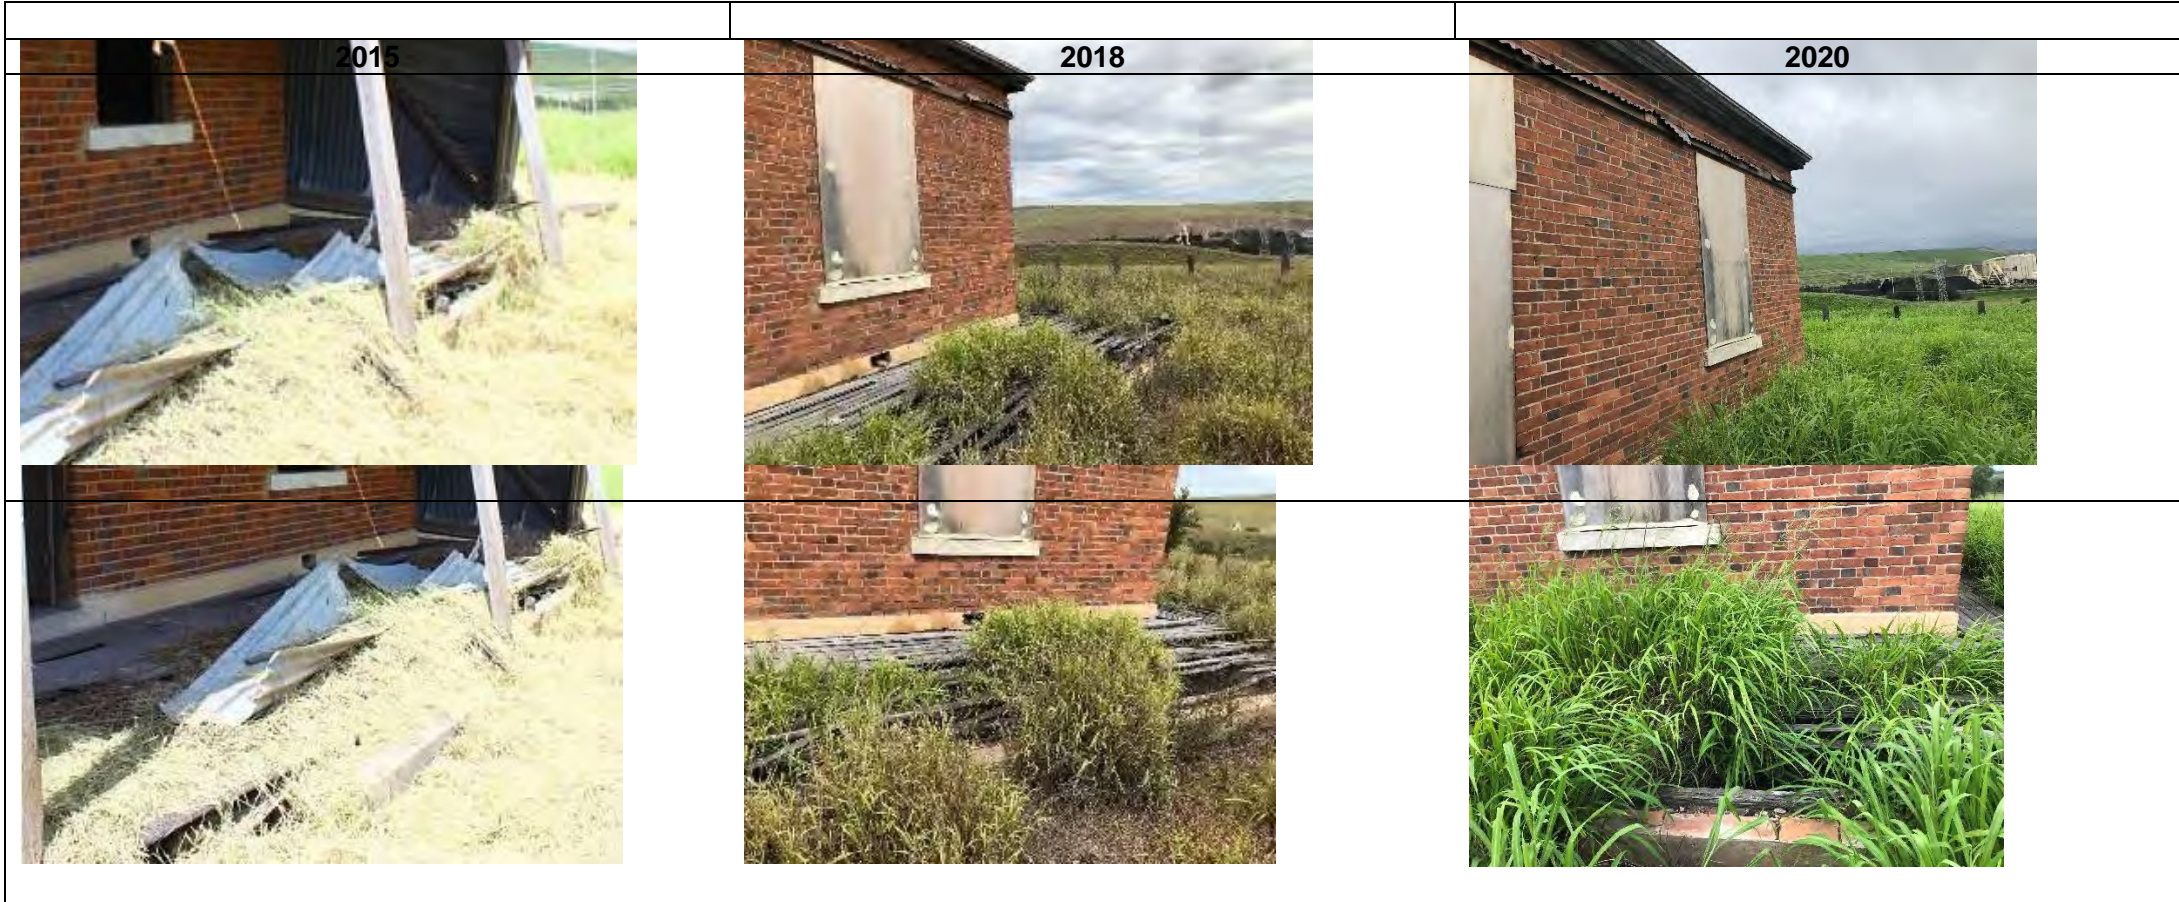
View of eastern verandah (focus on verandah floor)
2015-8: posts and sheeting removed, damaged boards remain exposed
2018-20: damaged boards remain and vegetation growth throughout

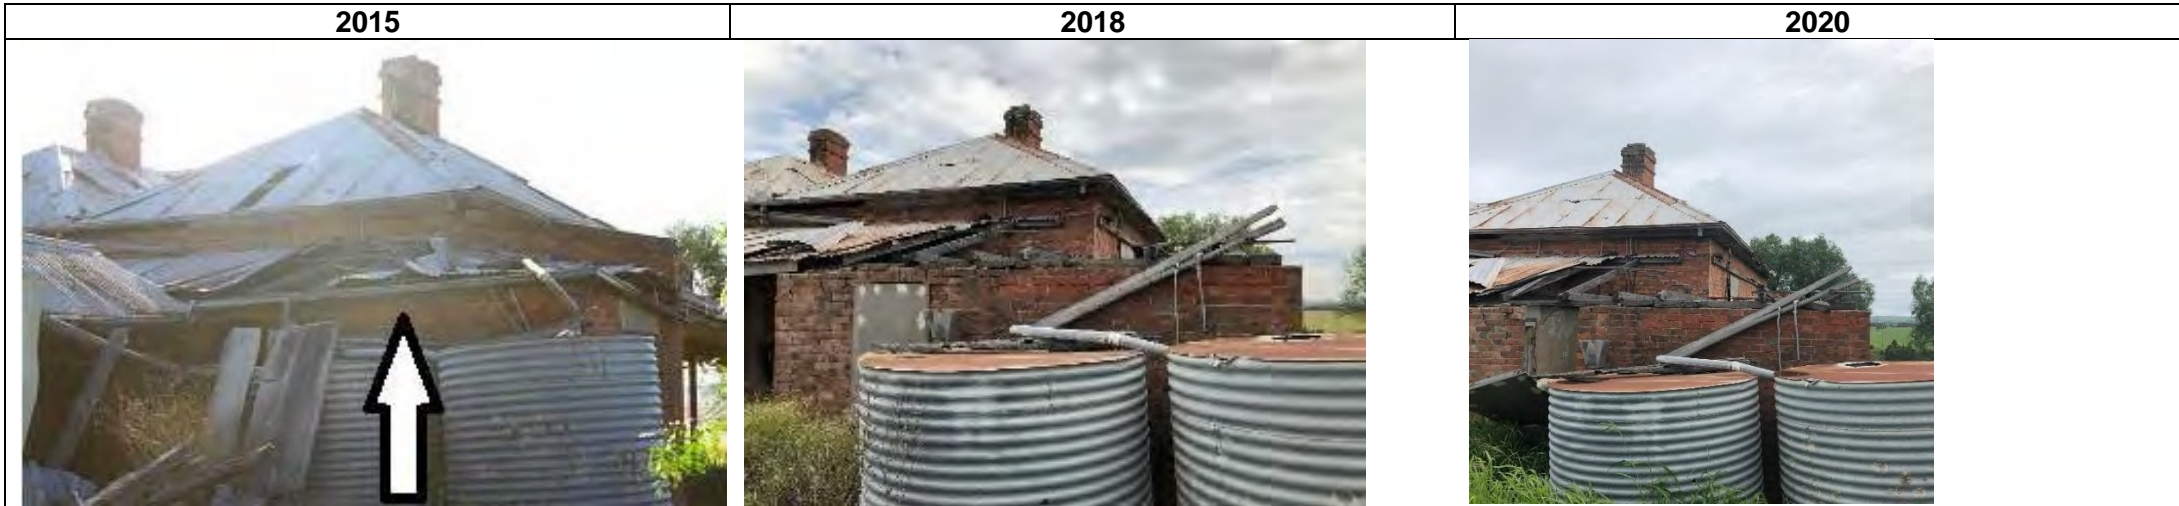
View of rear of building (focus on skillion roof)
2015-8: skillion roof and rafters have collapsed
2018-20: no discernible change

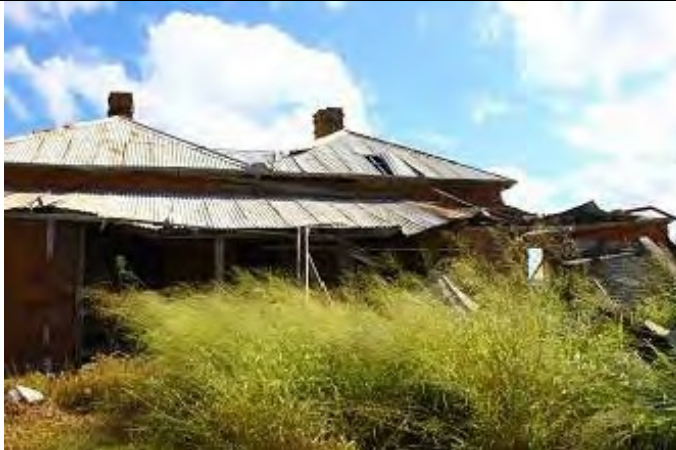
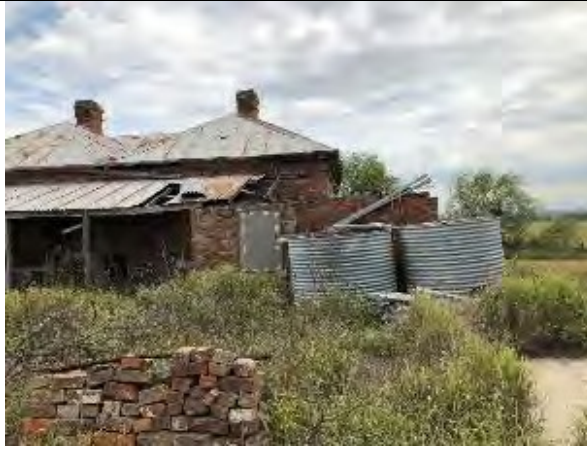
View of rear of building (focus on guttering)
2015-8: main roof holes repaired but northern section of skillion roof collapsed and guttering unchanged
2018-20: no discernible change, however vegetation regrowth evident
