Mount Thorley Warkworth Aboriginal Heritage Management Plan 2019 Compliance Audit Inspection

Report prepared for
Yancoal Australia, Mount Thorley Warkworth

March 2020

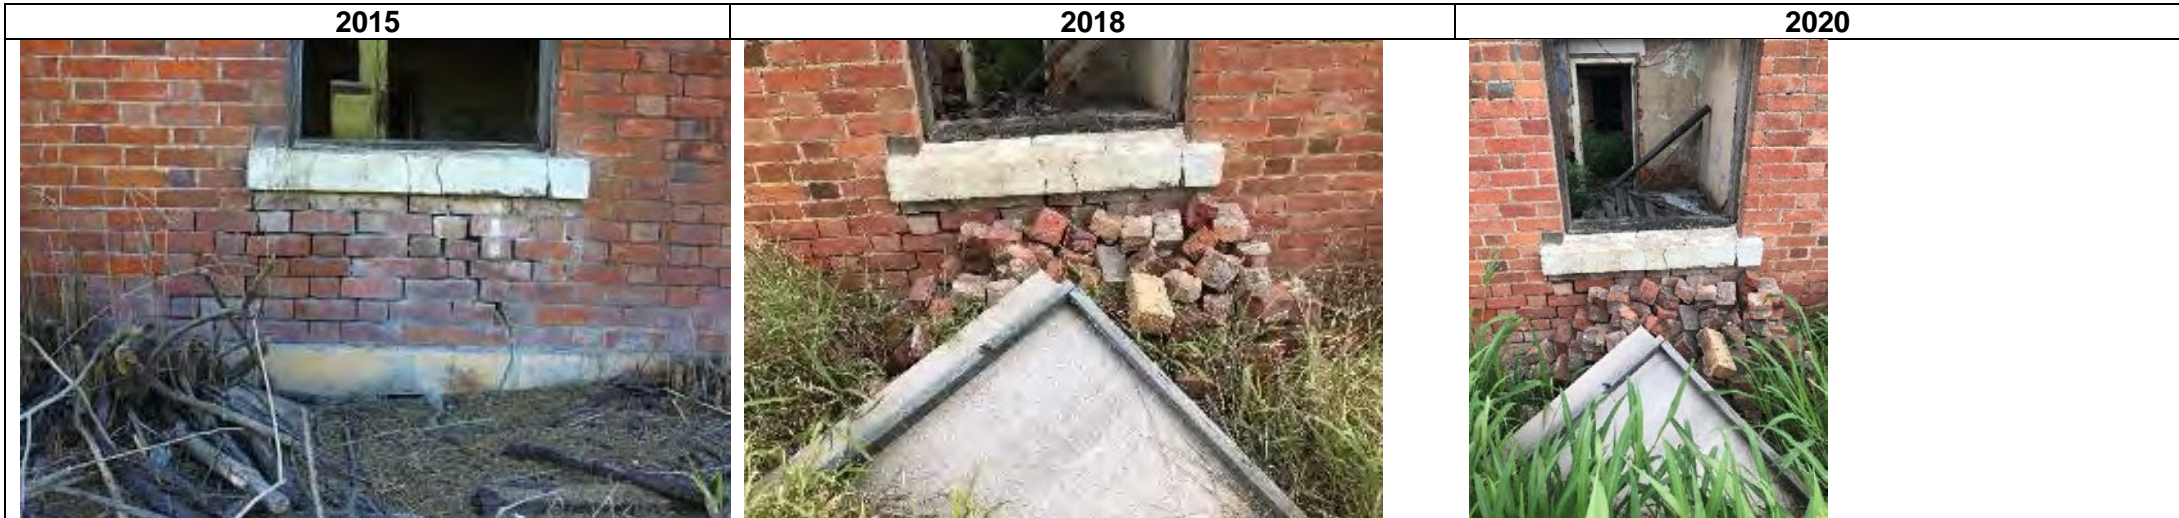
View of north-east corner of building (focus wall below window)
 2015-8: bricks from roof above stacked in front of required repointing, window sheeting removed
 2018-20: no discernible change

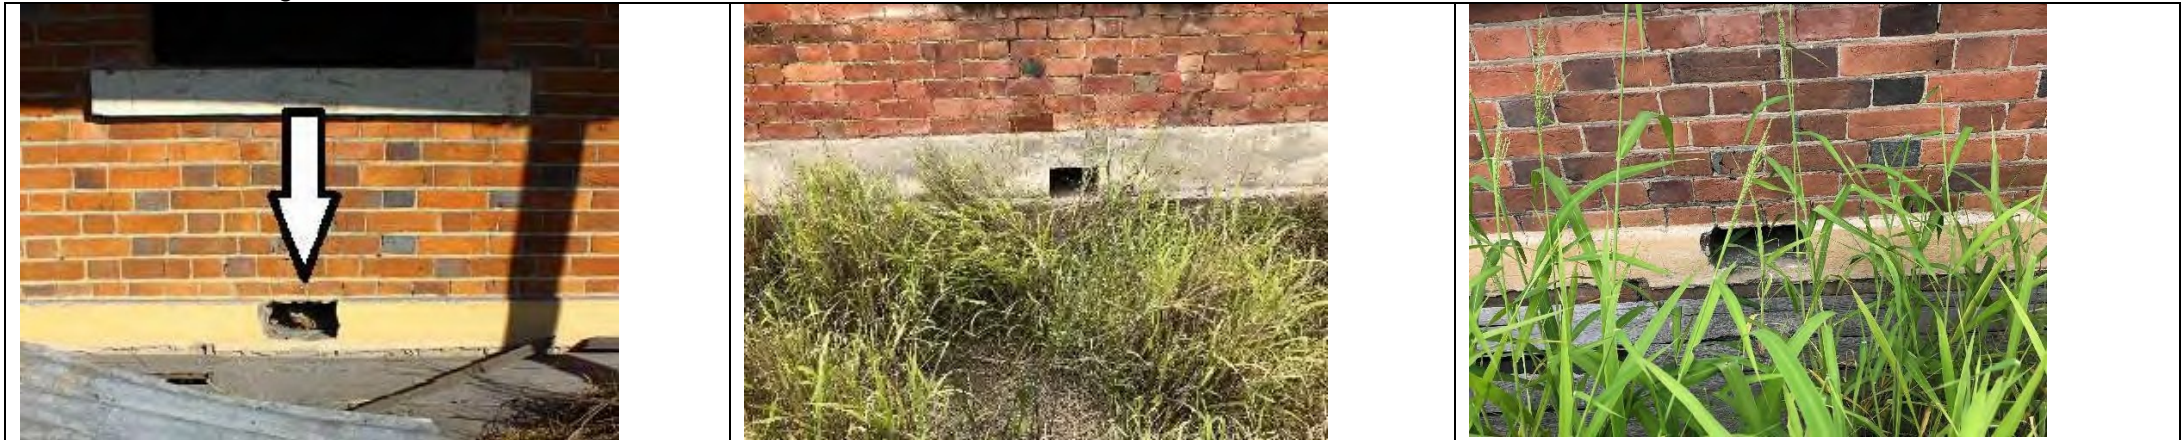
View of ventilation grilles

2015-8: grilles not replaced
2018-20: no discernible change
