2019 STREAM HEALTH AND STABILITY REPORT

Mount Thorley Warkworth

SLR Ref: 630.12941-R01
Version No: -v0.2
March 2020

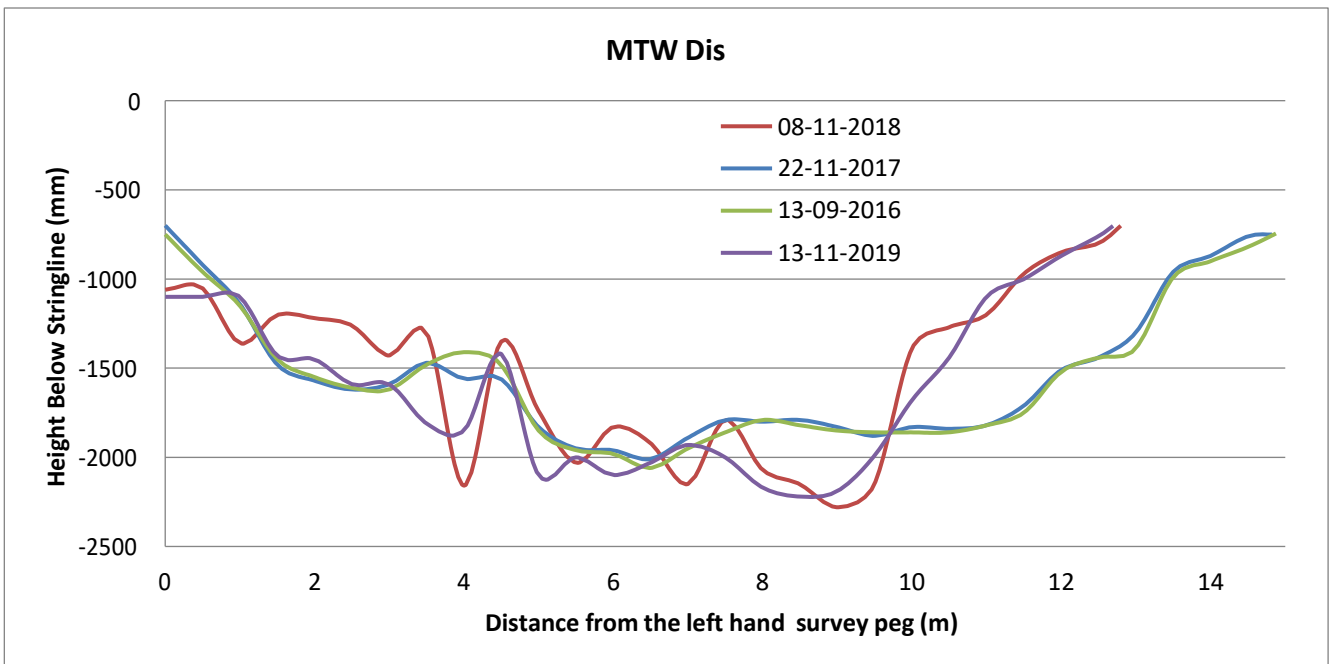
Figure 2 MTW Dis Transect Results

For the purpose of monitoring any changes to the creek, a creek line transect was established. The transect is shown in **Figure 2** and was taken from left to right looking downstream. It can be seen from this transect that the channel hasn't changed significantly since the previous monitoring cycle. It should also be noted that as part of the upgrade works, the peg on the left bank was removed which explains why this round of monitoring shows a shorter length of transect. Difference in the data appears to be within the expected transect accuracy tolerances, and it is not possible to discern if there has been bed erosion across at transect location.

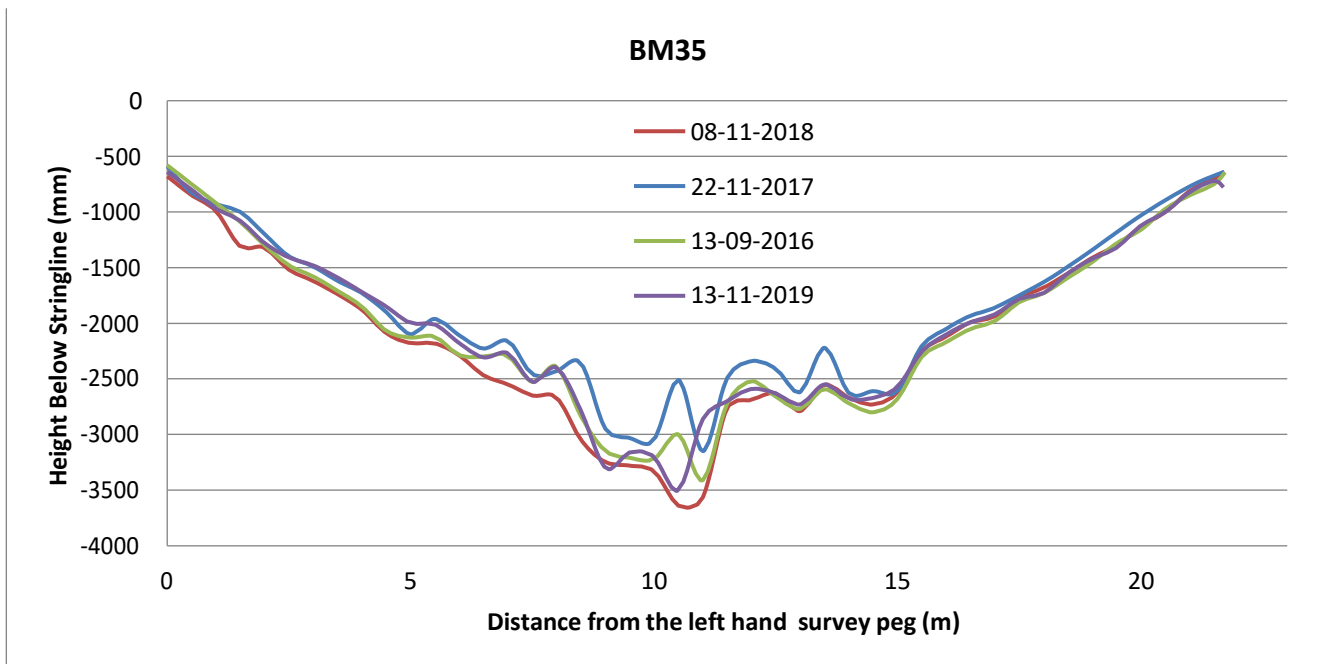
Figure 3 BM35 Transect Results

The channel at this location was observed to have a good coverage of long grass across the bed. The left bank also appears stable with good grass coverage. The right bank contains some lateral erosion (approximately 0.5m

high) at the top of the bank. The lateral erosion is forming some rill/gully erosion down this bank, however the rest of the right bank appears to be stable with good grass coverage. Overall, this location shows similar conditions to the previous monitoring cycle.

For the purpose of monitoring any changes of the creek, a creek line transect was established. The transect is shown in **Figure 3** and was taken from left to right looking downstream. It suggests that no significant scouring has occurred on the banks or creek bed since the previous monitoring cycles. Difference in the data appears to be within the expected transect accuracy tolerances.

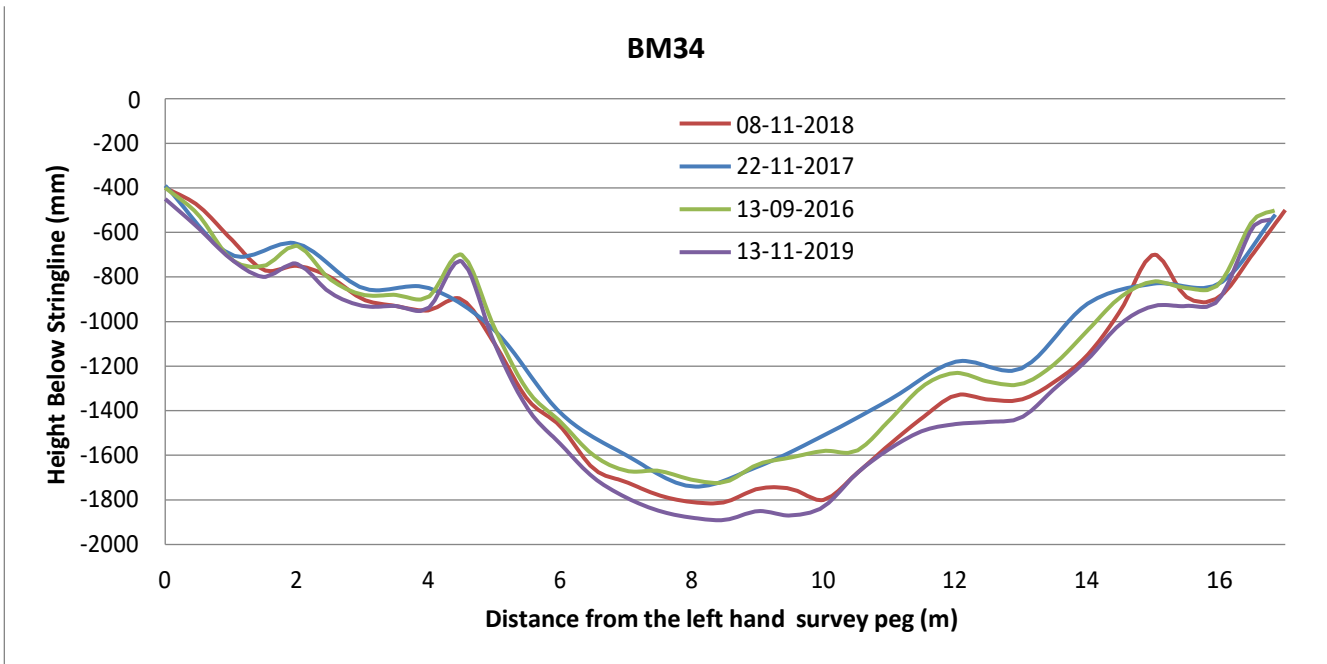
Figure 4 BM34 Transect Results

The creek bed at this monitoring point is covered by reeds and is stable. Both the left and right banks have good grass coverage and appear to be stable with gentle-moderate slopes. The creek upstream and downstream of the monitoring point also appears to be stable. The creek has a very slight meander at this monitoring point. Overall this location has remained the same as the previous monitoring cycle conditions.

For the purpose of monitoring any changes of the creek, a creek line transect was established. The transect is shown in **Figure 4** and was taken from left to right looking downstream. It suggests that no significant scouring has occurred on the banks or creek bed since the previous monitoring cycles. Difference in the data appears to be within the expected transect accuracy tolerances at most locations. The data also suggests that across the bed and right hand bank it is likely that there has been erosion over the past 3 years.

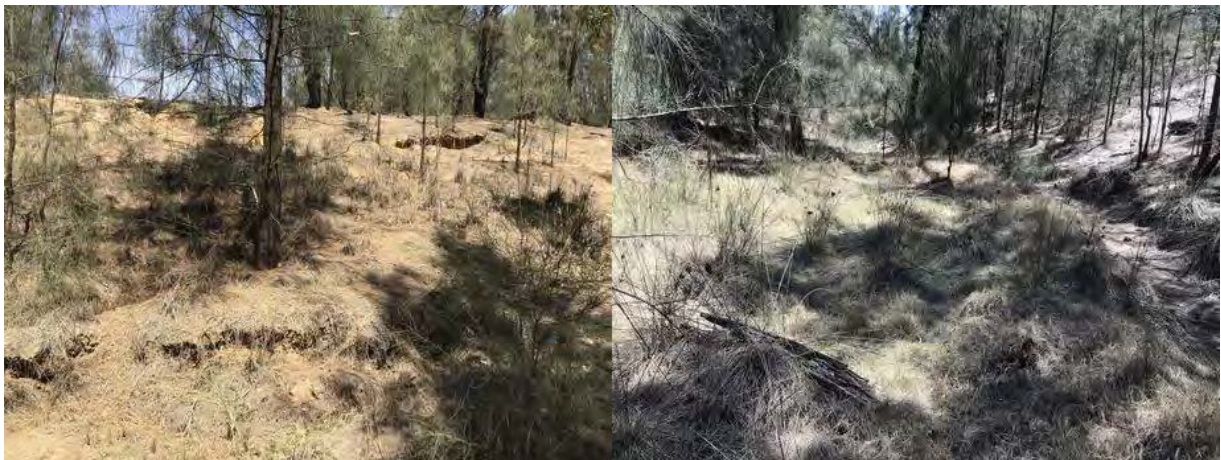
Plate 41 Right Bank

The erosion observed at LC7 included an area of active erosion of a steep comprising exposed dispersive clay material (approximately 0.8m high) on the right bank, however this erosion is not laterally extensive. The erosion appears to have been caused by lateral flow across the bare banks in the area. The right bank appears to be stable downslope of the eroded area, as does the creek bed and the left bank. Overall, this monitoring location has shown similar conditions to the previous monitoring cycle.

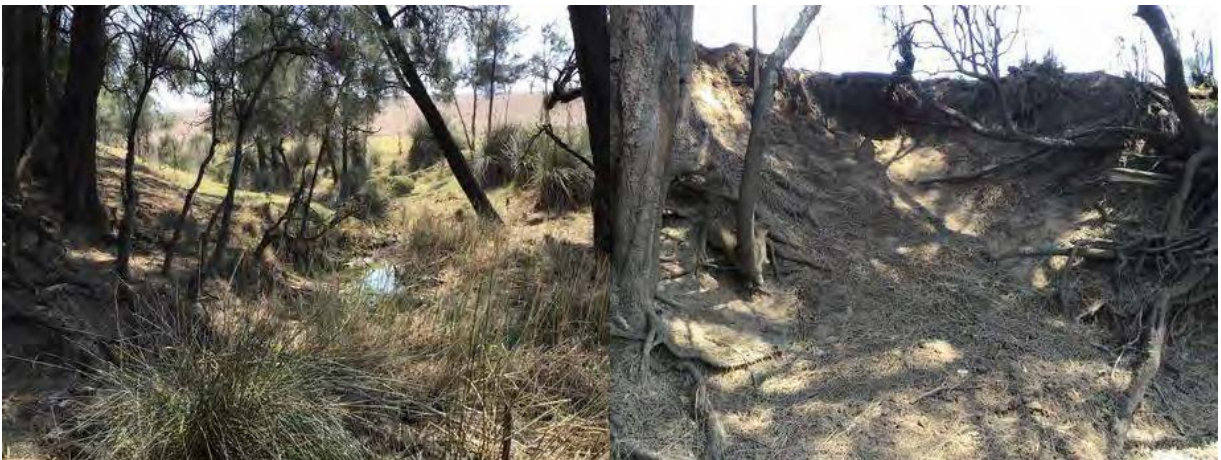
Plate 48 Downstream

The erosion observed at LC8 included significant erosion of the left bank (approximately 0.8m high with the overall bank at approximately 2.5m high) at a location with a slight meander in the creek as shown on Plate 57. The erosion has some minor undercutting with a section of vertical banks partly stabilised by tree roots. The soil appears to be alluvial and not particularly dispersive. Trees at this location are at risk of falling over due to loss of support. The creek bed and right bank appear to be stable. Overall, this monitoring location has shown similar conditions to the previous monitoring cycle.

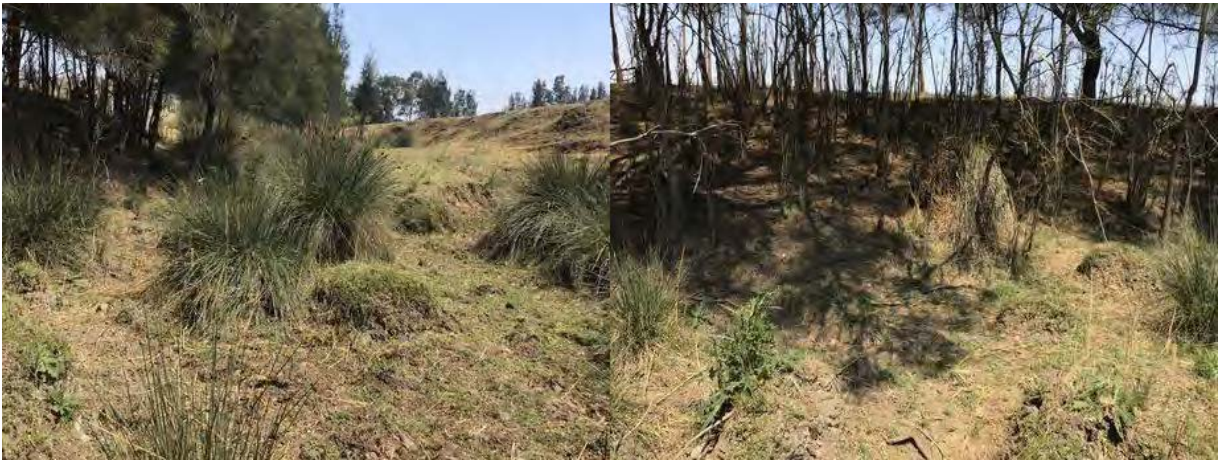
Plate 52 Downstream

The erosion observed at LC9 included some loss of exposed slightly dispersive material on the right bank which may have been caused by livestock in the area. This bank is about 2m high and has about 0.8m of exposed soil. The area appears to be stabilising. The creek bed and the left bank appear to be stable. Overall, this monitoring location has shown similar conditions to the previous monitoring cycle.

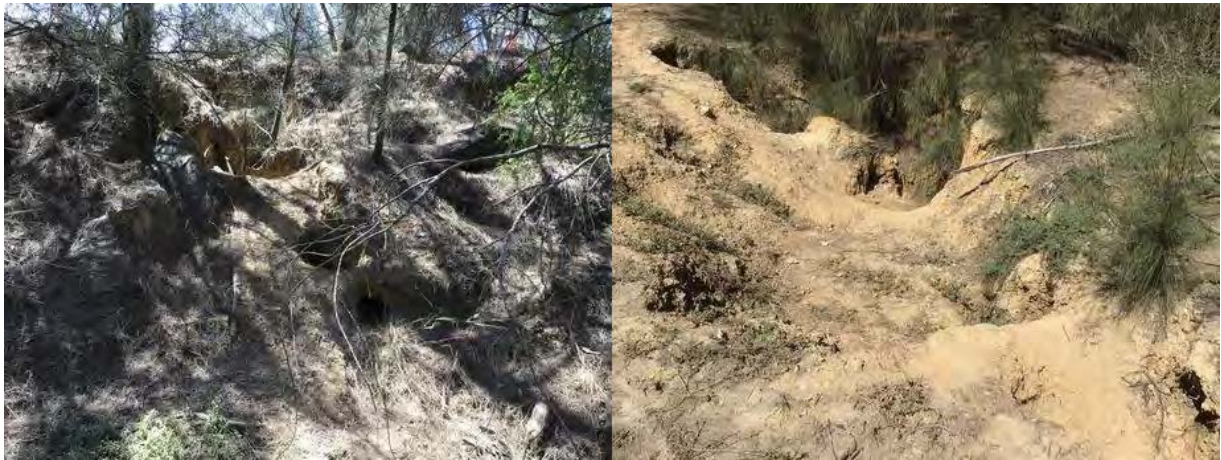
Plate 60 Erosion

The erosion observed at LC11 includes some significant tunnelling and active erosion on the left bank with exposed vertical dispersive soil. Potential causes for this erosion include wombat holes as well as the presence of a contour bank overflow (which is located immediately upslope of the erosion). Trees were observed on both banks and creek bed. The creek bed and the right bank both show stable conditions. Overall, this monitoring location has shown similar conditions to the previous monitoring cycle.

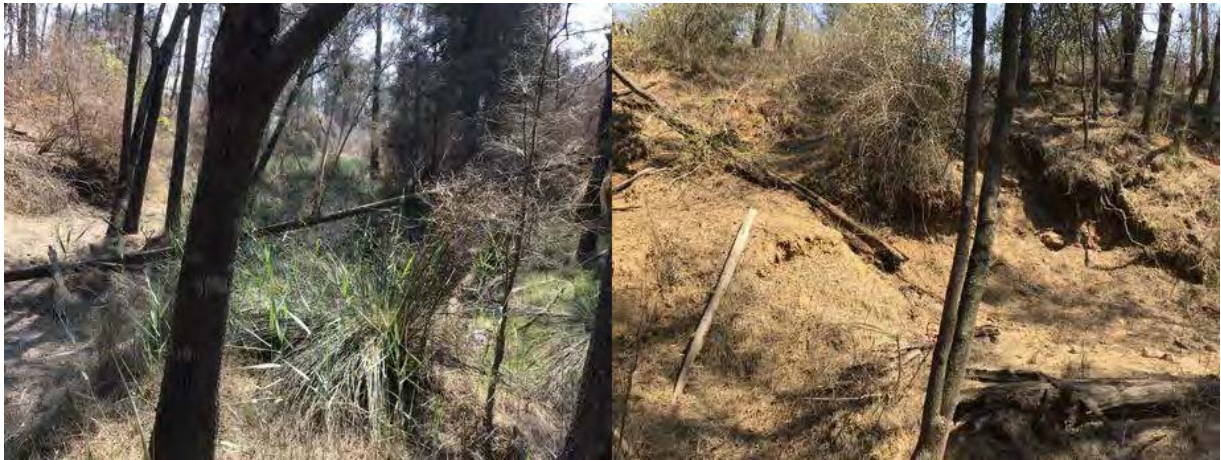
Plate 64 Downstream

The erosion observed at LC12 includes some erosion (approximately 2m high) on the left bank with exposed vertical dispersive soil. It is likely that this erosion was at least partially caused by a fallen tree at the monitoring point location. The left bank at the monitoring point is significantly higher than the right bank. The creek bed and the right bank both show stable conditions. Overall, this monitoring location has shown similar conditions to the previous monitoring cycle.

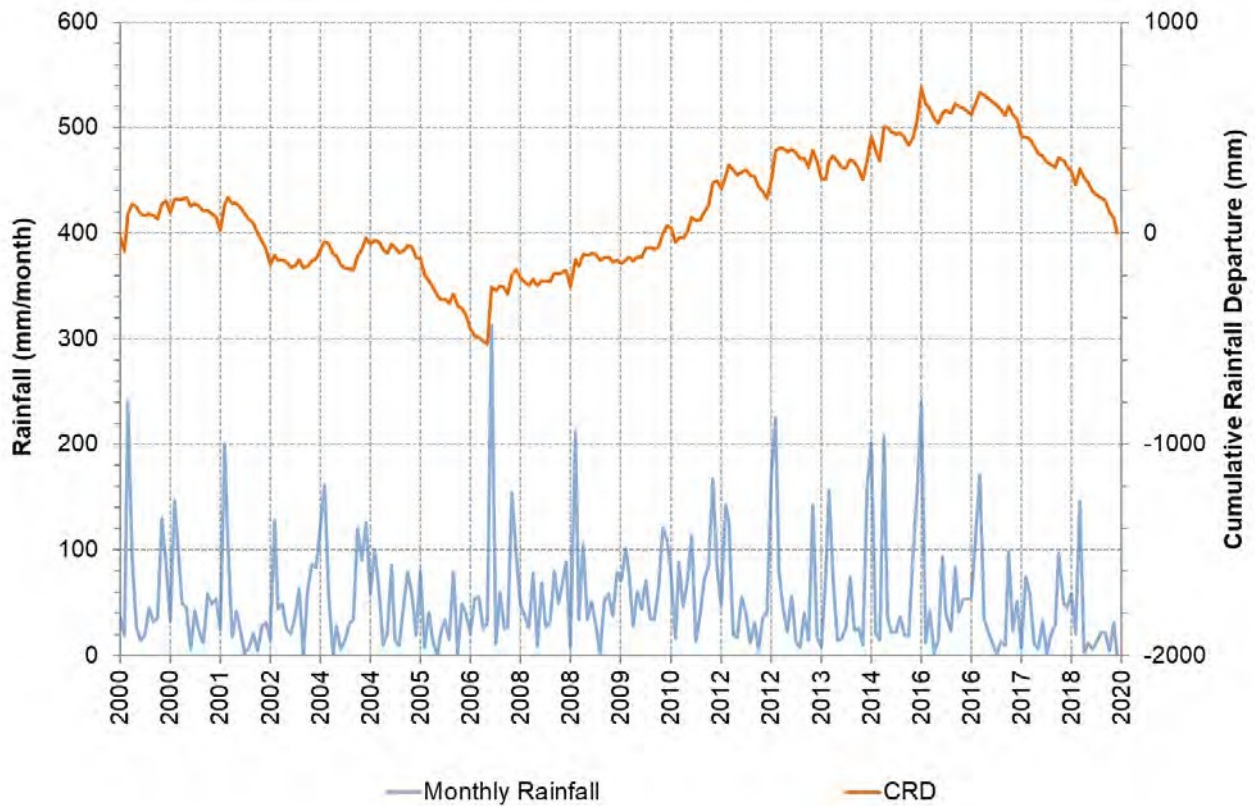
Figure 3-1 Cumulative Rainfall Departure and Monthly Rainfall

As shown in **Figure 3-1**, the region has generally experienced below average rainfall from 2016. Over 2019 rainfall was well below historical average for all months, except for March where 145.6 mm of rainfall was recorded, which was 78.9 mm above average.

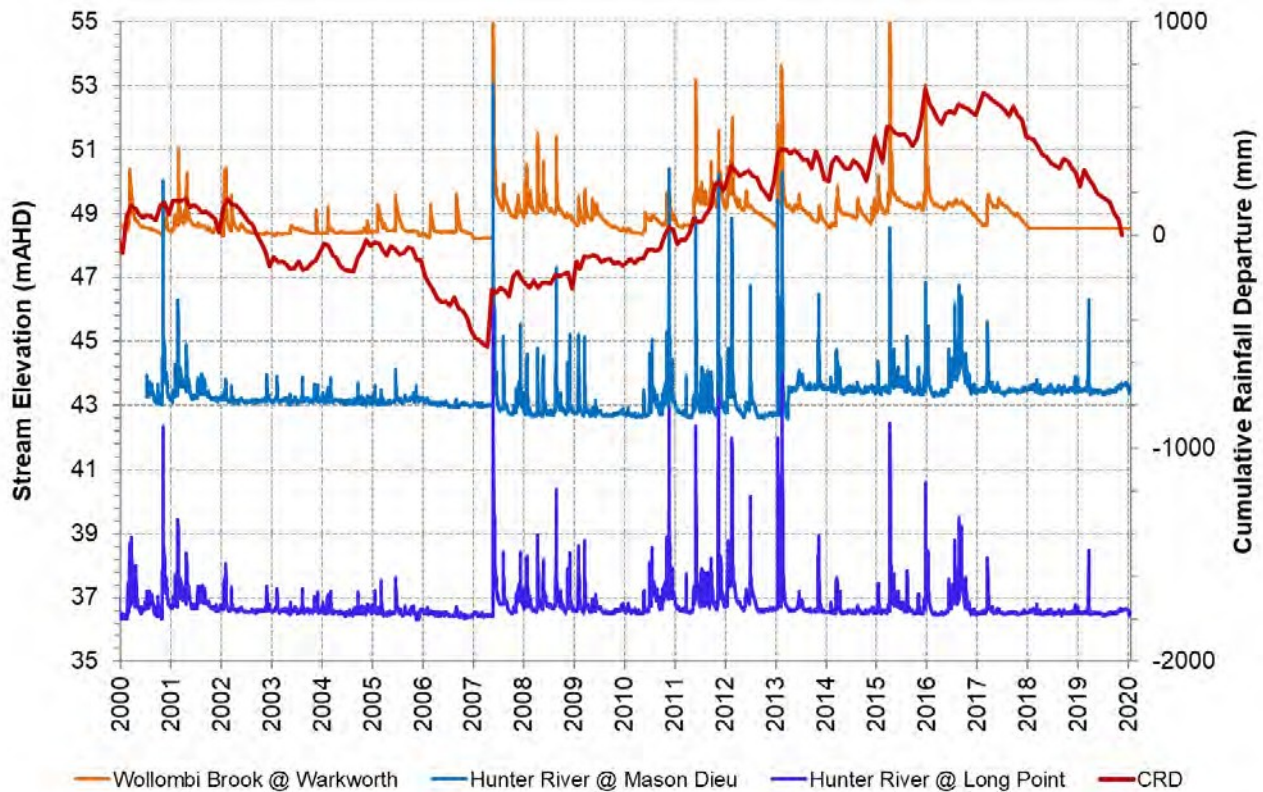
Figure 3-2 Surface Water Levels

As shown in **Figure 3-2**, over 2019 stream elevations within the Hunter River remained stable ranging between 36.43 mAHD and 38.49 mAHD at Long Point and between 43.32 mAHD and 46.32 mAHD at Mason Dieu. Glenbawn Dam is located approximately 135 km upstream of the project area. Daily regulated releases of the dam storage are undertaken to maintain flow and environmental quality of the Hunter River. Given the low rainfall recorded over 2019, the consistent elevations observed at both gauging stations are likely to be largely due to these storage releases. This is supported by the spike in elevation seen in April 2019 in contrast to the negligible rainfall (3.4 mm) recorded over the same period.

Figure 3-2 shows that over 2019, stream elevations within Wollombi Brook were recorded consistently at 48.5 mAHD. The zero gauge for Warkworth station (Station 210004) is 47.755 mAHD, meaning that water levels were recorded above the zero gauge over 2019 at 0.78 m. The stability of the water level over 2019 suggests pooled water has been measured rather than changes in stream elevations. Time series data of total rainfall against discharge volumes for Wollombi Brook is presented in **Figure 3-3**. The graph shows that since August 2017 no discharge volumes have been recorded within the brook, suggesting that that over 2019 Wollombi Brook did not flow, which is consistent with the observed water levels.

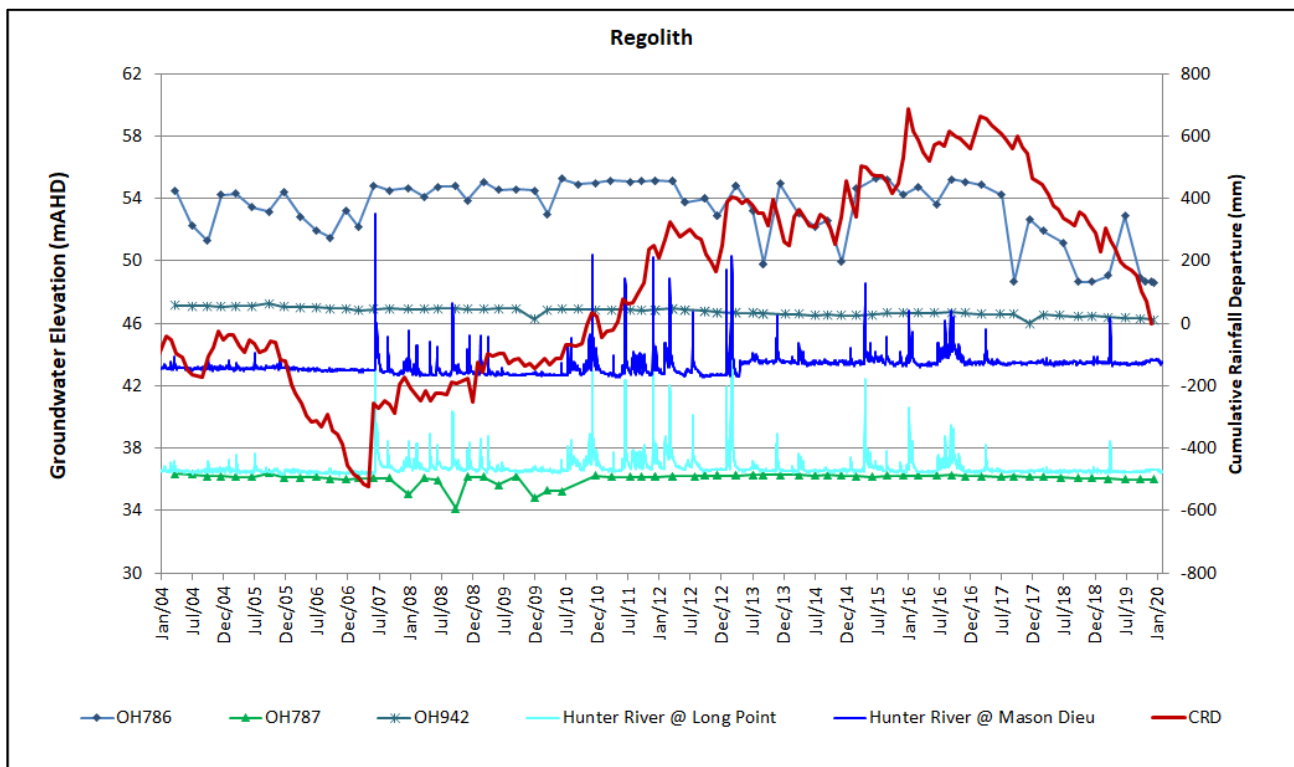
Figure 6-1 Groundwater Levels – Regolith

The greatest fluctuations in water level were recorded for bore OH786 which intersects the shallow regolith east of TD1 and Dam 1N. Fluctuations in groundwater levels within OH786 have fluctuated over time but generally show a decline since 2016. This may relate to climate trends and reduced rainfall recharge, or potentially relate to cessation of storage within TD1 from 2012 and water storage in Dam 1N. The adjacent bore OH942 is installed approximately 6 m deeper into the weathered Permian Coal Measures and recorded stable groundwater levels. This indicates the recharge source is largely restricted to the shallow regolith.

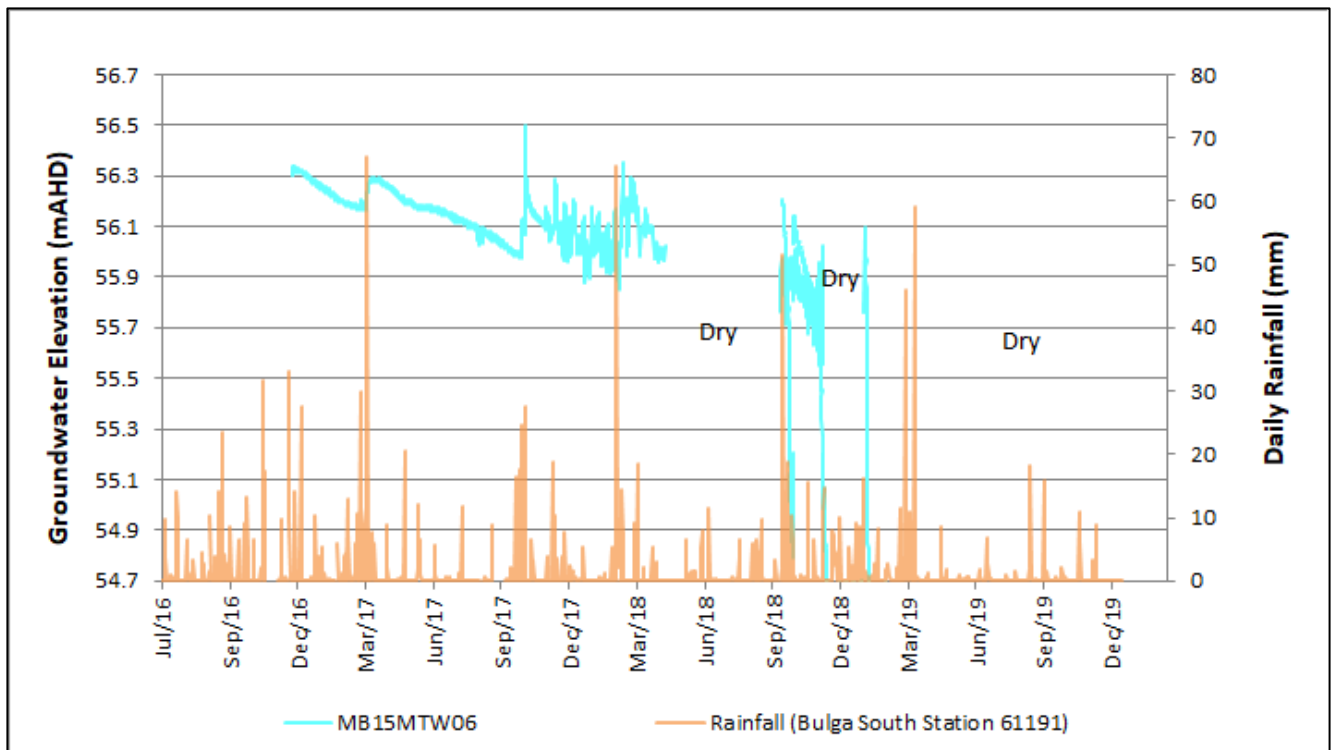
Figure 6-3 Groundwater Levels – Warkworth Sands Bore MB15MTW06

Bores MB15MTW04 to MB15MTW11 were generally recorded as dry since construction in 2016. An exception to this was bore MB15MTW06, which has historically shown a groundwater level response to rainfall events (**Figure 6-3**). Bore MB15MTW06 was generally recorded as dry throughout 2019, which generally corresponds with the below average rainfall recorded during this period, except for the above average rainfall in March 2019 (**Figure 6-3**). Further review into the groundwater conditions associated with the Warkworth Sands is recommended.

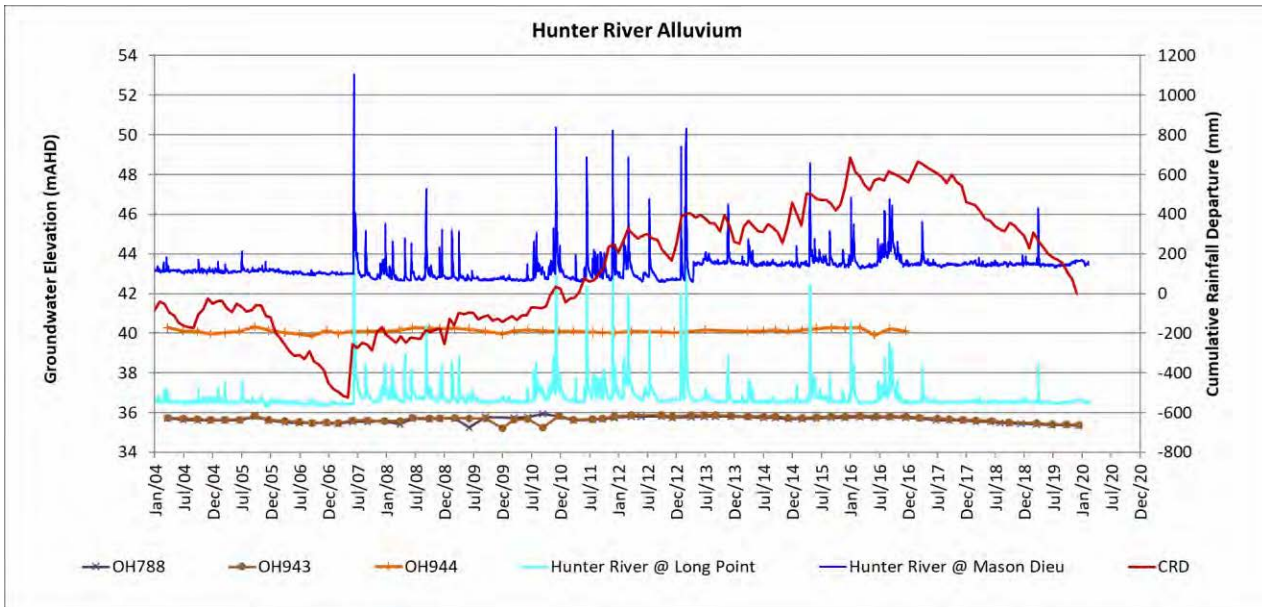
Figure 6-4 Groundwater Levels – Hunter River Alluvium

Of the bores with water present, alluvial groundwater occurred at depths of between 9.47 m and 9.61 m below surface over 2019. **Figure 6-4** presents the historical groundwater levels for all three Hunter River alluvium bores, along with rainfall trends (CRD) and stream elevations recorded at the Hunter River stream gauges at Mason Dieu and Long Point. As shown in **Figure 6-4**, groundwater levels have remained relatively stable at bores OH788 and OH943 since monitoring commenced in 2004, with less than 0.5 m variation in levels recorded. There is a very slight decline since 2016 recorded for both bores that may relate to the below average rainfall period. However, historical readings show no correlation with rainfall trends and no response to peak rainfall periods. It is recommended that the construction and geology at the two bores be reviewed to verify they do intersect alluvium.

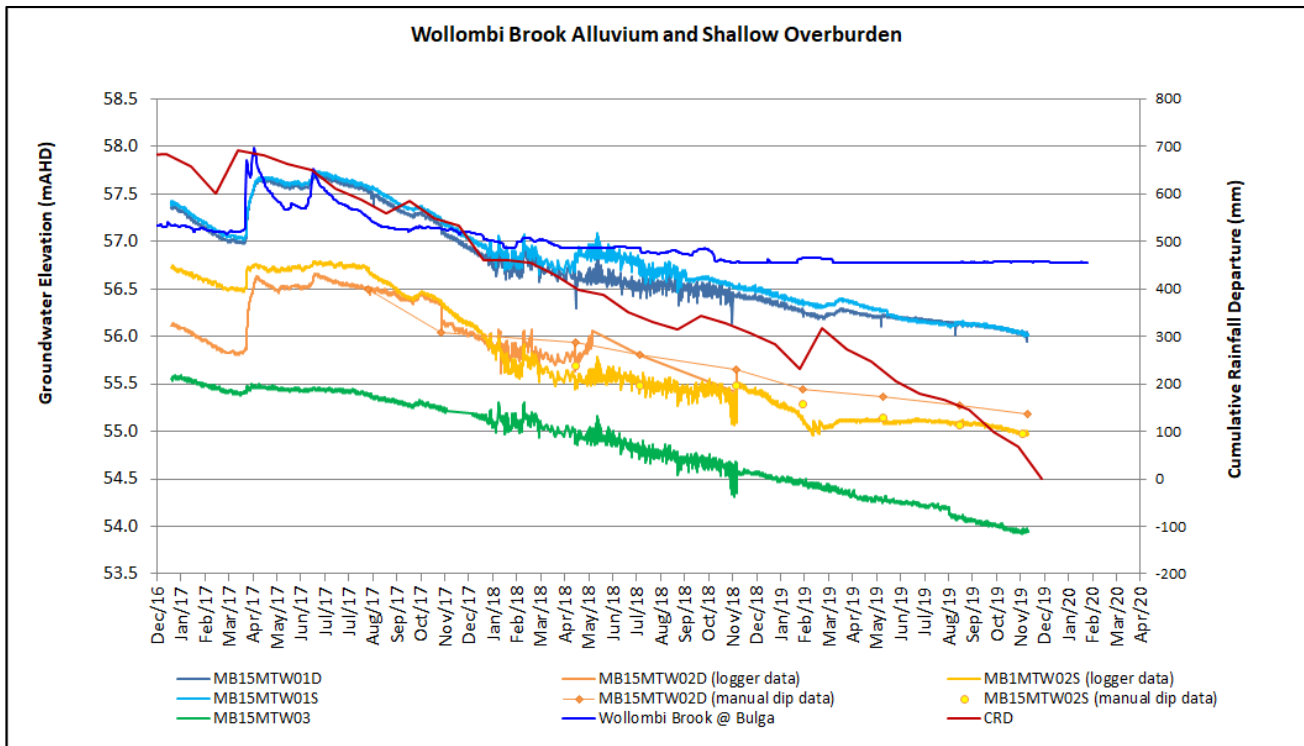
Figure 6-5 Groundwater Levels – Wollombi Brook Alluvium MB15MTW01 and MB15MTW02

Bores MB15MTW01 and MB15MTW02 are located adjacent to Wollombi Brook. **Figure 6-5** shows that over 2019 alluvial groundwater elevations along Wollombi Brook were below stream elevations, indicating losing conditions. Groundwater levels within the alluvium and shallow overburden steadily declined over 2019. Trends between the alluvium and underlying shallow overburden material follow similar trends along Wollombi Brook. This contrasts with observations further away from the Wollombi Brook, as discussed below.

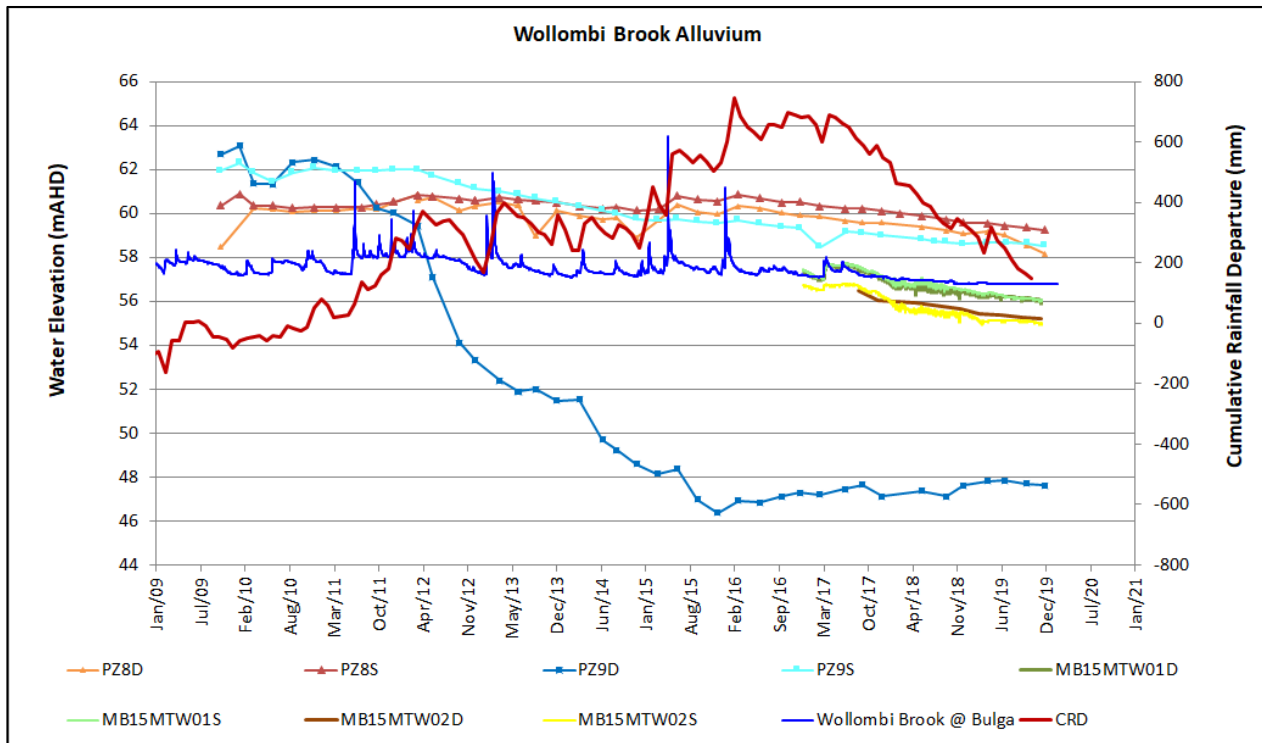
Figure 6-6 Groundwater Levels – Wollombi Brook Alluvium Bores PZ8, PZ9, MB15MTW01 and MB15MTW02

Groundwater level trends for bores over 600 m from Wollombi Brook, at the south-western end of site (PZ8 and PZ9), are presented in **Figure 6-6**. Trends for the MB15MTW alluvial bores are also included for comparison. The graph also includes rainfall trends (CRD) and stream elevations for Wollombi Brook as recorded at Bulga. As with the bores adjacent to Wollombi Brook, **Figure 6-6** shows a general decline in groundwater levels within the alluvium following rainfall trends, with a slight rise following the March 2019 above average rainfall event.

Figure 6-6 shows that alluvial groundwater elevations are higher than the underlying overburden material, indicating a downward flow gradient. The exception to this is bore site MB15MTW02 where the alluvial groundwater elevations are marginally lower than the underlying overburden material, indicating a potential upward flow gradient. It is also noted that groundwater levels within shallow overburden bore PZ9D declined from commencement of monitoring in 2009 to 2016. Between 2016 and 2017 groundwater levels gradually rose before becoming more stable over 2019. Bore PZ9D is positioned closest to the active operations at Loders Pit. Therefore, the decline in groundwater levels within the shallow overburden material likely reflects depressurisation from mining, as predicted as part of the mine approvals (AGE, 2014b). Both PZ9S and PZ9D are shallow, at 7 m and 24 m depth, respectively. Therefore, the difference in groundwater trends highlights limited vertical hydraulic connection between the Permian coal measures and surficial sediments at this location. Overburden bore PZ8D also recorded a decline in levels between June and December 2019, which is not observed in PZ8S alluvial bore. The bores are located approximately 800 m from Loders Pit and the decline in the overburden likely reflects depressurisation from mining, as predicted by AGE (2014b).

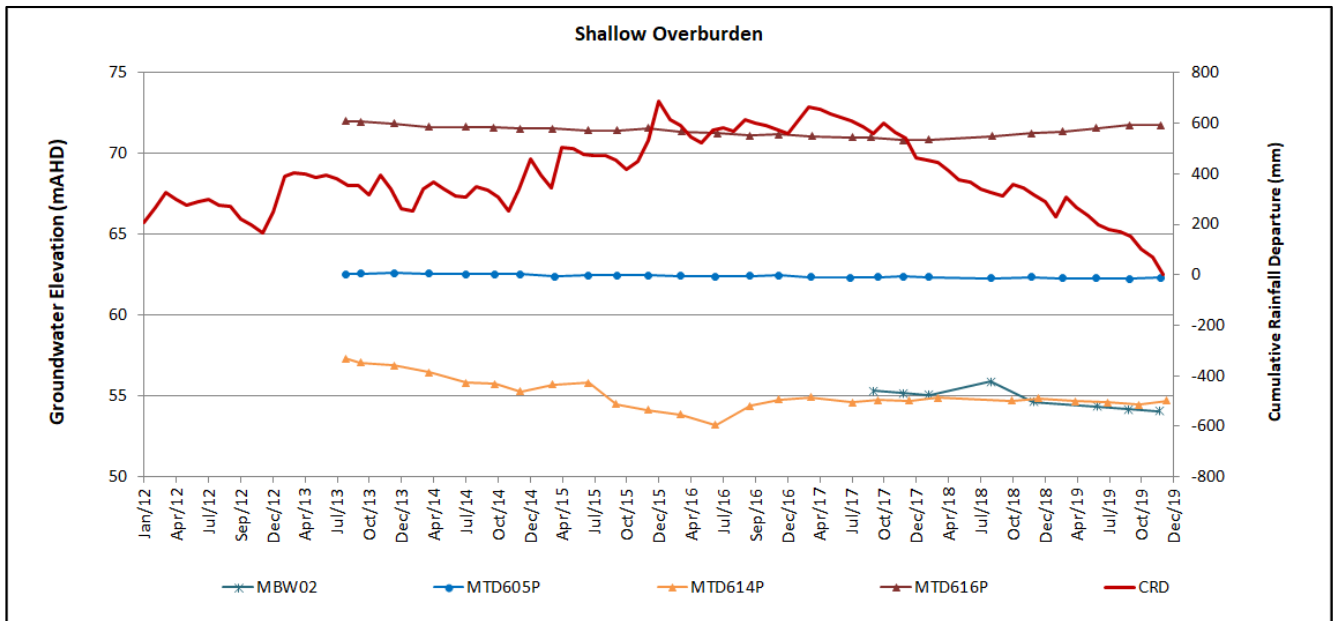
Figure 6-7 Hydrograph of Shallow Permian Coal Measures

Groundwater level trends for bores MTD605P, MTD614P, MTD616P, and MBW02 are presented in **Figure 6-7**. **Figure 6-7** shows stable to slightly declining groundwater levels within the shallow overburden material. The exception to this is bore MTD616P in which slightly increasing groundwater levels were recorded. No land use changes or activities are known to have occurred near the bore that may have caused this rising trend. Further investigation into site conditions around MTD616P should be undertaken to confirm this.

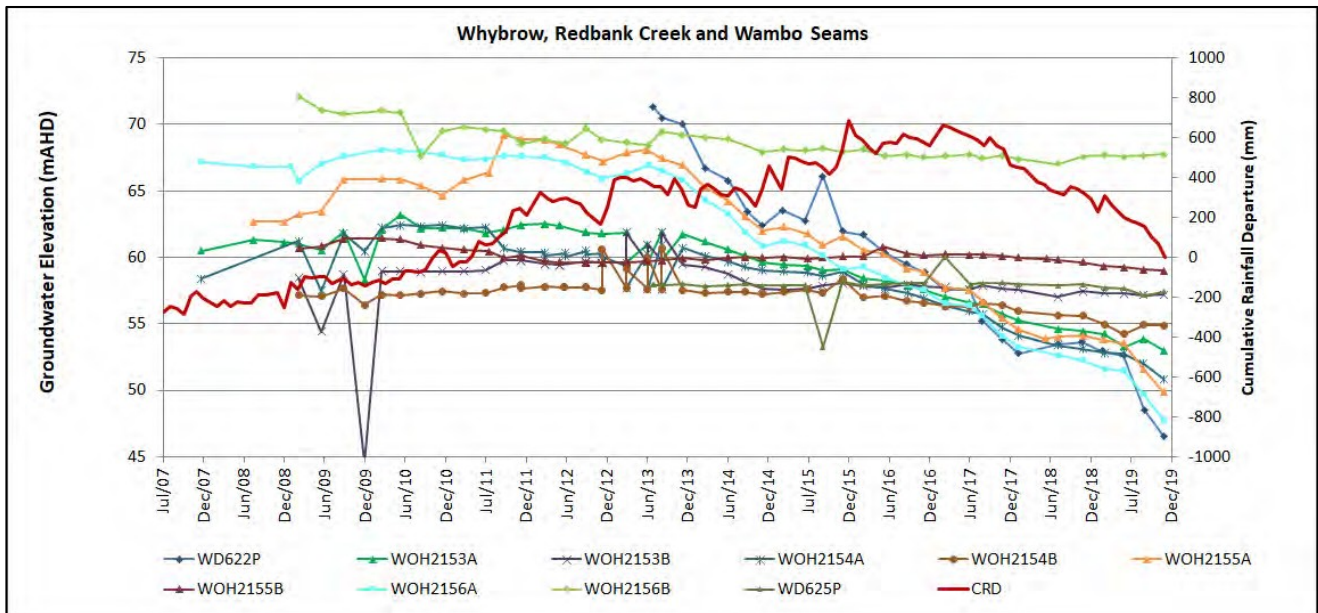
Figure 6-8 Hydrograph of Whybrow, Wambo and Redbank Creek Seams

Historical groundwater level trends for bores intersecting the shallow coal seams (Whybrow, Redbank Creek and Wambo seams) are presented in **Figure 6-8**. The graph shows that over 2019 groundwater elevations ranged between 46.6 mAHD and 67.7 mAHD. Over 2019 groundwater levels generally declined in bores WD622P, WOH2154B, WOH2155A, WOH2153A, WOH2154A, and WOH2156A. With the exception of bore WOH2153A, the rate of groundwater level decline increased from May 2019. Over 2019 groundwater elevations in WD622P, decreased from 52.96 m AHD to 46.56 m AHD; in WOH2154B decreased from 54.97 m AHD to 53.81 m AHD; in WOH2155A from 53.55 m AHD to 49.85 m AHD; and from WOH2156A from 51.63 m AHD to 47.75 m AHD. Bores WOH2154A, WOH2155A and WOH2156A all target the Redbank Creek Seam with WD622P and WOH2154B targeting the Wambo Seam. WD622P, is located within 300 m of the highwall at West Pit, with the remaining bores approximately 750m west of the North and West Pits. The increased decline in groundwater levels are therefore likely to be a response to the depressurisation of the coal seams as a result of mining operations. Groundwater levels remained relatively stable at bores WOH2153B, WOH2155B and WD625P, which are all located approximately 1 km west of Warkworth operations. Groundwater elevations were found to slightly increase throughout 2019 in WOH2156B.

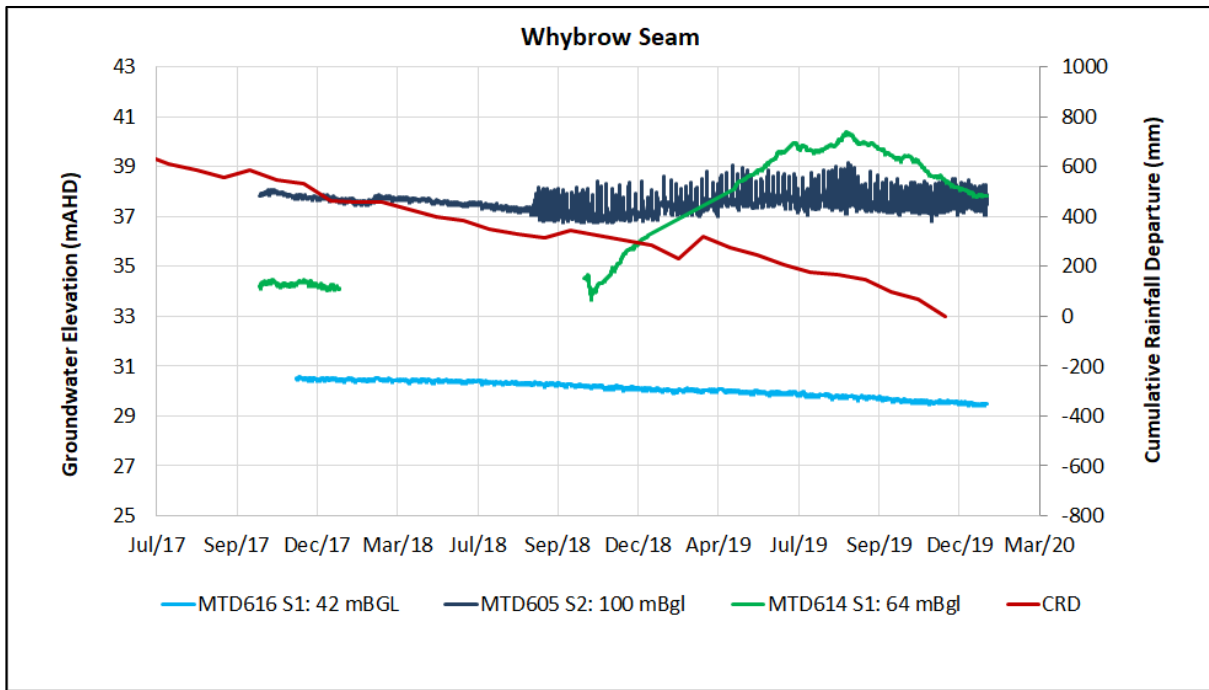
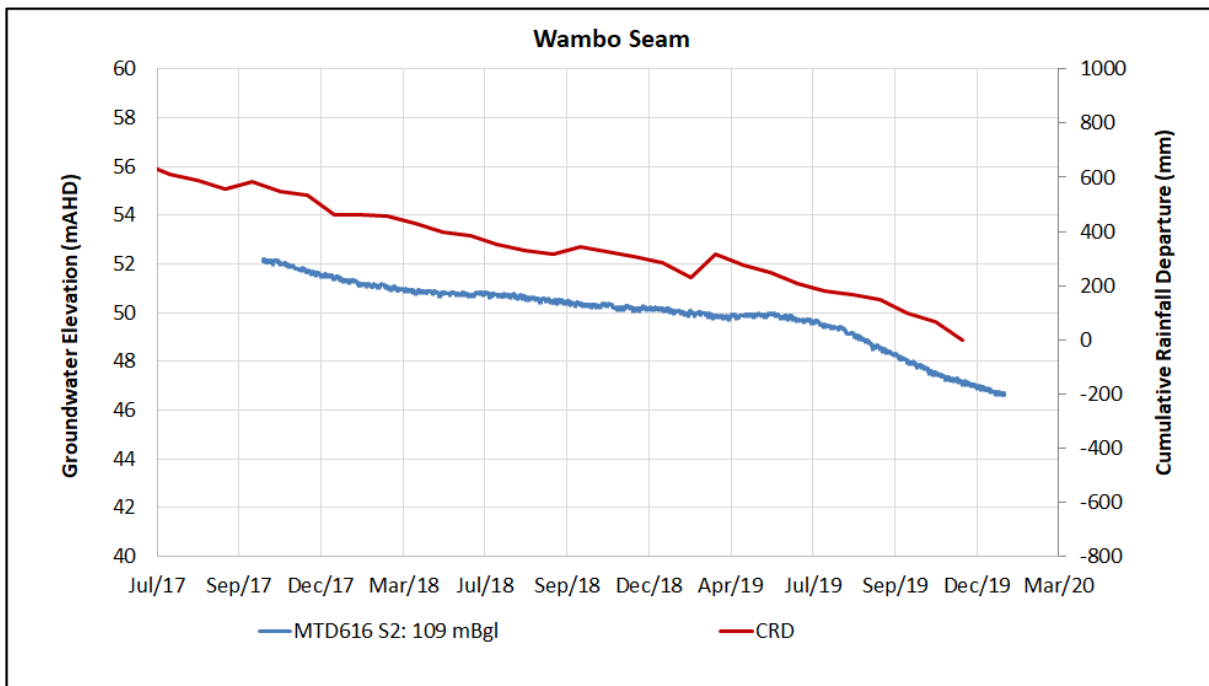
Groundwater level trends for VWP sensors installed within the Whybrow and Wambo seams are presented in **Figure 6-9** and **Figure 6-10** respectively. The graphs show that over 2019 groundwater elevations within both seams declined, with a steeper decline again observed within the Wambo Seam from May 2019. This corresponds with the monitoring bore data and is likely due to depressurisation of the seams from mining of West Pit and Loders Pit to the east.

In the 2018 annual environmental monitoring review it was found that the MTD614 sensor installed within the Whybrow Seam (sensor 1) recorded increasing groundwater elevations, this in contrast to the other Whybrow Seam sensors where declining elevations have been recorded. MTD614 is located directly to the west of Loders Pit which is actively mined down to the deeper Woodlands Hill Seam. The active mining should in theory result in lowering of groundwater levels through depressurisation. It was suggested that the increase in groundwater elevations may indicate that the sensor is not working correctly. Review of the 2019 data found that groundwater elevations recorded MTD614 (sensor 1) continued to increase until August after which they began to decrease. Review of the raw sensor data suggests that the sensor and logger are working correctly, with pressure and temperature readings relatively consistent since installation. This trend is also consistent with trends for nearby shallow overburden bore MTD616P.

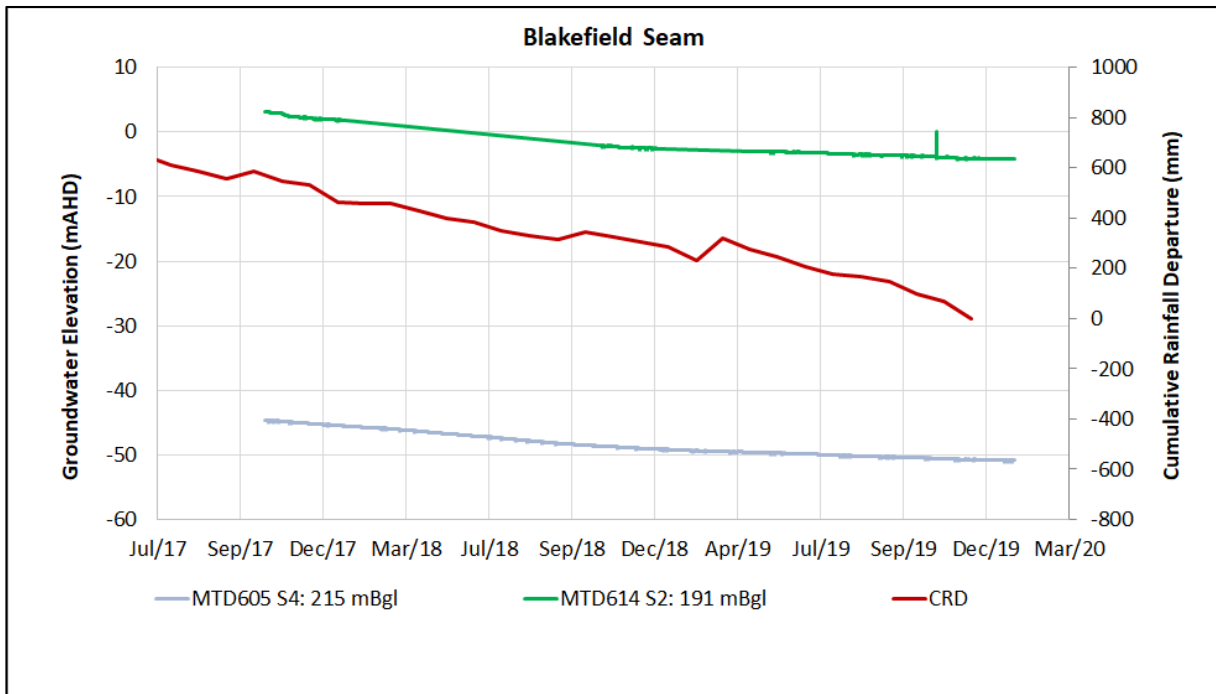
Figure 6-12 VWP Hydrograph of Blakefield Seam

Groundwater level trends for VWP sensors installed within the Blakefield Seam are presented in **Figure 6-12**. The graph shows that over 2019 groundwater elevations within the seam slightly declined. This corresponds with the monitoring bore data and is likely due to depressurisation of the seams from expansion of West Pit to the east.

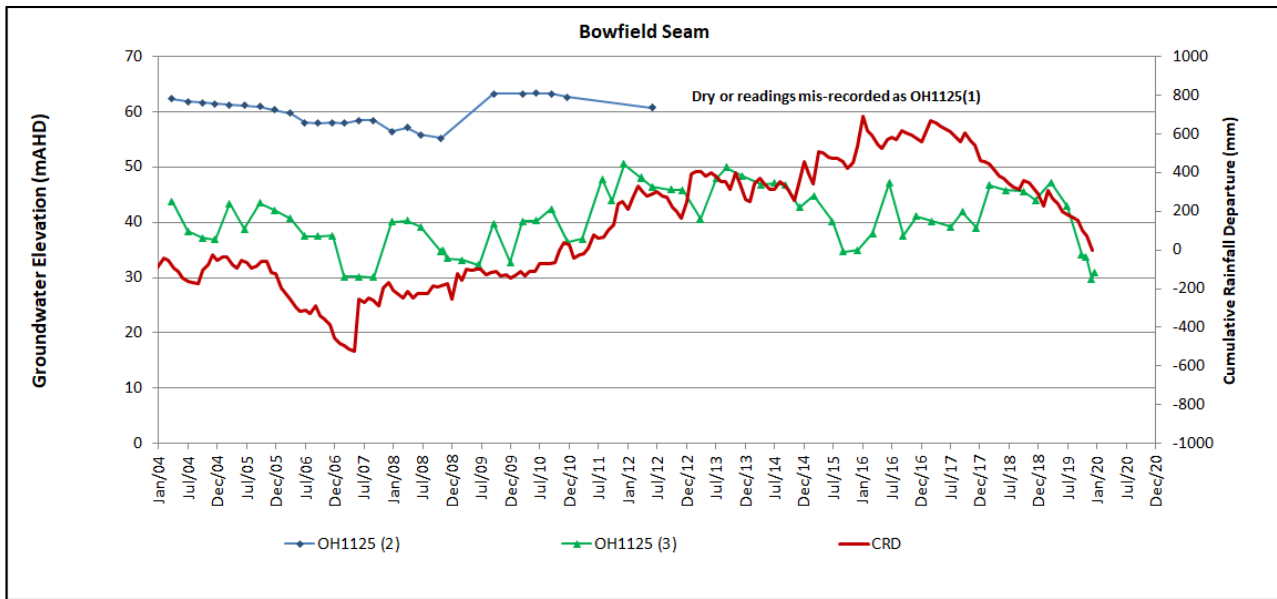
Figure 6-14 Hydrograph of Bowfield Seam

Historical groundwater level trends for bores intersecting the Bowfield Seam are presented in **Figure 6-14**. The graph shows that over 2019 groundwater elevations in Bore OH1125(3) decreased from 47.19 mAHD to 29.71 mAHD, corresponding to the decrease in rainfall over this period. Bore OH1125(3) is located directly to the north of North Pit and the decline may relate to drawdown towards active mining within the pit to the south. The trend may also be influenced by abstraction from LUG Bore located approximately 1.25 km to the north west. The LUG bore intersects the historical Lemington Underground workings, which mined through the deeper Mt Arthur Seam. The increased groundwater level drawdown observed over 2019 may therefore be a combination of the effects of mining of the North Pit and licenced abstraction from the LUG bore.

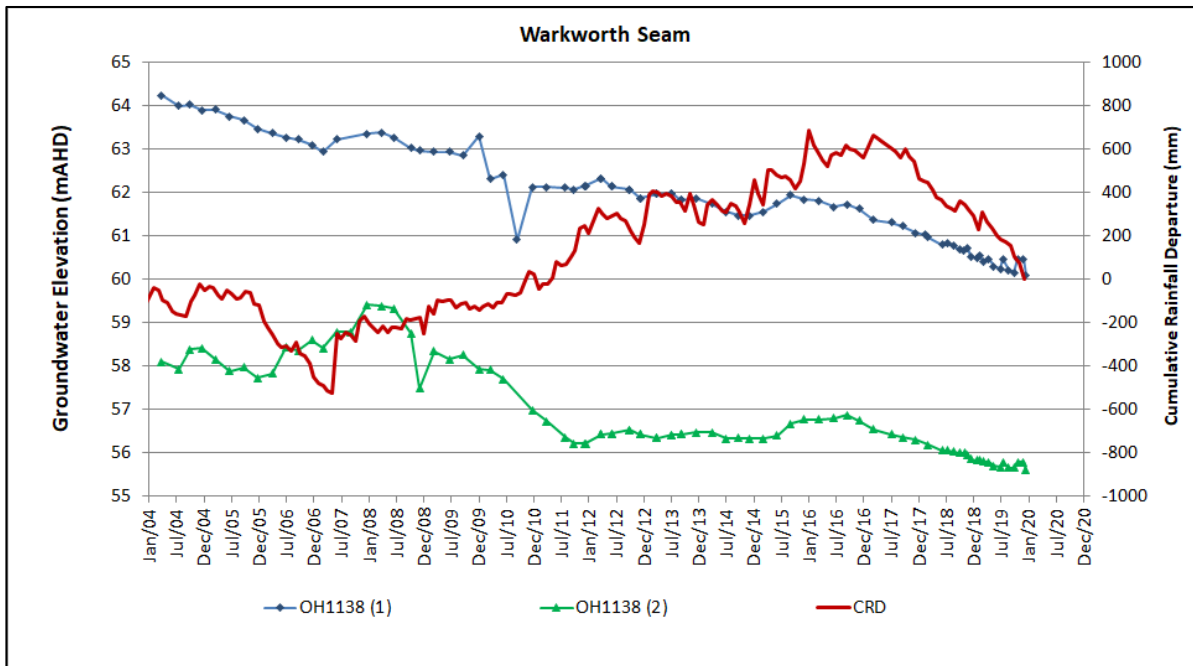
Figure 6-15 Hydrograph of Warkworth Seam

Historical groundwater level trends for bores intersecting the Warkworth Seam at bore OH1138 at two intervals (1 and 2) are presented in **Figure 6-15**. The graph shows that over 2019 groundwater elevations ranged between 55.59 mAHD and 60.53 mAHD and level declined by up to 0.46 m. The bore is located north of North Pit and the decline may relate to drawdown towards active mining within the pit to the south-west. The trend may also be influenced by abstraction from LUG Bore approximately 1.25 km to the north-west.
