2019 STREAM HEALTH AND STABILITY REPORT

Mount Thorley Warkworth

SLR Ref: 630.12941-R01
Version No: -v0.2
March 2020

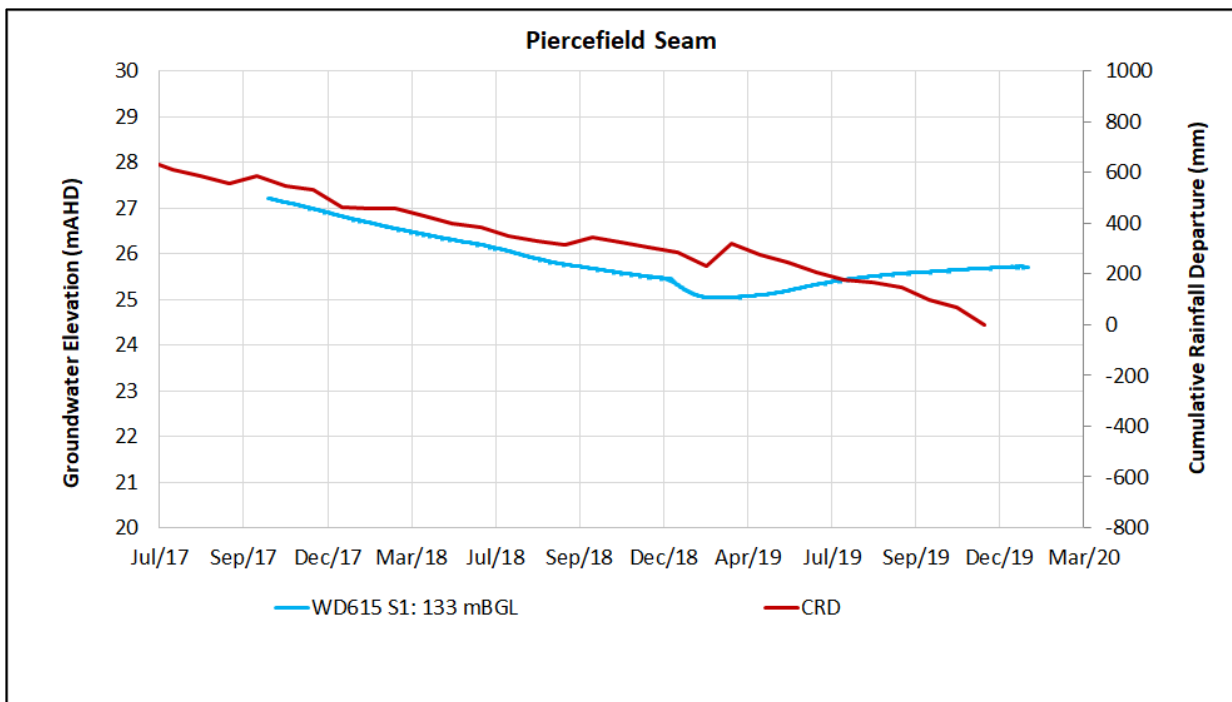
Figure 6-17 VWP hydrograph of Piercefield Seam

Figure 6-17 shows that over 2019 groundwater elevations within the Piercefield Seam increased from a low of 25.04 mAHD in February 2019 to 25.71 mAHD in December 2019 (0.67 m). VWP WD615 is located along the southern boundary of North Pit, within a rehabilitated area of the pit. The VWP sensor is located in the seam underlying the mined coal seam at this location. The increase in groundwater elevation within the Piercefield Seam is potentially an indication of recharge from the overlying spoil as groundwater recovery takes place in the rehabilitated areas.

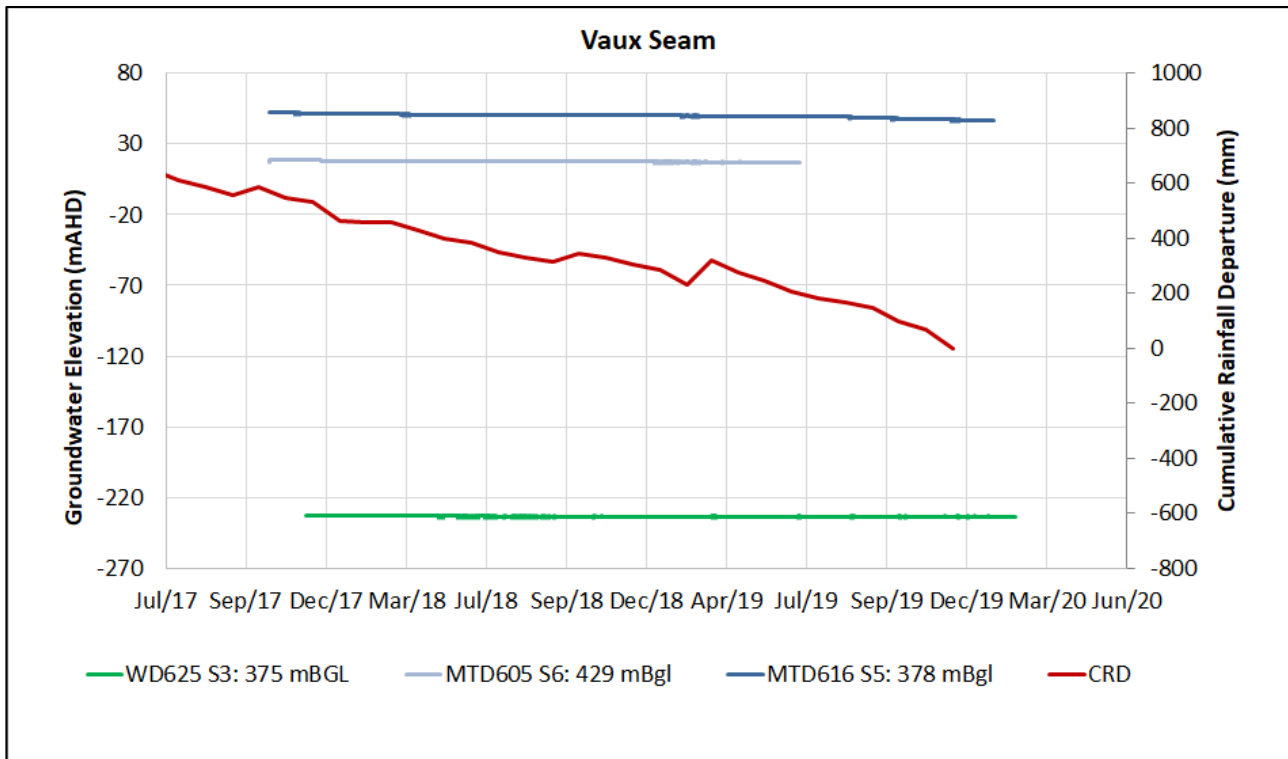
Figure 6-19 VWP hydrograph of Vaux Seam

Groundwater level trends for VWP sensors installed within the Vaux Seam are presented in **Figure 6-19**. Although the sensor for MTD605 appears to have failed in June 2019, the graph shows that over 2019 groundwater elevations were relatively stable. WD625 is located to the west of North Pit, MTD605 is located to the west of Loders Pit and MTD616 is located to the south west of West Pit. The VWP data therefore suggests that over 2019 groundwater levels within the Vaux Seam were not influenced by mine operations at these locations.

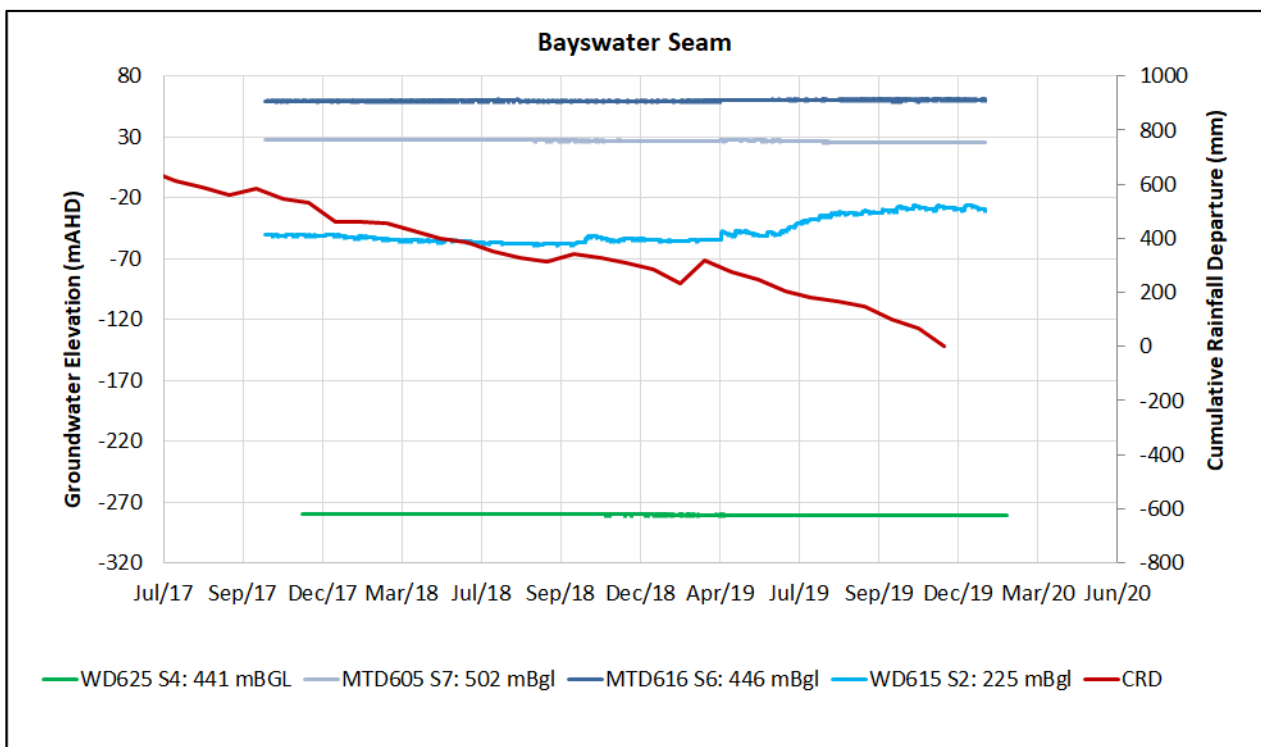
Figure 6-21 VWP hydrograph of Bayswater Seam

Groundwater level trends for VWP sensors installed within the Bayswater Seam are presented in **Figure 6-21**. The graph shows that over 2019 groundwater elevations were relatively stable. The exception to this is WD615 where groundwater elevations increased. With the exception of WD615 all VWP locations are located to the west of the main mine pits (North Pit, West Pit and Loders Pit). WD615 is located in the east of the North Pit. As observed within the Vaux Seam, the groundwater levels reported suggest that mine operations are not impacting groundwater levels within the Bayswater Seam at the VWP monitoring locations. The increase in groundwater elevations observed in WD615 corresponds with the increasing elevations observed within the Piercefield Seam at the same location. The increase may again be an indication of recovering groundwater levels within rehabilitated areas of the North Pit resulting in recharge to the underlying coal seams

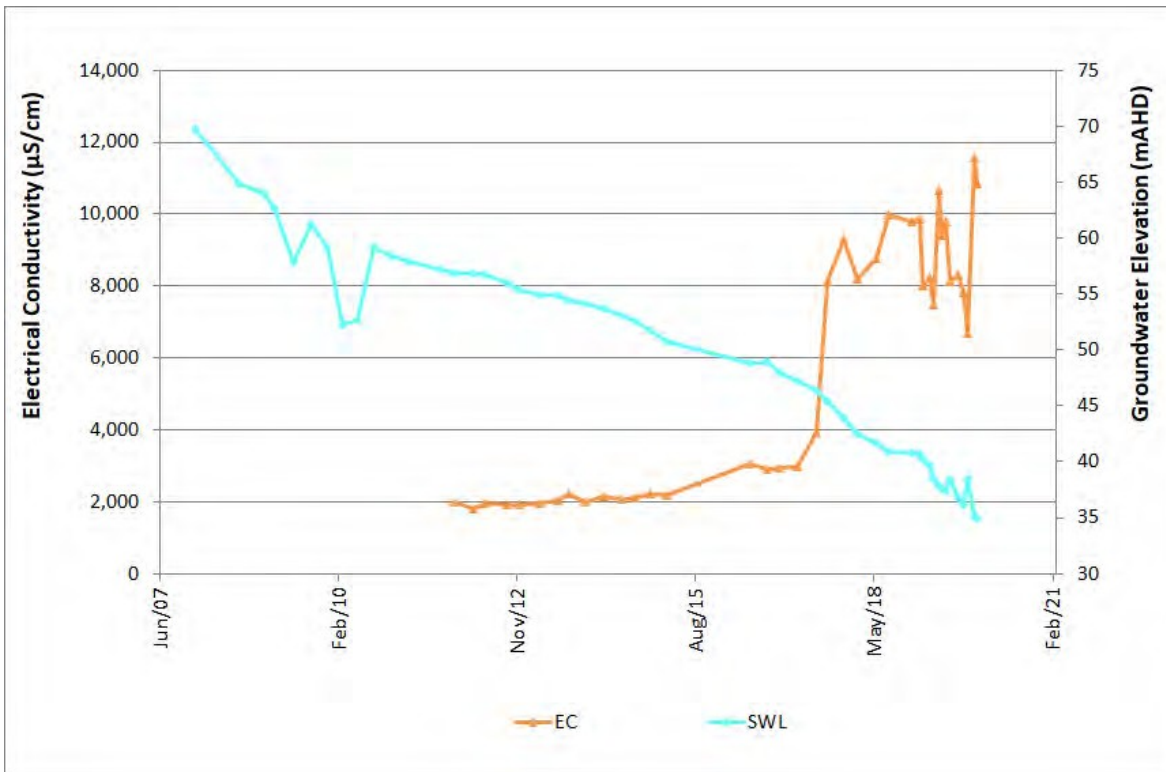
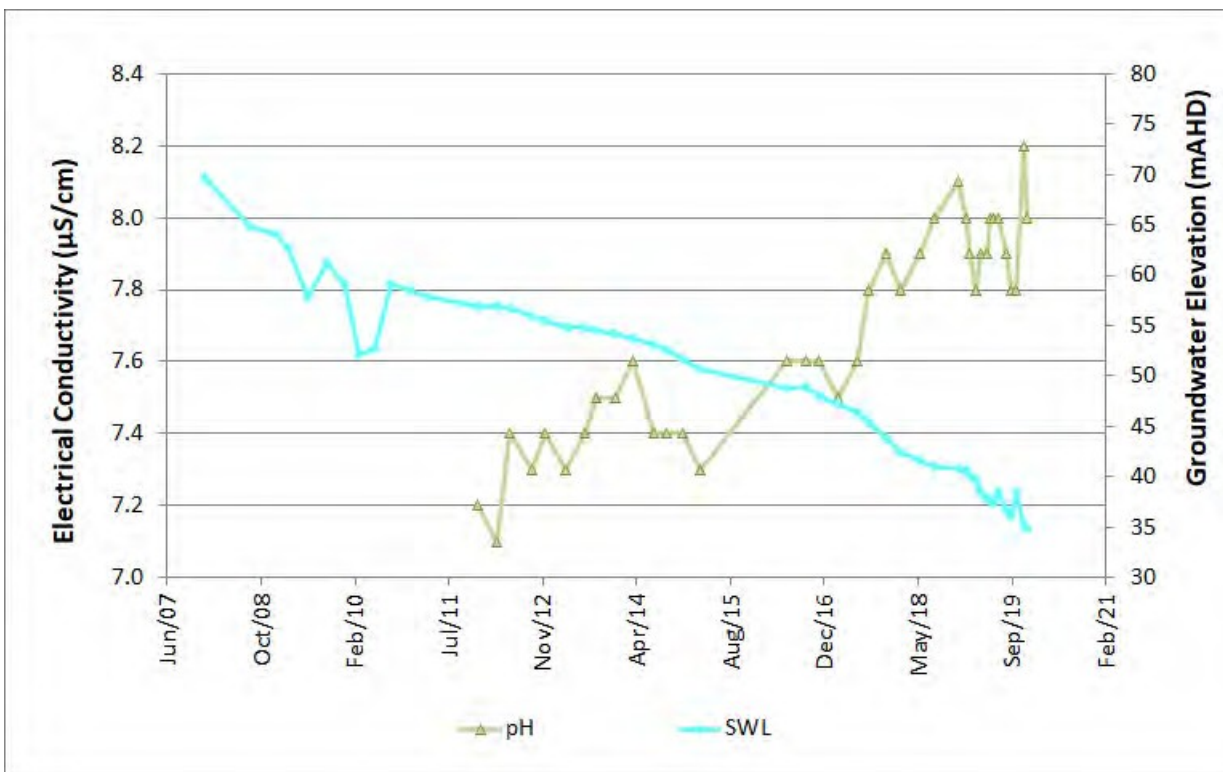
The EC concentrations and pH values for bore WOH2139A are not consistent with those recorded in the other monitoring bores intersecting the Blakefield Seam (OH1122 (1) and OH1125 (1)). Within the monitoring network bore OH1125 (1) is located directly to the north of the North Pit, with bore OH1122 (1) located directly to the south of the West Pit. Review of historical and 2019 water quality data shows that the pH values and EC concentrations within these bores are similar and are therefore potential more representative of the Blakefield Seam. A review of the construction details and lithological logs for each bore should be undertaken to confirm that each bore is targeting the Blakefield Seam. In addition, review of sampling techniques shows that WOH2139A is a grab sample whereas bore OH1122 (1) is sampled using full purge techniques. The difference in techniques may therefore result in the variability in quality observed between the bores.

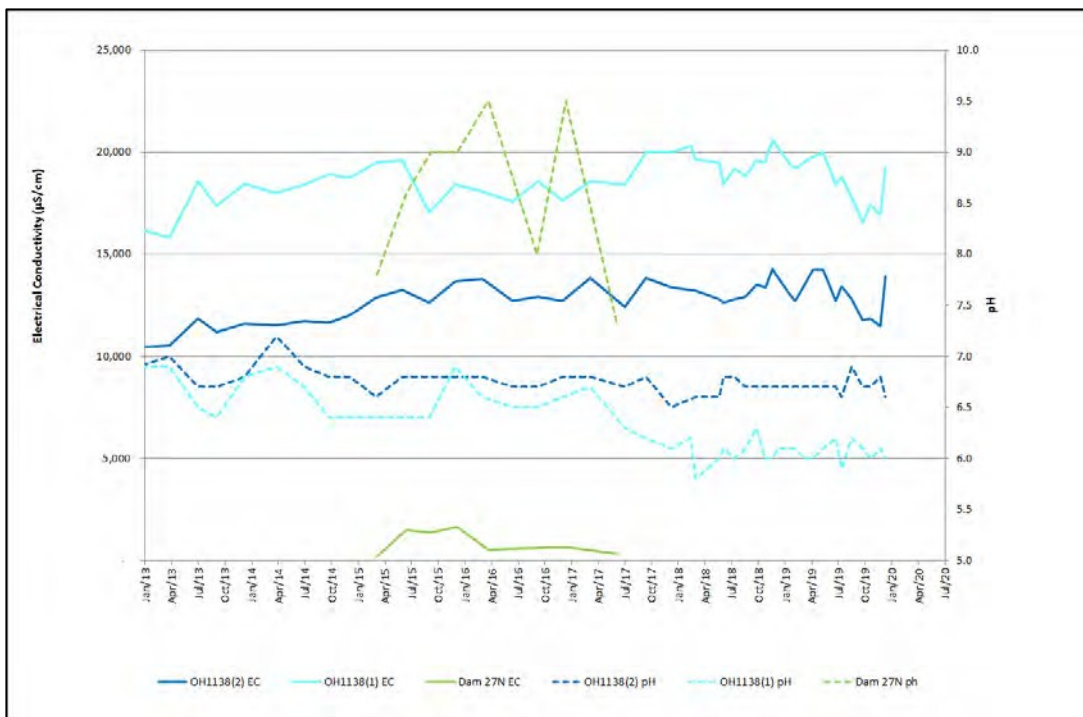
Figure 6-24 Water Quality Trends at OH1138(1) and OH1138(2)

Figure 6-24 shows that over 2019, trends in EC concentrations in both bore OH1138 (1) and OH1138 (2) were similar, with concentrations initially increasing until July 2019, decreasing until October 2019 and then increasing again across the rest of the year. Over 2019, the trigger level of 19,657 $\mu\text{S}/\text{cm}$ was exceeded in bore OH1138 (1) in April and May. The graph includes available water quality data for adjacent surface water dam 27N, which shows no clear correlation to trends in OH1138. **Figure 6-25** shows that EC concentrations have fluctuated in OH1138 (1) since 2013, with no apparent correlation with the observed decline in groundwater levels.
