# Mount Thorley Warkworth 2021 Annual Review

<b>Name of Operations</b>	Mount Thorley Warkworth
<b>Name of Operator</b>	Coal & Allied (NSW) Pty Ltd (wholly owned subsidiary of Yancoal Australia Ltd)
<b>Development consent /project approval</b>	SSD-6464 & SSD-6465
<b>Name of holder of development consent/project approval</b>	Warkworth Mining Ltd Mt Thorley Operations Pty Ltd
<b>Mining Lease #</b>	Contained within Section 3.1 of this report
<b>Name of holder of mining lease</b>	Warkworth Mining Ltd Mount Thorley Operations Pty Ltd
<b>Water Licence #</b>	Contained within Section 3.1 of this report
<b>Name of holder of water licence</b>	Contained within Section 3.1 of this report
<b>MOP/RMP start date</b>	30/11/2021
<b>MOP/RMP end date</b>	02/07/2022
<b>Annual Review Start Date</b>	01/01/2021
<b>Annual Review End Date</b>	31/12/2021
<p><b>I, Gary Mulhearn, certify that this audit report is a true and accurate record of the compliance status of Mount Thorley Warkworth for the period 1 January 2021 to 31 December 2021 and that I am authorised to make this statement on behalf of Coal &amp; Allied (NSW) Pty Ltd.</b></p> <p>Note.</p> <p>a) The Annual Review is an ‘environmental audit’ for t

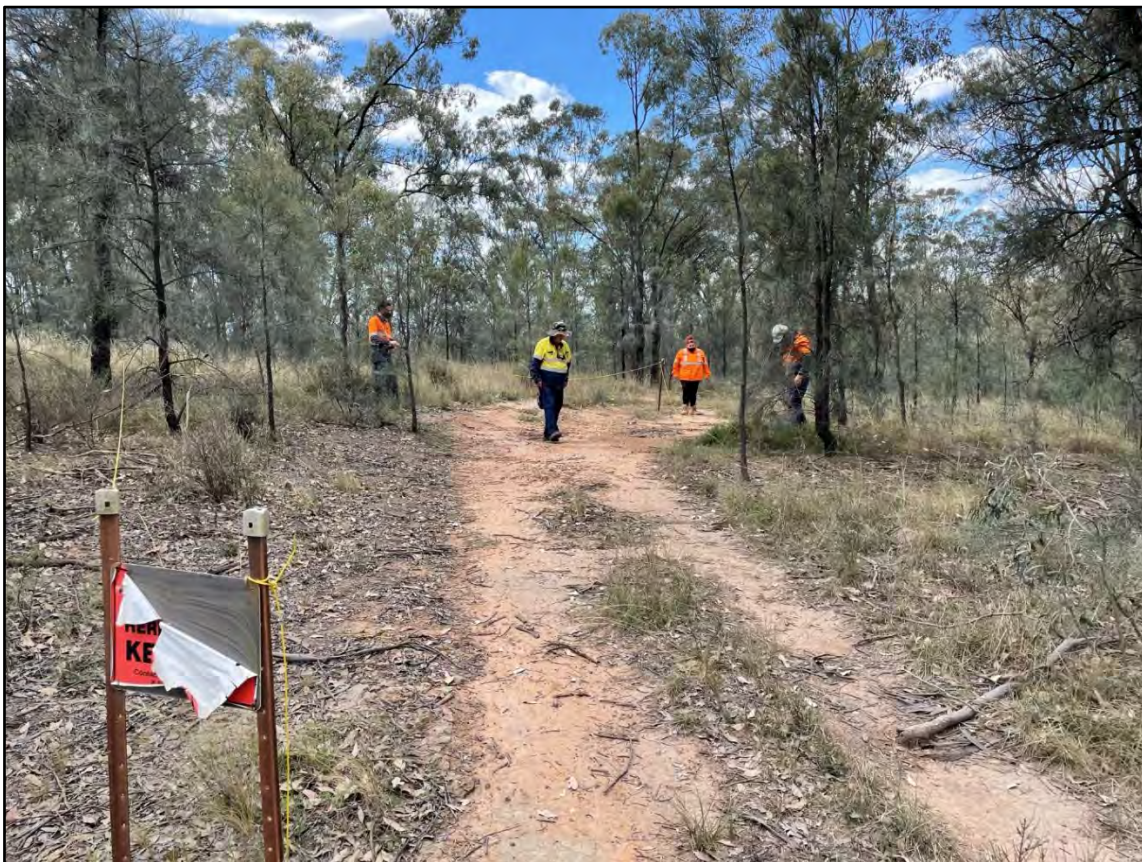
***Example of dilapidated barricading (at MTW-320)***

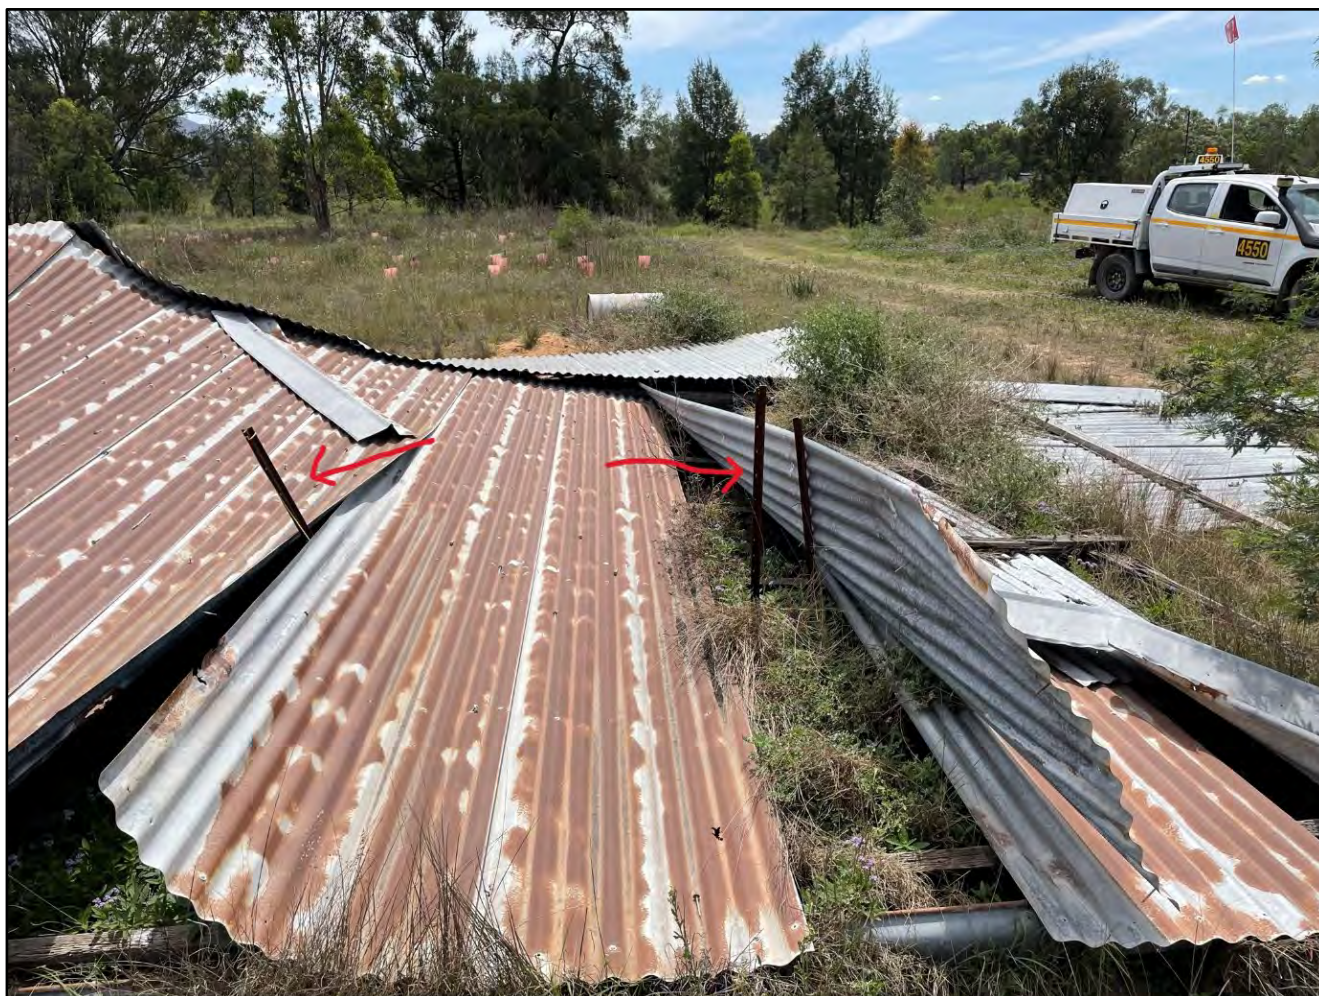
***Star pickets indicate location of artefacts at MTW-668 underneath collapsed shed***

In order to complete the clean up of this area, it is recommended that the shed be removed, by hand where possible (especially in the vicinity of the artefacts), and the process monitored by a representative of the CHWG. Once the shed is removed and the artefacts reidentified, barricading can be erected around the site, which is located within the WBACHCA and cannot, therefore, be salvaged under the terms of the current management plans.

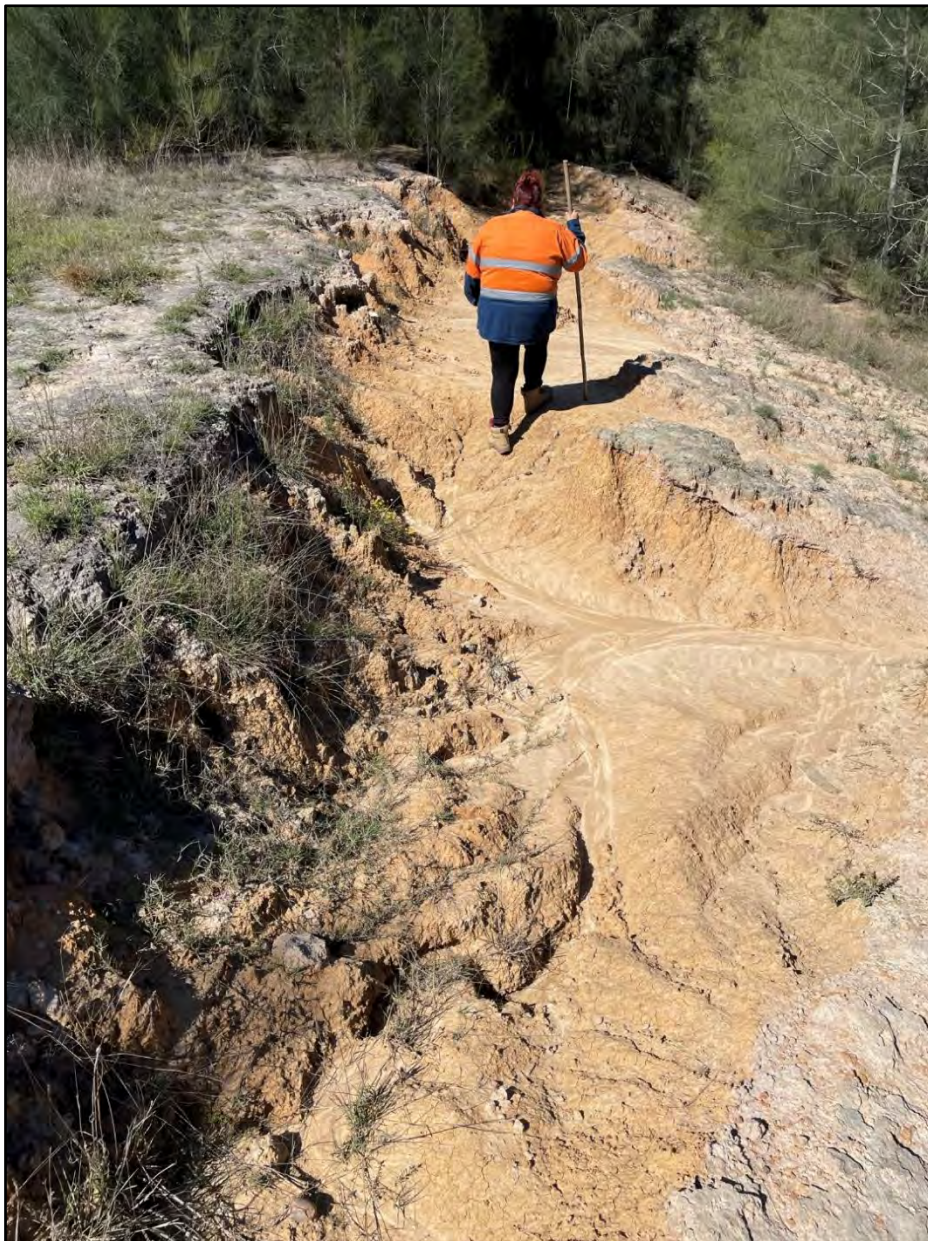
These four ACH sites are located within the LCACHCA and are currently being affected by erosion. MTW-618 is located adjacent to a vehicle crossing on the banks of an eroding gully, the effects of which have been exacerbated by traffic. As this crossing is now too steep for continued use, the closing of this track should allow vegetation to regenerate and stabilise the bank. The remaining three sites are located on the bank of Loder Creek, where deeply incised erosion channelling is occurring, which is having the effect of washing artefacts away or covering them with sediment.

**Severe erosion at MTW-632**

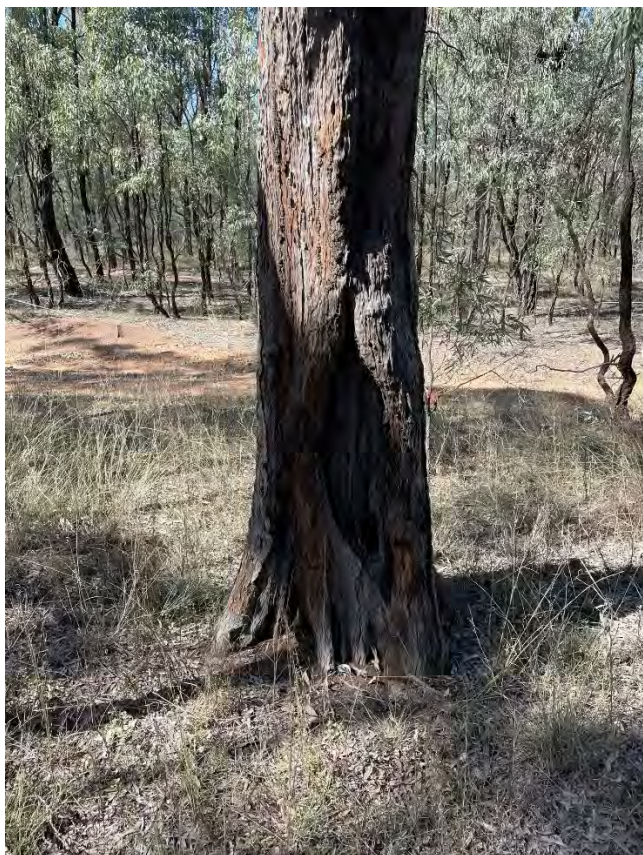
**Scarred tree MTW-8**

These three scarred trees are located within the approved future mining area at MTW and have been assessed by an arborist regarding the best method of removal and relocation. These scarred trees have also been visited by RAPs during this compliance inspection and during other inspections and assessments. A removal and relocation plan has been developed by MTW and the salvage of these trees is planned for 2022, with representatives of the CHWG to be involved.

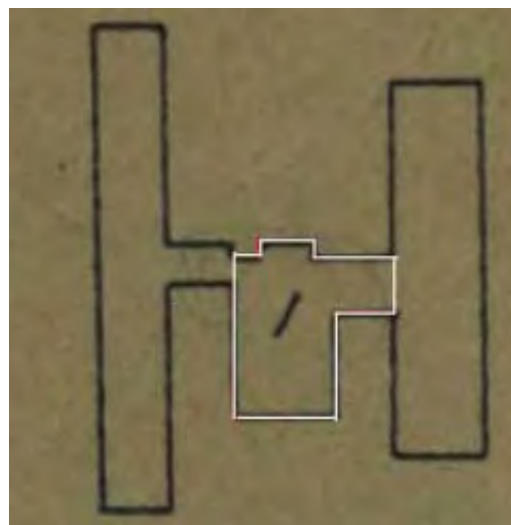
*Remaining structure*

The building is currently structurally unsound, with a number of timber elements either missing or in a deteriorated state. Corrugated asbestos roof sheeting is also missing in some places, and damaged and in poor condition where it remains. Much of the corrugated iron sheeting is corroded. Brickwork is also cracking in a number of locations resulting in significant movement outward, loss of mortar and loss of bricks along the southern and eastern elevations.

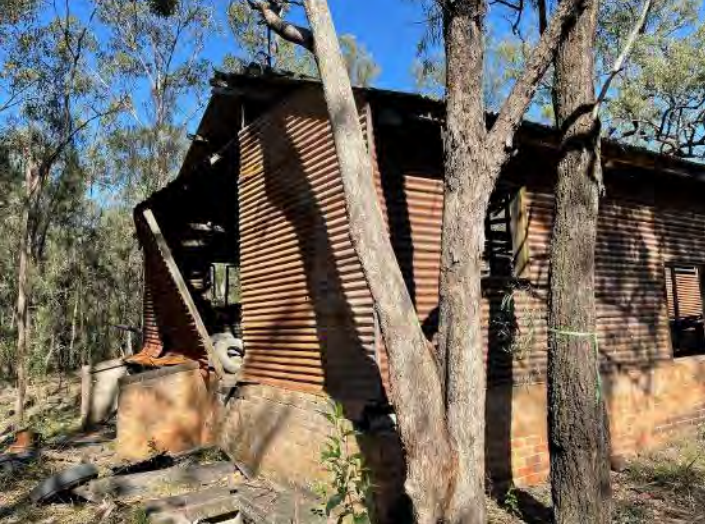
<p><b><u>South-east elevation</u></b></p> <p><b>2012-18:</b> evidence of increased bow to southern wall.  <b>2018-20 (Mar):</b> bow in wall appears to have increased.  <b>Mar 2020 – Dec 2020:</b> bow in wall continues to increase.  <b>Dec 2020 – 2021:</b> gap in bowing has increased.</p>

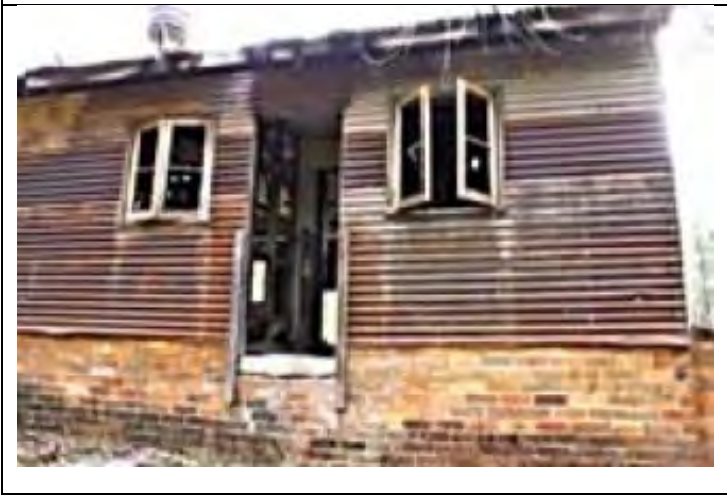
<p style="text-align: center;"><b>2018</b></p>  
<p style="text-align: center;"><b>2020 (Mar)</b></p>  	<p style="text-align: center;"><b>2020 (Dec)</b></p>  
<p style="text-align: center;"><b>2021</b></p>  	<p><b><u>Windows and entry at west elevation</u></b></p> <p><b>2012-18:</b> shows large trunk/branch portions of tree collapsed on roof, which has destroyed roof ventilator.</p> <p><b>2018-20 (Mar):</b> shows majority of branches fallen from roof, leaving increased damage to sheeting.</p> <p><b>Mar 2020 – Dec 2020:</b> no discernible change.</p> <p><b>Dec 2020-2021:</b> no discernible change.</p>

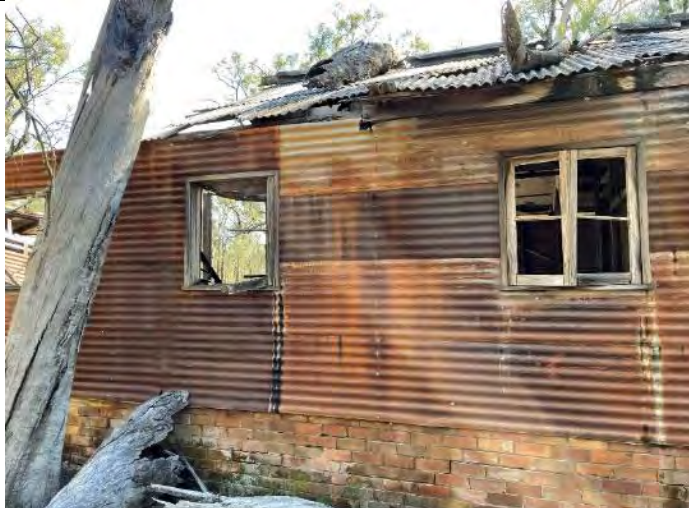
<p><b><u>Showing cylindrical ventilator and damage to roof, view from west</u></b></p> <p><b>2012-18:</b> shows significant roof damage from fallen dead tree, including to ventilator.  <b>2018-20 (Mar):</b> shows increased damage to roof edge sheeting from fallen branch.  <b>Mar 2020 – Dec 2020:</b> no discernible change.  <b>Dec 2020-2021:</b> deterioration of left window frame.</p>

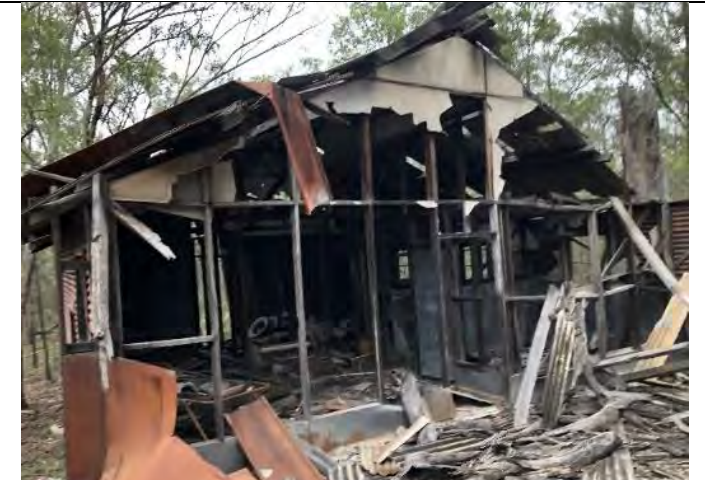
<p style="text-align: center;"><b>2020 (Dec)</b></p>  
<p style="text-align: center;"><b>2021</b></p>  	<p><b><u>View to interior of south end of building, view from east</u></b>  <b>2012-18:</b> shows increased collapse over open kitchen area.  <b>2018-20 (Mar):</b> shows further minor deterioration of asbestos panelling.  <b>Mar 2020 – Dec 2020:</b> no discernible change.  <b>Dec 2020 – 2021:</b> no discernible change.</p>

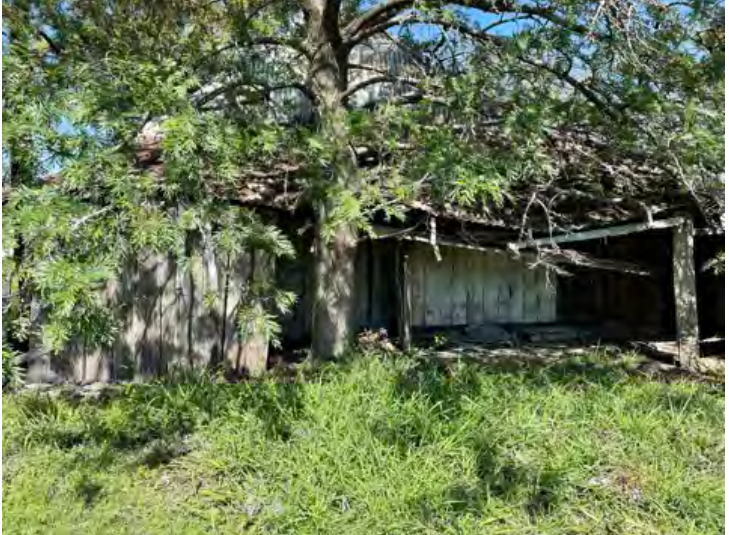
<p><b><u>Eastern elevation</u></b></p> <p><b>2014-8:</b> no discernible change.</p> <p><b>2018-20 (Mar):</b> roof slumping appears to have increased.</p> <p><b>Mar 2020-Dec 2020:</b> heavy leaf litter on roof persists. Positively, vegetation clearing surrounding the house is occurring regularly.</p> <p><b>Dec 2020 – 2021:</b> tree growth and associated leaf litter/structural impacts increasing.</p>

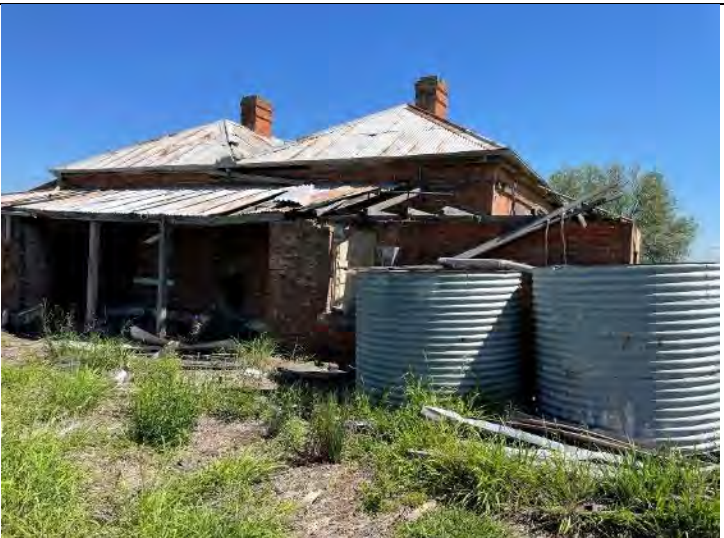
<p><b><u>View of rear of building (focus on roof)</u></b></p> <p><b>2015-8:</b> skillion roof, guttering and rafters have collapsed; main roof holes repaired</p> <p><b>2018-20 (Mar):</b> no discernible change</p> <p><b>Mar 2020-Dec 2020:</b> some minor holes in roofing require repair</p> <p><b>Dec 2020 – 2021:</b> minor roofing holes remain.</p>
