Mount Thorley Warkworth 2018 Annual Review

Mount Thorley Warkworth (MTW) is an integrated operation of two open cut coal mines, Warkworth Mining Limited (WML) and Mount Thorley Operations (MTO). This Annual Review reports on the environmental performance of Mount Thorley Warkworth (MTW) for the period 1 January 2018 to 31 December 2018.

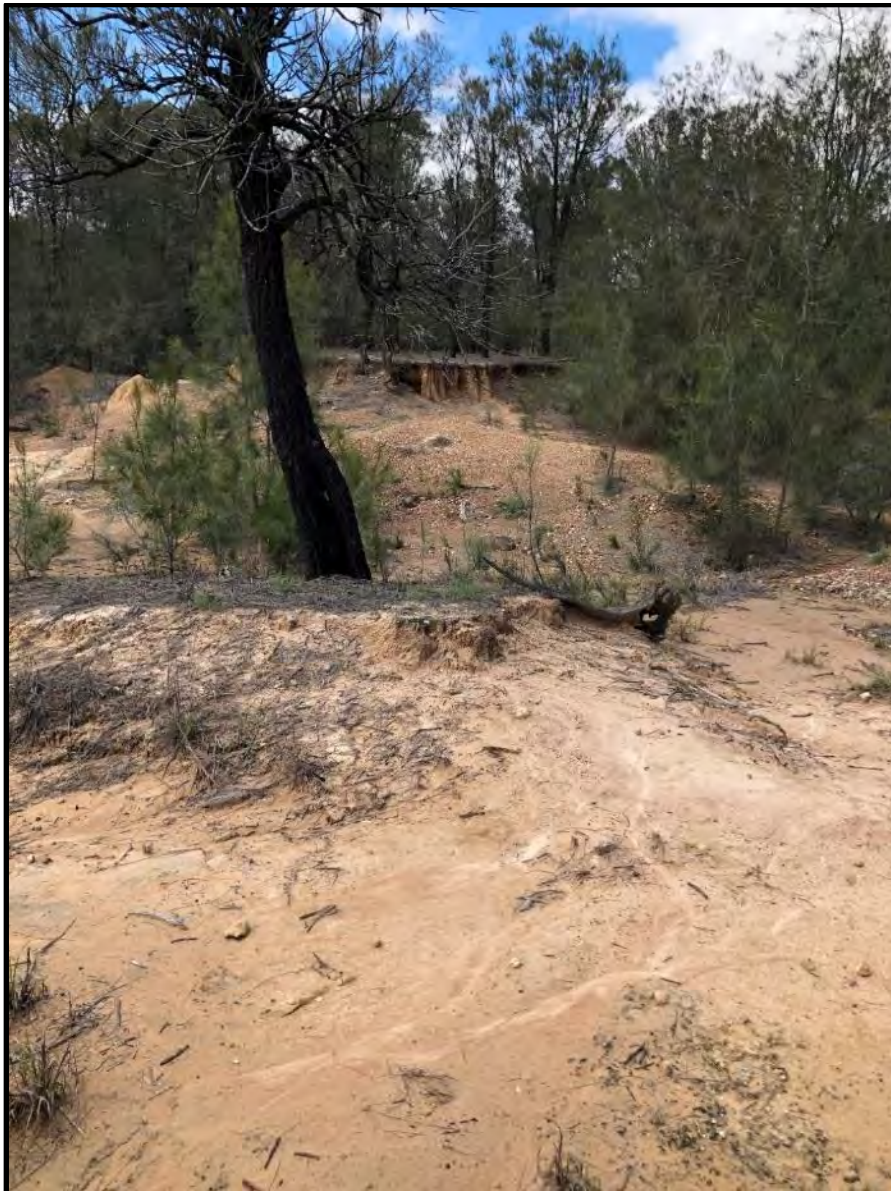
This is an extremely dense Aboriginal heritage site containing hundreds if not thousands of artefacts. It is located in a short, bowl-shaped eroded gully that seems to attract the run-off from the evident sheet-wash in the area. Due to the very large number of artefacts present, the erosion control methods recommended above may not be suitable, however, it is vital that measures are implemented to prevent further possible loss of artefacts through washing into the nearby creek. It is suggested that other rehabilitation methods are explored at this site, in consultation with the MTW CHWG, rather than a collection of artefacts. Such other methods may involve erosion control around the site rather than on the site itself, and efforts to divert run off around the gully rather than through it. Being located within an Aboriginal cultural heritage conservation area, it is important that sites such as this remain in situ for the education and appreciation of future generations.

MTW-655 located around and across eroding gully

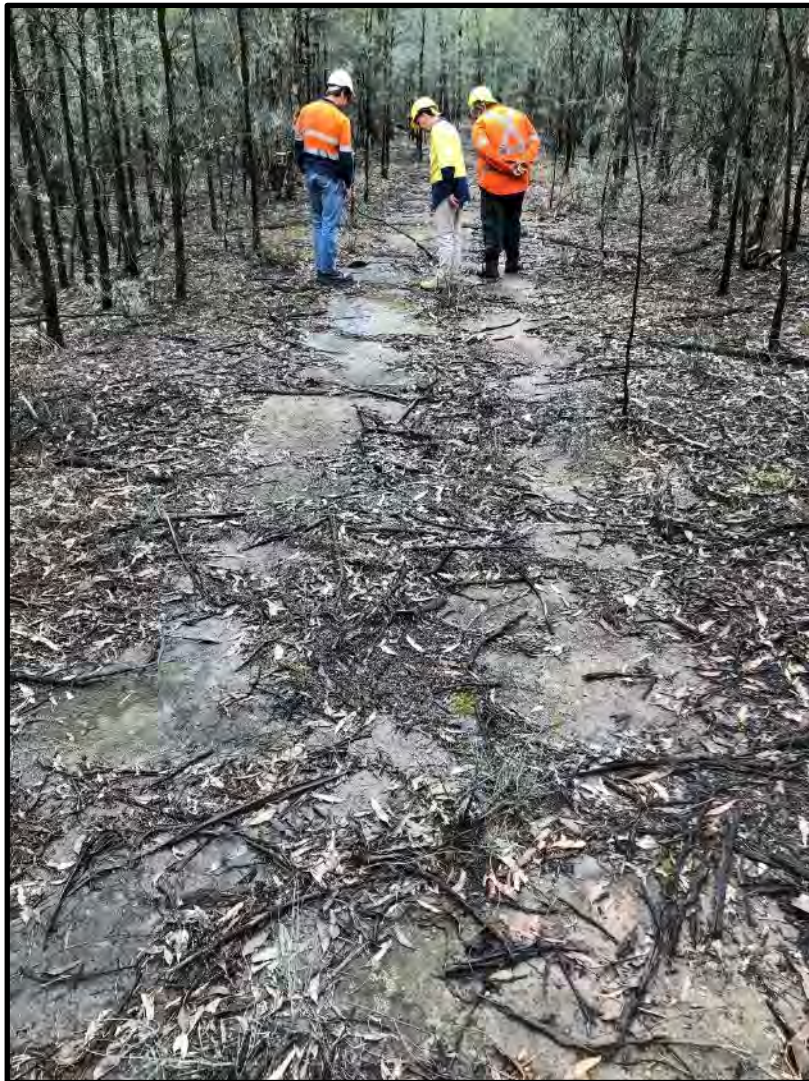
These sites are located on and immediately adjacent to a now disused vehicle track, which, although naturally revegetating, can still be accessed. As this track appears to have no current value as an accessway, it is recommended that this track be physically blocked at either end (either with an earthen bund or tree fall) to prevent inadvertent access and subsequent potential damage to these Aboriginal heritage sites.

MTW-89 located on disused access track

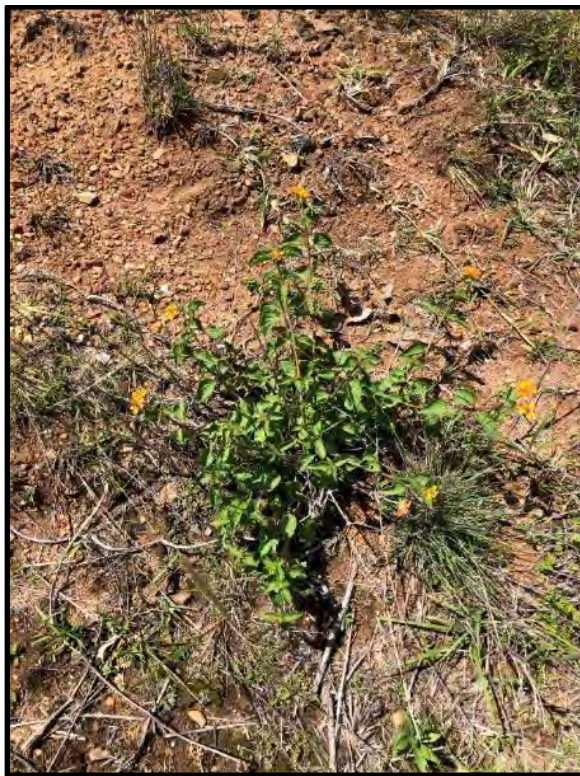
Introduced weeds or noxious plants were identified at eight specific Aboriginal heritage sites, but were also noted throughout the LCACHCA. These species included green cestrum (MTW-618), prickly pear (MTW-639, 640, 86, WS7), spiny rush (MTW-639), boxthorn (MTW-641), galenia (MTW-643), lantana (MTW-646) and fireweed (MTW-648). Although the presence of such species is not specifically detrimental to the Aboriginal heritage sites, their presence is noted so that these areas can be included in MTW's regular weed eradication programs. Eradication of weeds within the LCACHCA would also fit well within the environmental remediation program suggested above. If these areas are to be treated, then access for any poisoning or plant removal must be on foot, with no unnecessary ground disturbance to be conducted.

Lantana identified at MTW-646

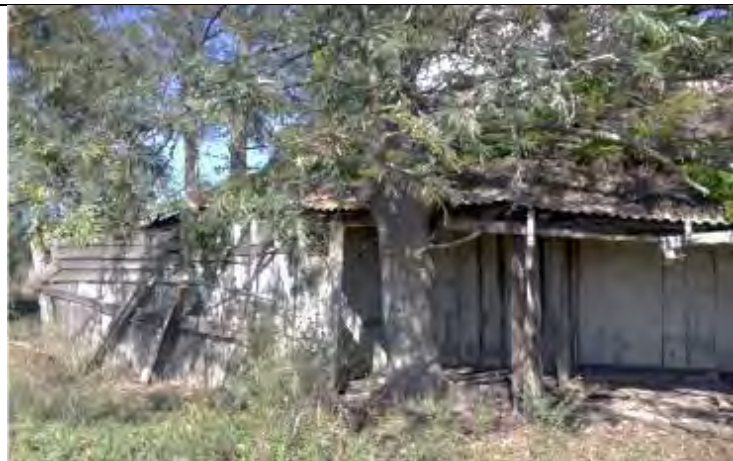
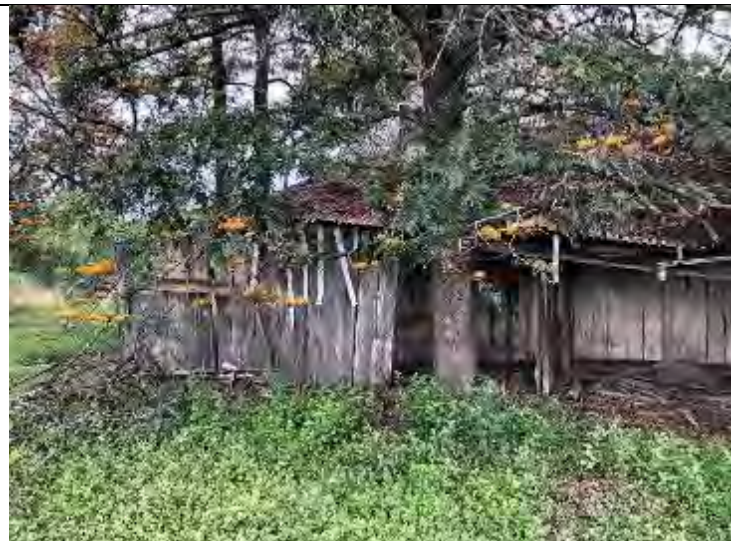
Eastern elevation: no discernible change.

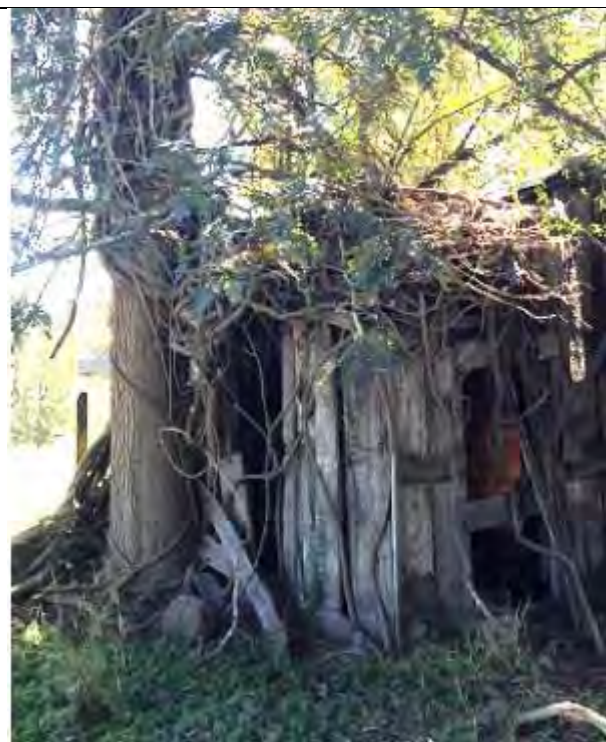
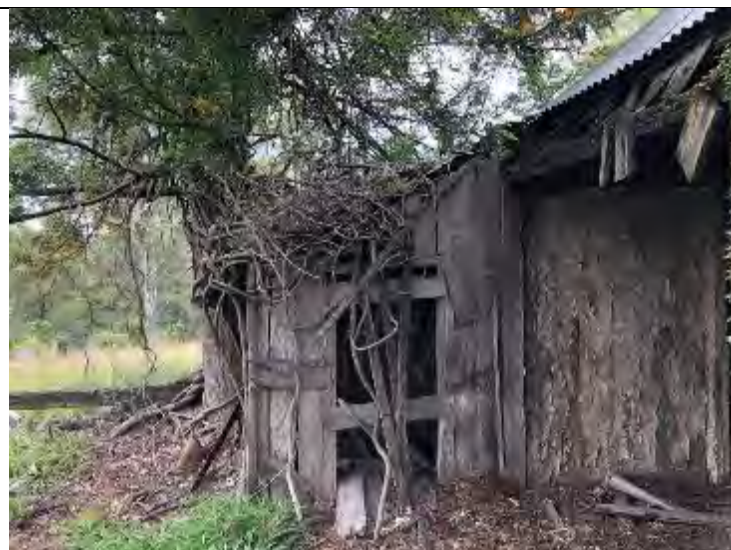
Looking towards south-west corner from east: no discernible change to tree impact, but note missing vertical slabs from southern wall.

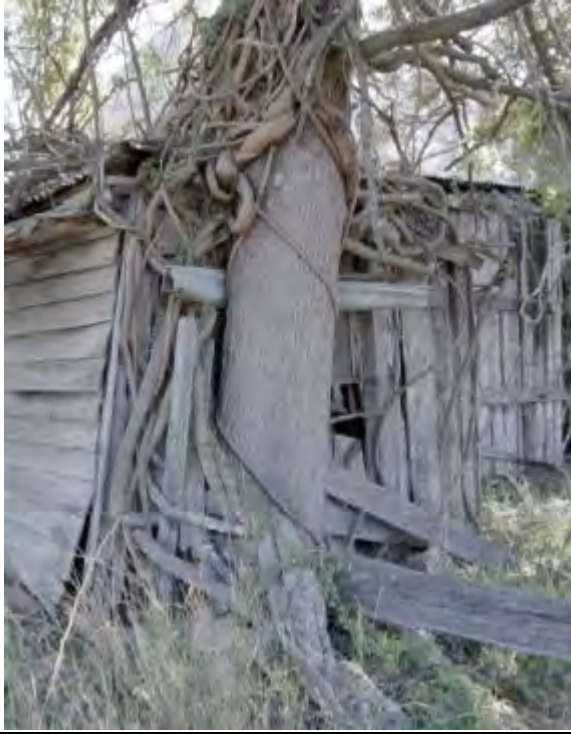
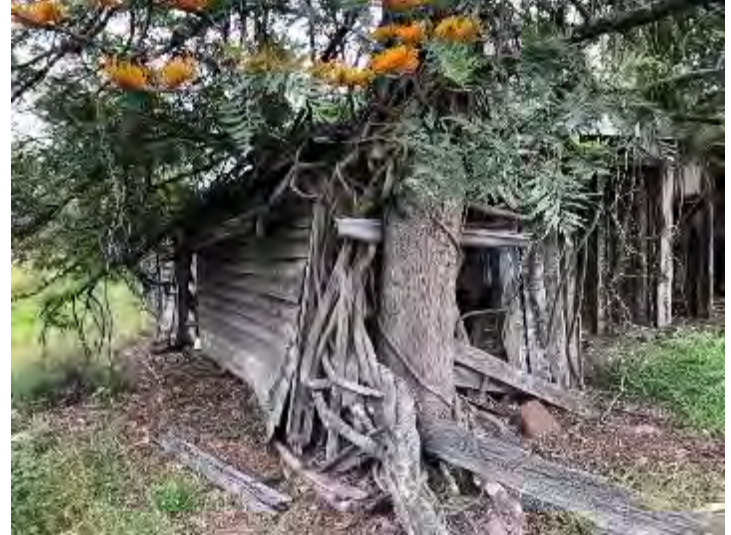
Looking towards south-west corner from south-west: no discernible change to tree impact, but note missing vertical slabs from southern wall.

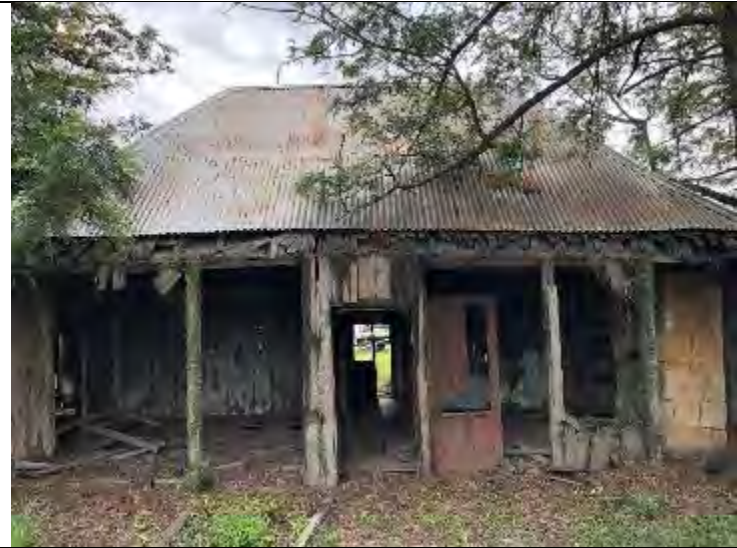
Southern elevation: vertical timber slabs have been removed from southern wall.

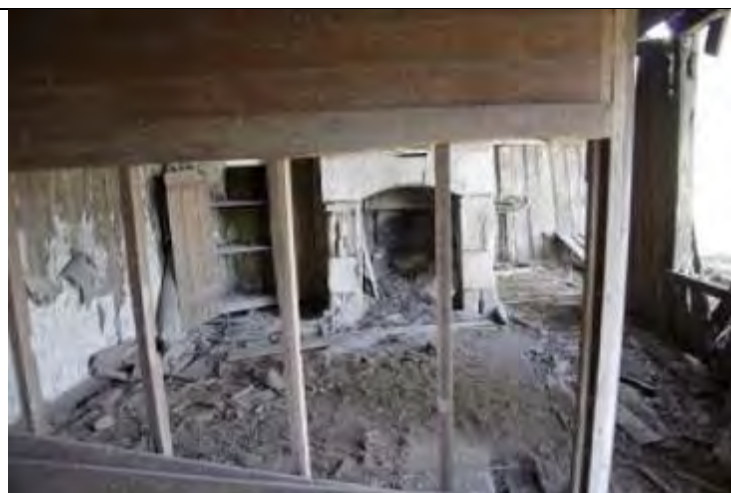
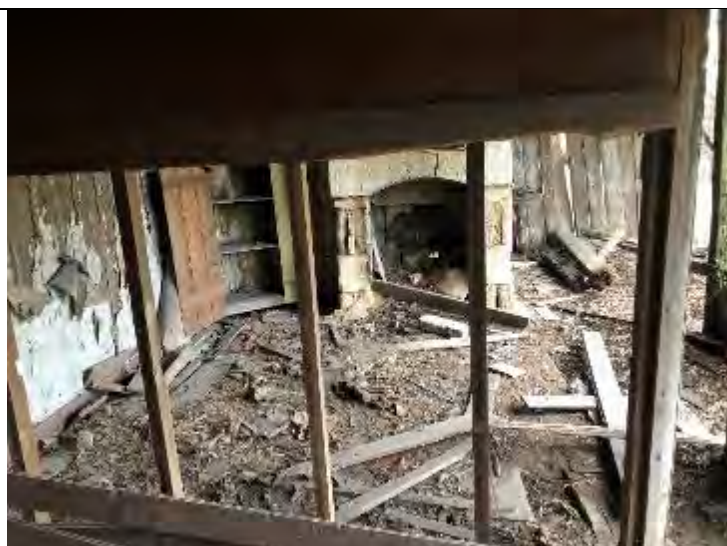
Room 2 interior: increased debris caused by removal of southern wall.

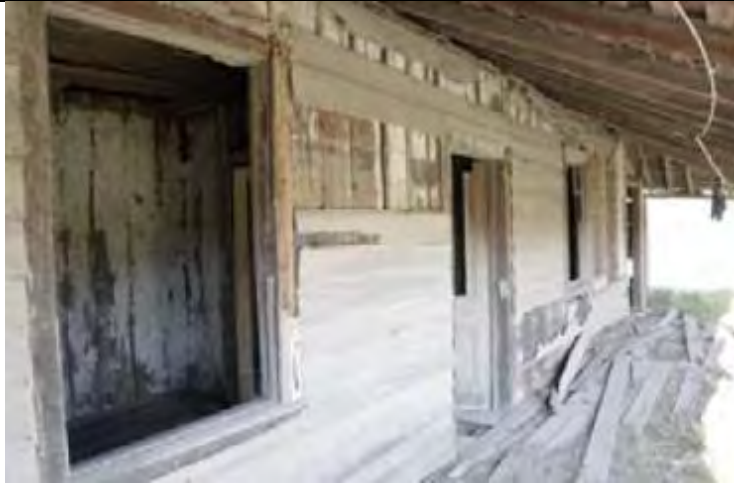
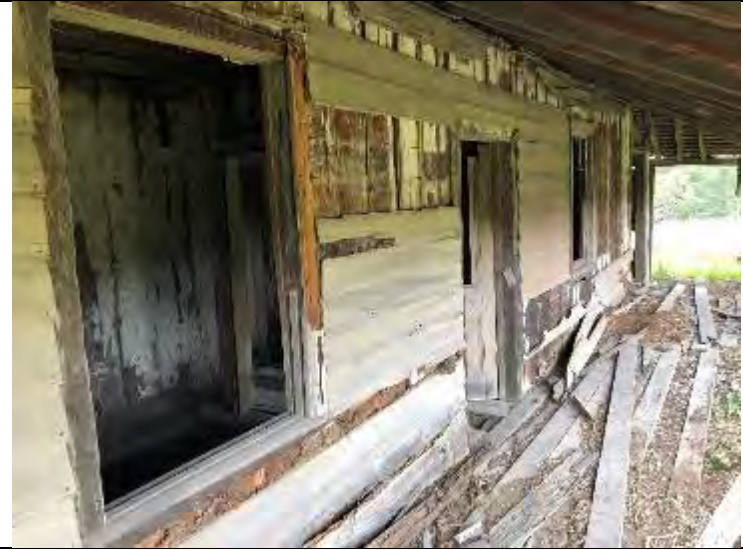
Northern elevation: further deterioration of weatherboard panelling.

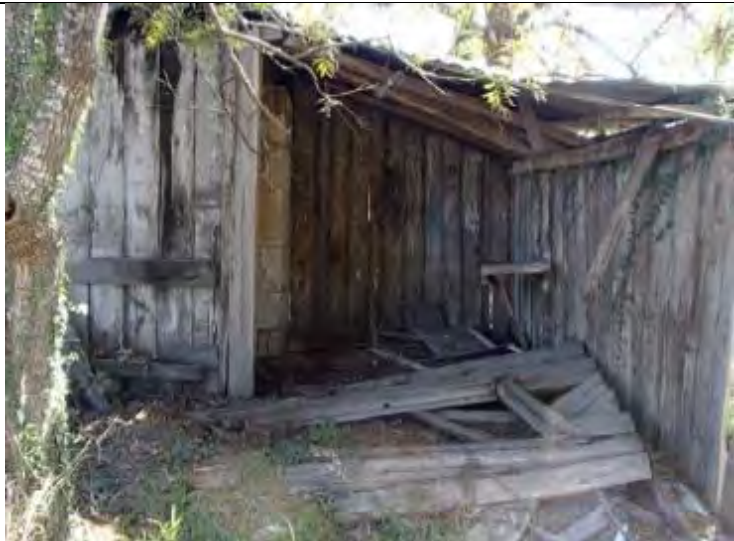
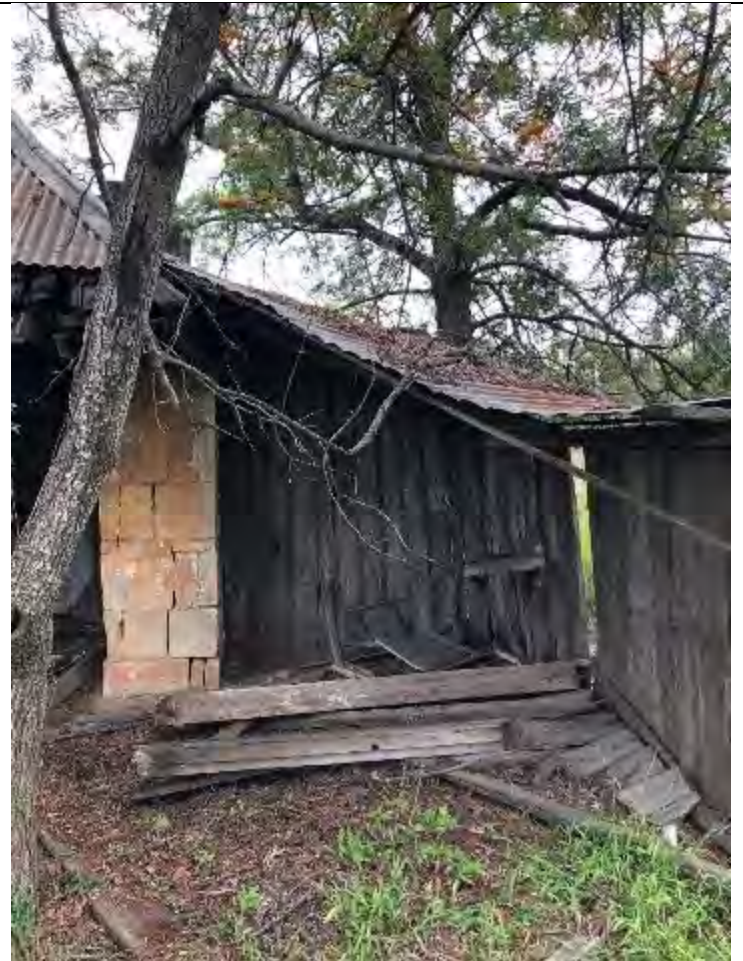
South-east corner: shows removal of vertical slabs from southern wall and further collapse of roof.

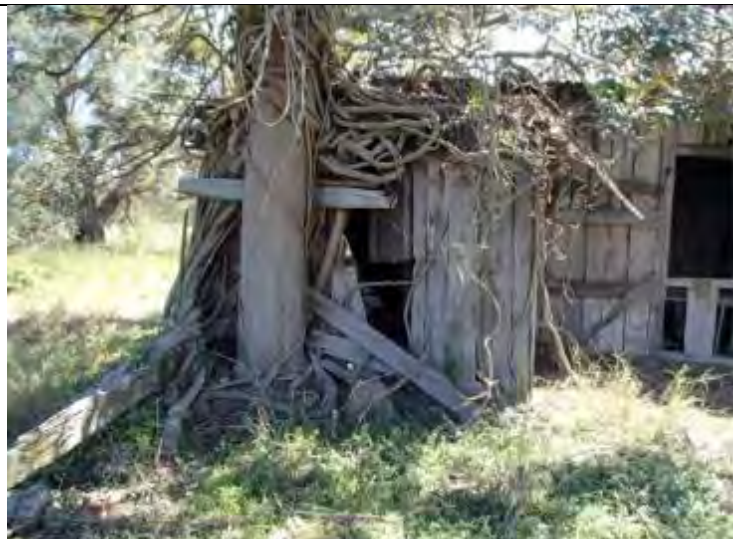
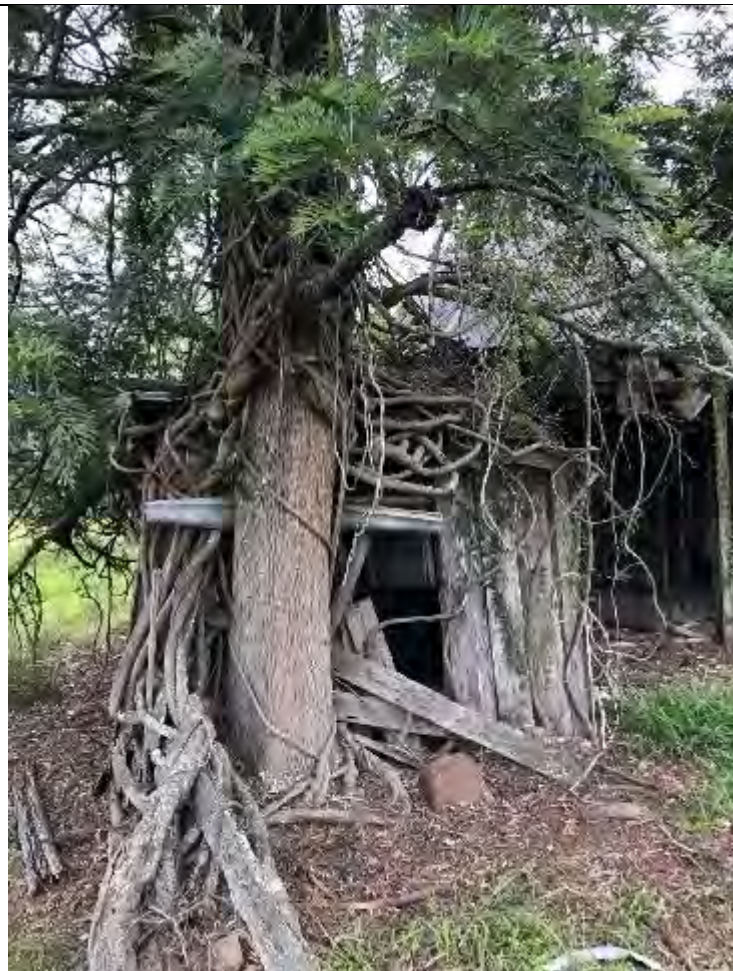
View of south-west corner from south: shows removal of vertical slabs from southern wall as well as some increase in vegetation growth.

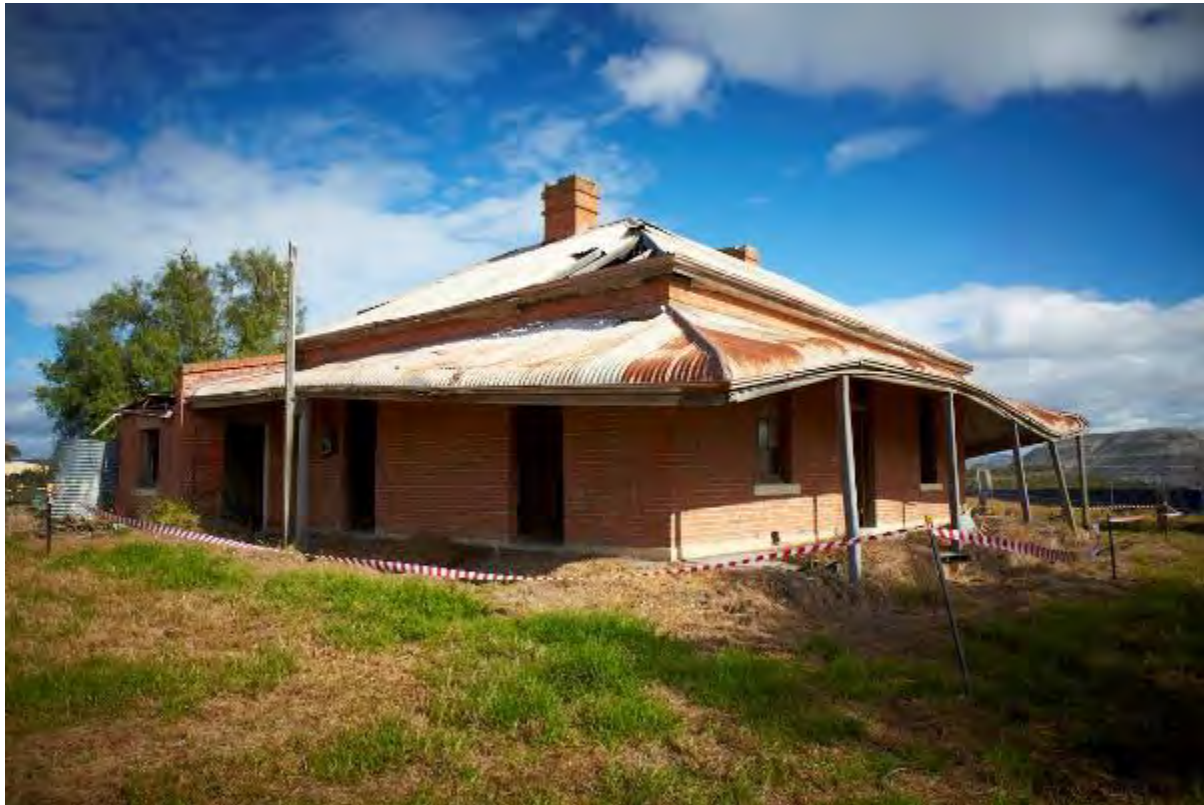
Mount Thorley Brick Farm House (2012)

The masonry structure of the building is sound, however, it was noted as being in poor physical condition in 2015 (when a CMP was developed for the site by ERM), with a collapsed verandah roof, missing or loose roof sheeting, missing or collapsed verandah posts, and floorboards and areas affected by termites. Recommendations are made within the CMP's conservation works schedule to arrest the deterioration of the building, a number of which appear to have been completed by the proponent.

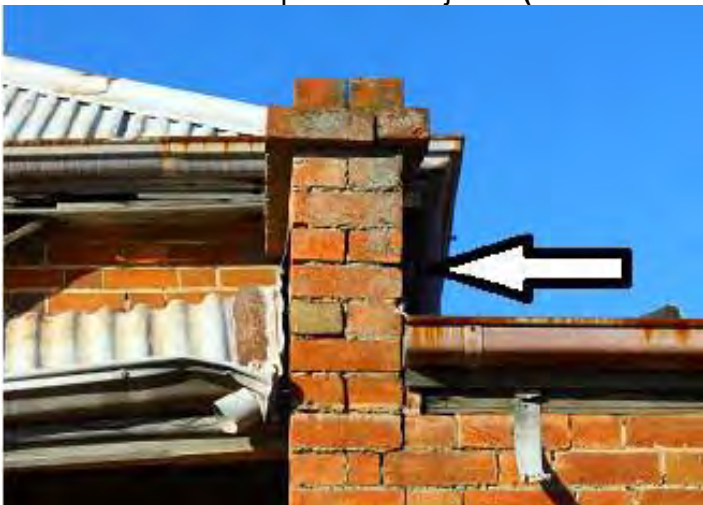
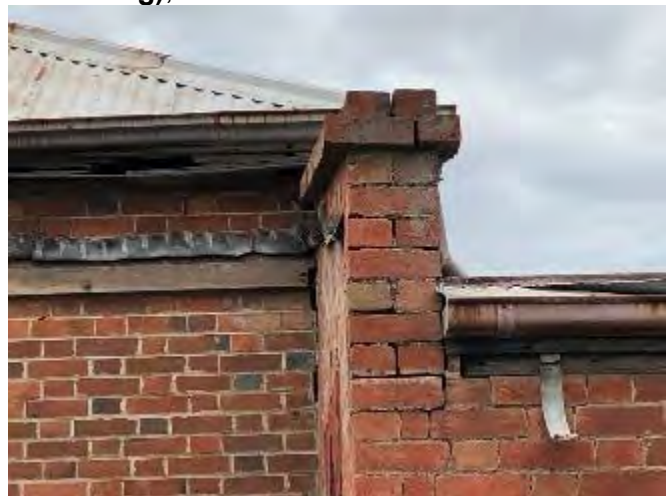
12. Monitor northern wall of Room 5, and if cracking or leaning worsens rebuild brick wall and repoint mortar joints (**no discernible worsening**);
