ASHTON LONGWALL 102 – MID PANEL REPORT

This report has been prepared by Ashton Coal Operations Pty Ltd (ACOL) and RPS Aquaterra.

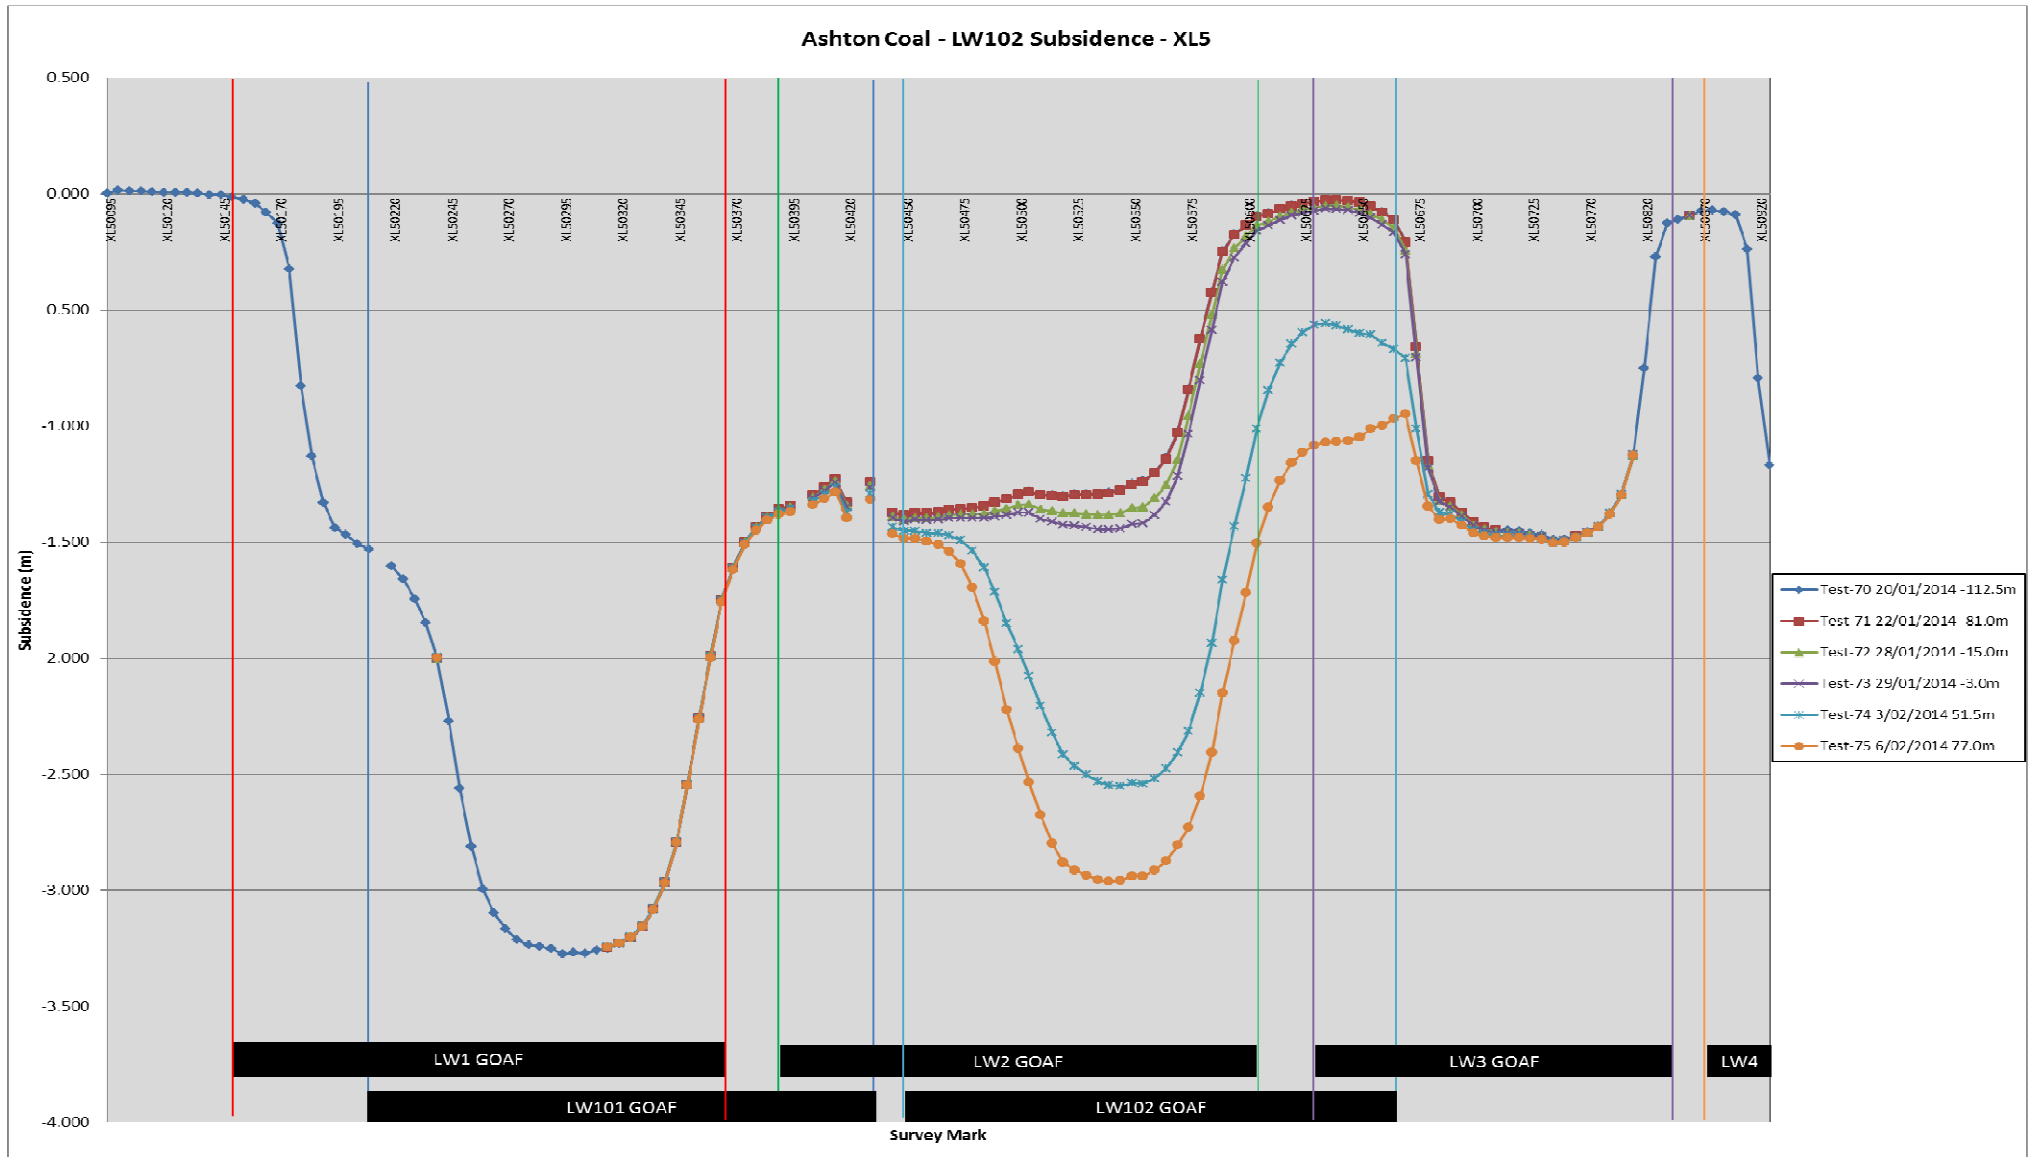
Figure 3: Vertical subsidence of XL5 – Pre and Post LW102

Subsidence monitoring over Longwall 102 to date consists of regular survey of centreline 1 (LW102 CL1) and cross line 5 (XL5). The frequency and results of the monitoring has been maintained per monitoring document "*Ashton Mine Subsidence Monitoring Programme Longwall 101 to 104*". This information is being supplied to the Principal Subsidence Engineer. A graph of the vertical subsidence of cross line 5 is shown in **Figure 3**.

Maximum Predicted SMP	Maximum Measured as at 06/02/2014		
		LW102 CL1	LW2 CL1	XL5
Longwall 102				
Subsidence (mm)	4000	2015	2897	2962
Tilt (mm/m)	189	23.9	38.9	51
Tensile Strain (mm/m)	76	11	15.4	21.4

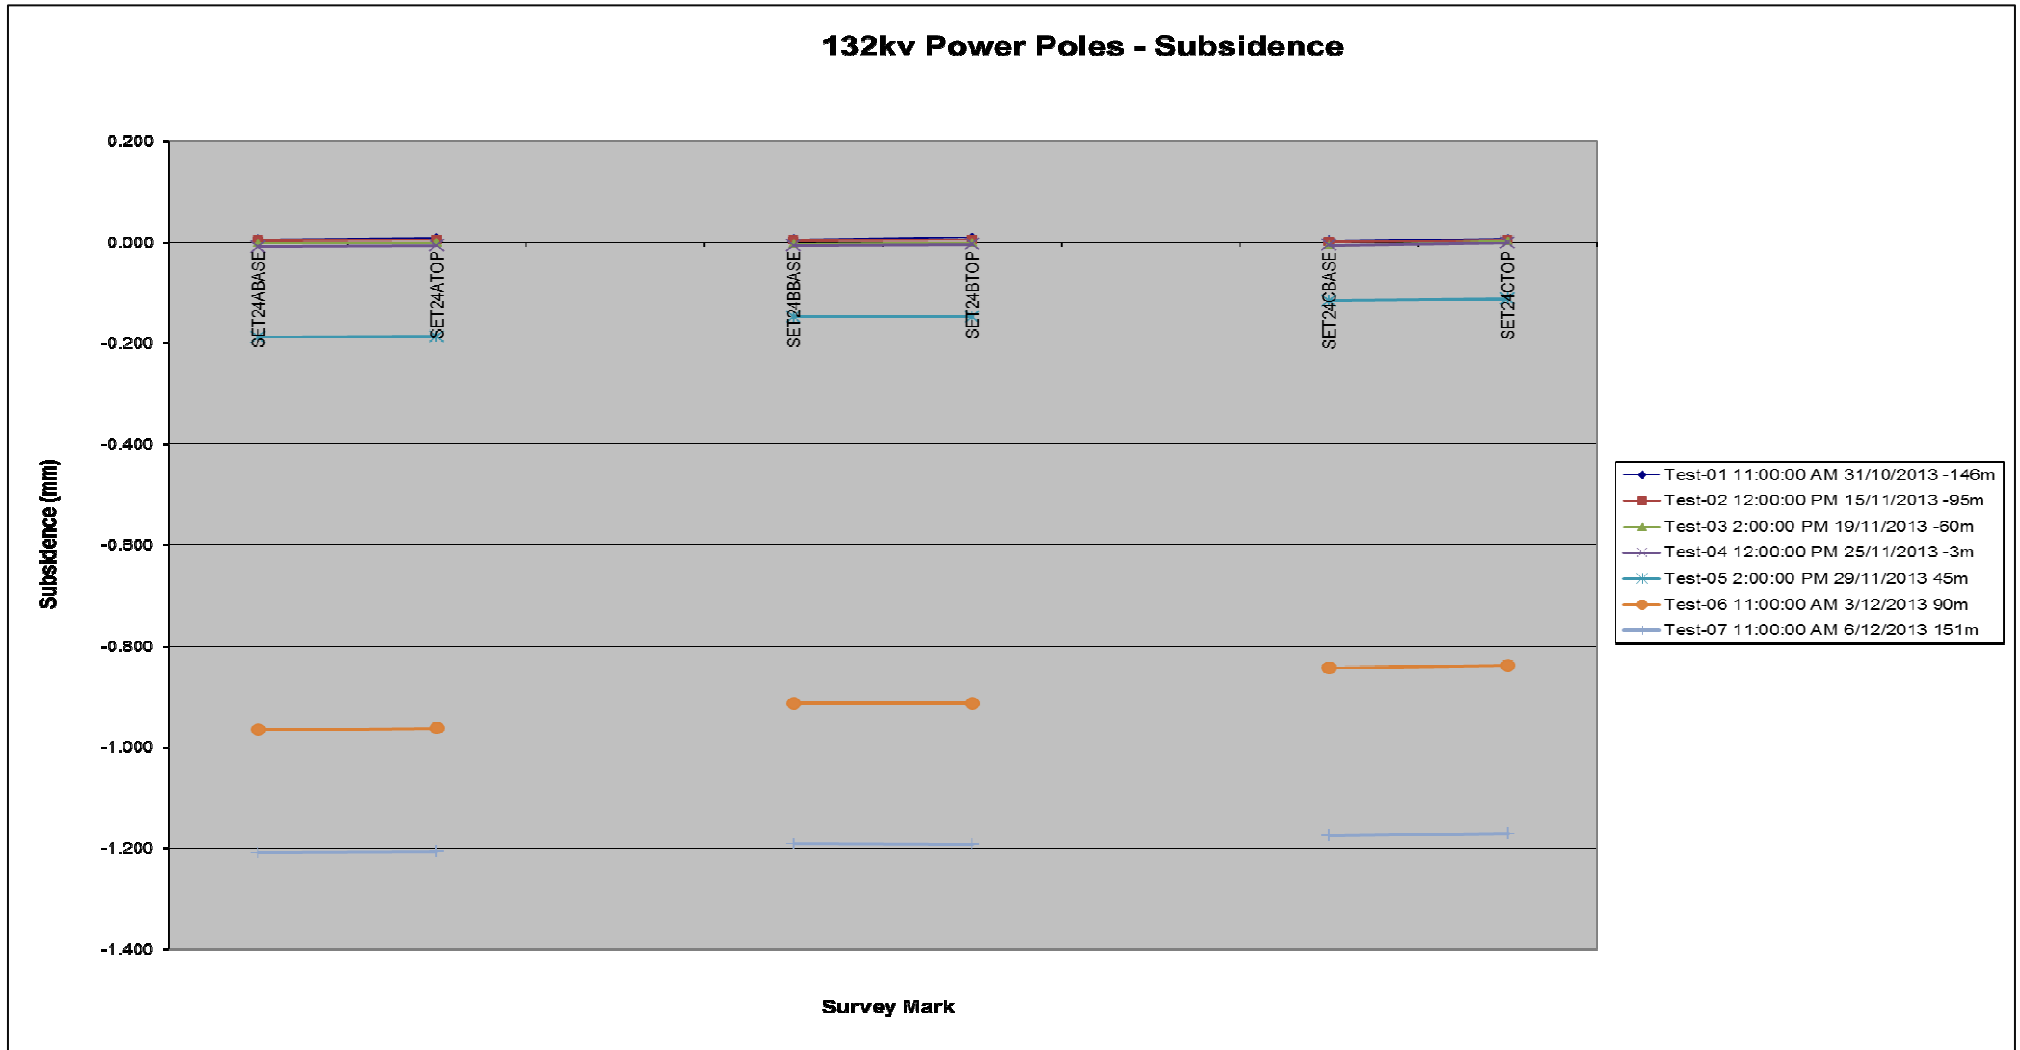
Figure 4: Subsidence Monitoring Data 132kv Power Poles – Set24 A, B and C

Visual and survey monitoring of existing 132kV power transmission structures over Longwall 102 was undertaken regularly. The 132kV poles have been referenced as SET24 – A, B & C, and SET25. The 132kV transmission line was surveyed prior to, during and post undermining. Survey data from the 132kV power lines was recorded and supplied to the Principal Subsidence Engineer as per the "*Ashton Mine Subsidence Monitoring Programme Longwall 102*". The effects of subsidence on the 132kV structures can be seen in **Figure 4**. Maximum subsidence measured on power poles (SET24 – A, B & C, and SET25) during Longwall 102 mining was: 1.21, 1.19m , 1.17m and 0.06 respectively.

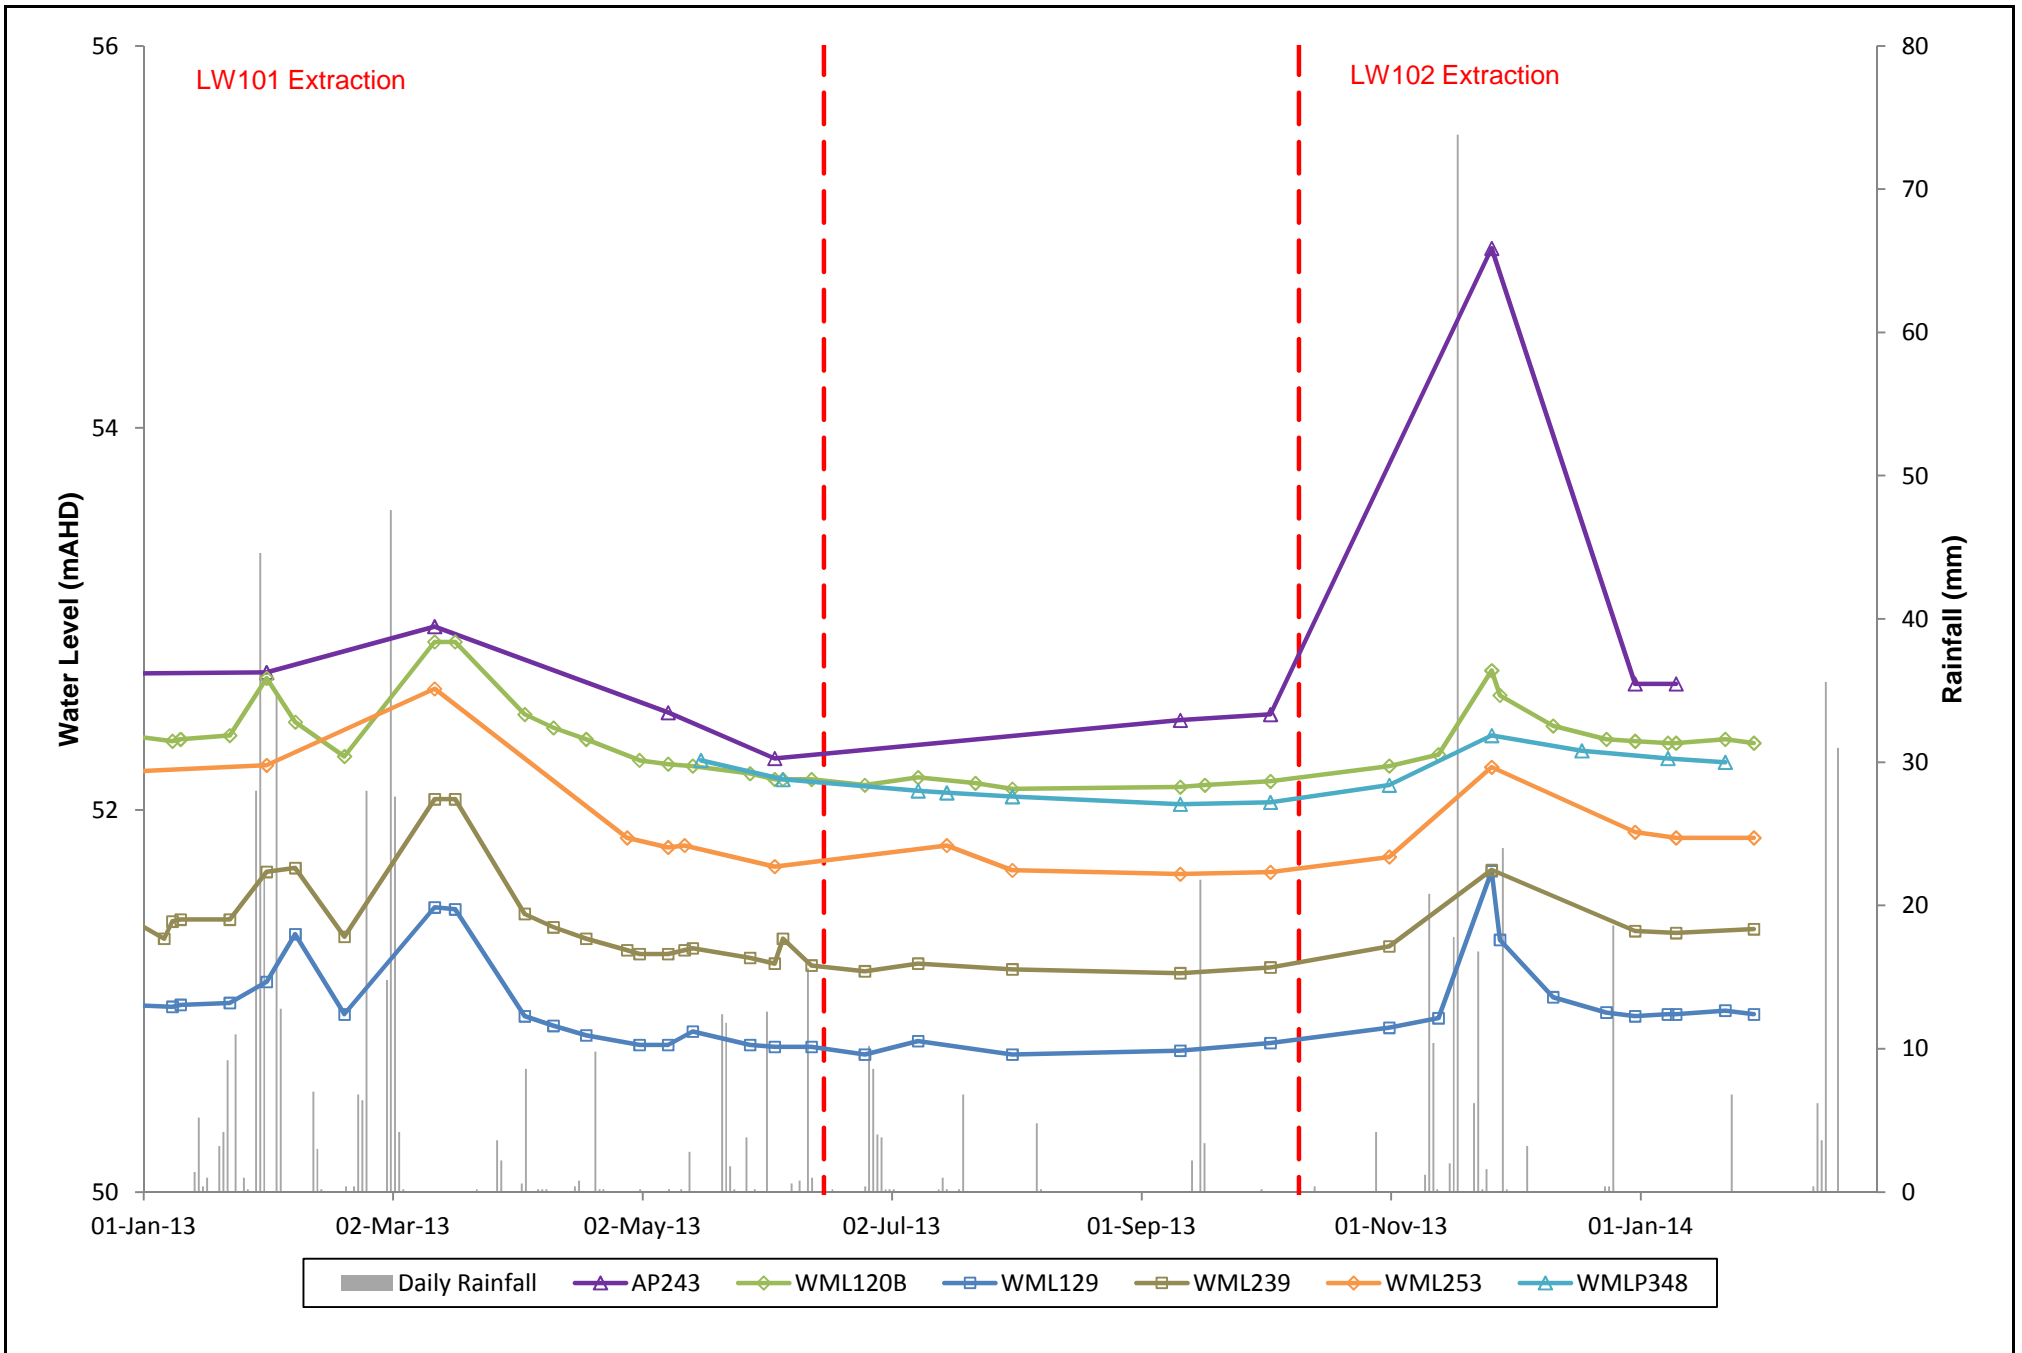
HYDROGRAPH: GLENNIES CREEK ALLUVIUM FIGURE 1

- Glennies Creek Alluvium: Monitoring shows no response in the Alluvium to the extraction of LW102. There was a significant recharge rainfall event in November that caused a response. The monitoring shows the saturation of the alluvium is being influenced by the rainfall events with a rise in levels during higher average rainfall and a decline in dry periods;

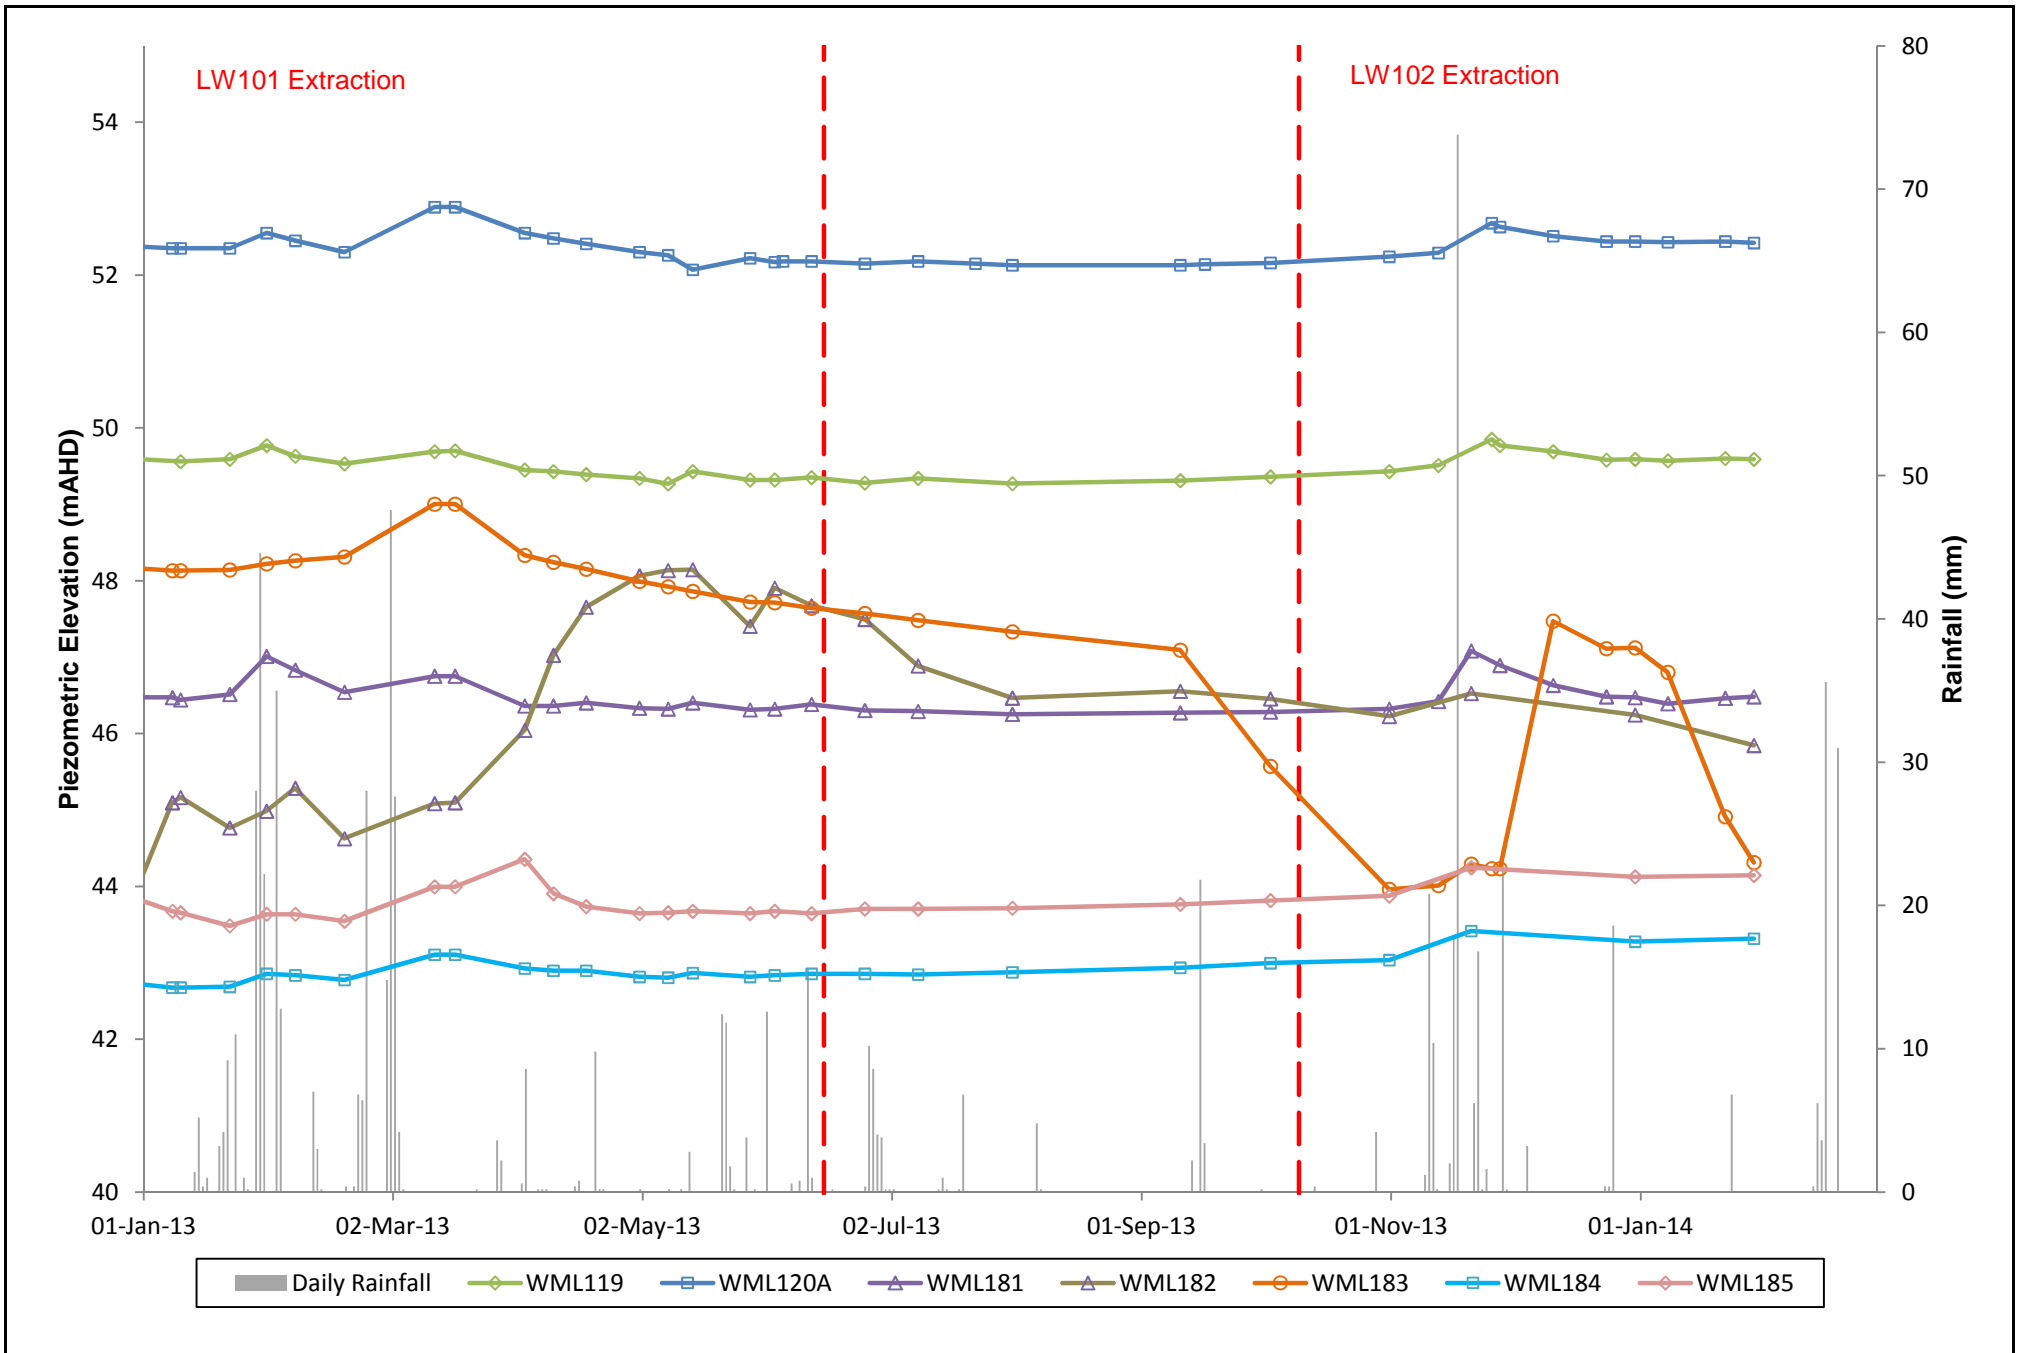
HYDROGRAPH: PIKES GULLY SEAM FIGURE 5

- Pikes Gully seam: The monitoring shows no change in the saturation of the Pikes Gully seam from LW102 extraction. This is as predicted as it is assumed to be slowly draining due to the previous extraction of the seam within the approved mine area. WML183 shows behaviour that is not consistent with adjacent monitoring bores and does not coincide with any mining activity or rain events. The monitoring bore is being investigated.
