ASHTON LONGWALL 7A – END OF PANEL SUMMARY REPORT**1 INTRODUCTION**

End of Panel Report

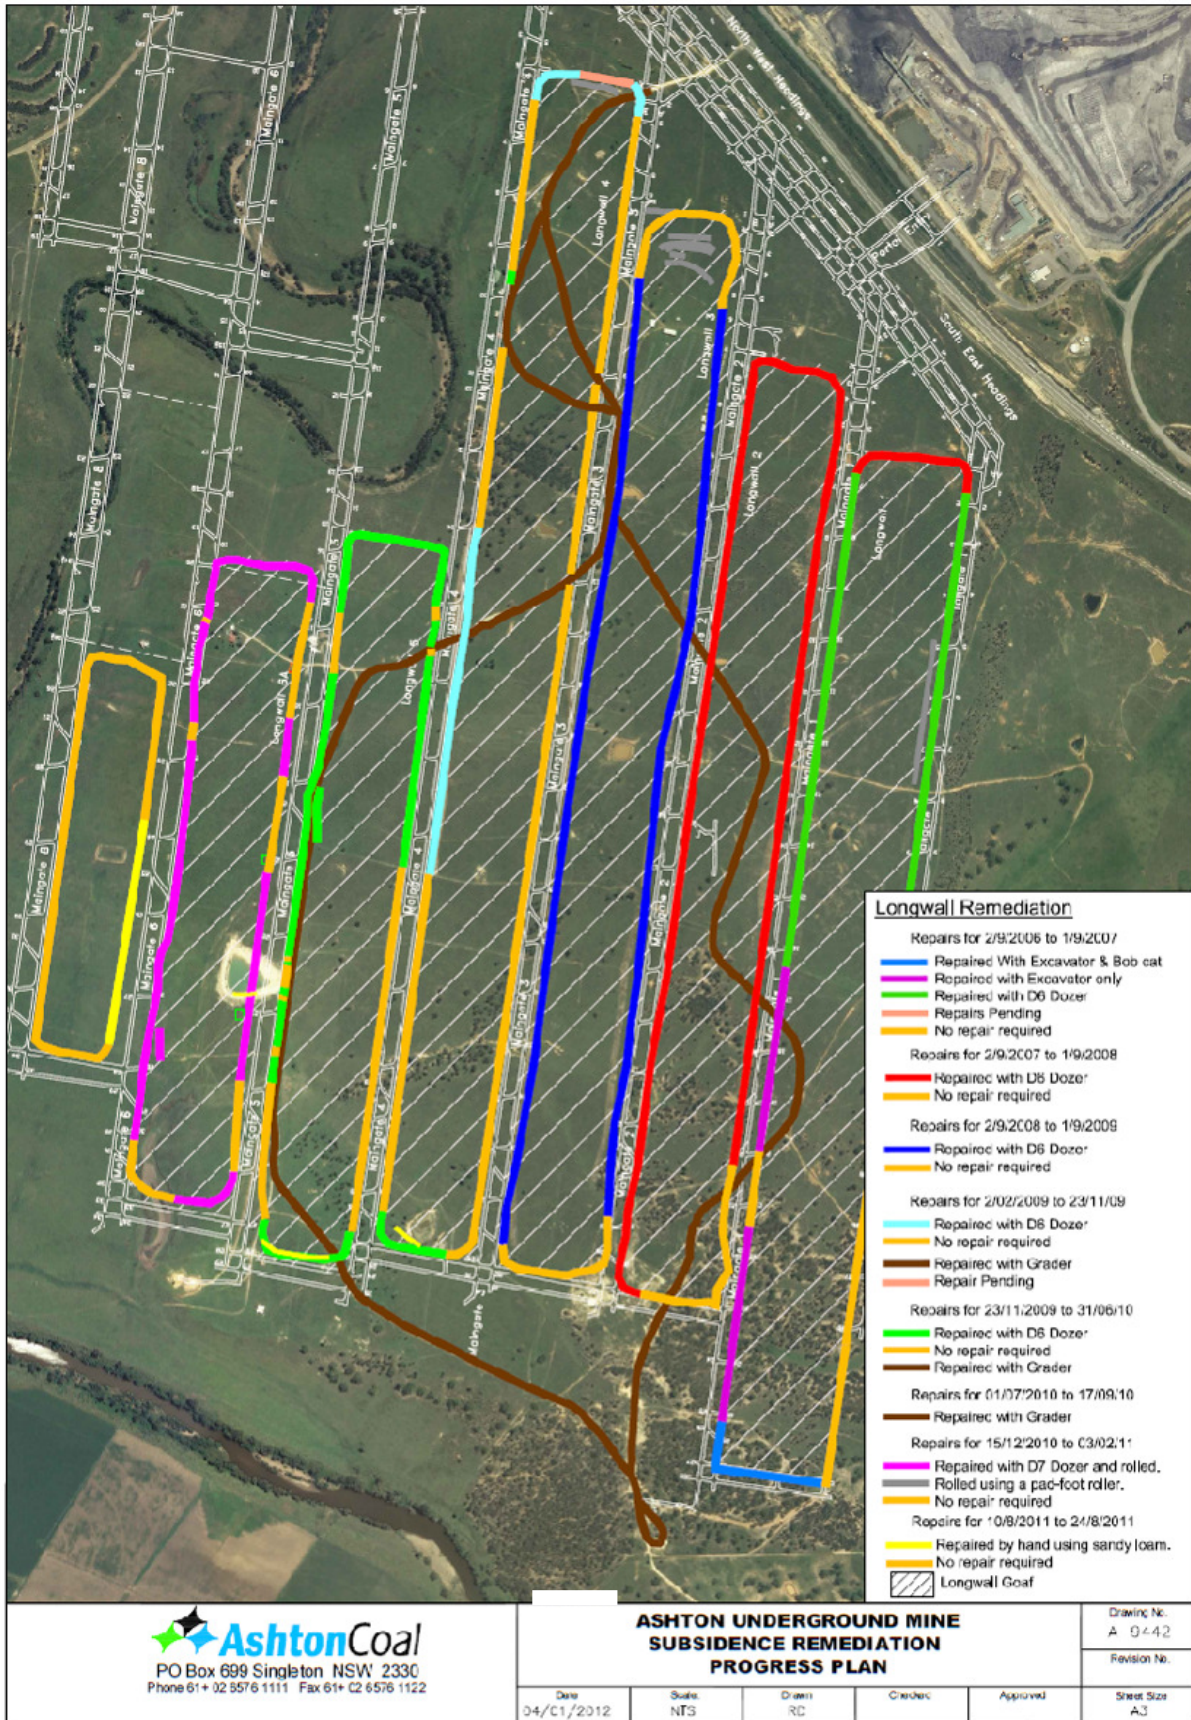
Figure 3: Subsidence remediation progress.

The extent of subsidence remediation at the goaf edge for all longwall's is outlined in **Figure 3**. A specific, defined example of gateroad cracking which developed over Longwall 7A is shown

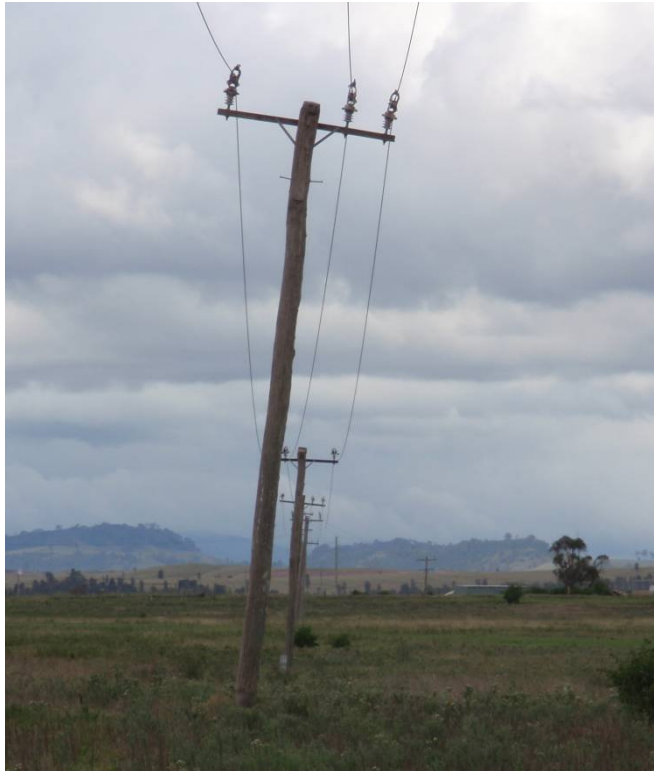
Figure 4: 11kV power line located mid panel in LW7A looking north pre-undermining (05/04/2011). Rollers have been fitted to this line in preparation for undermining.

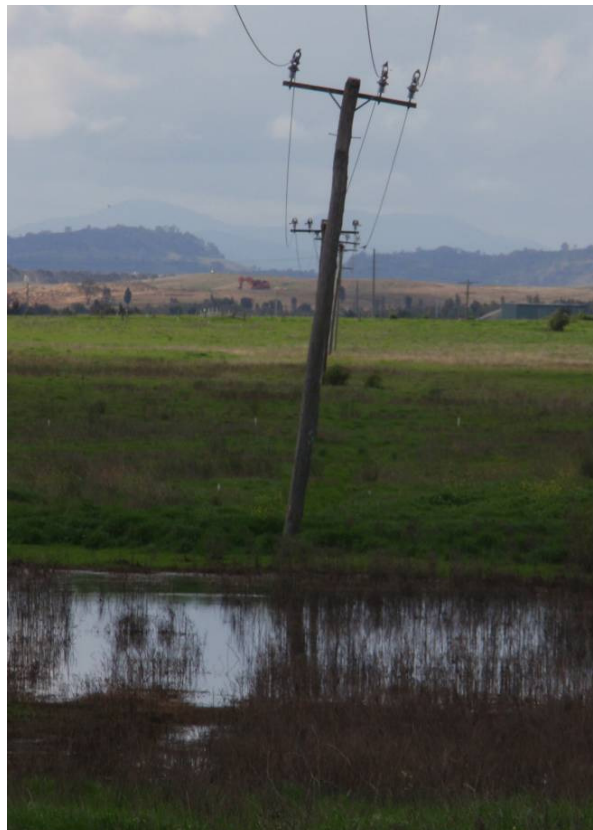
No overhead power lines were negatively impacted by undermining or repair work of Longwall 7A subsidence cracks. This infrastructure included an overhead 11kV and 132kV power line. No buried power/phone cables were disturbed by Longwall 7A undermining or remediation. One cable exists over the gate-edge of LW7A and feeds a neighbouring mine sites dust monitor. Remediation occurred around this site with no ill effects. The powerline infrastructure undermined had rollers installed to prevent any subsidence induced tension on the lines. Powerlines remained visually stable and relatively straight during and post undermining.

Figure 5: 11kV power line located mid panel in LW7A looking north post-undermining (02/09/2011).

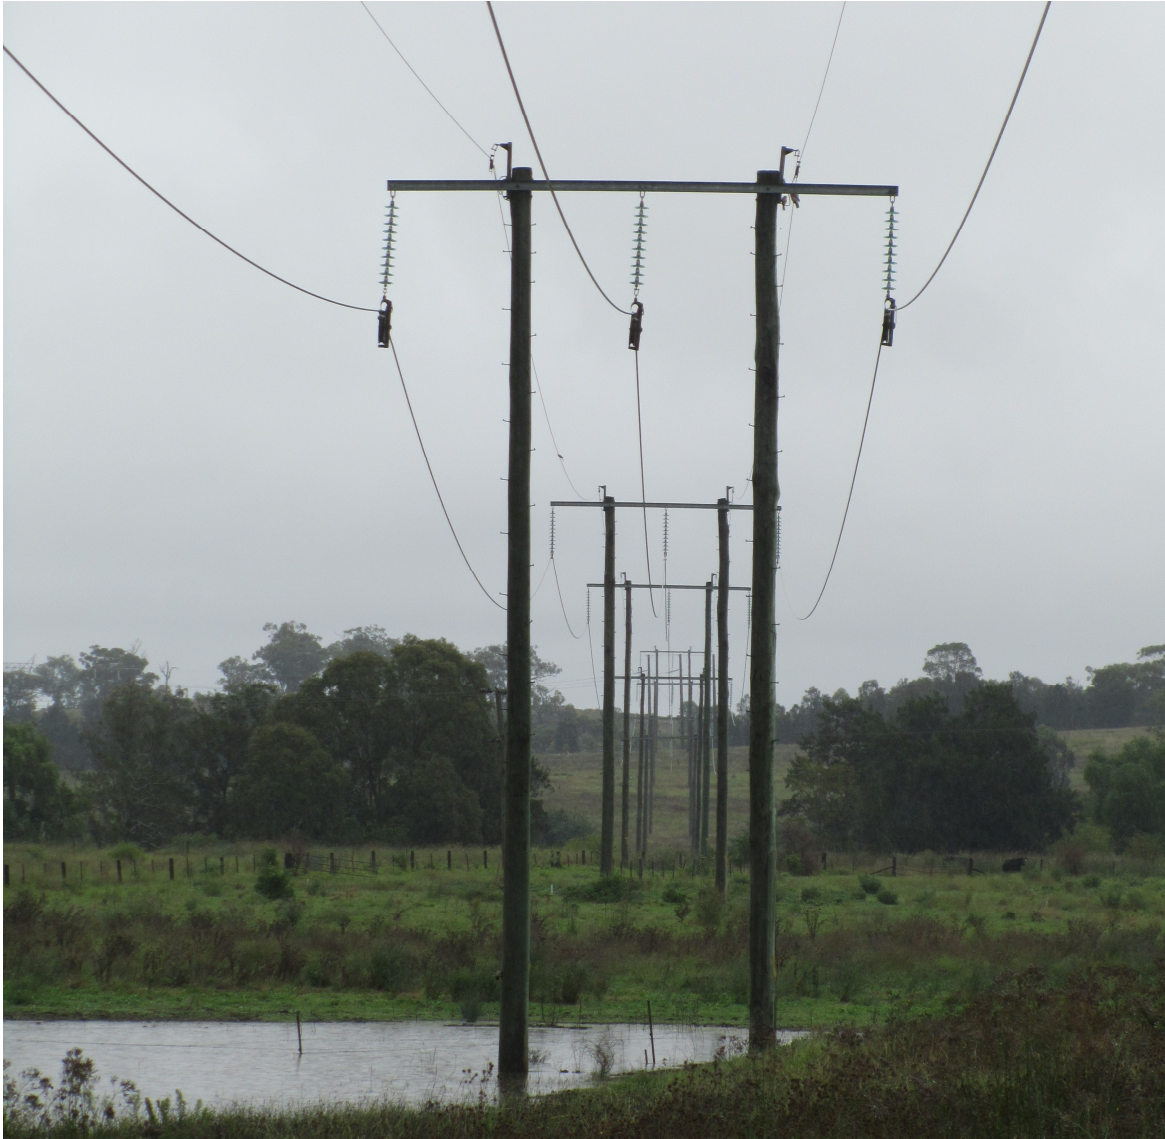
Visual and survey monitoring of two existing 2 pole 132kV power structures and an 11kV line over Longwall 7A was undertaken regularly. The 132kV pole sets have been referenced as Set 11 (located towards the Tailgate of LW7A) and Set 12 (located near the Maingate of LW7A). The 11kV powerline was surveyed prior to undermining and visually inspected during/post undermining to ensure adequate clearance and safety. **Appendix 1, Figure 4 and 5** shows the 11kV powerline post rollers being fitted and post undermining respectively whilst **Figure 6** shows the 132kV line post subsidence. Survey data from the 132kV powerline set was recorded and supplied to the Principal Subsidence Engineer as per the *Ashton Mine Subsidence Monitoring Programme Longwall 6B-8*. The effects of subsidence on both 132kV structures can be seen in **Appendix 2**. A maximum of 0.09m and 0.03m of subsidence has been recorded to date on pole Set 11 and Set 12 respectively.

Figure 6: Pole set 11 (foreground) and Pole set 12 (Background) post subsidence.

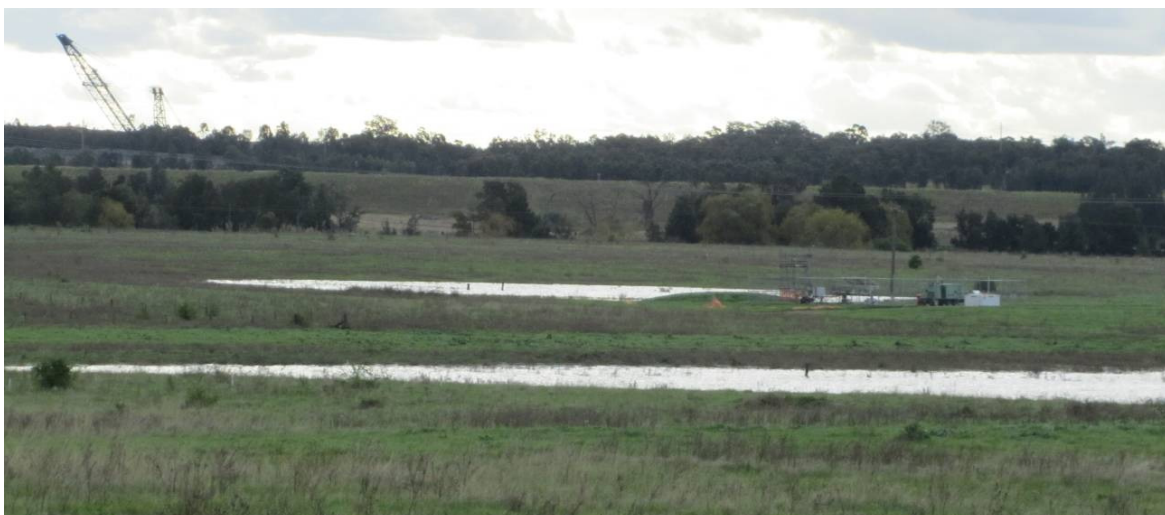
Initial caving over the start of Longwall 7A was typical of the caving behaviour observed elsewhere at ACOL and consistent with predicted subsidence behaviour. No crack was observed over the LW7A start line however a shallow depression formed. This resulted in localised ponding and is discussed further below.

Figure 7: LW7A ponding in the background behind Gas Drainage Plant 4 (16/06/2011). The ponding in the foreground is dam 10 which includes the ponding caused by subsidence during Longwall 6A.

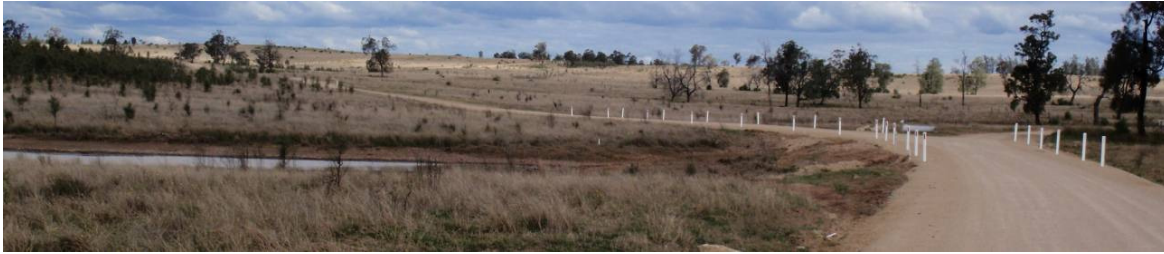
Ponding over Longwall 3 (at chainage 530m) has been left as a water storage area. Because of its size and tendency to fill after rain events repair will not occur at this stage. Other areas where ponding has become evident is three zones over Longwall 5 (at Chainage 1,090m, 400m and 80m) and Longwall 6A (at Chainage 2,360m and adjoining Dam 10). Ponding above LW6A adjoining Dam 10 is shown in **Figure 7** (foreground). Ponding has developed adjacent to gas drainage plant 4 (~65m outbye the LW7A start point) during Longwall 7A extraction. This is the only site of ponding over the Longwall 7A panel and is shown in **Figure 7** (background). All areas of ponding currently pose no safety or environmental issues however they may need to be pumped out or have natural drains re-established to prevent continual filling and holding post lower seam extraction. This is planned as future remediation. Works were undertaken independent of, but during the Longwall 7A mining period, to install culverts under the dirt access road to allow suitable drainage of the Longwall 3 ponding. This is shown in **Figure 8**.

Figure 8: Roadworks completed on the dirt access road to install suitable drainage for the Longwall 3 ponding.

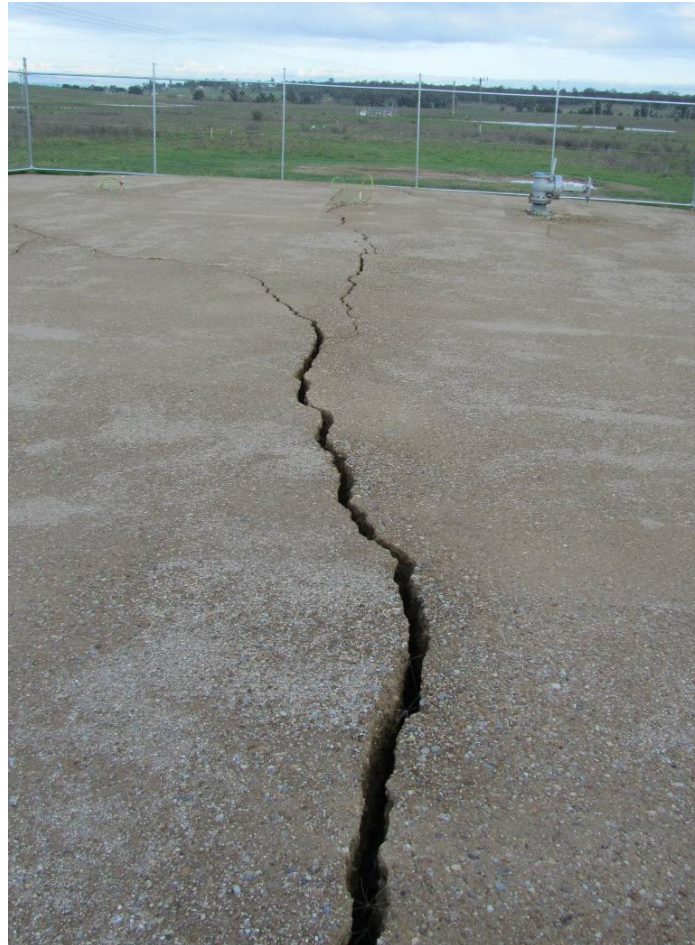
Figure 9: LW7A Gateroad cracking through the compacted pad area at Gas Drainage Plant 5 pre-remediation (16/06/2011).

Remediation of cracking over Longwall 7A was undertaken by filling the cracks with loam (sand and clay mixture). This was pushed into the cracks by hand using a shovel with a small 'dingo' loader used to deliver material to the crack. The loader was used to compact the soil into the void where possible. Post initial filling of the crack, secondary filling occurred once the loam had settled into the crack. Secondary filling was minimal for most cracks if the loader was able to be used during primary crack filling. Where this wasn't the case, the soil took time to settle resulting in some minor depressions.

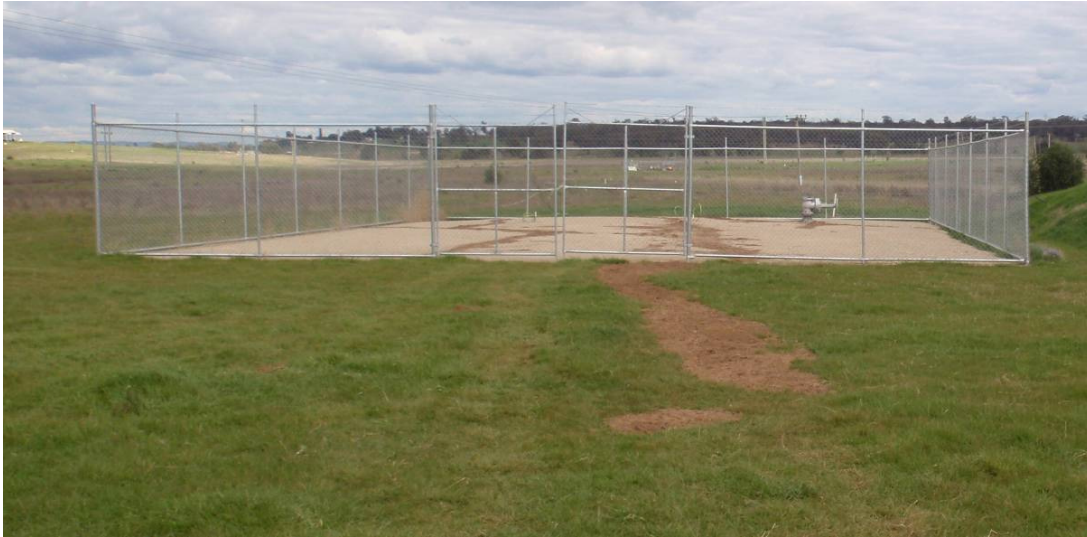
Figure 10: LW7A Gas drainage plant 5 following remediation (10/08/2011).

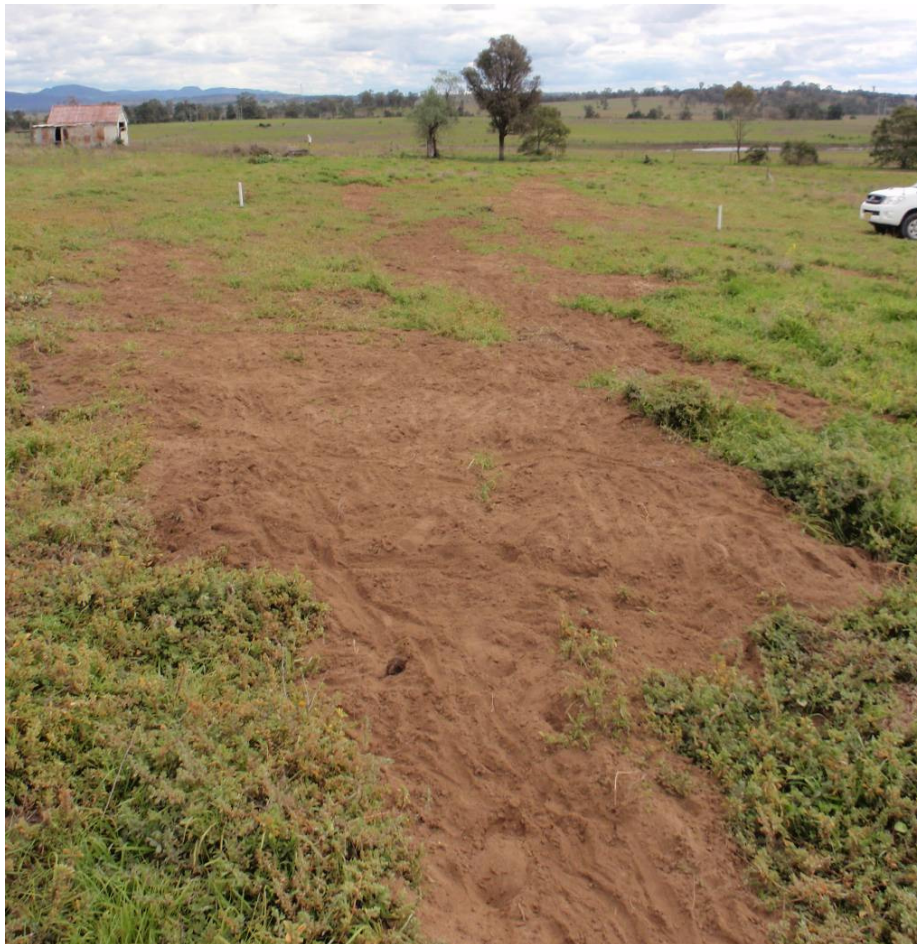
During Longwall 7A subsidence remediation, some previously remediated cracks areas which required secondary remediation had loam spread into depressions and eroded areas. This was the case for the Longwall 4 and 5 start lines. The depressions and holes which had formed were the result of the ripped soil settling into the crack with rainfall and compaction. The loam was used to re-level the surface and was fine enough to flow down any un-filled sub surface cracks. **Figure 11** shows the result of re-levelling the LW5 start line depressions.

Figure 11: Longwall 5 secondary remediation (10/08/2011). Loam was used to re-level the ground following settling of the ripped soil.
