ASHTON LONGWALL 4 – END OF PANEL SUMMARY REPORT

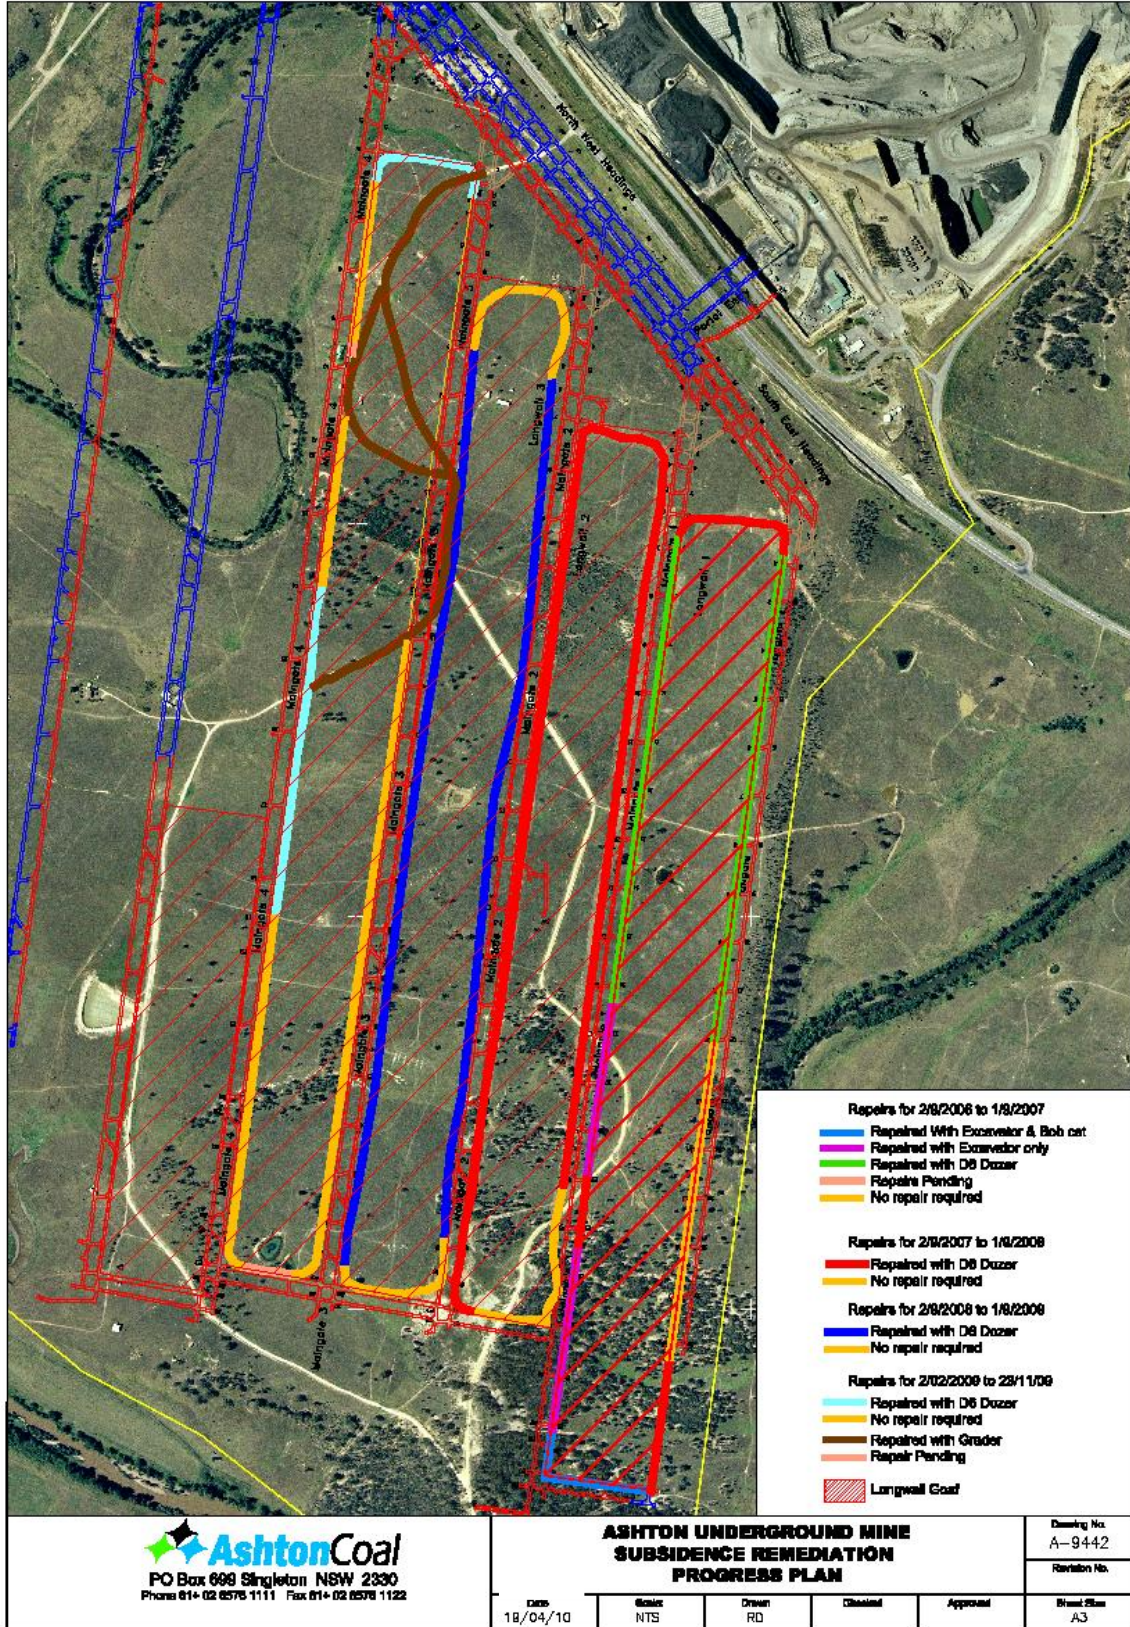
Figure 3: Subsidence remediation progress.

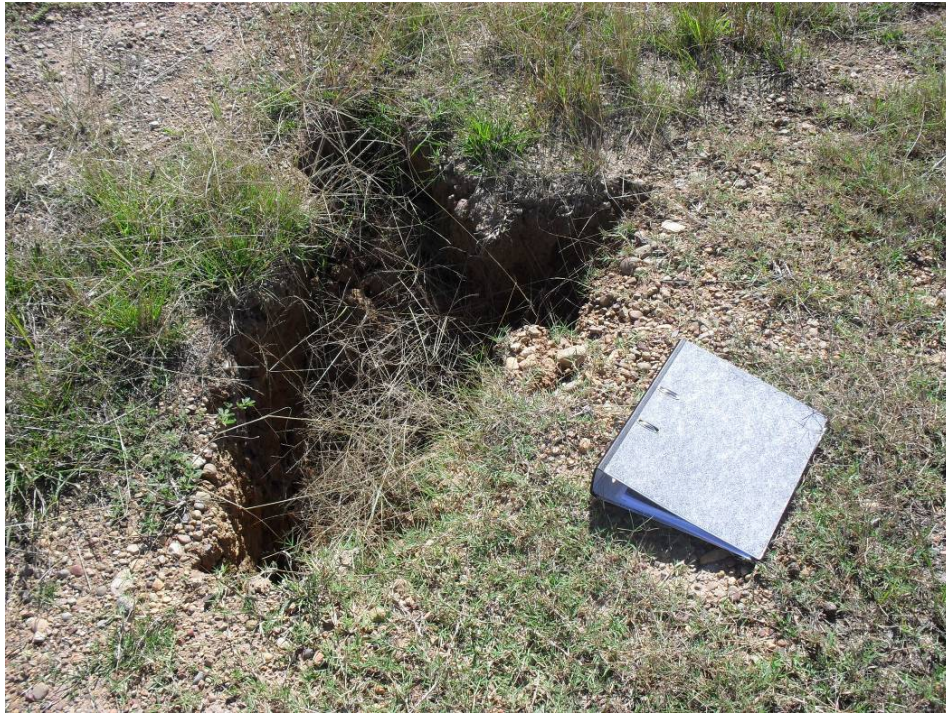
A small farm shed was undermined at chainage 510m. This had no visible subsidence damage. Mining progressed adjacent to a house in the paddock. The 'Blue House' had no structural signs of damage with cracks developing just outside the house yard. A subsidence hole (**Appendix 1, Figure 4**) in front of this house will require repair when the start line is being ripped and remediated. This house was evacuated prior to the area in front of it being undermined.

Figure 4: Subsidence in front of Blue House (Chainage 420m)

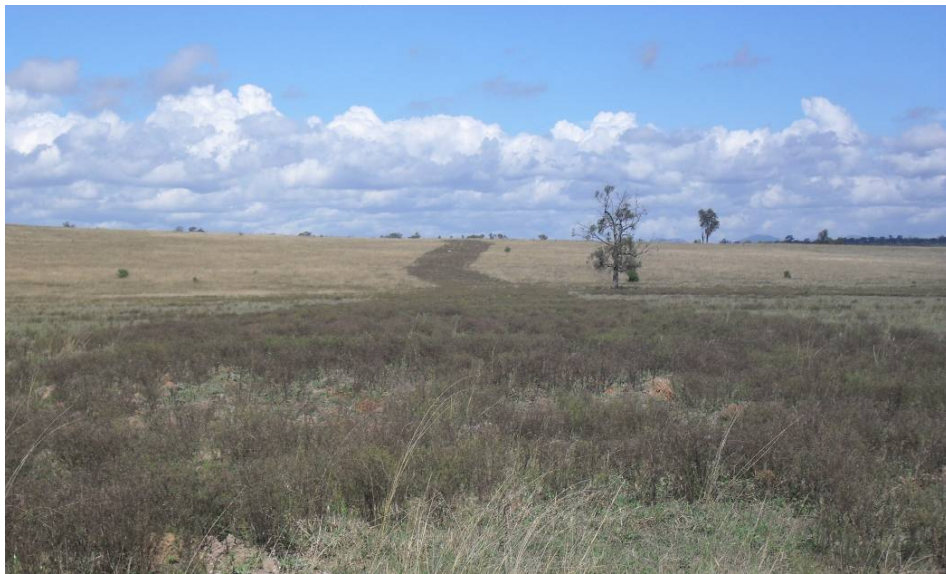
Figure 5: Subsidence Remediation looking south-south west from 23/11/09

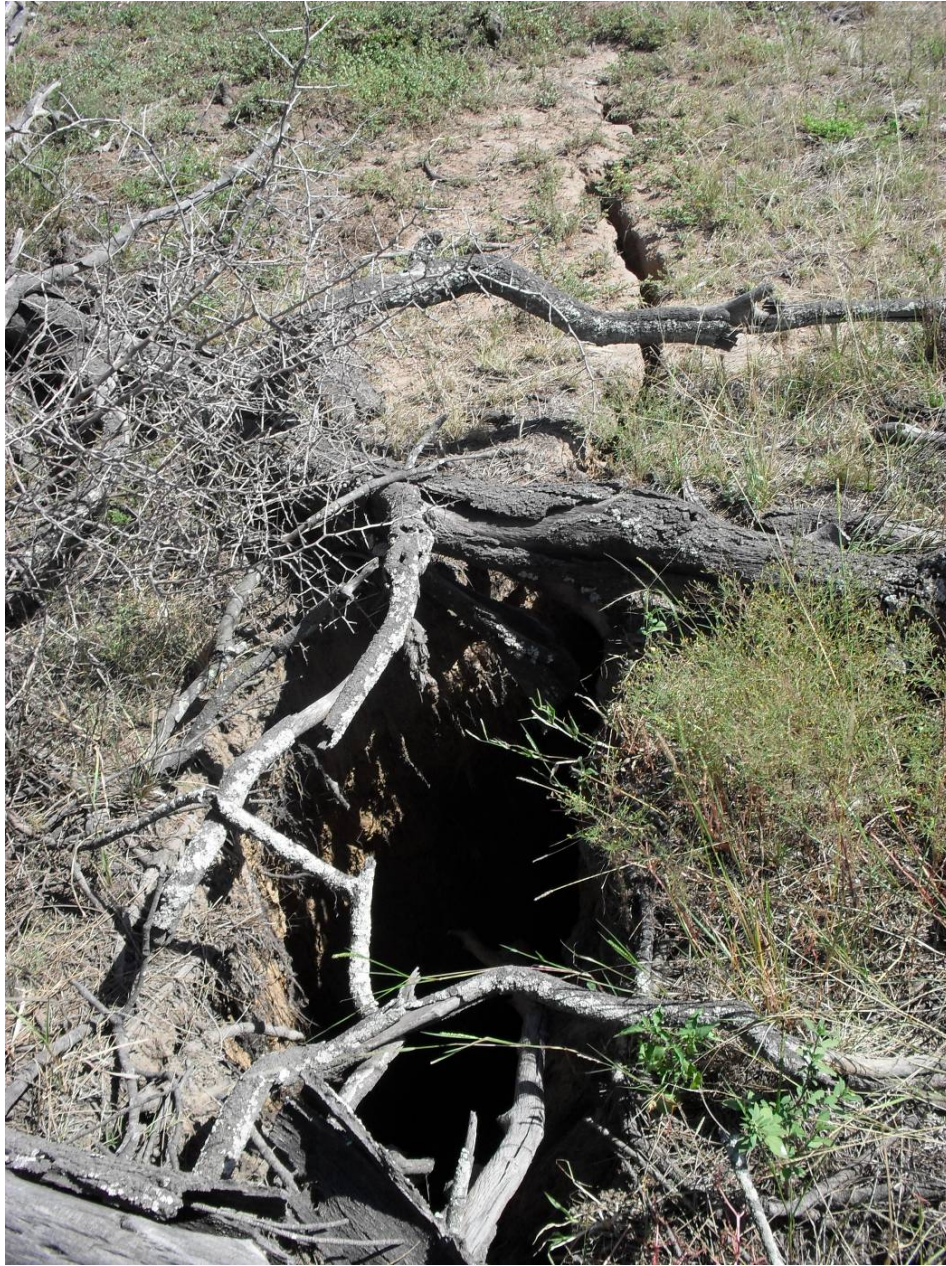
Initial caving over the start of Longwall 4 was typical of the caving behaviour observed elsewhere and consistent with predicted subsidence behaviour. **Appendix 1, Figures 6 and 7** show the cracking which has developed over the Longwall 4 start line. Little remediation has been done on these cracks and they remain open for remediation in the future. The timing of this will follow archaeological work which must first be done in the area.

Figure 6: Start line crack in drained dam. This has formed under a tree positioned in the side of the dam wall.

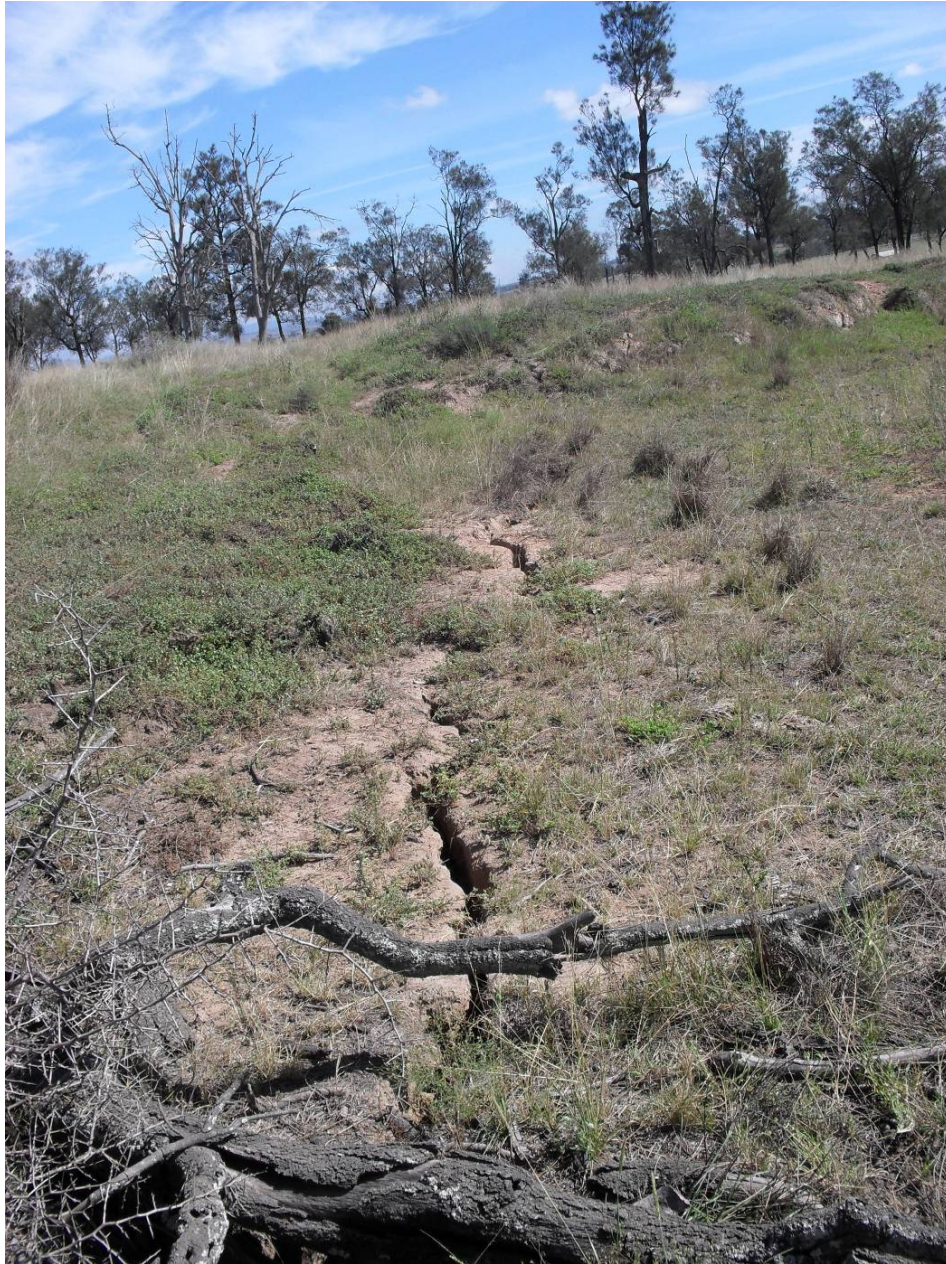
Figure 7: Start line crack continuing up towards dam wall (Background) from under tree. Crack starts from LW4 CL1.

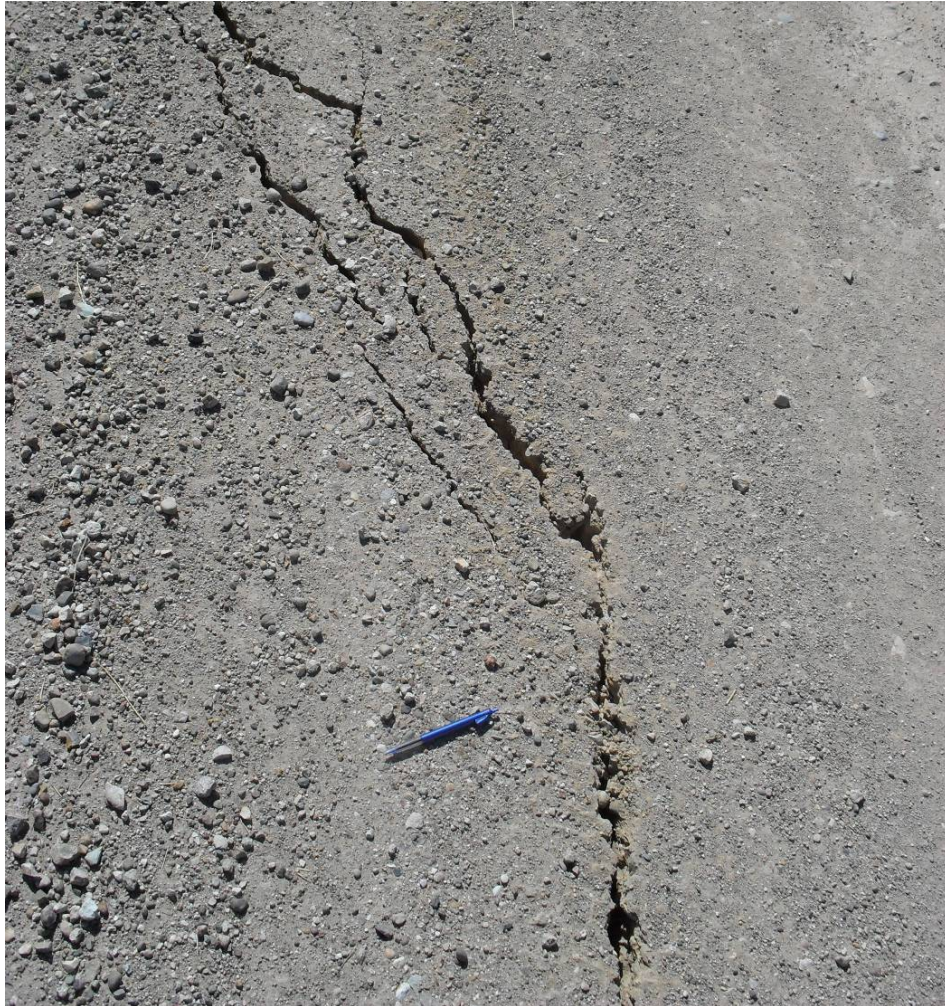
The Access Road was cracked during mining. A diversion was put in place during the impact period until the road was repaired. Remediation occurred frequently using a grader. Diversions were also put into place while any road was being undermined. This was the case for all roads bar the single access road. The single access road required a grader to be permanently on site during mining so that any cracks could be repaired thus allowing the road to remain open and serviceable. This occurred from chainage 590 to 20m. All stakeholders were informed of road closures before undermining occurred.

Figure 8: Cracks in the access road which required grading.

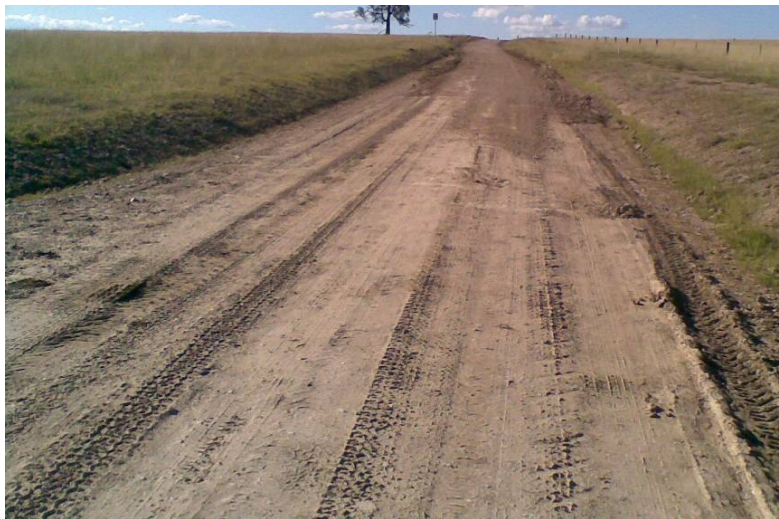
Figure 9: Access road post repairs.

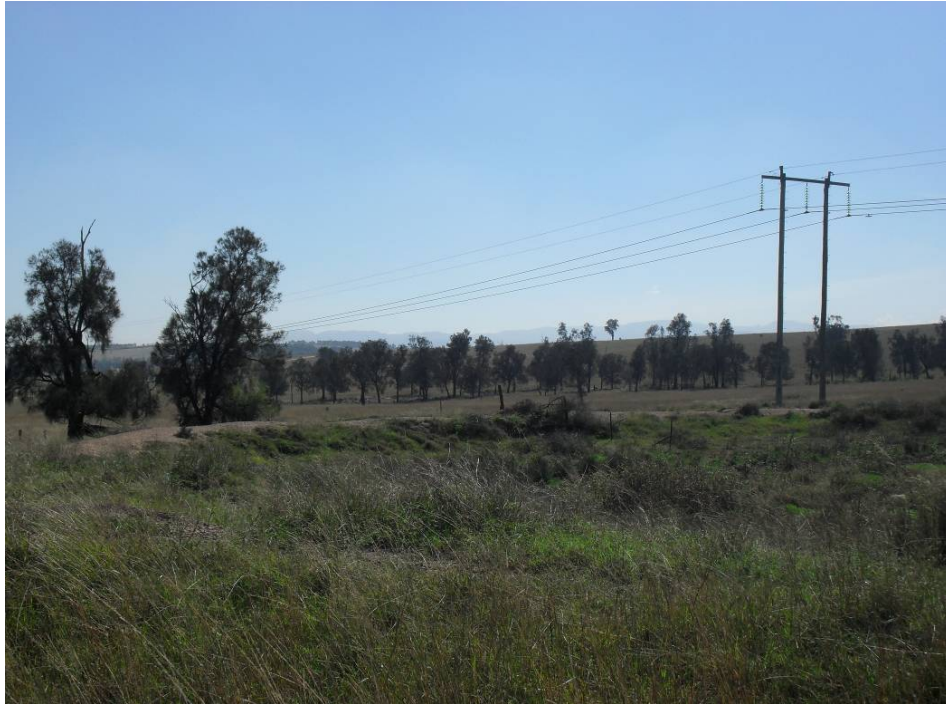
Visual and survey monitoring of the existing 2 pole 132kV power structure over Longwall 4 was undertaken regularly. **Appendix 1, Figure 10** shows the 2 pole structure in relation to the Longwall 4 dams. The survey data was recorded and again supplied to the Principal Subsidence Engineer as per the *Ashton Mine Subsidence Monitoring Programme Longwall 4*. The effects of subsidence on this structure can be seen in **Appendix 2**.

Figure 10: 2 pole power line and Dam
