# Mount Thorley Warkworth 2019 Annual Review

Mount Thorley Warkworth (MTW) is an integrated operation of two open cut coal mines, Warkworth Mining Limited (WML) and Mount Thorley Operations (MTO). This Annual Review reports on the environmental performance of MTW for the period 1 January 2019 to 31 December 2019.

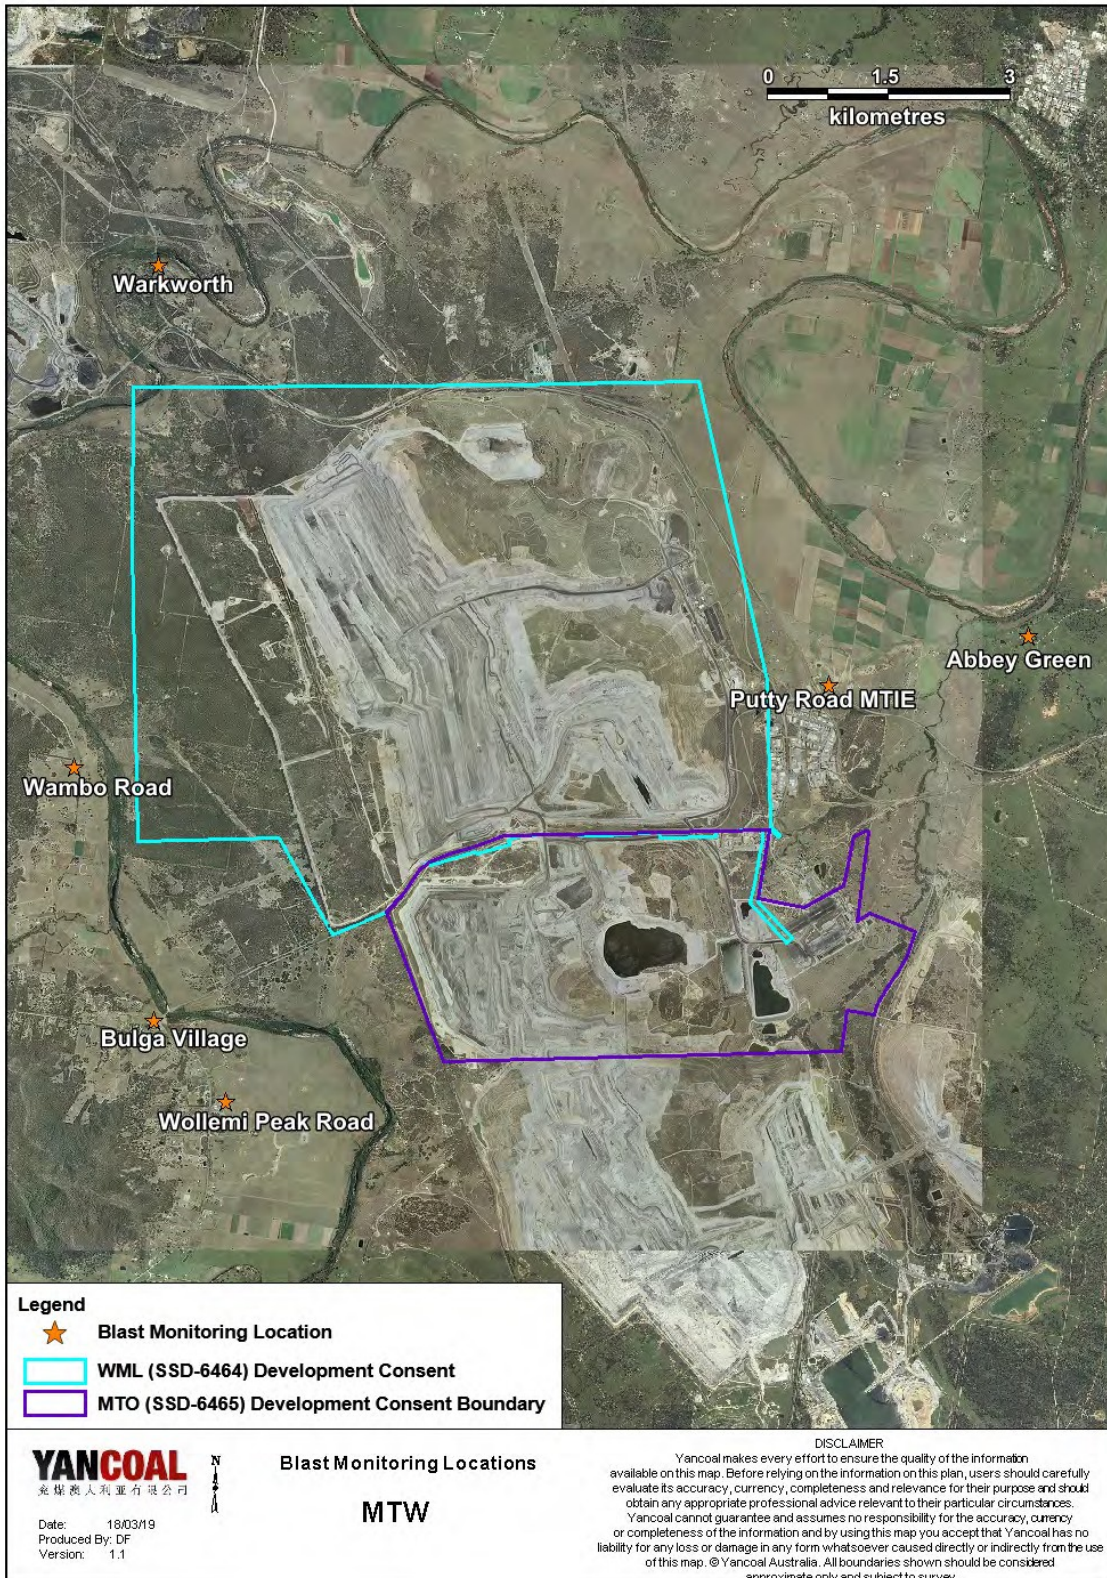
**FIGURE 4: BLAST MONITORING LOCATIONS**

These locations are shown on **Figure 4** below.

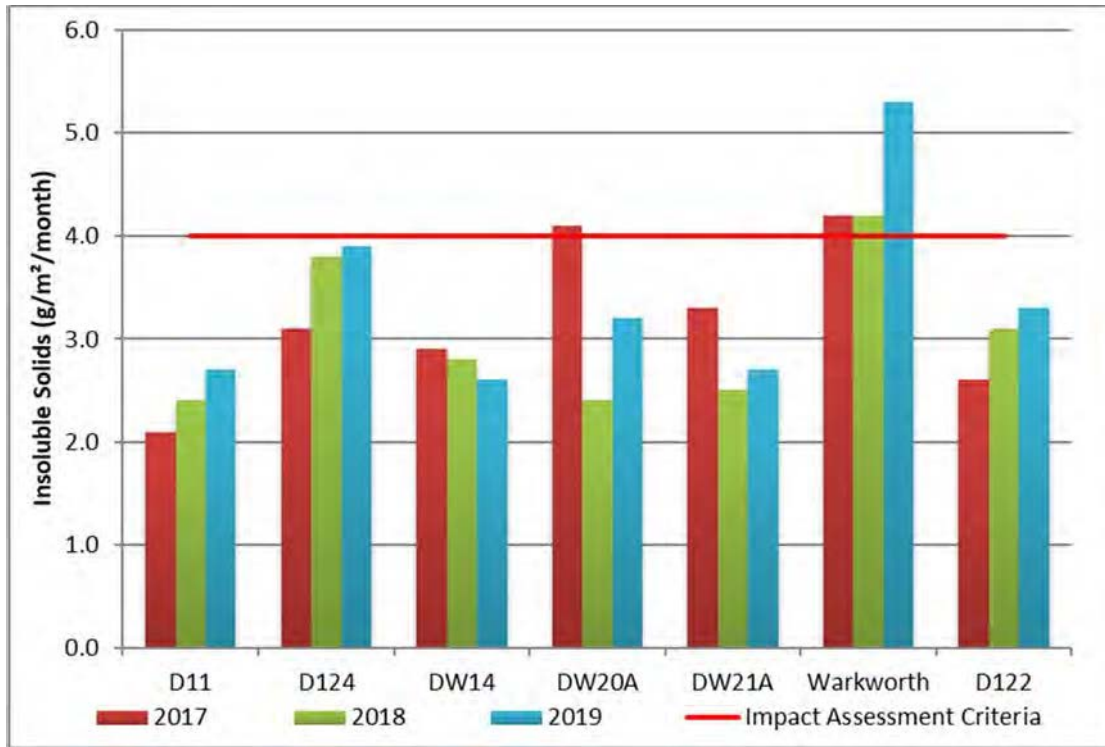
**FIGURE 13: 2019 DEPOSITIONAL DUST RESULTS COMPARED AGAINST THE IMPACT ASSESSMENT CRITERIA AND PREVIOUS YEARS' RESULTS**

It should be noted that during 2019, monthly dust deposition rates equal to or greater than the long-term impact assessment criteria of 4g/m<sup>2</sup>/month were recorded at multiple sites. Where field observations denote a sample as contaminated (typically with insects, bird droppings or vegetation), the results are excluded from Annual Average compliance assessment. Meteorological conditions and the results of nearby monitors for the sampling period are also considered when determining MTW's level of contribution to any elevated result. Details of excluded results are presented in the relevant MTW Monthly Environmental Monitoring Report. The graphs below illustrate a general trend in increased Depositional Dust in 2019 compared to 2018. This is consistent with well below average rainfall totals recorded in 2017 (444 mm), 2018 (457 mm) and 2019 (304 mm).

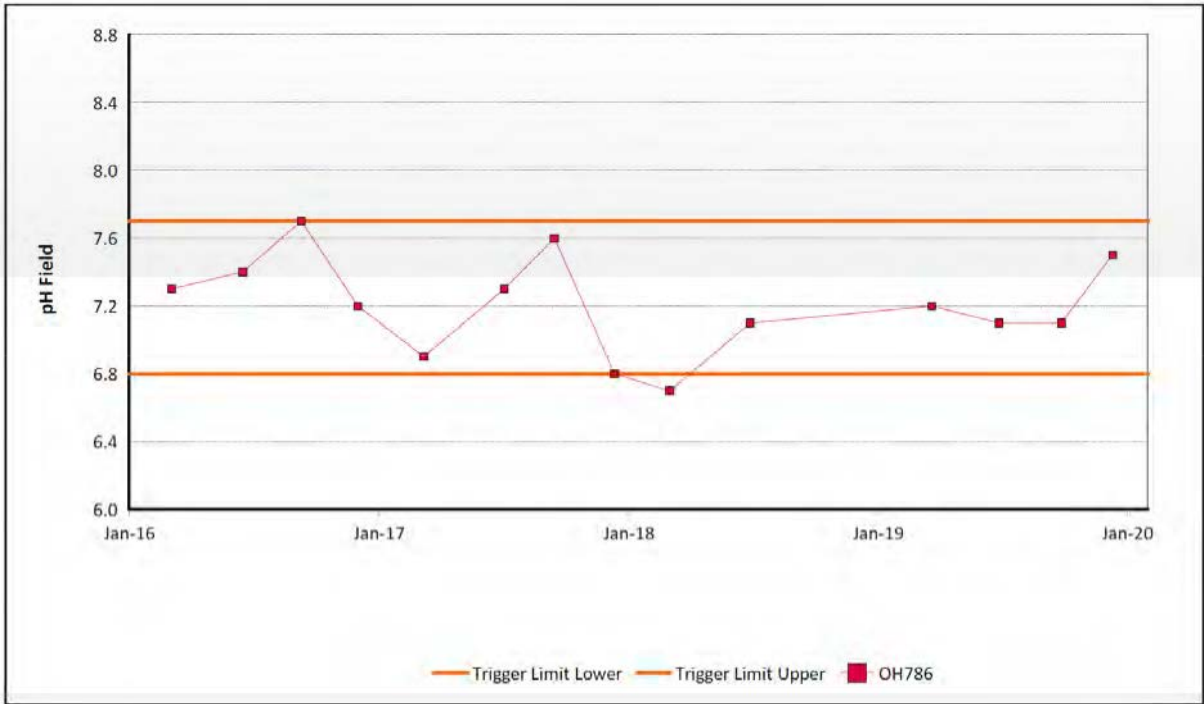
**FIGURE 42: HUNTER RIVER ALLUVIUM BORE OH786 PH TREND 2016 TO 2019**

Groundwater monitoring in the Hunter River Alluvium was undertaken from five sites during 2019. A total of 17 samples were collected during the reporting period. The pH, EC and SWL trends for 2016 to 2019 for Hunter River Alluvium groundwater bores are shown in **Figure 42** to **Figure 52**. Over the 2019 monitoring period bore OH788 recorded pH levels at and marginally below the lower trigger level of 7.1 throughout 2019. EC concentrations were also recorded above the trigger level of 11,742  $\mu\text{S}/\text{cm}$  in Q2, Q3 and Q4.

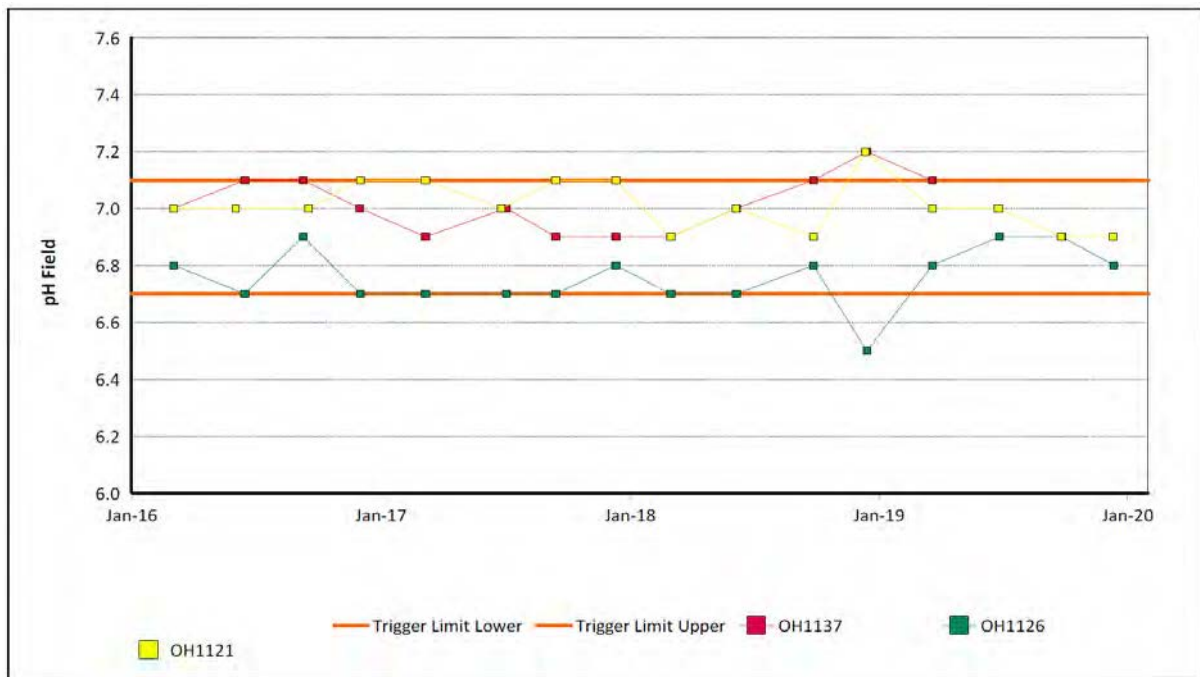
Note: Missing data indicates that there was insufficient water to take a sample.

**FIGURE 59: VAUX SEAM GROUNDWATER PH TRENDS 2016 TO 2019**

Groundwater monitoring in the Vaux Seam was undertaken from three sites during 2019; a total of 9 samples were collected. The pH, EC and SWL trends for 2016 to 2019 for Vaux groundwater bores are shown in **Figure 59**, **Figure 60** and **Figure 61** respectively. Bores OH1126 and OH1121 showed elevated EC results during the reporting period. It is likely that the values recorded are a result of the dry climatic conditions and the new sampling methodology that was adopted during the reporting period. Monitoring of these bores will continue in the next reporting period.

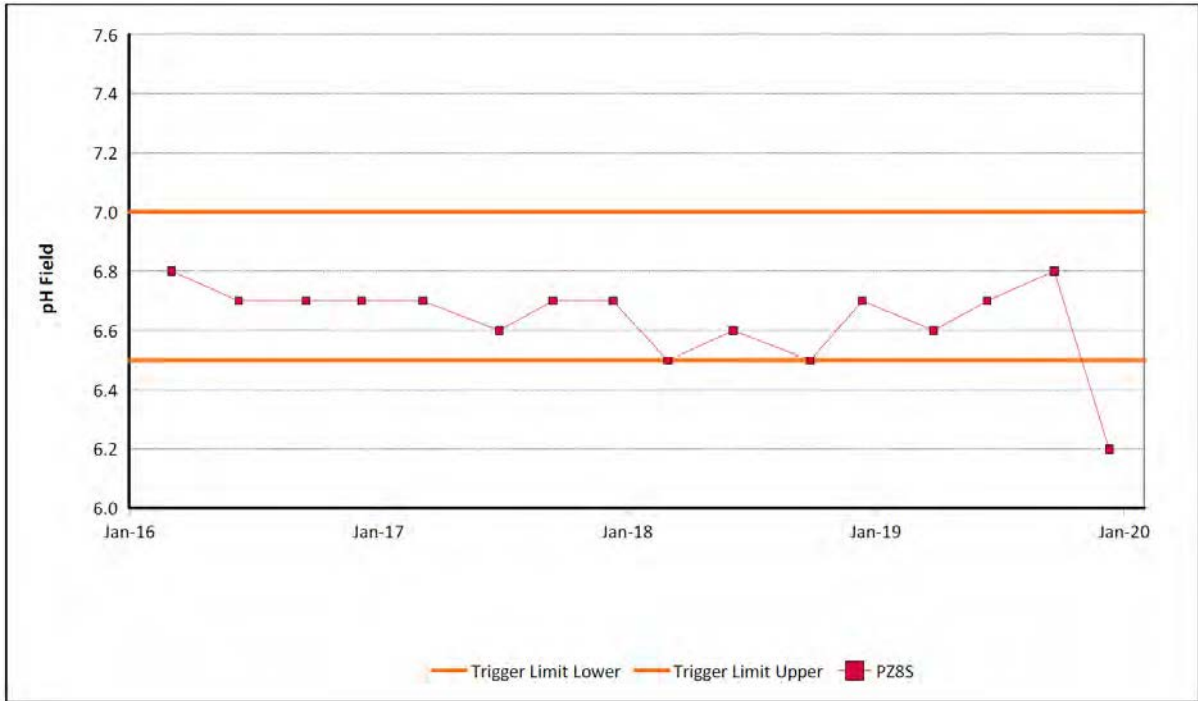
**FIGURE 68: WOLLOMBI BROOK ALLUVIUM GROUNDWATER PH TRENDS 2016 TO 2019**

Groundwater monitoring in the Wollombi Brook Alluvium was undertaken from two sites during 2019; five samples were collected. The pH, EC and SWL trends for 2016 to 2019 are shown in **Figure 68** to **Figure 72** respectively. **Table 6.26** shows the Trigger summary.

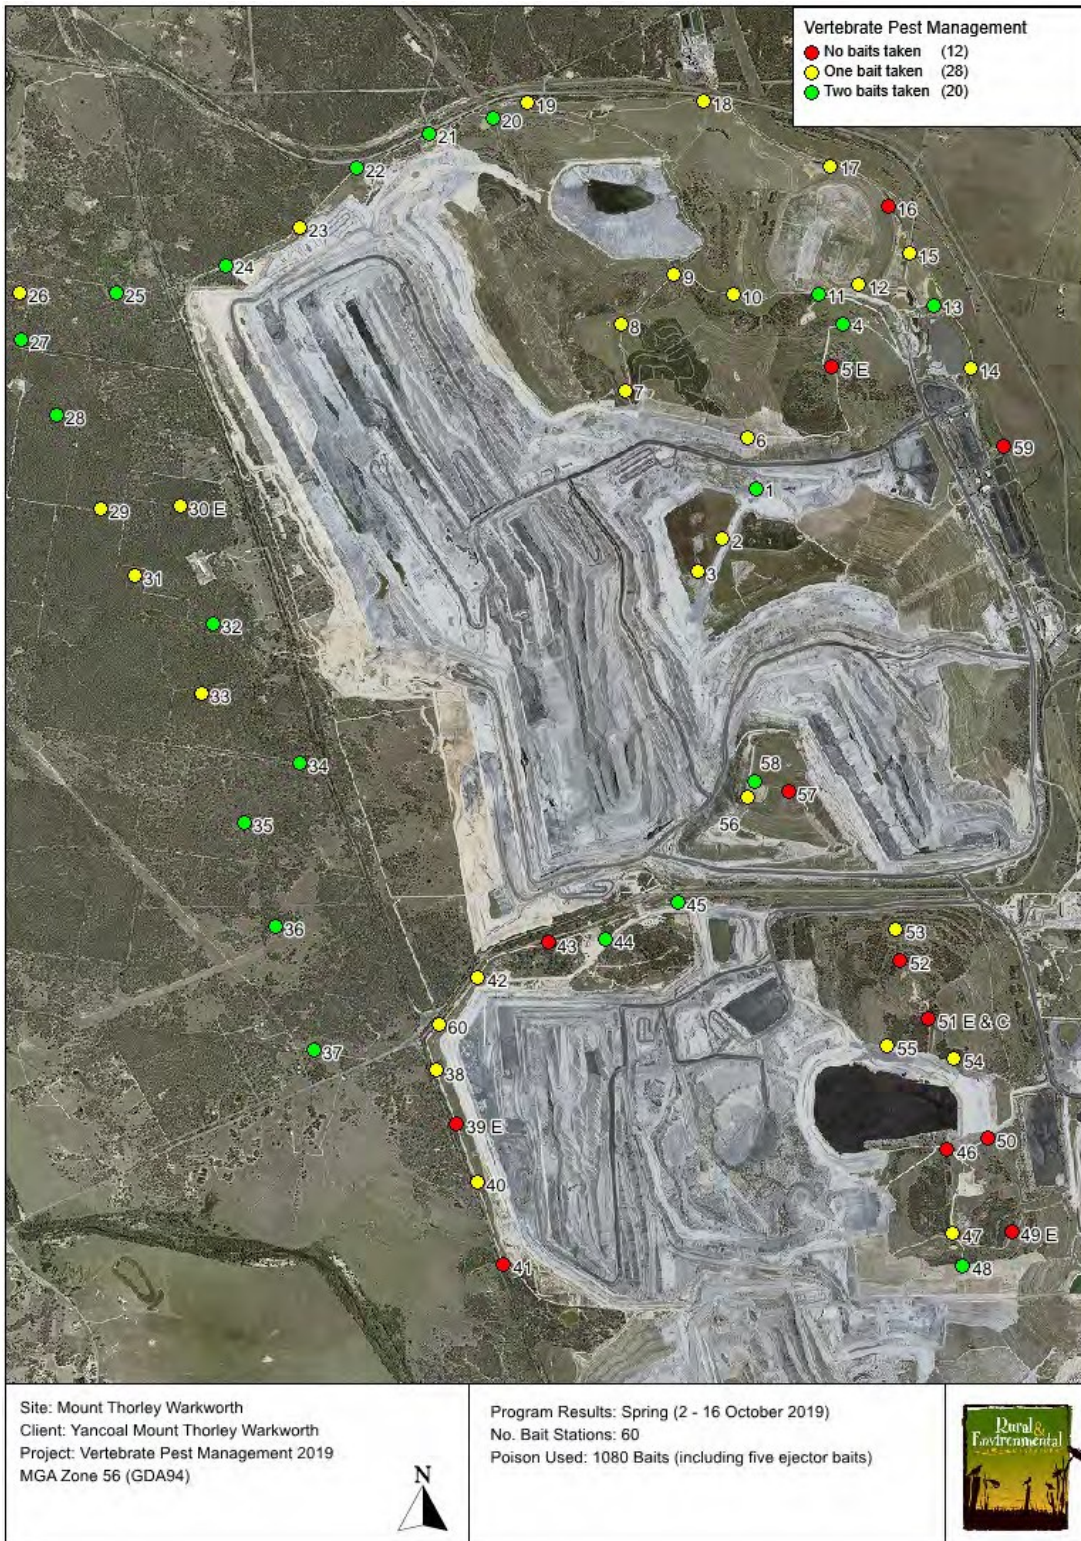
**FIGURE 82: BAITING STATION LOCATIONS AND RESULTS AT MTW DURING SPRING 2019 VERTEBRATE PEST MANAGEMENT PROGRAMME**

**Table 7.6** summarises the results from the programmes carried out at MTW during 2019 with baiting locations and results for the programmes are illustrated in **Figure 81** to **Figure 82**.

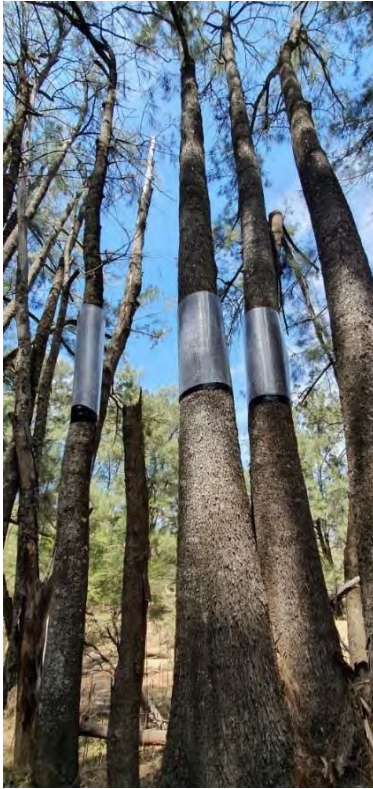
**FIGURE 84: NEST PROTECTION MEASURES AT THE GOULBURN RIVER BIODIVERSITY AREA**

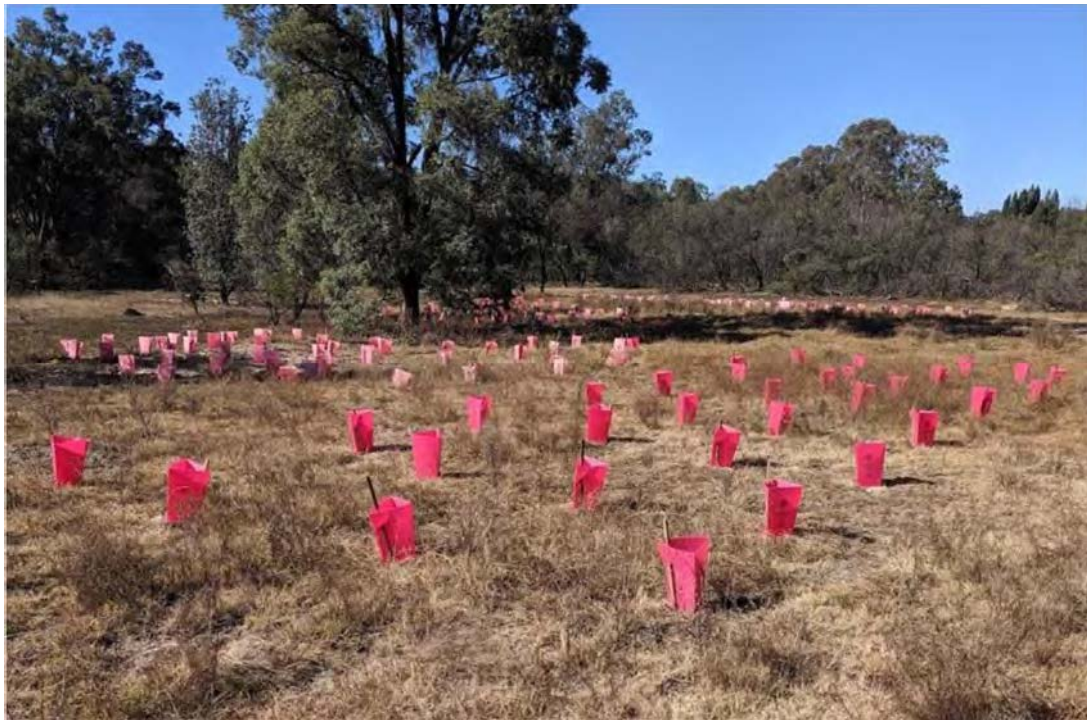
**FIGURE 85: TUBE STOCK PLANTED INTO THE SOUTHERN BIODIVERSITY AREA**

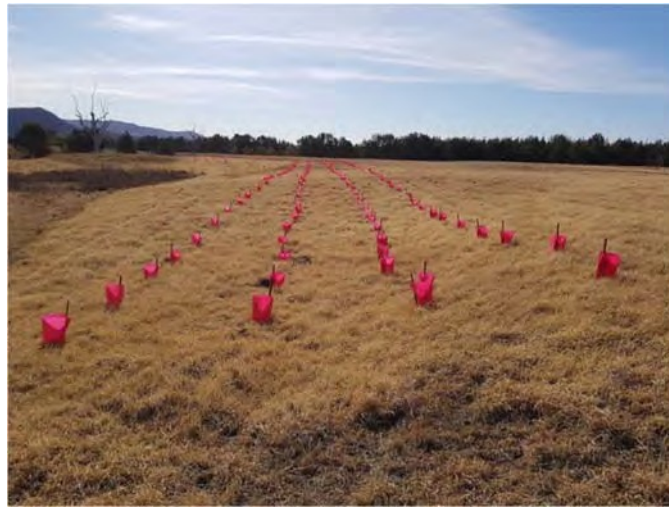
**FIGURE 86: TUBE STOCK PLANTED INTO RIP LINES AT THE SOUTHERN BIODIVERSITY AREA**

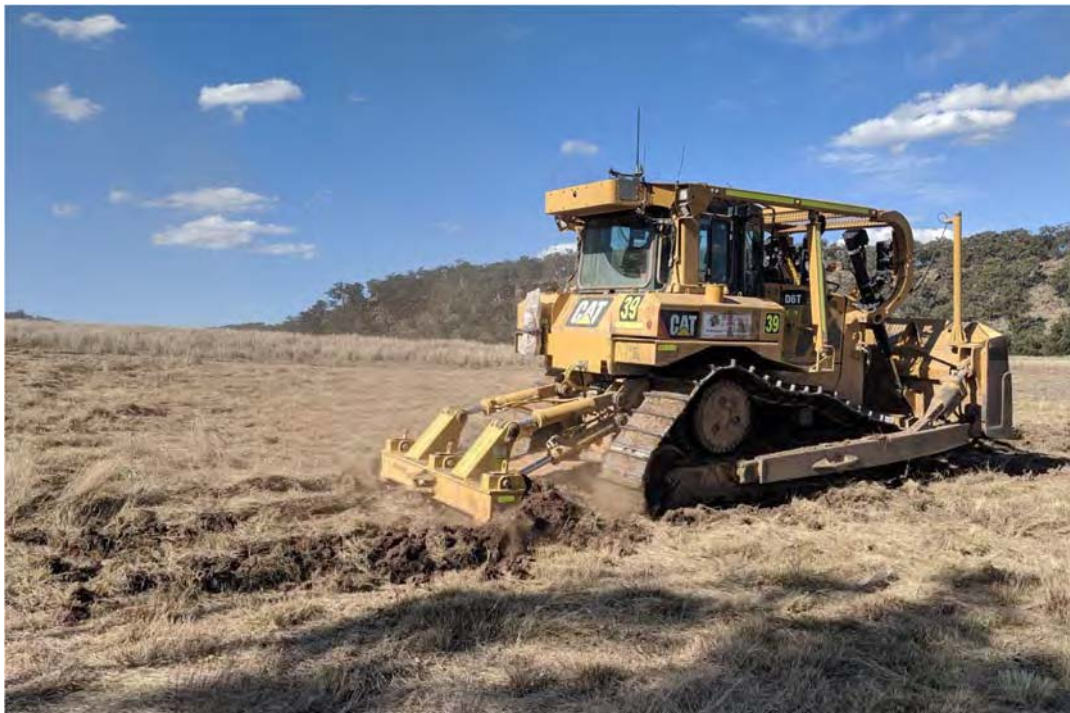
**FIGURE 87: RIPPING BEING UNDERTAKEN IN THE GOULBURN RIVER BIODIVERSITY AREA**
