# Monthly Environmental Monitoring Report

Yancoal Mount Thorley Warkworth

March 2024

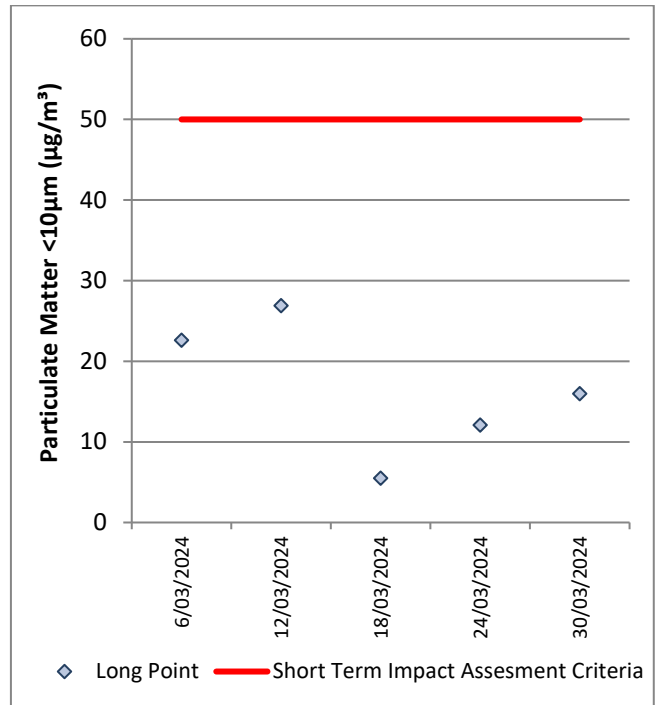
**Figure 5: Individual PM<sub>10</sub> Results – March 2024**

**Figure 5** shows the individual PM<sub>10</sub> results at each monitoring station against the short-term impact assessment criteria of 50µg/m<sup>3</sup>.

There were no exceedances of the short term (24hr) PM<sub>10</sub> impact assessment criteria during March 2024

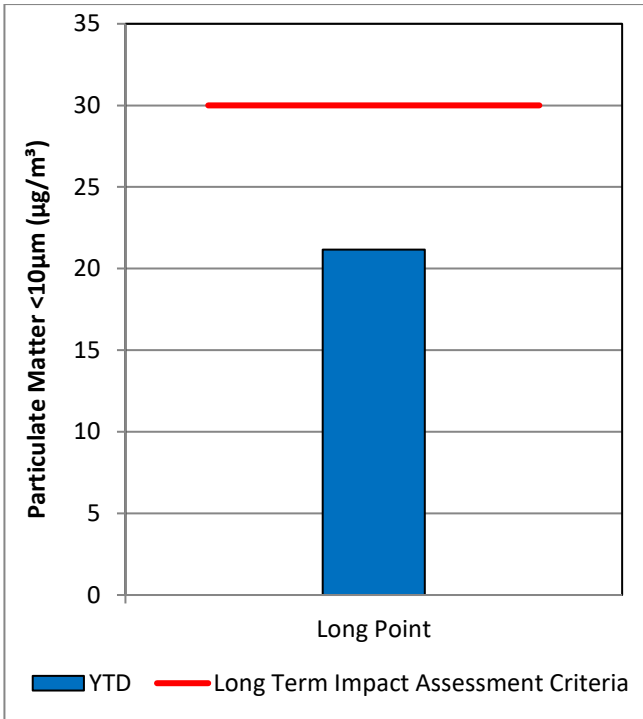
Figure 6: Annual Average PM<sub>10</sub> – March 2024

**Figure 6** shows the annual average PM<sub>10</sub> result against the long-term impact assessment criteria.

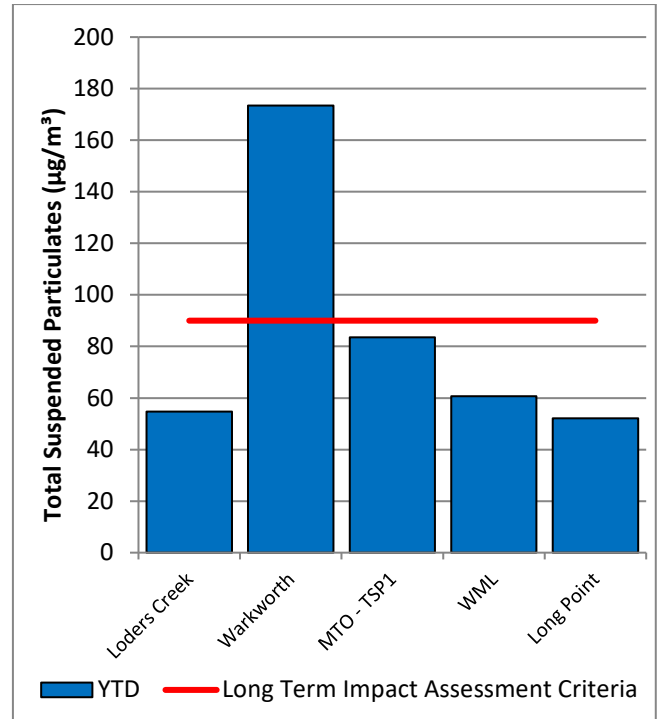
Figure 7: Annual Average Total Suspended Particulates – March 2024

Figure 7 shows the annual average TSP results compared against the long-term impact assessment criteria of 90µg/m<sup>3</sup>.

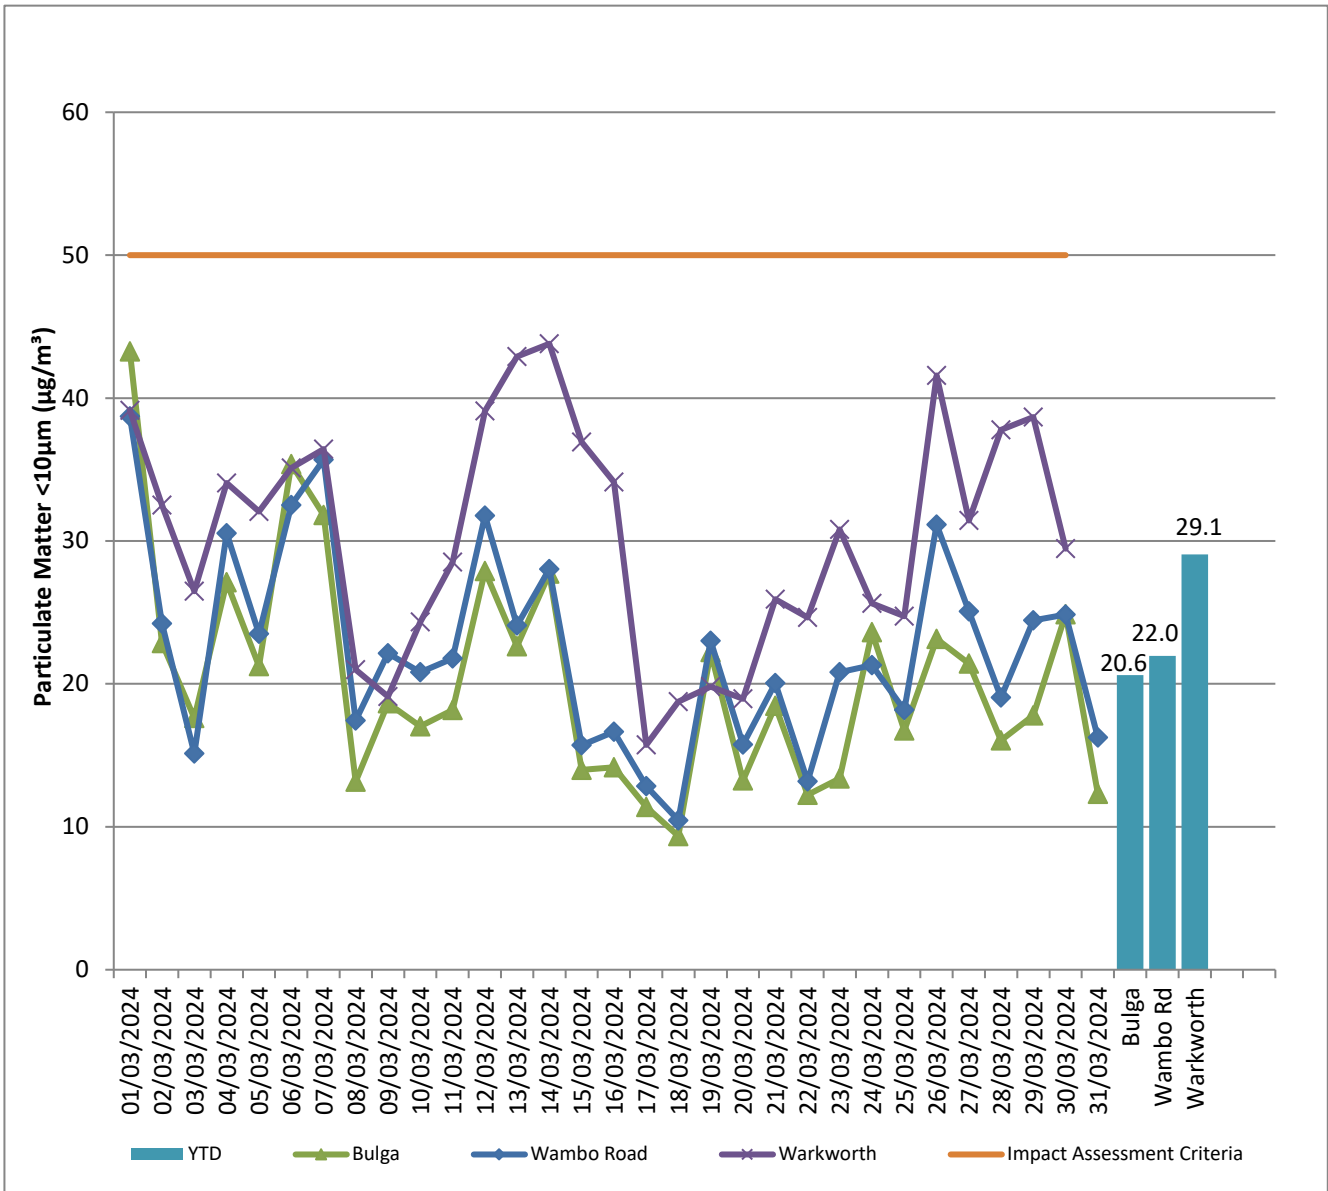
Figure 8: Real Time  $PM_{10}$  daily 24hr average (line graphs) and YTD annual average (column graphs) – March 2024

Results for real time dust sampling are shown in Figure 8, including the daily 24-hour average PM<sub>10</sub> result and the annual PM<sub>10</sub> average.

During March, the real time monitoring system generated 67 automated air quality related alerts, including 3 alerts for adverse meteorological conditions and 64 alerts for elevated PM<sub>10</sub> levels.

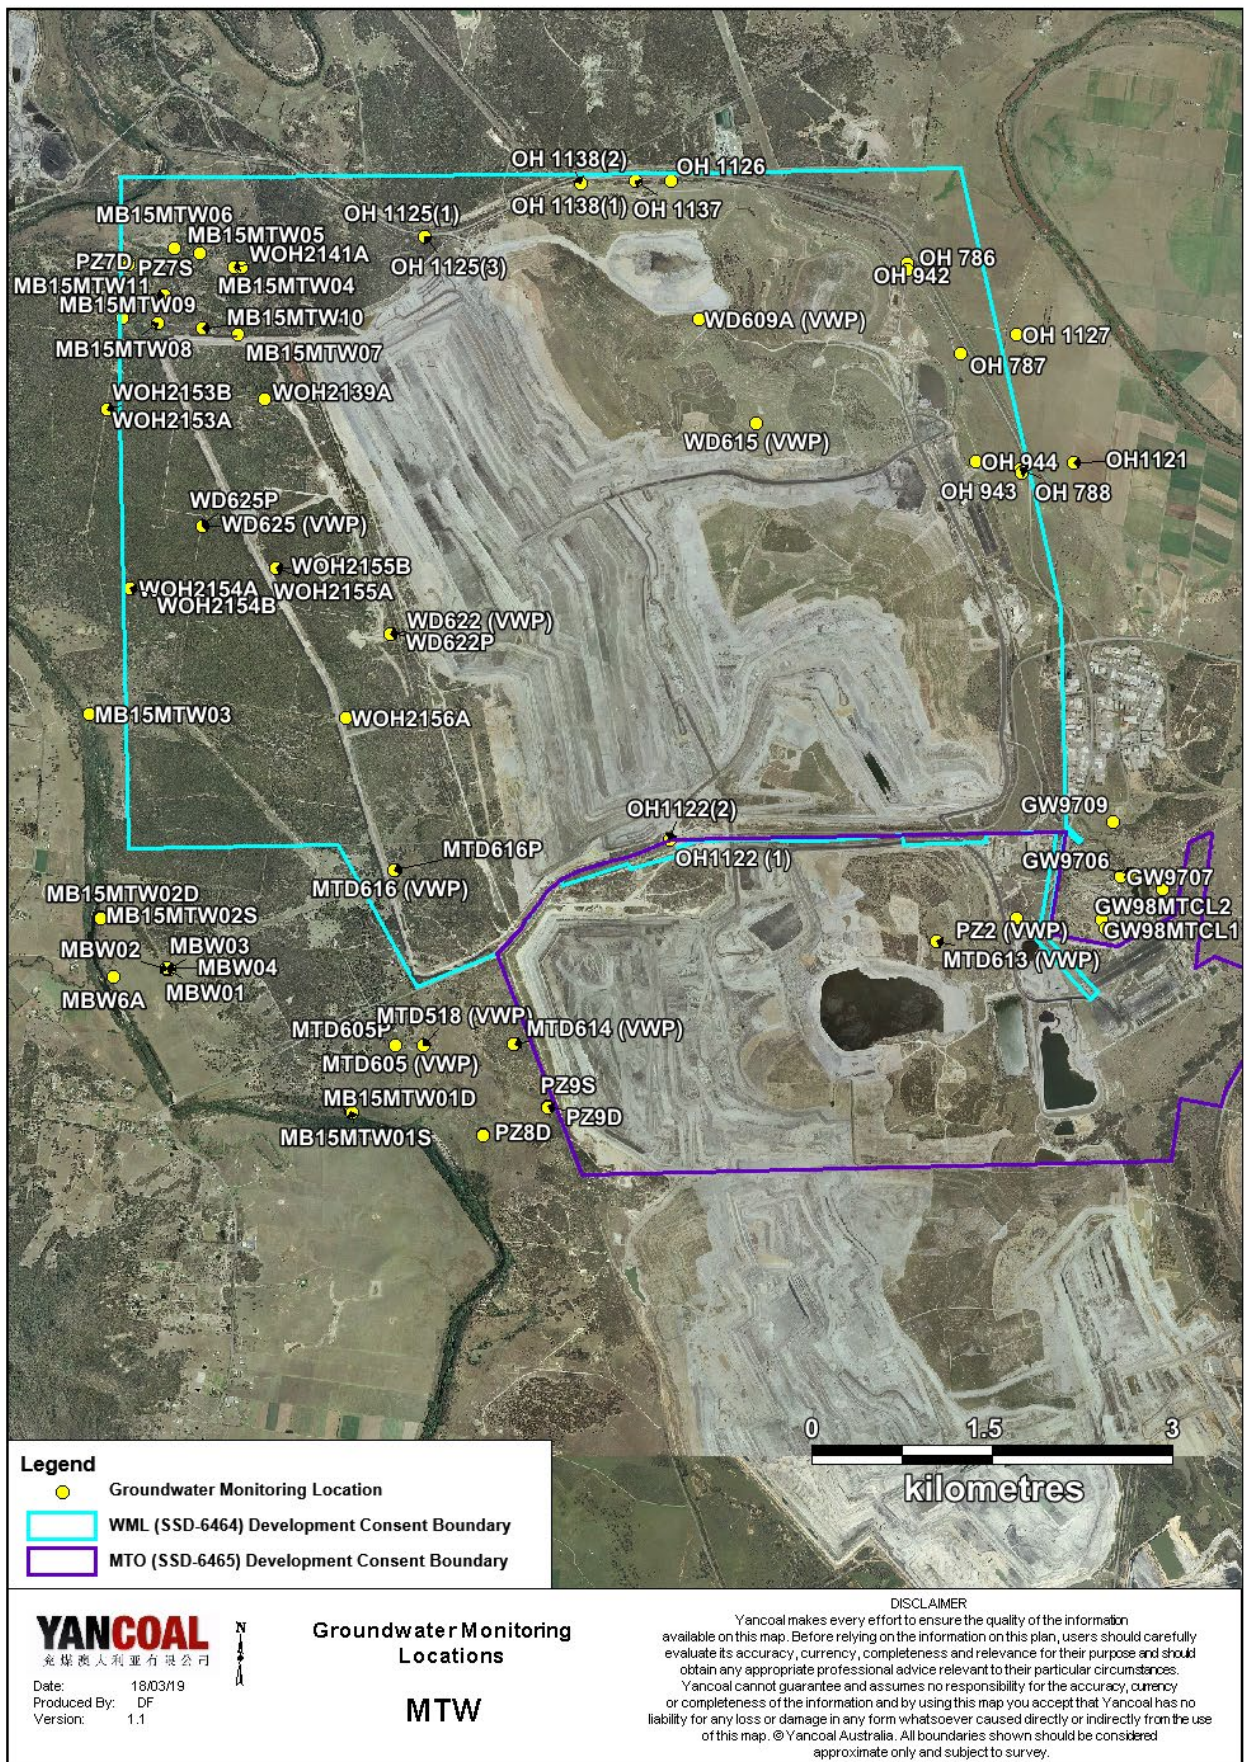
Figure 65: Groundwater Monitoring Location Plan

Internal trigger limits have been developed to assess monitoring data on an on-going basis, and to highlight potentially adverse groundwater impacts. The process for evaluating monitoring results against the internal triggers and subsequent responses are outlined in the MTW Water Management Plan. Locations of groundwater bores are shown in **Figure 65**.

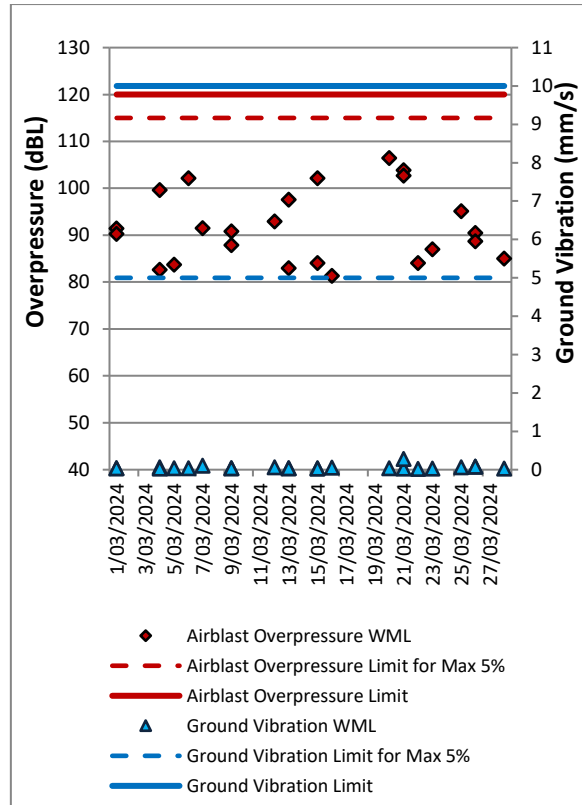
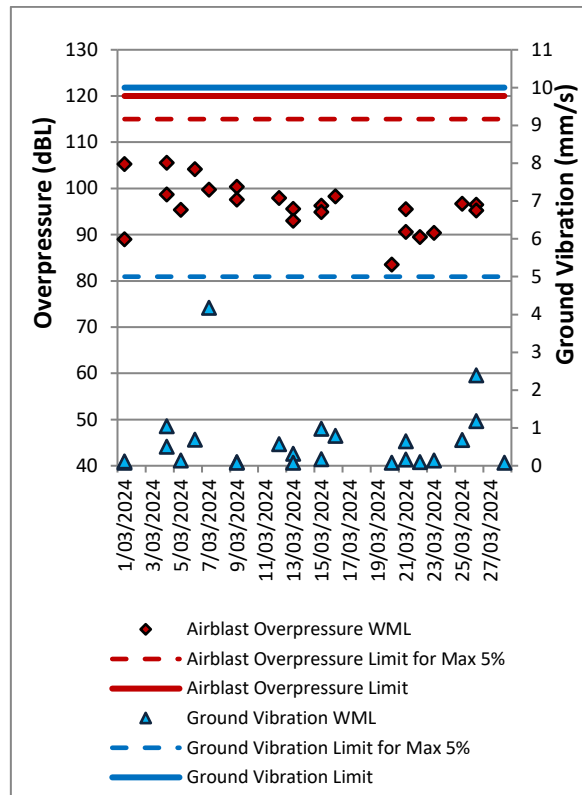
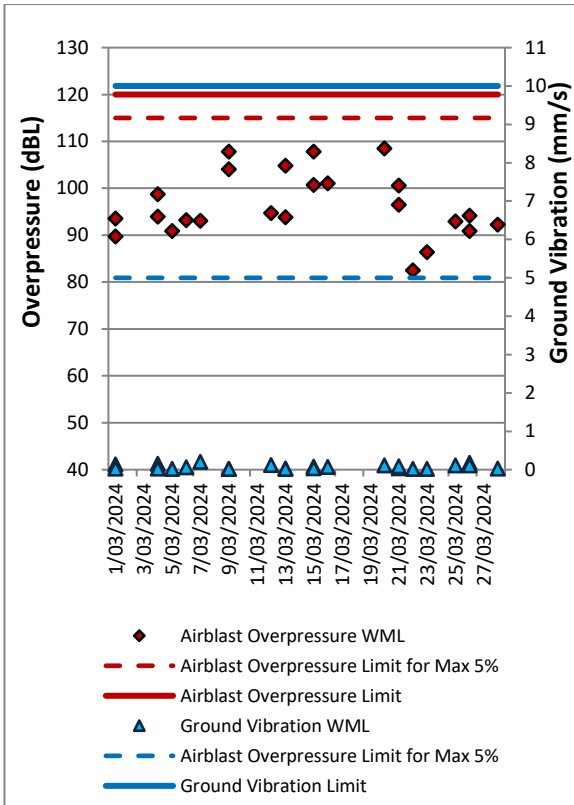
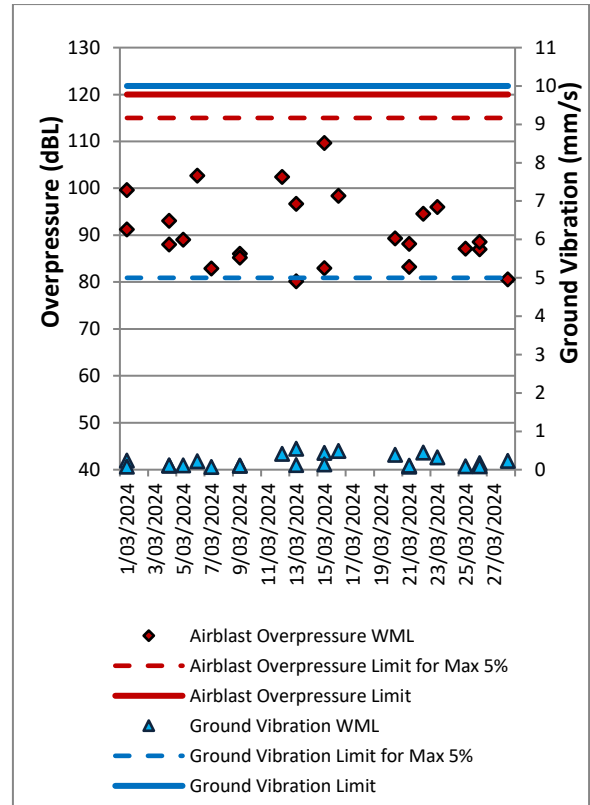
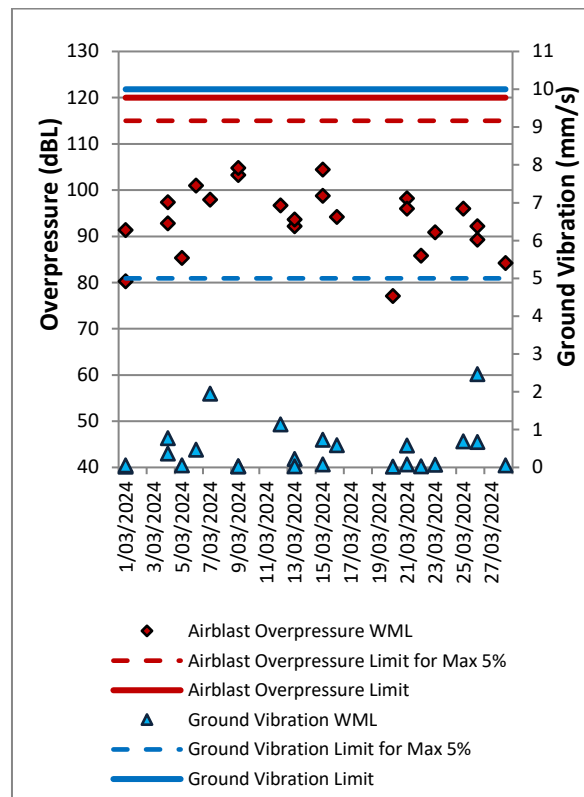
During March 2024, 24 blasts were initiated at MTW. **Figure 9** to **Figure 14** show the blast monitoring results for the reporting period against the impact assessment criteria. The criteria are summarised in **Table 4**.

During the reporting period no blasts exceeded the 5mm/s criteria for ground vibration, or the 115dB(L) threshold for airblast overpressure.

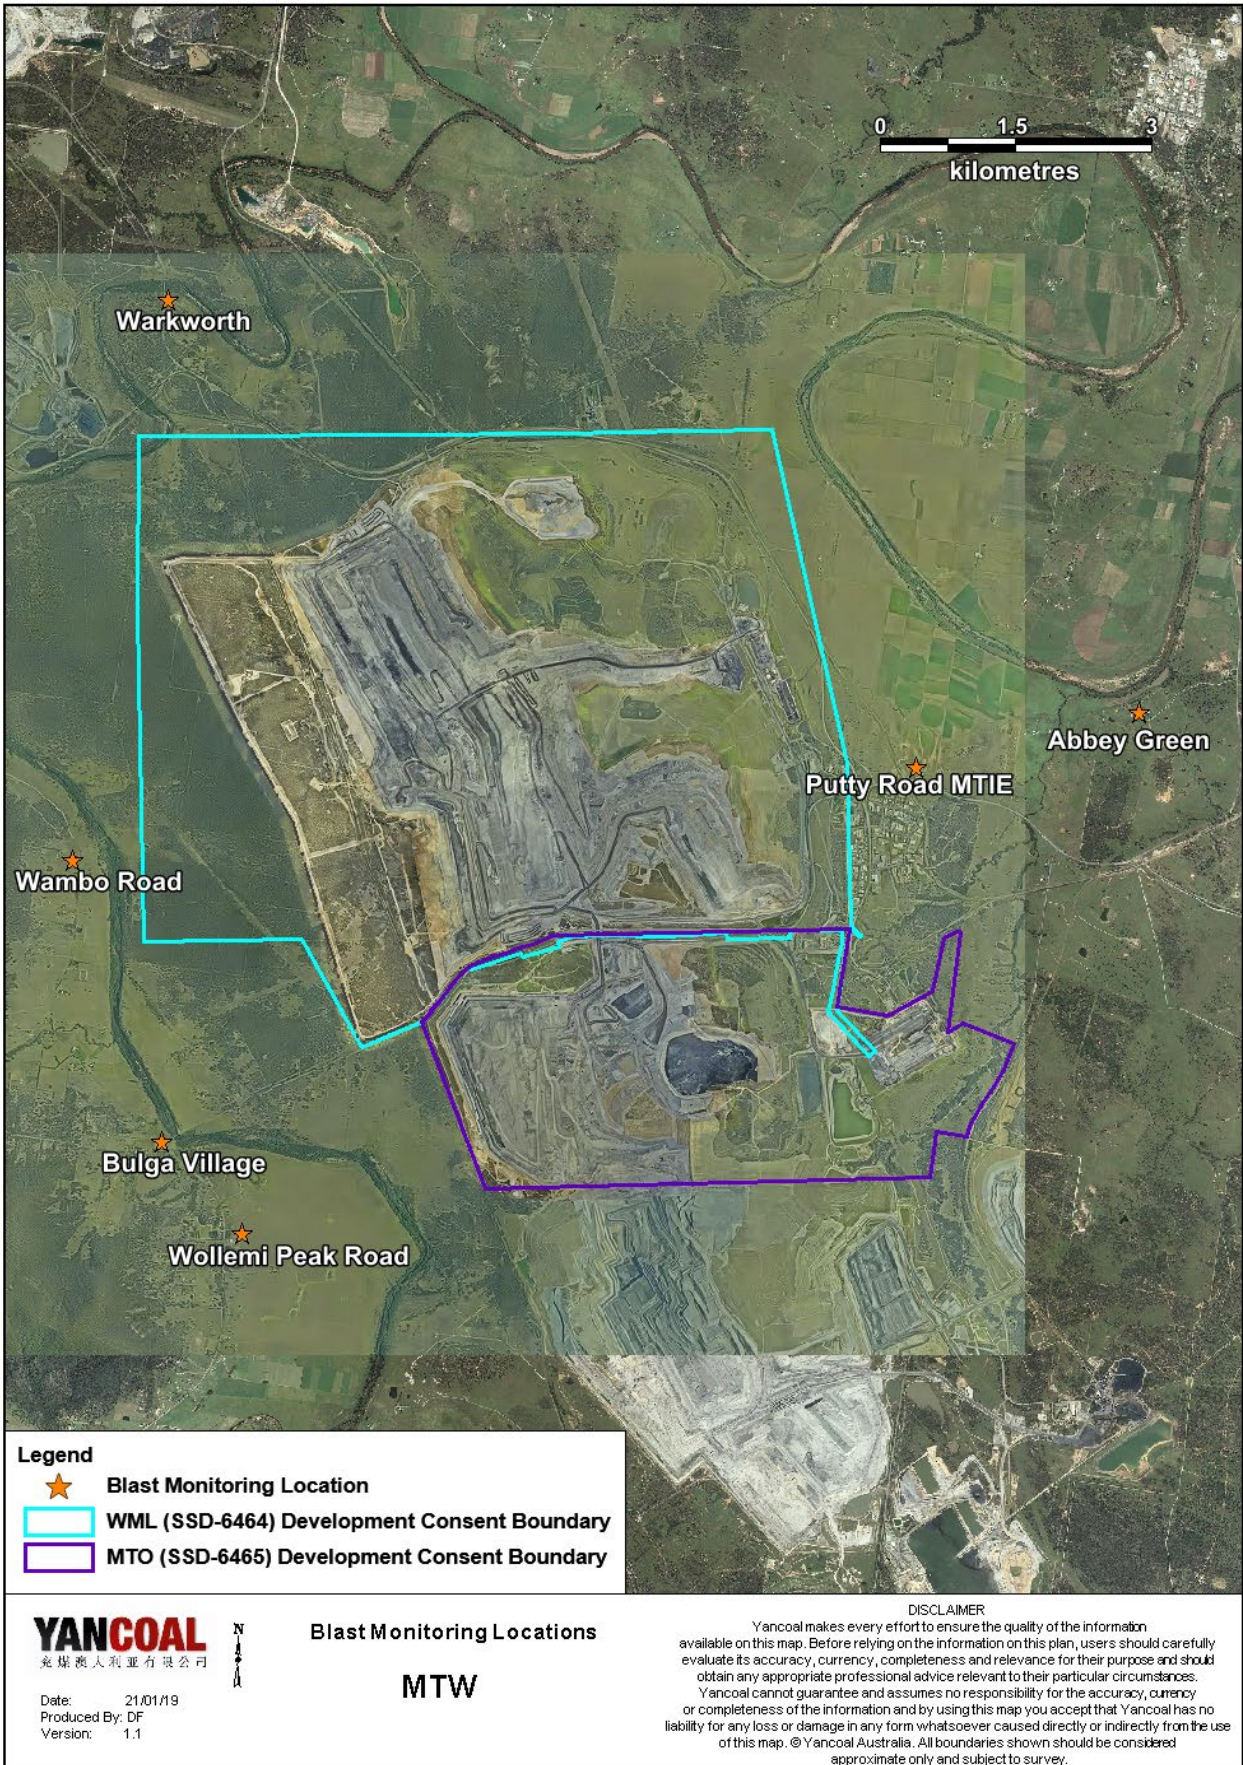
Figure 72: MTW Blast Monitoring Location Plan

MTW have a network of six blast monitoring units. These are located at nearby privately owned residences and function as regulatory compliance monitors.

The location of these monitors can be found in **Figure 72**.

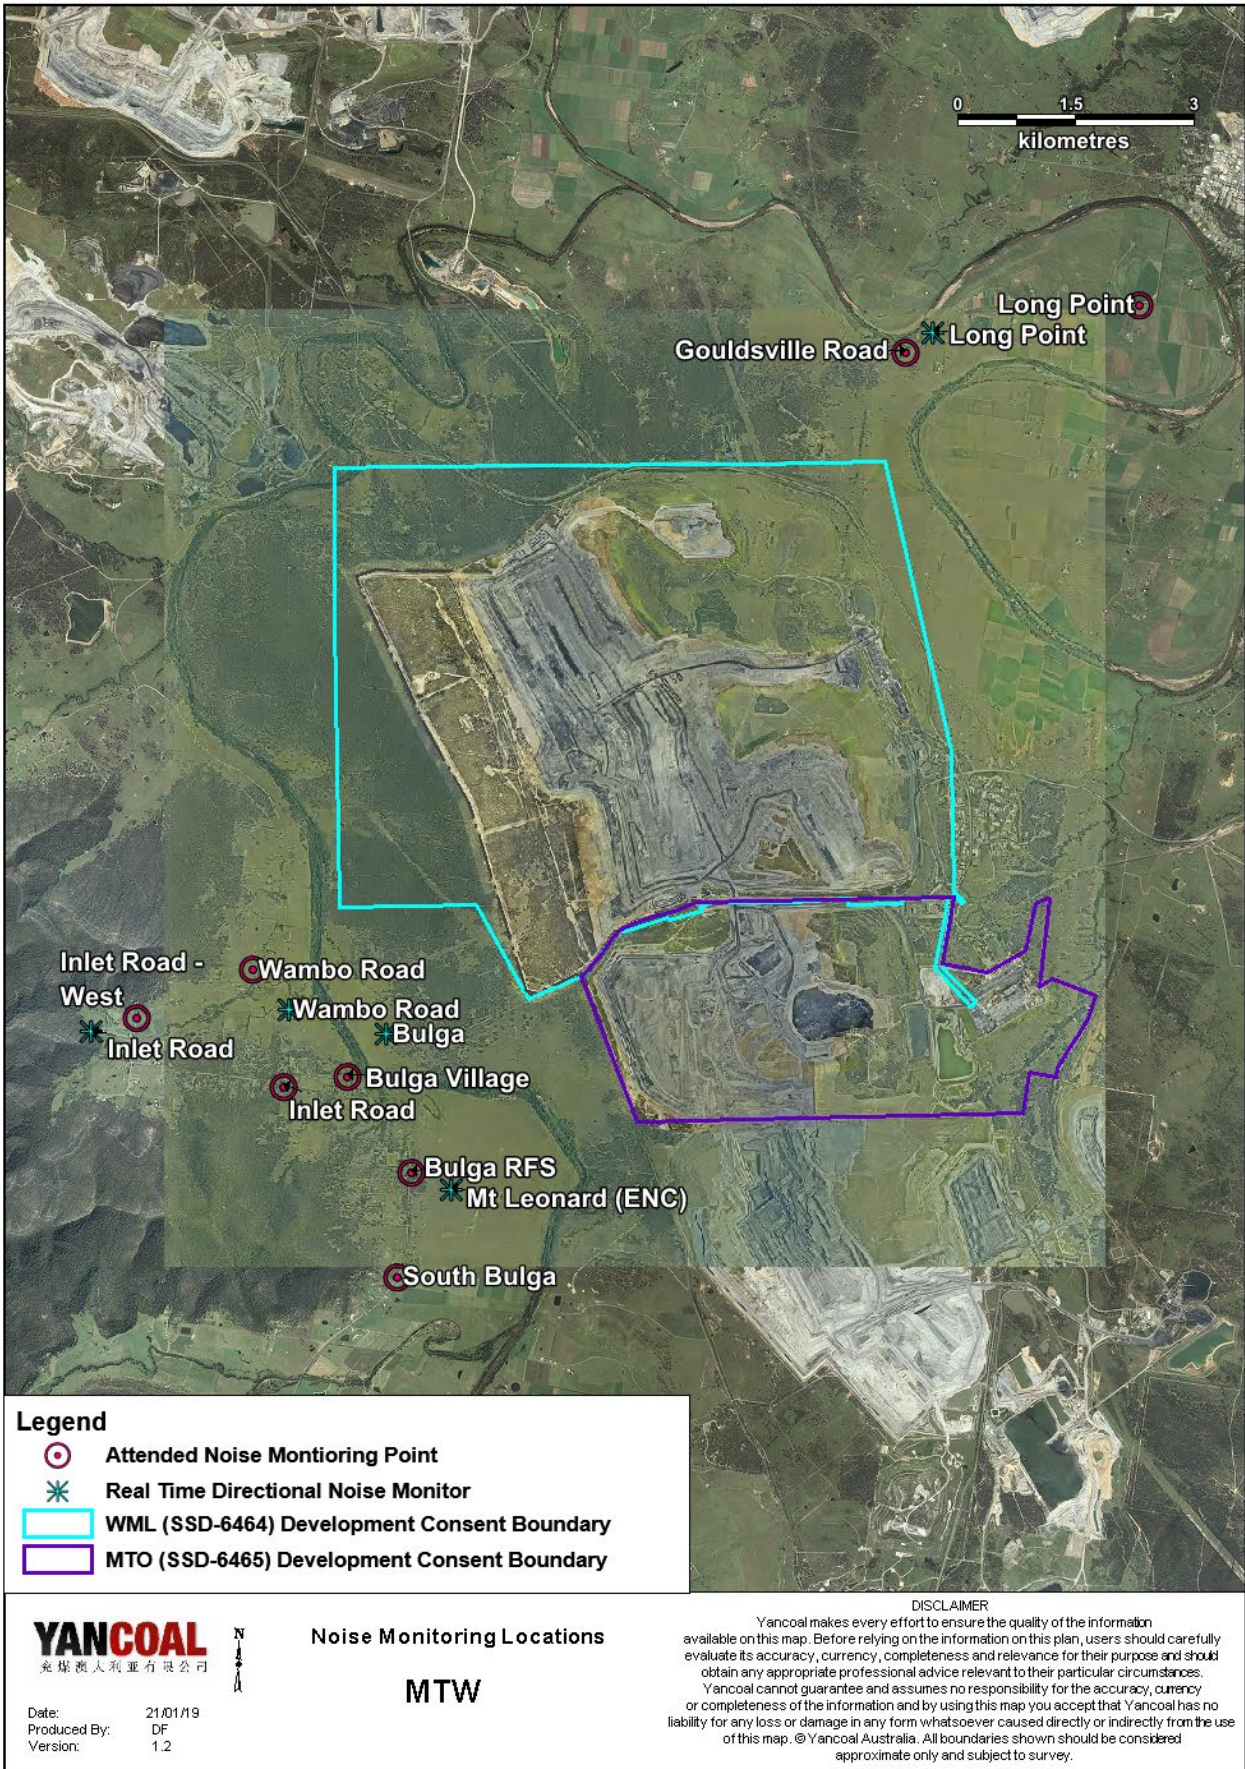
Figure 73: Noise Monitoring Location Plan

Routine attended noise monitoring is carried out in accordance with the MTW Noise Management Plan. A review against EIS predictions will be reported in the Annual Review. The purpose of the noise surveys is to quantify and describe the acoustic environment around the site and compare results with specified limits. Real time noise monitoring also occurs at five sites surrounding MTW. Noise monitoring locations are displayed in **Figure 73**.

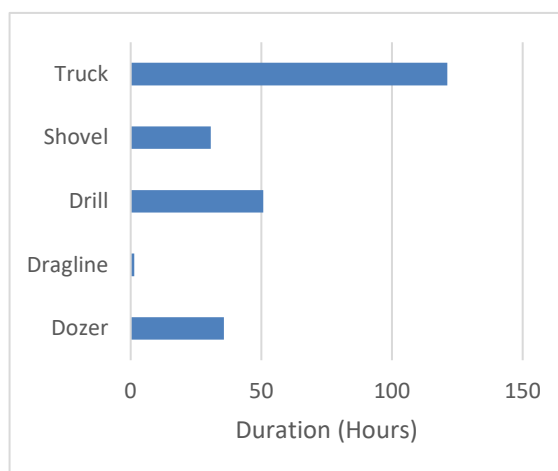
**Figure 74: Operational Downtime by Equipment Type – March 2024**

During March, a total of 239.7 hours of equipment downtime was logged in response to environmental events such as dust, noise and adverse meteorological conditions. Operational downtime by equipment type is shown in **Figure 74**.
