STRATFORD MINING COMPLEX

ANNUAL REVIEW

Reporting Period: 1st January 2019 to 31st December 2019

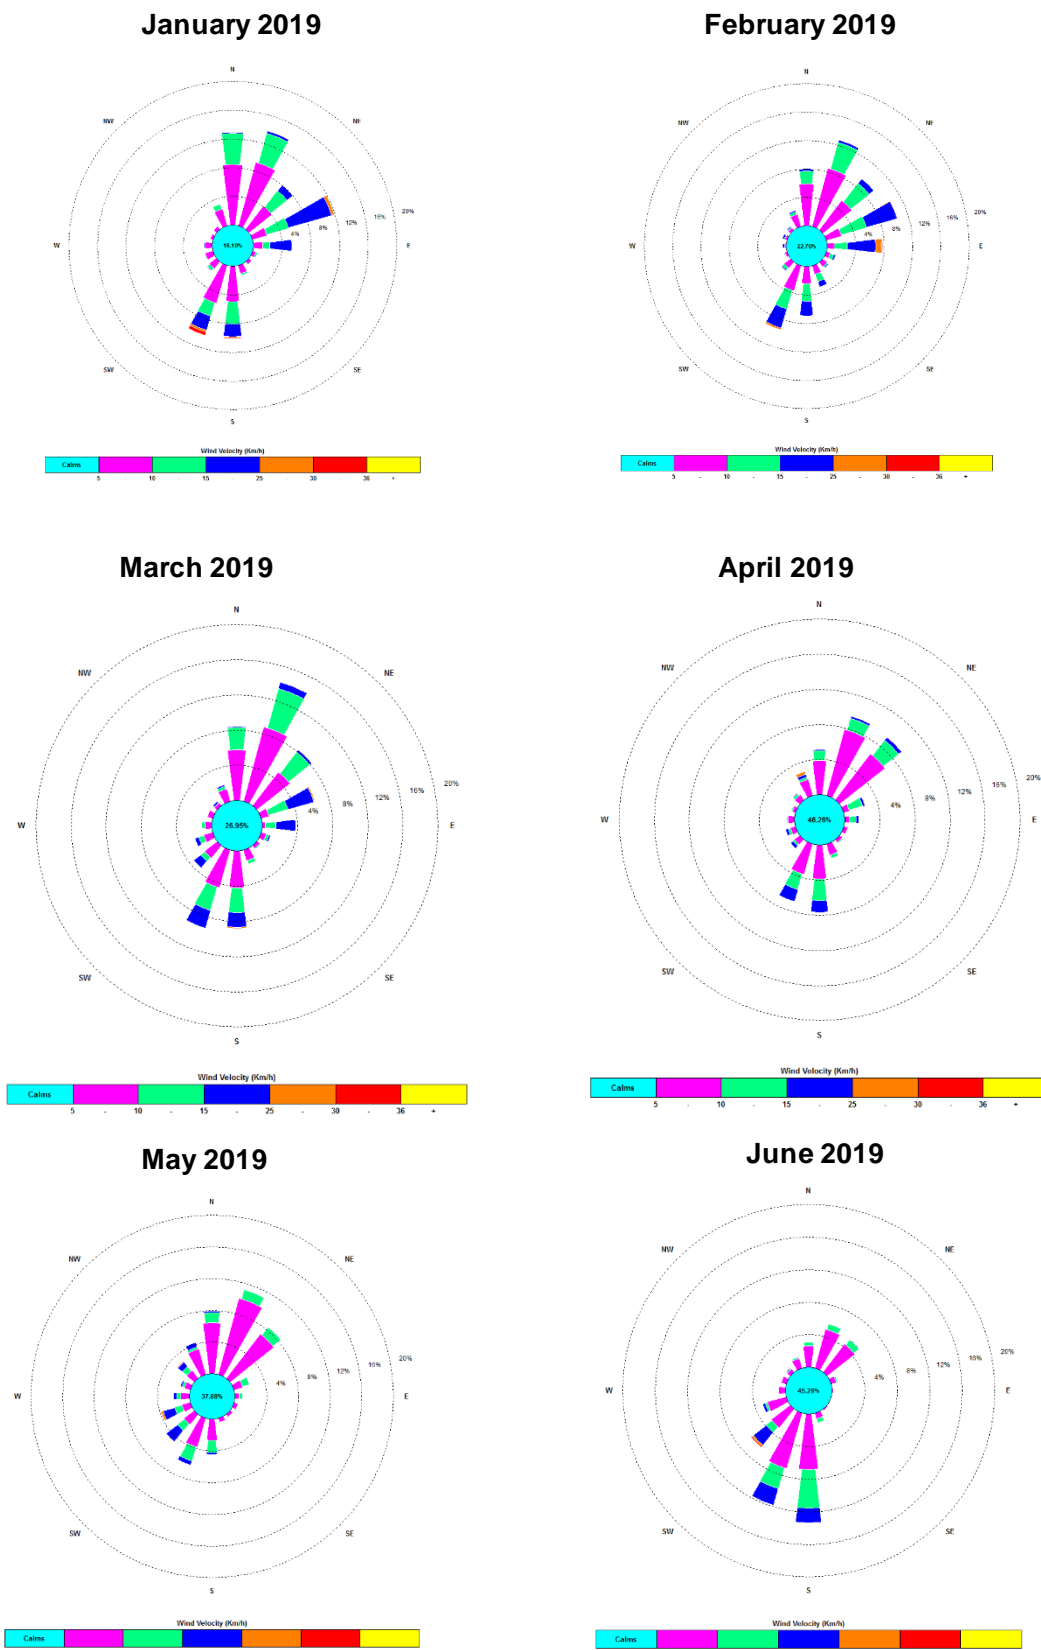
Figure 2.4: Monthly Windroses Displaying Wind Direction and Speed Frequencies during the Reporting Period

Figure 2.4: (Continued) Monthly Windroses Displaying Wind Direction and Speed Frequencies during the Reporting Period

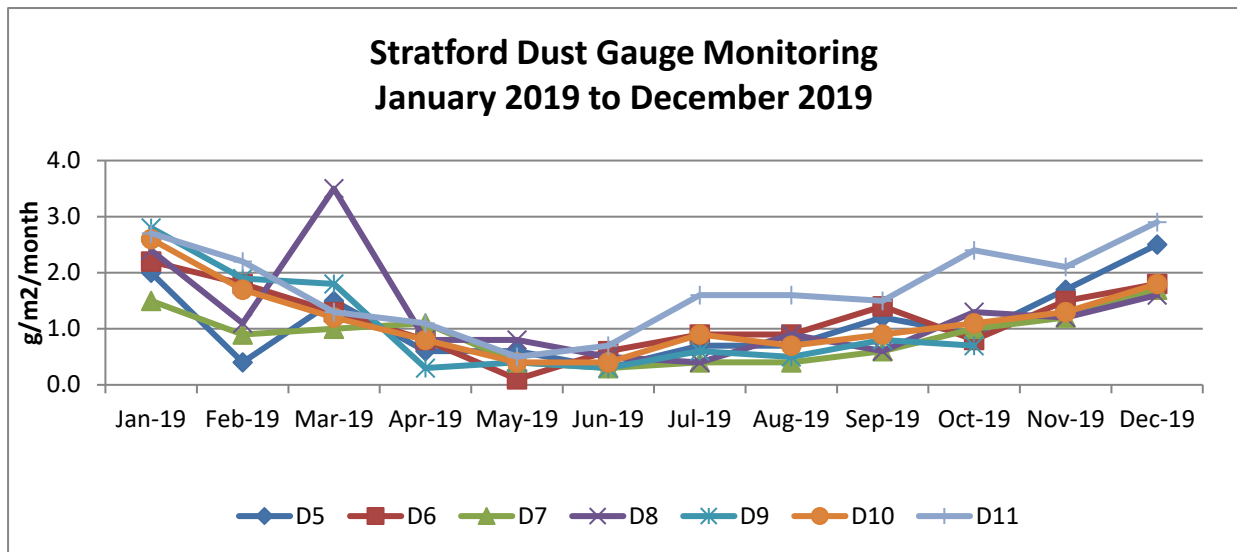
Figure 3.1: Depositional Dust Monitoring Results from January 2019 to December 2019

Non-contaminated dust levels were all less than 4.0g/m²/month. The annual average dust levels did not exceed the conditions of consent annual average limit of 4g/m²/month for any deposition gauge. Graphical representation of the dust deposition results and annual averages for the seven (7) dust deposition gauges (D5-D11) are provided within **Appendix 3**.

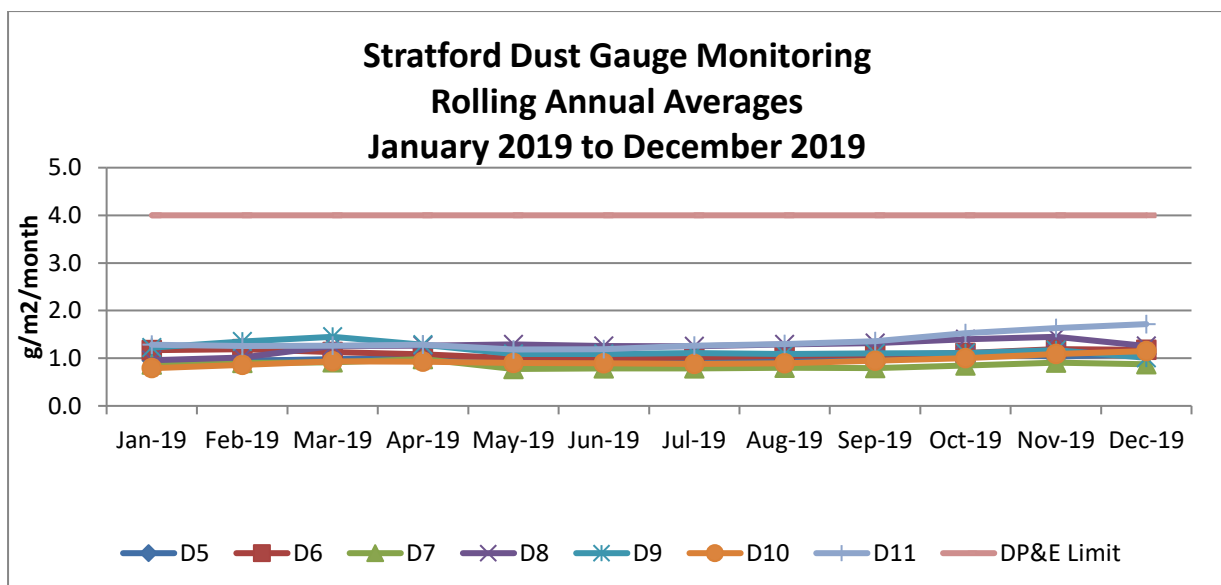
Figure 3.2: Depositional Dust Annual Averages from January 2019 to December 2019

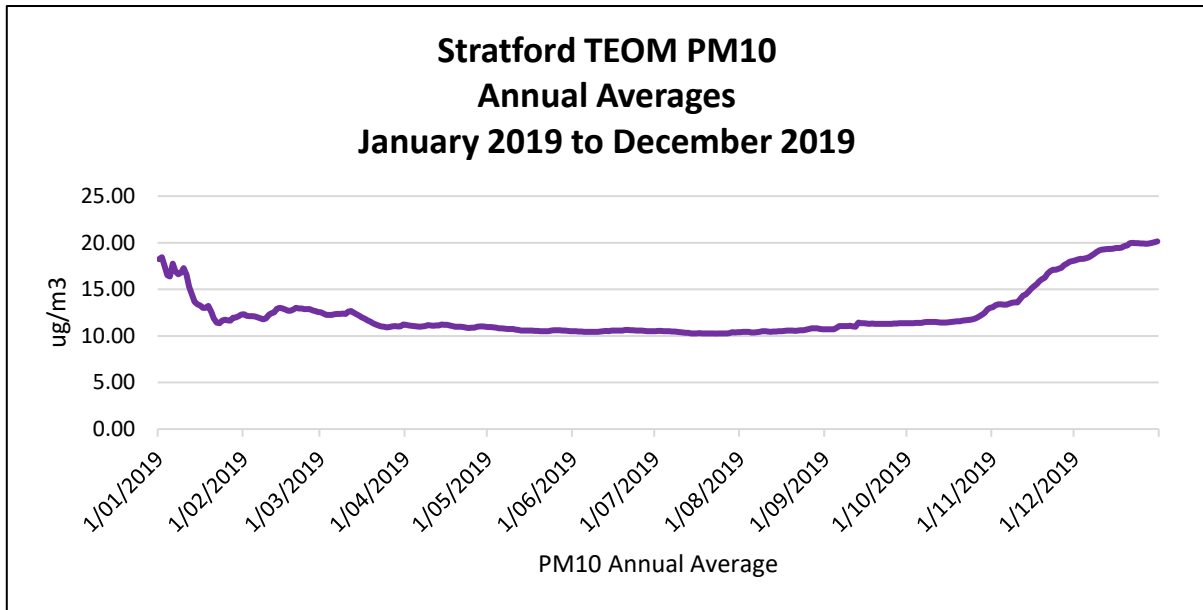
Figure 3.7: Rolling Annual Average Stratford TEOM (PM₁₀) Results
