Coal & Allied – Mount Thorley Warkworth Operations
Community Consultative Committee Meeting – Monday 8 August 2106

Warkworth Mining Limited EMERGENCY EVACUATION PROCEDURES

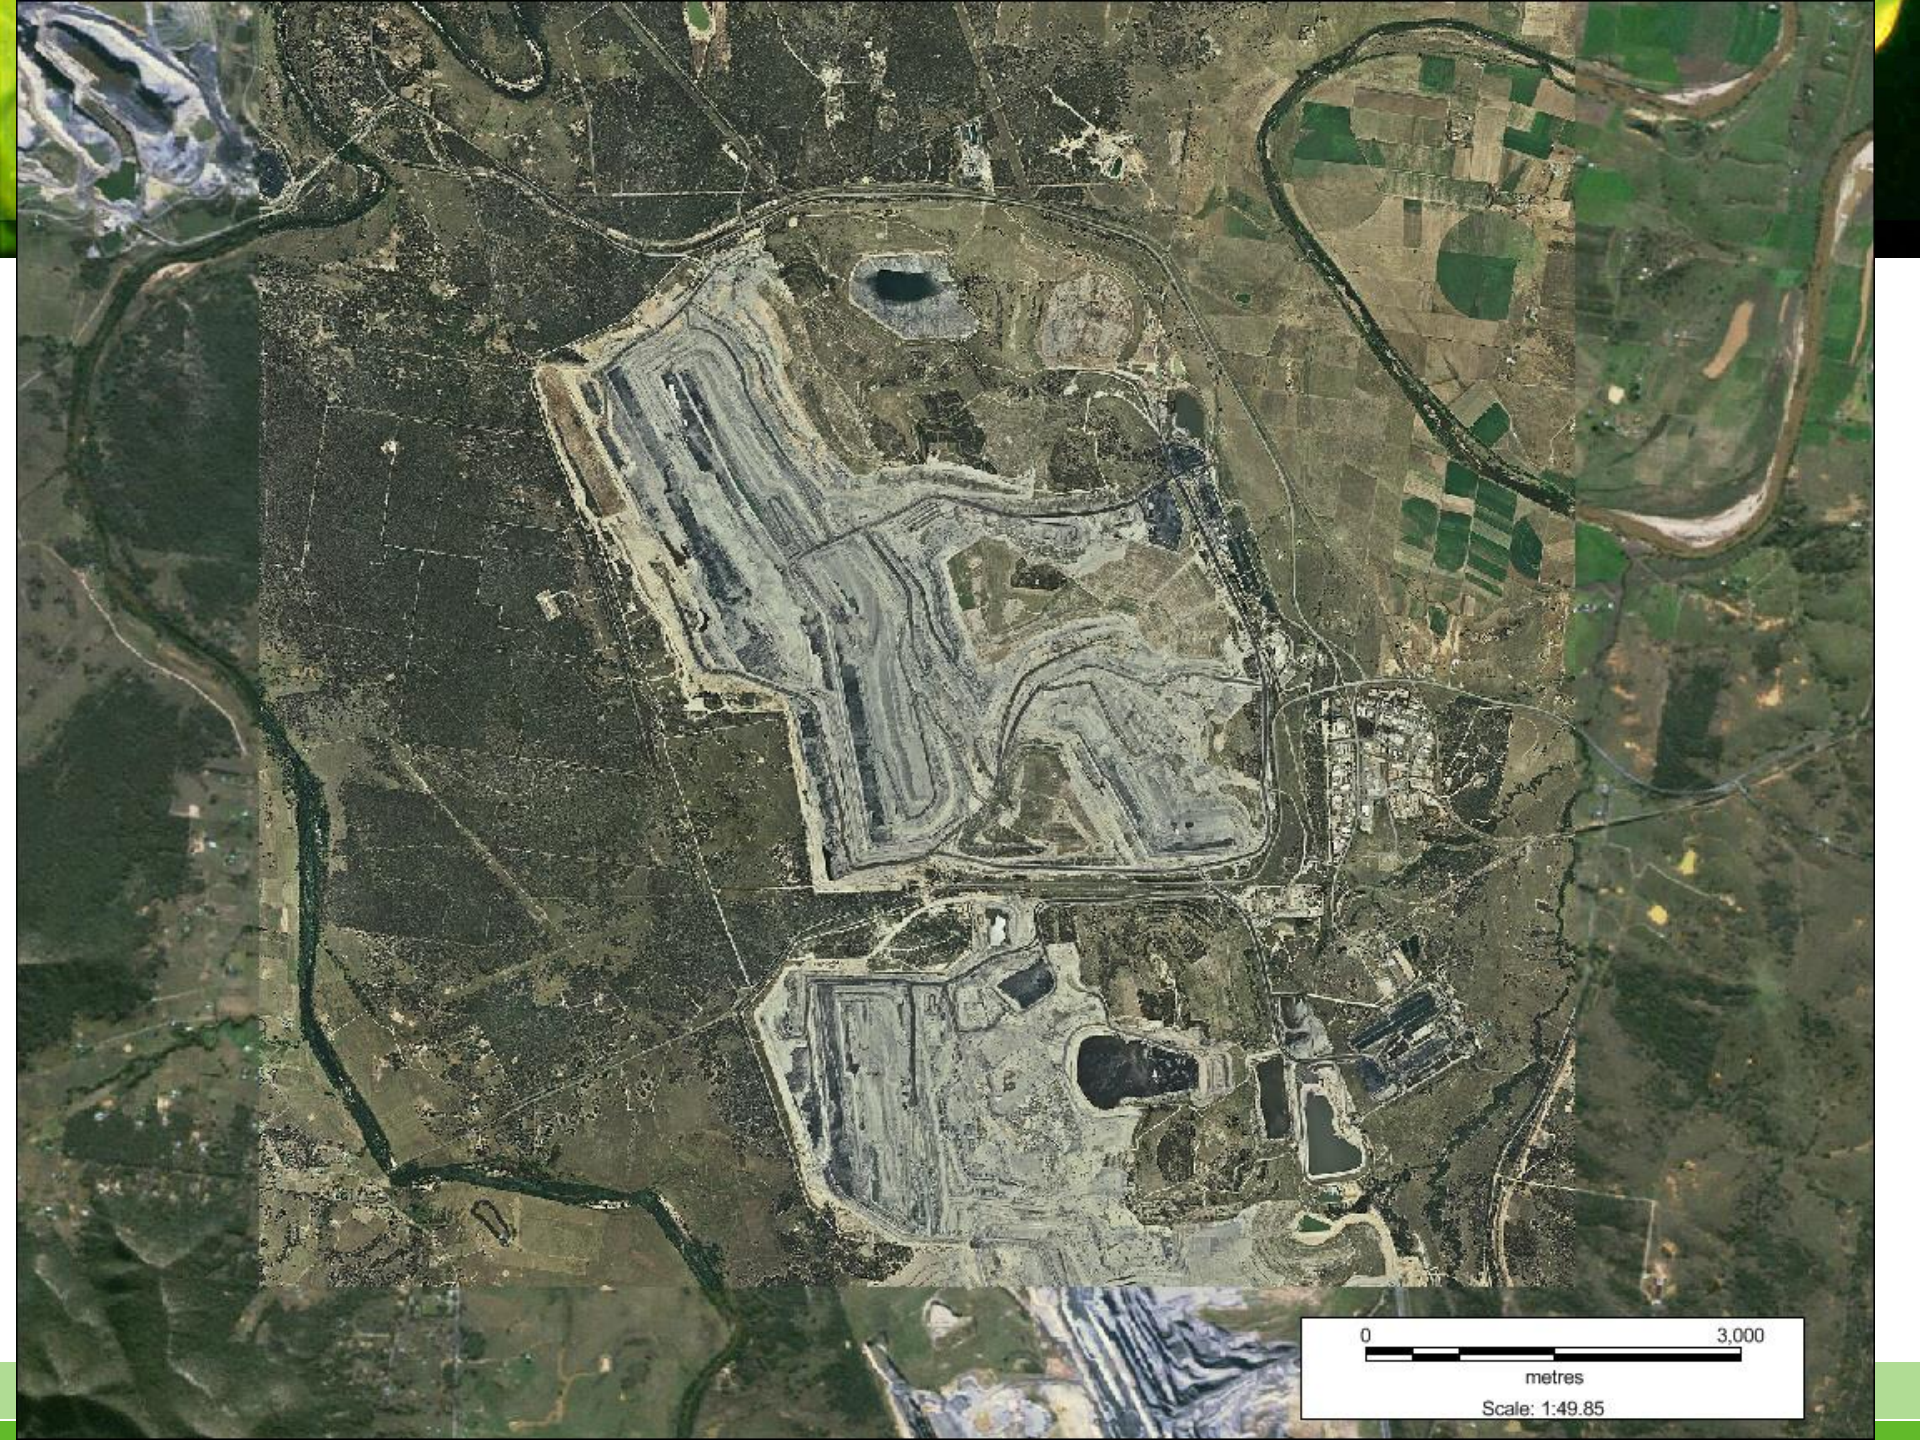
Rehabilitation

Rehabilitation target for 2016 = 83.3 ha
(outlined in red)

At the end of the June rehabilitation is progressing well with 47.9 ha of the targeted areas bulk shaped, 17.5 ha of topsoiled, 21.5 ha composted and 8.1 ha seeded.

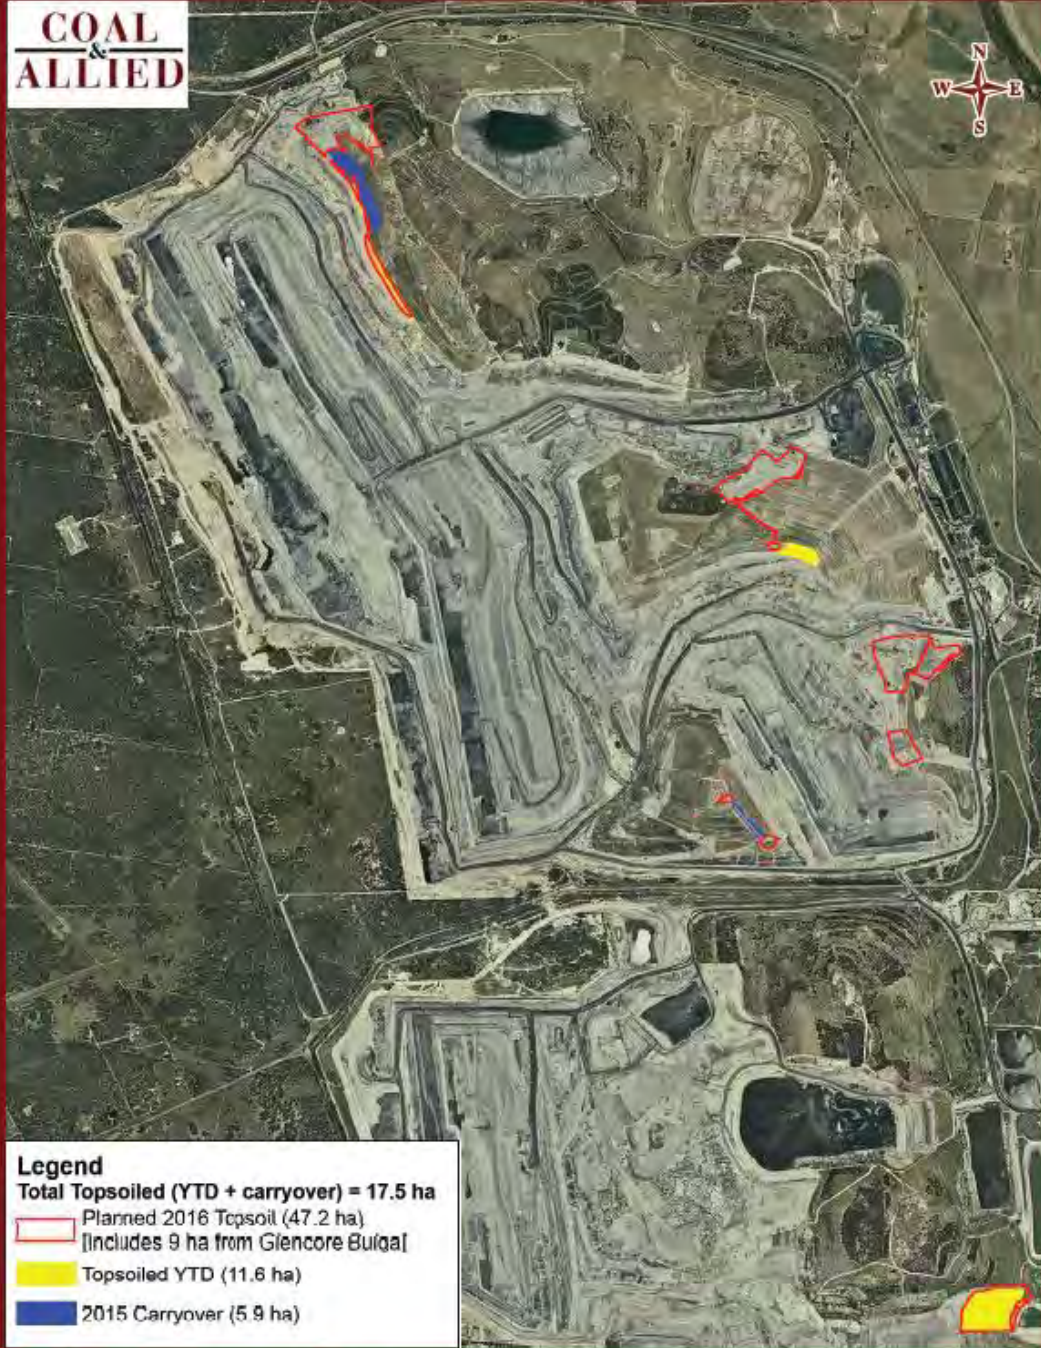
Plan of: Topsoiled 2016
Location: MTW

Legend
Total Topsoiled (YTD + carryover) = 17.5 ha
Planned 2016 Topsoil (47.2 ha)
[Includes 9 ha from Glencore Buïqa]
Topsoiled YTD (11.6 ha)
2015 Carryover (5.9 ha)

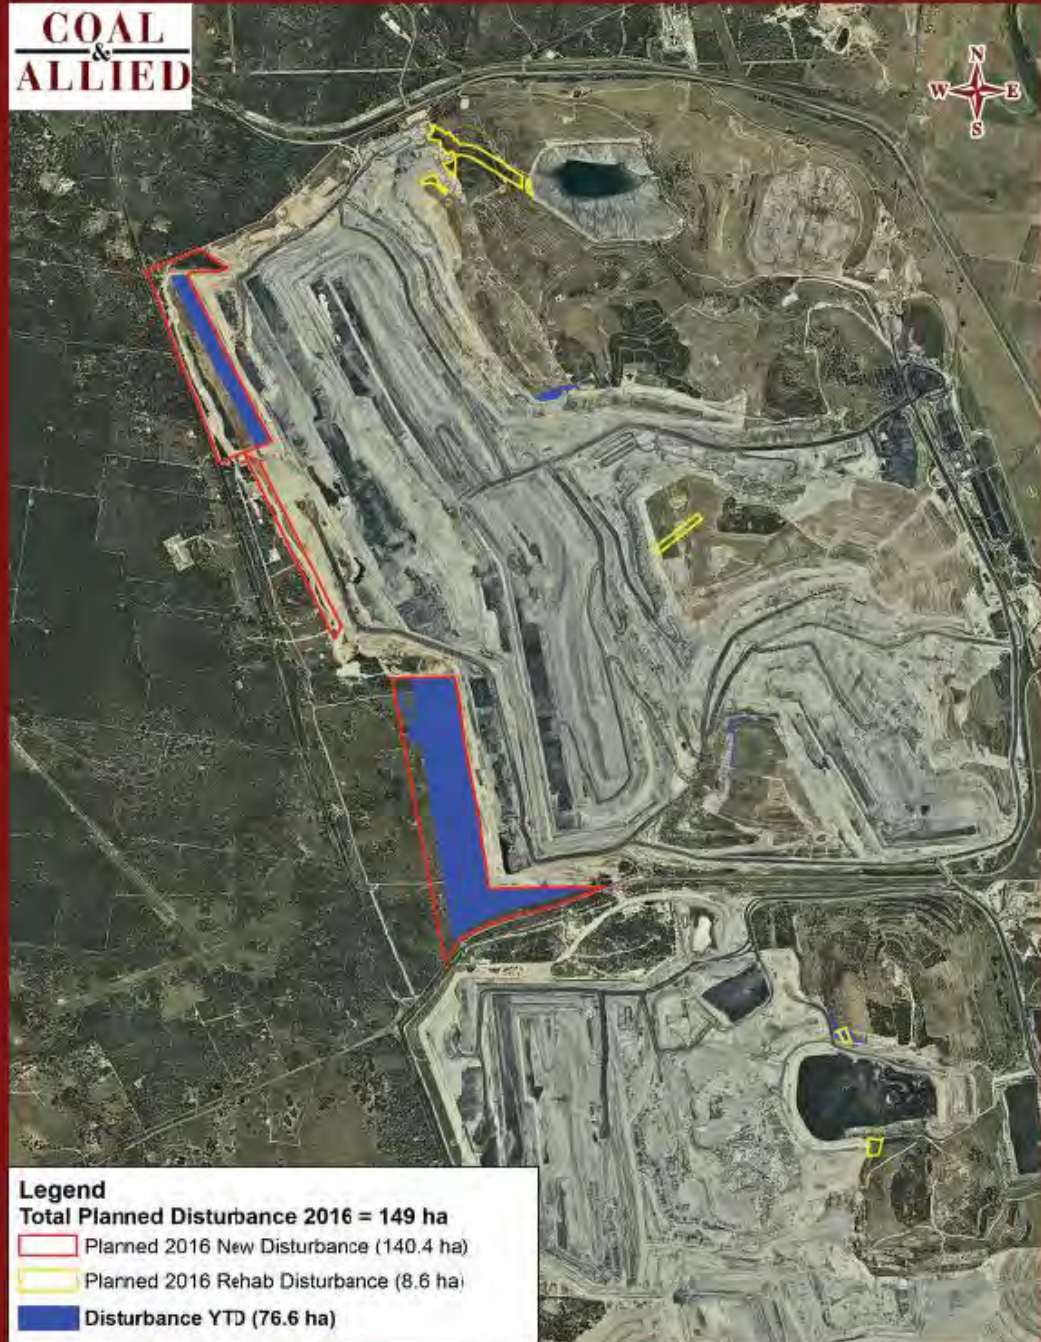
Disturbance was predominantly in Warkworth's West Pit area, for mine advance, and to construct a water management contour along the western extent of the disturbance to manage water off pre-strip activities. A total of 76.6 ha has been disturbed at end of June.

Legend
Total Planned Disturbance 2016 = 149 ha
Planned 2016 New Disturbance (140.4 ha)
Planned 2016 Rehab Disturbance (8.6 ha)
Disturbance YTD (76.6 ha)

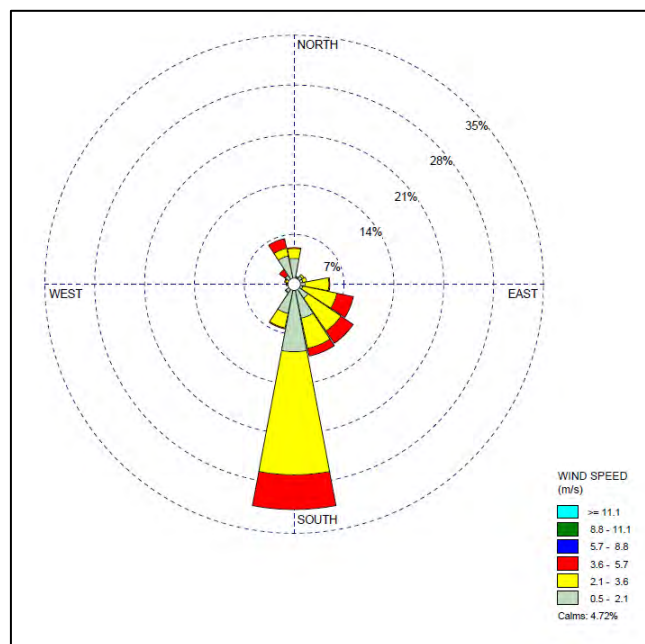
Figure 2: Charlton Ridge Wind Rose – April 2016

Winds from the South were dominant throughout the reporting period as shown in Figure 2.

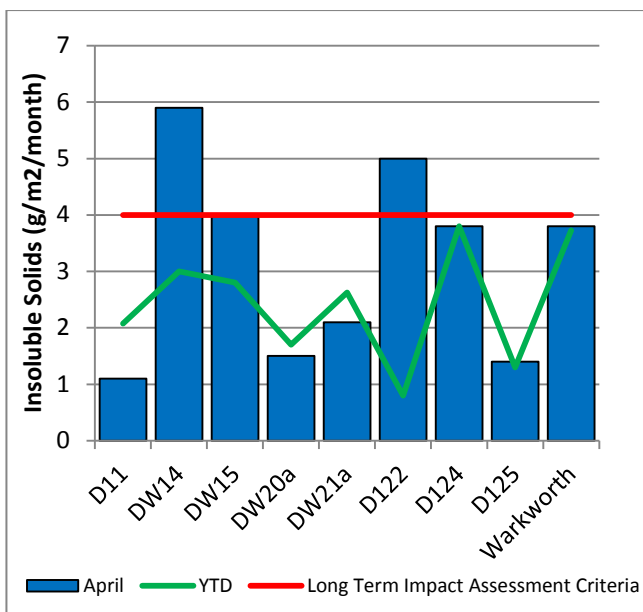
Figure 4: Depositional Dust – April 2016

During the reporting period the DW14 and D122 monitors recorded monthly results above the long term impact assessment criteria of 4.0 g/m² per month. The field notes associated with the results confirm the presence of insects. As such the results are considered contaminated and will be excluded from calculation of the annual average.

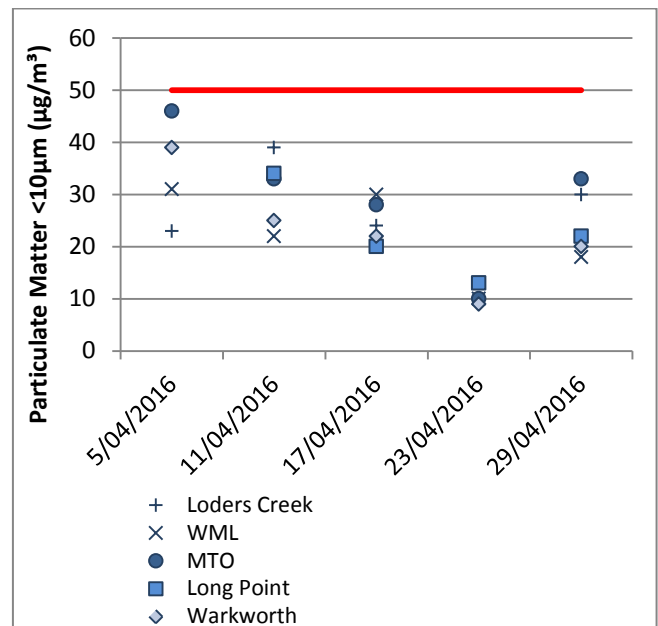
Figure 5: Individual PM₁₀ Results – April 2016

Figure 5 shows the individual PM₁₀ results at each monitoring station against the short term impact assessment criteria of 50µg/m³.

The Long Point HVAS did not run on the 5th of April due to a power outage.

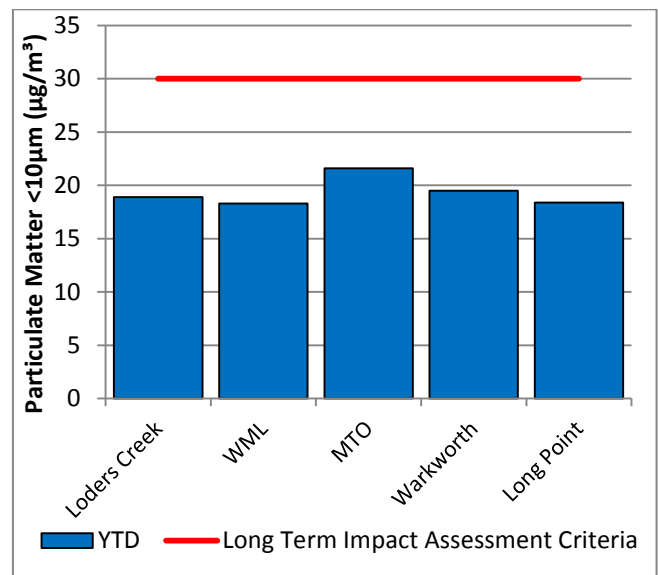
Figure 6: Annual Average PM₁₀ – April 2016

Figure 6 shows the annual average PM₁₀ results against the long term impact assessment criteria.

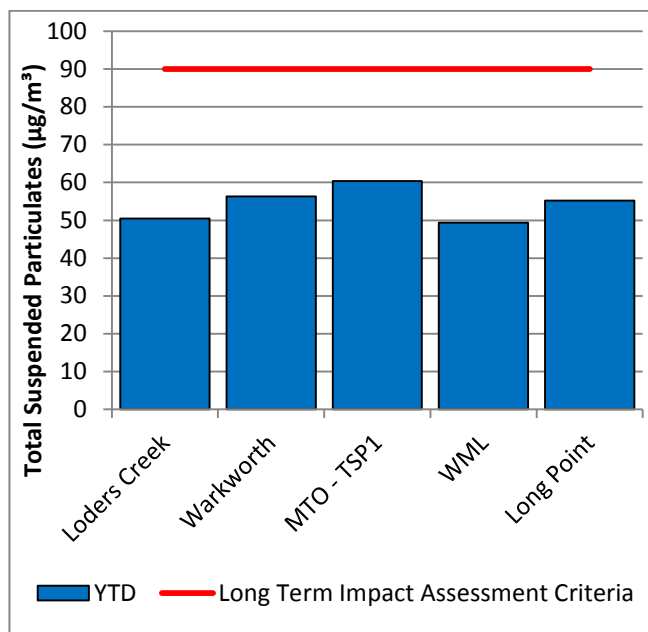
Figure 7: Annual Average Total Suspended Particulates – April 2016

Figure 7 shows the annual average TSP results compared against the long term impact assessment criteria of $90\mu\text{g}/\text{m}^3$.

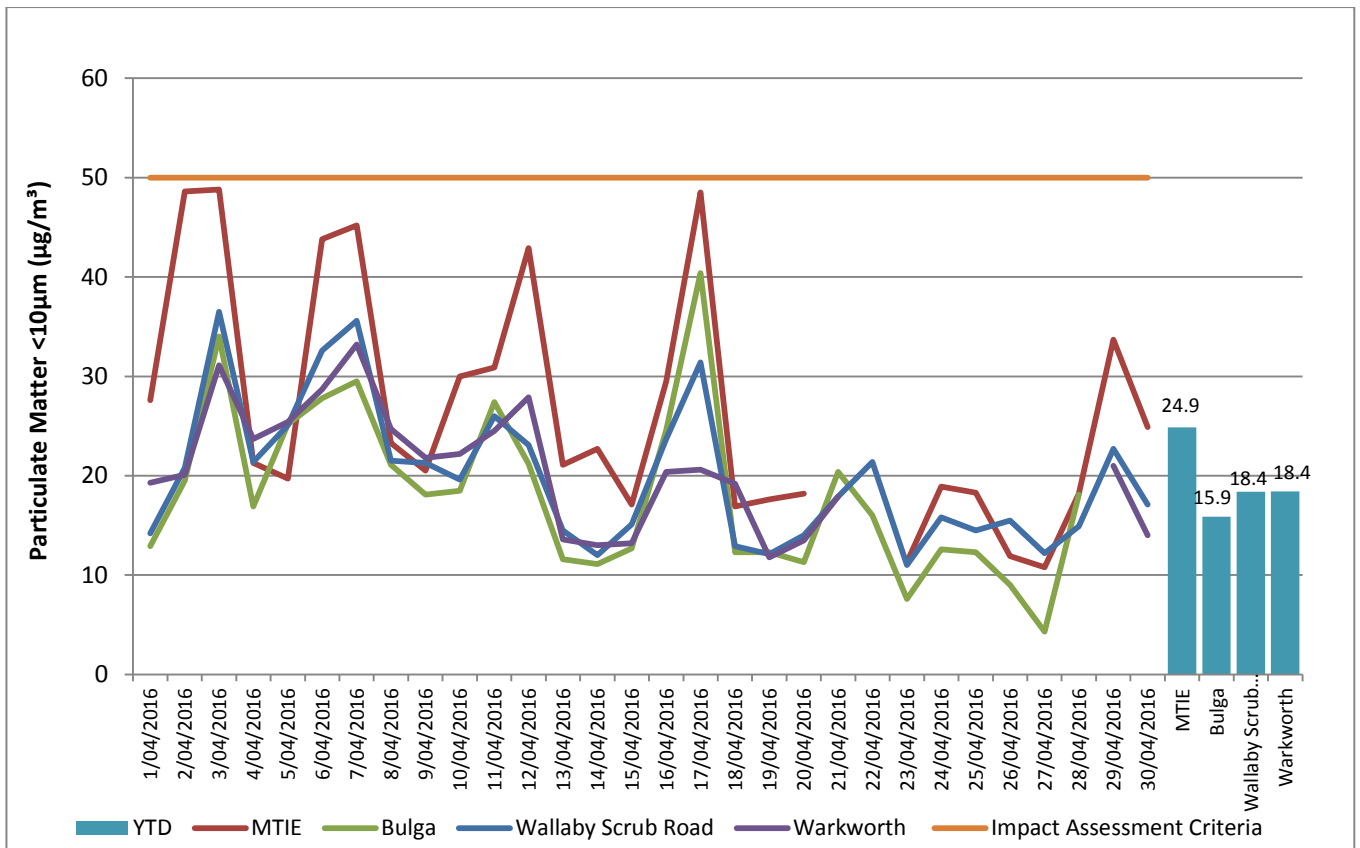
Figure 8: Real Time PM₁₀ daily 24hr average and annual average – April 2016

During April, the real time monitoring system generated 72 automated air quality related alerts, including 1 alert for adverse meteorological conditions and 71 alerts for elevated PM₁₀ levels.

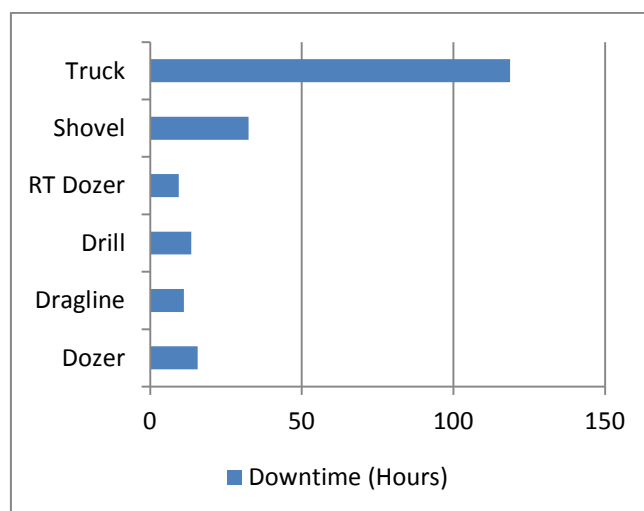
Figure 17: Operational Downtime by Equipment Type – April 2016

During April, a total of 200.8 hours of equipment downtime was logged in response to environmental events such as dust, noise and elevated wind impacts. Operational downtime by equipment type is shown in Figure 17.

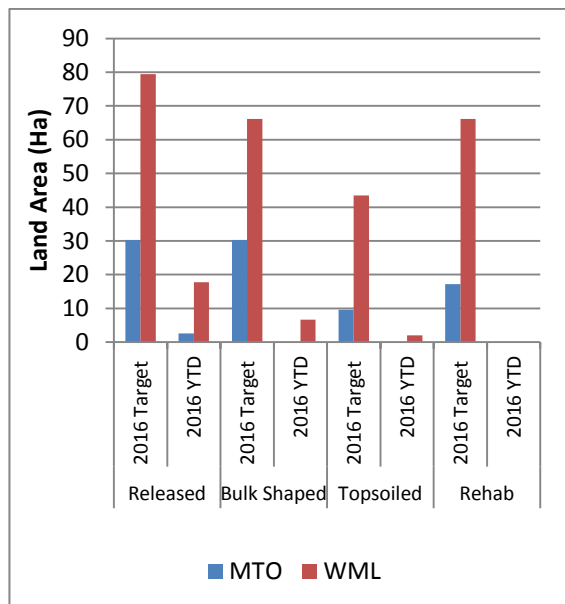
Figure 18: Rehabilitation YTD – April 2016

During April, 7.7 Ha of land was released. Year-to-date progress can be viewed in Figure 18.

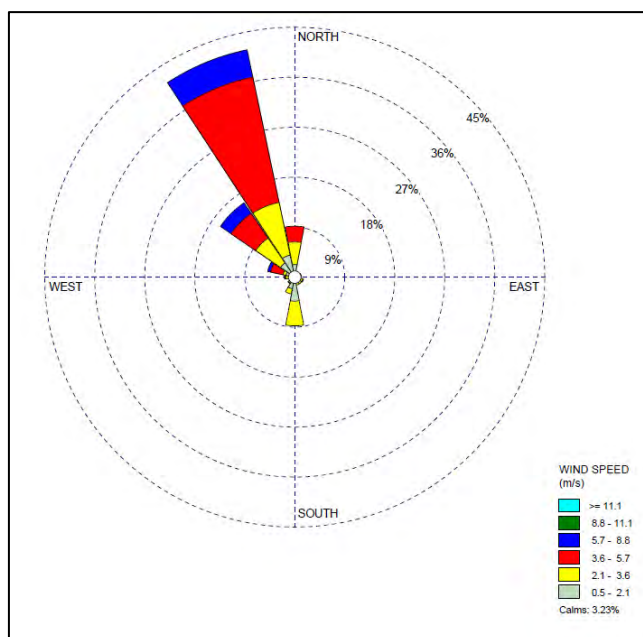
Figure 2: Charlton Ridge Wind Rose – May 2016

Winds from the Northwest were dominant throughout the reporting period as shown in Figure 2.

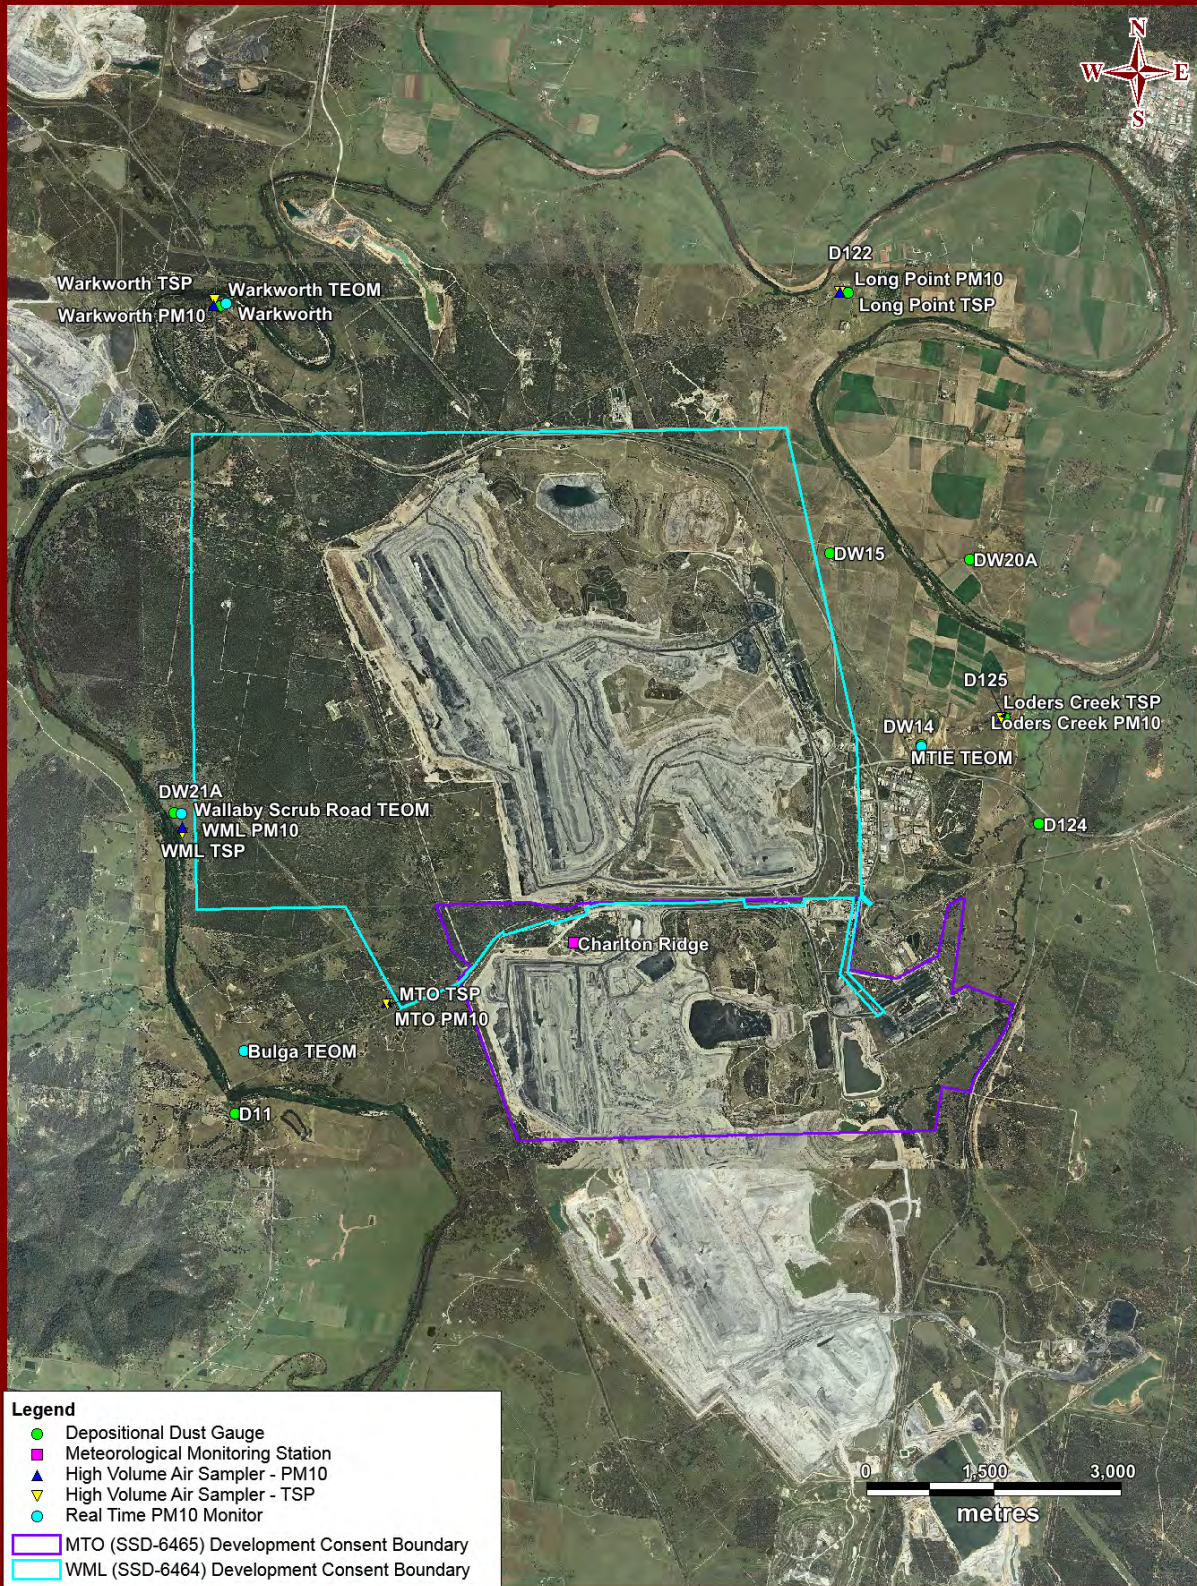
Figure 3: Air Quality Monitoring Locations

**Mount Thorley Warkworth
Air Quality Monitoring Programme**

Meteorological data is collected at MTW's 'Charlton Ridge' meteorological station (refer to Figure 3: Air Quality Monitoring Locations).

Suspended particulates are measured by a network of High Volume Air Samplers (HVAS) measuring Total Suspended Particulates (TSP) and Particulate Matter <10µm (PM₁₀). The location of these monitors can be found in Figure 3. Each HVAS was run for

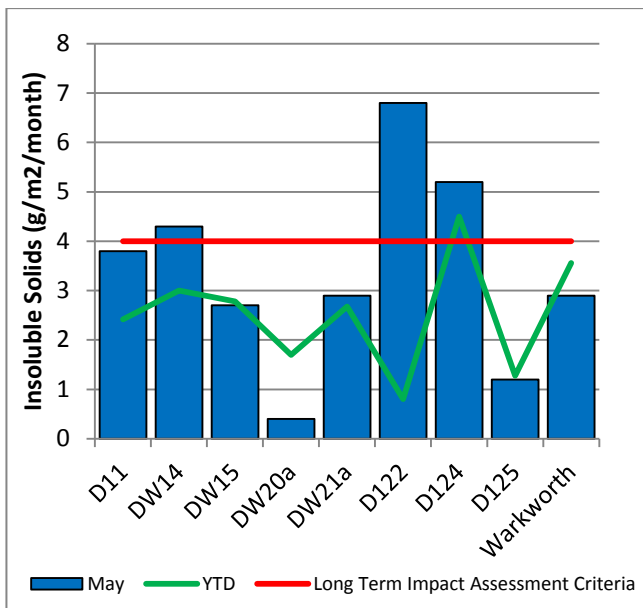
Figure 4: Depositional Dust – May 2016

During the reporting period the DW14, D122 and D124 monitors recorded monthly results above the long term impact assessment criteria of 4.0 g/m² per month. Field notes associated with DW14 and D122 confirm the presence of insects and bird droppings. As such the results are considered contaminated and will be excluded from calculation of the annual average. There is no evidence to suggest that the D124 result is contaminated. Accordingly, this result will be included in the annual average calculation.

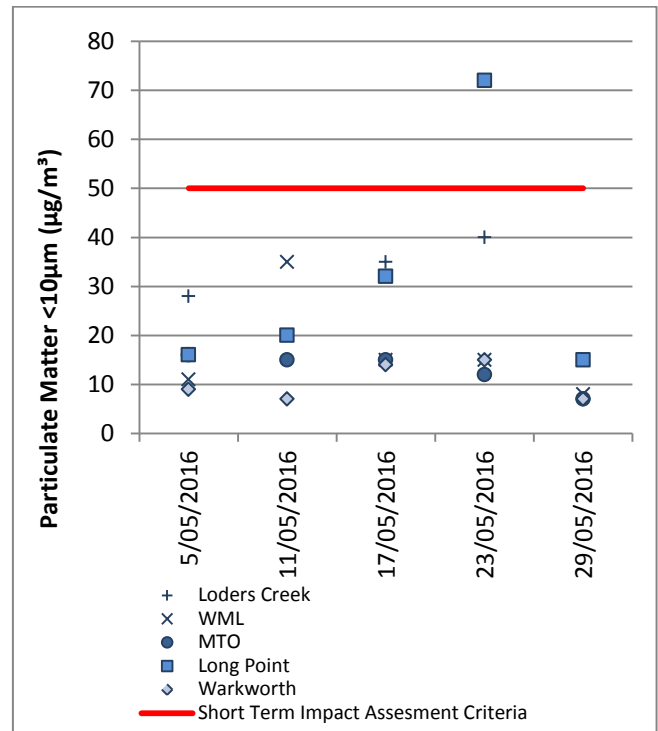
Figure 5: Individual PM₁₀ Results – May 2016

On 23/05/2016 one HVAS PM₁₀ unit recorded a result greater than the short term (24hr) PM₁₀ impact assessment criteria; Long Point (72 µg/m³). At the time of preparation of this report, the result is under investigation. Preliminary advice has been provided to the Department of Planning & Environment.

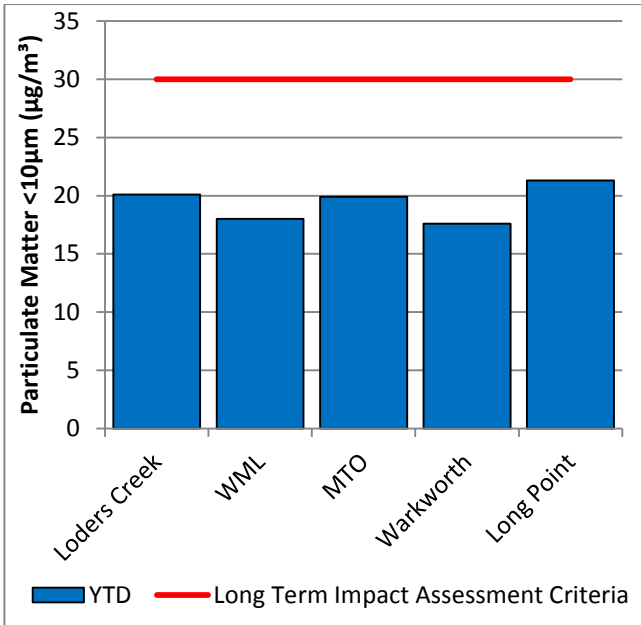
Figure 6: Annual Average PM₁₀ – May 2016

Figure 6 shows the annual average PM₁₀ results against the long term impact assessment criteria.

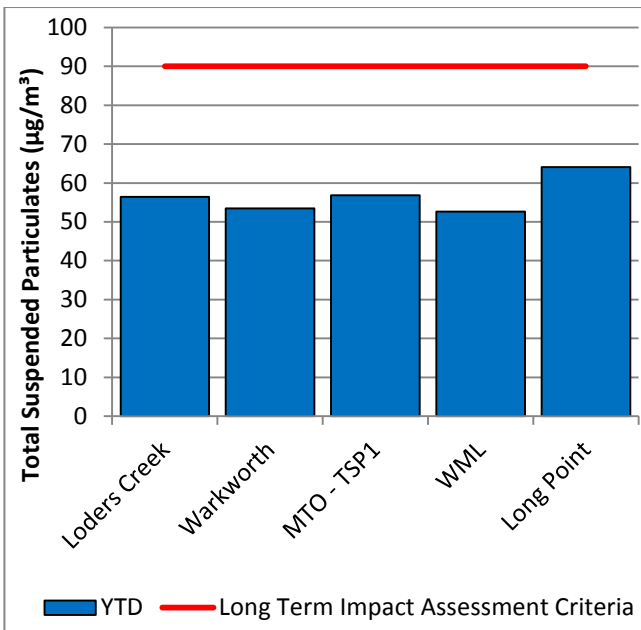
Figure 7: Annual Average Total Suspended Particulates – May 2016

Figure 7 shows the annual average TSP results compared against the long term impact assessment criteria of 90µg/m³.

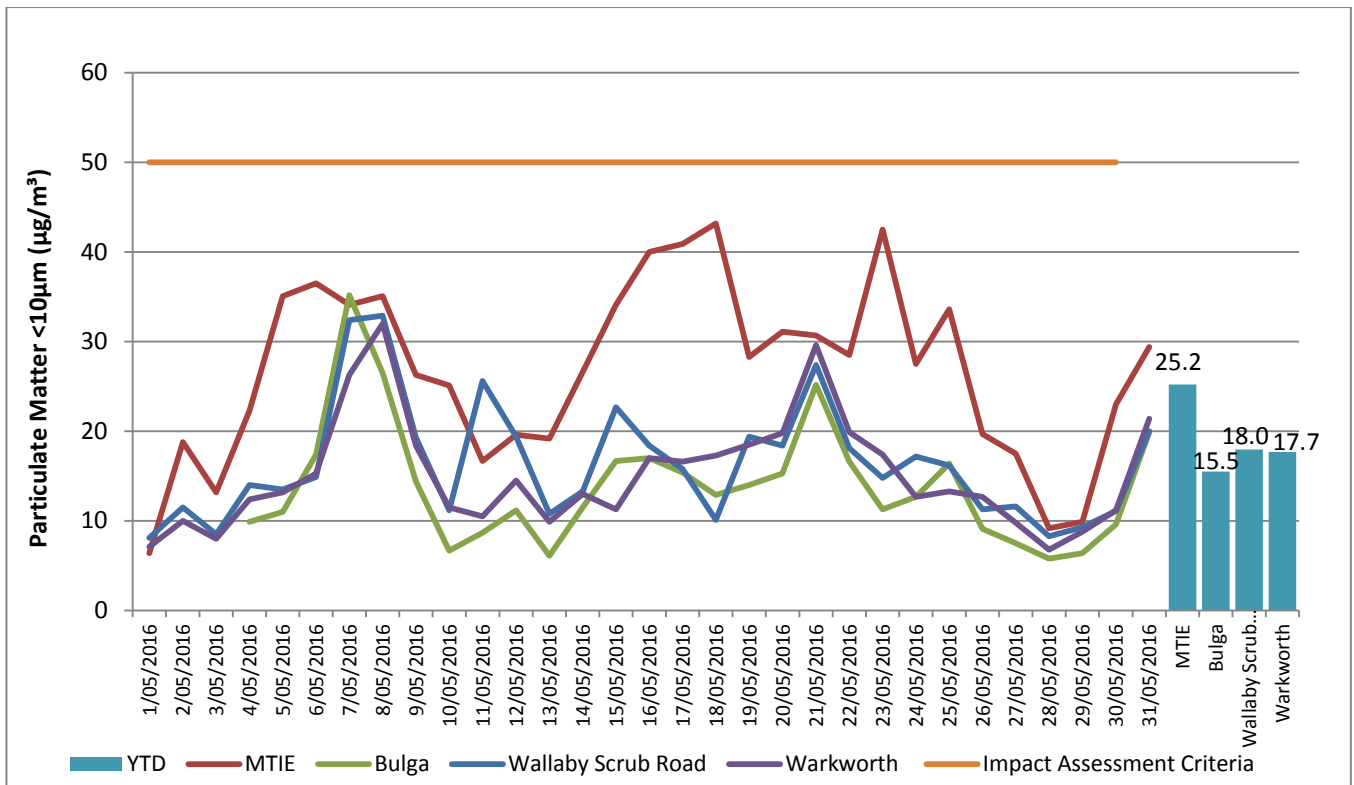
Figure 8: Real Time PM₁₀ daily 24hr average and annual average – May 2016

During May, the real time monitoring system generated 59 automated air quality related alerts, including 27 alerts for adverse meteorological conditions and 32 alerts for elevated PM₁₀ levels.

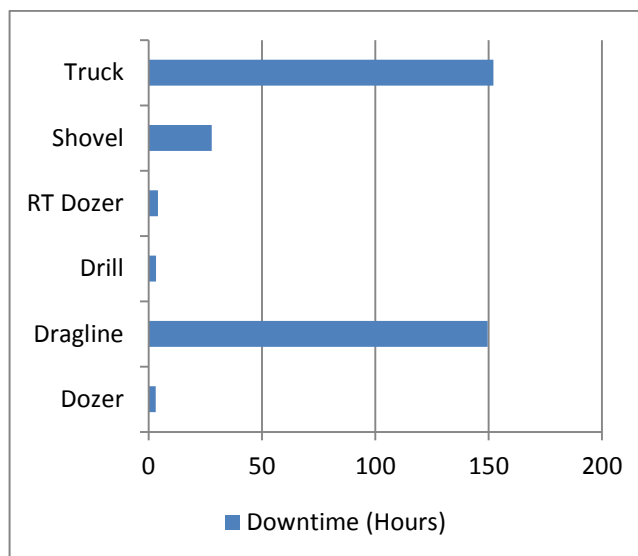
Figure 17: Operational Downtime by Equipment Type – May 2016

During May, a total of 340.2 hours of equipment downtime was logged in response to environmental events such as dust, noise and elevated wind impacts. Operational downtime by equipment type is shown in Figure 17.

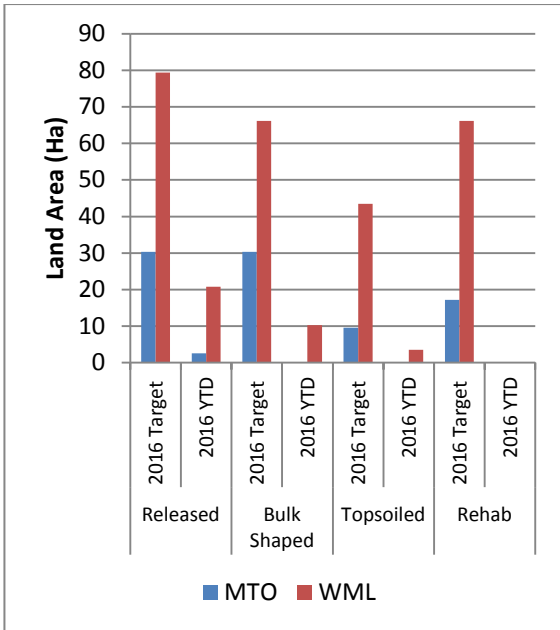
Figure 18: Rehabilitation YTD – May 2016

During May, 3.0 Ha of land was released, 3.6 Ha of land was bulk shaped, 1.6 Ha of land was topsoiled and 8.2 Ha of land was composted. Year-to-date progress can be viewed in Figure 18.

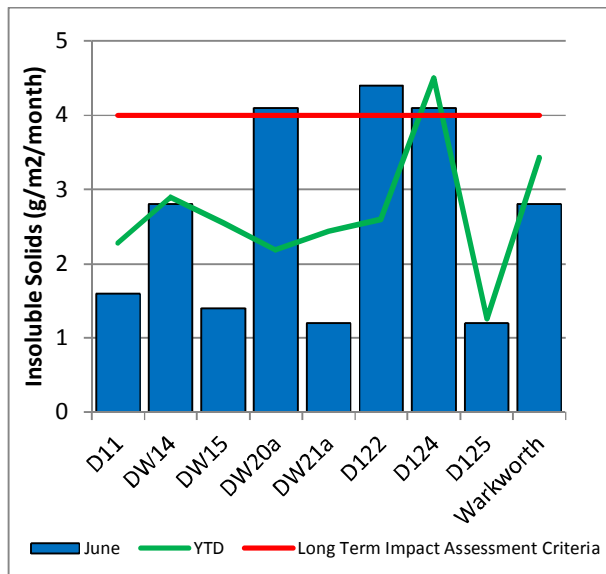
Figure 4: Depositional Dust – June 2016

Monitors DW20A, D122 and D124 recorded results of 4.1, 4.4 and 4.1 g/m² respectively for the month. The field notes associated with the D124 result confirms the presence of insects and bird droppings. As such the result is considered contaminated and will be excluded from calculation of the annual average. There is no evidence to suggest that the DW20a or the D122 result is contaminated. Accordingly, this result will be included in the annual average calculation.

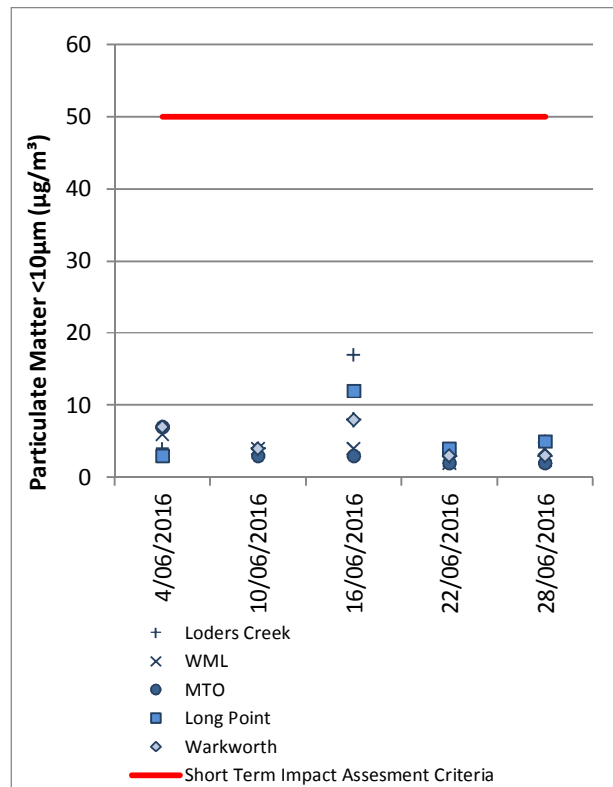
Figure 5: Individual PM₁₀ Results – June 2016

The Long Point HVAS failed to collect a valid sample on the 10th June due to a technical issue.

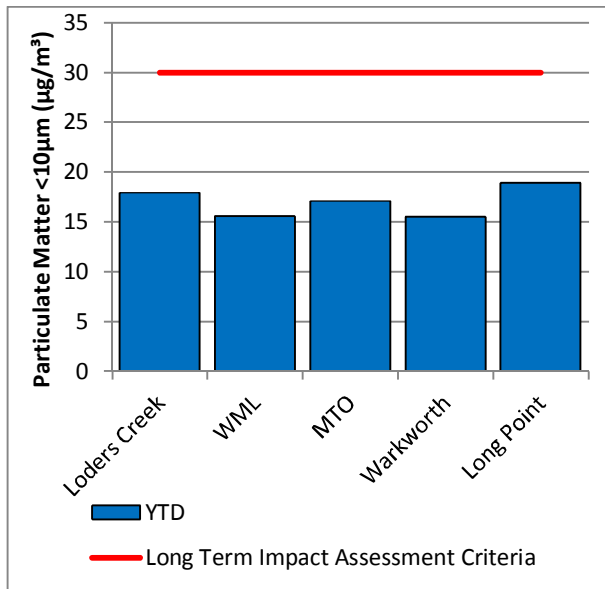
Figure 6: Annual Average PM₁₀ – June 2016

Figure 6 shows the annual average PM₁₀ results against the long term impact assessment criteria.

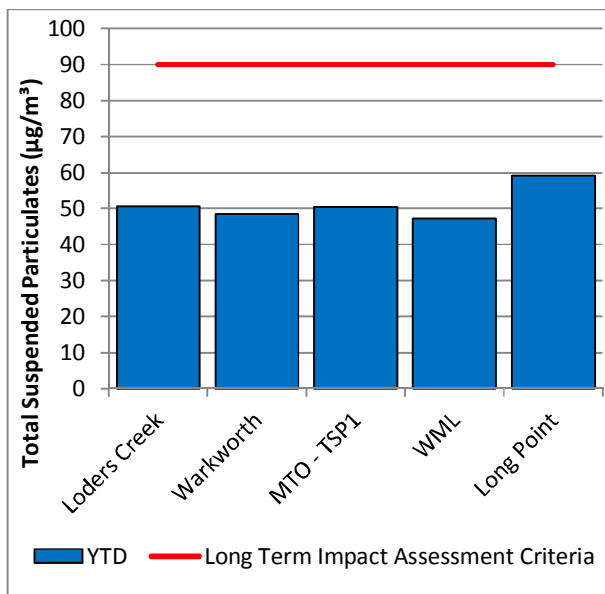
Figure 7: Annual Average Total Suspended Particulates – June 2016

Figure 7 shows the annual average TSP results compared against the long term impact assessment criteria of 90µg/m³.

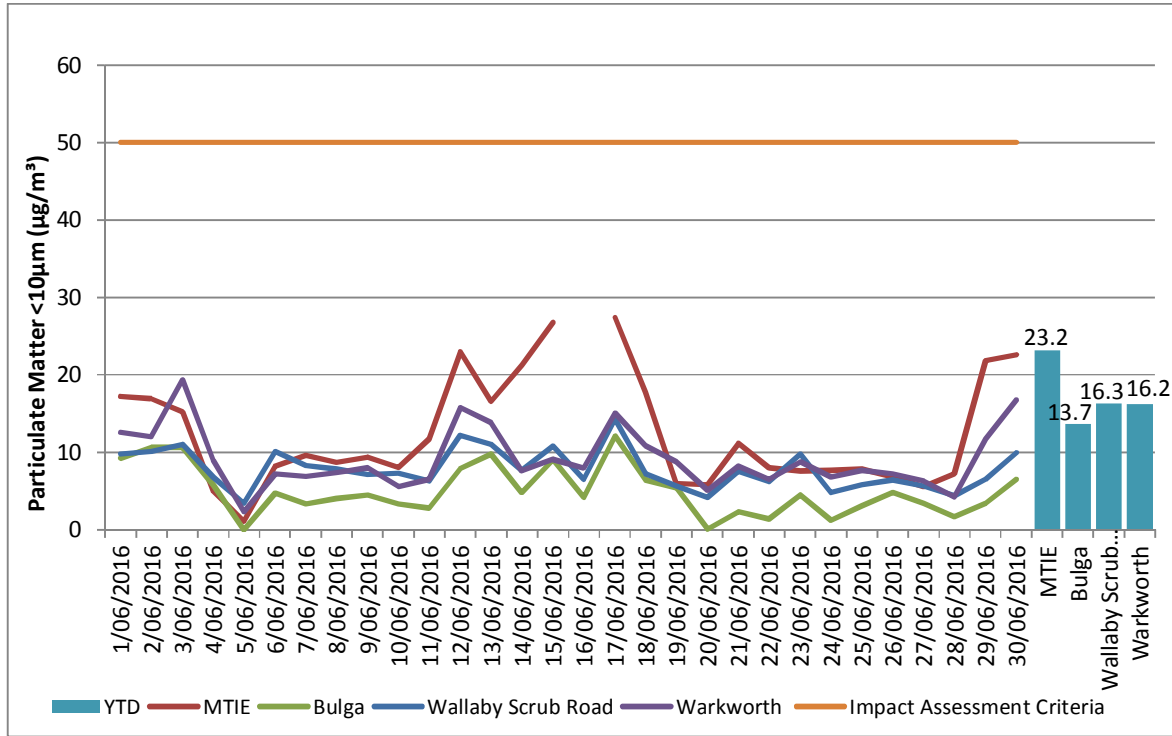
Figure 8: Real Time PM₁₀ 24hr average and Year-to-date average – June 2016

During June, the real time monitoring system generated 34 automated air quality related alerts, including 25 alerts for adverse meteorological conditions and 9 alerts for elevated dust levels.

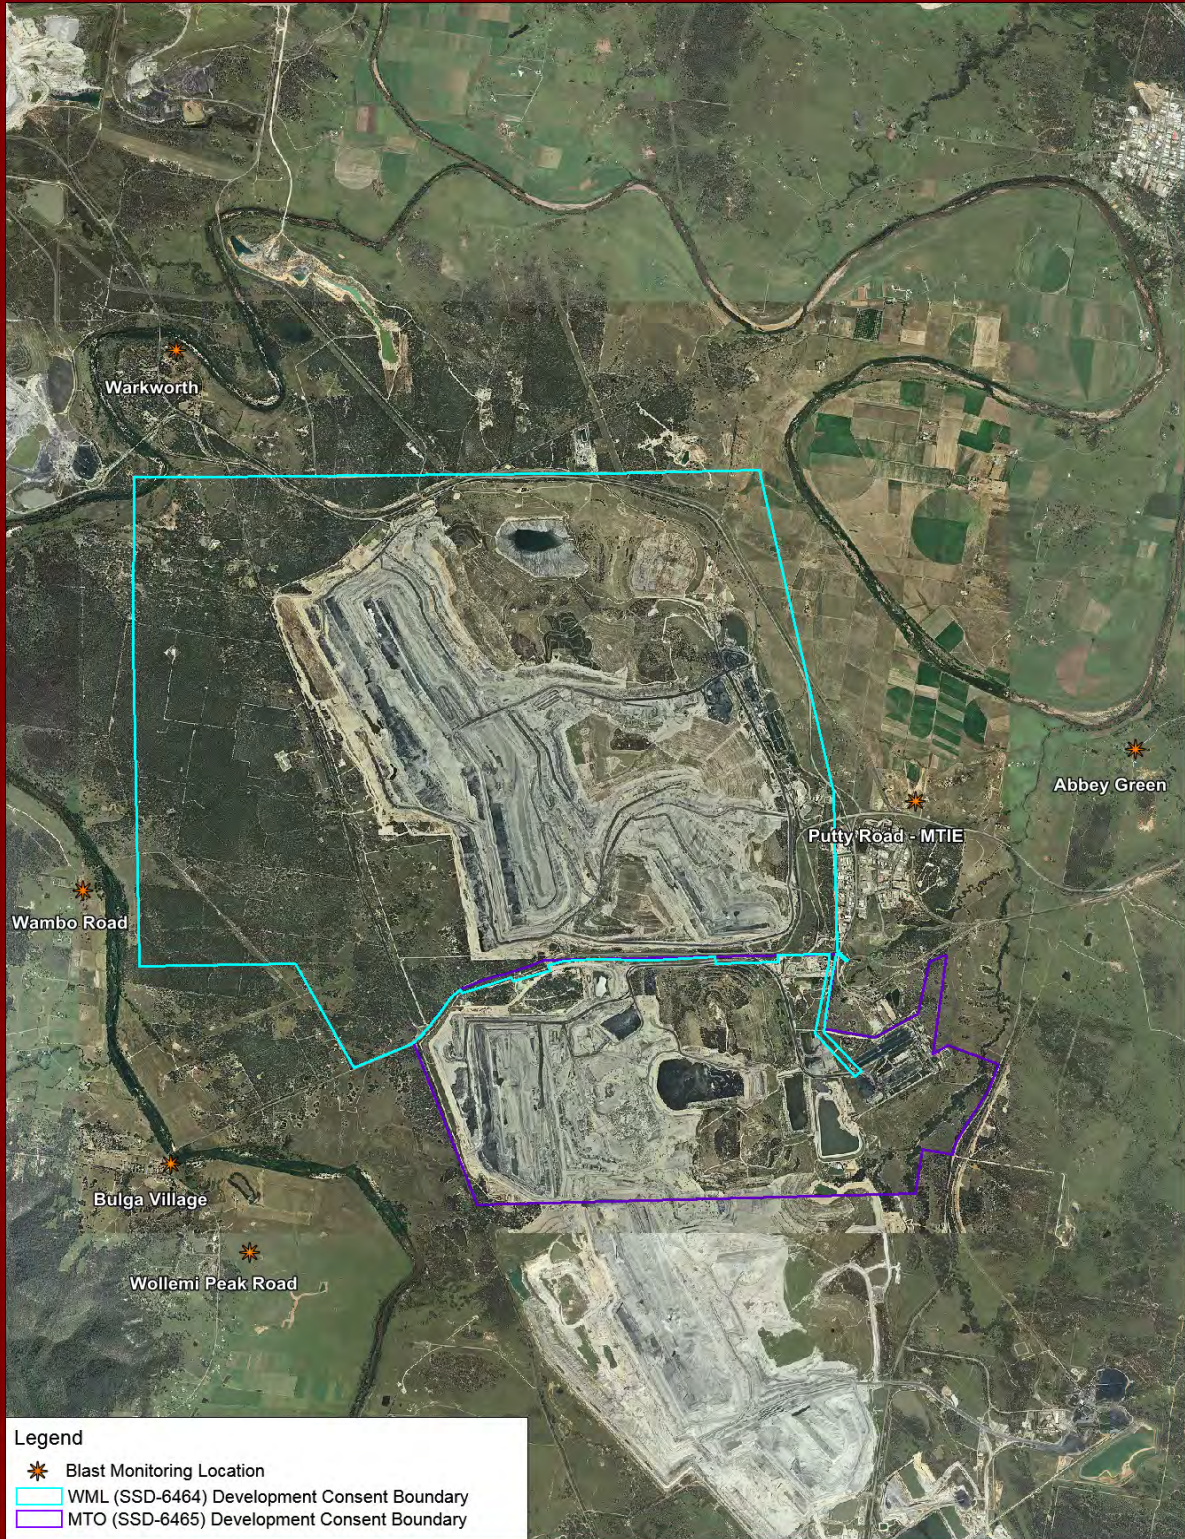
Figure 66: Blast and Vibration Monitoring Location Plan

Mount Thorley Warkworth
Blast Monitoring Locations

The location of these monitors can be found in Figure 66.

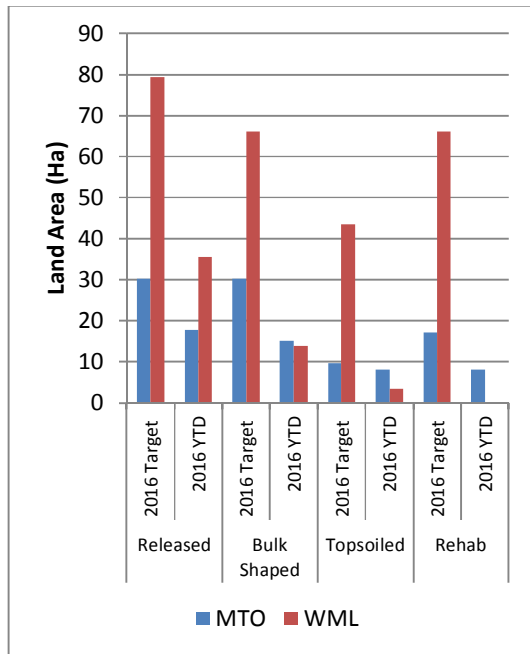
Figure 69: Rehabilitation YTD - June 2016

During June, 30.01 Ha of land was released, 18.8Ha was bulk shaped, 8.1Ha was topsoiled, 8.1Ha was composted and 8.1Ha was rehabilitated. Year-to-date progress can be viewed in Figure 69.
