Yancoal
Mount Thorley Warkworth Operations
Community Consultative Committee Meeting
Monday 13 August 2018

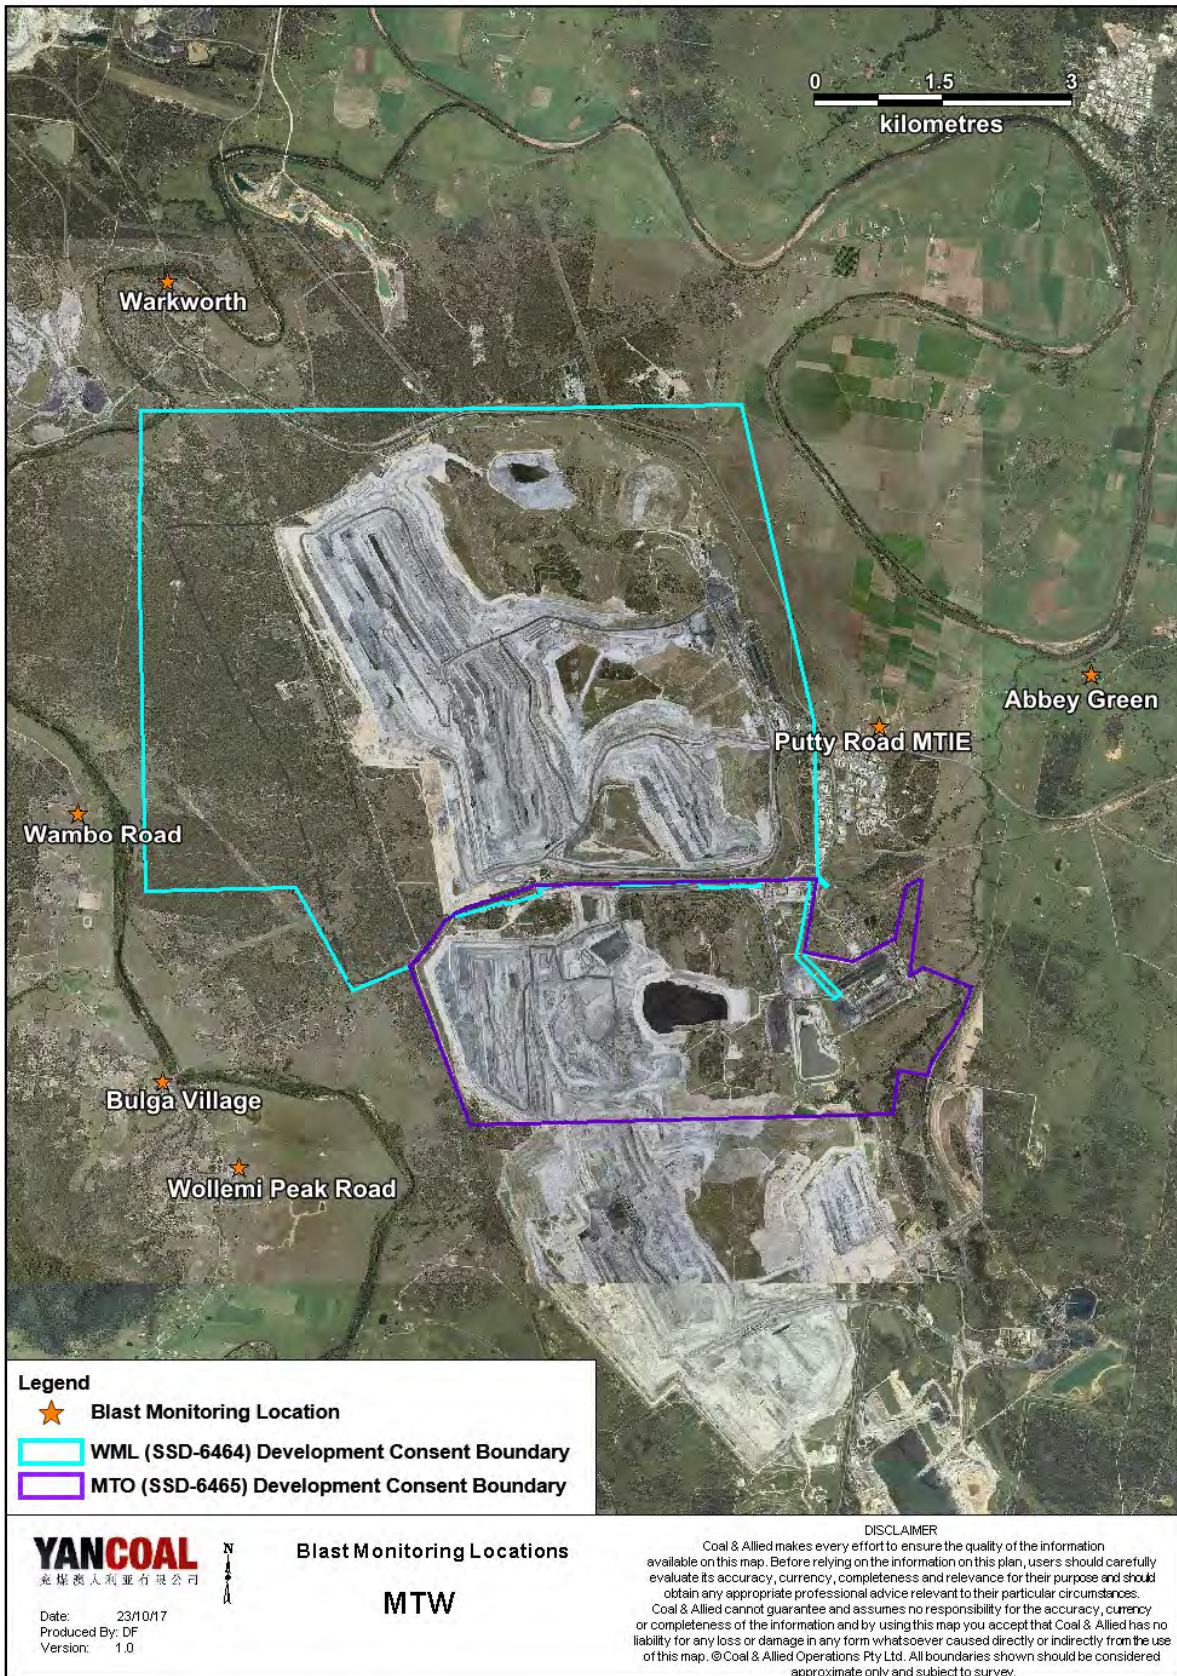
Figure 15: MTW Blast Monitoring Location Plan

The location of these monitors can be found in **Figure 15**.
