Duralie Coal Mine Annual Review

2019

ANNUAL REVIEW

Reporting Period: 1st July 2018 to 30th June 2019

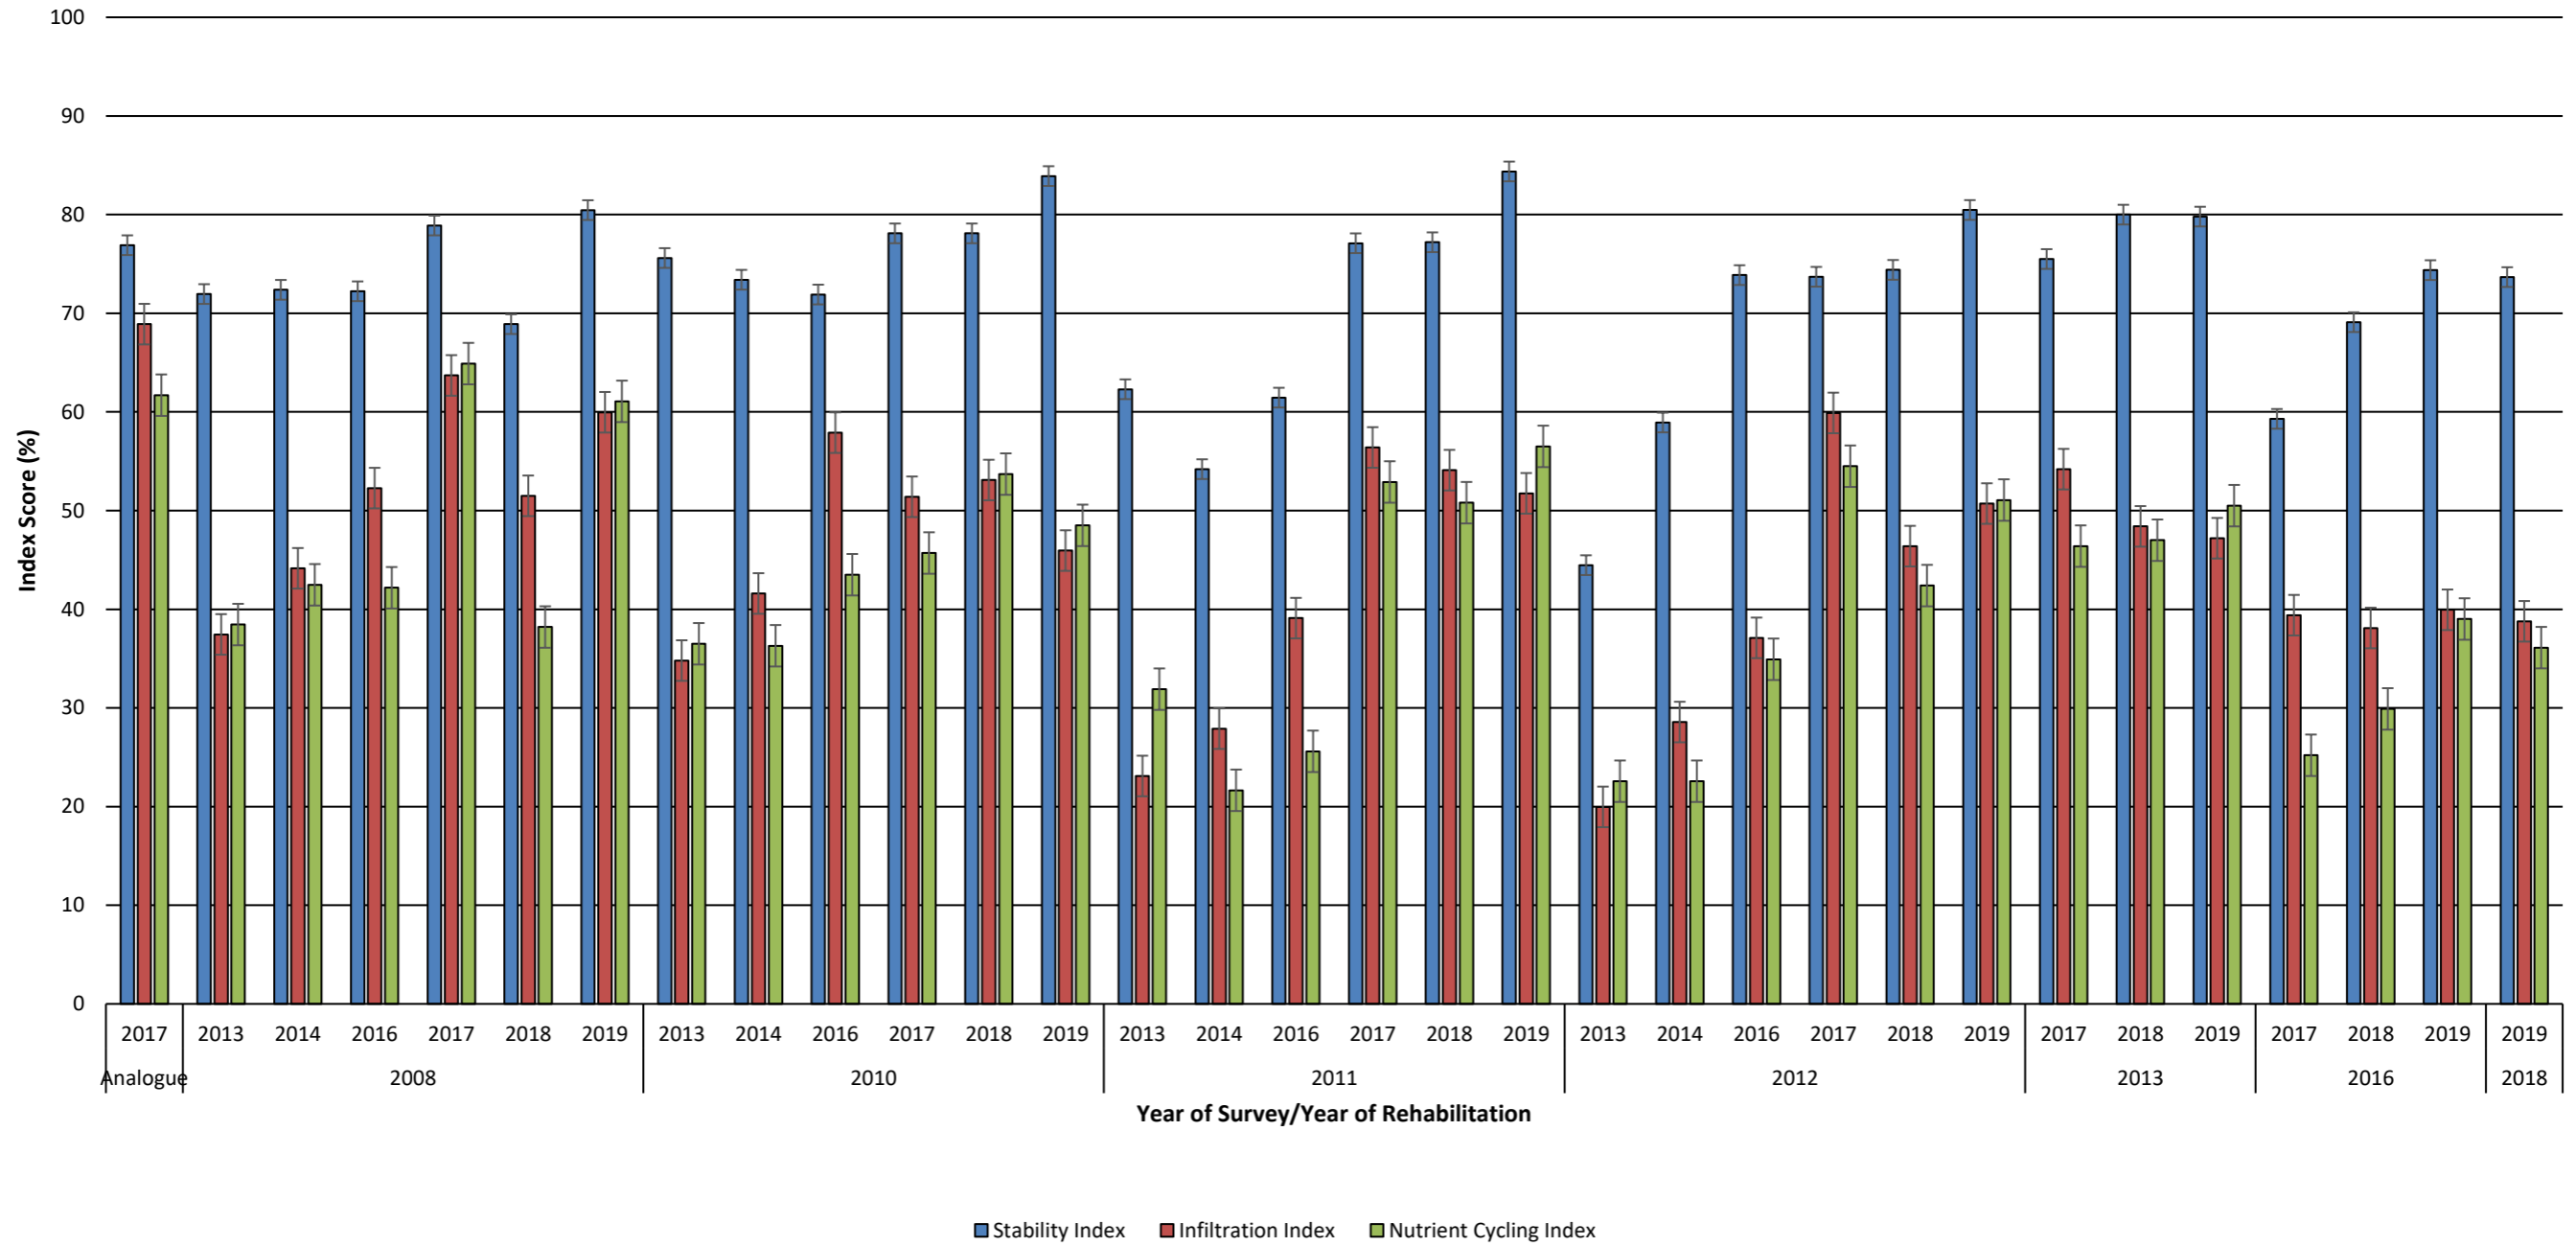
Figure 3: Landscape Functional Analysis results for the surveys for the different aged rehabilitation areas on the Duralie Coal Mine spoil emplacement and comparison to the 2017 average analogue sites derived from the Biodiversity Offsets Areas. Standard Error bars are shown where statistically valid, i.e. three or more transects in that age cohort for the 2019 survey

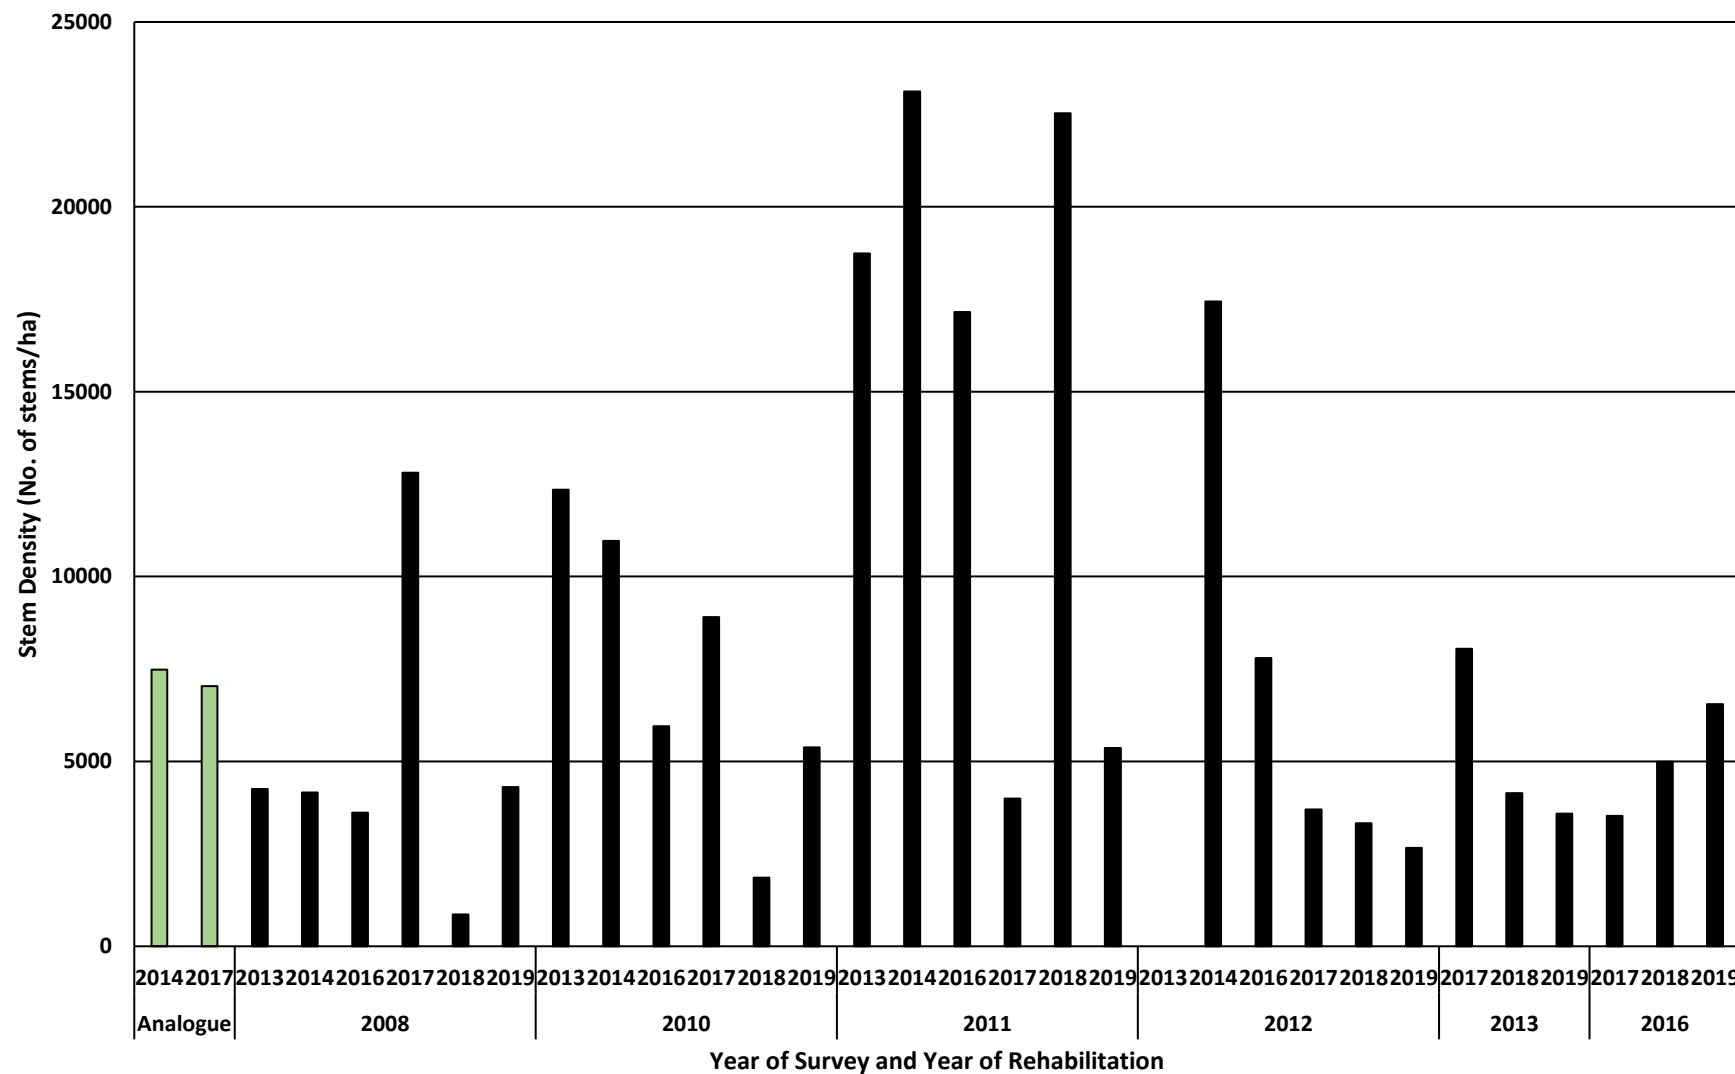
Figure 6: Average Total Stem Density (stems/ha) values recorded from the 2019 survey, comparison to previous surveys and the 2017 Average Analogue values derived from the Biodiversity Offsets Areas

The 2016 rehabilitation has increased the average stem density from the 2018 survey (4988 stems/ha) with 6548 stems/ha in 2019 and continues the upward trend. Canopy volume has also continued to increase, recording a substantial jump to 11,486 m³/ha compared to 2168 m³/ha for 2018.

Stem densities are variable across many of the rehabilitation areas (**Figure 6**). Partly this is an artefact of the transects monitored from year to year, but some direct comparisons can be made. The 2008 rehabilitation has recorded large swings in stem densities between surveys. The very low number of stems in the 2018 survey indicates that these two areas had a relatively

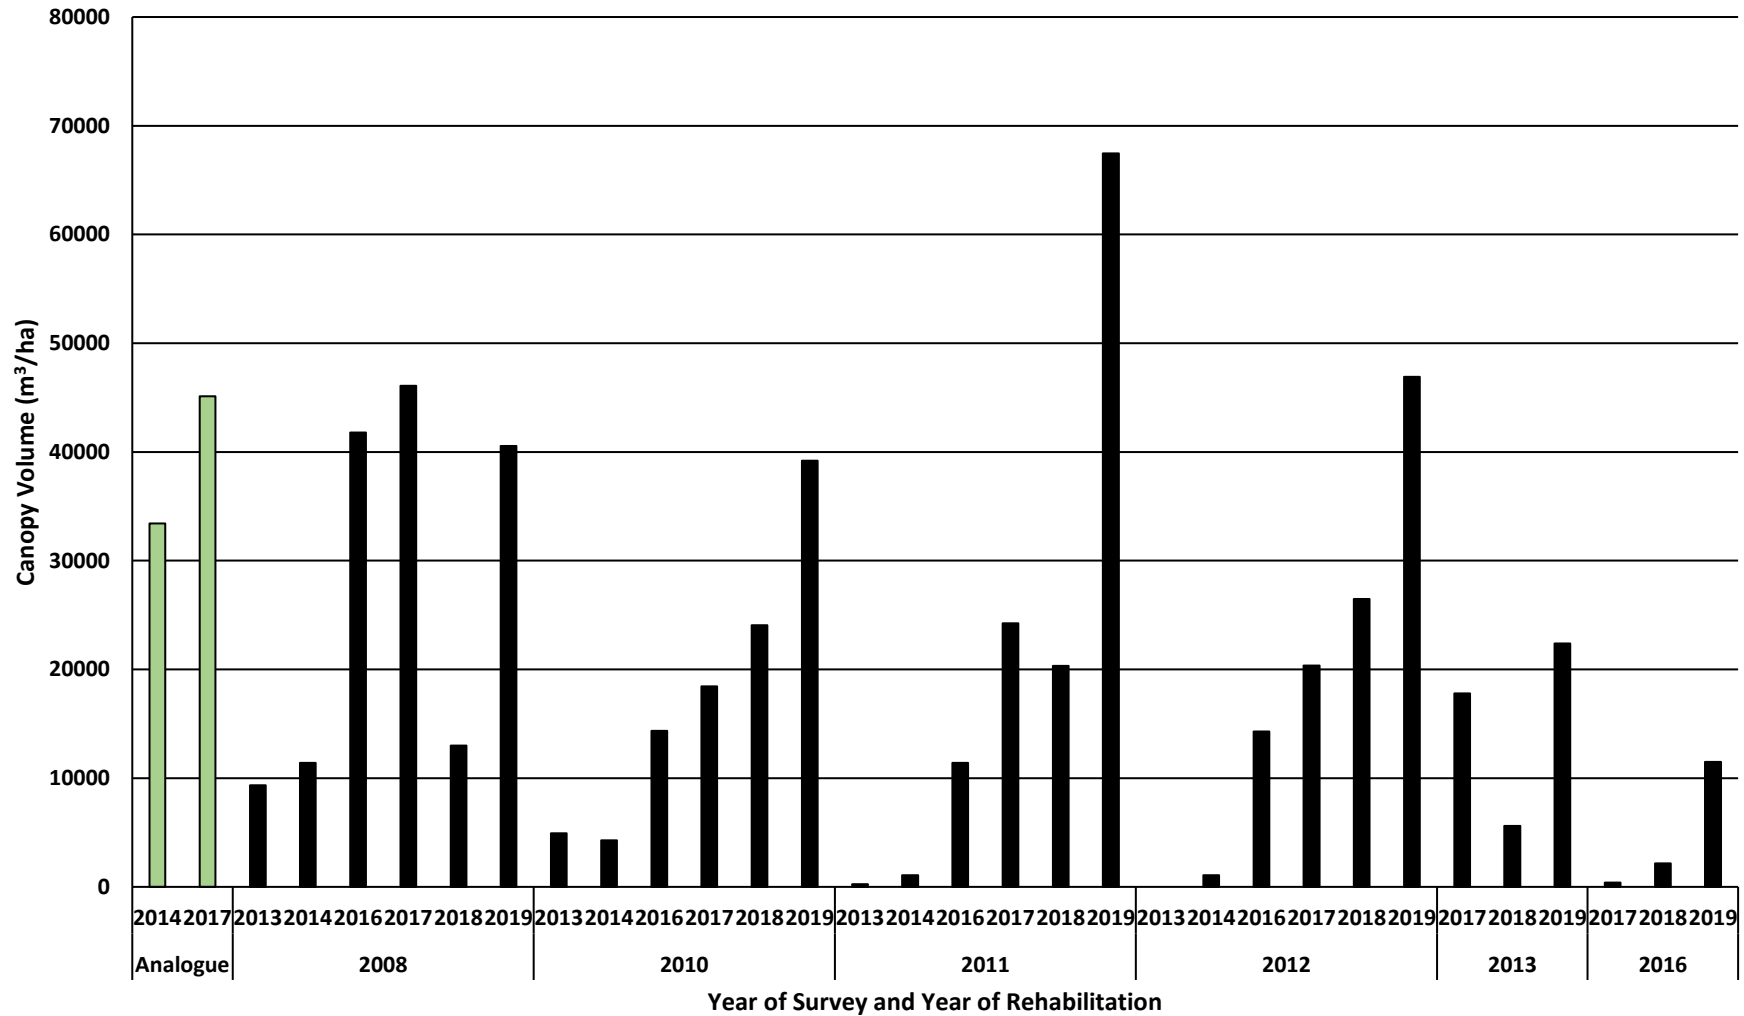
Figure 7: Average Total Woody Vegetation Volume (m³) values recorded from the 2019 survey, comparison to previous surveys and the 2014 and 2017 Average Analogue values derived from the Biodiversity Offsets Areas

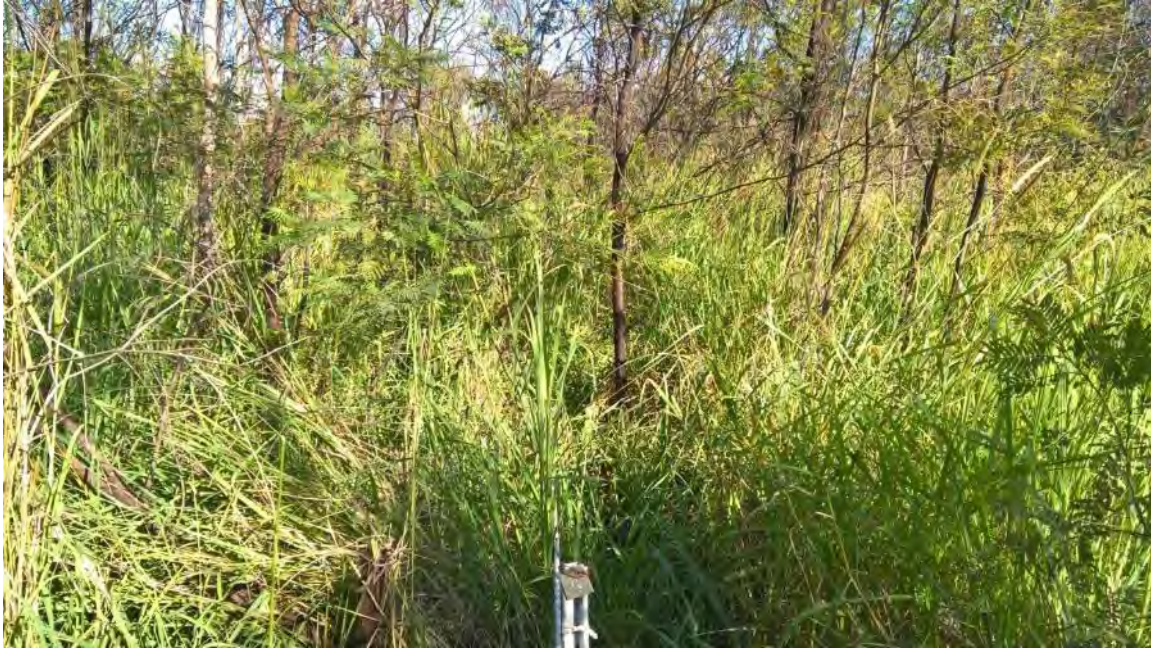
Plate 1: Transect 3041 (2008 rehab) – looking down LFA transect. Note the open nature of the woody vegetation due to *Acacia* species die-off and the dense exotic groundcover

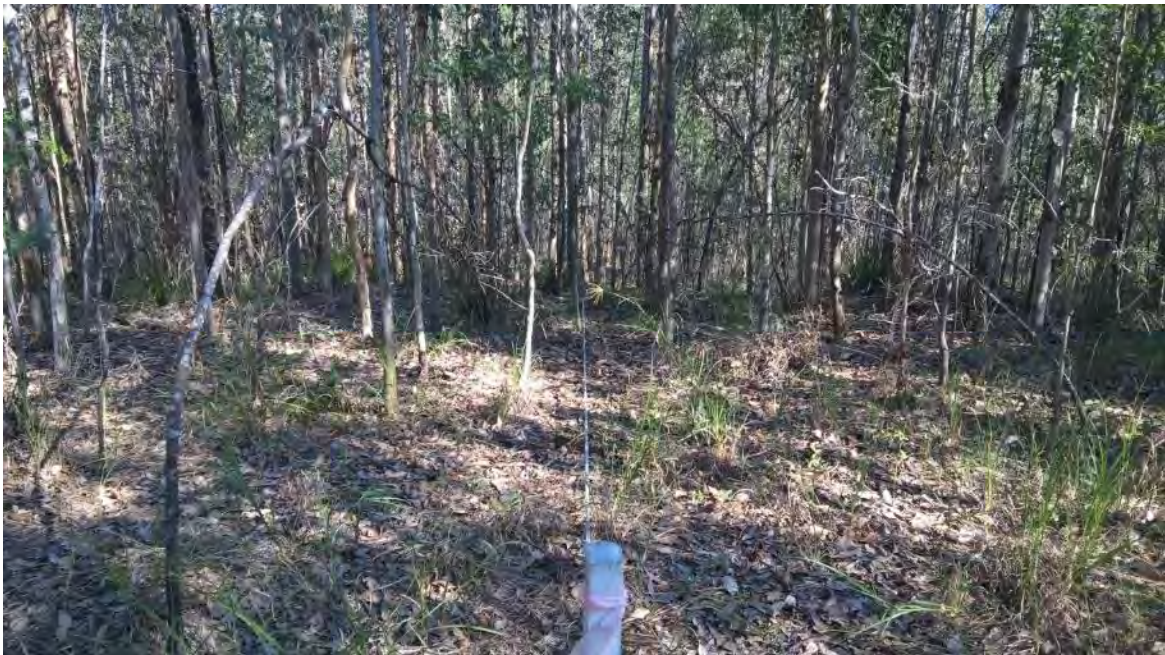
Plate 2: Photograph of Transect 3444 LFA in the 2008 rehabilitation area. Note the dense Eucalypts, litter layer and sparser groundcover

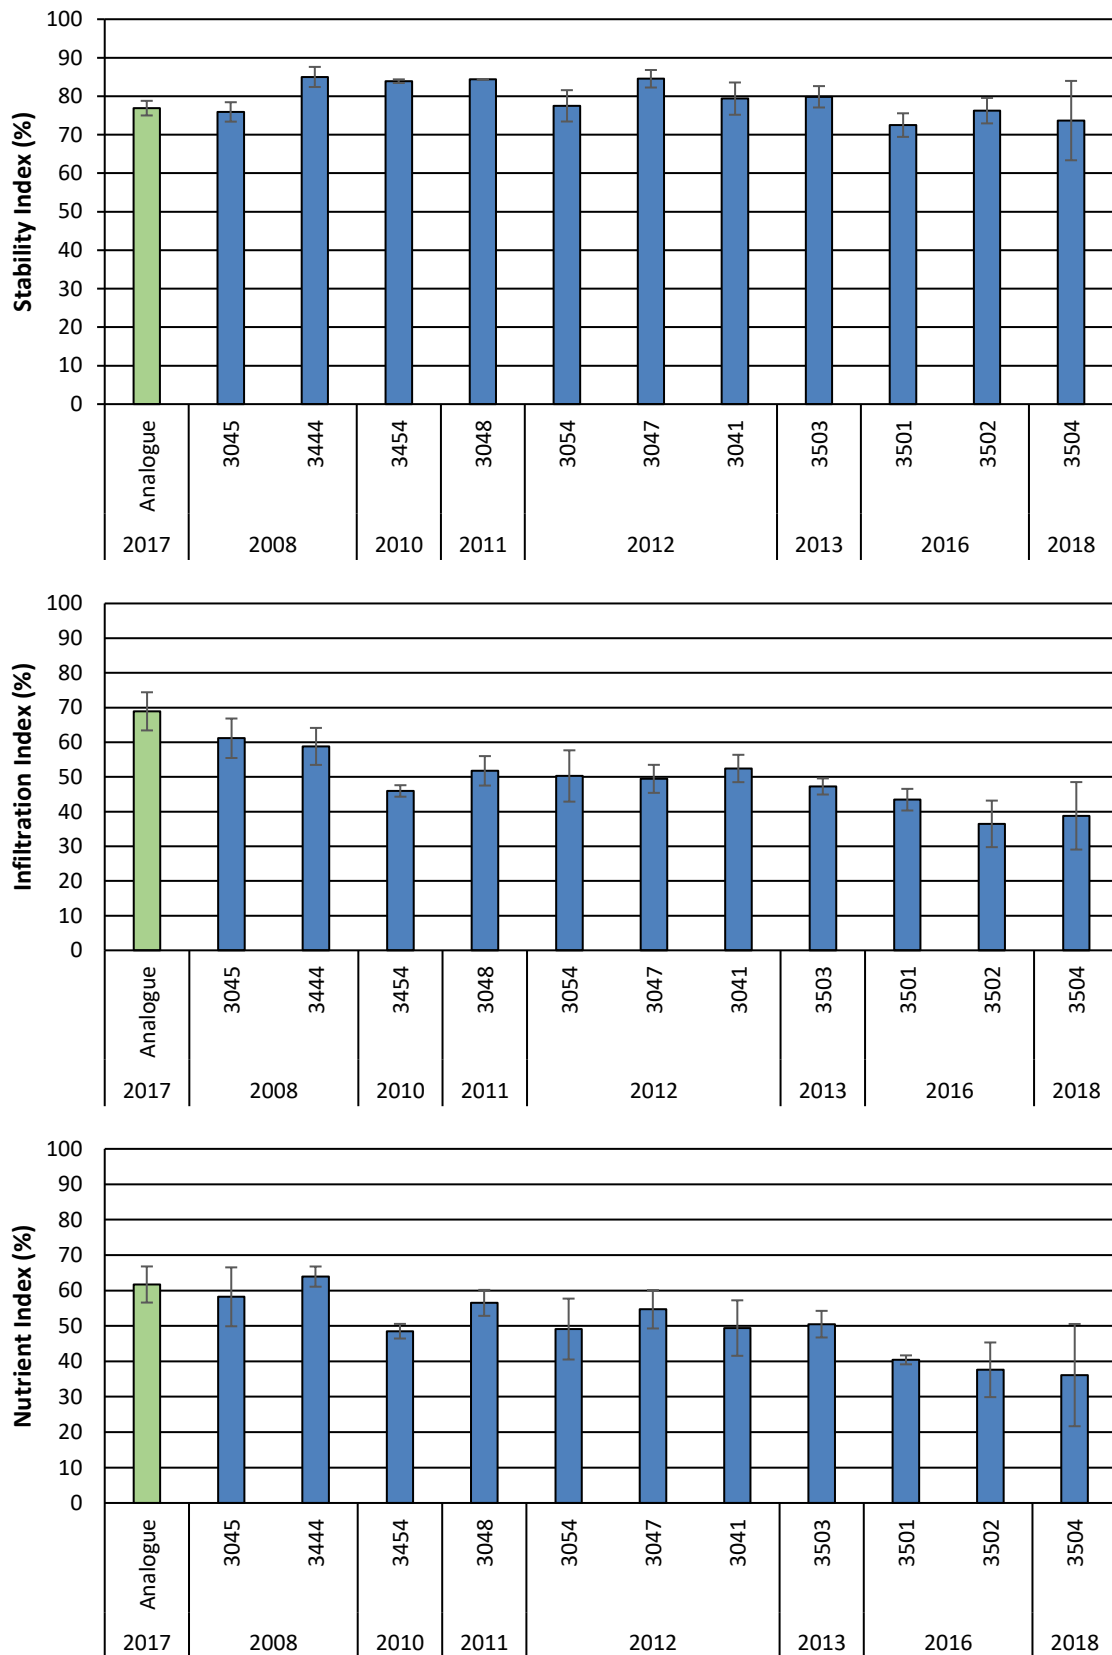
Figure 8: Individual transect scores for the three LFA indices from the 2019 survey. Error bars are SE generated by the LFA software

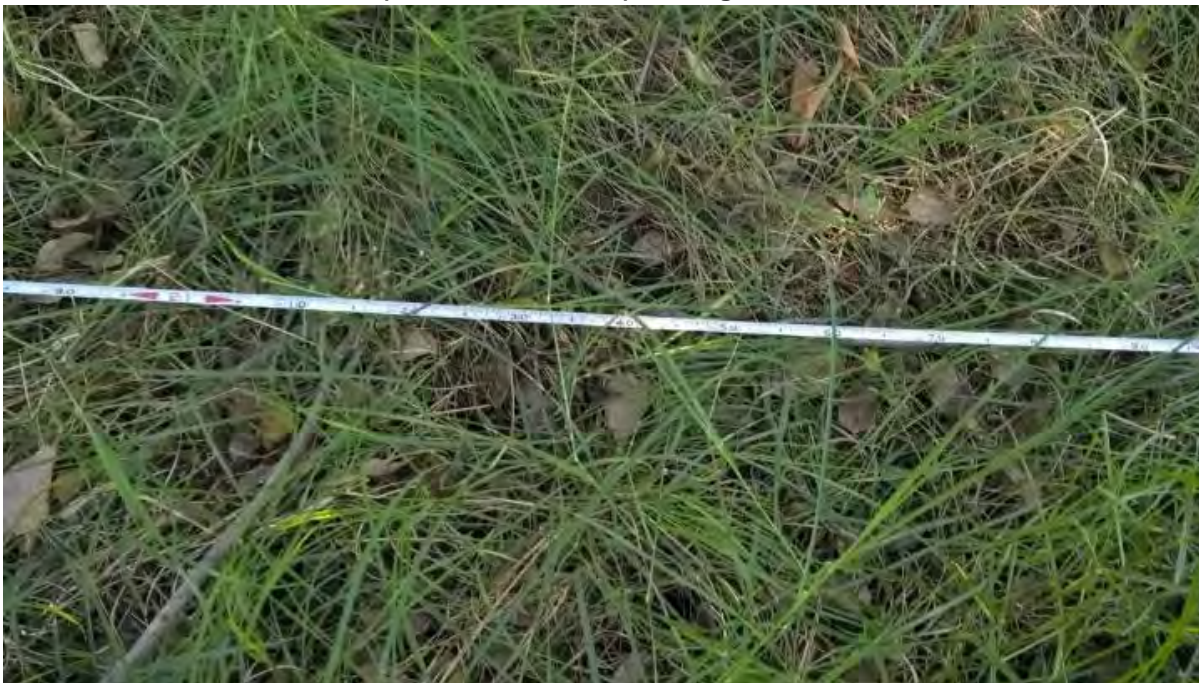
Plate 4: Transect 3045 – view of typical groundcover taken at the 21-22m point on the LFA transect. Grassy sward and sparse litter cover.

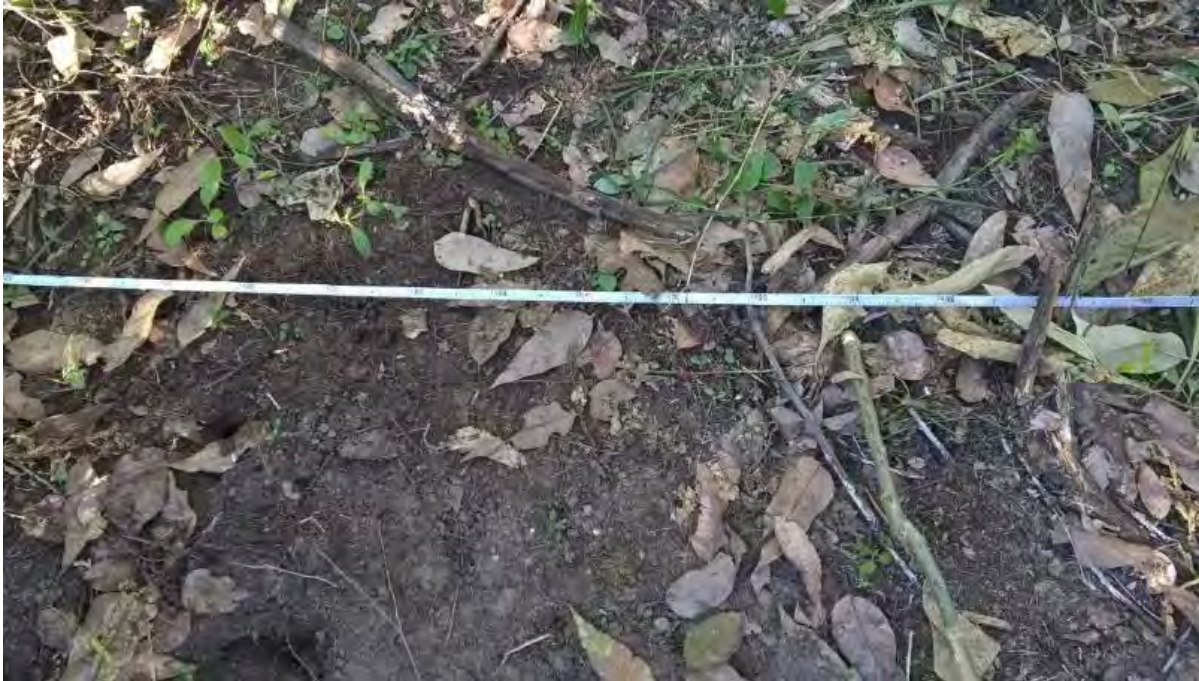
Plate 5: Transect 3045 – view of typical groundcover taken at the 14.5-15.5m point on the LFA transect. Bare ground and sparse litter cover.

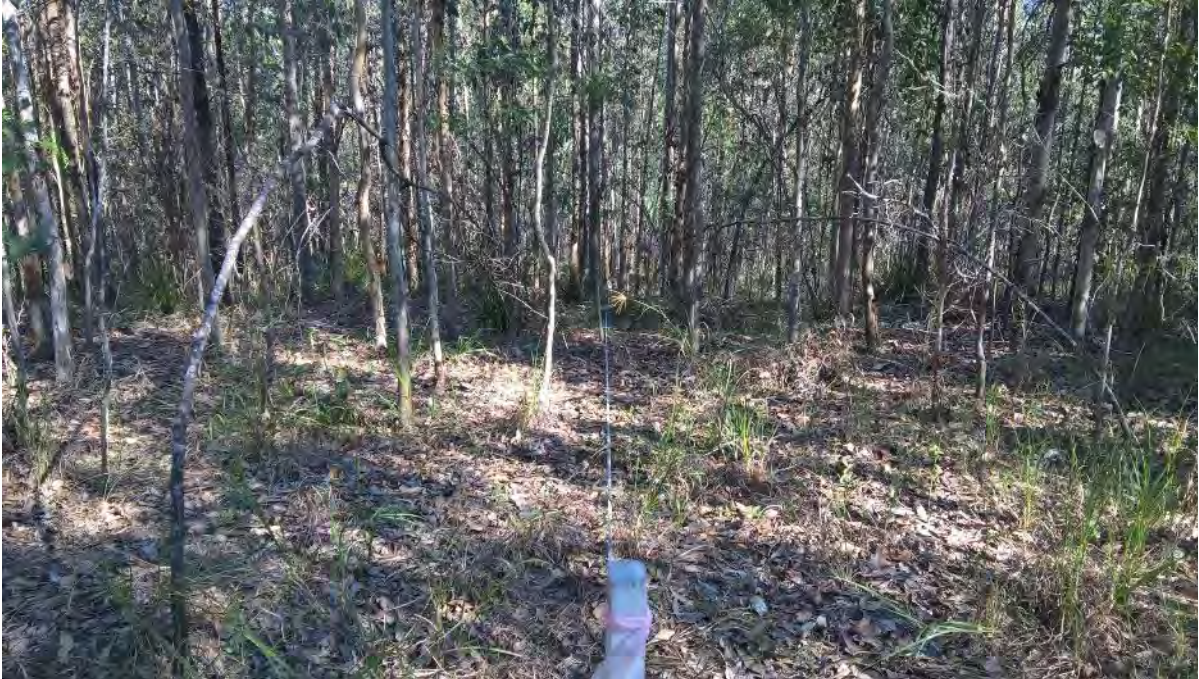
Plate 7: Top of Transect 3444 (2008 rehab) looking down LFA transect. Vegetation density increases down the transect.

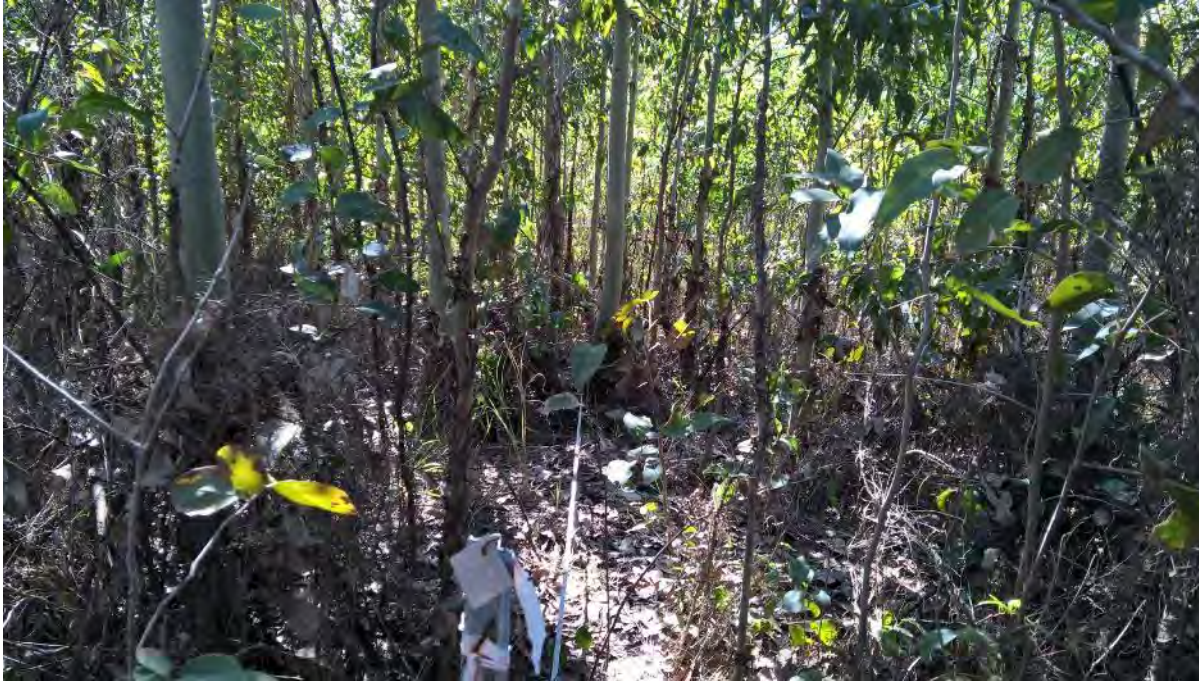
Plate 9: Start of Transect 3454 (2010 rehabilitation) looking down LFA transect. Note the proliferation of saplings

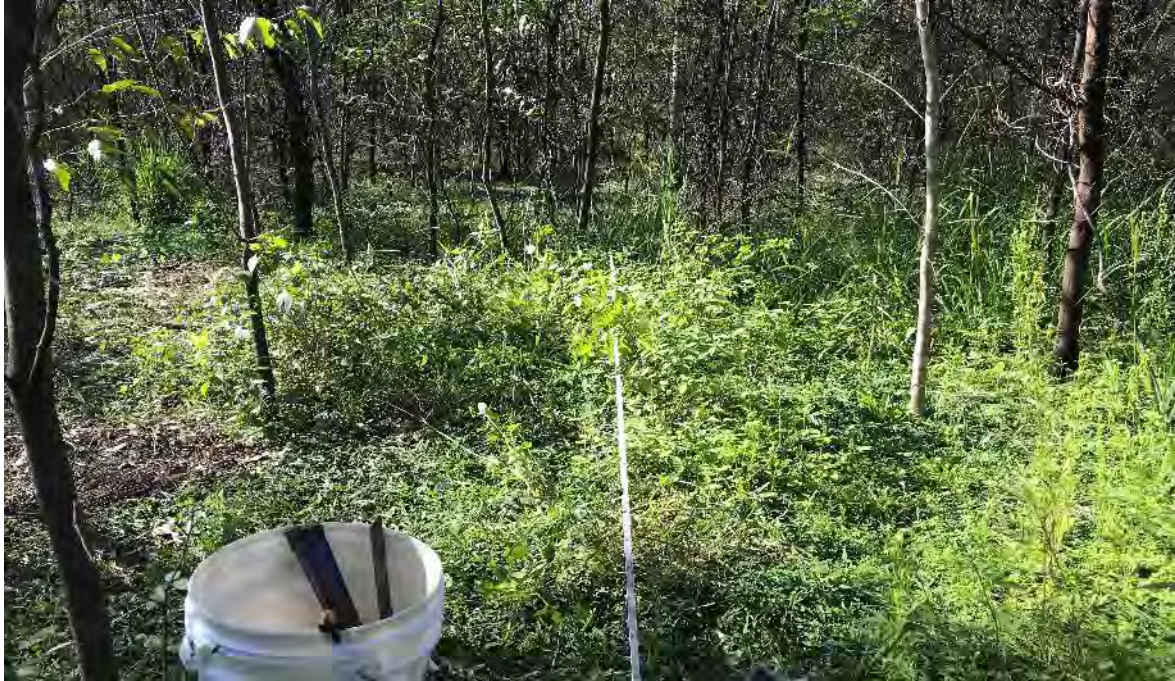
Plate 18: Start of Transect 3054 (2012 rehabilitation area) looking down the LFA transect. This area is largely flat with the initial few metres regenerating from slashing

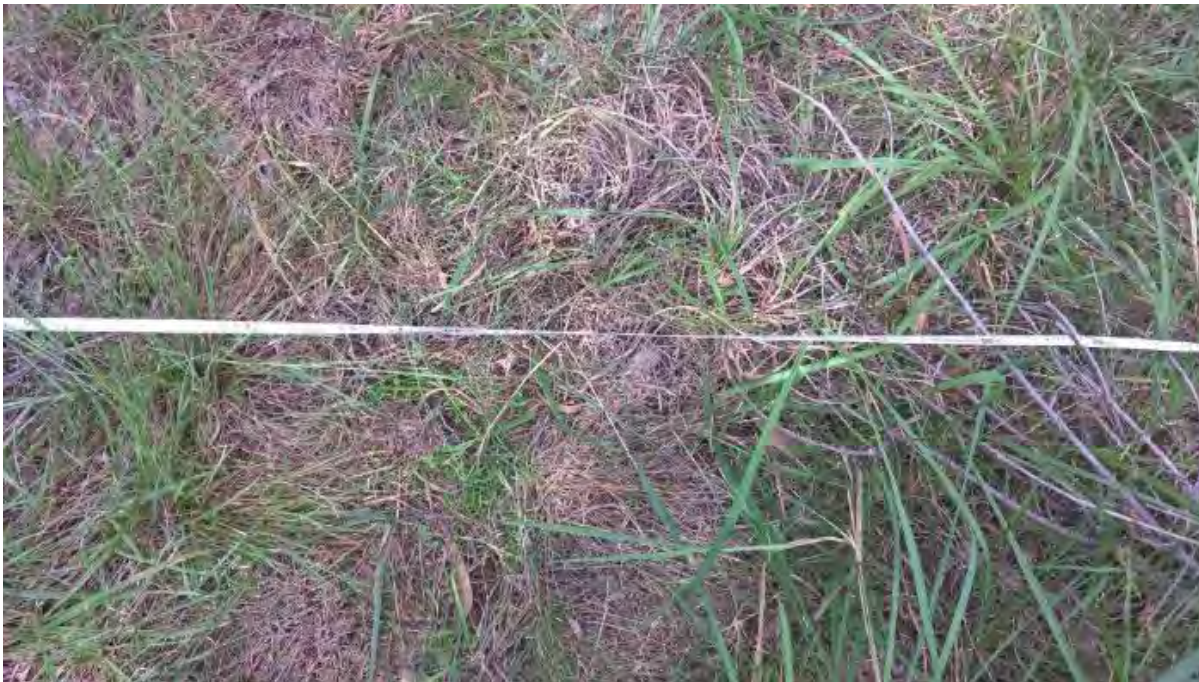
Plate 21: Transect 3466 at the 3m point showing the clumped nature of the grassy groundcover and grassy litter

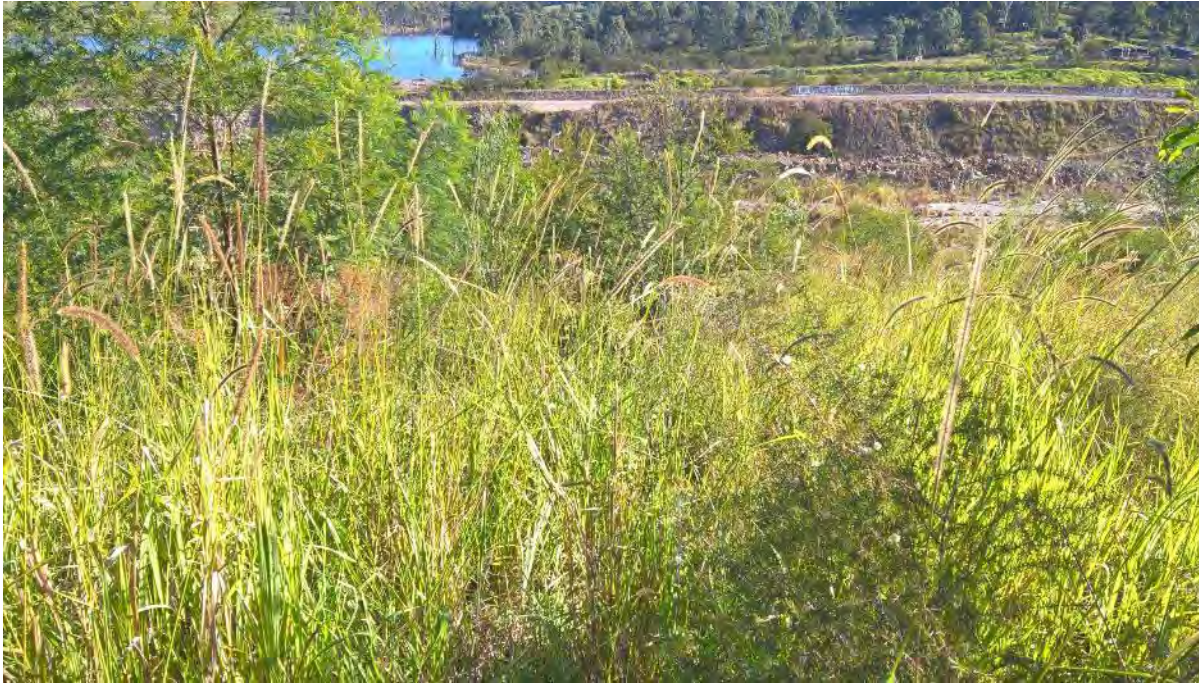
Plate 27: Start of Transect 3501 (2016 rehabilitation) looking down the LFA transect. Note the tall exotic grasses with native shrubs and canopy beginning to emerge

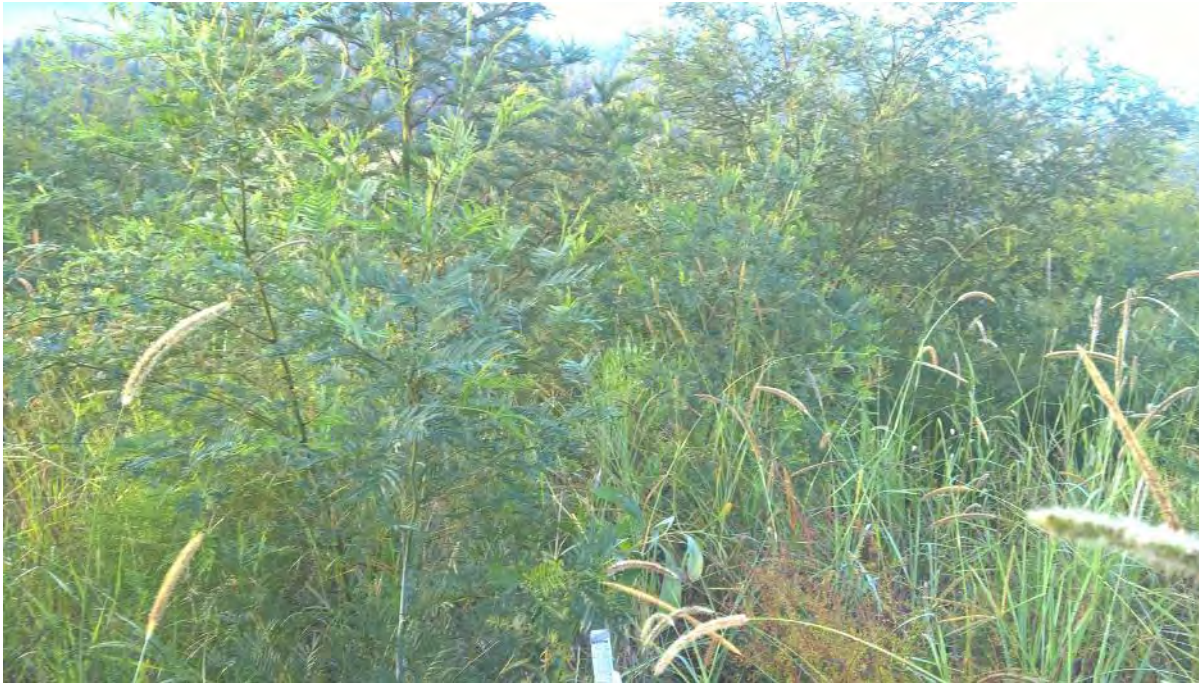
Plate 29: Start of Transect 3502 (2016 rehabilitation area) looking down the LFA transect. Native shrubs are increasing in size

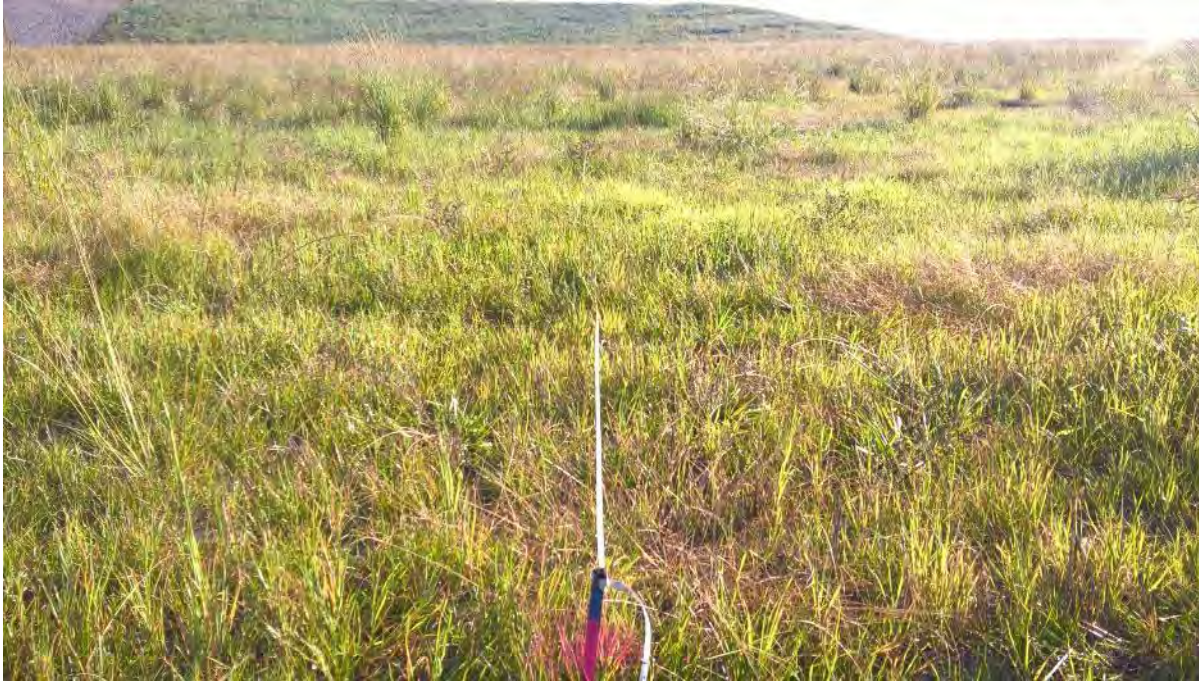
Plate 31: Start of Transect 3504 (2018 rehab) looking along the transect

One new transect (3504) (**Plate 31**) was established in the 2019 monitoring round. However, the age of the rehabilitation is young, and the intended land use is grazing - there were no stems to measure.
