Coal & Allied – Mount Thorley Warkworth Operations
Community Consultative Committee Meeting – Monday 22 February 2016

Mount Thorley Warkworth Community Consultative Committee

Monday 22 February 2016

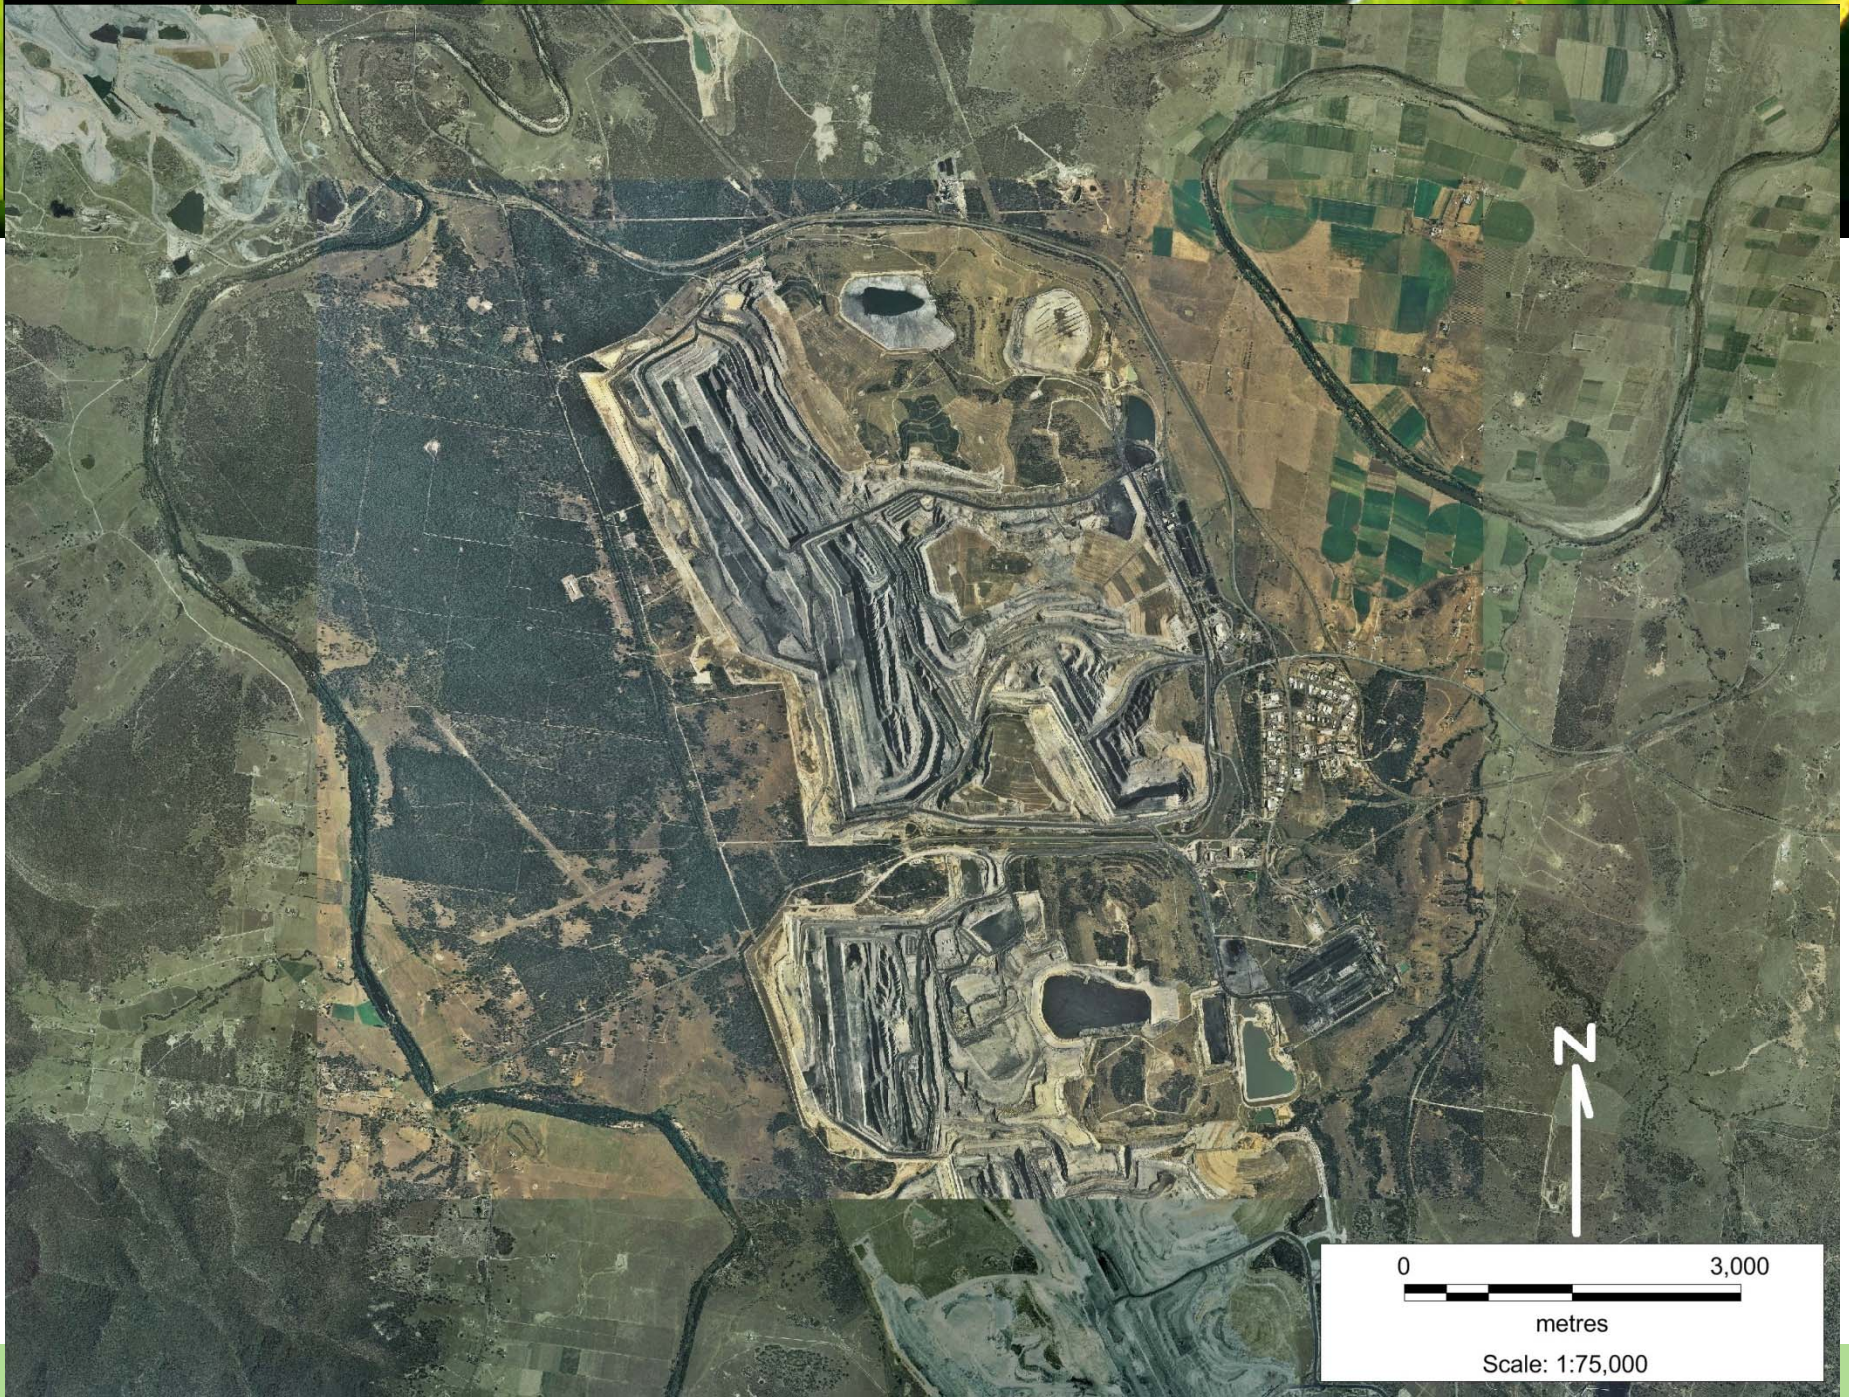
Rehabilitation

Rehabilitation target for 2015 = 74 ha
(outlined in red)

75.7 ha completed rehab

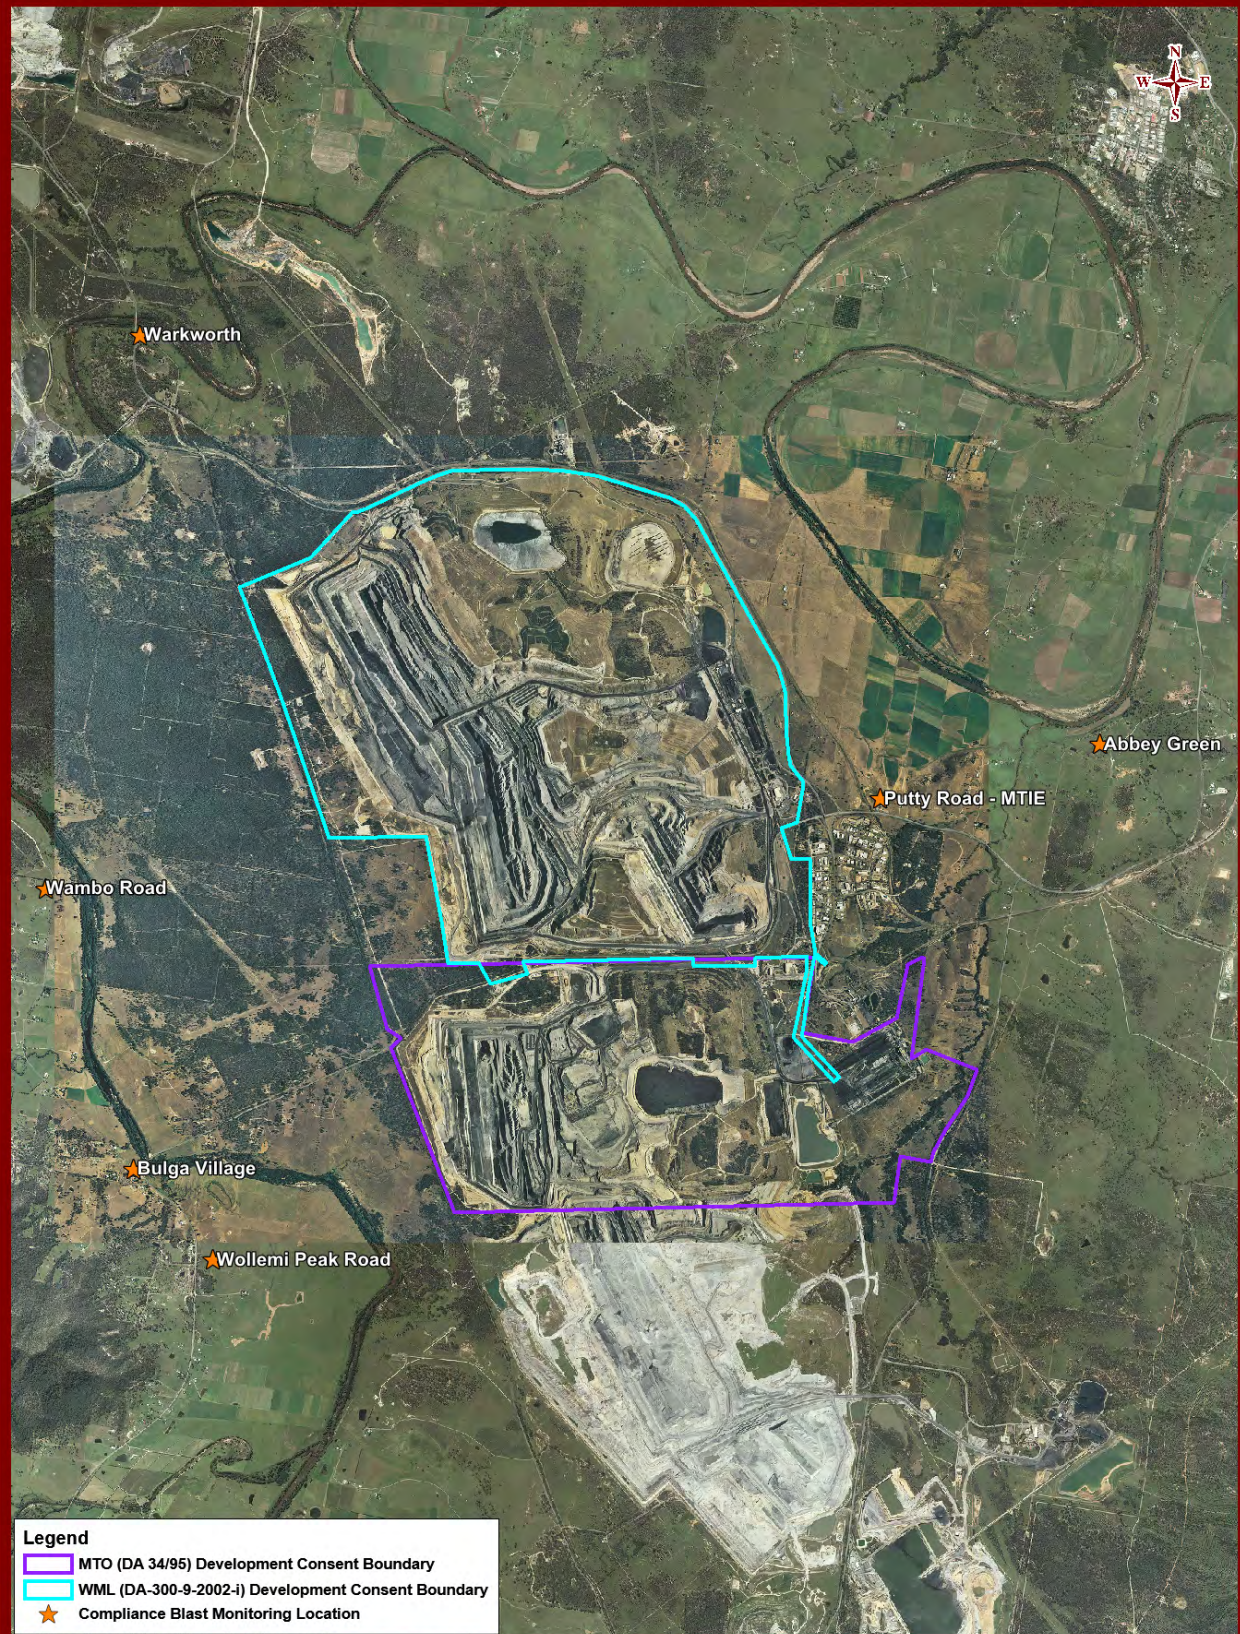
Figure 15: MTW Blast Monitoring Location Plan

The location of these monitors can be found in Figure 15.

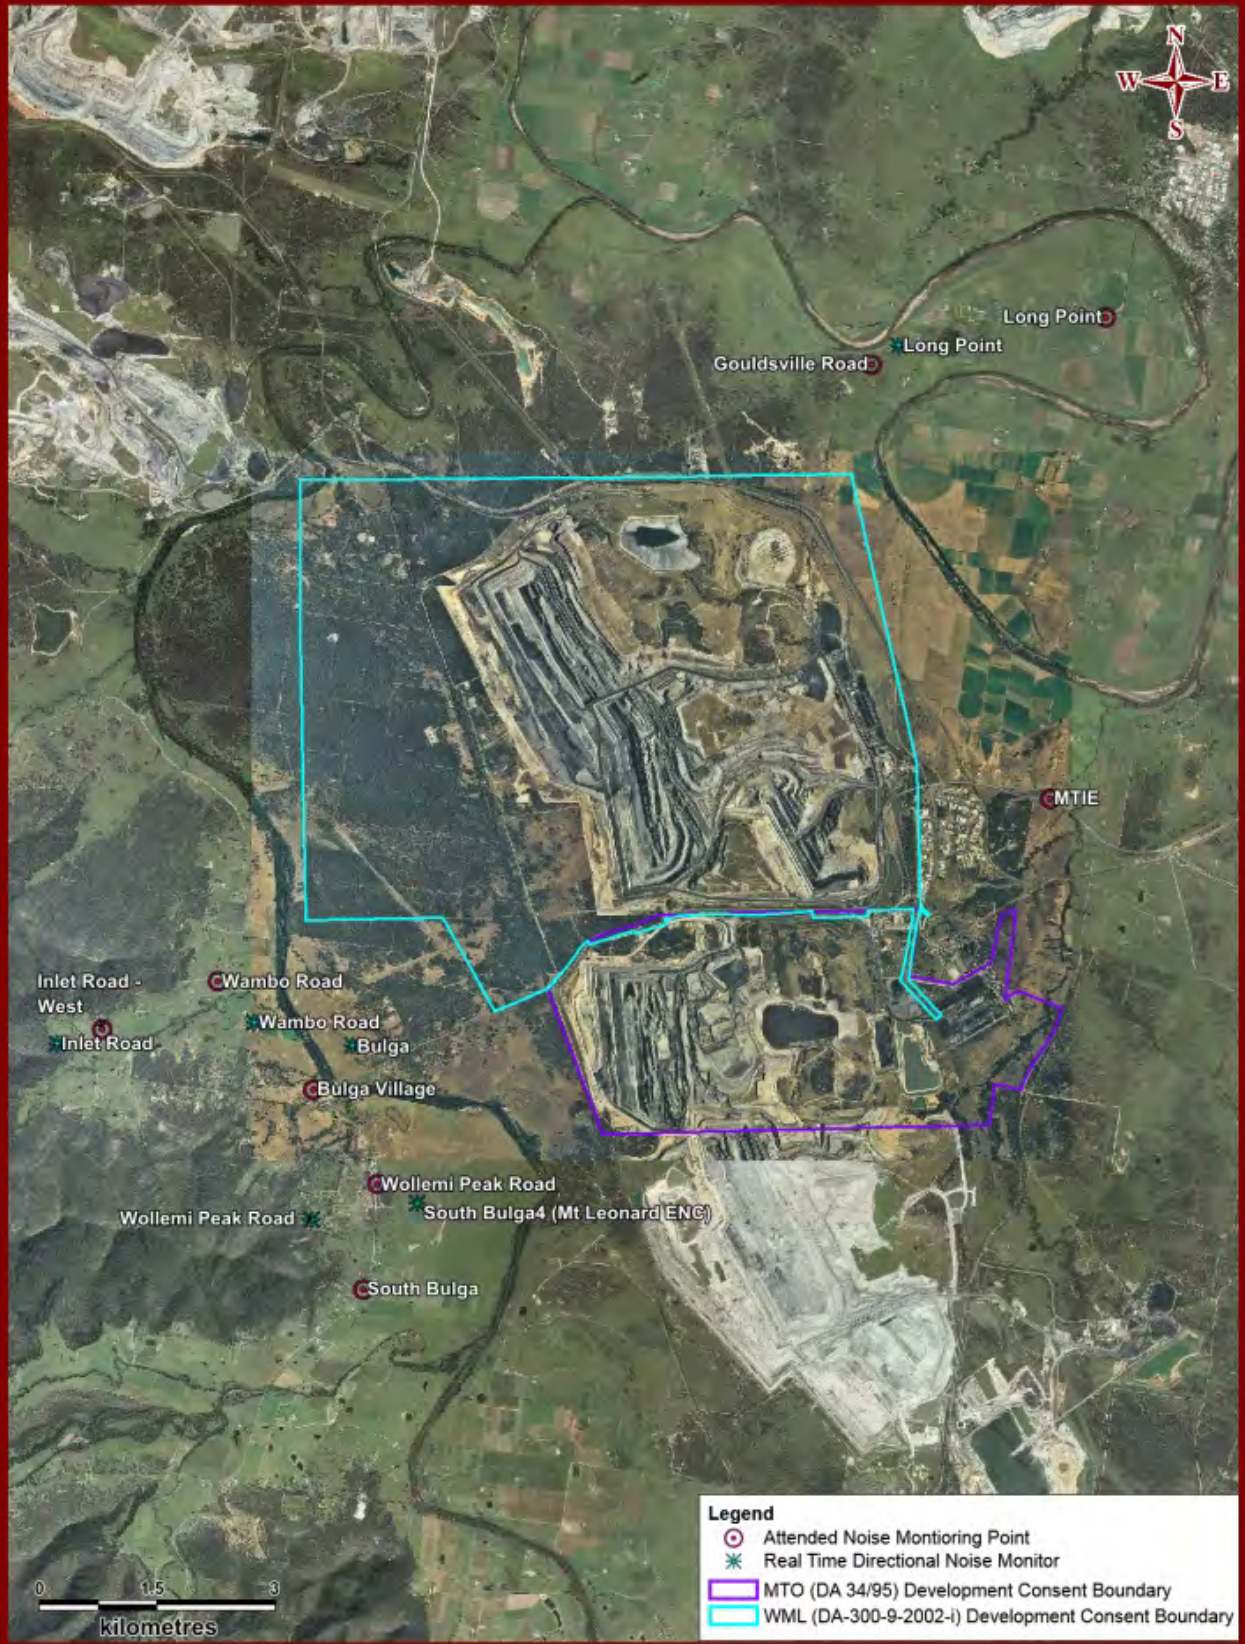
Figure 16: Noise Monitoring Location Plan

Routine attended noise monitoring is carried out in accordance with the MTW Noise Management Plan. A review against EIS predictions will be reported in the Annual Review. The purpose of the noise surveys is to quantify and describe the acoustic environment around the site and compare results with specified limits. Real time noise monitoring also occurs at nine sites surrounding MTW. Noise monitoring locations are displayed in Figure 16.

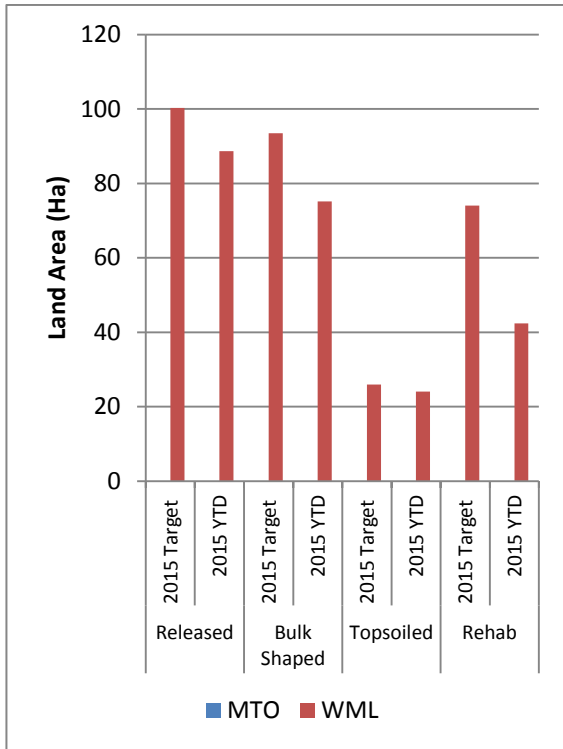
Figure 18: Rehabilitation YTD - October 2015

During October, 19.70 Ha of land was released, 8.12 Ha of land was bulk-shaped, 0.78 Ha was topsoiled, 22.81 Ha of land was composted and 13.06 Ha of land was rehabbed. Year-to-date progress can be viewed in Figure 18.

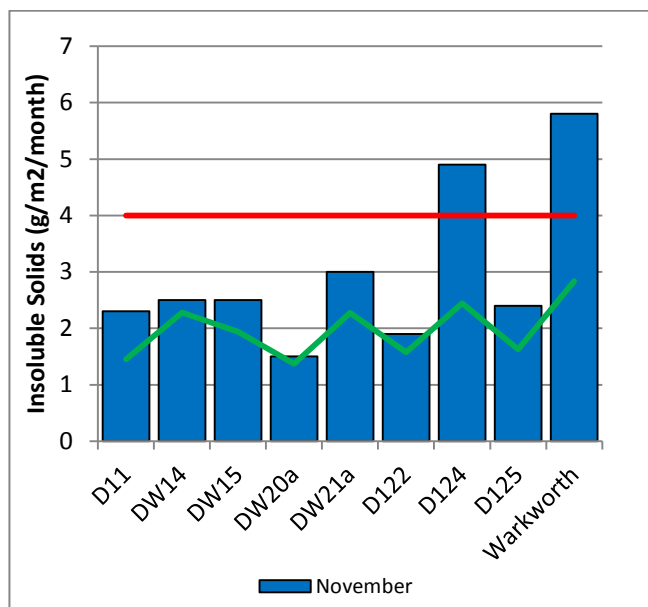
Figure 4: Depositional Dust – November 2015

During the reporting period the D124 and Warkworth monitors recorded monthly results above the long term impact assessment criteria of 4.0 g/m² per month.

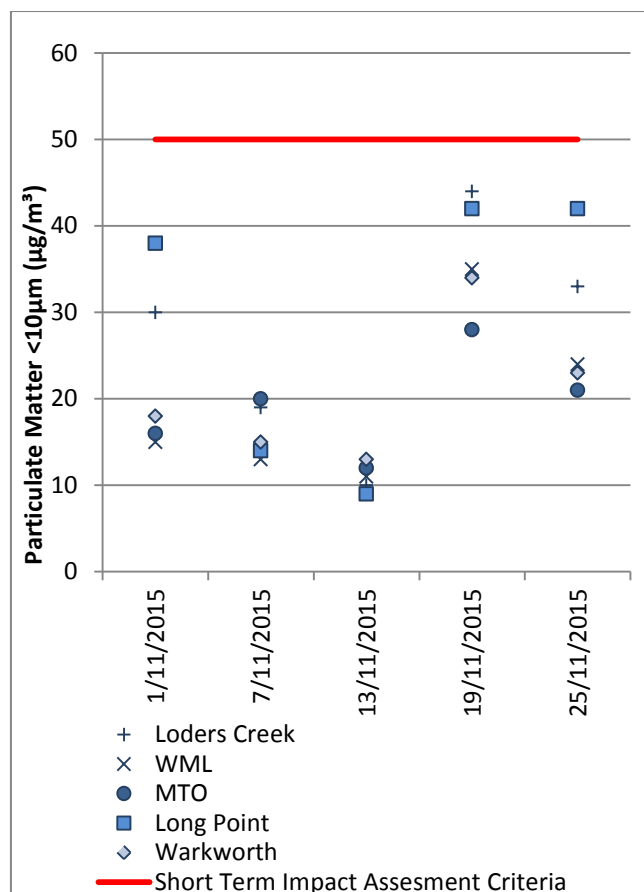
Figure 5: Individual PM₁₀ Results – November 2015

Figure 5 shows the individual PM₁₀ results at each monitoring station against the short term impact assessment criteria of 50µg/m³.

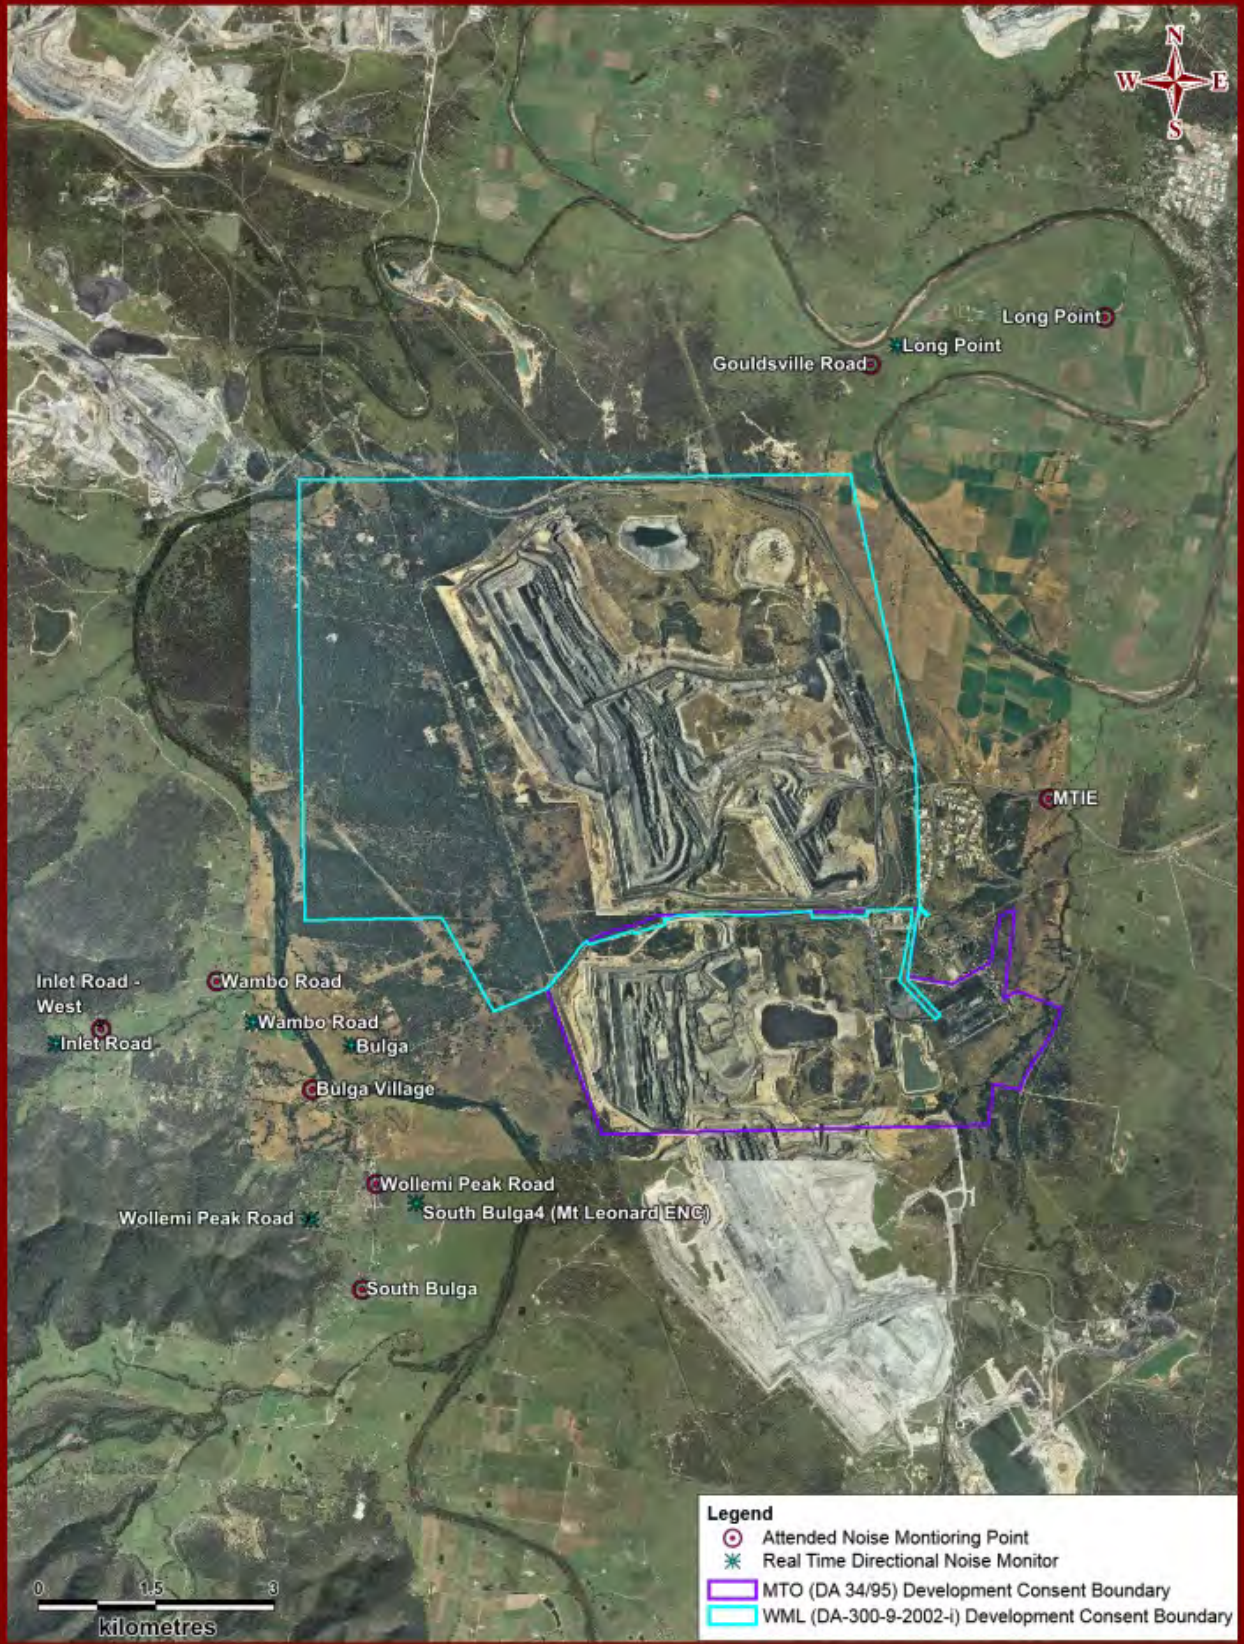
Figure 16: Noise Monitoring Location Plan

Routine attended noise monitoring is carried out in accordance with the MTW Noise Management Plan. A review against EIS predictions will be reported in the Annual Review. The purpose of the noise surveys is to quantify and describe the acoustic environment around the site and compare results with specified limits. Real time noise monitoring also occurs at nine sites surrounding MTW. Noise monitoring locations are displayed in Figure 16.

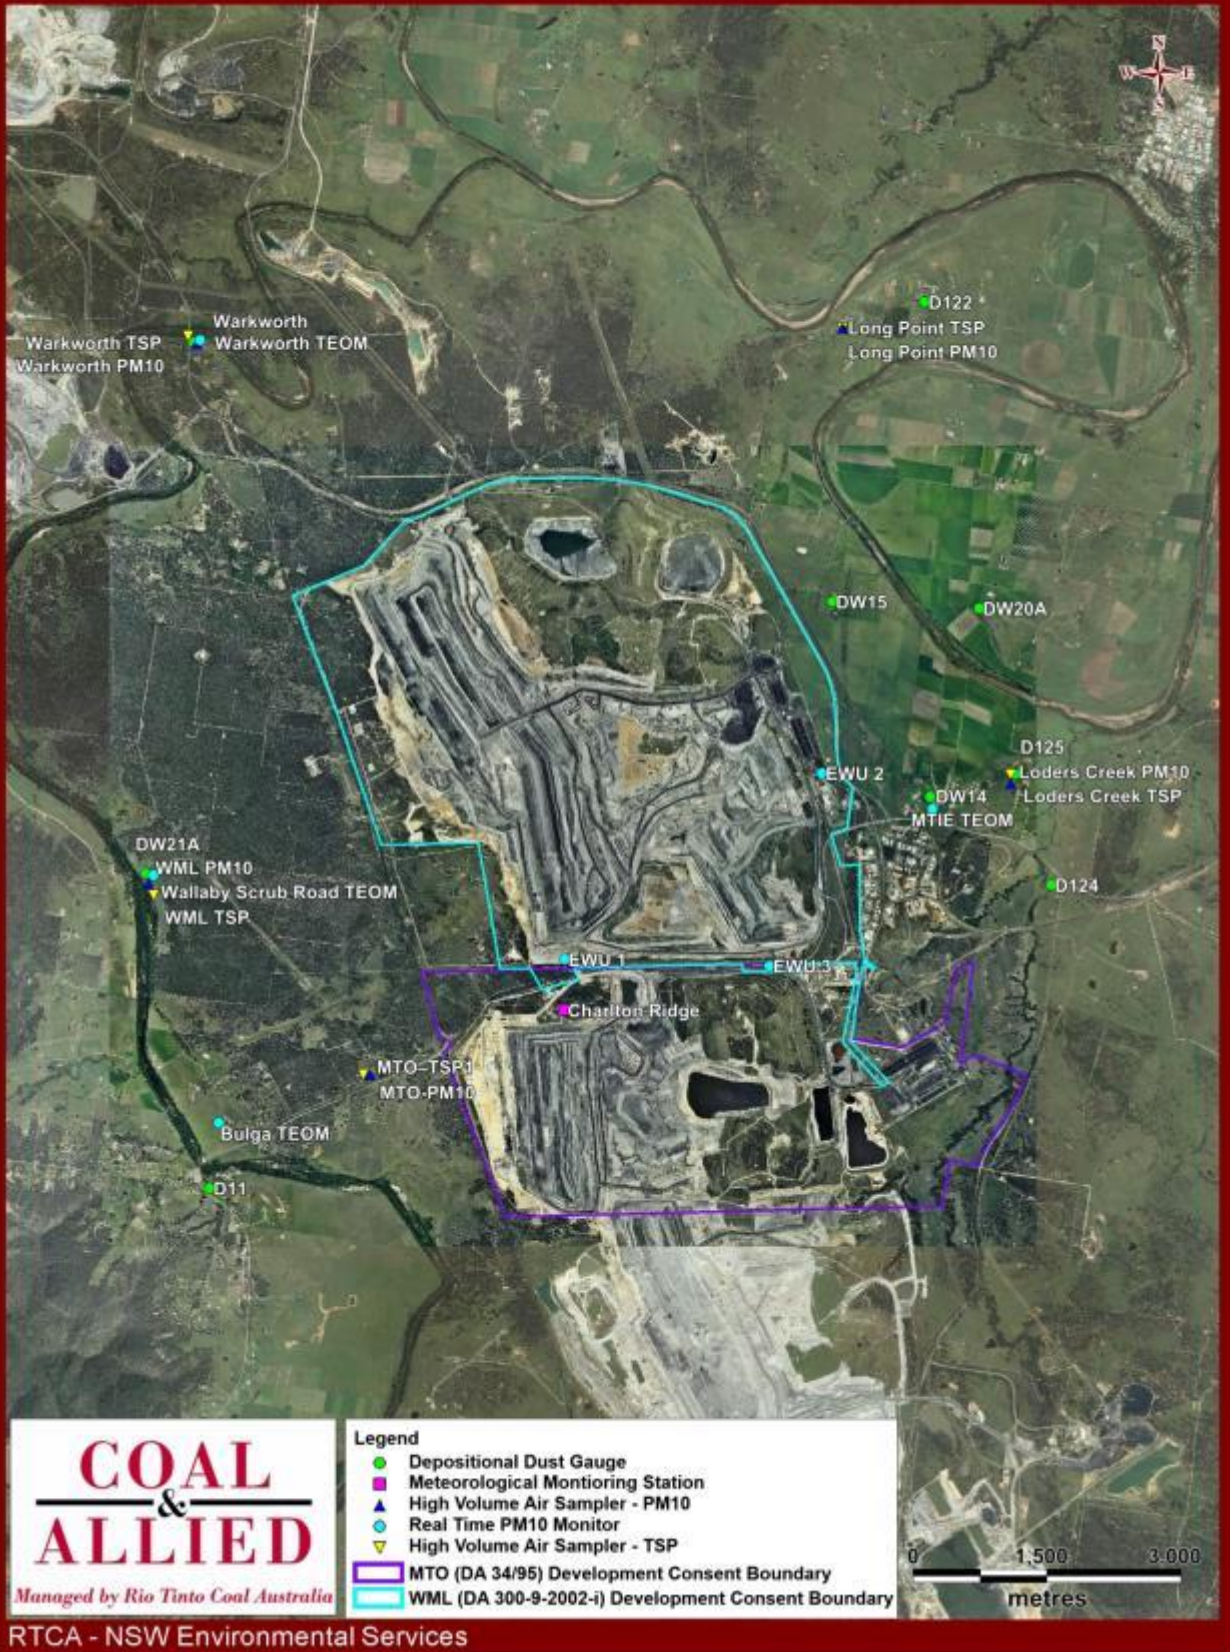
Figure 3: Air Quality Monitoring Locations

**Mount Thorley Warkworth
Air Quality Monitoring Locations**

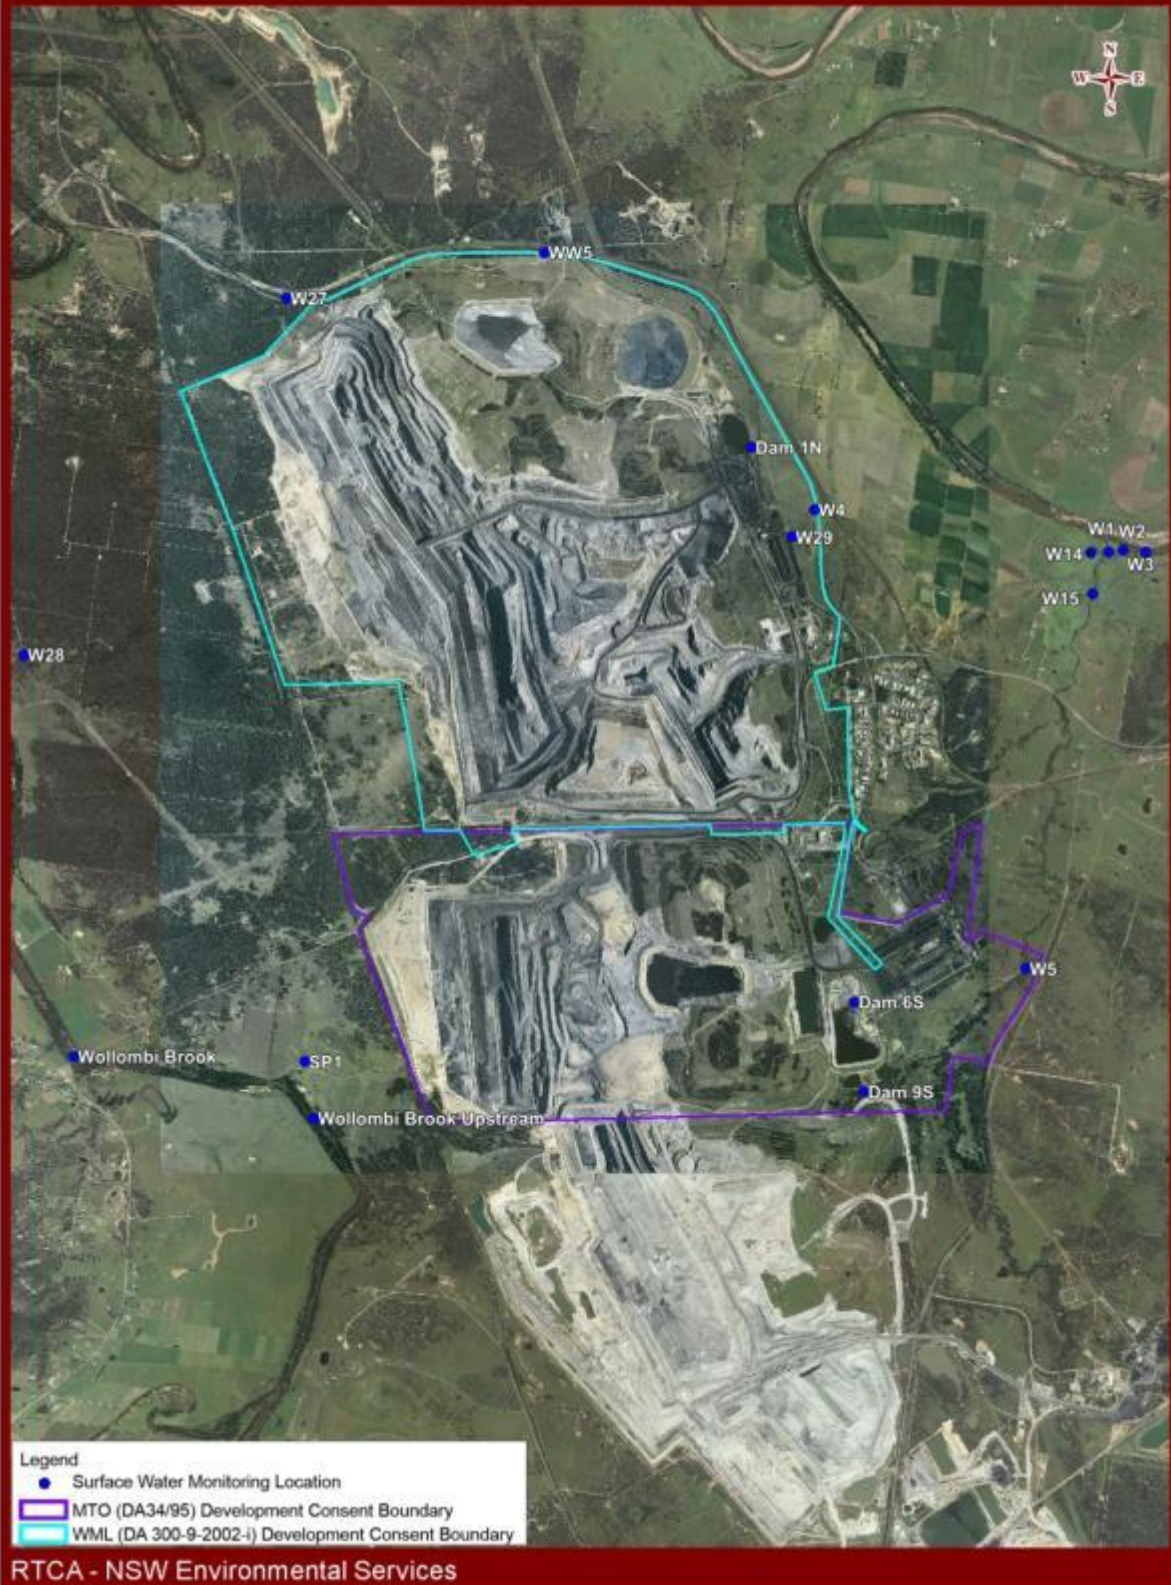
Figure 15: Surface Water Monitoring Location Plan

Monitoring is conducted at mine site dams and surrounding natural watercourses. The surface water monitoring locations are outlined in Figure 15.

Mount Thorley Warkworth
Surface Water Monitoring Locations

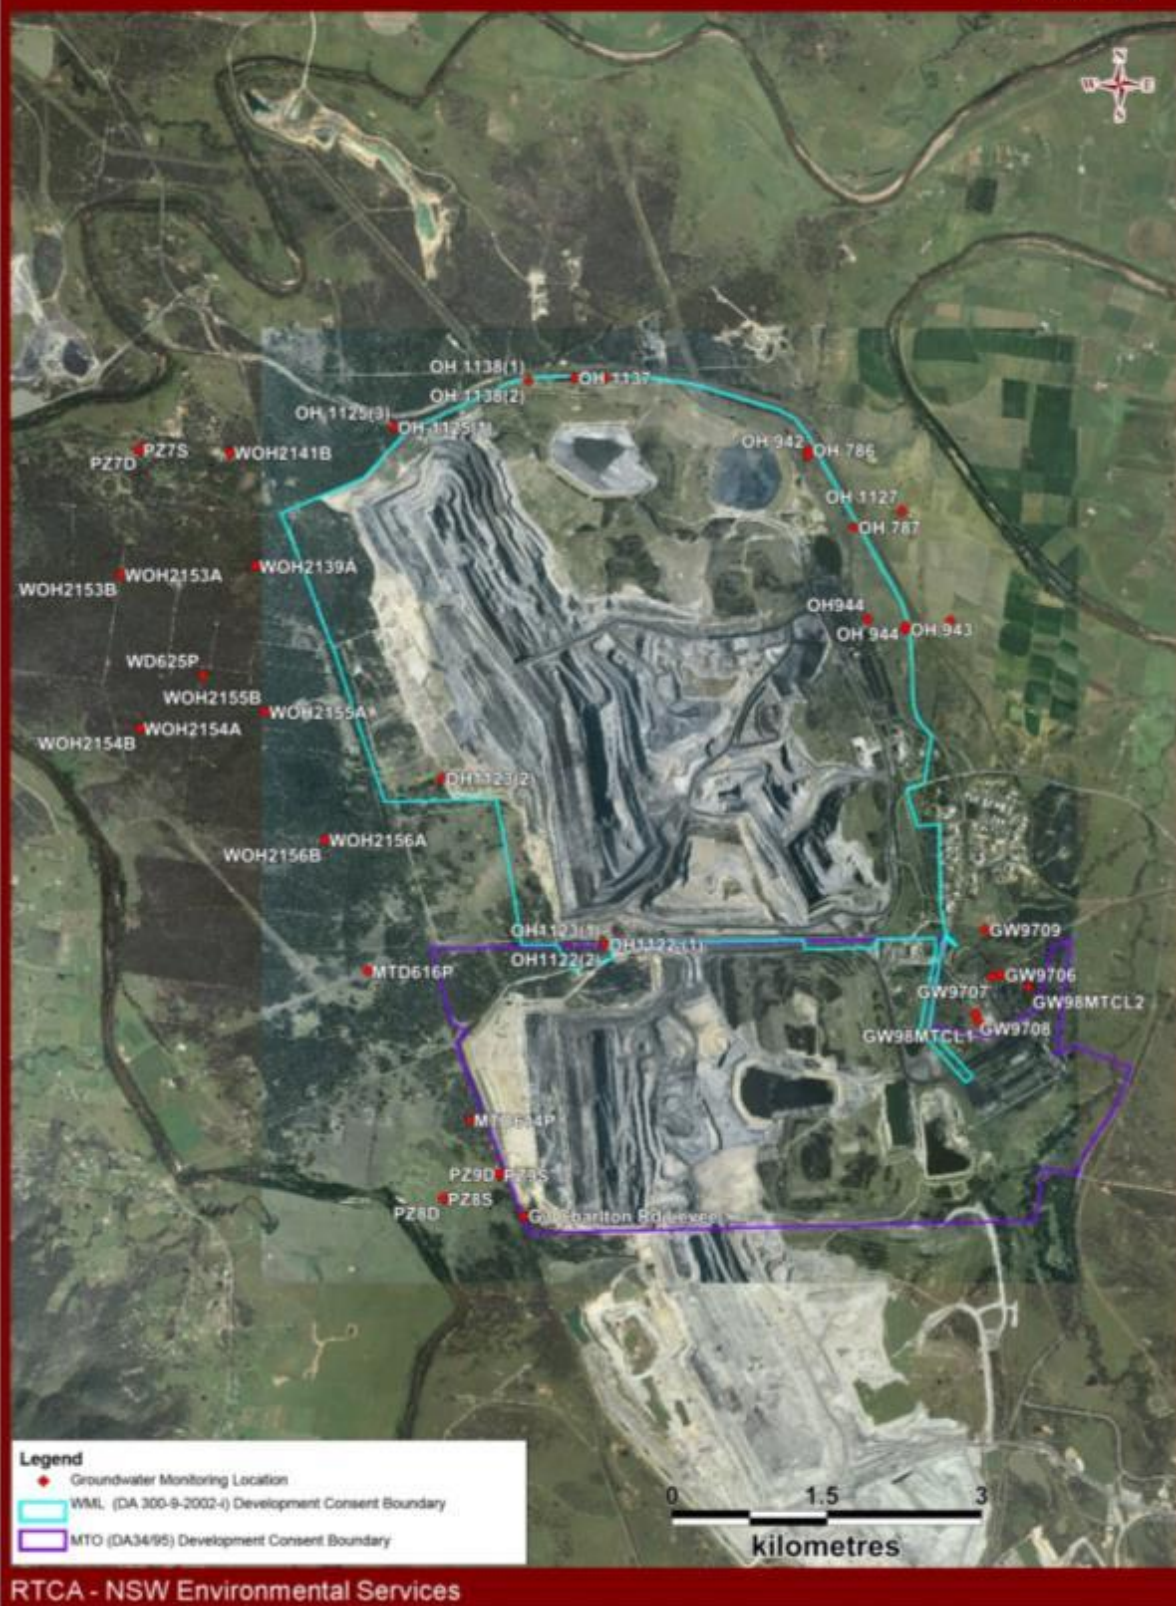
Figure 49: Groundwater Monitoring Location Plan

Internal trigger limits have been developed to assess monitoring data on an on-going basis, and to highlight potentially adverse groundwater impacts. The process for evaluating monitoring results against the internal triggers and subsequent responses are outlined in the MTW Water Management Plan. Locations of groundwater bores are shown in Figure 49.

**Mount Thorley Warkworth
Groundwater Monitoring Locations**

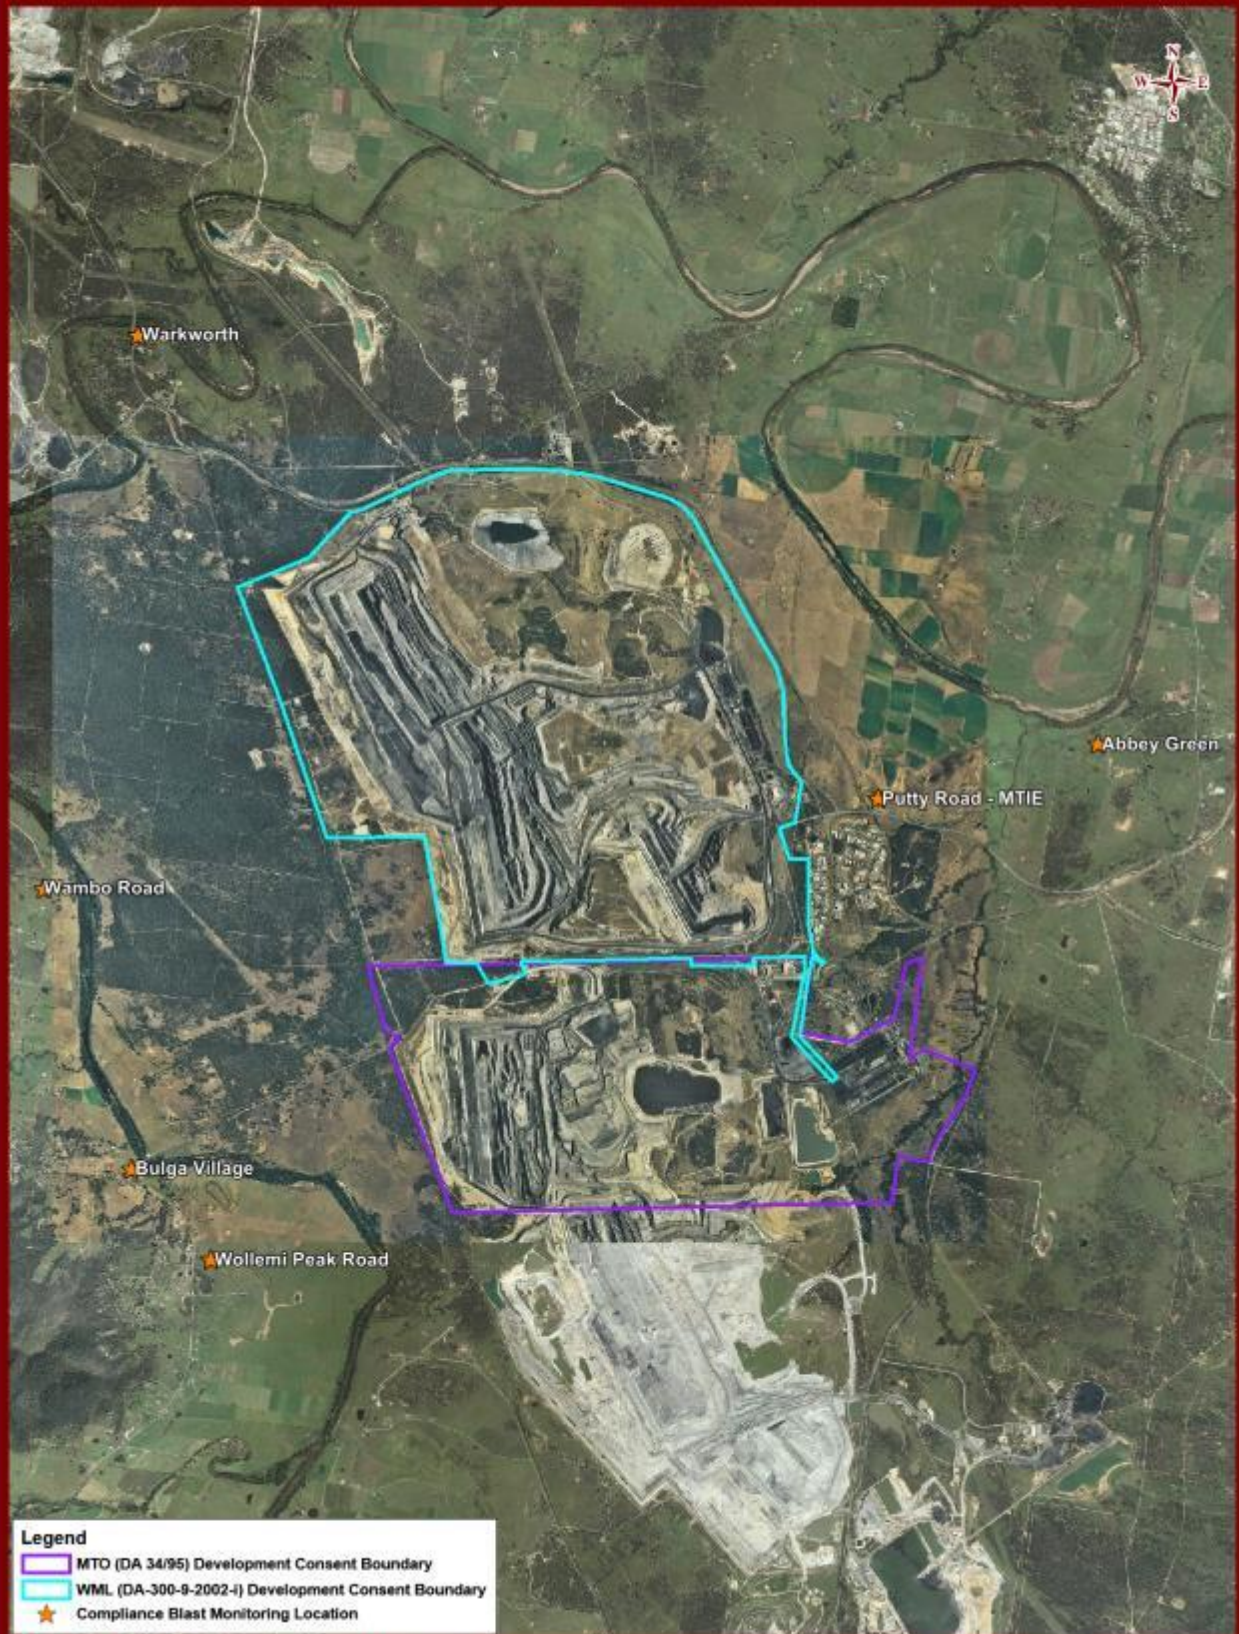
Figure 56: Blast and Vibration Monitoring Location Plan

The location of these monitors can be found in Figure 56.

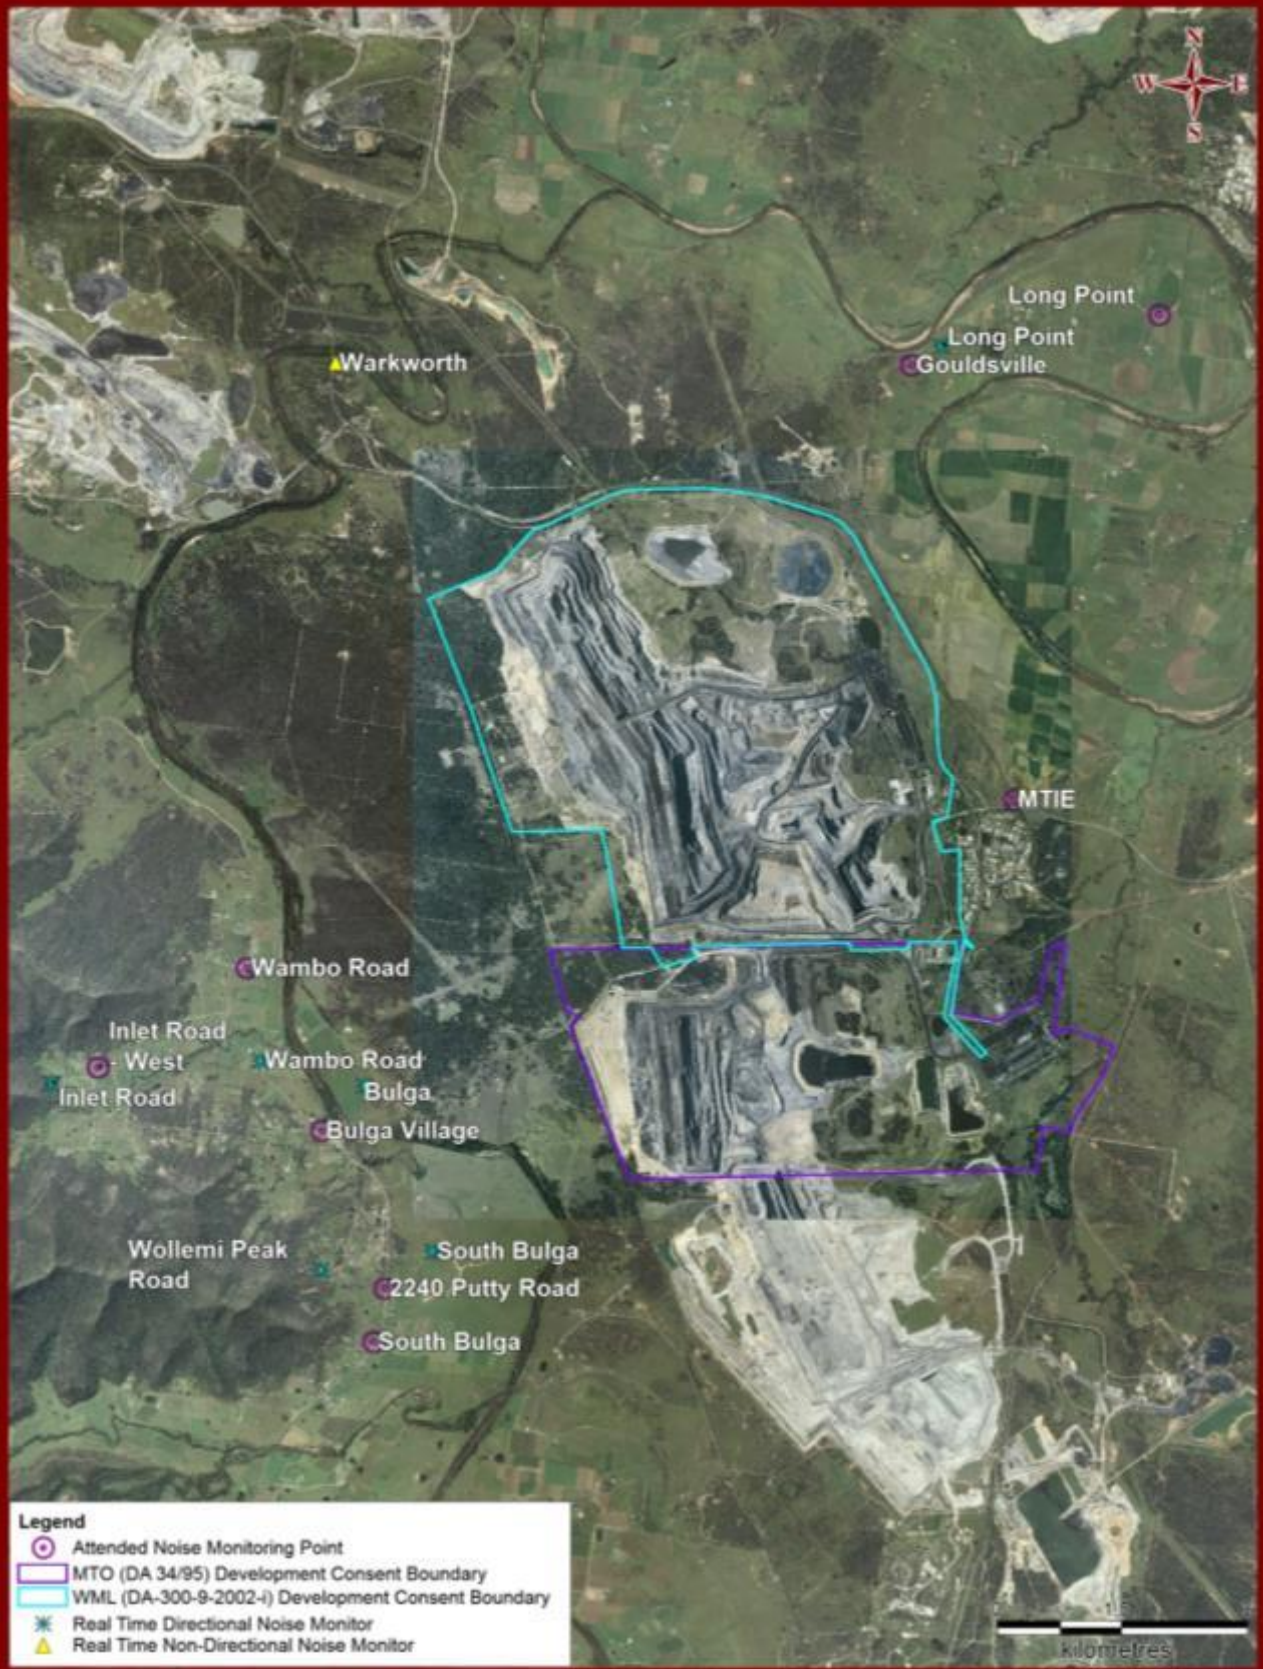
Figure 57: Noise Monitoring Location Plan

Routine attended noise monitoring is carried out in accordance with the MTW Noise Management Plan. A review against EIS predictions will be reported in the Annual Review. The purpose of the noise surveys is to quantify and describe the acoustic environment around the site and compare results with specified limits. Unattended monitoring (real time noise monitoring) also occurs at nine sites surrounding MTW. The attended noise monitoring locations are displayed in Figure 57.

**Mount Thorley Warkworth
Noise Monitoring Locations**
