Coal & Allied – Mount Thorley Warkworth Operations
Community Consultative Committee Meeting – Monday 13 February 2017

2.0 Incidents

**Mount Thorley Warkworth
Air Quality Monitoring Programme**

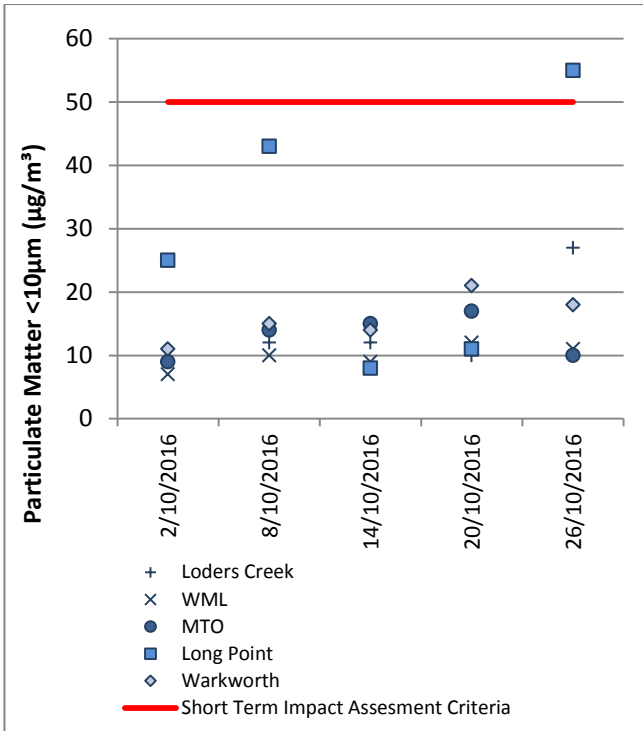
Figure 5: Individual PM₁₀ Results – October 2016

Figure 5 shows the individual PM₁₀ results at each monitoring station against the short term impact assessment criteria of 50µg/m³.

On 26/10/2016 one HVAS PM₁₀ unit recorded a result greater than the short term (24hr) PM₁₀ impact assessment criteria; Long Point (55 µg/m³). At the time of preparation of this report, the result is under investigation. Preliminary advice has been provided to the Department of Planning & Environment.

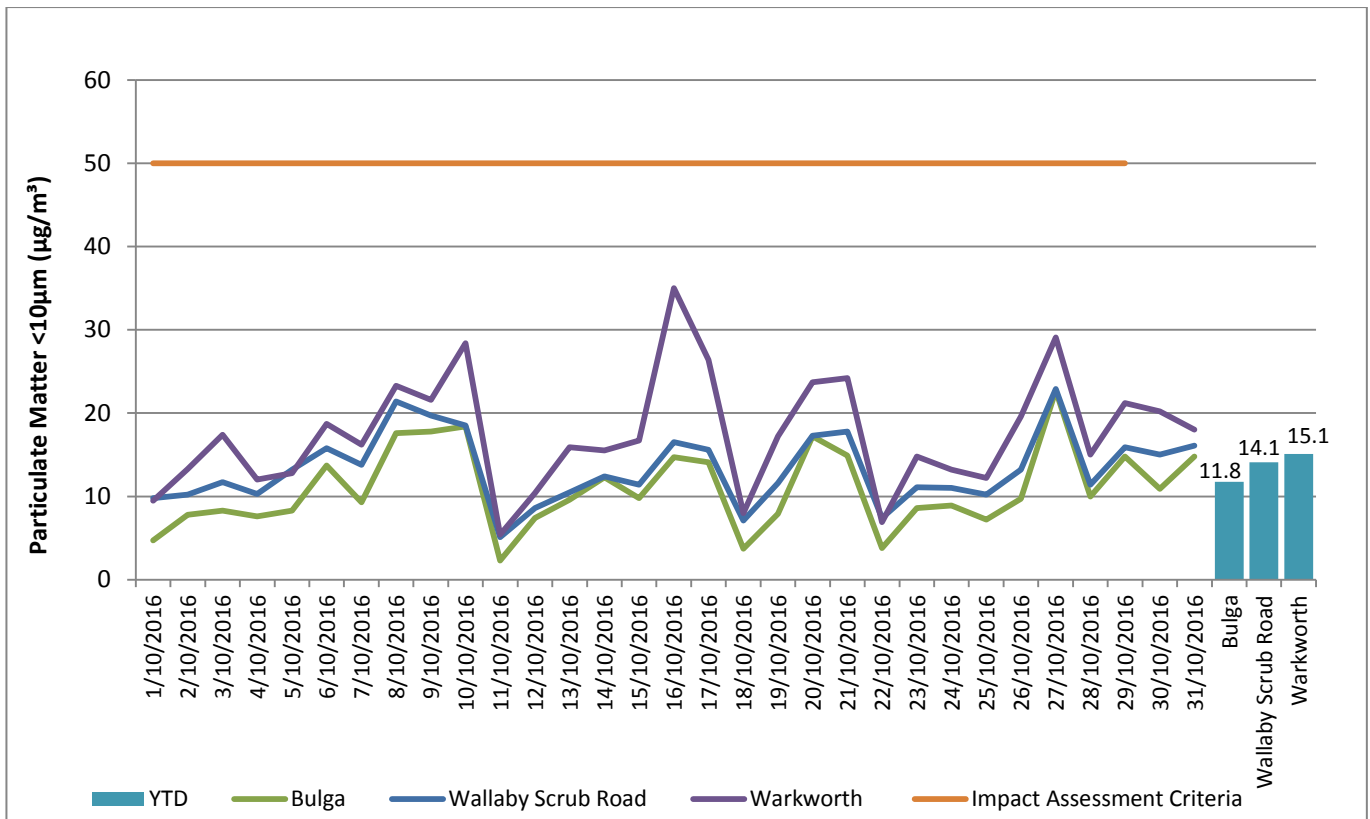
Figure 8: Real Time PM₁₀ daily 24hr average and annual average – October 2016

During October, the real time monitoring system generated 45 automated air quality related alerts, including 37 alerts for adverse meteorological conditions and 8 alerts for elevated PM₁₀ levels.
