Managed by Rio Tinto Coal Australia

Mount Thorley Warkworth
Monthly Environmental Report
April 2017

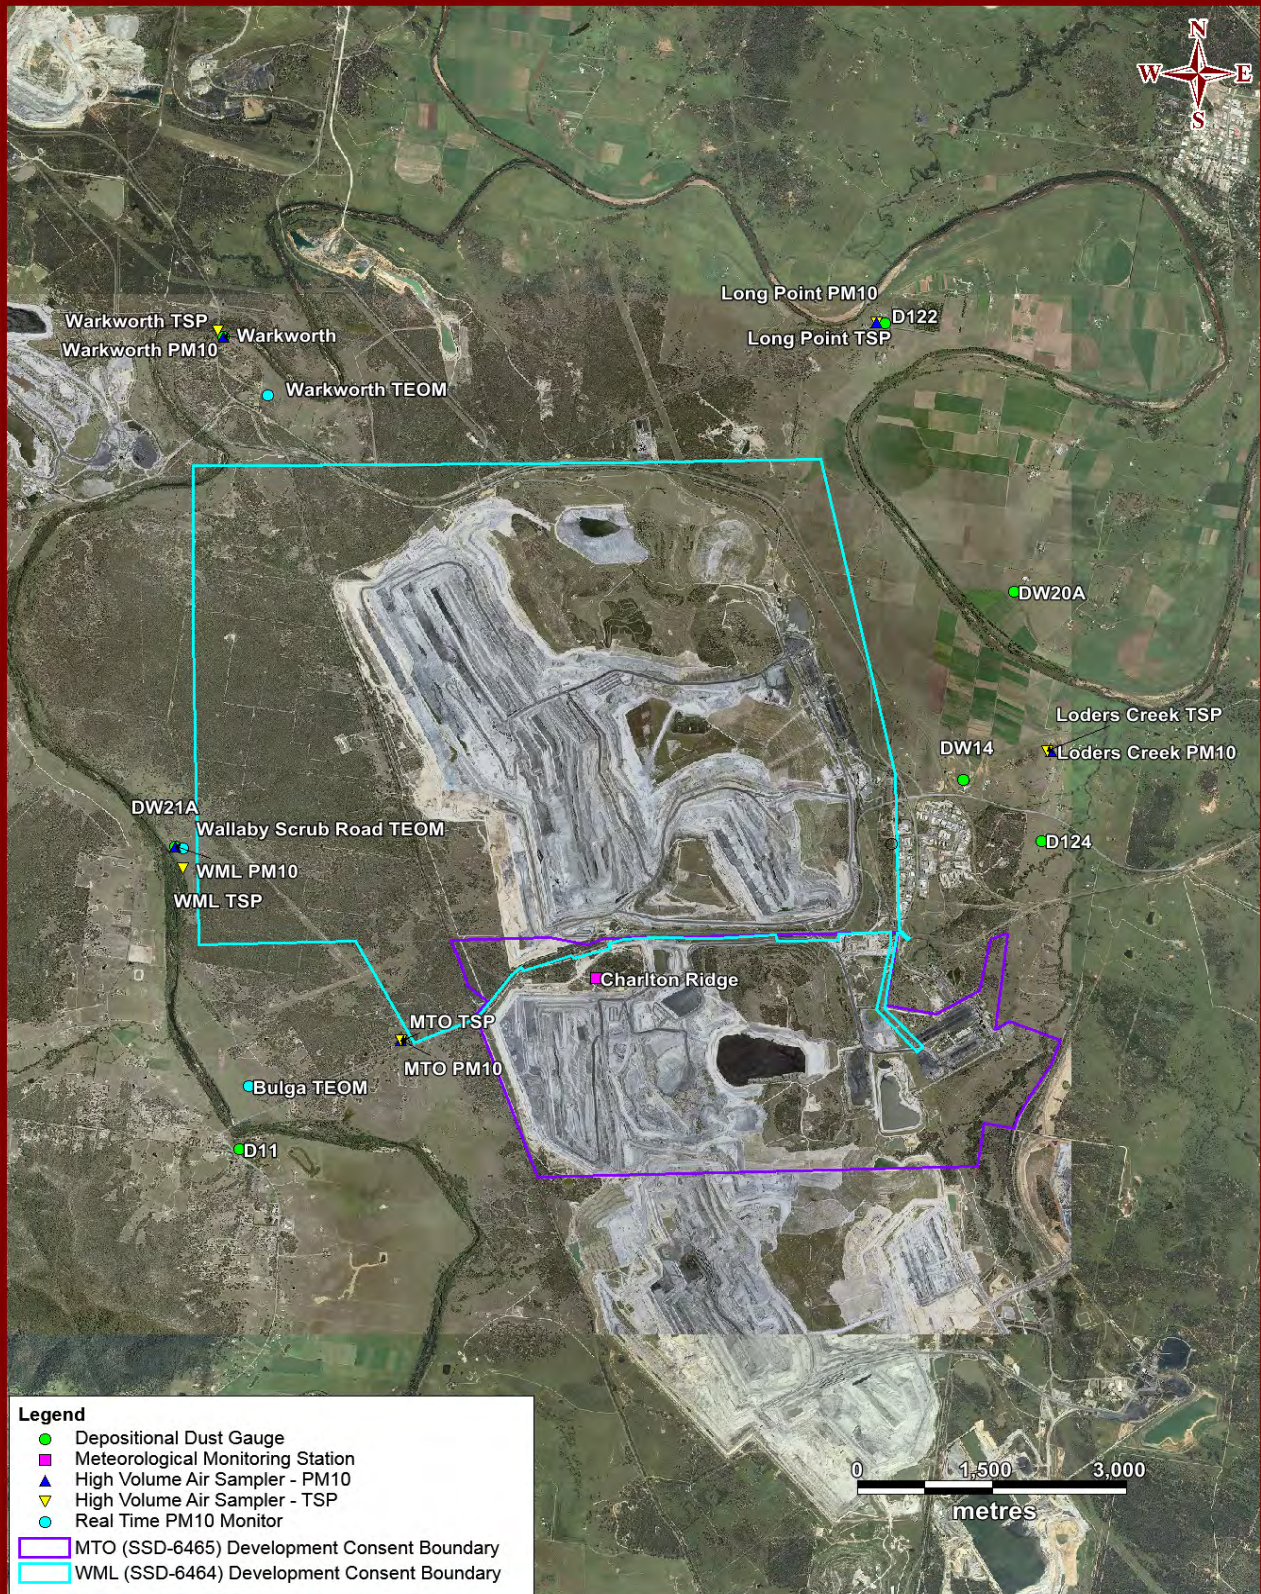
Figure 3: Air Quality Monitoring Locations

Meteorological data is collected at MTW's 'Charlton Ridge' meteorological station (refer to Figure 3: Air Quality Monitoring Locations).

Suspended particulates are measured by a network of High Volume Air Samplers (HVAS) measuring Total Suspended Particulates (TSP) and Particulate Matter <10µm (PM₁₀). The location of these monitors can be found in Figure 3. Each HVAS was run for 24 hours on a six-day cycle in accordance with EPA requirements.

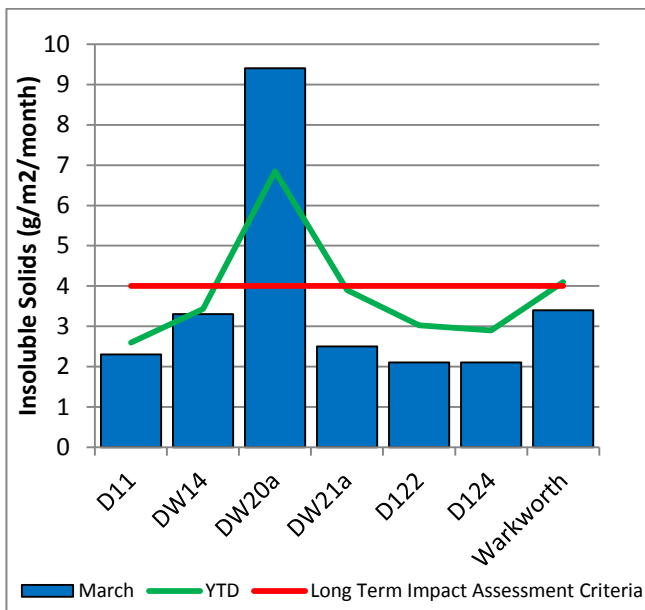
Figure 4: Depositional Dust – April 2017

Figure 4 displays insoluble solids results from depositional dust gauges during the reporting period compared against the year-to-date average and the annual impact assessment criteria.

During the reporting period the DW20a monitor recorded a monthly result above the long term impact assessment criteria of 4.0 g/m² per month. There is no evidence to suggest that the Dw20a result was contaminated. Accordingly, this result will be included in the annual average calculation.

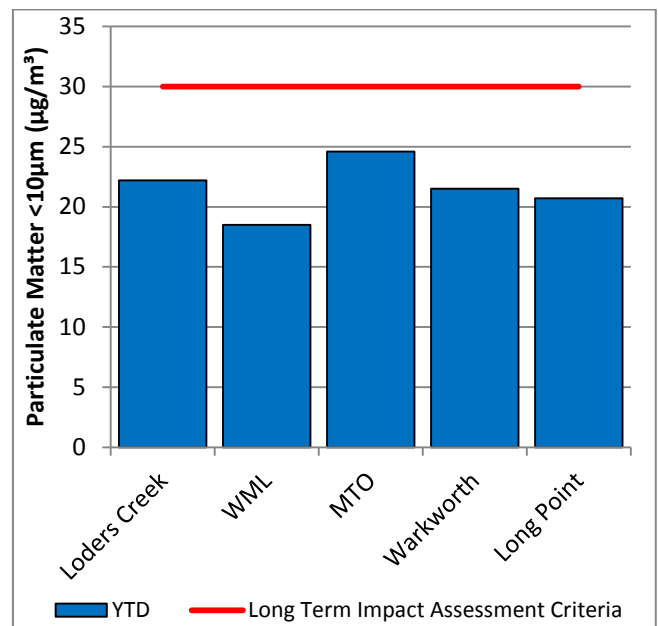
Figure 6: Annual Average PM₁₀ – April 2017

Figure 6 shows the annual average PM₁₀ results against the long term impact assessment criteria.

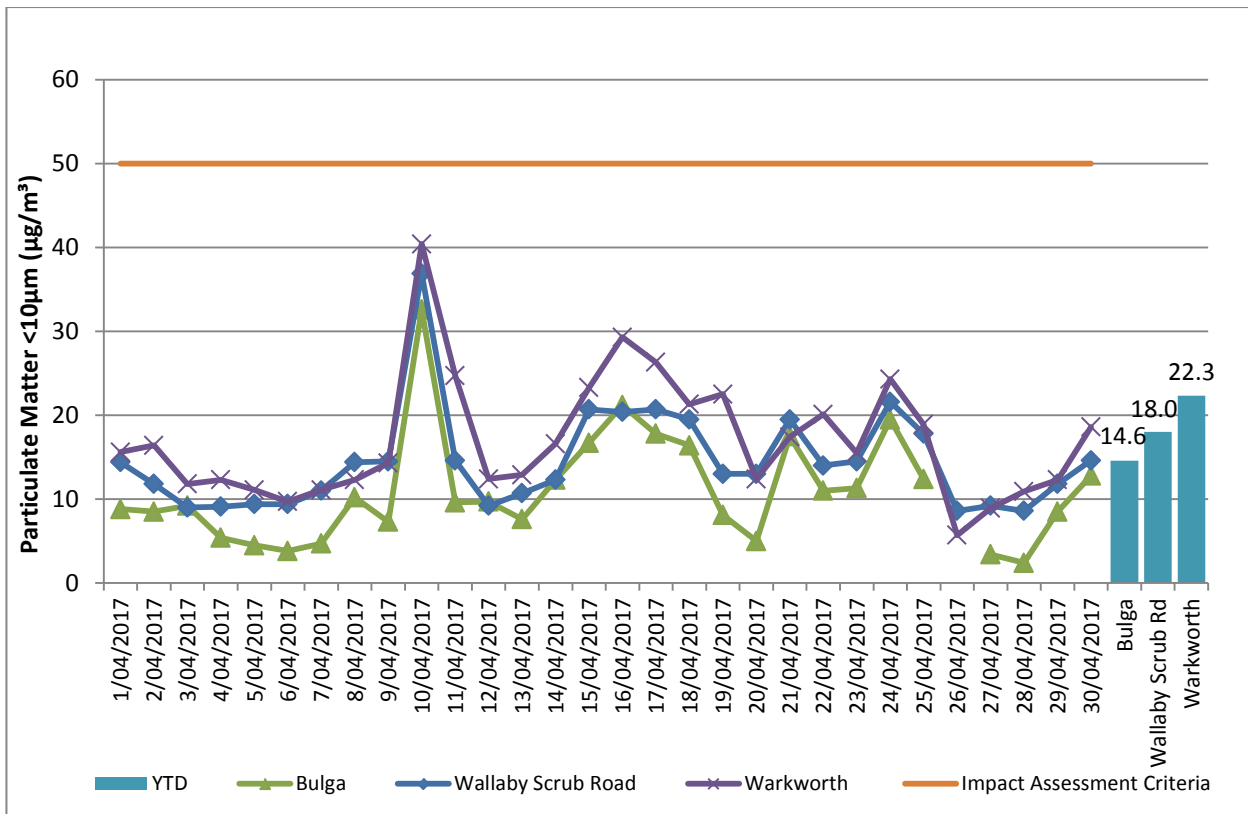
Figure 8: Real Time PM₁₀ daily 24hr average and annual average – April 2017

Results for real time dust sampling are shown in Figure 8, including the daily 24 hour average PM₁₀ result and the annual PM₁₀ average.

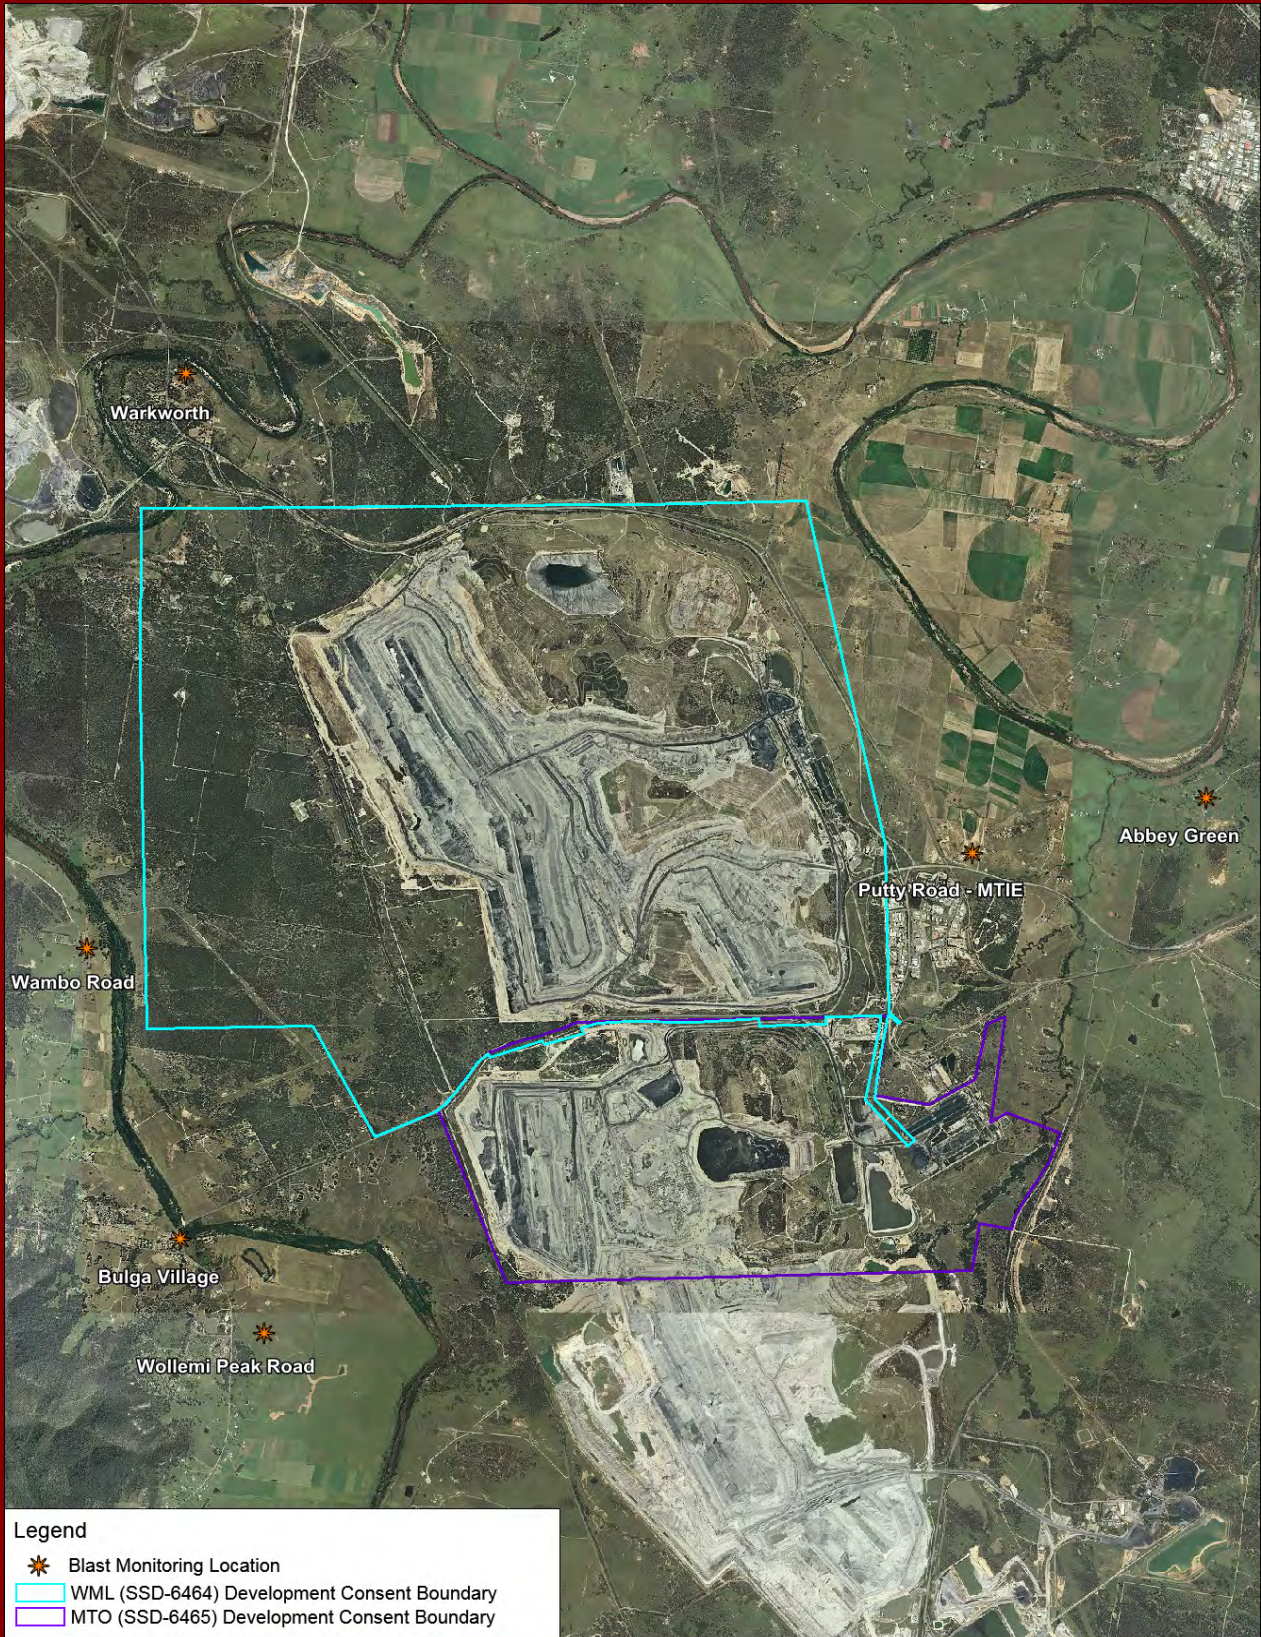
Figure 15: MTW Blast Monitoring Location Plan

MTW have a network of six blast monitoring units. These are located at nearby privately owned residences and function as regulatory compliance monitors.

The location of these monitors can be found in Figure 15.

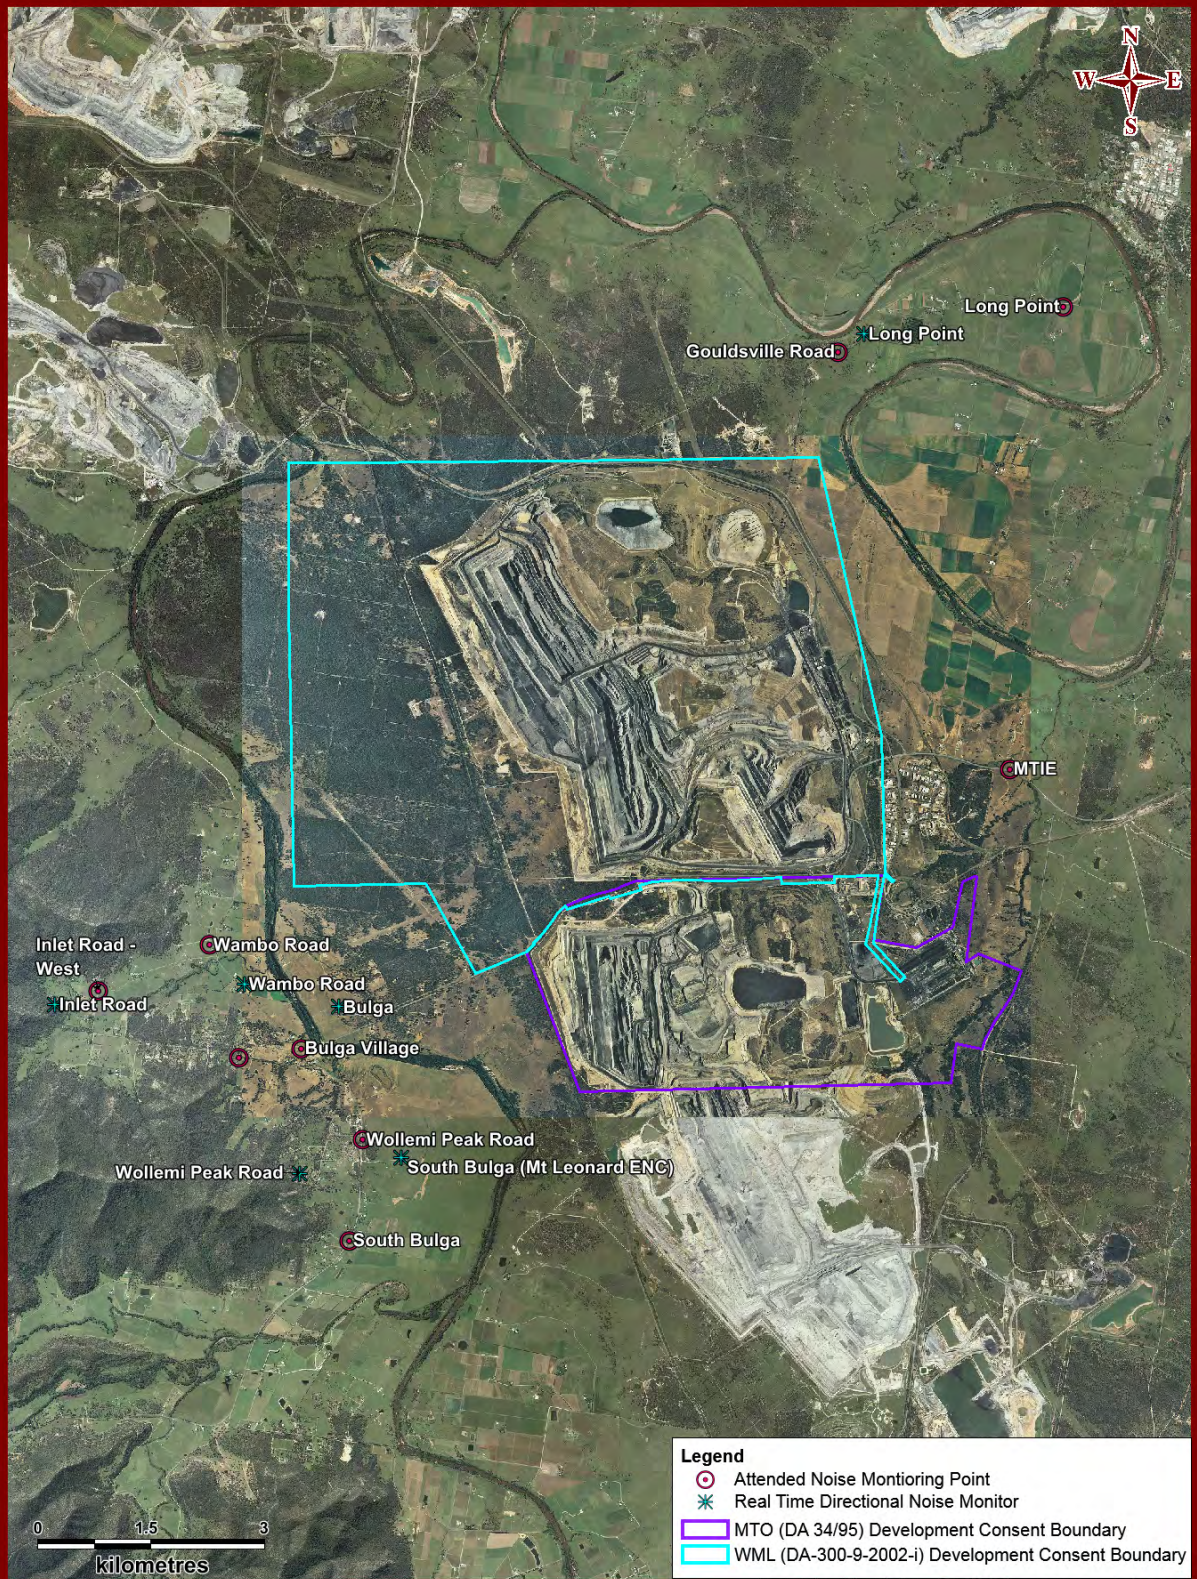
Figure 16: Noise Monitoring Location Plan

Routine attended noise monitoring is carried out in accordance with the MTW Noise Management Plan. A review against EIS predictions will be reported in the Annual Review. The purpose of the noise surveys is to quantify and describe the acoustic environment around the site and compare results with specified limits. Real time noise monitoring also occurs at nine sites surrounding MTW. Noise monitoring locations are displayed in Figure 16.
