**Coal & Allied – Mount Thorley Warkworth Operations
Community Consultative Committee Meeting – Monday 9 May 2106**

Mine-site Air Quality Monitoring Optimisation (AQMO)

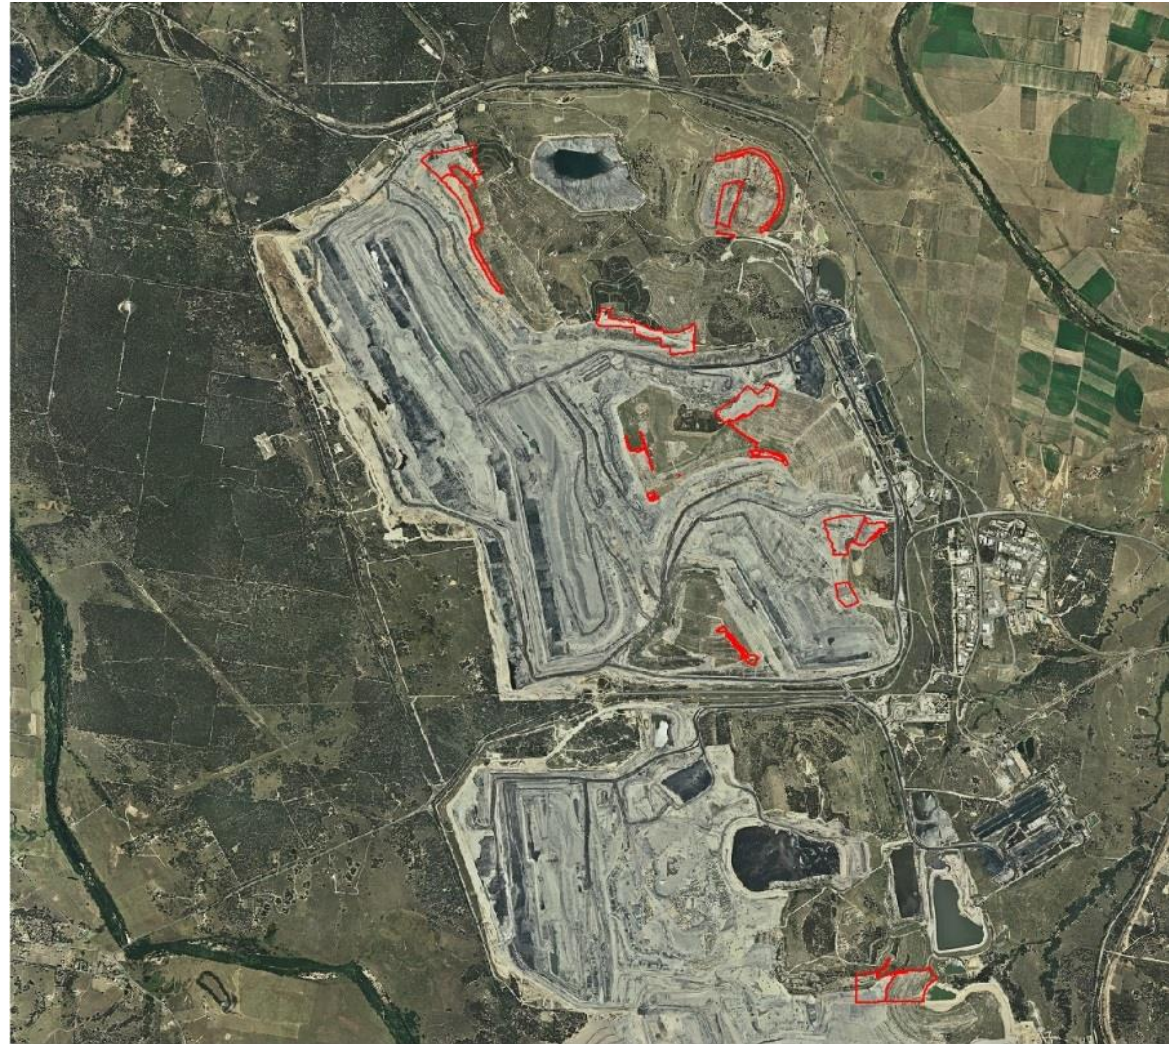
Rehabilitation target for 2016 = 83.3 ha
(outlined in red)

27.0 ha bulk shaped

8 ha topsoiled

At the end of the March rehabilitation is progressing well with 27 ha of the targeted areas bulk shaped, 8 ha of topsoiled and 5.2 ha composted.

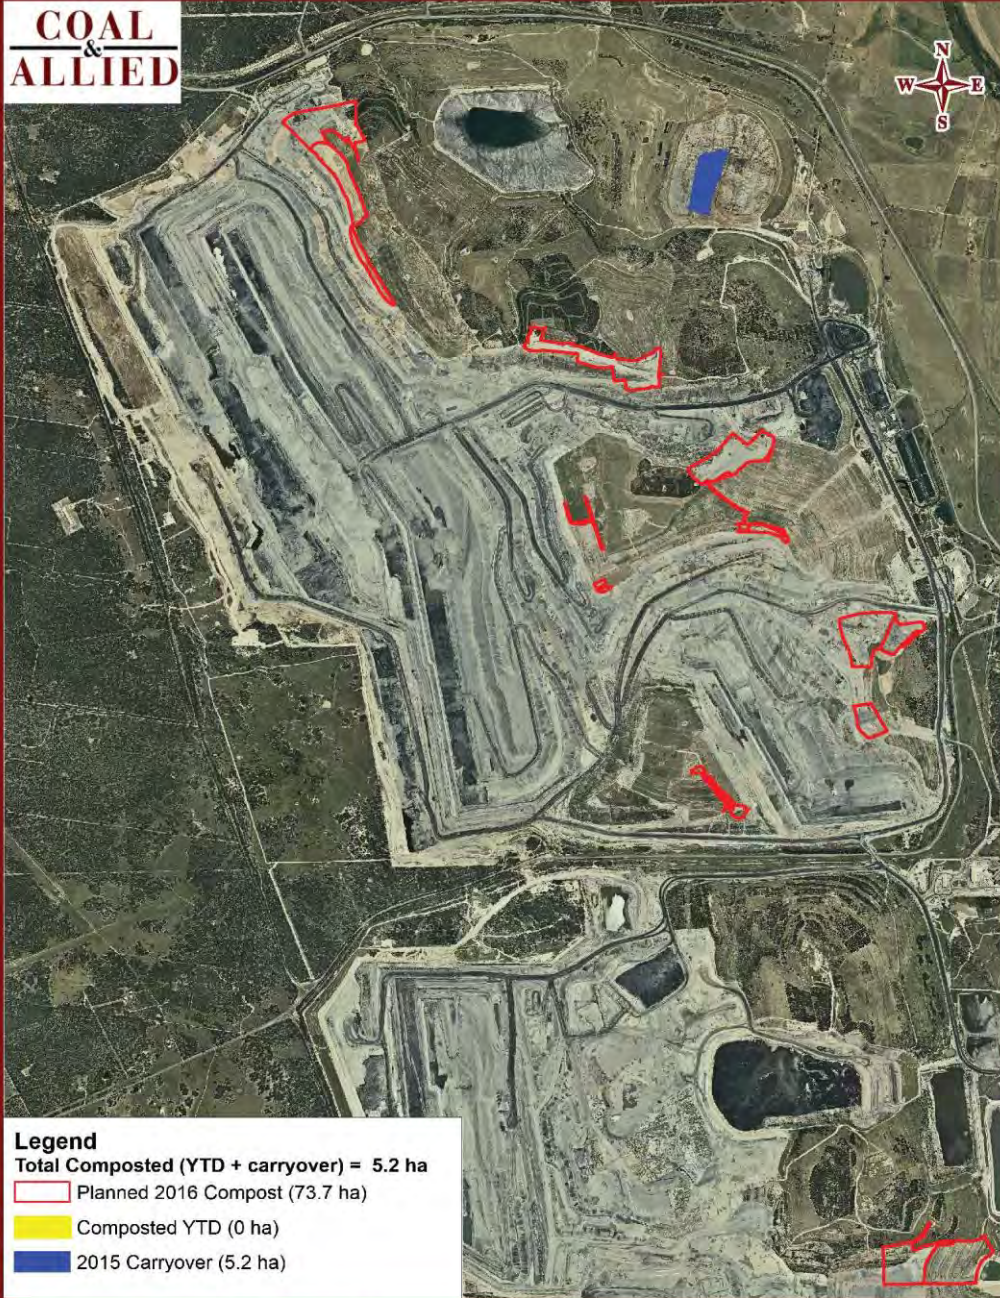
Plan of: Composted 2016
Location: MTW

Legend
Total Composted (YTD + carryover) = 5.2 ha
Planned 2016 Compost (73.7 ha)
Composted YTD (0 ha)
2015 Carryover (5.2 ha)

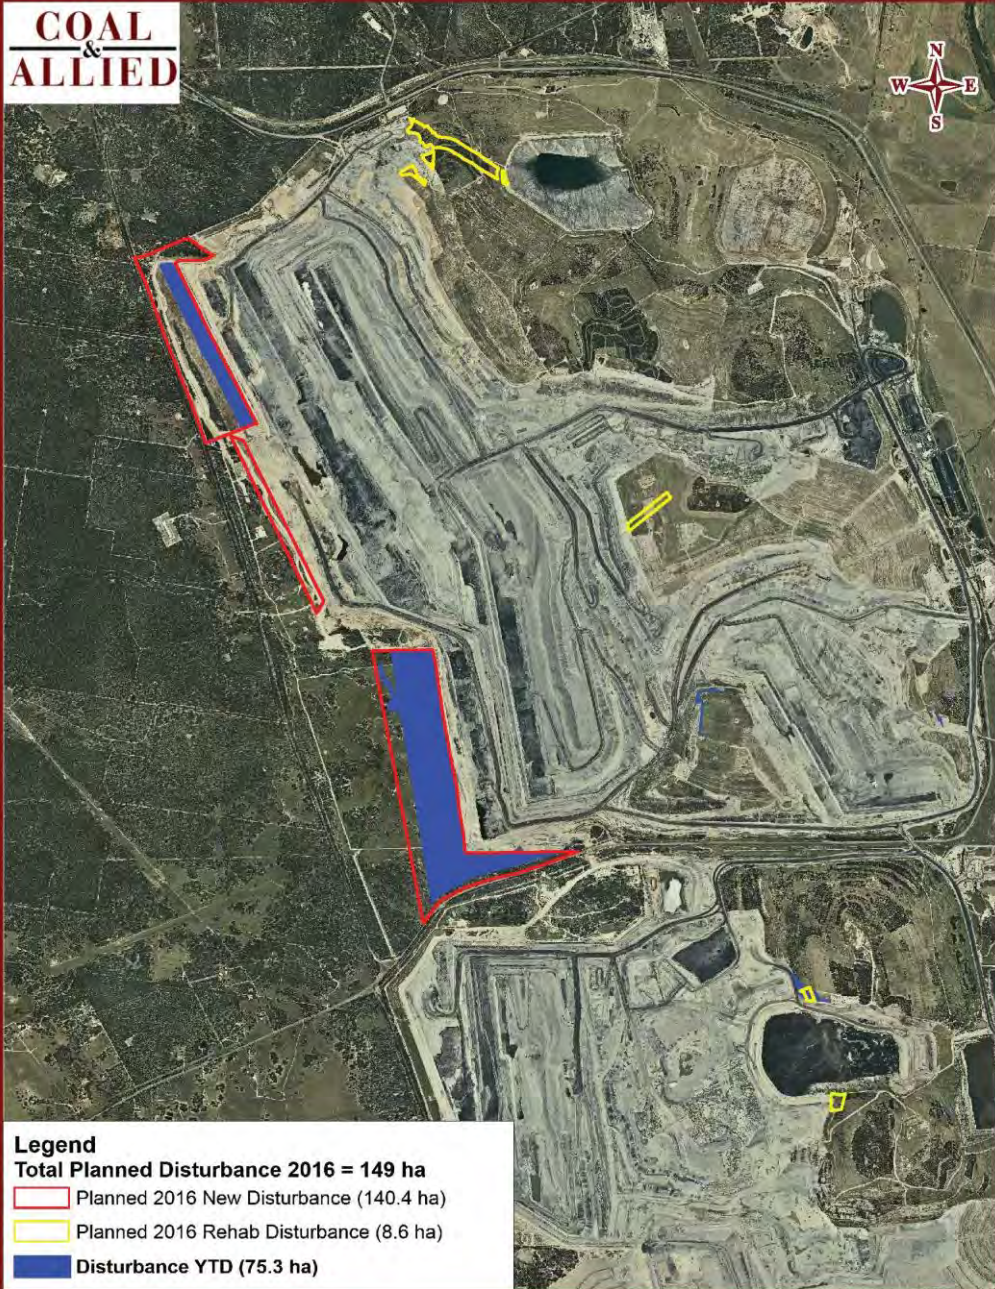
- Total Planned Disturbance 2016 = 149 ha**
-

Disturbance was predominantly in **Warkworth's West Pit area, for mine advance, and to construct a water management contour along the western extent of the disturbance to manage water off pre-strip activities.** A total of 75.3 ha has been disturbed at end of March.

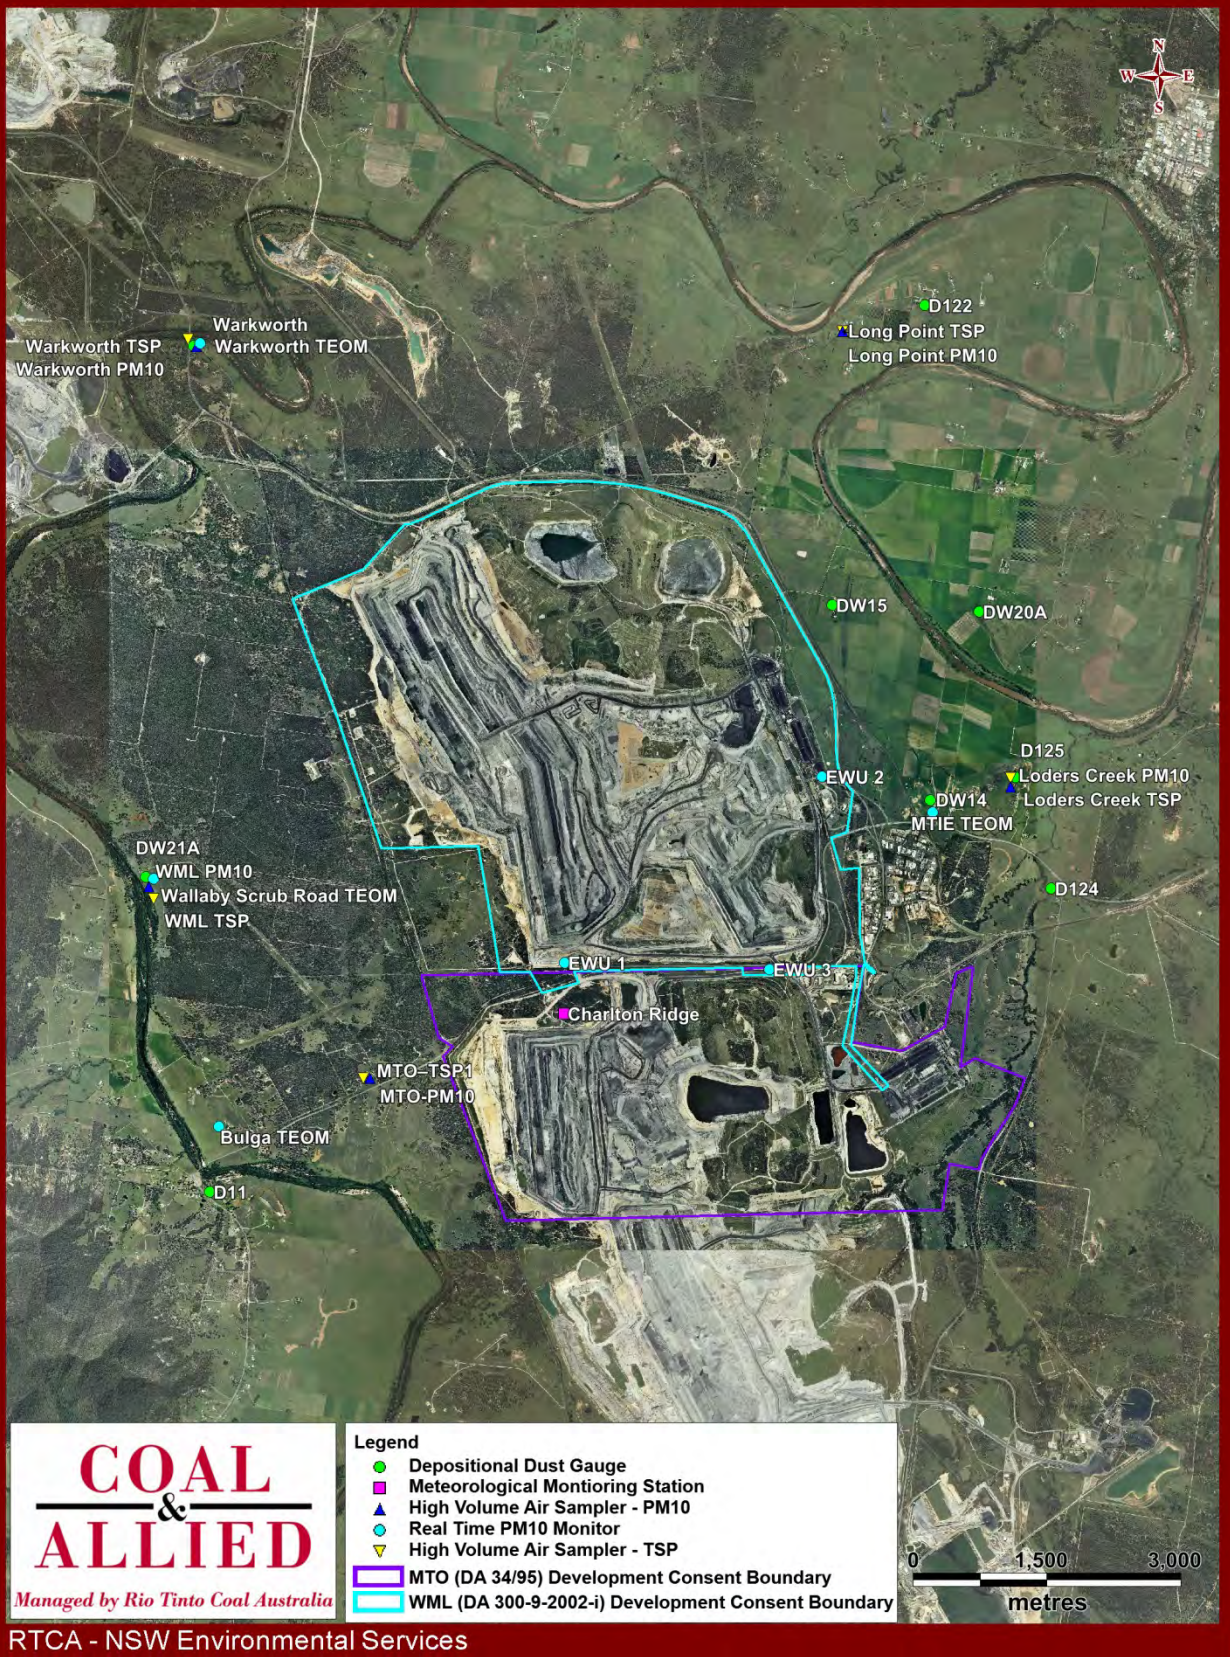
Figure 3: Air Quality Monitoring Locations

**Mount Thorley Warkworth
Air Quality Monitoring Locations**

Suspended particulates are measured by a network of High Volume Air Samplers (HVAS) measuring Total Suspended Particulates (TSP) and Particulate Matter <10µm (PM₁₀). The location of these monitors can be found in Figure 3. Each HVAS was run for 24 hours on a six-day cycle in accordance with EPA requirements.

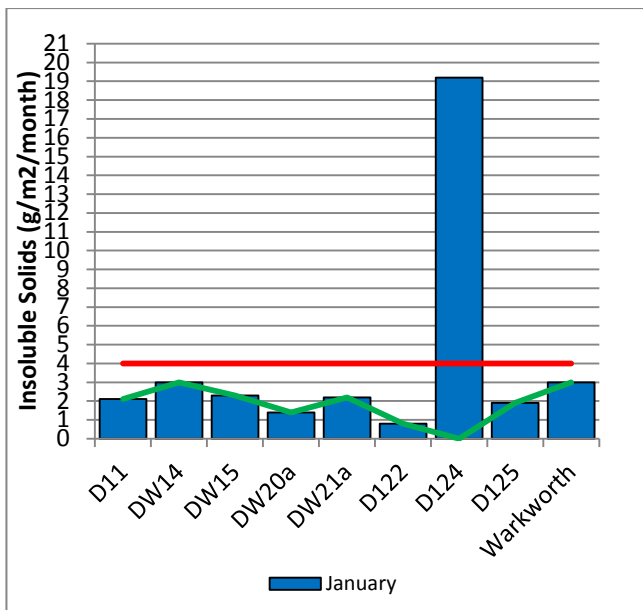
Figure 4: Depositional Dust – January 2016

During the reporting period the D124 monitor recorded a monthly result above the long term impact assessment criteria of 4.0 g/m² per month. The field notes associated with the D124 result confirm the presence of insects and bird droppings. As such the result is considered contaminated and will be excluded from calculation of the annual average.

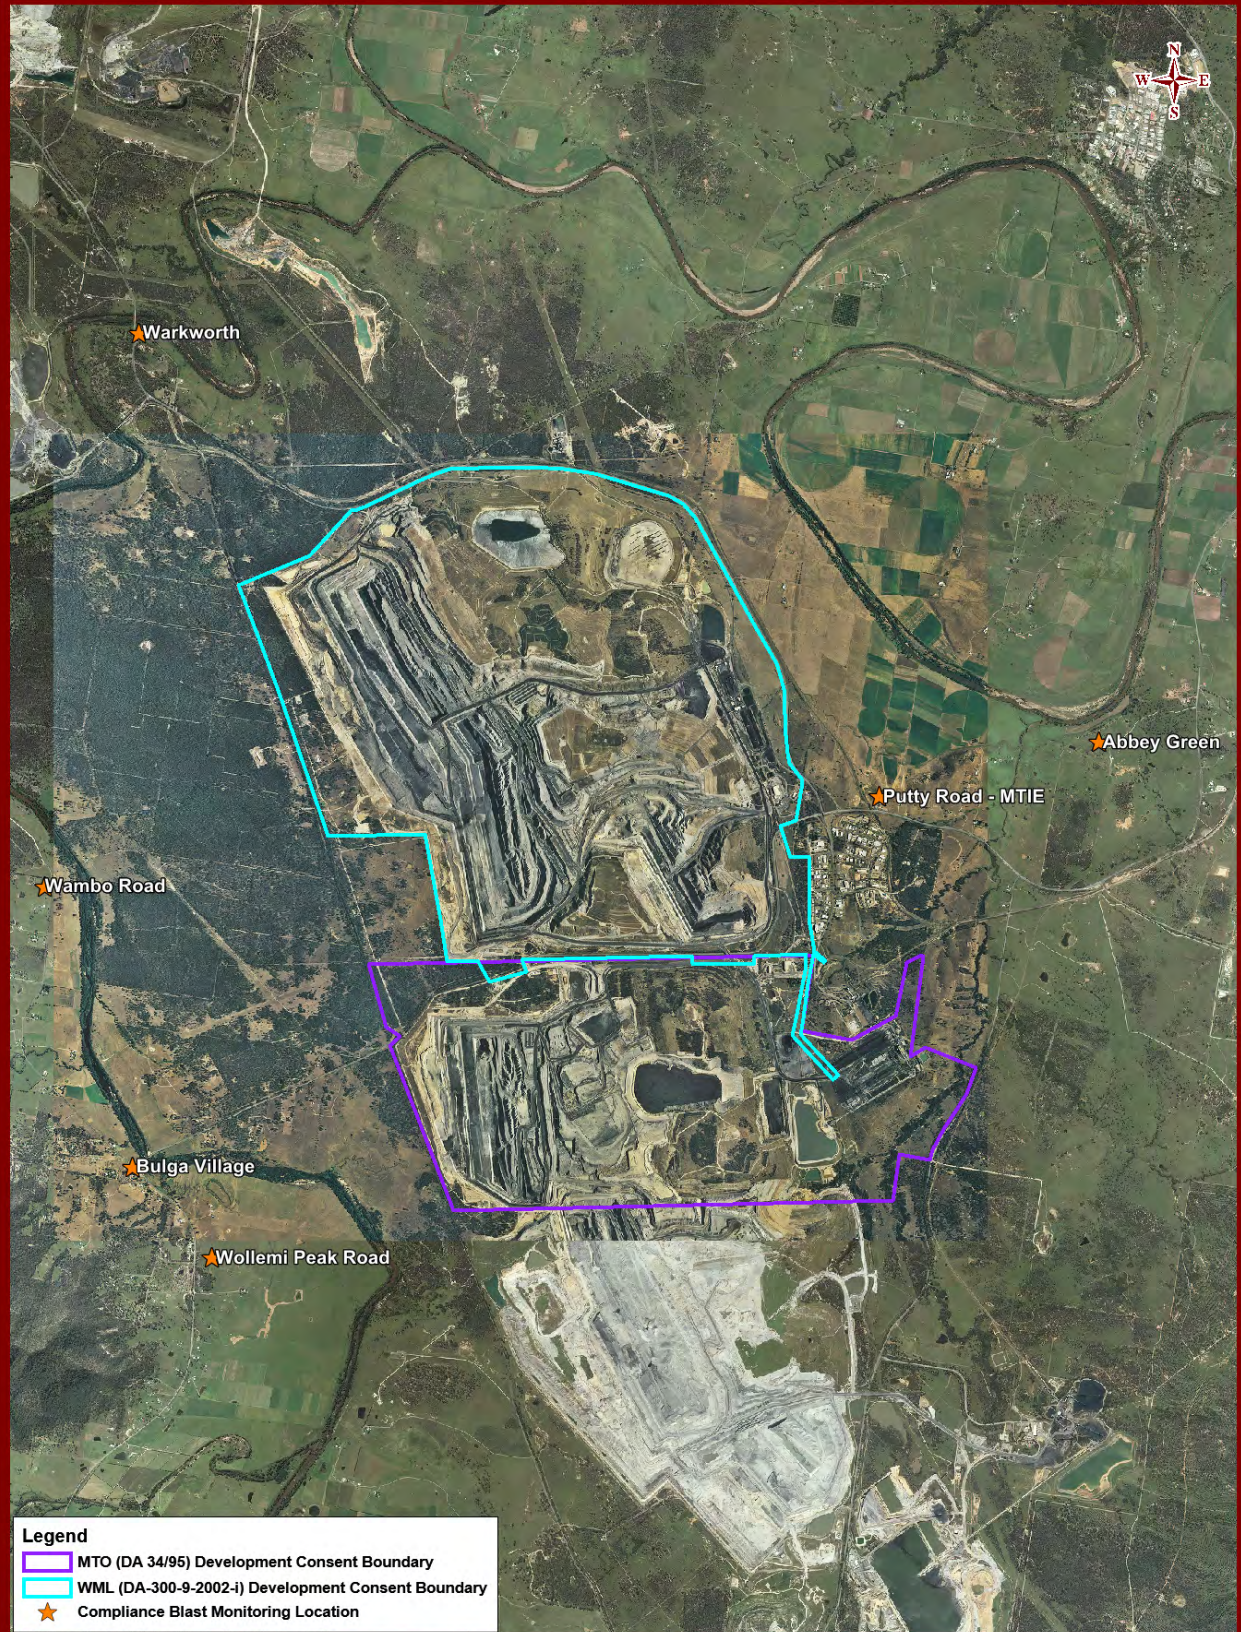
Figure 15: MTW Blast Monitoring Location Plan

Mount Thorley Warkworth
Blast Monitoring Network

The location of these monitors can be found in Figure 15.

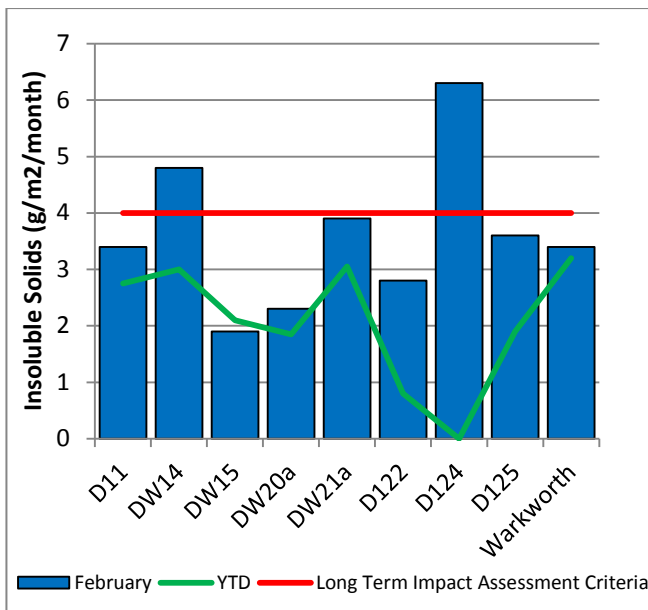
Figure 4: Depositional Dust – February 2016

During the reporting period the DW14 and D124 monitors recorded monthly results above the long term impact assessment criteria of 4.0 g/m² per month. The field notes associated with the results confirm the presence of insects and bird droppings. As such the results are considered contaminated and will be excluded from calculation of the annual average.

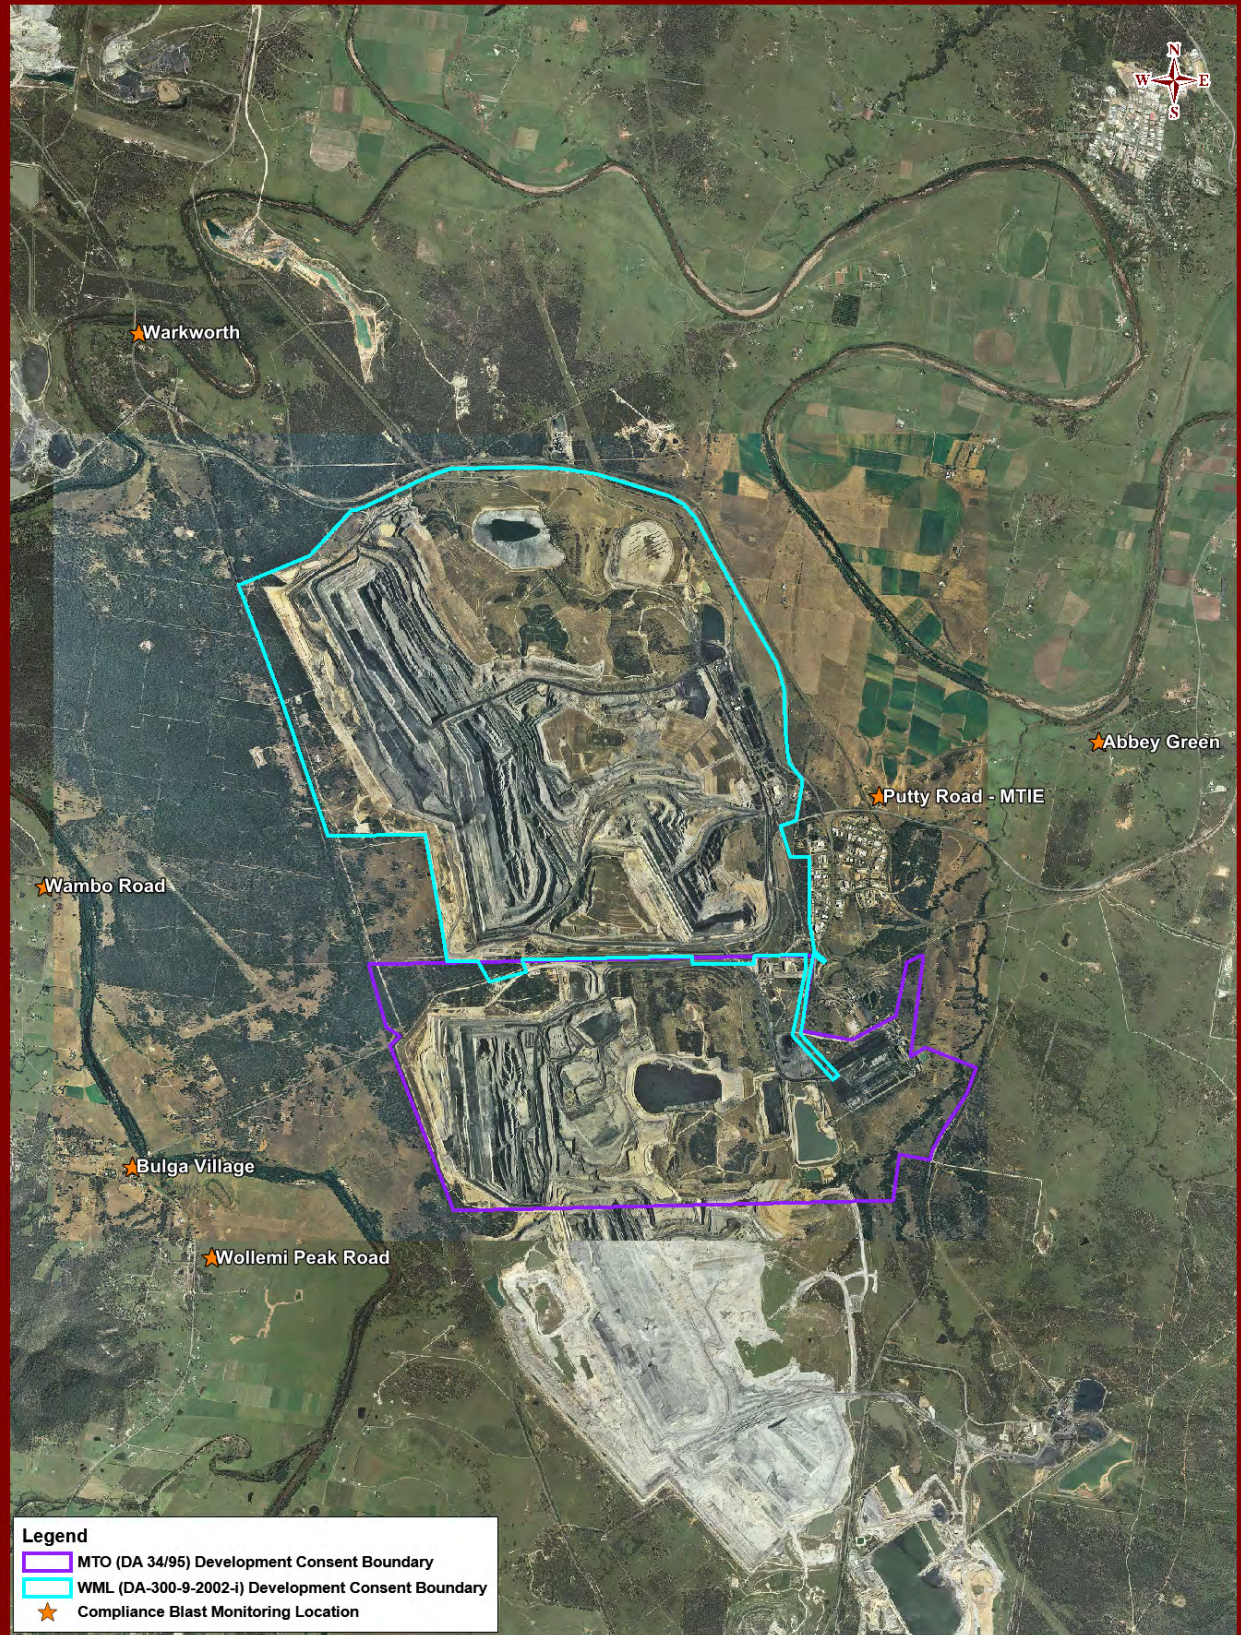
Figure 15: MTW Blast Monitoring Location Plan

Mount Thorley Warkworth
Blast Monitoring Network

The location of these monitors can be found in Figure 15.

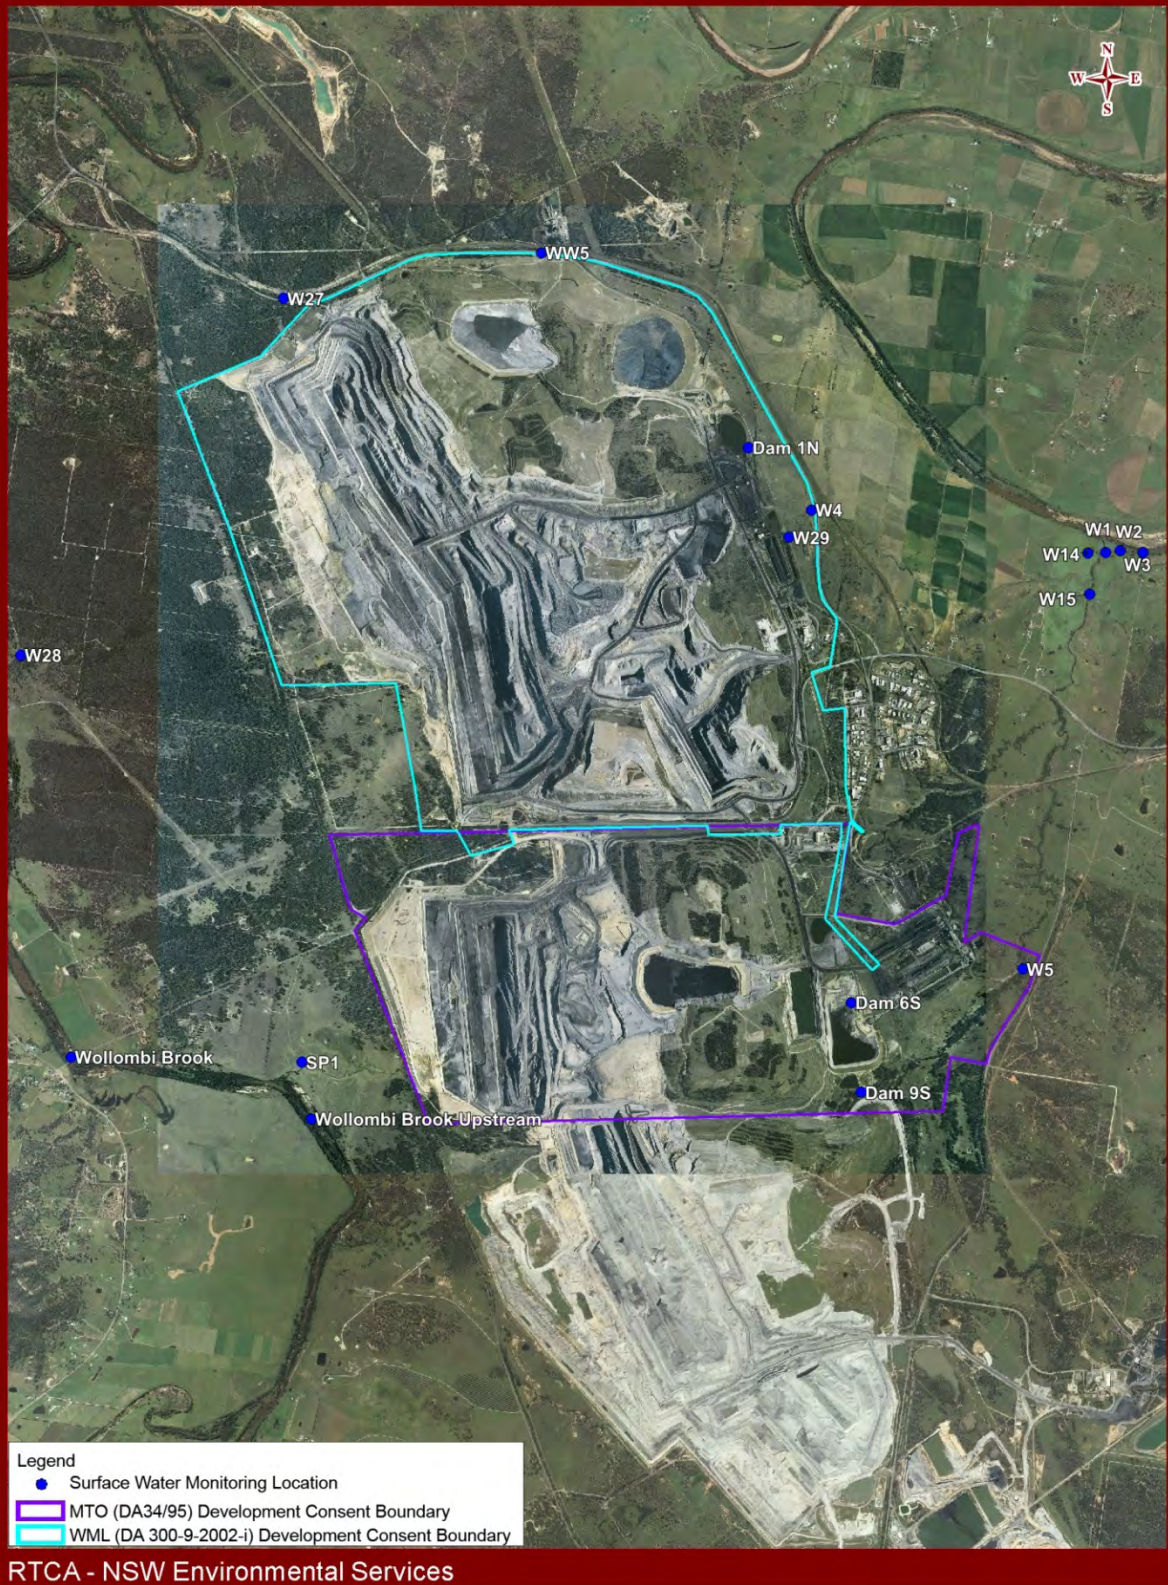
Figure 15: Surface Water Monitoring Location Plan

Mount Thorley Warkworth
Surface Water Monitoring Locations

Monitoring is conducted at mine site dams and surrounding natural watercourses. The surface water monitoring locations are outlined in Figure 15.

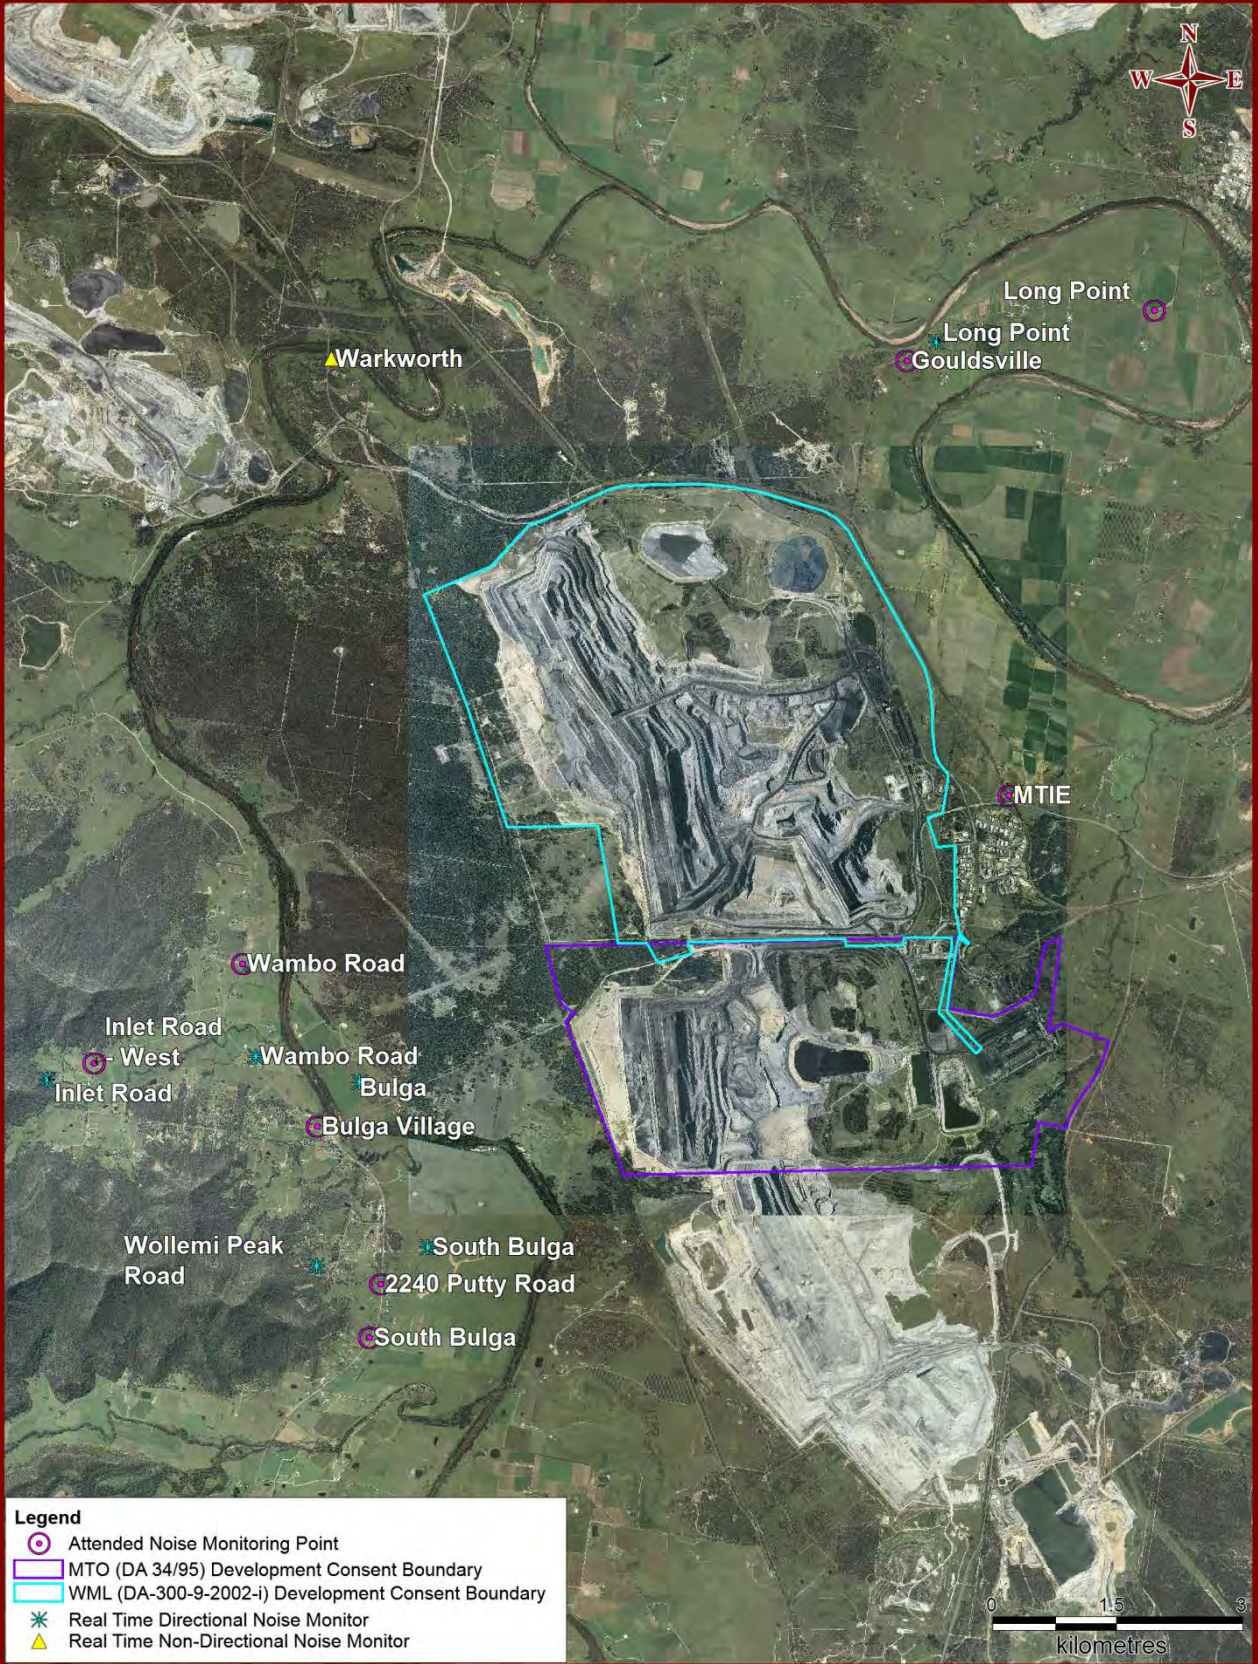
Figure 67: Noise Monitoring Location Plan

**Mount Thorley Warkworth
Noise Monitoring Locations**

Routine attended noise monitoring is carried out in accordance with the MTW Noise Management Plan. A review against EIS predictions will be reported in the Annual Review. The purpose of the noise surveys is to quantify and describe the acoustic environment around the site and compare results with specified limits. Unattended monitoring (real time noise monitoring) also occurs at seven sites surrounding MTW. The attended noise monitoring locations are displayed in Figure 67.
