Stratford Coal CCC Meeting

Presentation –
Company Report &
Overview of Activities

February 2019

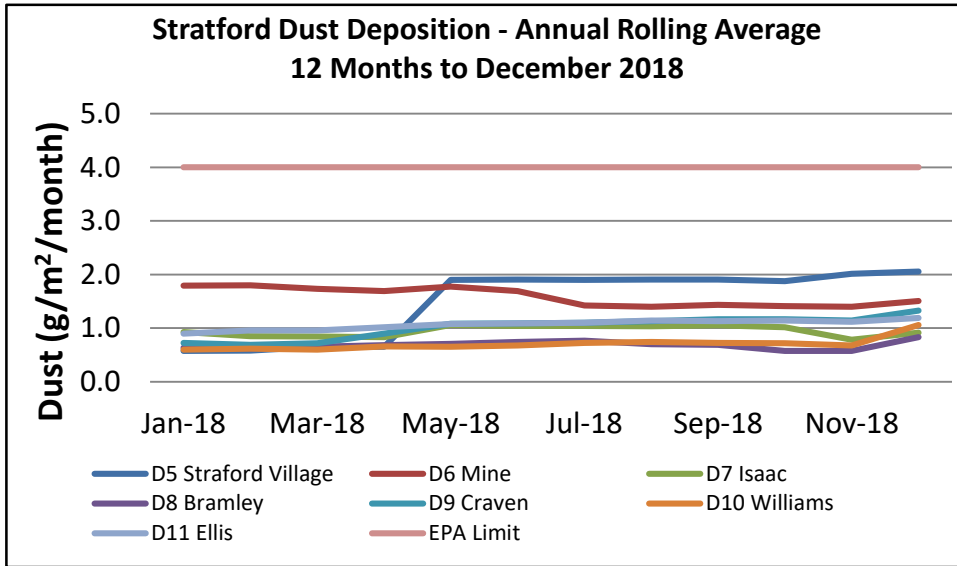
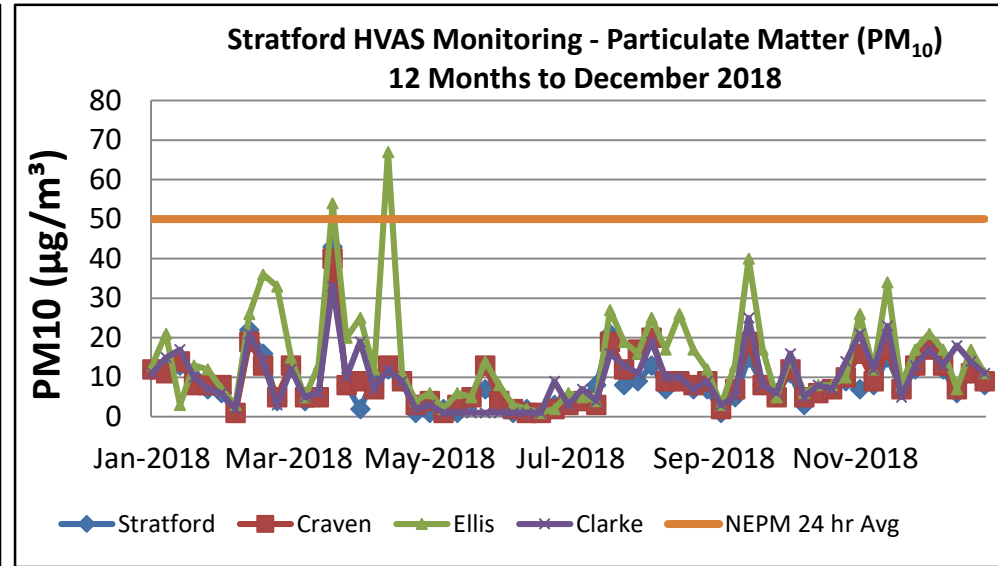
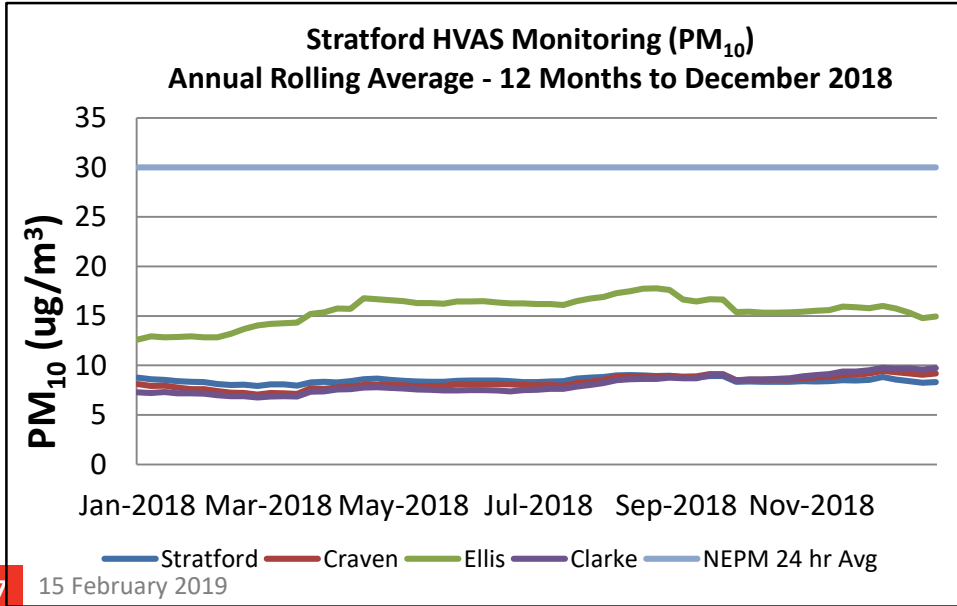
3a. Air Quality Management

- All sites below DP&E limit. Typically low results during winter and higher during spring/summer.
- High results across all monitors on 20-Mar-18 due to hazy conditions across valley following a southerly change and prolonged dry weather.
- Flat trend over previous 12 months.
- HVAS results provide more reliable data compared to dust deposition results and should be referred to when interpreting dust emissions.

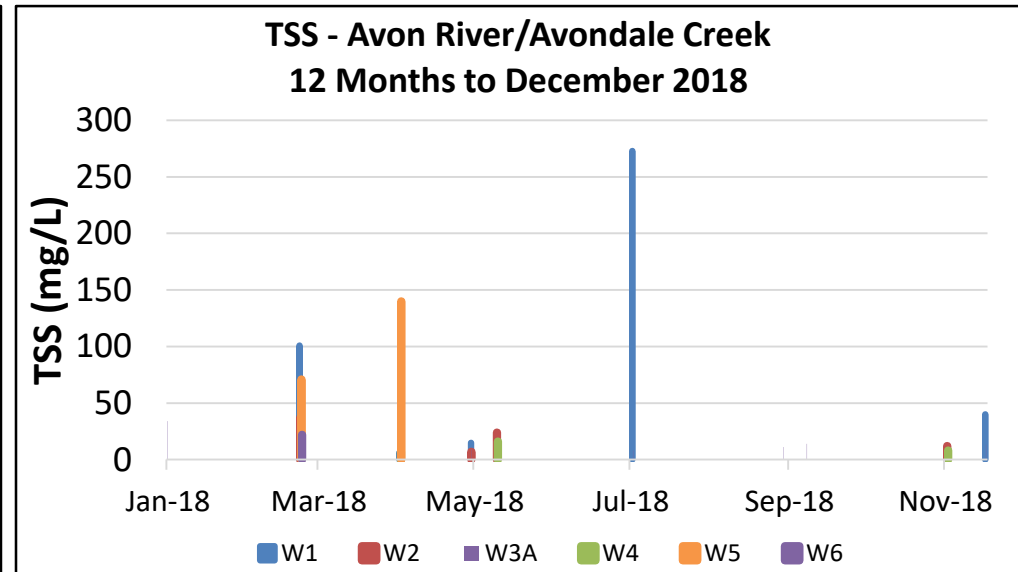
3d. Water Management

Management Area	Project	Status
Site Water Management	<ul style="list-style-type: none"> • Site Water Balance • Erosion and sediment control • Flood Modelling 	<ul style="list-style-type: none"> • The annual site water balance review is currently being prepared. A summary will be included in the Annual Review. • Erosion and sediment control infrastructure has been constructed for the Avon North boxcut and waste emplacement area. The Avon North Sediment dam has been completed. • Avon North eastern clean water drain construction commenced in February 2019. • Preparation of a revised flood model for the Avondale Creek has been completed. The flood model will guide the designs of water infrastructure for Avon North.
Surface Water Monitoring	<ul style="list-style-type: none"> • Routine monitoring 	<ul style="list-style-type: none"> • Sporadic and low rainfall conditions persisted through spring/summer 2018. • Routine water sampling continued. All results consistent with the SCM Environmental Assessment predictions. Generally “no flow” conditions have persisted across all sites.

Groundwater Monitoring	<ul style="list-style-type: none"> • Routine monitoring 	<ul style="list-style-type: none"> • Routine groundwater sampling continued. All results consistent with the SCM Environmental Assessment predictions.

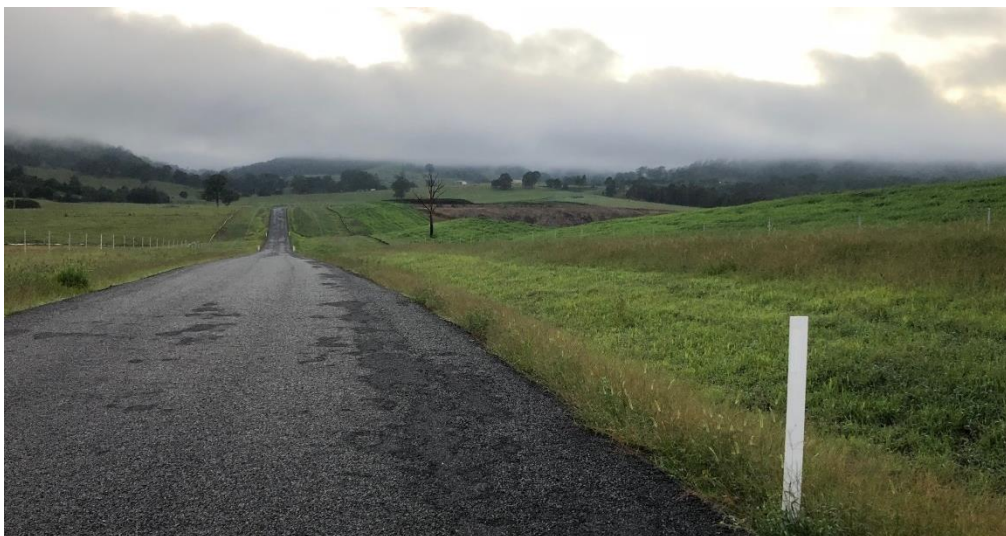
Photo: Avon North visual screen rehabilitation, Dec 2018.

Management Area	Project	Status
Rehabilitated Waste Emplacements	<ul style="list-style-type: none">• Avon North visual bund• Avon North waste emplacement	<ul style="list-style-type: none">• Construction and rehabilitation of the Avon North visual bund along Wenham Cox Road has been finalised. The visual bund was seeded in October 2018. Rehabilitation was also completed along the Wenham Cox Road Diversion.• Bulk shaping of the Avon North waste emplacement has commenced focusing on areas with offsite visual impact. Planting is proposed in spring 2019 with native vegetation.
	Rehabilitation Maintenance	<ul style="list-style-type: none">• Slashing and fertilising has been undertaken on the codam pasture during November 2018.
Monitoring	<ul style="list-style-type: none">• Vegetation Monitoring - Ecosystem Function Analysis	<ul style="list-style-type: none">• Rehabilitation monitoring incorporating landscape function analysis and vegetation dynamics was undertaken in May 2018. The report is has been finalised and a summary will be included in the Annual Review.

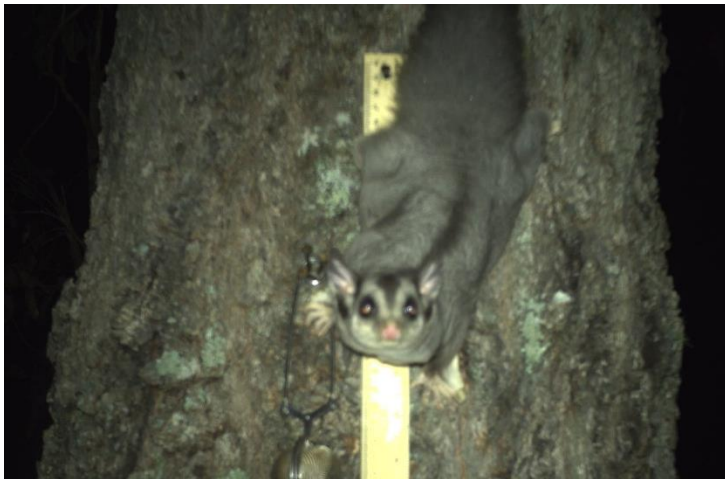
16 15 February 2019 Photo: Squirrel Glider camera monitoring, Dec 2018.

Management Area	Project	Status
Squirrel Glider Management	<ul style="list-style-type: none"> Squirrel Glider Colony Surveys Squirrel Glider Home Range Surveys 	<ul style="list-style-type: none"> The initial surveys of the Squirrel Glider colonies was undertaken during December 2018. The monitoring involved the installation of 40 remote cameras over a 4 week period. Squirrel Gliders were identified in 5 separate locations. Squirrel Glider home range monitoring is currently being undertaken via a trapping and radio tracking program. 8 gliders from 4 colonies are currently being tracked to determine their home ranges. These studies will guide the ongoing management of glider populations.
Weed Management	<ul style="list-style-type: none"> Weed Spraying 	<ul style="list-style-type: none"> Weed spraying in the Stratford biodiversity areas commenced in November 2018. The initial focus is in the areas proposed for revegetation in 2019. The main target species are blackberry, wild tobacco, lantana, privet and GPG.

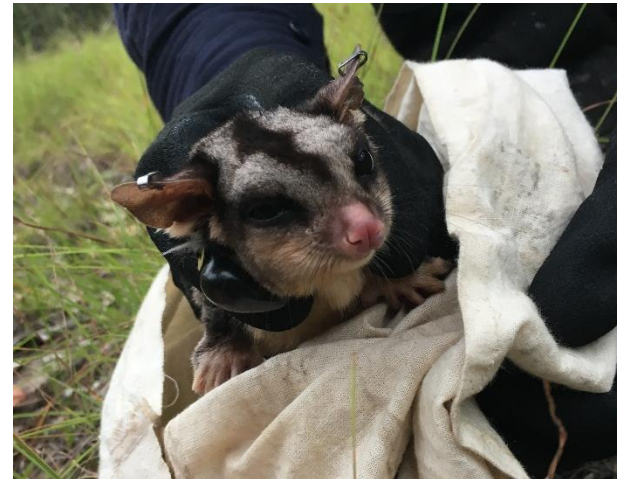
Photo: Squirrel Glider radio tracking, Feb 2019.
