Stratford Coal CCC Meeting

Presentation –
Company Report &
Overview of Activities

May 2019

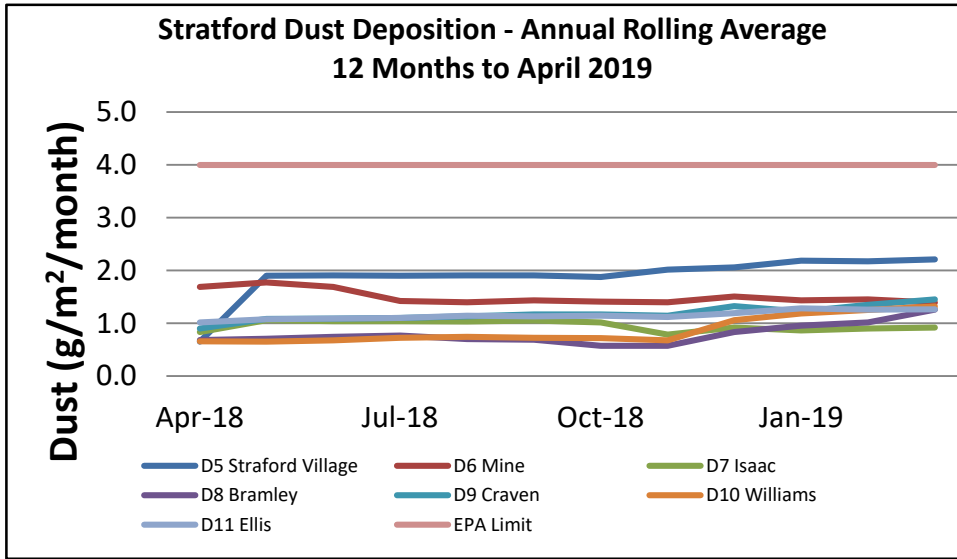
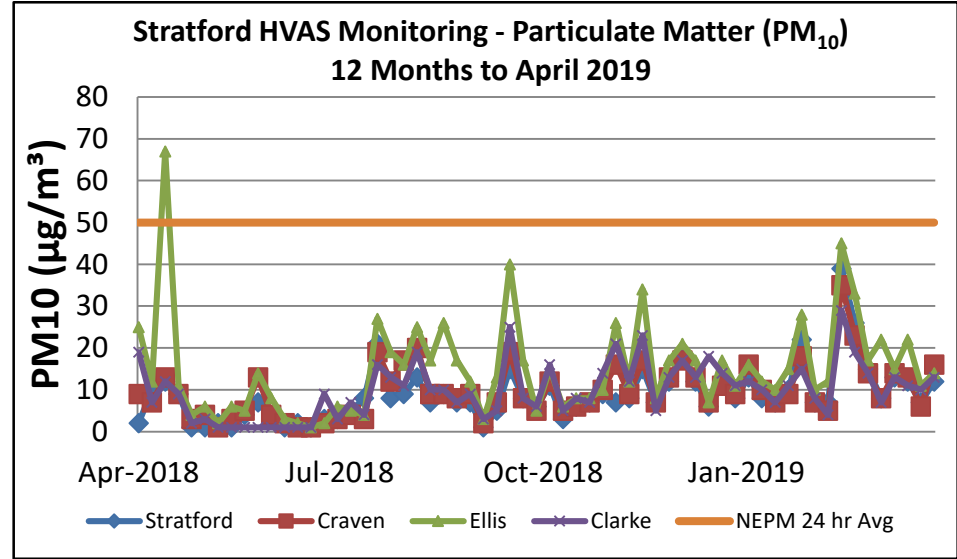
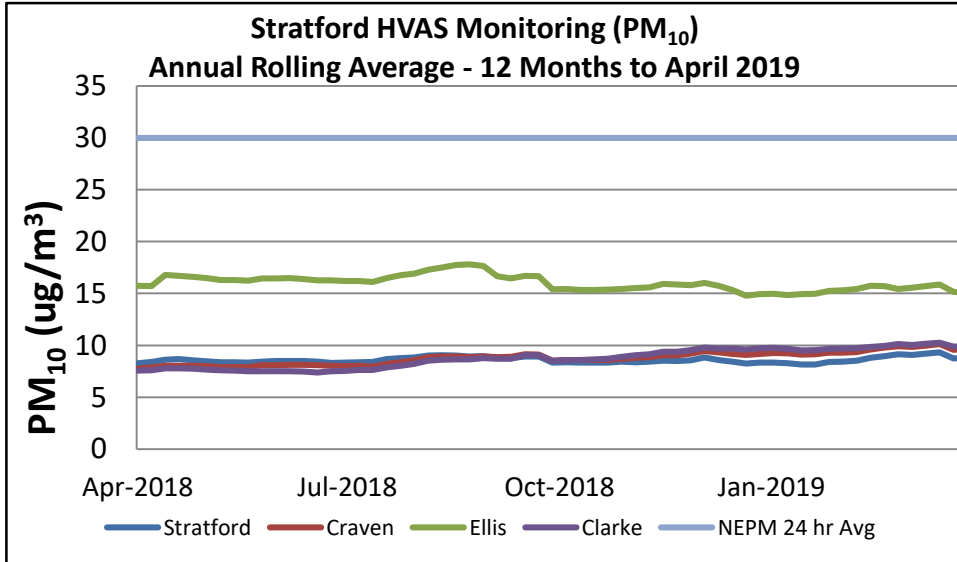
3a. Air Quality Management

- All sites below DP&E limit. Typically low results during winter and higher during spring/summer.
- High results at Ellis HVAS monitor on 13-Apr-18 due to a semi-trailer being loaded on a nearby dirt track.
- Flat trend over previous 12 months.
- HVAS results provide more reliable data compared to dust deposition results and should be referred to when interpreting dust emissions.

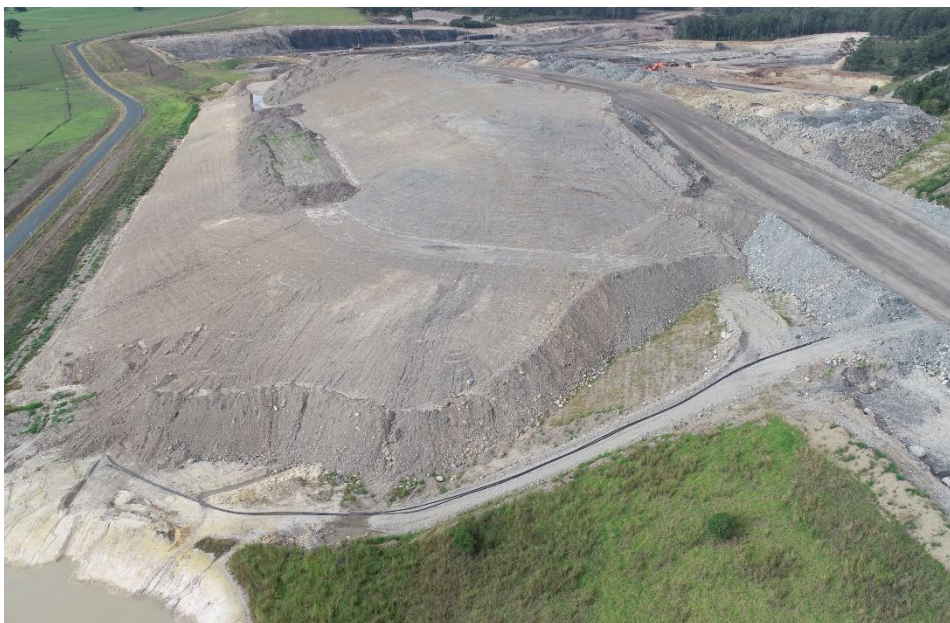
Photo: Bulk shaping on the Avon North Waste Emplacement, May 2019.

Management Area	Project	Status
Rehabilitated Waste Emplacements	<ul style="list-style-type: none">Avon North waste emplacement	<ul style="list-style-type: none">Bulk shaping of the Avon North waste emplacement has continued focusing on areas with offsite visual impact. Planting is proposed in spring 2019 with native vegetation.
	Rehabilitation Maintenance	<ul style="list-style-type: none">Slashing and fertilising has been undertaken on the centre pivot area and codam pasture during May 2019.
Monitoring	<ul style="list-style-type: none">Vegetation Monitoring - Ecosystem Function Analysis	<ul style="list-style-type: none">Rehabilitation monitoring incorporating landscape function analysis and vegetation dynamics is scheduled to be undertaken in May 2019. A summary will be included in the Annual Review.

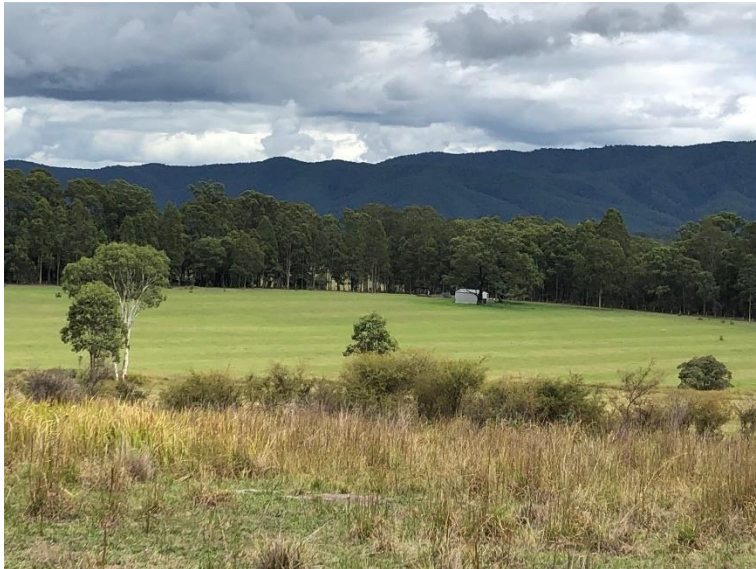
Photo: Biodiversity Offset preparation for tubestock planting, Mar 2019.

Management Area	Project	Status
Biodiversity Offset Area	<ul style="list-style-type: none"> Revegetation Works 	<ul style="list-style-type: none"> In 2019 SCPL is planning for the planting of approximately 60,000 trees over 150 hectares along the Glen Road area. Tubestock planting in the biodiversity offset area commenced in April 2019. Prior to planting ground preparation was undertaken including weed spraying, slashing and ripping.
Biodiversity Offset Area	<ul style="list-style-type: none"> Vegetation Monitoring 	<ul style="list-style-type: none"> The first round of vegetation monitoring for the biodiversity offset area was undertaken in February 2019. This report will establish the baseline vegetation condition for the ongoing revegetation works in the offset area. A summary of the report will be included in the next Annual Review.
Weed Management	<ul style="list-style-type: none"> Weed Spraying 	<ul style="list-style-type: none"> Weed spraying in the Stratford biodiversity areas continued until May 2019. The initial focus is in the areas proposed for revegetation in 2019. The main target species are blackberry, wild tobacco, lantana, privet and GPG.

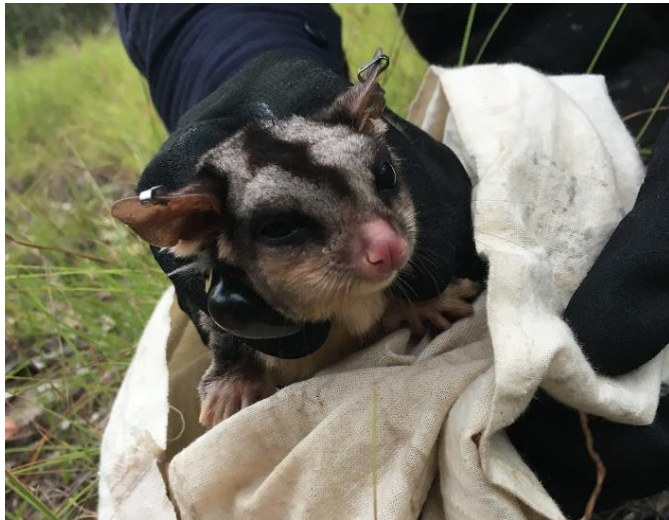
Photo: Squirrel Glider radio tracking, Feb 2019.

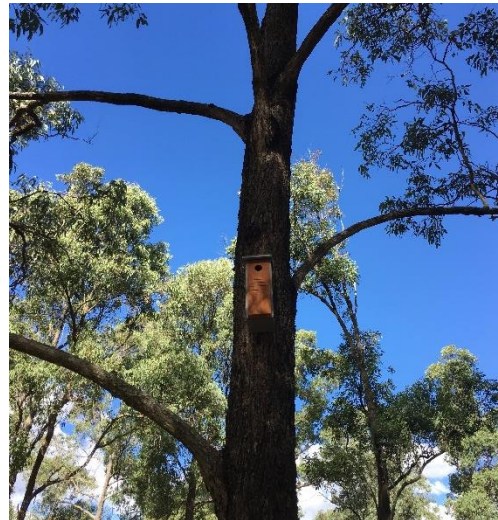
Photo: Squirrel Glider nest box installations, May 2019.

Management Area	Project	Status
Squirrel Glider Management	<ul style="list-style-type: none"> Squirrel Glider Colony Surveys Squirrel Glider Home Range Surveys Nest box installations 	<ul style="list-style-type: none"> Squirrel Glider colony surveys were completed in December 2018. Squirrel Gliders were identified in 5 separate locations. Squirrel Glider home range monitoring was undertaken during March/April 2019 via a trapping and radio tracking program. 8 gliders from 4 colonies were tracked to determine their home ranges. Records of other gliders encountered were also obtained. These studies will guide the ongoing management of glider populations. The second round of radio tracking will commence in June 2019. During May 2019 25 Squirrel Glider boxes were installed surrounding the home ranges identified in the radio tracking program.
Pest Control	<ul style="list-style-type: none"> Wild Dog control program 	<ul style="list-style-type: none"> Wild dog and fox trapping is recommenced in May 2019 covering all Stratford Coal owned properties including biodiversity offsets and Mining Leases.
