# Stratford Coal CCC Meeting

Presentation –  
Company Report &  
Overview of Activities

May 2020

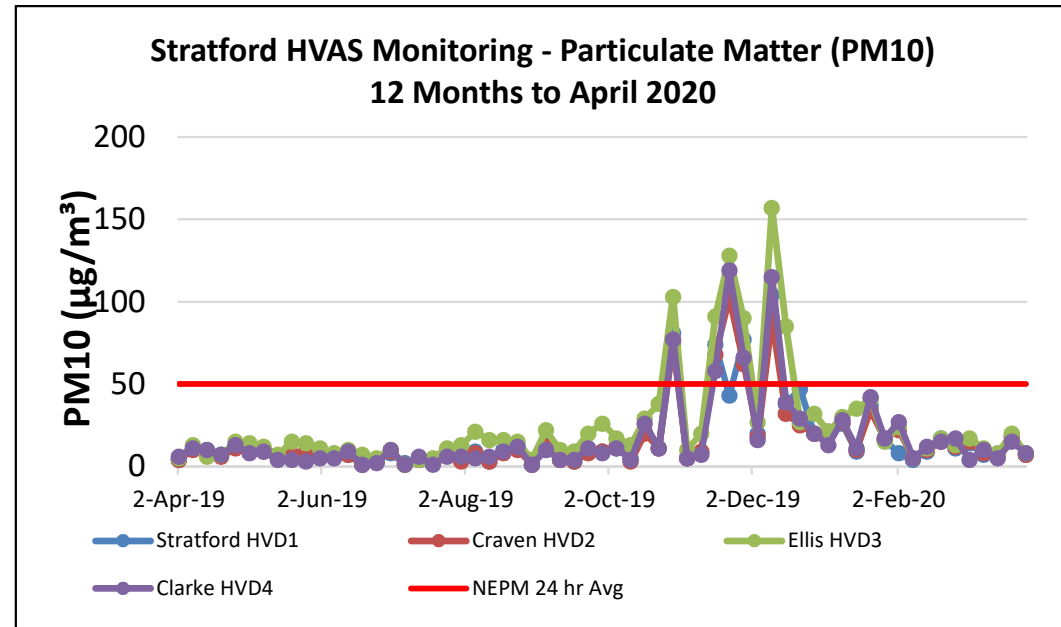
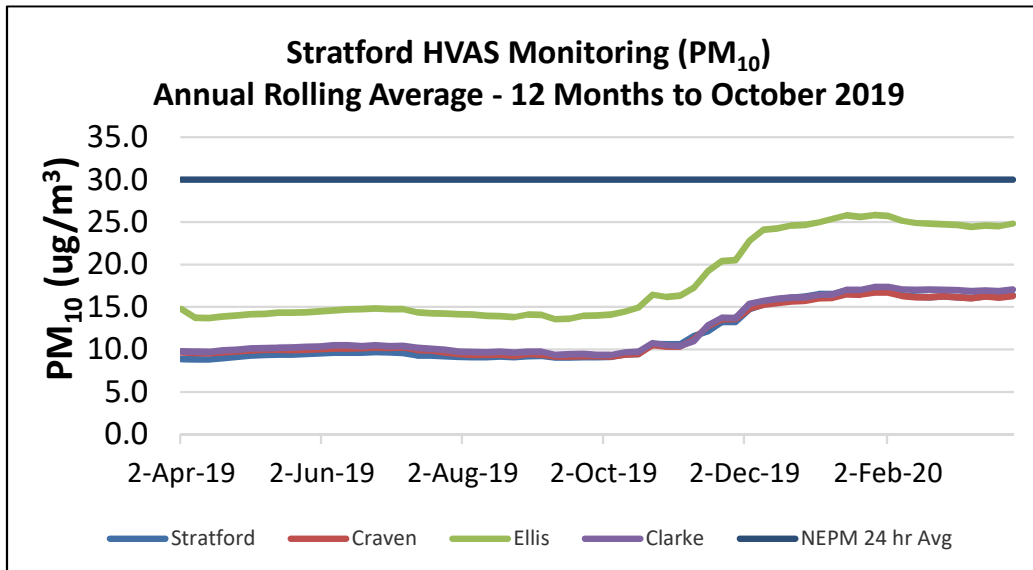
- Increased results in October, November and December attributable to very poor regional air quality due to bush fire smoke.
- All sites below DP&E limit. Typically low results during winter and higher during spring/summer.
- Flat trend over previous 12 months.
- HVAS results provide more reliable data compared to dust deposition results and should be referred to when interpreting dust emissions.

Management Area	Project	Status
Air quality monitoring	<ul style="list-style-type: none"><li>Real-time air quality monitoring</li></ul>	<ul style="list-style-type: none"><li>The real-time air quality TEOM monitors in Stratford and Craven villages continue to operate.</li><li>General ambient PM10 dust levels have been elevated due to ongoing drought conditions. Elevated PM10 levels have also been recorded from smoke during recent bushfires.</li></ul>

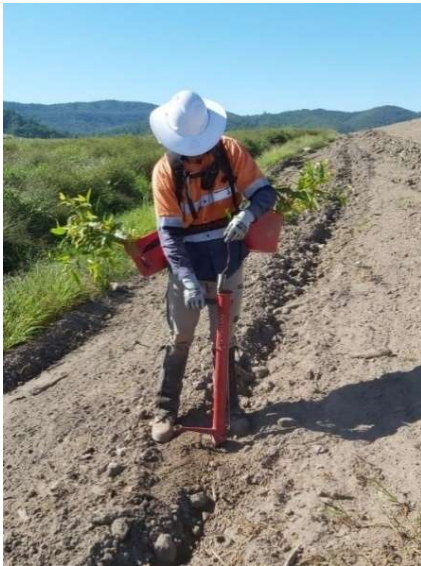
Photo: Avon North rehabilitation Tube Stock planting, March 2020.

Management Area	Project	Status
Rehabilitated Waste Emplacements	<ul style="list-style-type: none"> <li>Avon North waste emplacement</li> </ul>	<ul style="list-style-type: none"> <li>Bulk shaping of the Avon North waste emplacement completed focusing on areas with offsite visual impact (North Aspect). Native Tree Seed and Native Grass Seed spread on approx. 11ha.</li> </ul>
Tube Stock	<ul style="list-style-type: none"> <li>Avon North waste emplacement</li> </ul>	<ul style="list-style-type: none"> <li>250 Tube Stock were planted as part of the Avon North waste emplacement rehabilitation to mitigate visual amenity.</li> </ul>
Monitoring	<ul style="list-style-type: none"> <li>Vegetation Monitoring - Ecosystem Function Analysis</li> </ul>	<ul style="list-style-type: none"> <li>Rehabilitation monitoring incorporating landscape function analysis and vegetation dynamics is scheduled for May 2020.</li> </ul>

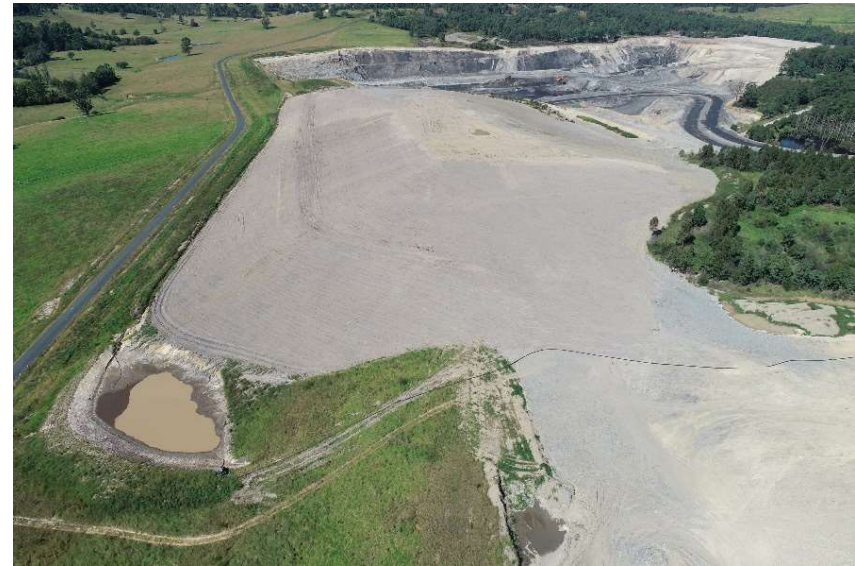
Photo: Avon North rehabilitation, April 2020.

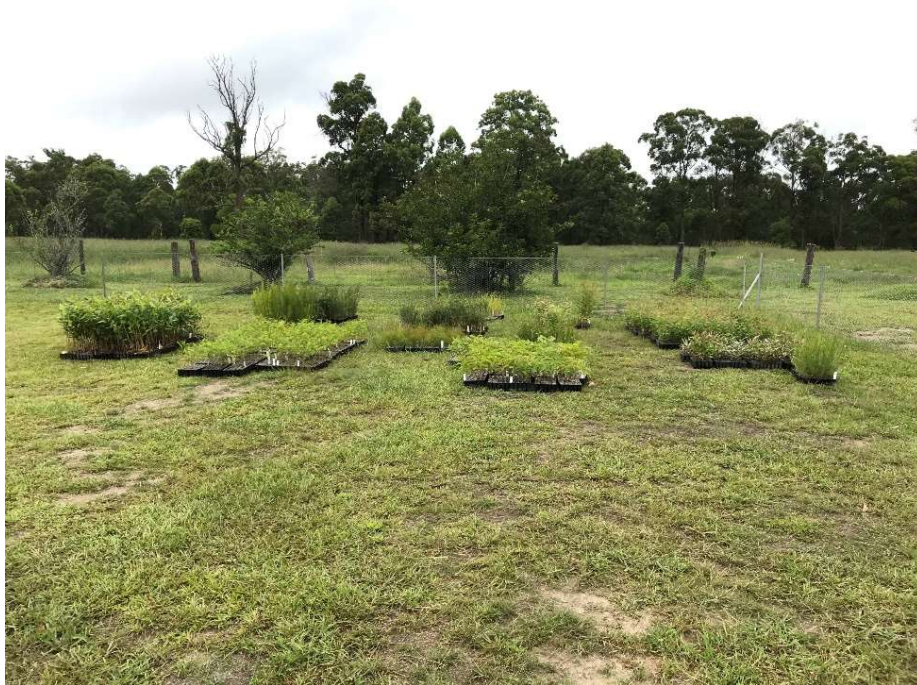
Photo: Biodiversity Offset tubestock delivery, April 2020.

Management Area	Project	Status
Biodiversity Offset Area	<ul style="list-style-type: none"> <li>Revegetation Works</li> </ul>	<ul style="list-style-type: none"> <li>In Q1 2020 SCPL has planted approximately 56,000 trees over 76 hectares along the Glen Road area in the Biodiversity Offset.</li> <li>Tubestock planting in the biodiversity offset area commenced in March 2020 finishing in May 2020. Prior to planting ground preparation was undertaken including weed spraying, crash grazing, slashing and ripping.</li> </ul>
Biodiversity Offset Area	<ul style="list-style-type: none"> <li>Vegetation Monitoring</li> </ul>	<ul style="list-style-type: none"> <li>The second round of vegetation monitoring for the biodiversity offset area is planned to be completed in May 2020. A summary of the report will be included in the next Annual Review.</li> </ul>

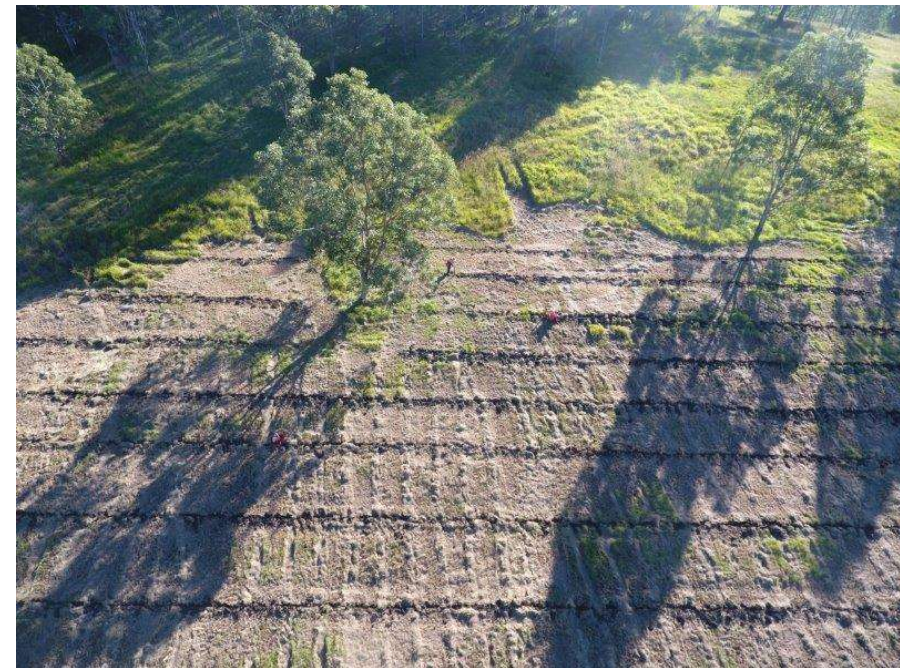
Photo: Biodiversity Offset tubestock planting, April 2020.

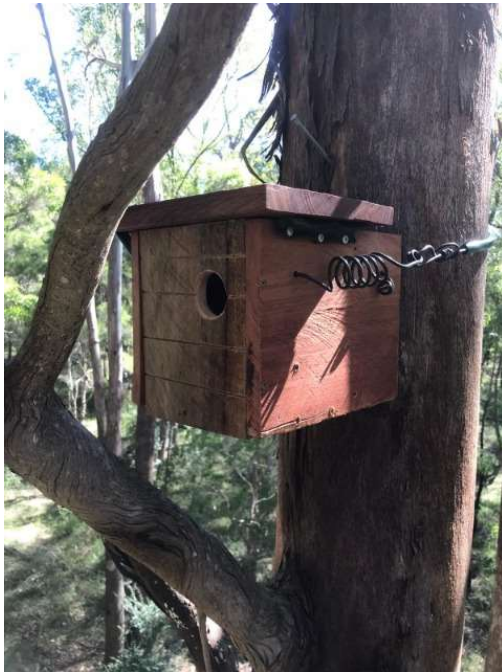
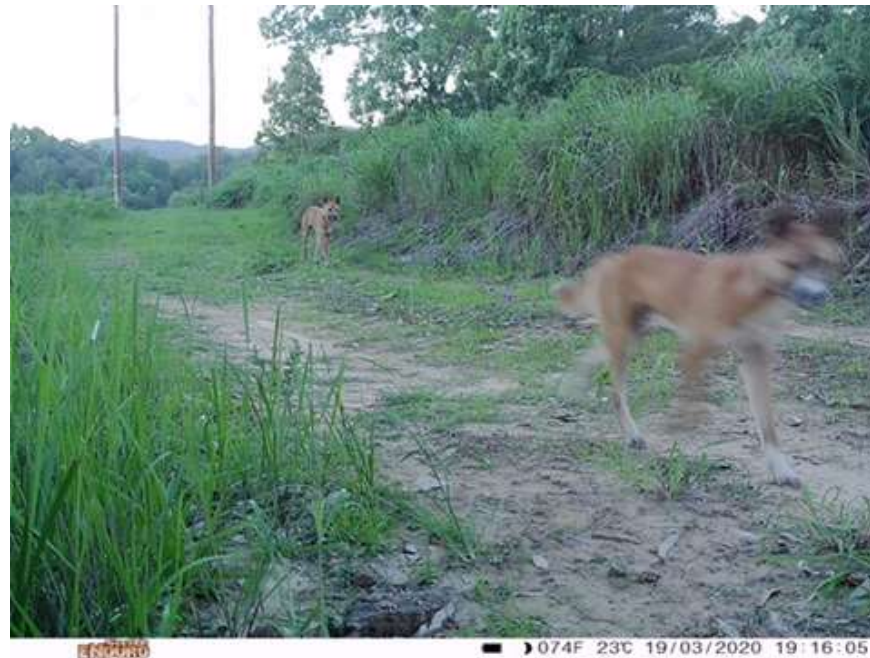
Management Area	Project	Status
Nest Box Program	<ul style="list-style-type: none"> <li>Nest Box Installation</li> </ul>	<ul style="list-style-type: none"> <li>70 Nest boxes have been installed in the Stratford Biodiversity Area and Biodiversity Enhancement Area in April 2020. 54 of these boxes are to specifically target the Squirrel glider and 16 of these boxes are designed to target other arboreal fauna.</li> </ul>
Pest Control	<ul style="list-style-type: none"> <li>Wild Dog control program</li> </ul>	<ul style="list-style-type: none"> <li>Wild dog and fox trapping was completed in April 2020 covering all Stratford Coal owned properties including biodiversity offsets and Mining Leases.</li> <li>Further trapping of Wild Cat is scheduled for Q2 2020.</li> </ul>
Weed Control	<ul style="list-style-type: none"> <li>Weed spraying program</li> </ul>	<ul style="list-style-type: none"> <li>Weed spraying has been undertaken in the Stratford Biodiversity Area in April and May 2020 targeting Blackberry, Crofton weed, Tobacco bush, Privet and Lantana.</li> </ul>
