Ashton Coal Operations Pty Limited Annual Environmental Management Report

2011/2012

Name of Mine:	Ashton Coal Mine
Titles/Mining Leases:	ML1529 and ML1533
MOP Commencement Date:	1 November 2007
MOP Completion Date:	31 December 2012
AEMR Commencement Date:	2 September 2011
AEMR Completion Date:	31 December 2012
Name of Leaseholder:	White Mining NSW Limited & ICRA (Ashton) Pty Ltd
Name of Operator (if different):	Ashton Coal Operations Pty Ltd
Reporting Officer:	Brian Wesley
Title:	General Manager
Signature <u>

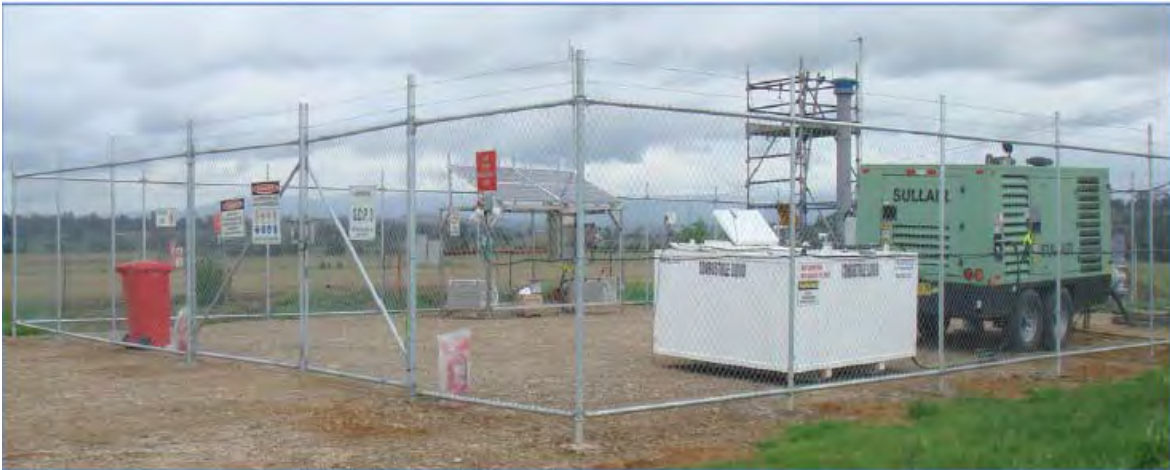
Figure 2. Typical layout of the goaf drainage plant

Along with the construction of the goaf gas drainage hole, a surface pad was constructed which allowed a suitable foundation for the mobile plant and associated monitoring equipment and compressor. Each borehole when constructed was fenced to prevent stock and unauthorised personnel interaction.

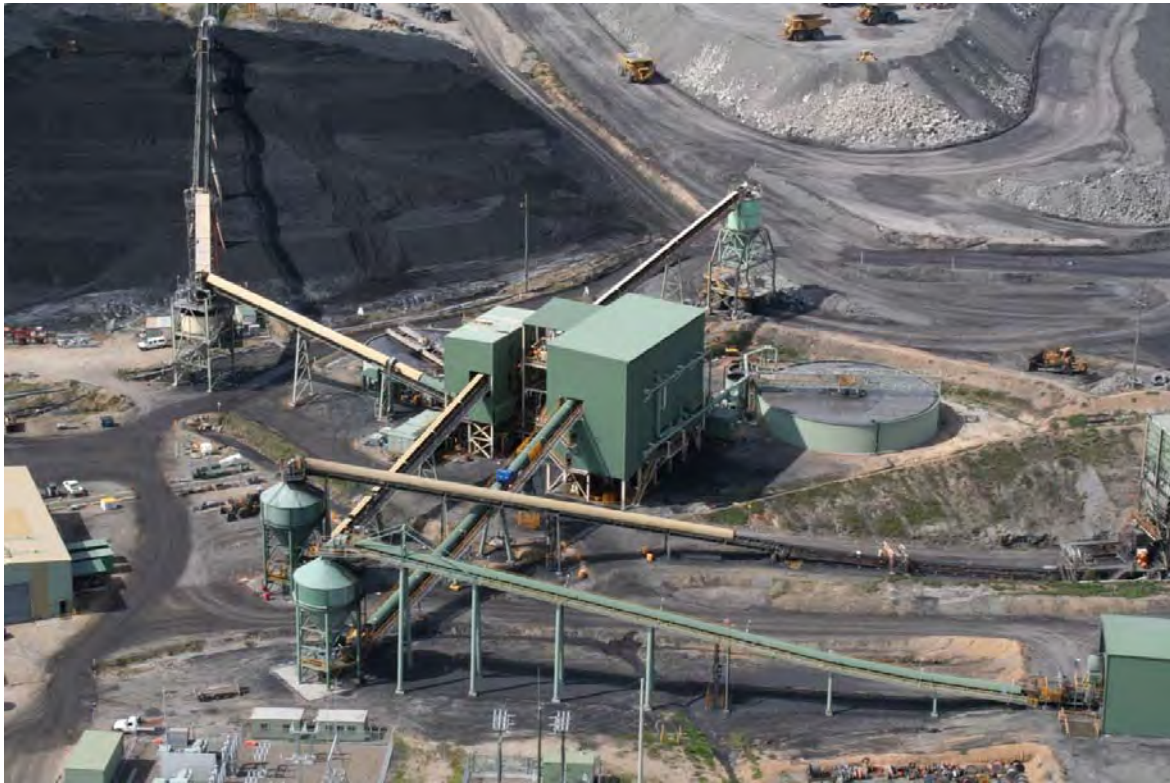
Figure 3. Coal Handling Preparation Plant

The CHPP processed 3.138Mt ROM coal during the reporting period to produce 1.063Mt of semi-soft product coal and a trial of 16.9Kt of thermal coal. Coal was transported by rail to the Port of Newcastle for sale on the export market. Some semi soft coking coal was sold to domestic steel mills.

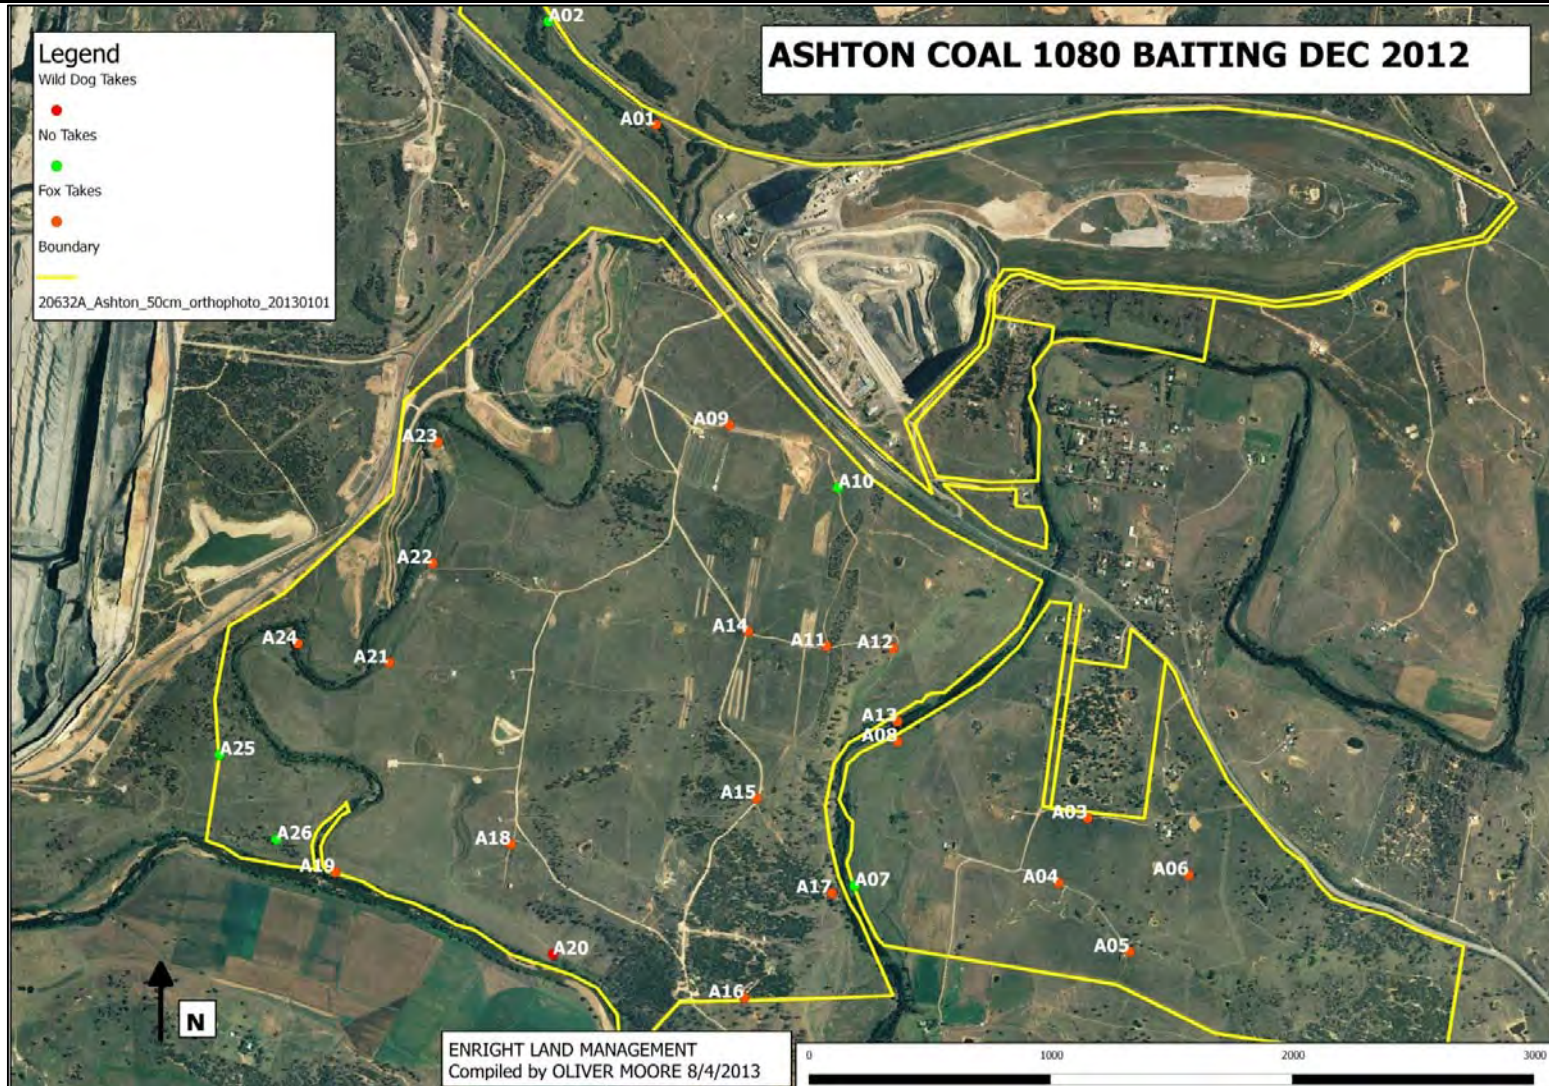
Figure 52. Pest Control – 1080 Ground Baiting Locations December 2012

Ashton Coal has a vertebrate pest program in place. In December 2012 a campaign under this program was undertaken by Enright Land Management Pty Ltd on behalf of Ashton Coal. 1080 baits were used to target wild dogs and foxes on Ashton Coal land. There were a total of 26 bait stations (**Figure 52**) that were used to present the 1080 baits to the target species. Each station is checked on four separate occasions over a two week period with all baits not taken removed on the fourth and final check. The remaining baits are buried onsite as per the Pesticide Control Order 2008. 30 of the 104 presented baits were positively identified as being taken by foxes and one bait taken by a Wild Dog, with another seven baits being taken however the mounds were disturbed by cattle and vehicles making it hard to determine what had taken the baits, but with such a high population of foxes in the area it is highly likely that these baits had been picked up by foxes.

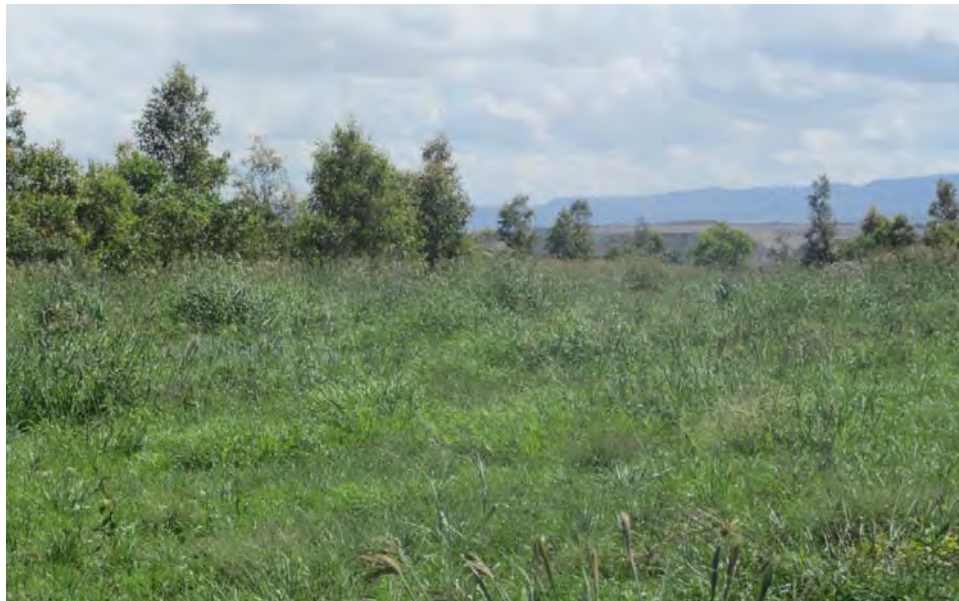
Figure 63. 2012 Pasture rehabilitation in trial plot 3A with 2009 native woodland in background.

- **Control:** A horizon top soil + 100t/ha compost
- **Treatment Area 1:** B horizon top soil + 100t/ha compost + 1L/ha evergreen + 1L/ha digester + 1L/ha green manure
- **Treatment area 2A:** A horizon top soil + 100t/ha compost + 1L/ha of green manure
- **Treatment Area 3A:** A horizon top soil + 100t/ha compost + 2L/ha digester + 1L/ha green manure
- **Treatment area 3B:** A horizon top soil + 100t/ha of compost + 750g/ha BDX + 1L/ha green manure

SITA in conjunction with Ashton started a trial with varying microbial sprays on compost to investigate possible improvements to soil health, pasture coverage and diversity, . The trial was conducted on the autumn 2012 pasture rehabilitation. The trial consists of the following plots:

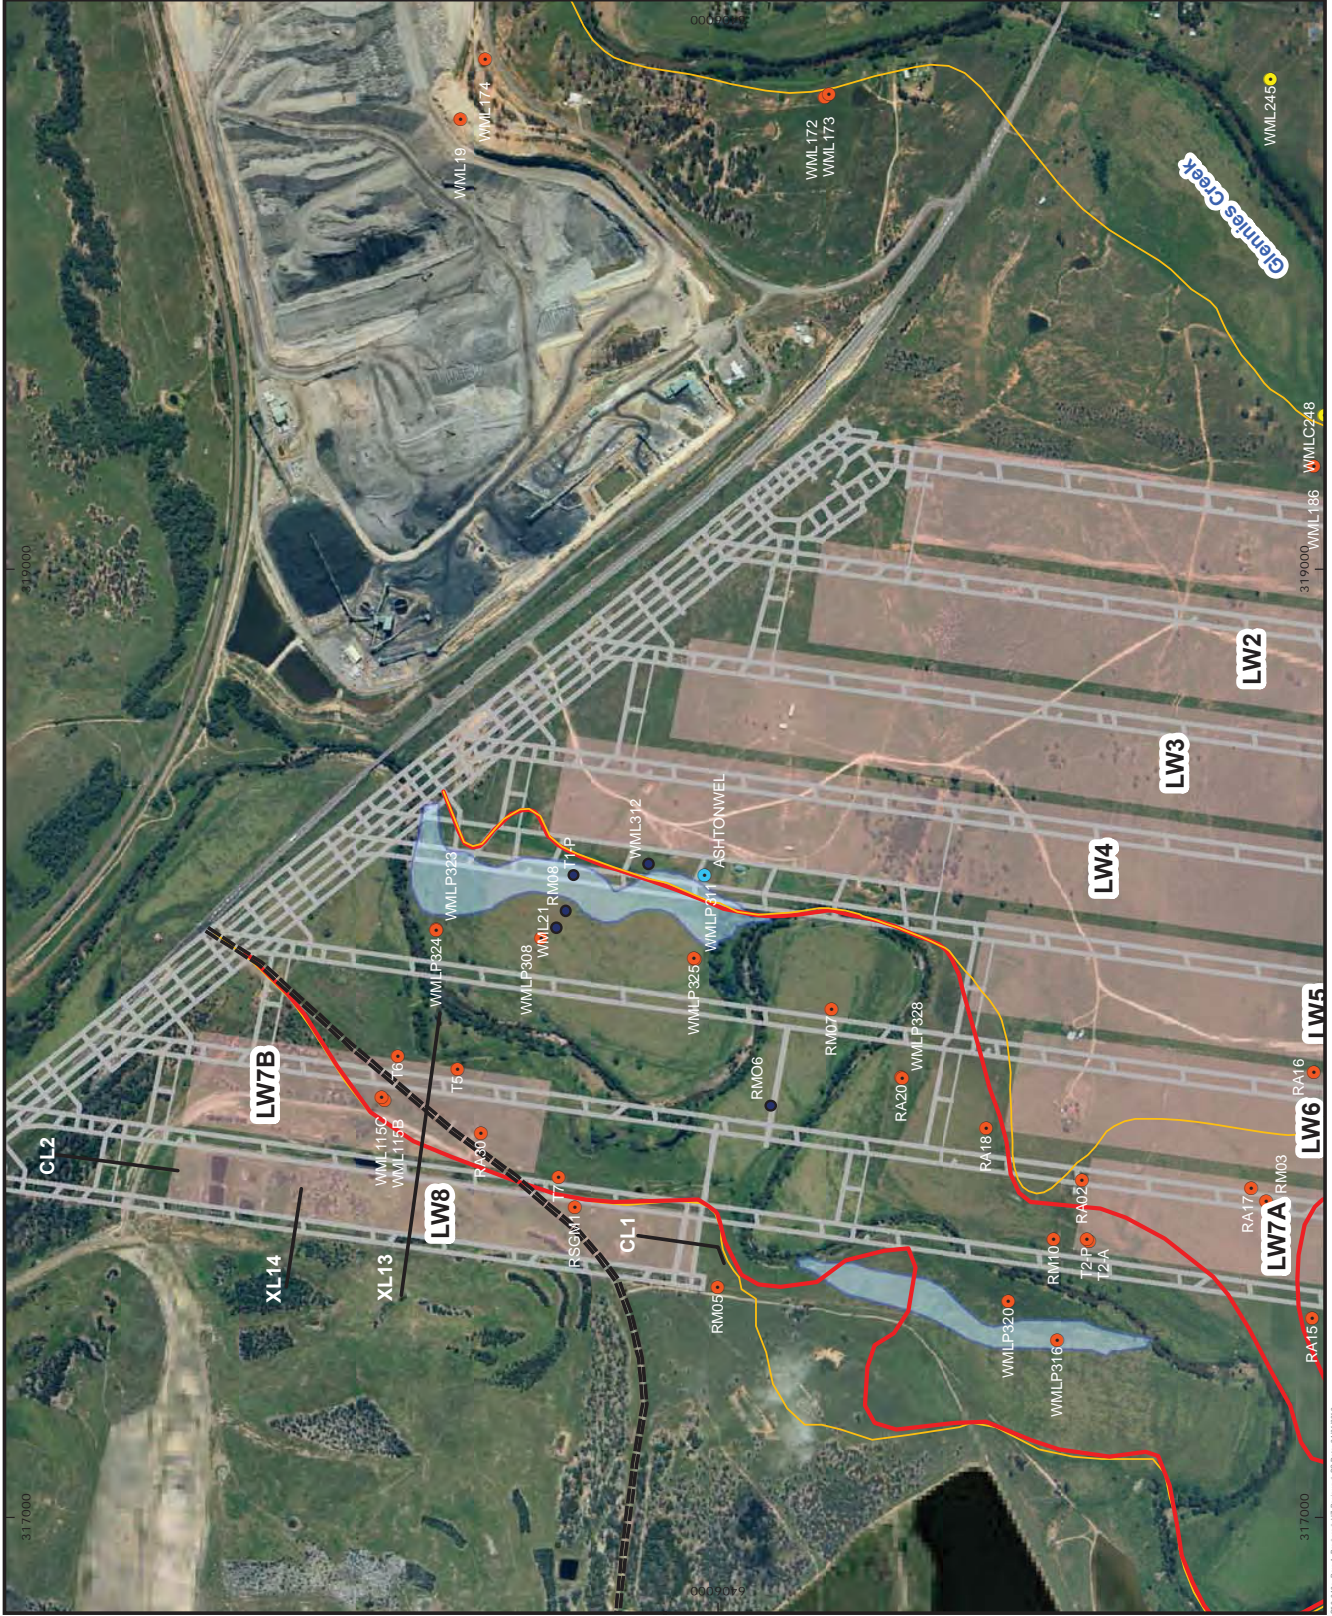
FIGURE 2

Groundwater Monitoring Network (Pikes Gully LW7B & LW8)
