ASHTON COAL OPERATIONS LIMITED

2015 ANNUAL REVIEW

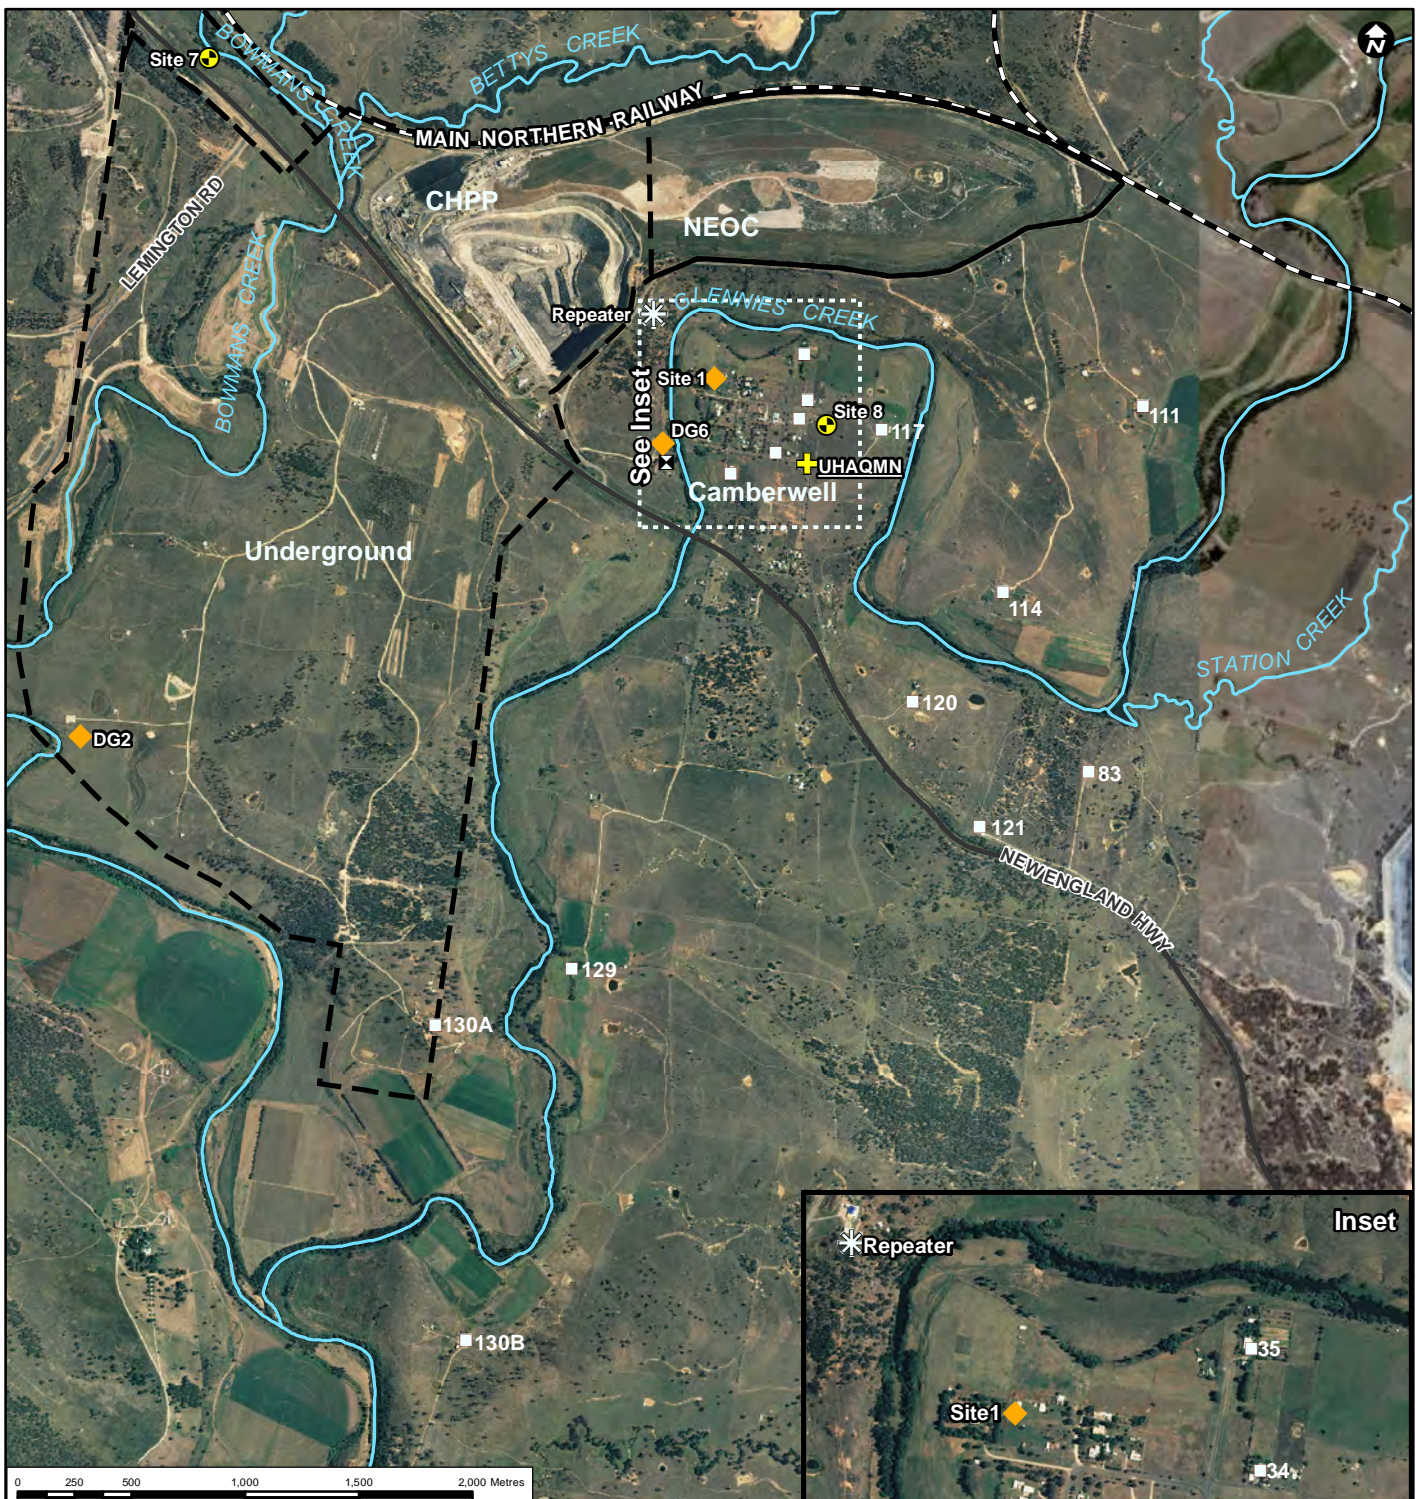
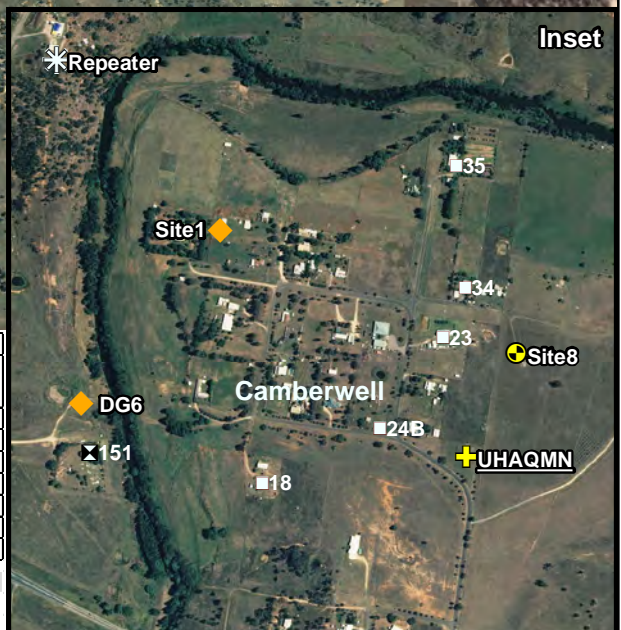
Map Reference	Instruments present at monitoring stations						
	Meteorological Station	Dust Gauge	HVAS	TEOM 2.5µm	TEOM 10µm	Noise - Attended	Noise - Real Time
Site 1		DG7					
Site 7					Site 7		
Site 8		DG14	HVAS 8		Site 8		
DG2		DG2					
DG6		DG6					
Repeater	Repeater						
UHAQMN				2.5µm	10µm

PM10: Particulate Matter less than 10µm
 HVAS: High Volume Air Sampler (Samples 1 day every 6) TEOM: Tapered Element Oscillating Microbalance (Sample Real Time)
 TSP: Total Suspended Particulate DG: Dust Gauge (Samples Monthly) UHAQMN: Upper Hunter Air Quality Monitoring Network
 Management Tool Only (label underlined)

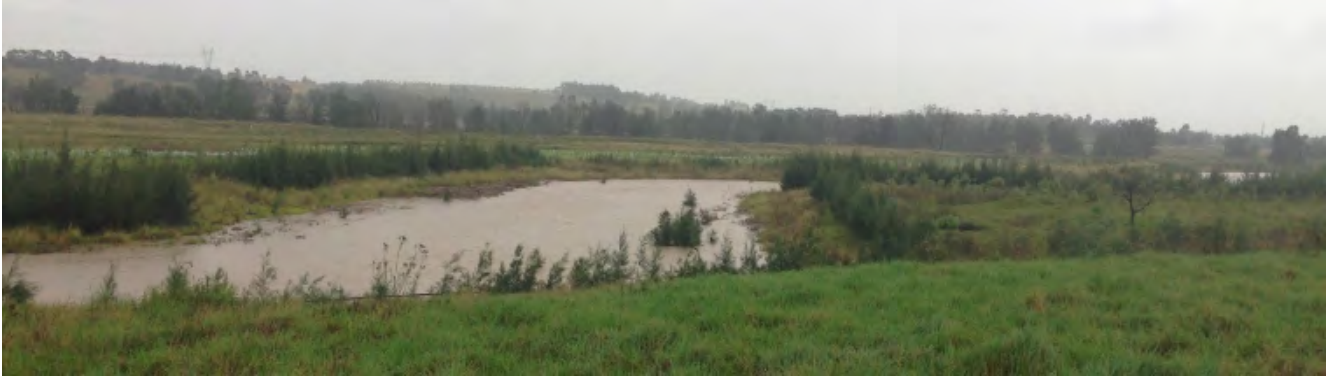
Figure 7 Mid-stream of the Eastern Diversion Channel during April 21 flow event

The large flood event in late April resulted in large scouring flood volumes through both the Bowmans Creek Diversion Channels (BCDs) and the excised creek channels.

As the upper block banks are still low, a significant volume of the flood water was diverted through the old creek sections, with the result that there was little or no impact to the developing riparian habitats of the BCDs and no significant damage to the structure or form of the BCD channels. The flood volumes were sufficient to scour out or mobilise aquatic biota to the effect that following the floods the recolonisation of aquatic habitats would most likely have been initiated by opportunistic short-lived taxa with longer-lived taxa recolonisation taking longer. This results in higher swings in both diversity and macroinvertebrate stream health indices as they follow the rapid changes in the makeup of the assemblages immediately post-flood. These continuing post-flood effects on aquatic biota assemblages are the main basis for a number of low performance index results over the two sampling seasons this year.

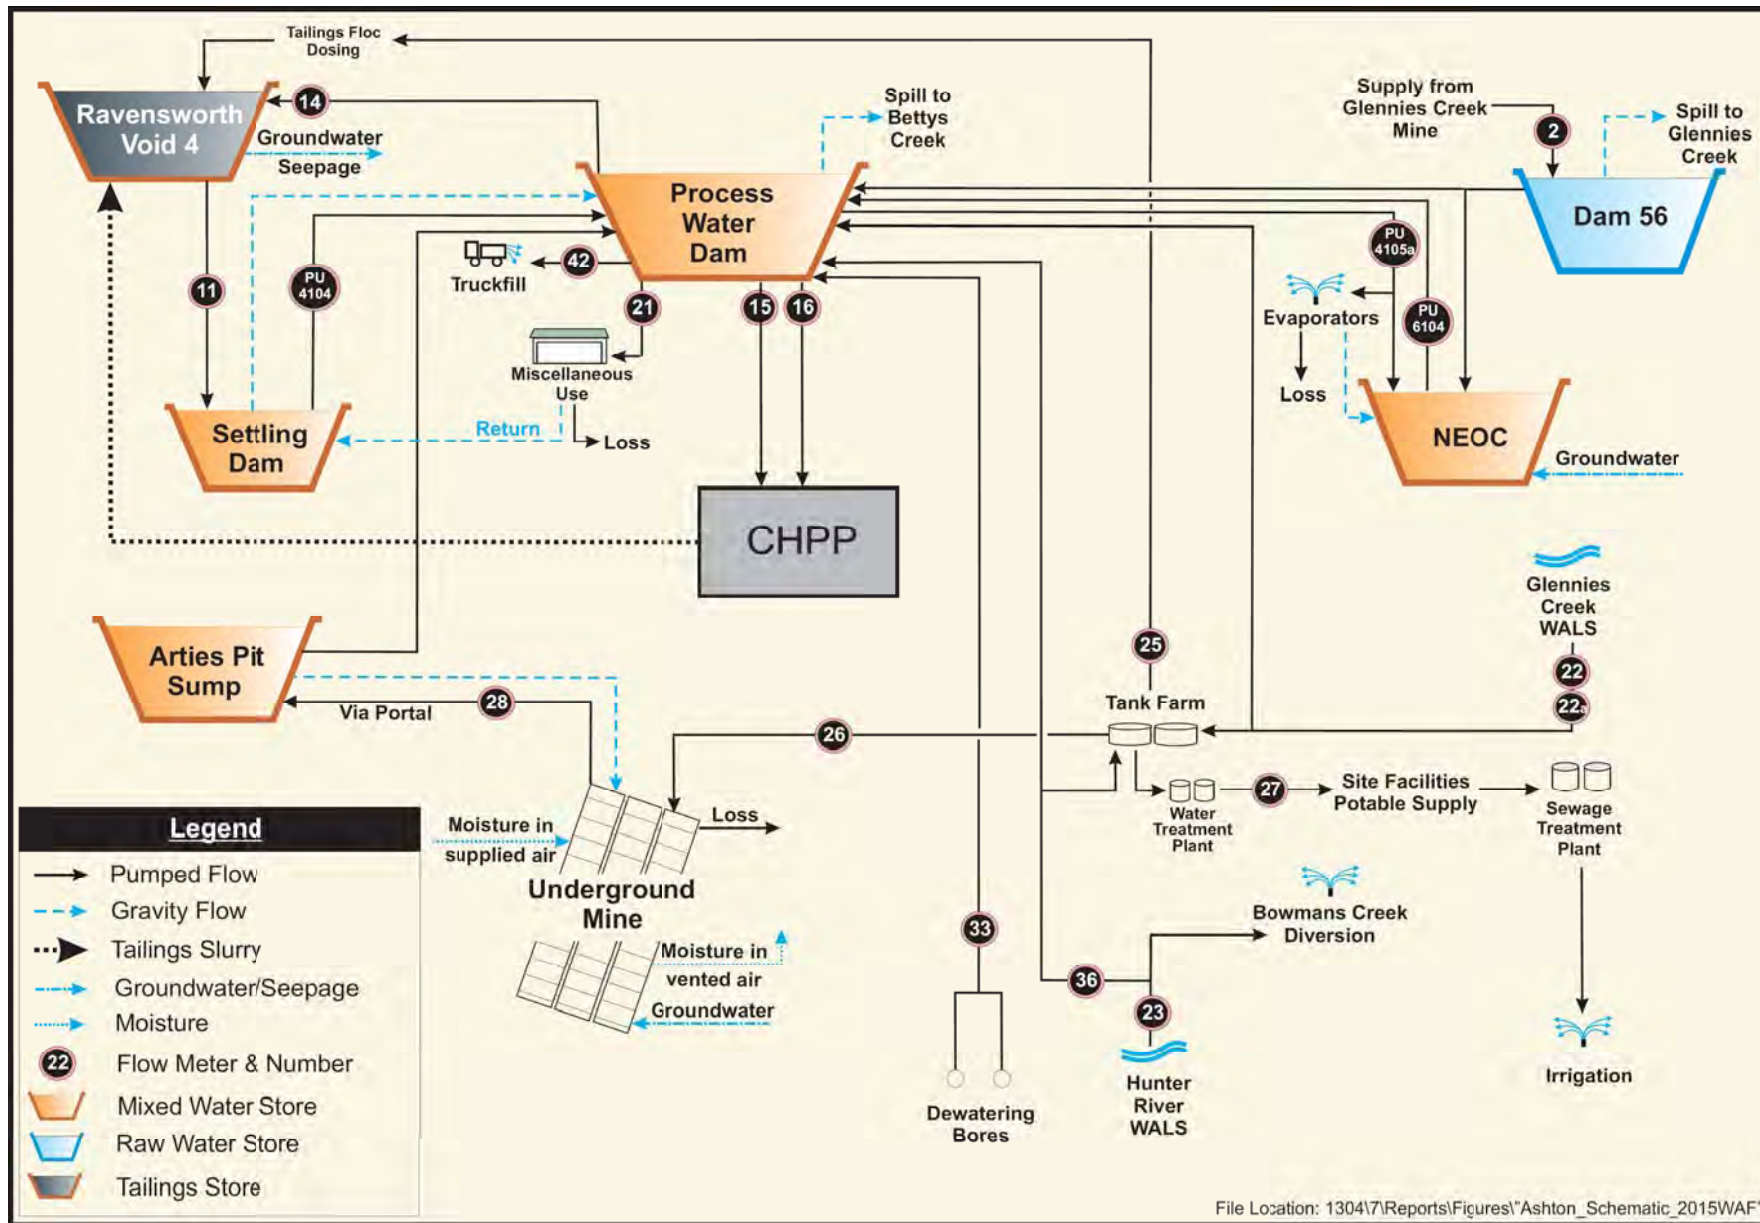
Figure 10 ACOL Water schematic*

ACOL regularly monitor the water balance for the operation to assist forecasting and modelling for different climatic and site scenarios. A series of flow meters and surveyed volumes are utilised to monitor the use and transfer of water between key water storages. Water storages are surveyed on a regular basis to ensure the accuracy of water volume data. A schematic overview of the site's water management system can be found in Figure 10.

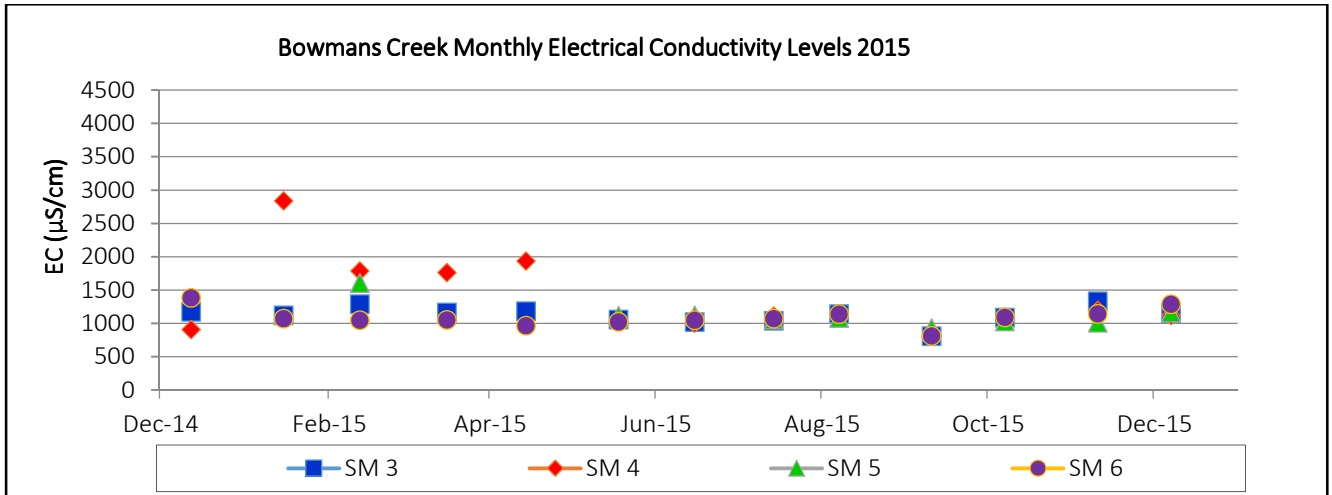
Figure 15: Bowmans Creek EC during 2015

Bowmans Creek EC levels fluctuated between 805 - 2840 μ S/cm (Figure 15). Elevated levels of EC at SM4 have been observed previously and result from natural saline groundwater inflows to the pool. During periods of low flow in Bowmans Creek, the saline groundwater discharge becomes the dominant supply of water to the pool resulting in increasingly elevated EC levels. EC levels greater than 10,000 μ S/cm have been historically observed at the site.

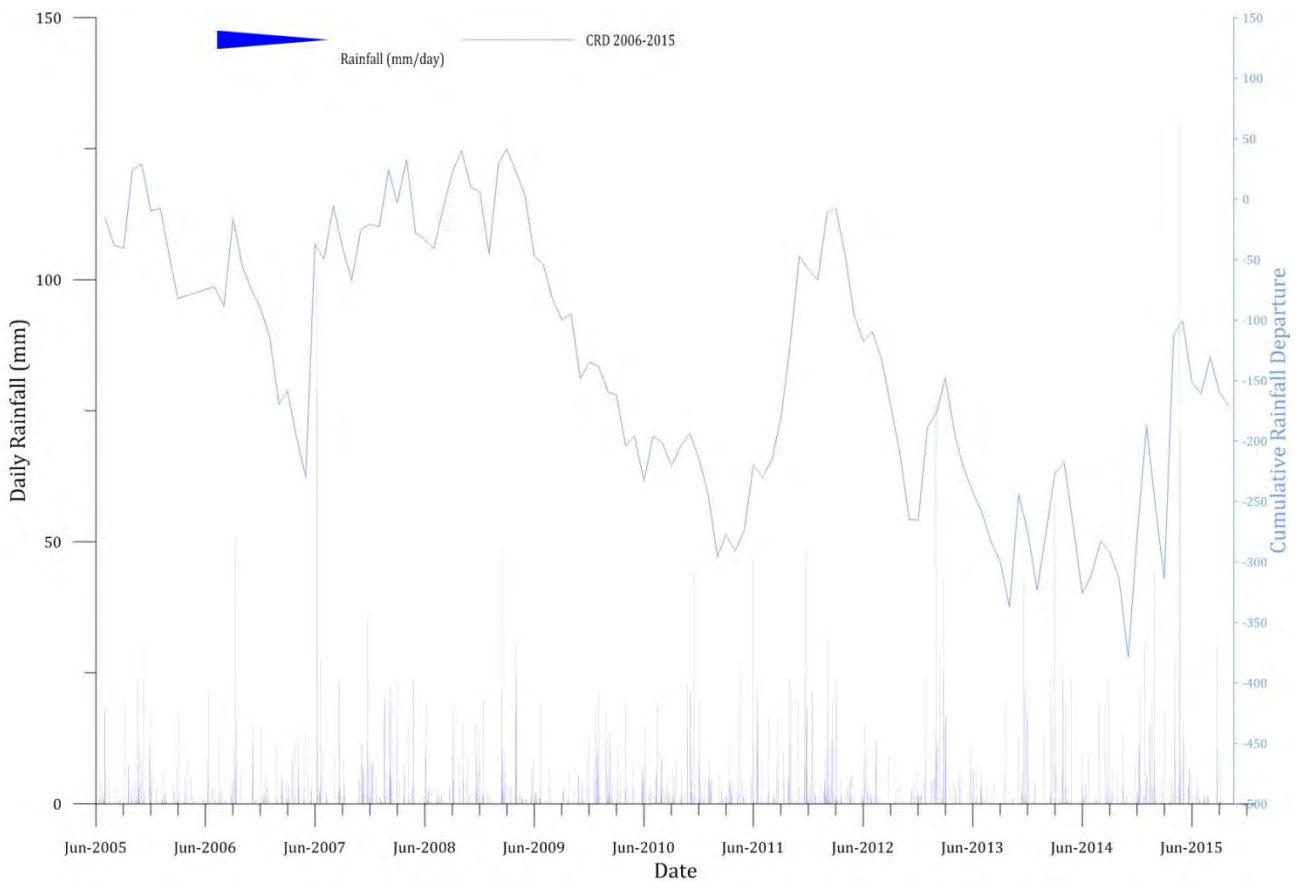
Figure 2-4 Comparison of monthly rainfall and CRD

- average rainfall between mid-2005 and mid-2009, except the summer 2006-2007 which was drier;
- rainfall predominantly below average between mid-2009 and mid-2015. Specifically, the area is noted to have periods of prolonged below average rainfall between mid-2009 and mid-2011, and between mid-2012 and mid-2015.

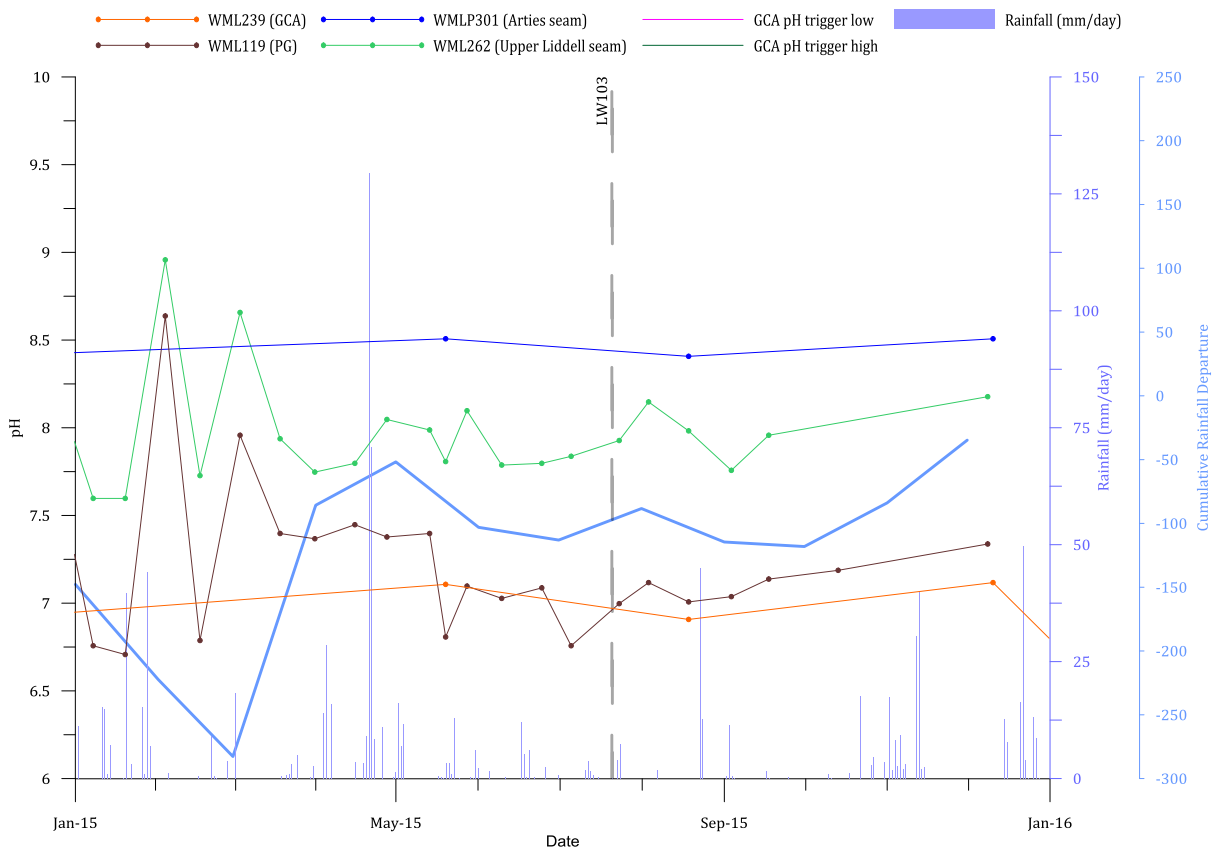
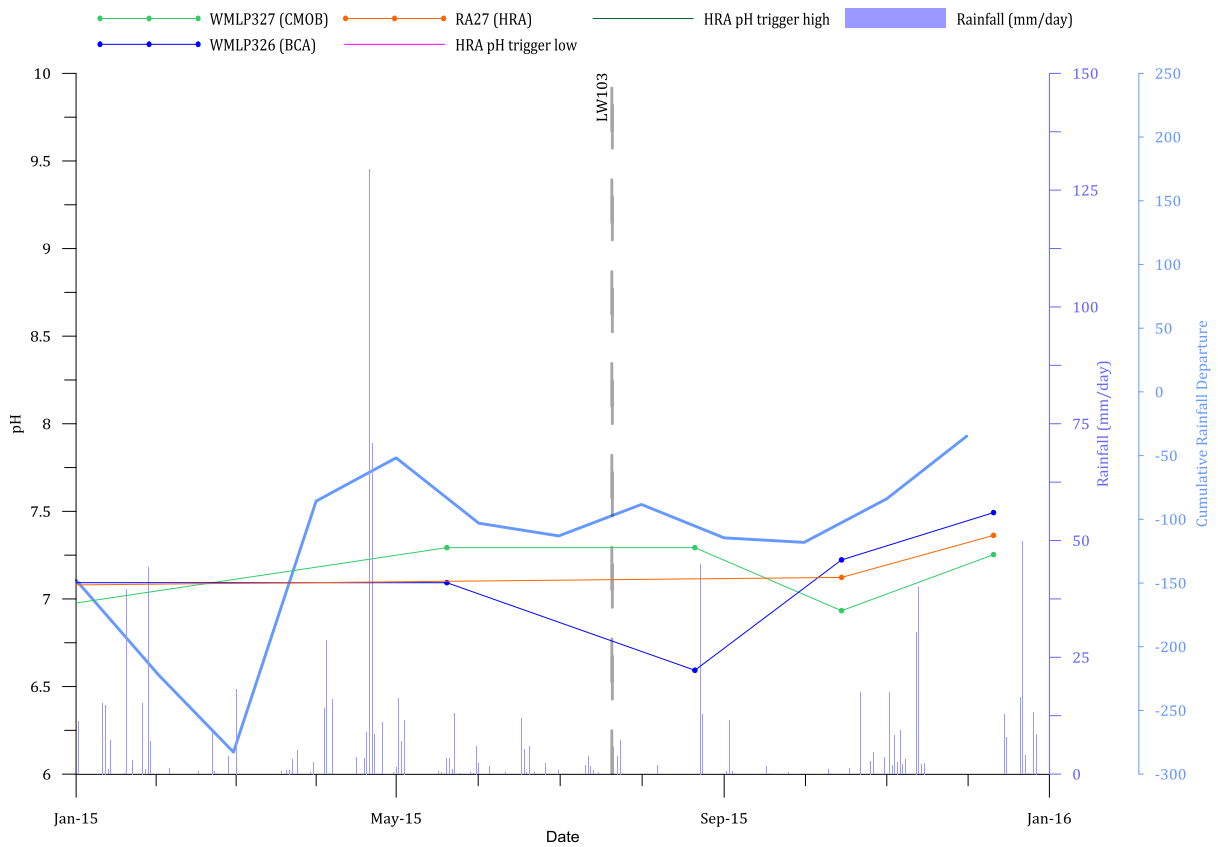
- bores screened in GCA, BCA, HR and various coal seams tend generally to have similar pH variation;
- there are no reportable exceedances of the WMP trigger values;
- pH is highly variable and the trends generally match seasonal variation. Periods of low rainfall are characterised by low pH (< 7 pH units) and vice versa for periods of elevated rainfall; and
- there are no obvious impacts from mining to the pH measured on these monitoring bores during the Year 2015.

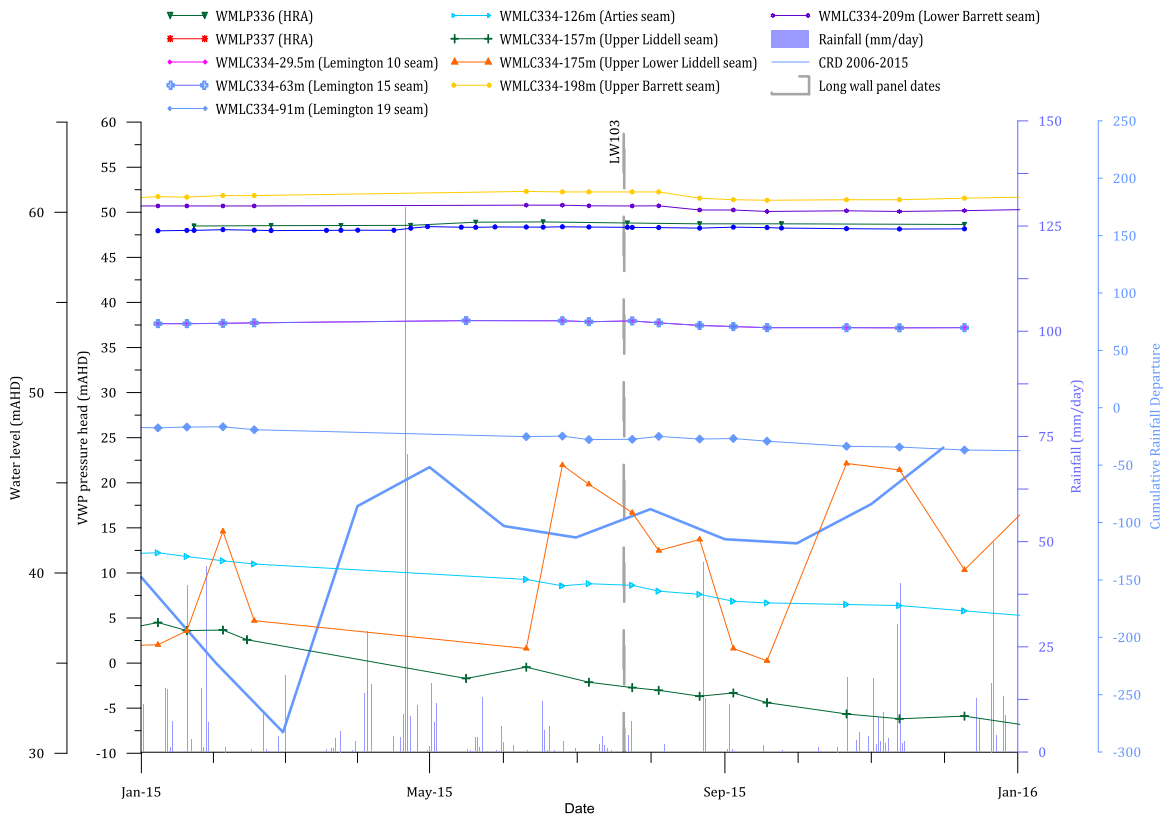
- Groundwater levels in the HRA to Lemington 17 seam and Upper and Lower Barrett, are generally constant during the year and do not seem affected by the mine.
- Groundwater levels from the Lemington 19 seam to the Upper Liddell seam are constantly decreasing due to the dewatering in the ULD.
- The groundwater levels in the Lower Liddell seam are variable between the VWP WMLC334 and WMLC335. In the WMLC334, the water level appears to be affected by the dewatering, with similar elevation than the Upper Liddell seam, with high variation in February and mid-June. However, in the WMLC335, the groundwater level is not affected by the dewatering and the water elevation is above the Lemington seam, around 45 m AHD.
- There is no water variation related to rainfall in the fractured rock, however groundwater variation is observed in the HRA after the rainfall event in April 2015.
