# **ANNUAL ENVIRONMENTAL MANAGEMENT REPORT**

**2007 / 2008**

**Name of mine** Ashton Coal Mine

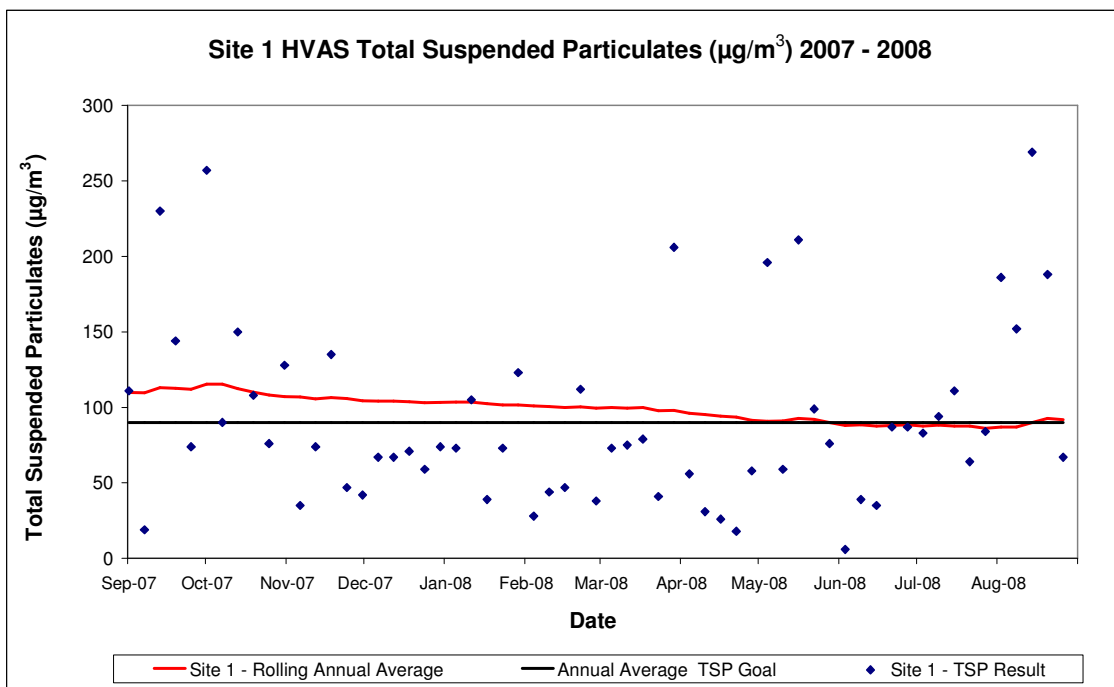
**Site 1 HVAS**

The cumulative rolling annual average for TSP at site 1 demonstrated non-compliance with the annual average criteria of  $90\mu\text{g}/\text{m}^3$ . The final annual average was  $92\mu\text{g}/\text{m}^3$ . The figure above shows the marked decrease in TSP levels at Site 1 over the past 12 months. The alleviation of drought conditions over the past 12 months is likely to have played a great part in reducing these levels.

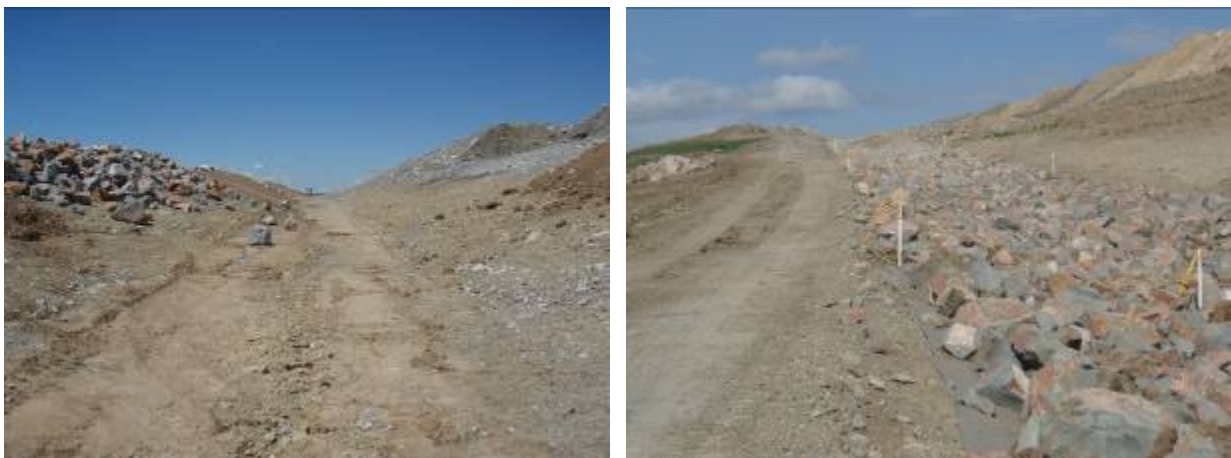
**Figure 5. Northern drop structure under construction**

Work was undertaken during the period to complete the two main drop structures for the Eastern Emplacement Area (EEA). The structures receive water from the rehabilitated and disturbed slopes of the EEA and transport the water to sediment containment dams. The structures have been designed to handle a 1 in 100 ARI storm event. The drop structures are constructed by shaping the spoil on a 10% slope. Biddim is placed along the entire length of the structure and covered with rock ranging from 0.4 to 0.6m diameter. A velocity dissipation basin was constructed at the base of each drop structure because of the change in direction required. These basins were also lined with biddim and armoured with rock.

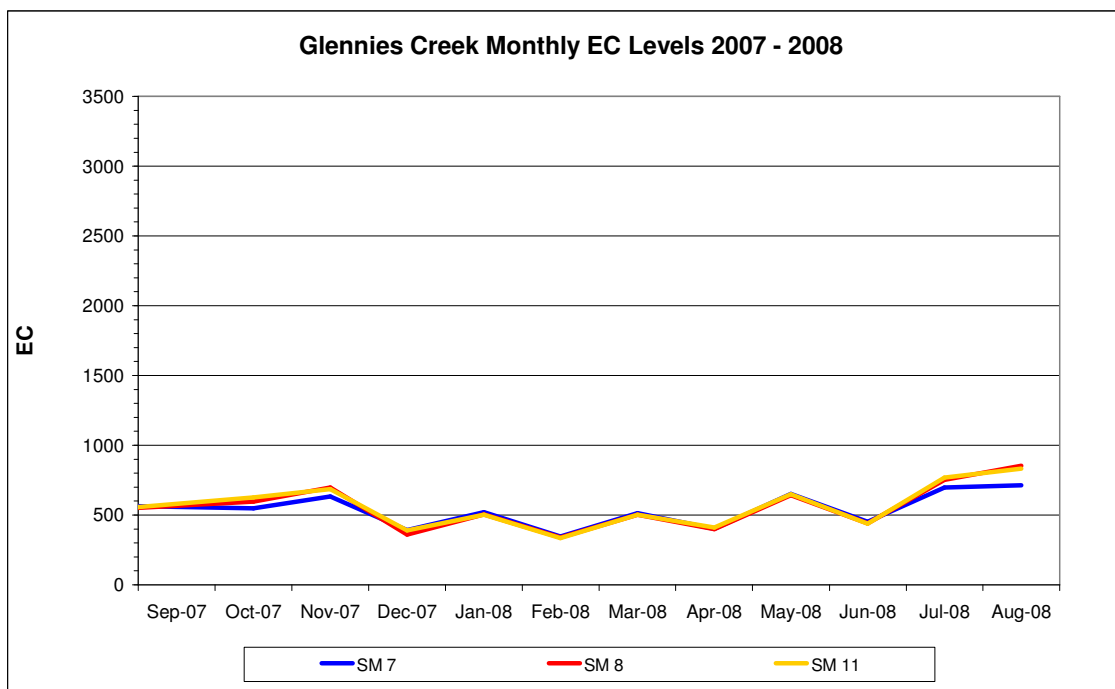
The EC of water in Glennies Creek (SM7, SM8 and SM11) remained consistently low. All three sites trended together throughout the period indicating no impacts from Ashton Coal Operations.

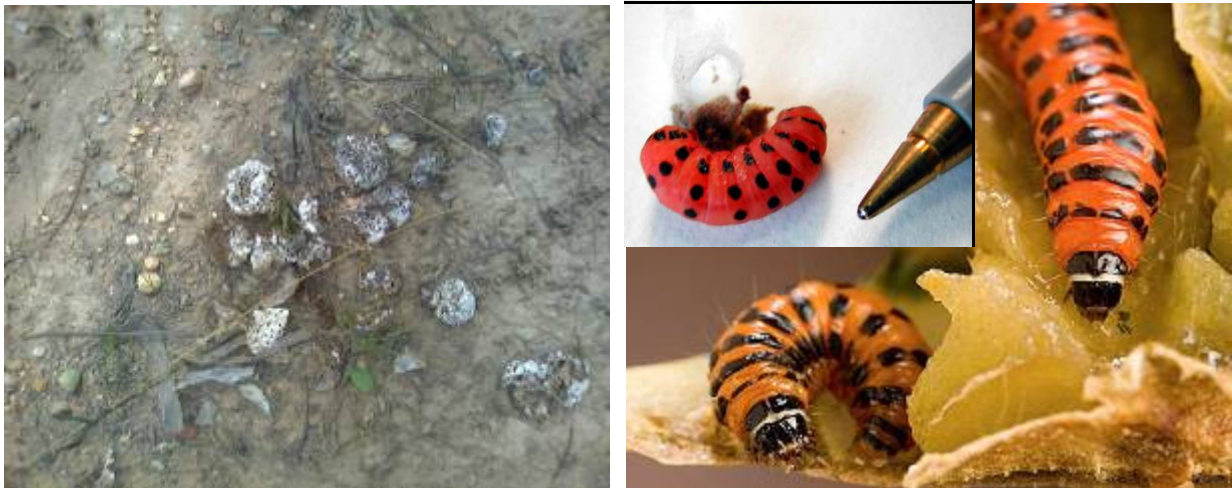
**Figure 17. Damage to Creeping Pear from Cacto-blastis larvae and larvae in action**

The Cacto-blastis moth larvae were found in areas of the prickly pear infestation. It appeared that the larvae were preventing the spread of the pear species. The impact of the larvae is shown in **Figure 17**.

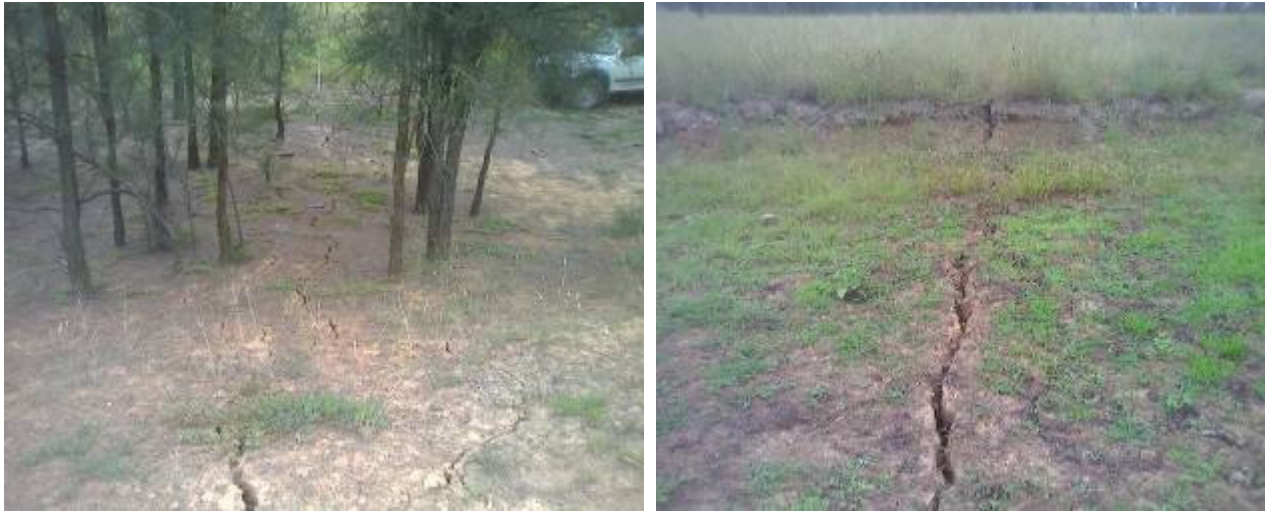
**Figure 26. Subsidence cracks, Longwall 2**

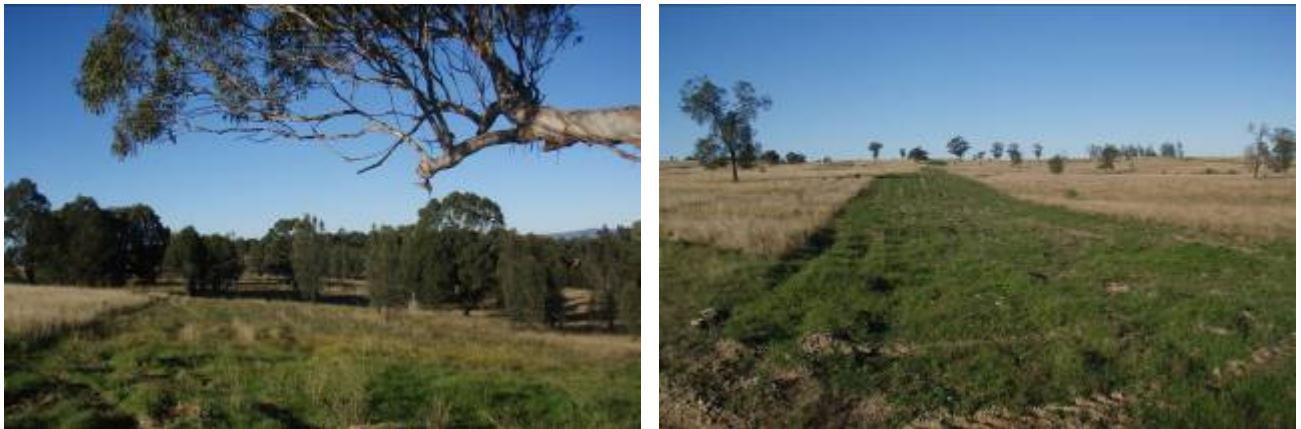
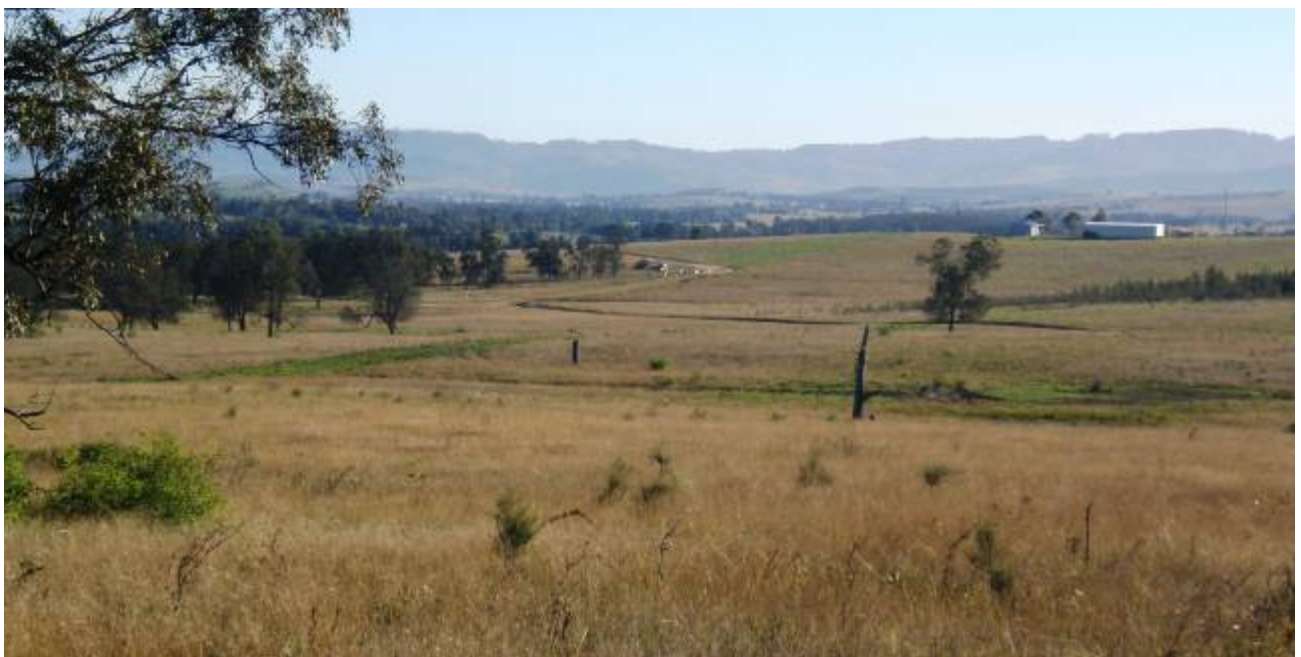
**Figure 27. Subsidence crack remediation**
