# ANNUAL ENVIRONMENTAL MANAGEMENT REPORT 2006 / 2007

<b>Name of mine</b>	Ashton Coal Mine			
<b>Titles/Mining Leases</b>	ML1526 and ML1533			
<b>MOP Commencement Date</b>	25/08/2004	<b>MOP Completion Date</b>	25/08/2009	
<b>AEMR Commencement Date</b>	2/09/2006	<b>AEMR</b>	<b>Completion</b>	<b>Date</b>
	1/09/2007			
<b>Name of Leaseholder</b>	White Mining NSW Limited & ICRA (Ashton) Pty Ltd & International Marine Corporation			
<b>Name of Operator (if different)</b>	Ashton Coal Operations Pty Ltd			
<b>Reporting Officer</b>	Peter Barton			
<b>Title</b>	General Manager			
<b>Signature</b>	_____			<b>Date</b>

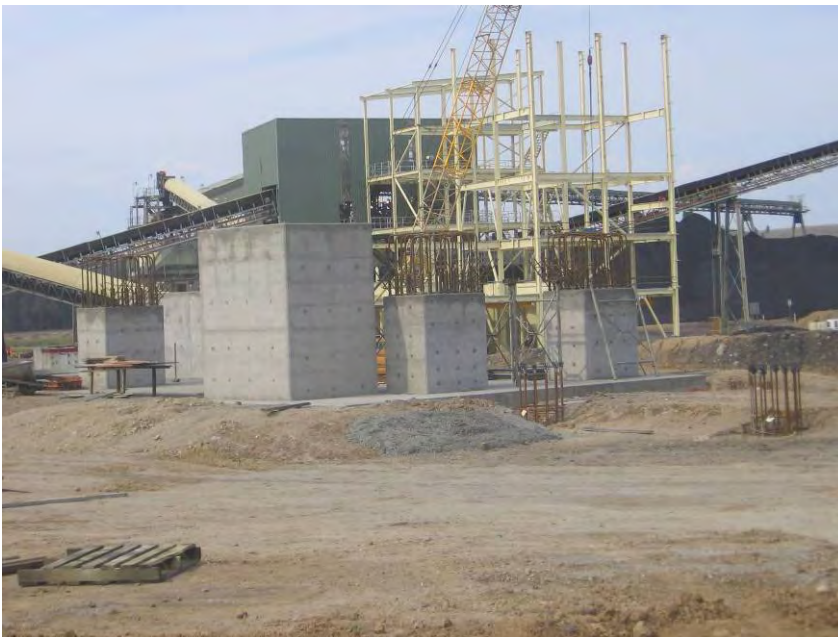
Module 2 Breaker Station Foundations

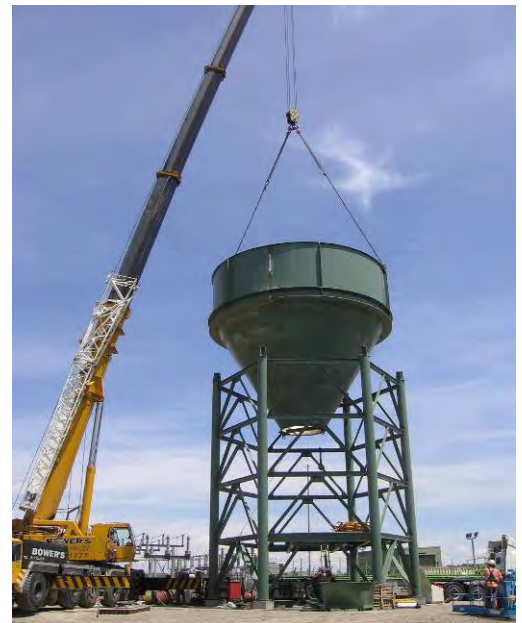
Module 2 300T ROM Coal Bin

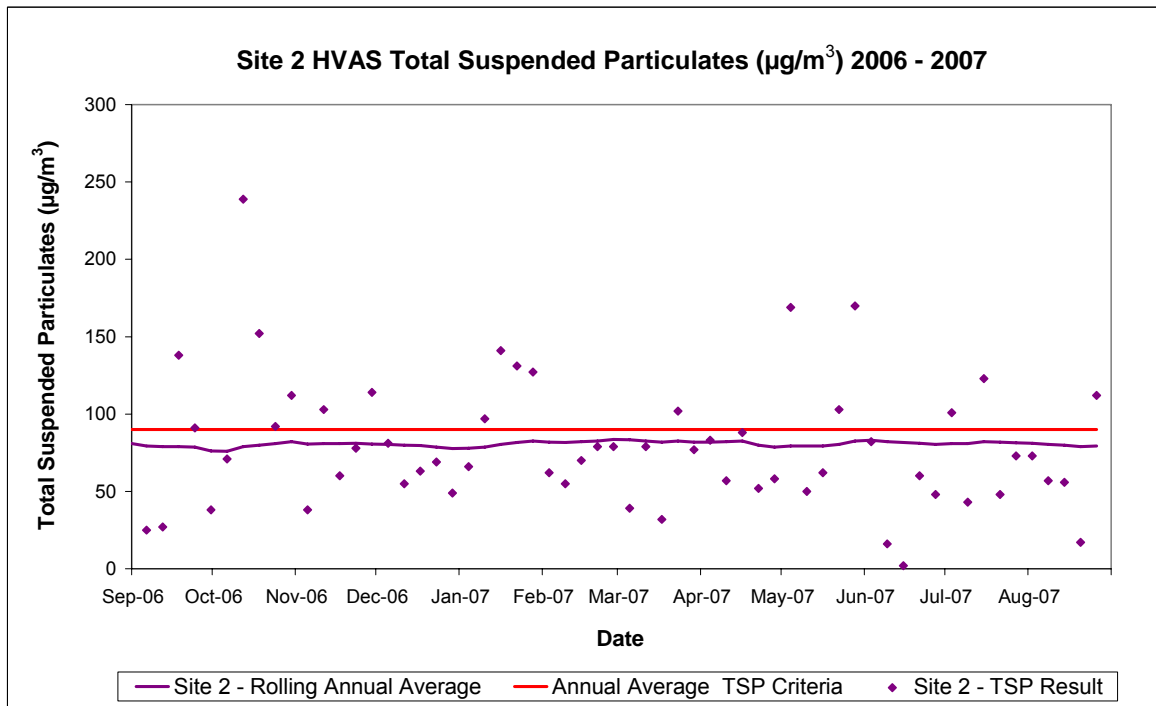
**Site 2 HVAS**

The rolling average TSP results for Site 2 was below the annual average TSP goal of 90µg/m<sup>3</sup> for the reporting period. The final annual average at Site 2 was 79.5µg/m<sup>3</sup>.

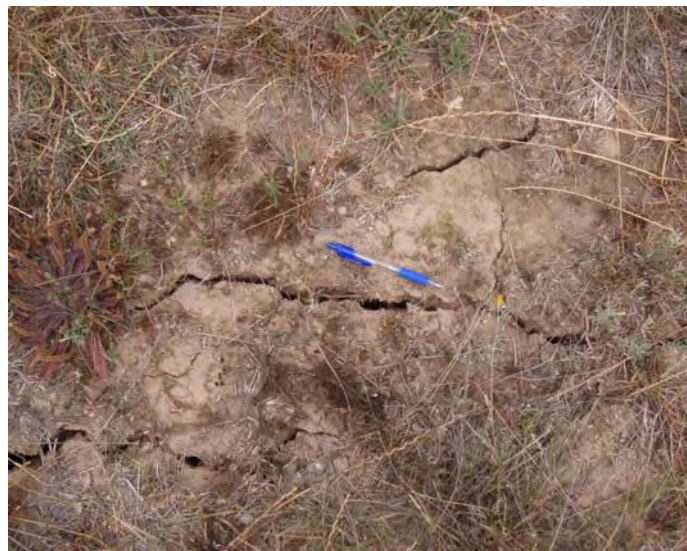
**Figure 23. Subsidence Crack**

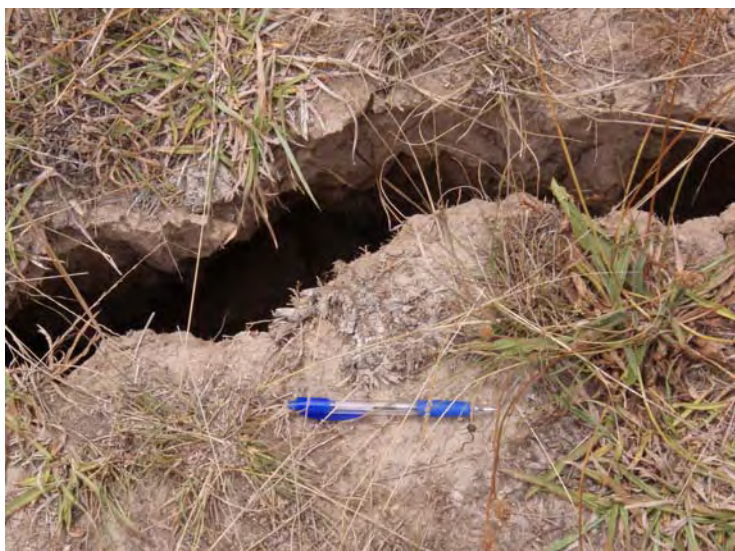
**Figure 21. Subsidence Crack**

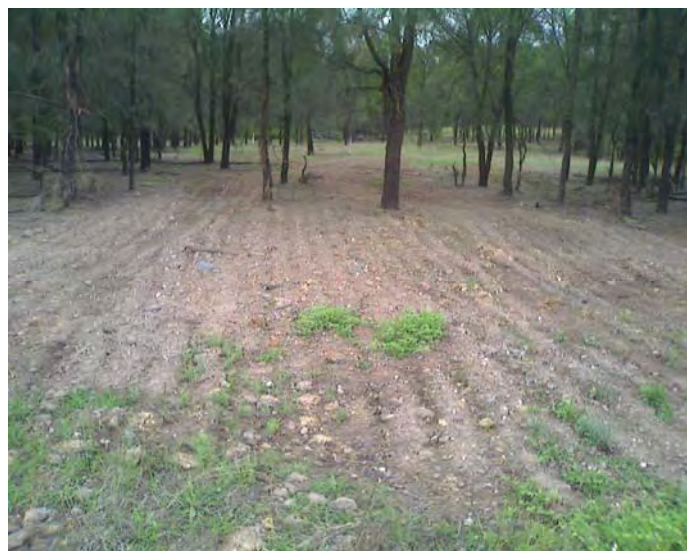
**Figure 24. Woodland Subsidence Remediation**

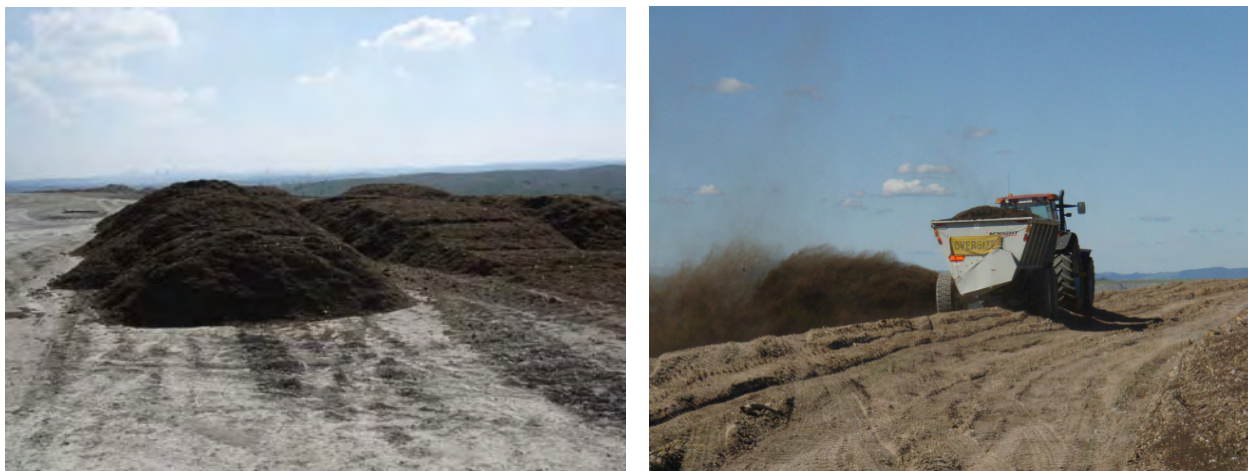
**Figure 29. OGM Stockpile and OGM spreader in action**
