# Appendix 11

## Aquatic Ecology

South East Open Cut Project  
&  
Modification to the  
Existing ACP Consent

**ASHTON COAL  
SOUTH-EAST OPEN CUT  
ENVIRONMENTAL ASSESSMENT  
AQUATIC ECOLOGY IMPACT ASSESSMENT**

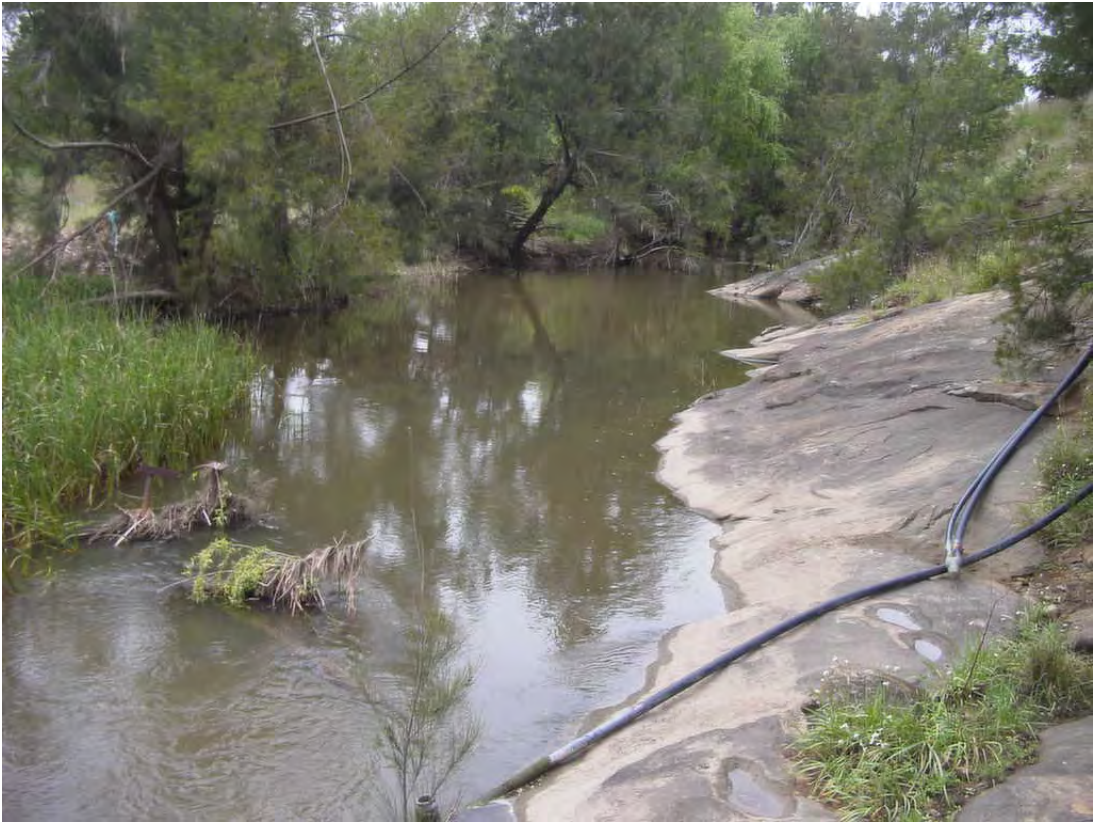
The creekbed meanders through the site bordered by floodplains of varying heights. Instream banks are commonly near vertical at the pool edges and undercut in parts. Most of the study area supports relatively steep (45°) riparian banks angled up to the perched floodplain reaching heights of 10m above the creekbed in parts.

Channel substrates consist of gravel and cobble beds with some sandbanks in areas of lower flow, and very few accumulations of finer material have been observed during field inspections or aquatic ecology sampling. Bank instability has been noted in the creek channel areas where exposed cobble banks have been opportunistically colonised by River She-Oak and Willow (*Salix babylonica*), shrubs and introduced weeds.

**Figure 4**  
**Glennies Creek Upstream of New England Highway**

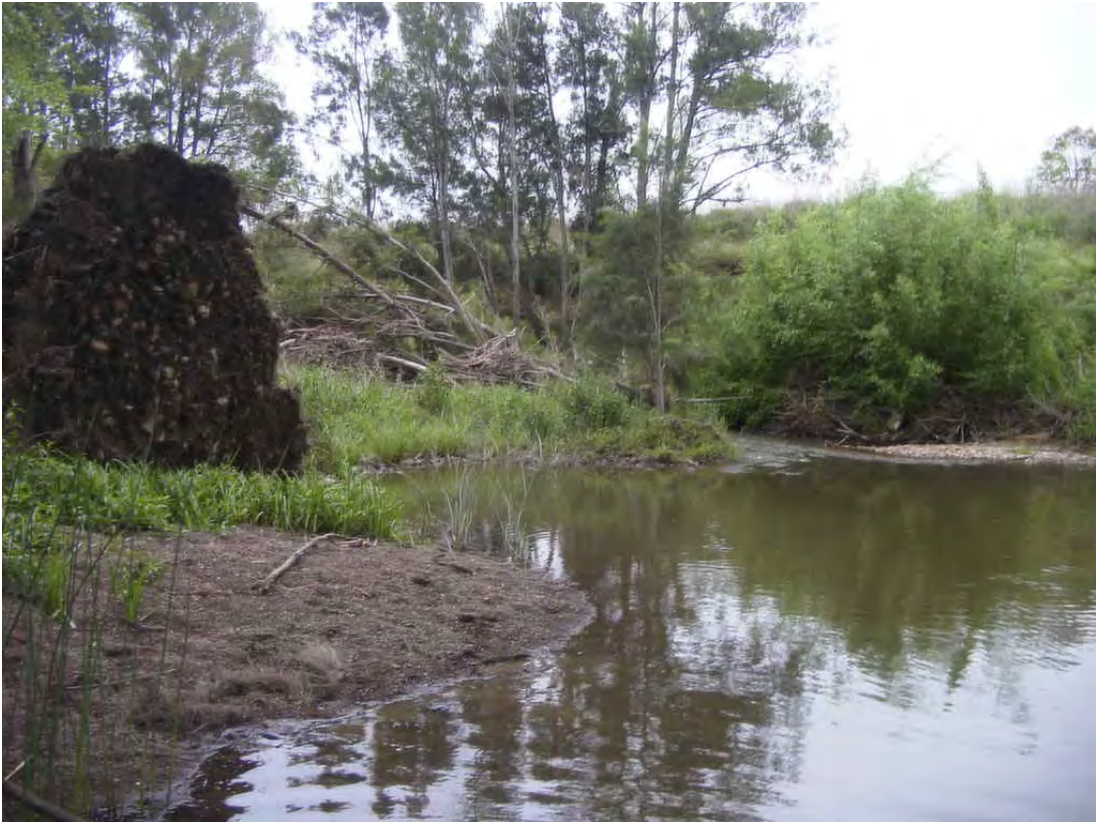
**Figure 5**  
**Glennies Creek Immediately Downstream of New England Highway**

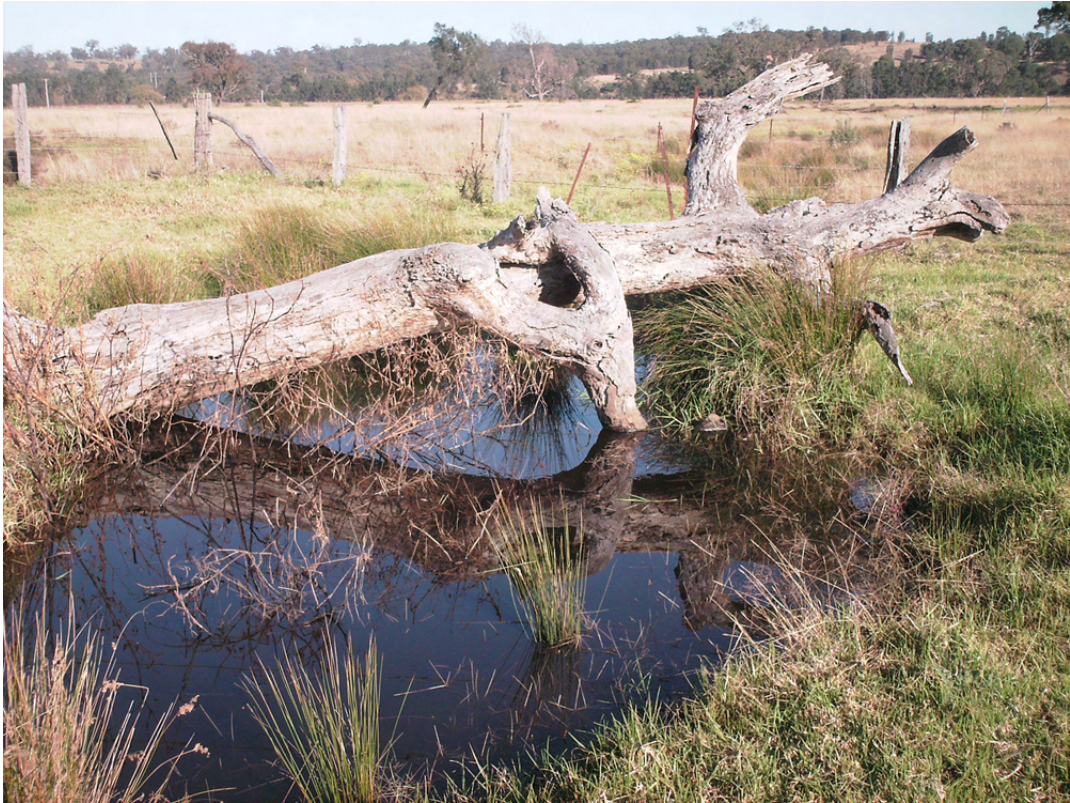
T3 sub-catchment tributary extends for approximately 1.8km from the New England Highway west to the alluvial floodplain of Glennies Creek before heading to in a south-westerly direction toward the confluence with Glennies Creek. The majority of the tributary channel consists of non-defined grassy swales intersected by stock watering dams, however a number of smaller depressions and erosion holes exist downstream from Glennies Rd to the alluvial floodplain which would offer some degree of refuge habitat for aquatic fauna for a period after rainfall (see Figure 8 below). The final 500m of T3 overlying Glennies Creek alluvial terraces consists of broad, deeply grassed channels with no indication of providing any form of sustained aquatic habitat. The channel area leading up to the confluence of T3 and Glennies Creek is non-distinct, and rises up to a bench at the Glennies Creek channel edge.

**Figure 8 T3 inline aquatic habitat**

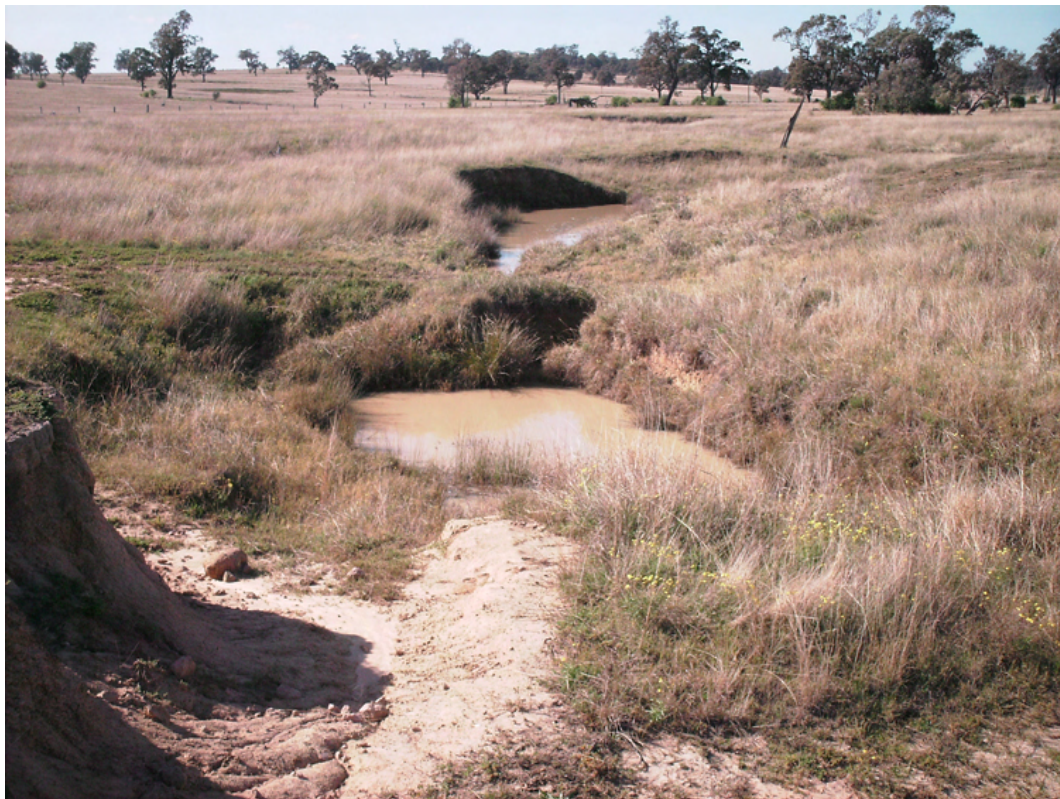
Sub-catchment tributary T4 is the longest drainage within the study area reaching 4km from the headwaters adjacent the New England Highway to Glennies Creek confluence, of which the upper 1.8km is located above the SEOC mine footprint boundary. The channel structure for much of the tributary is characterised by sections of stepped in-line ponds separated by grassed swales with no real stream structure at all (as seen in Figure 9 below). Gully erosion is prevalent throughout the cleared sections of T4, although there were some sections in the upper study area (around sample site P4) with rocky pools and riparian vegetation, which stabilise the banks and minimise the impacts of stock. The condition of the banks varied between being vegetated by grasses to bare clayey banks, and the substrates within sample sites were consistently soft and muddy.

**Figure 9 Channel structure in T4**
