Annual Environmental Management Report 2013-2014

Name of mine	Moolarben Coal Mines
Titles/Mining Leases	EL 6288, 7073, 7074 ML 1605, 1606, 1628, 1691
MOP Commencement Date	July 2014
MOP Completion Date	December 2015
AEMR Commencement Date	01/09/2013
AEMR Completion Date	31/12/2014
Name of Leaseholder	Moolarben Coal Mines Pty Limited
Name of Operator (if different)	Moolarben Coal Operations Pty Ltd
Reporting Officer	Steve Archinal
Title	General Manager
Date:	31st March 2015

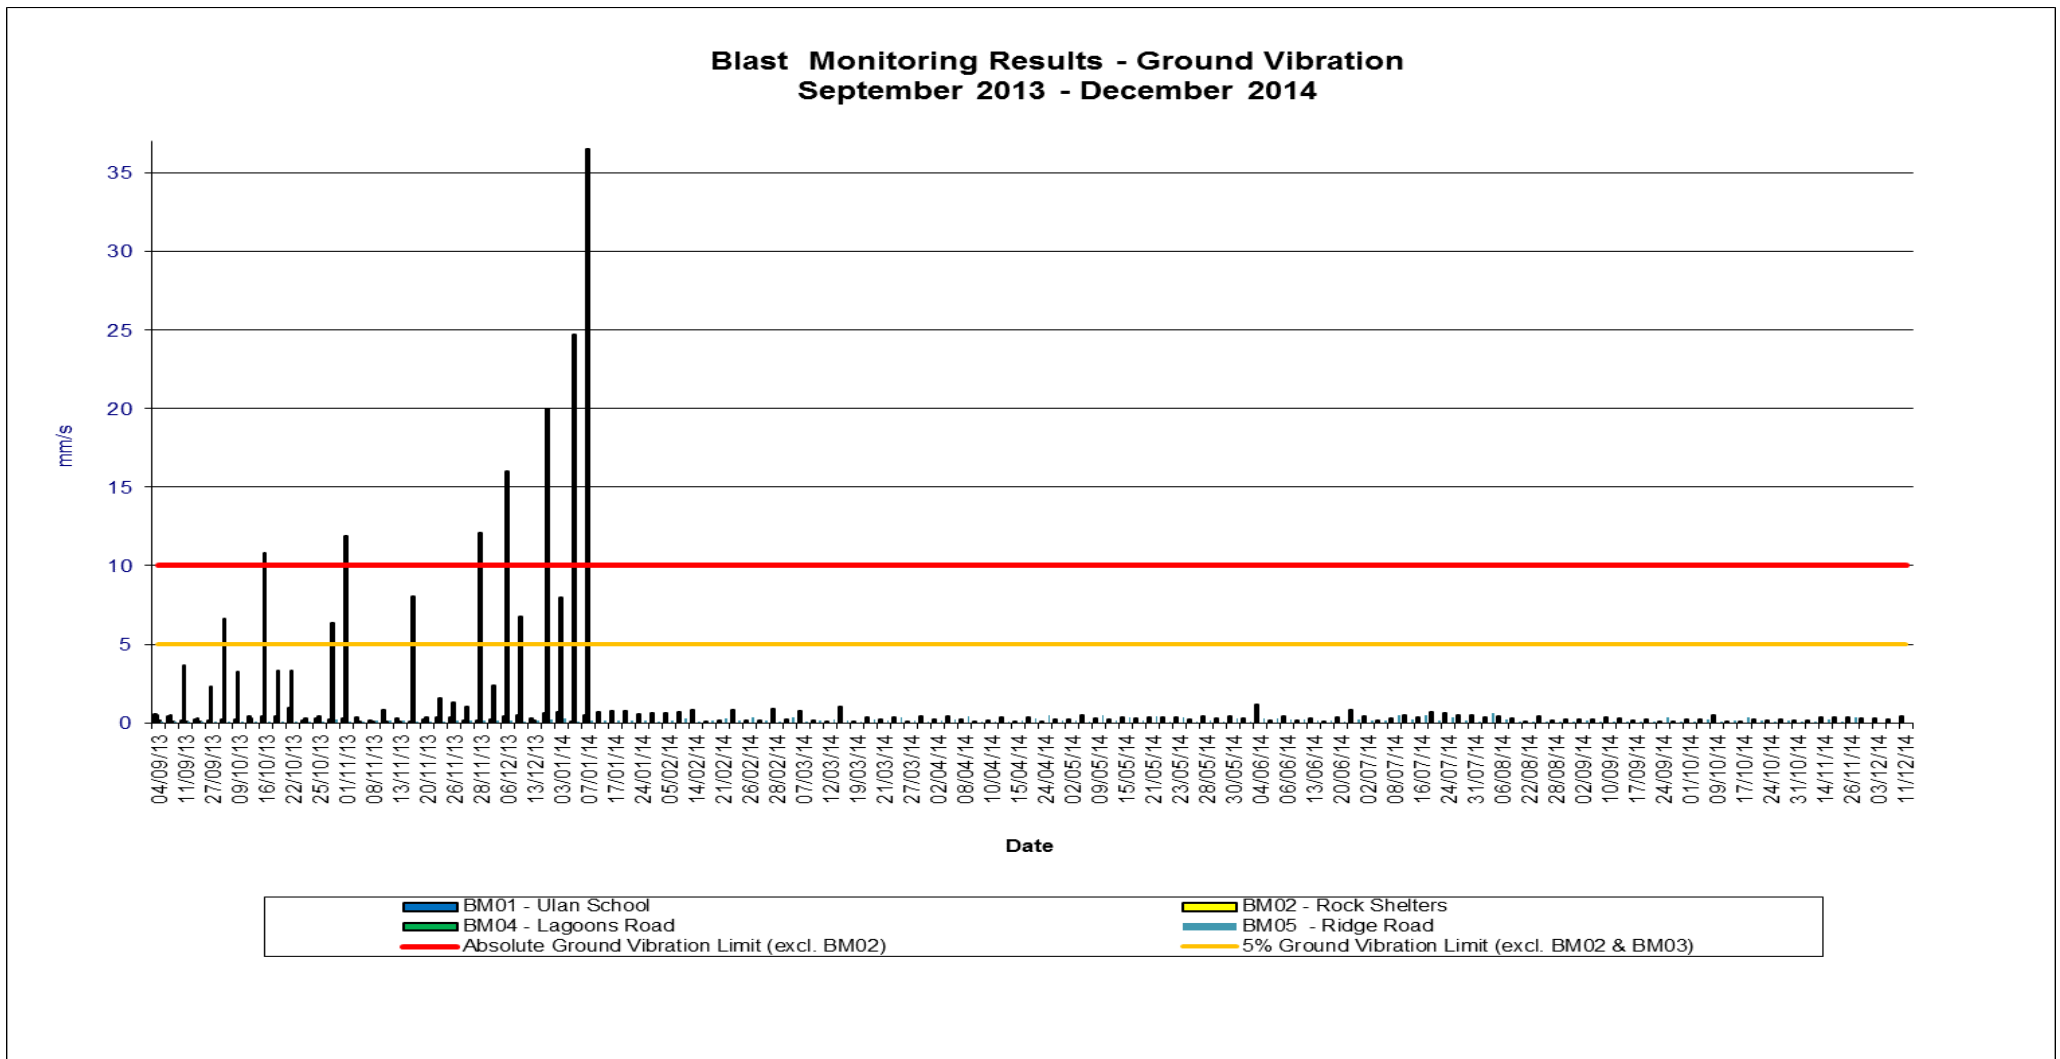
Figure 55: Vibration Results

Date	Time	Blast Location	Type	BM1 Ulan School		BM2 Rock Shelters		BM4 Lagoons Rd		BM5 Ridge Road	
				Ground Vibration (mm/s)	Blast Overpressure (dBL)	Ground Vibration (mm/s)	Blast Overpressure (dBL)	Ground Vibration (mm/s)	Blast Overpressure (dBL)	Ground Vibration (mm/s)	Blast Overpressure (dBL)
26/11/14	12:44	S01B03	Overburden	0.32	95.9					0.01	88
28/11/14	12:04	S01B03	Overburden	0.27	97.5					0.07	97.5
03/12/14	12:01	S04B02	Coal	0.26	94.0					0.22	88
05/12/14	12:00	S04B02	Coal	0.22	94.0					0.11	91
11/12/14	12:01	S06B01	Overburden	0.45	94.0					0.36	95.9

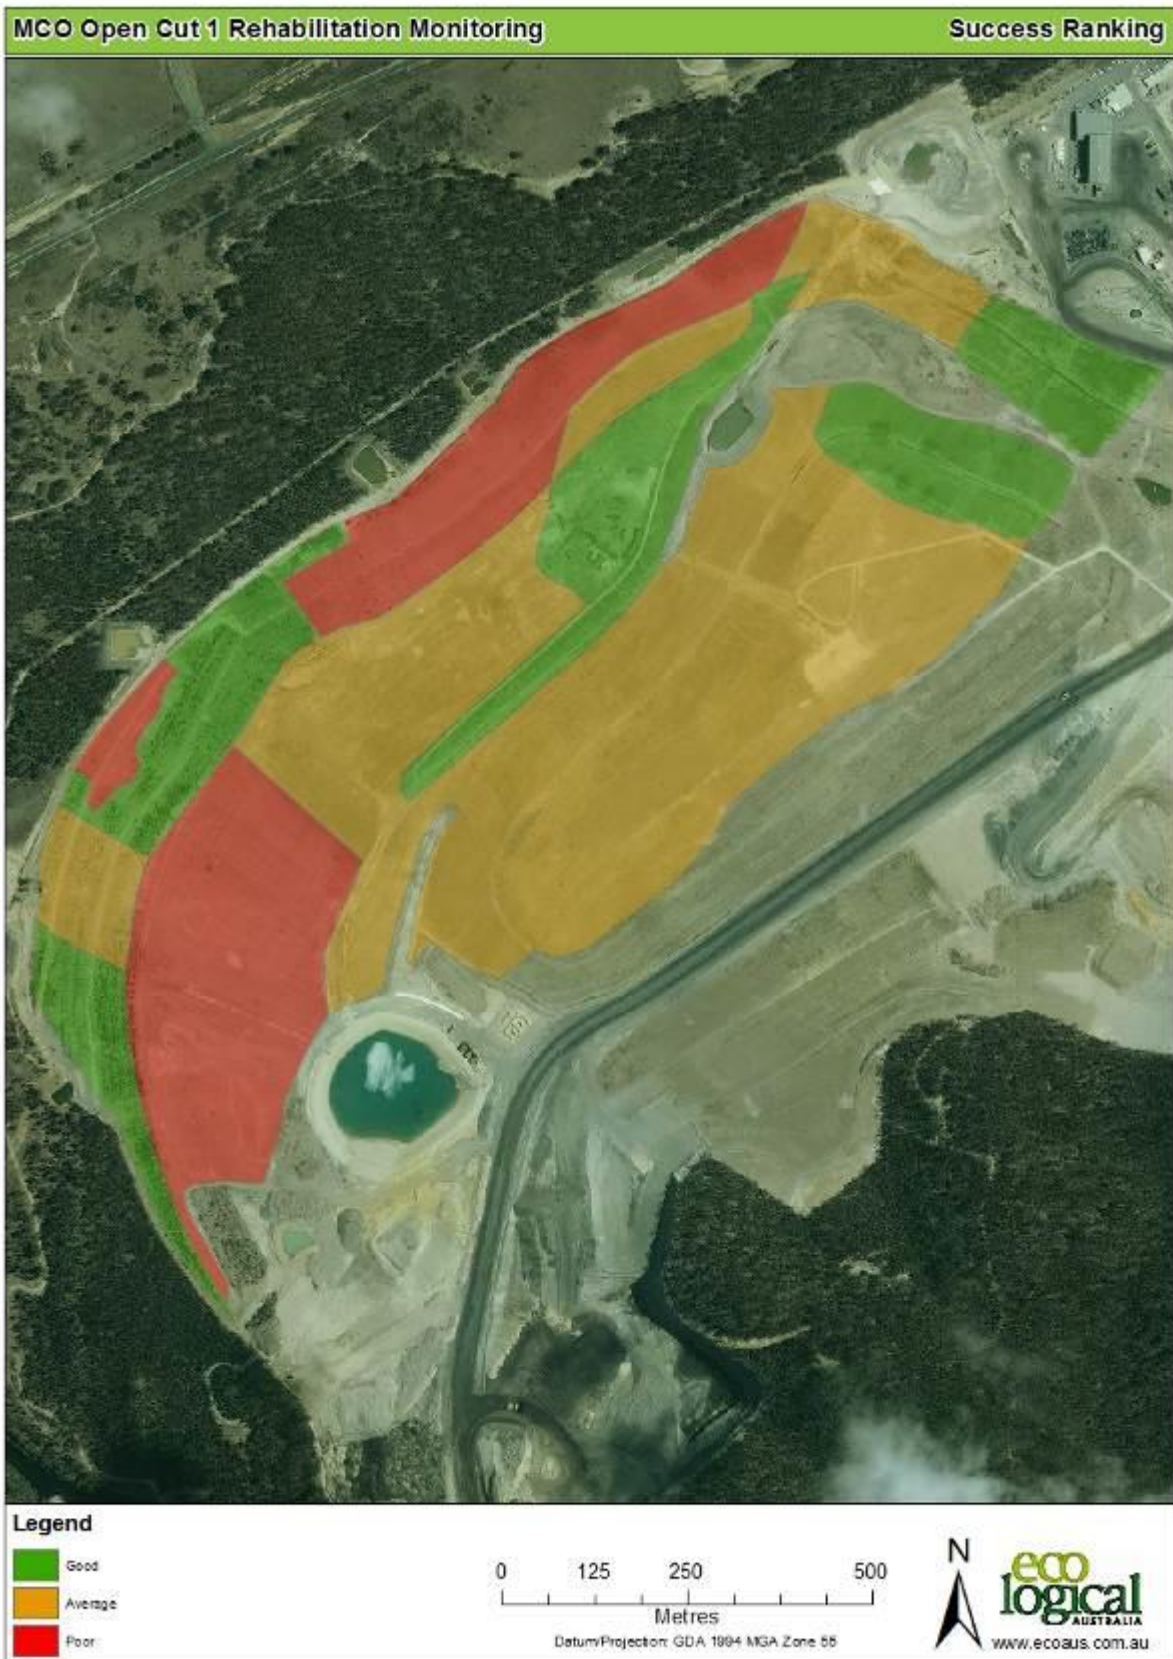
Figure 63: Success Ranking of OC1 Rehabilitation Monitoring 2013

The data collected during the 2013 and 2014 monitoring periods allows an assessment to be made of success in meeting a selected number of the completion criteria. **Figure 63** and **Figure 64** below illustrates the success of the rehabilitation works undertaken so far, assessed against the performance criteria. The success of the rehabilitation has been based upon the results obtained during the 2013 and 2014 spring monitoring with success ranked as good, average or poor.

Overall, the most noticeable gap between preliminary Completion Criteria and the current situation is the lack of eucalypts that will form the dominant layer of the target vegetation communities of Box Gum Woodland and Sedimentary Ironbark Forests in some areas. It should be noted however rehabilitated areas are less than 5 years old. The area around R1 has low eucalypt numbers (40/ha), although very good establishment of understorey species. Eucalypts numbers are on the low side in the area of R2 and R7 ($\leq 100/\text{ha}$). In contrast some areas have

up to 3,000 eucalyptus (R3) stems per hectare. This issue of patches of low eucalypt numbers may require consideration of further broadcasting of seed or use of tubestock planting.

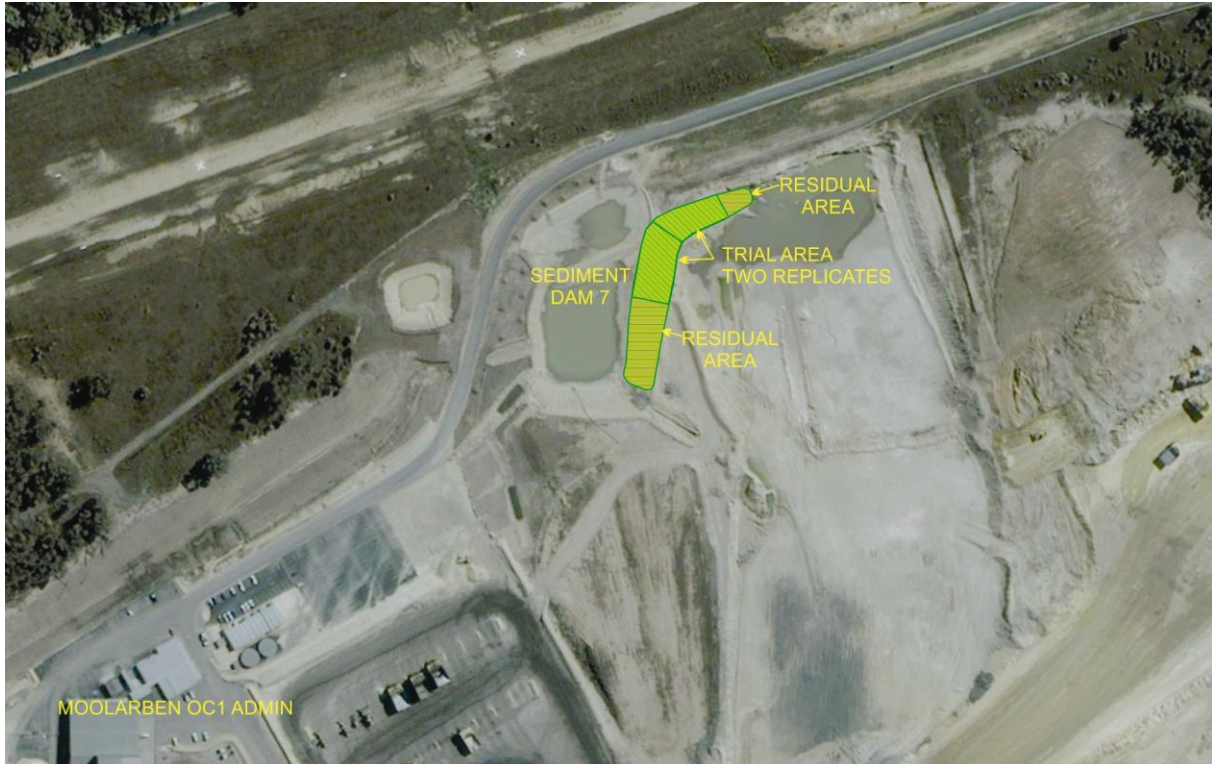
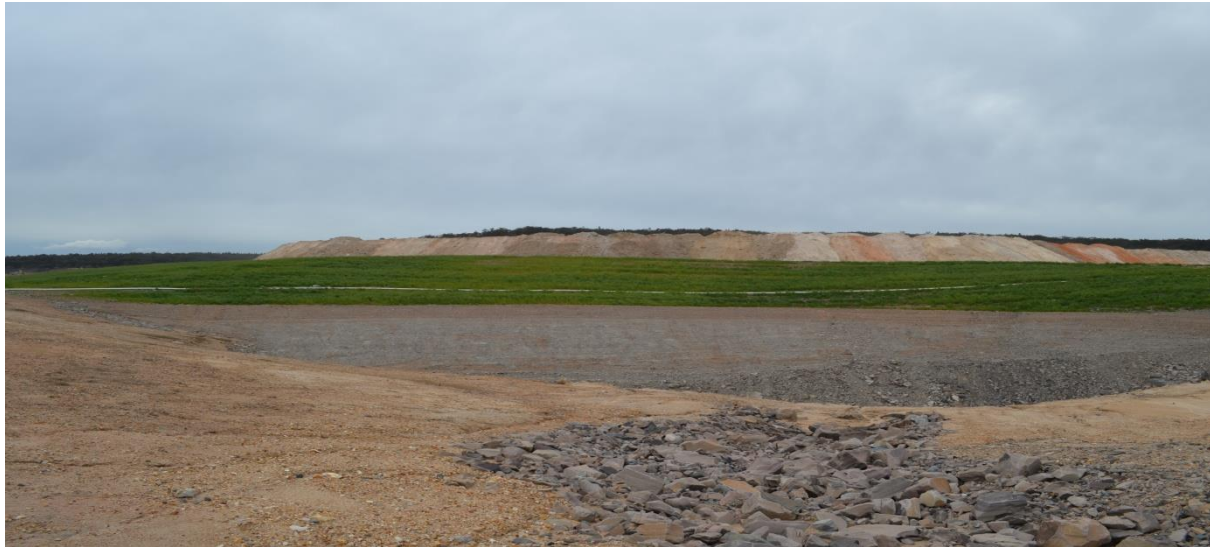
Figure 65: Rehabilitation Trial Location and Set Up

Varying rates of compost (Nitrohumus) were applied to provide insight to the effectiveness of control (0m³/ha), 50m³/ha and 100m³/ha. Seed, fertiliser application and ground preparation remained constant across all plots.

A total of 15kg of native tree and shrub seed was applied at a rate of 6kg/ha. The seed mix is shown in Table 101. Twenty five per cent of *Acacia* seed was heat treated to induce early germination. Seed oats was also sown at a rate of 30kg/ha. Inorganic (quick release) and organic (slow release) fertiliser were also applied at a total combined rate of 400kg/ha. Gypsum was also spread at a rate of 2 tonne/ha.
