Annual Environmental Management Report

July 2014 – June 2015

Name of Mine: Austar Coal Mine

Subsidence – Stage 3 End of Panel Report, Longwall A8

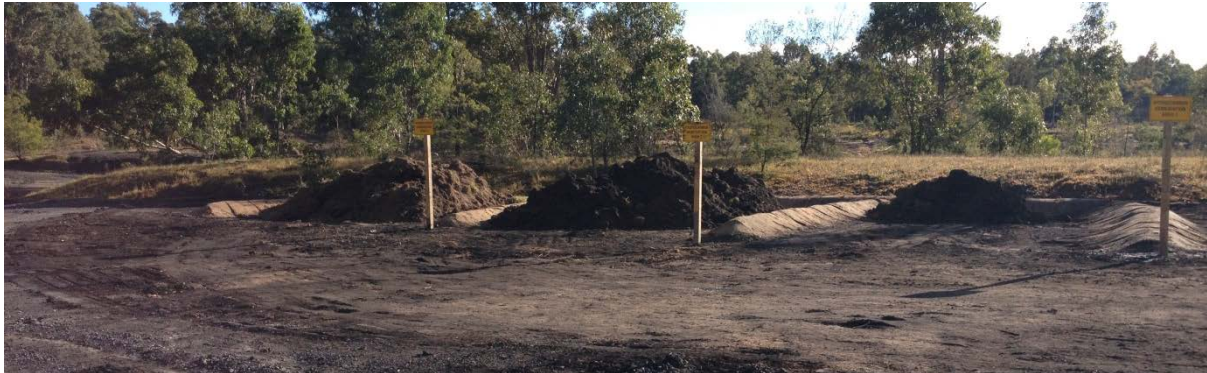
FIGURE 2.1 HYDROCARBON REMEDIATION AREA

Austar operates a hydrocarbon remediation area at the CHPP to manage hydrocarbon contaminated material retrieved from the site. As shown in **Figure 2.1** the area is signposted and has three bunded cells for segregation of materials of different ages. The bunded area was constructed on a disused laydown area and is within the sites dirty water catchment. The contaminated materials are periodically turned to allow an adequate supply of oxygen to microbes that use the contaminants as a source of food and energy.

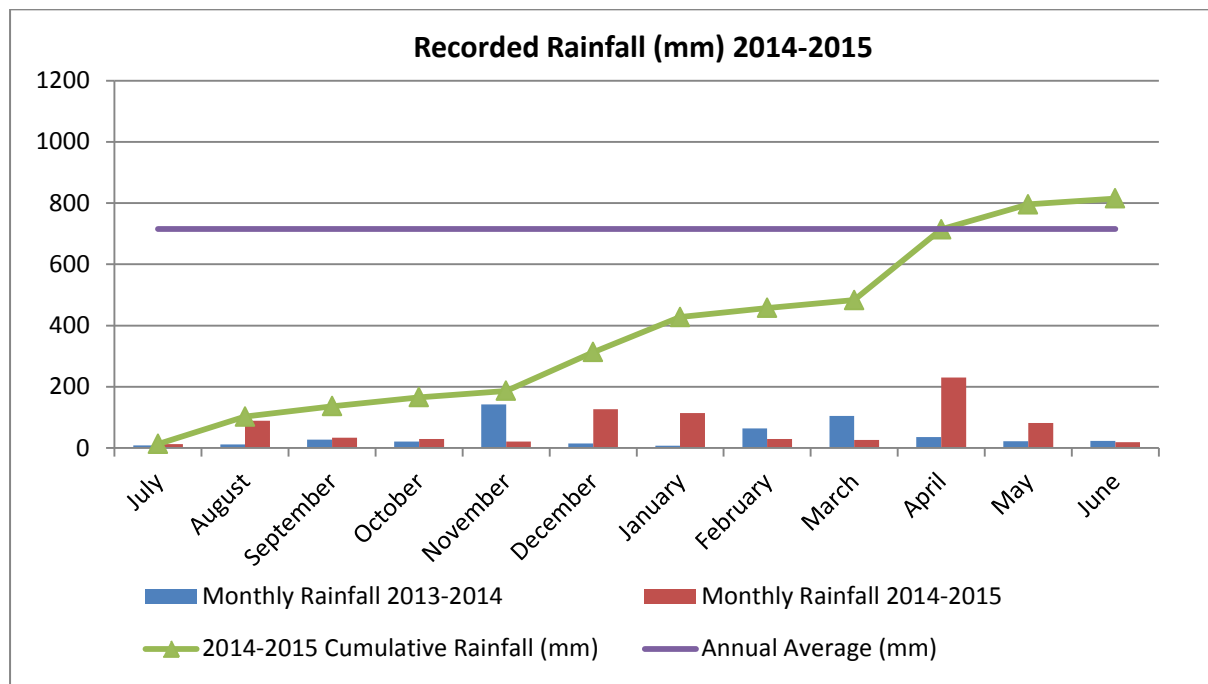
FIGURE 3.2 RECORDED RAINFALL AT AUSTAR METEOROLOGICAL STATION (MM) 2014-2015

Total Monthly Rainfall (mm)												
Jul	Aug	Sep	Oct	Nov	Dec	Jan	Feb	Mar	Apr	May	Jun	Total
13.2	89.2	33.8	29.4	20.8	126.8	114.4	29.6	26	230.6	81.6	19.4	814.8
Number of Rain Days (>0.2mm)												
3	12	7	8	6	17	12	10	9	11	11	9	115
