# Austar Coal Mine Annual Review

July 2017 – June 2018

**ANNUAL REVIEW 2018**

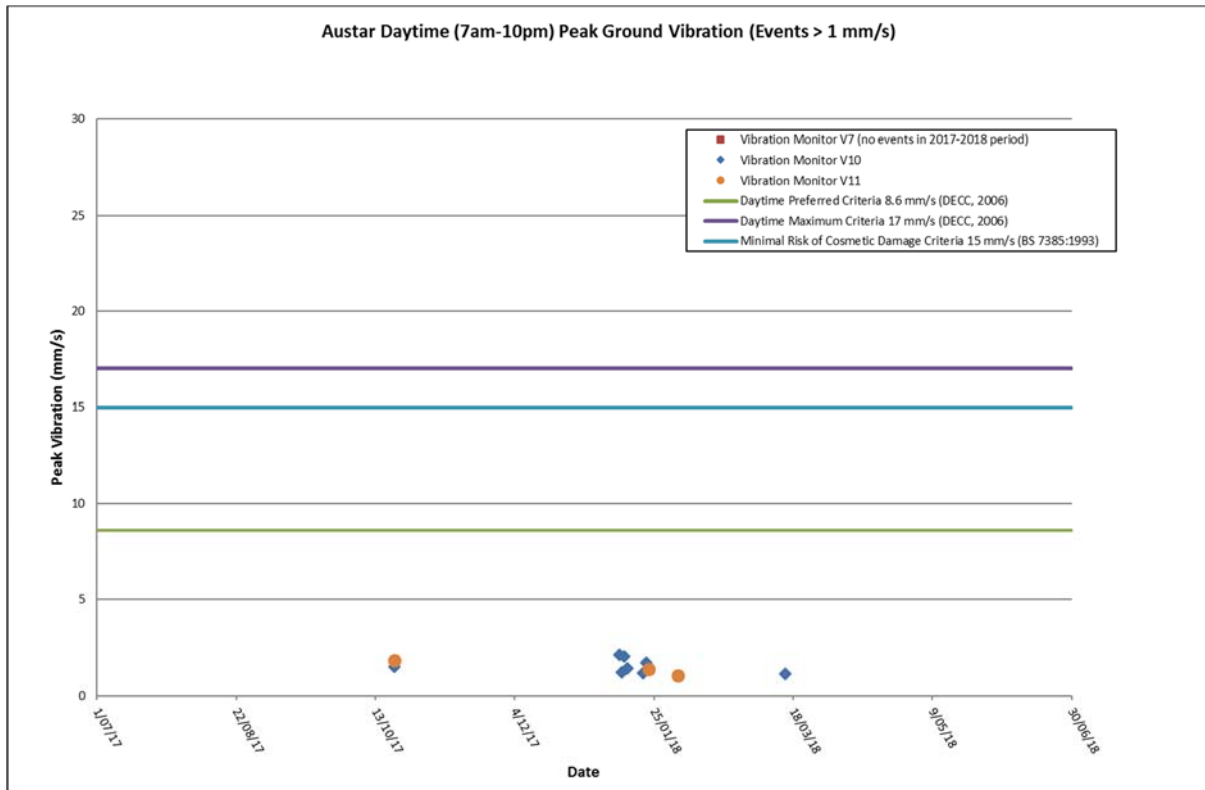
FIGURE 6-7 DAY TIME GROUND VIBRATION EVENTS

In general accordance with the NVMP, vibration monitors are set to trigger and record an event when vibration is greater than 1mm/second. Vibration monitoring results are presented in **Figure 6-7** and **Figure 6-8**.

Monitoring undertaken in previous reporting periods has indicated vibration in the mining area is event based, and normally occurs when the longwall equipment is extracting coal. Vibration is typically generated from the caving zone behind the longwall, or from tensile fractures in the overlying strata immediately above the longwall mining area. There were 21 vibration events recorded (PVS >1mm/s) during the 2017-18 reporting period. This is a significant decrease from the 85 vibration events recorded in the 2016-17 reporting period.

The British Standard provides guideline values for building vibration based on the lowest vibration levels above which damage has been credibly demonstrated and where minimal risk of cosmetic damage may occur (15mm/s). The maximum recorded event for the current reporting period was 2.14mm/s.

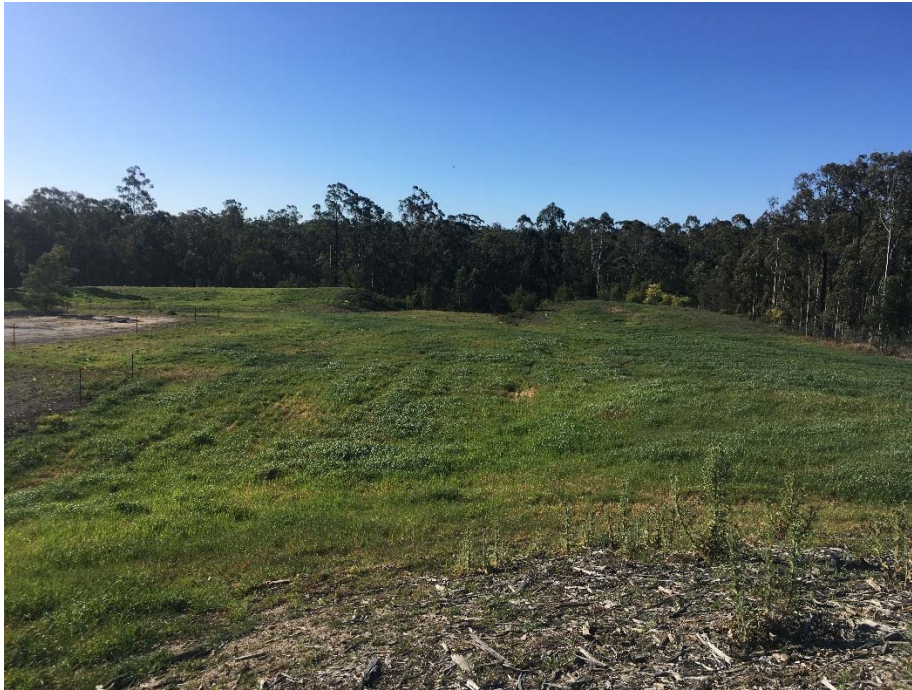
**PHOTO 1 KITCHENER SIS - 30/07/18**

There was 4.4 hectares of disturbed land at the Kitchener Surface Infrastructure Site (SIS) temporarily stabilised during the reporting period. Soil testing was undertaken in the previous period to determine the rates for application of ameliorants. Lime, gypsum, compost, mulch, seed and fertiliser were applied to areas to be vegetated.

Following application of ameliorants and seed a watering system was established to spray clean treated water from the Reverse Osmosis plant on stabilised areas. The land stabilisation project was successful in reducing erosion and sedimentation as evidenced in the **Photo 1** below.
