Austar Coal Mine Annual Review

July 2019 – June 2020

ANNUAL REVIEW 2020

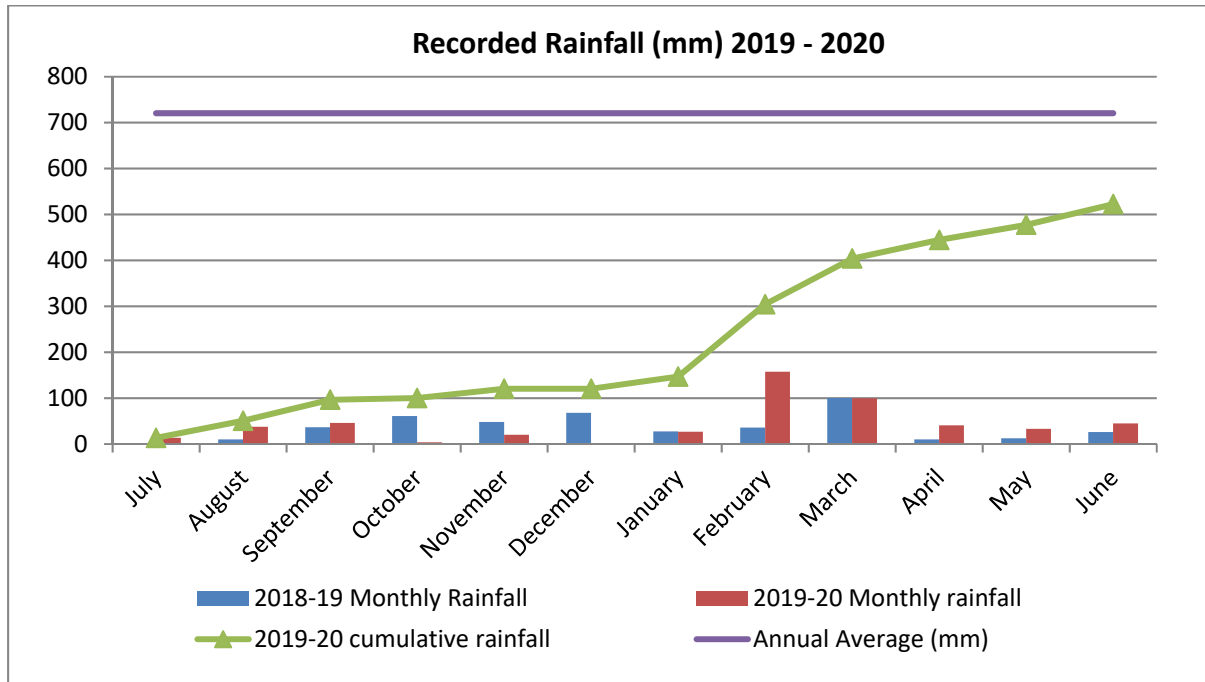
FIGURE 6-1 RECORDED RAINFALL (MM) AT AUSTAR METEOROLOGICAL STATION 2019-2020

February recorded the highest rainfall of any month in the reporting period (157.4mm), which helped ease bushfire threats and reduced regional particulate matter loads.

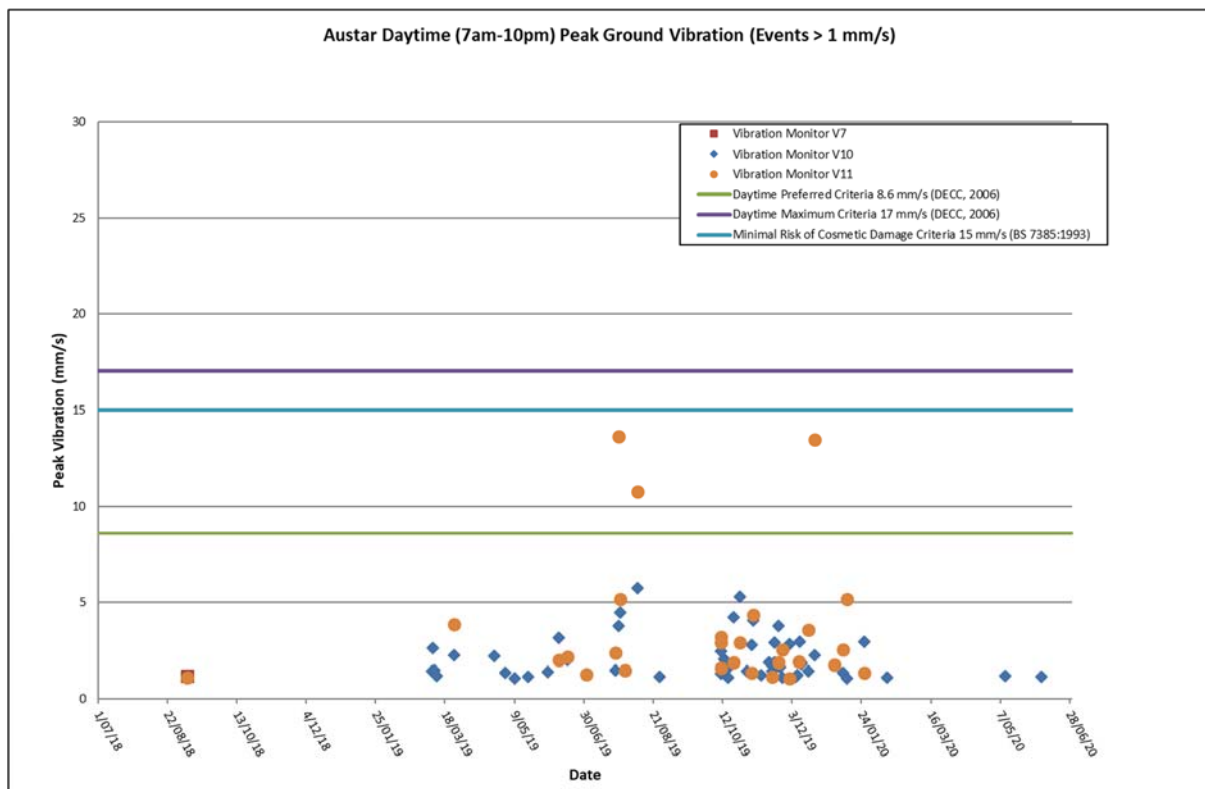
FIGURE 6-7 DAY TIME GROUND VIBRATION EVENTS

Monitoring undertaken in previous reporting periods has indicated vibration in the mining area is event based, and normally occurs when the longwall equipment is extracting coal. Vibration is typically generated adjacent to the longwall mining area, or from tensile fractures in the overlying strata immediately above and surrounding the longwall mining area.

The maximum recorded event for the current reporting period was 13.46mm/s, less than the British Standard guide of 15mm/s for minimal risk of cosmetic damage.

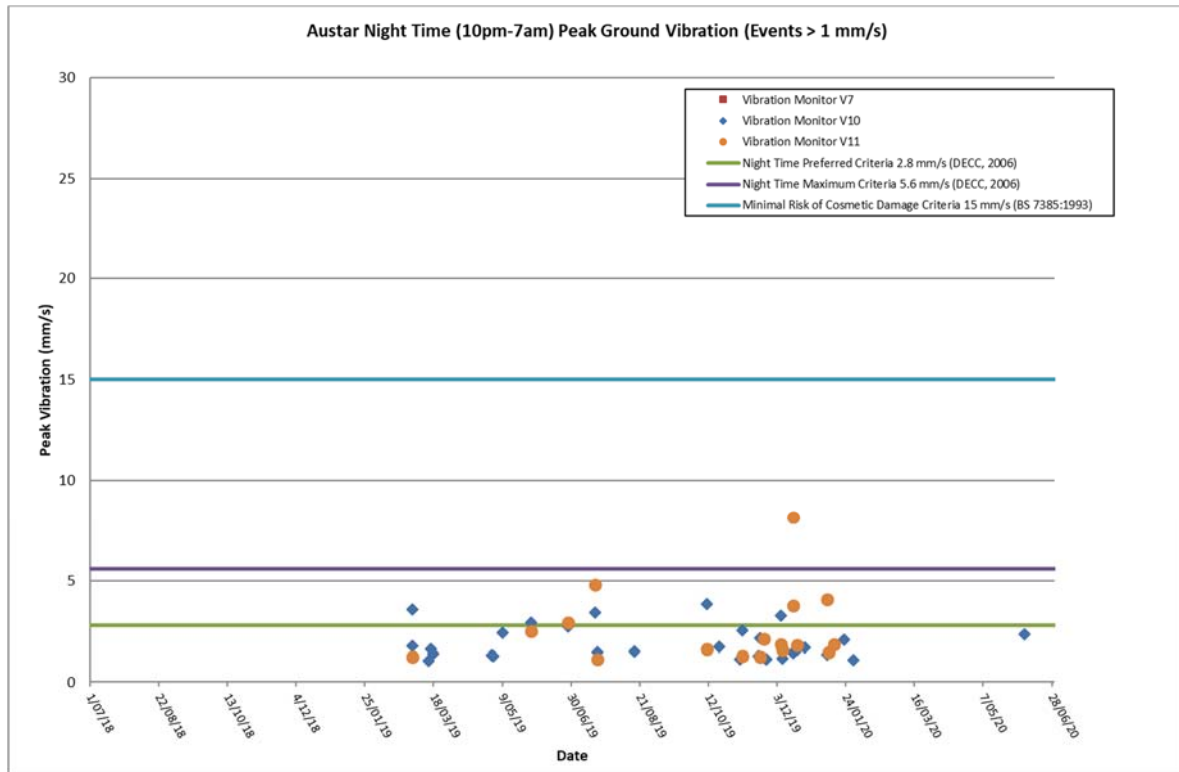
FIGURE 6-8 NIGHT TIME GROUND VIBRATION EVENTS

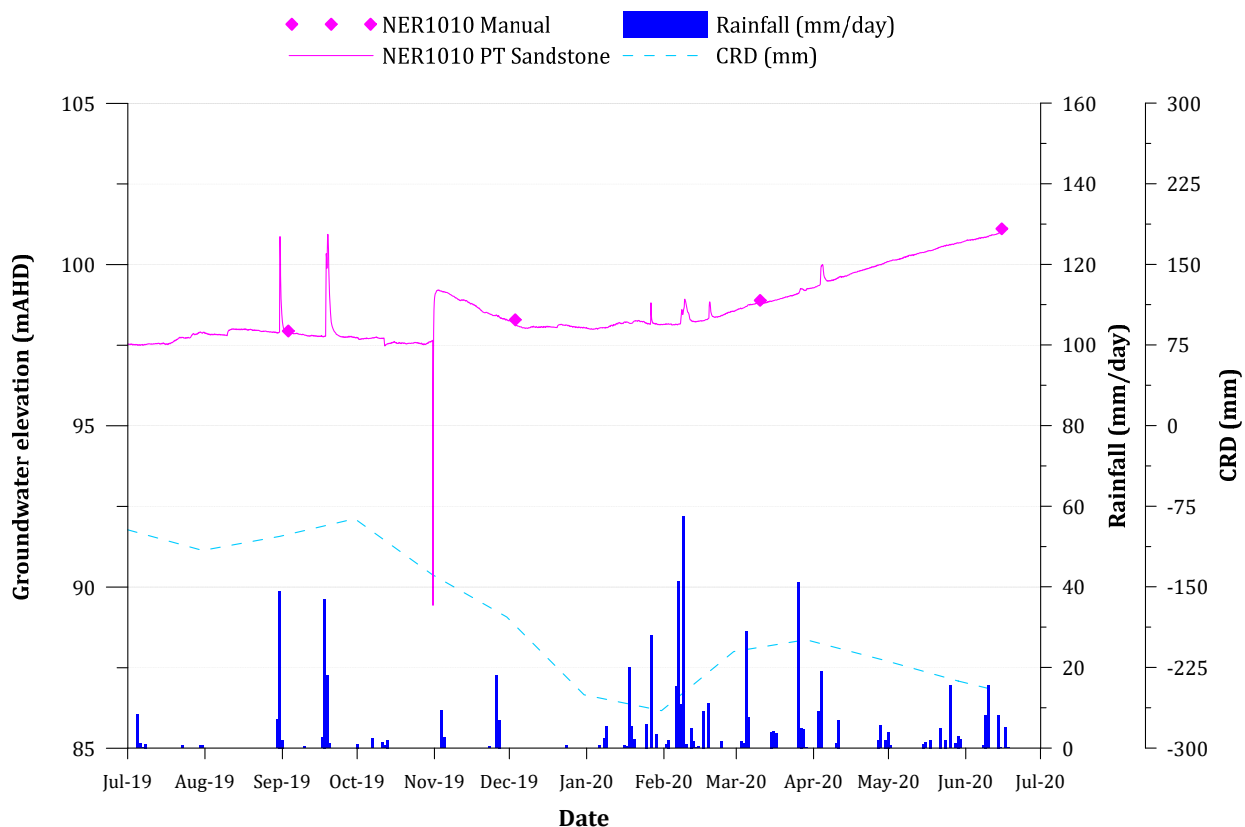
FIGURE 12-1 NER1010 GROUNDWATER LEVEL HYDROGRAPH

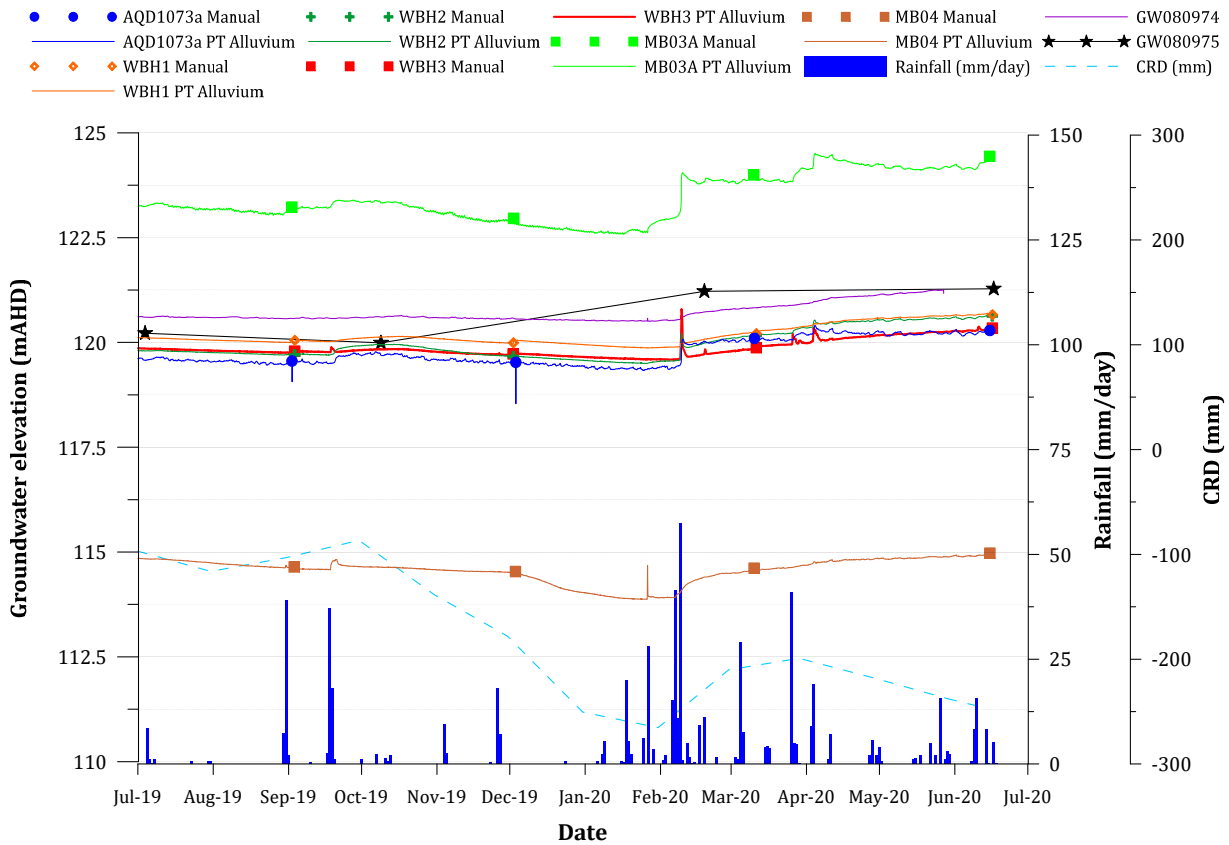
FIGURE 1-2 STAGE 2 AND BELLBIRD SOUTH ALLUVIUM AND WATERNSW GROUNDWATER LEVEL HYDROGRAPHS

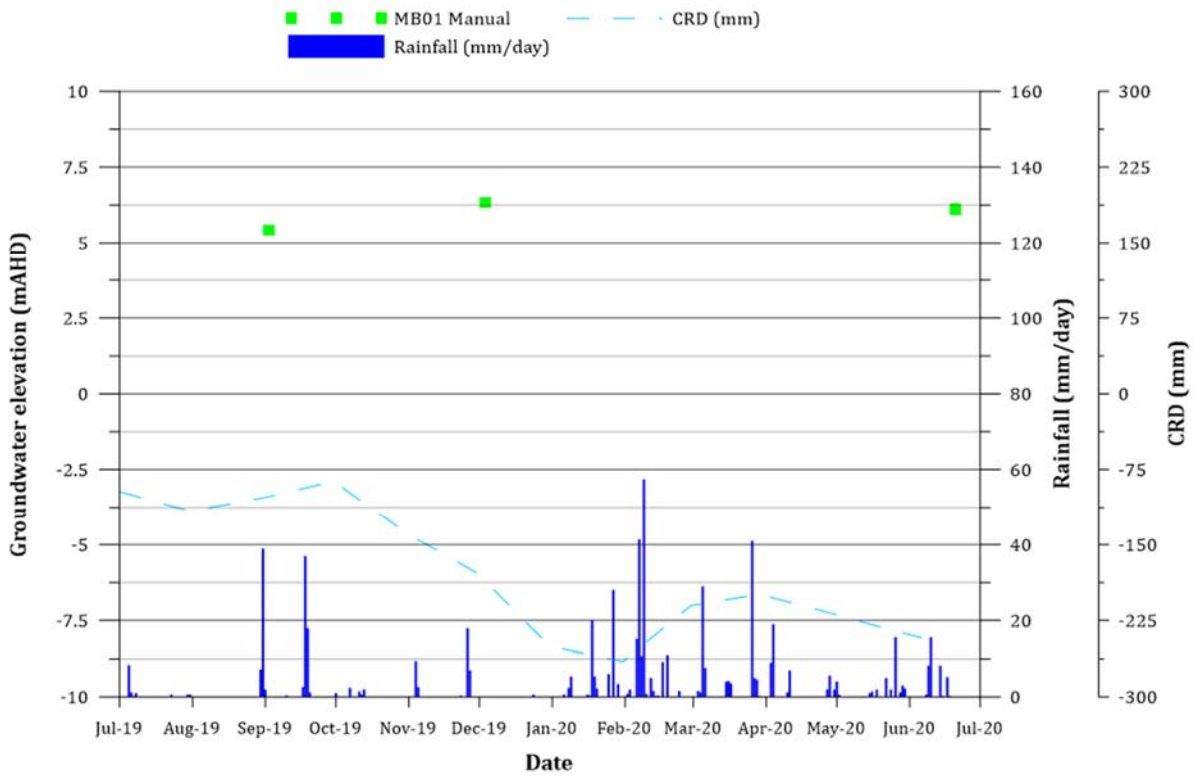
FIGURE 1-3 STAGE 3 MB01 SANDSTONE AQUIFER GROUNDWATER LEVEL HYDROGRAPH

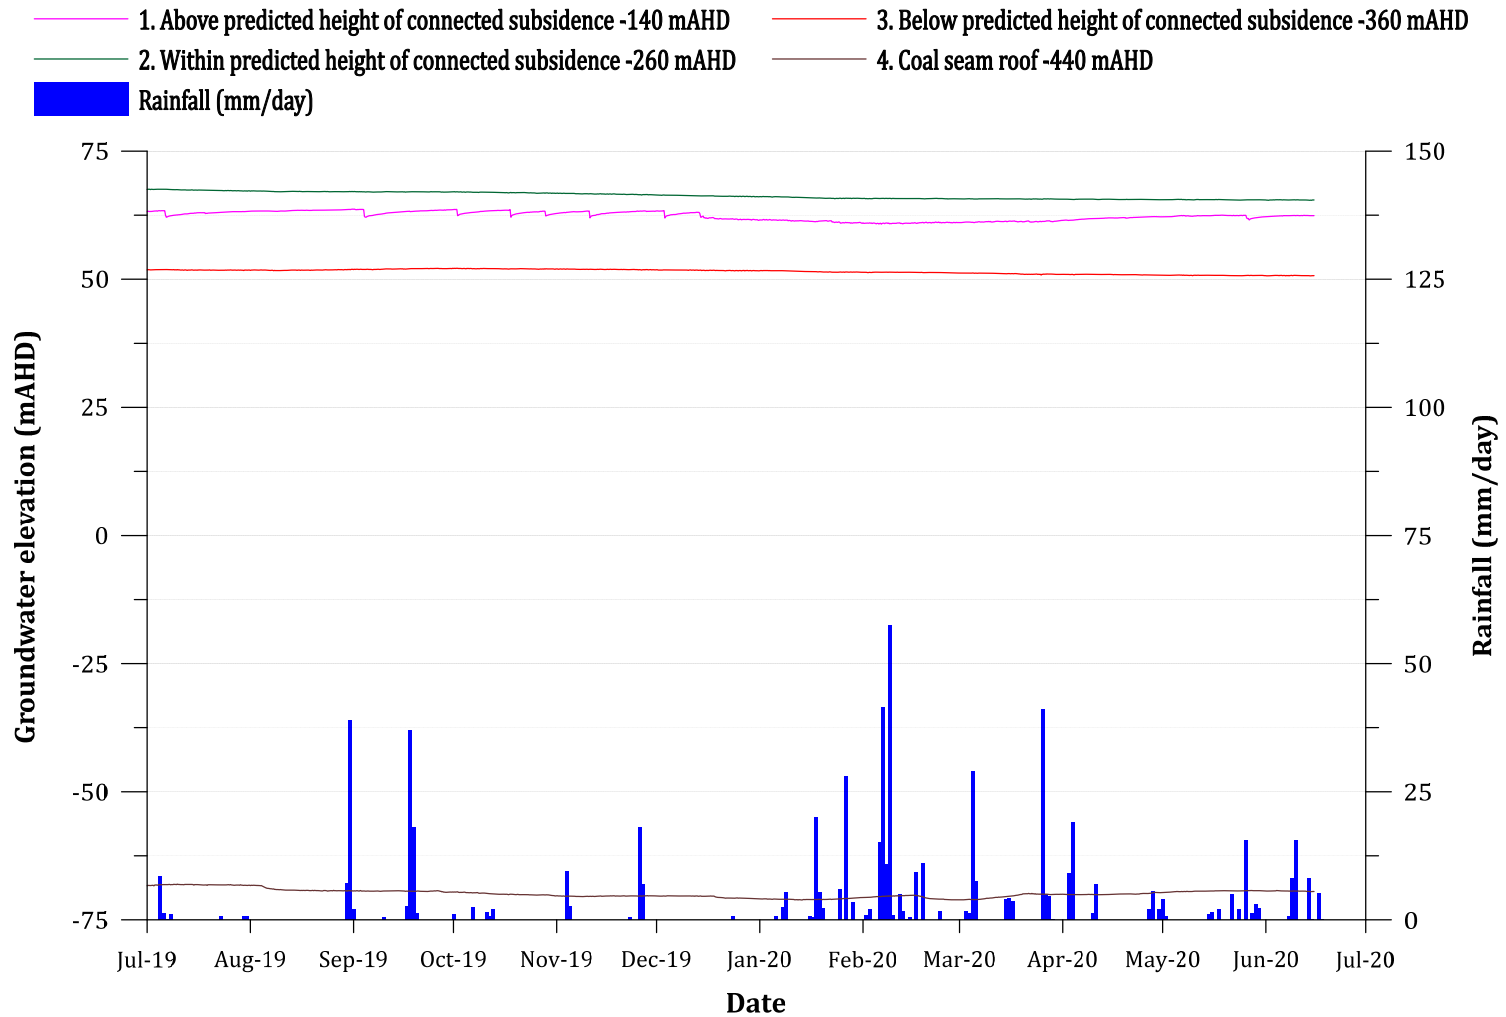
FIGURE 1-5 EX01H PIEZOMETRIC HEAD MEASUREMENTS: SENSORS NO.1 TO NO.4

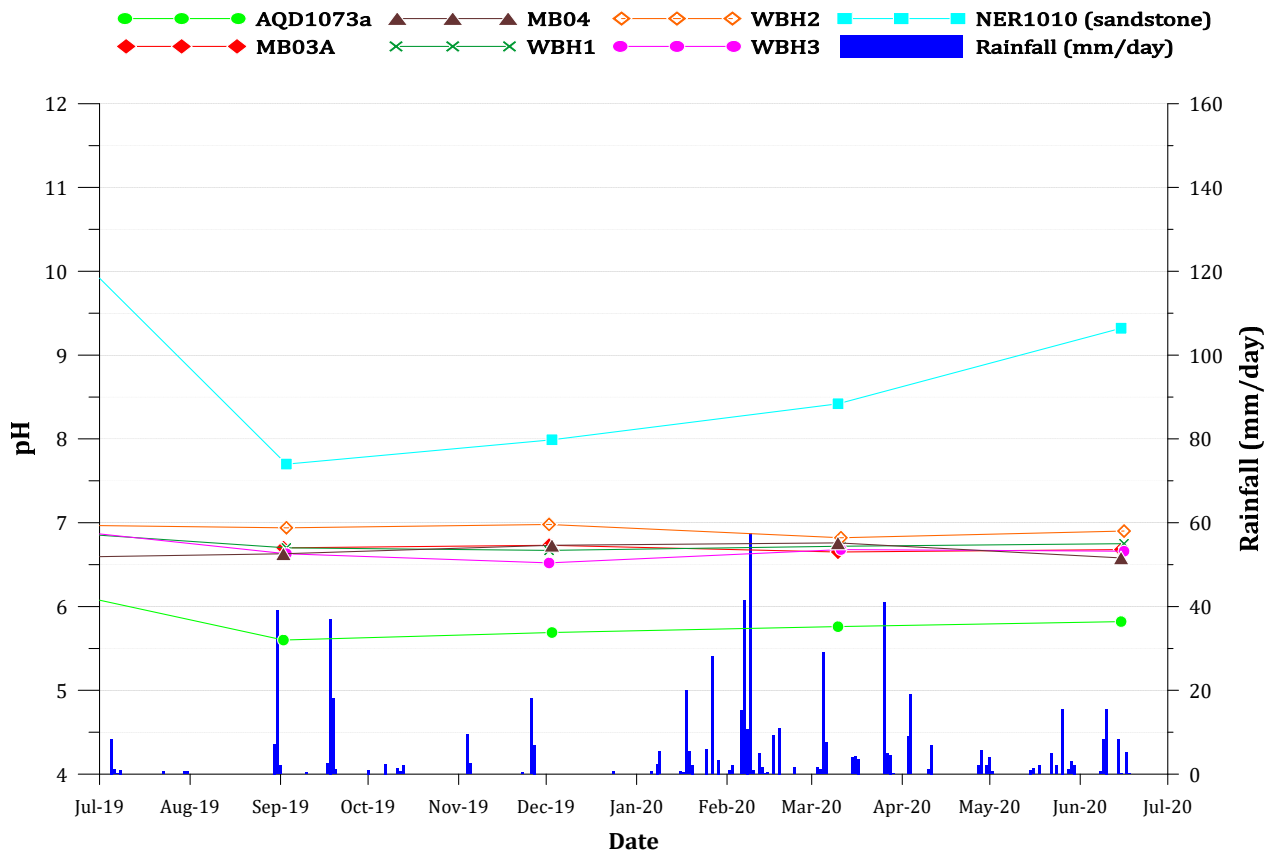
FIGURE 1-7 STAGE 2 AND BELLBIRD SOUTH ALLUVIUM AND SANDSTONE AQUIFER PH TRENDS

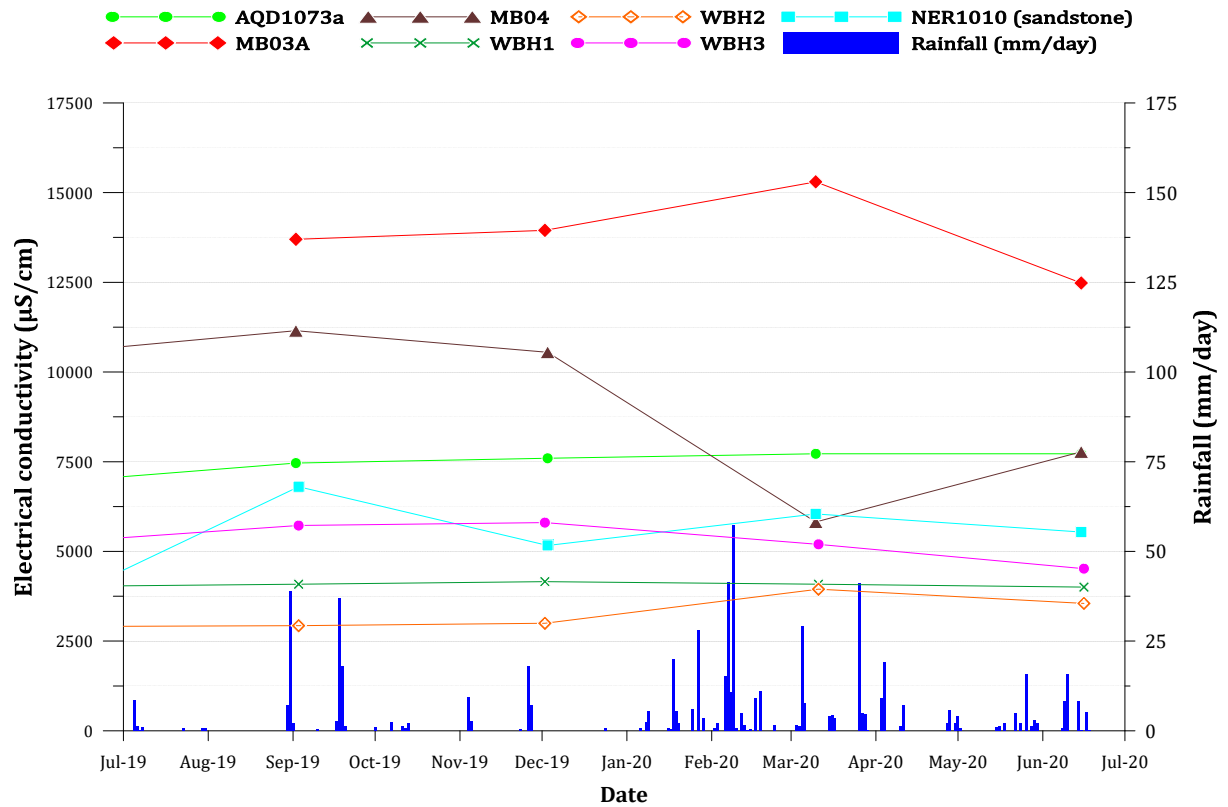
FIGURE 1-9 STAGE 2 AND BELLBIRD SOUTH ALLUVIUM AND SANDSTONE AQUIFER EC TRENDS

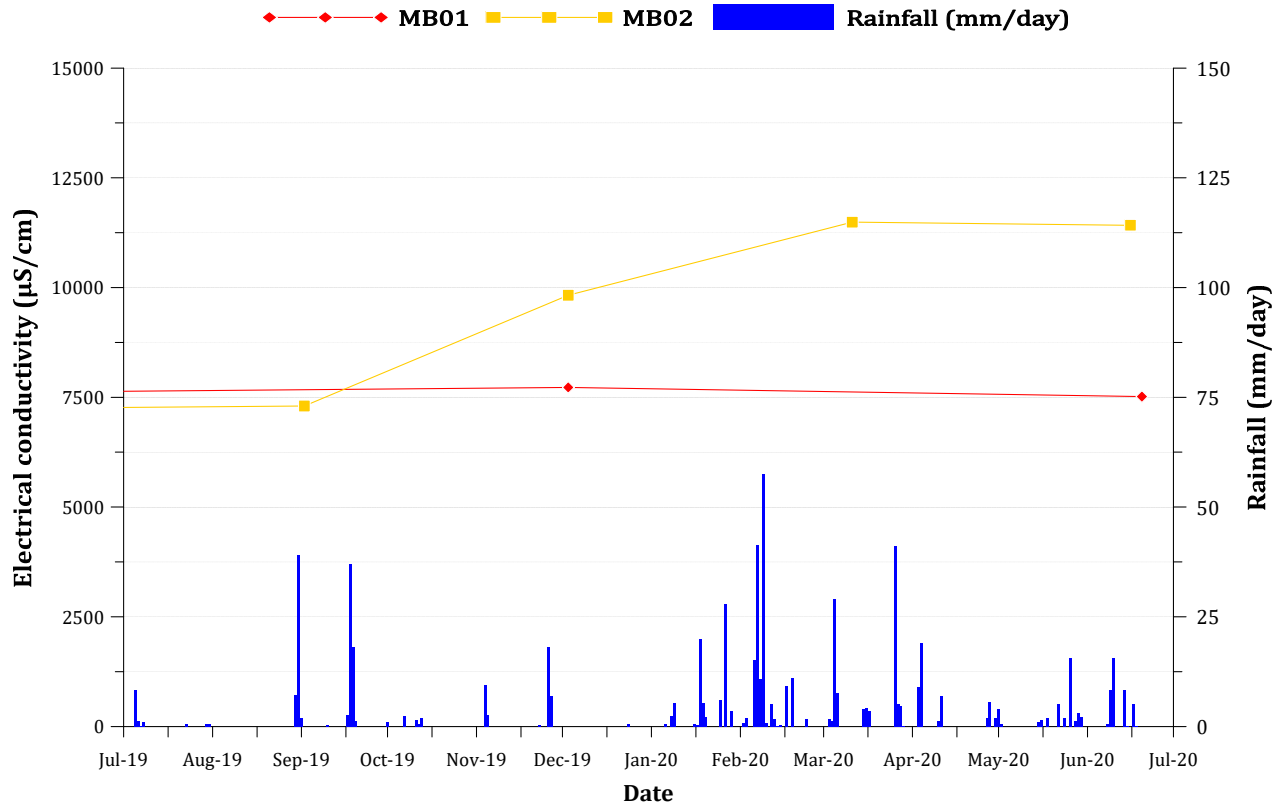
FIGURE 1-10 STAGE 3 SANDSTONE AQUIFER EC TRENDS
