Austar Coal (MP08_0111 and DA 29/95) - Annual Review 2022

Austar Coal Mine Annual Review

July 2021 – June 2022

ANNUAL REVIEW 2022

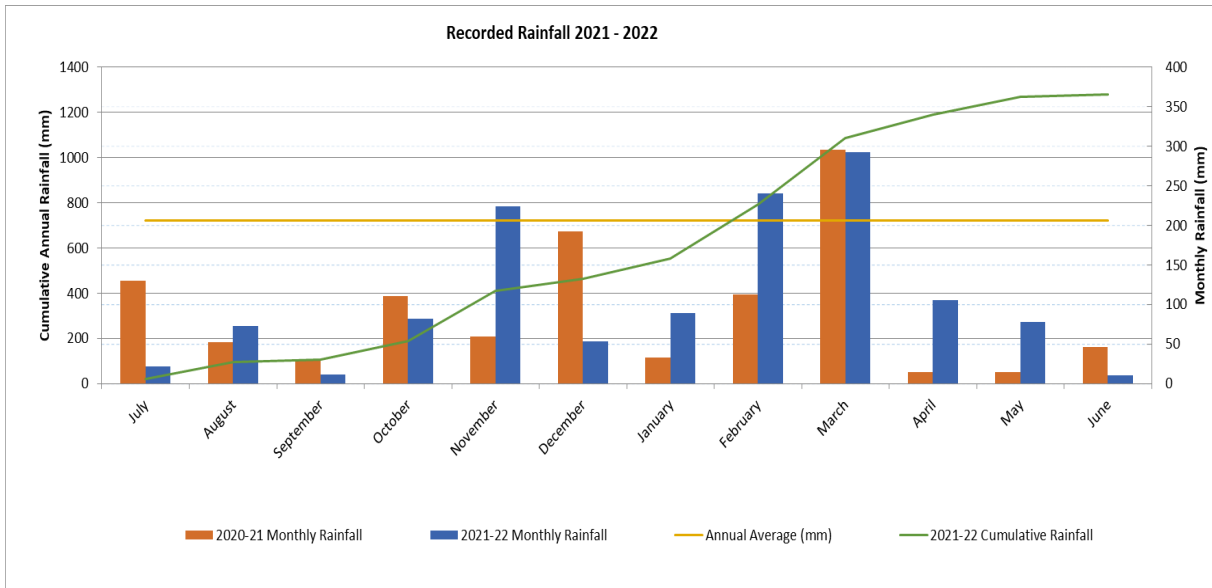
FIGURE 6-1 RECORDED RAINFALL (MM) AT AUSTAR METEOROLOGICAL STATION 2021-2022

A total rainfall of 1278 mm was recorded during the 2021-2022 reporting period. This represents an increase of 188 mm from the previous reporting period and is approximately 75% greater than the annual average rainfall for the Cessnock area (729.4mm) (Bureau of Meteorology Cessnock Airport AWS 1968 - 2020). Eight months reported rainfall above their long-term average being January, February, March, April, May, August, October, and November. March recorded the highest rainfall of any month in the reporting period being 292 mm.

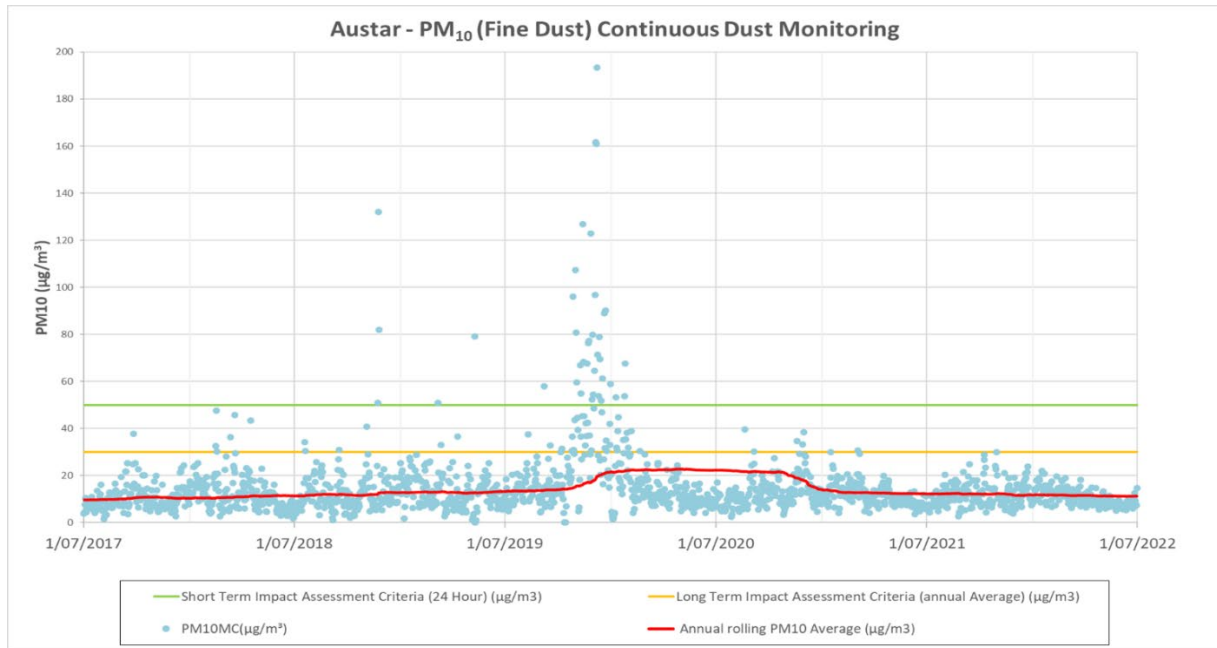
FIGURE 6-4 AUSTAR TEOM PM₁₀ CONTINUOUS DUST MONITORING 2017-2022

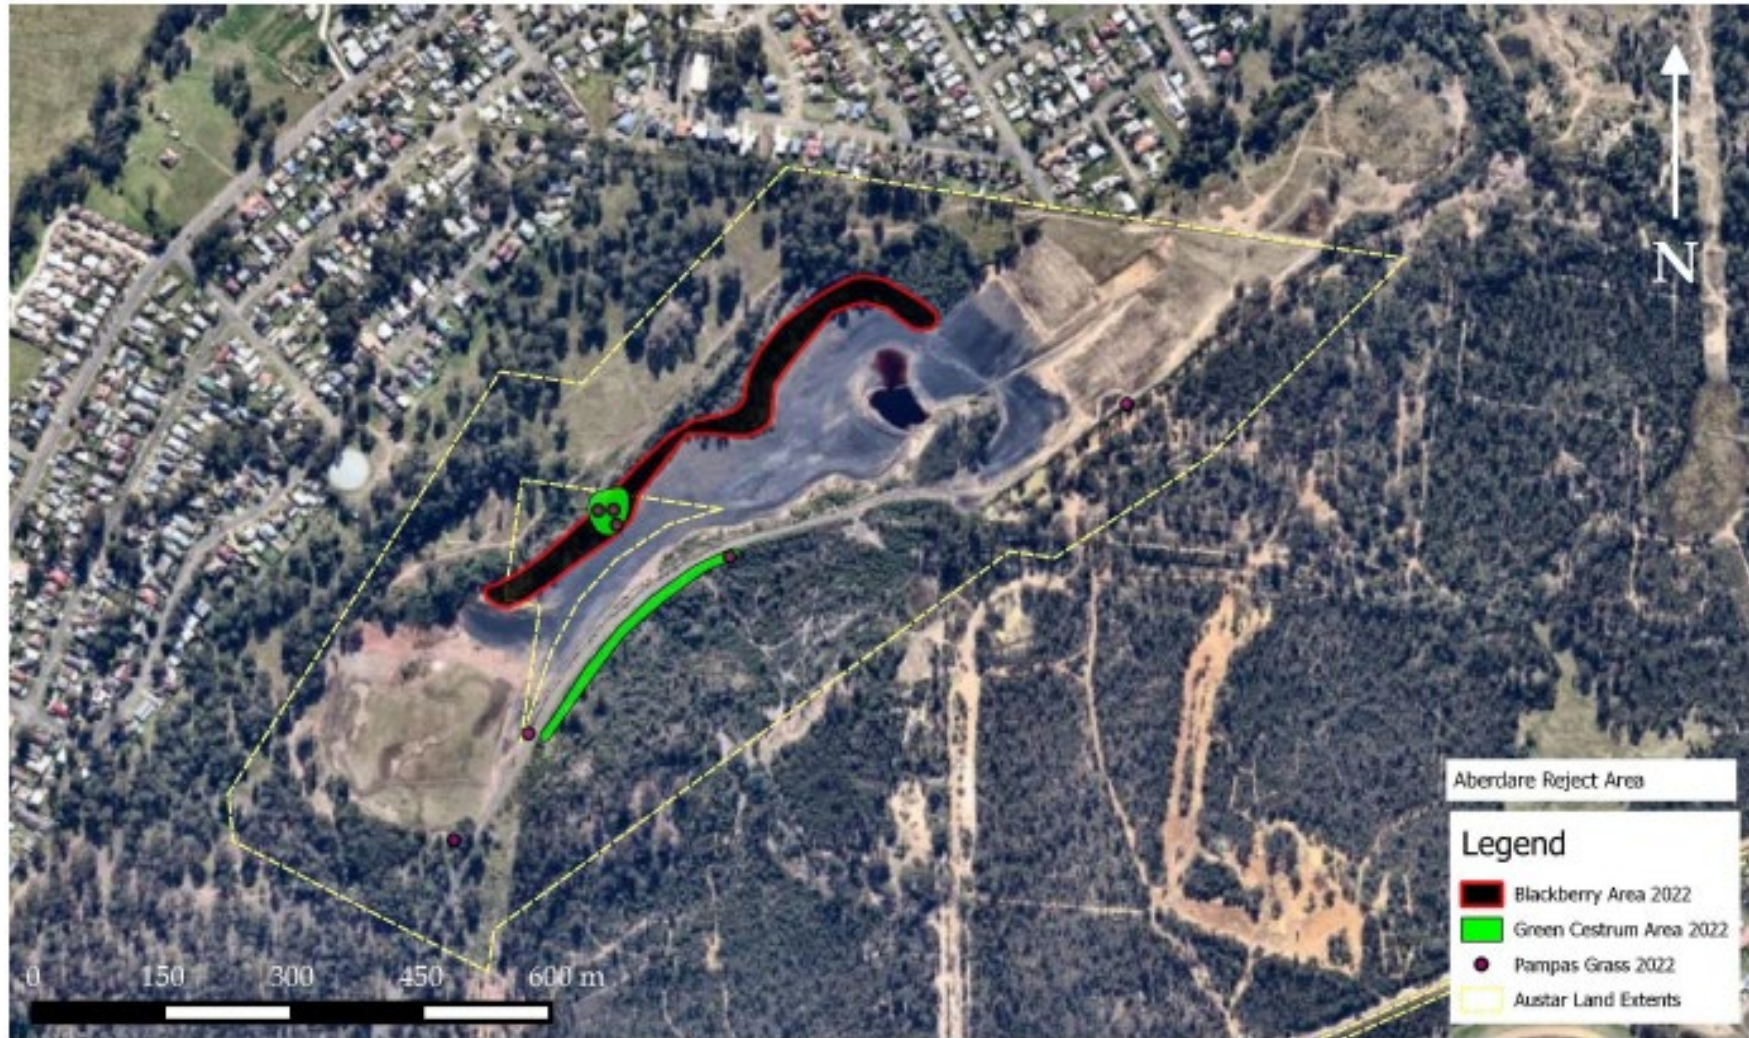
FIGURE 6-6 ABERDARE REJECT AREA WEED TREATMENT (SOURCE: AUSTAR WEED WORKS COMPLETED JULY 2021 TO JUNE 2022)

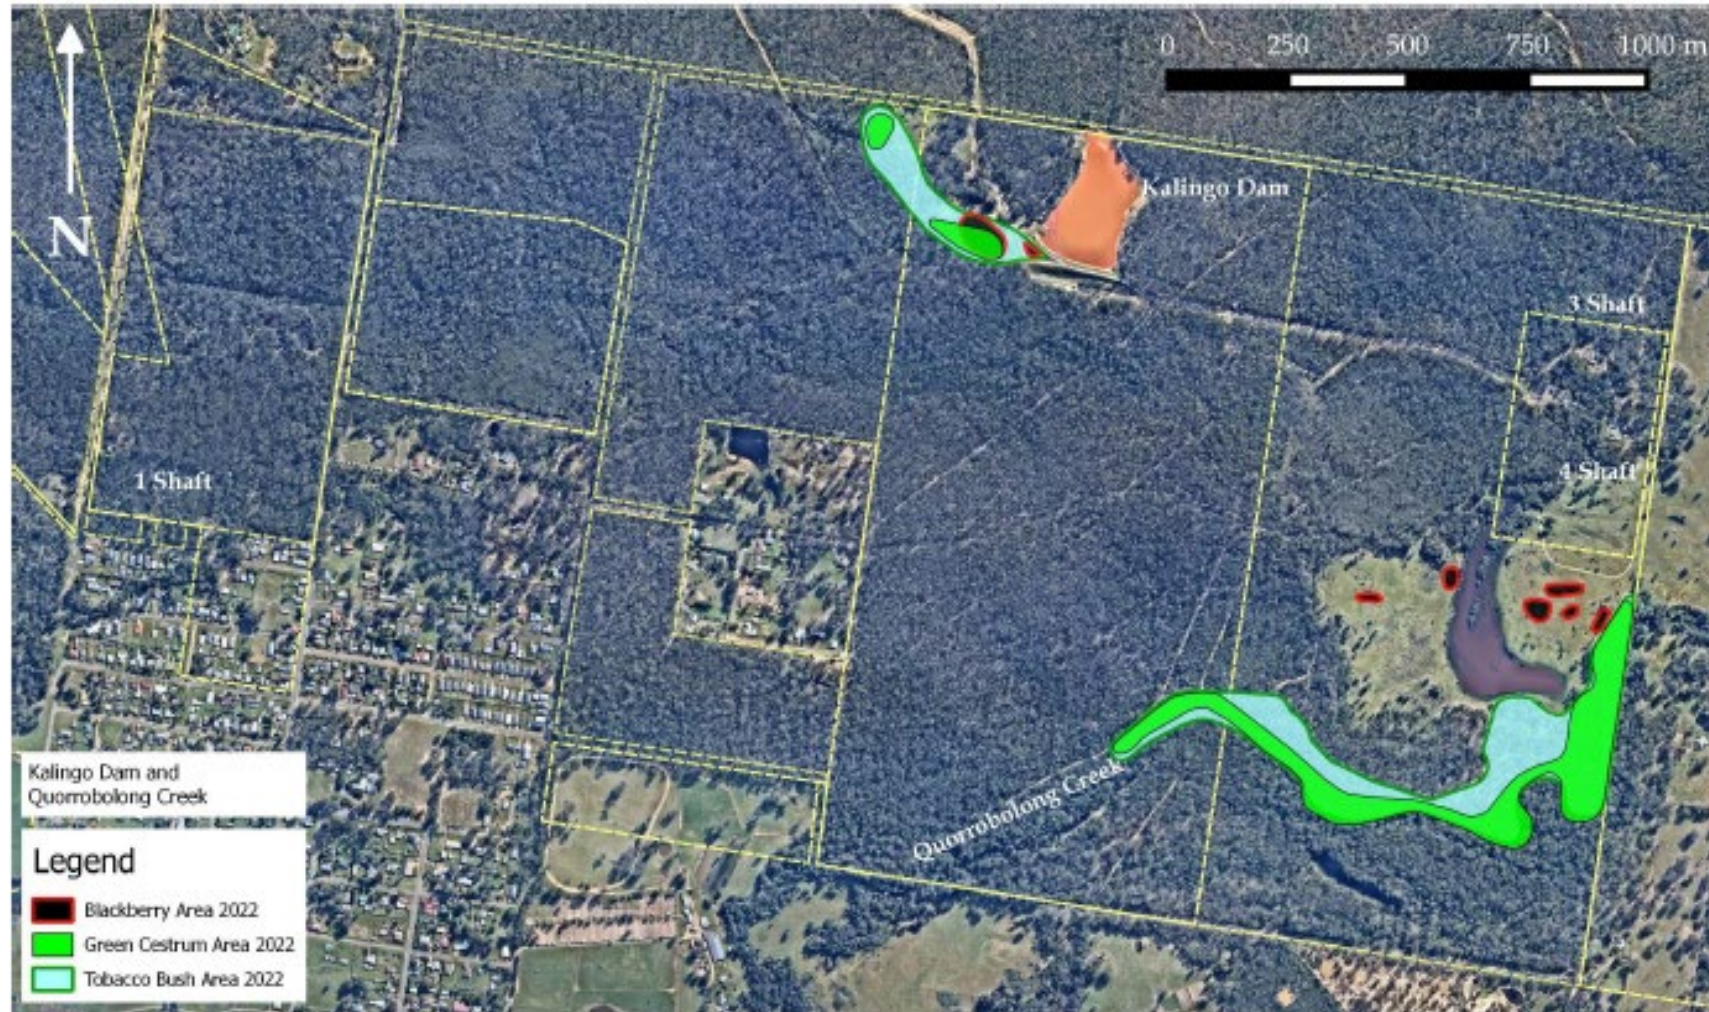
FIGURE 6-7 KALINGO DAM AND QUORROBOLONG CREEK WEED TREATMENT (SOURCE: AUSTAR WEED WORKS COMPLETED JULY 2021 TO JUNE 2022)

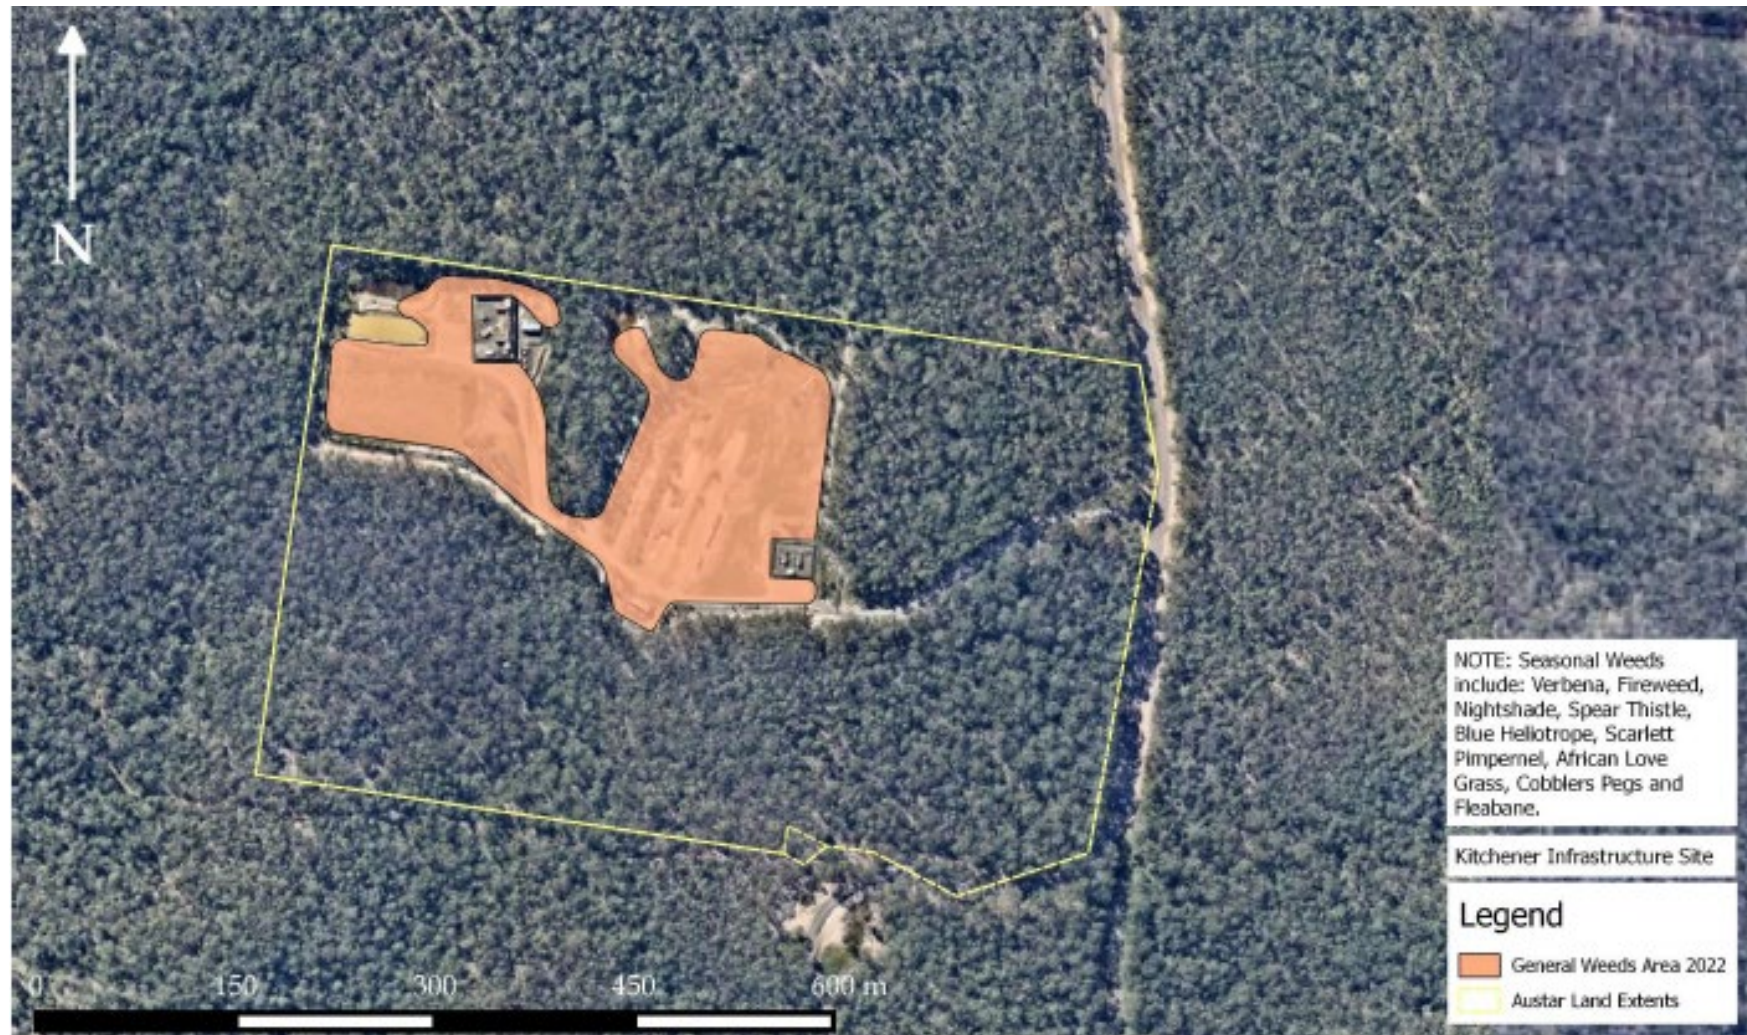
FIGURE 6-8 KITCHENER INFRASTRUCTURE SITE WEED TREATMENT (SOURCE: AUSTAR WEED WORKS COMPLETED JULY 2021 TO JUNE 2022)

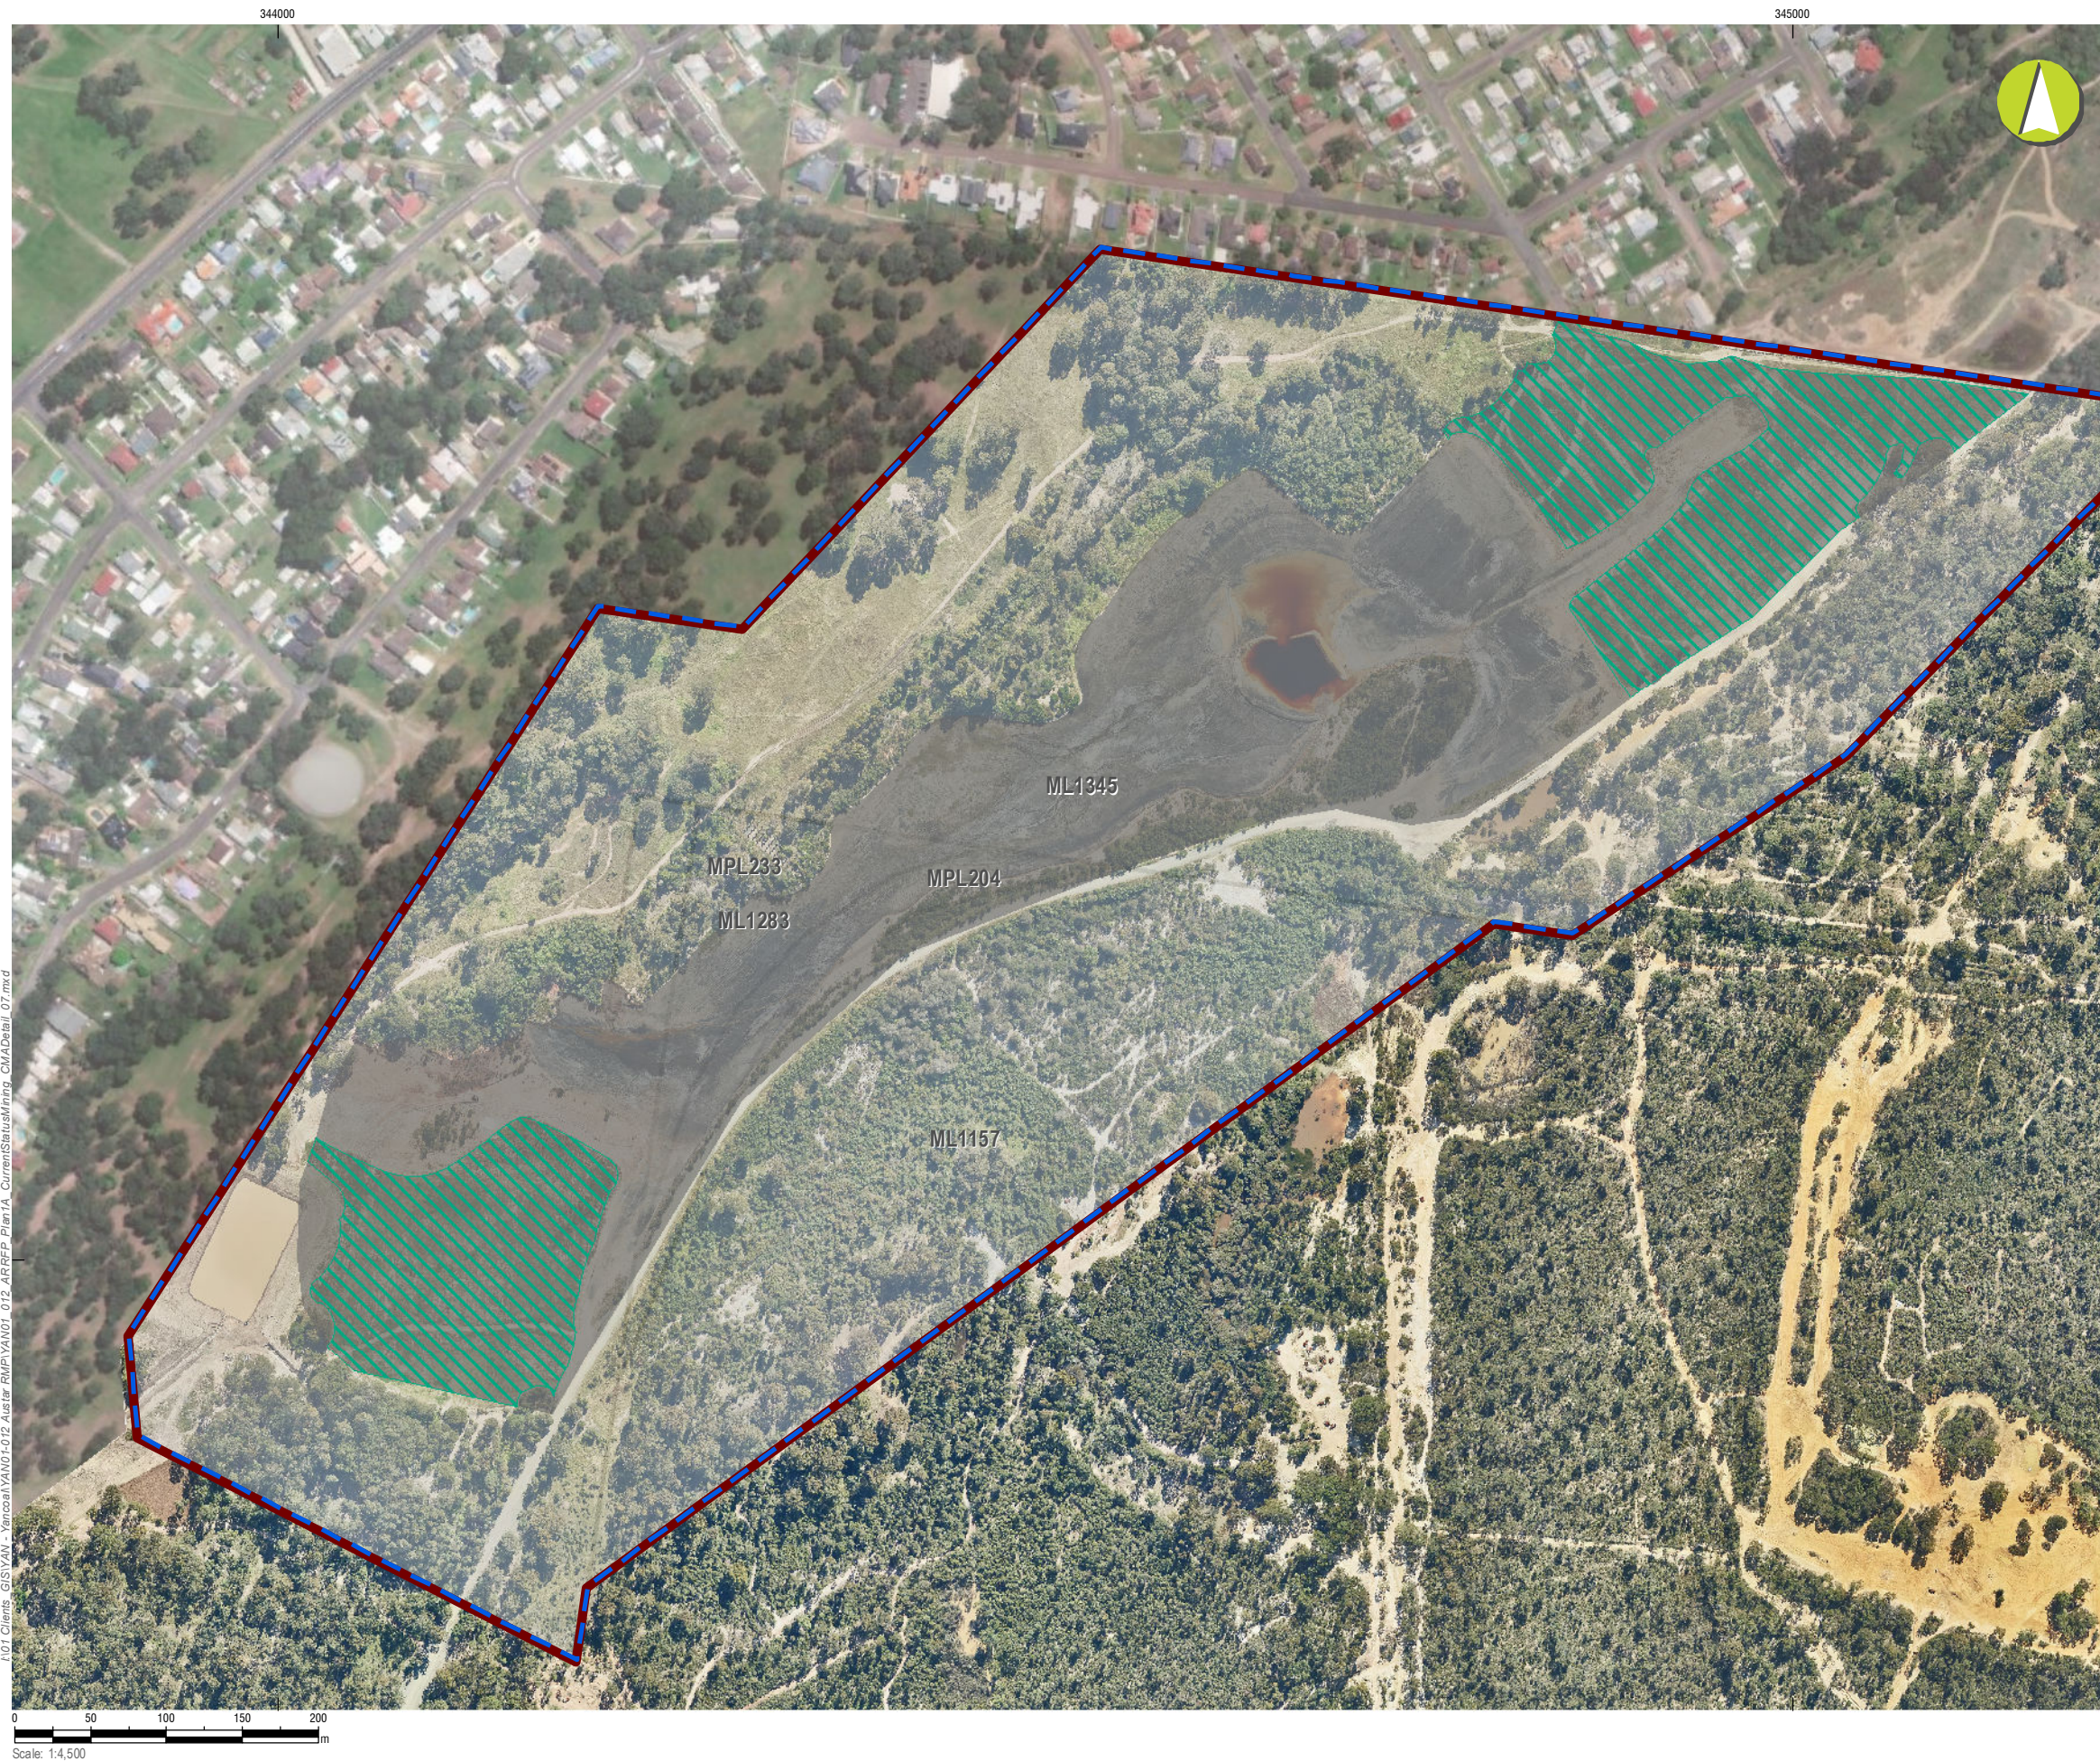
Austar Coal ARR 2022
CMA 7 - Aberdare Extended Emplacement Area

Current Status of Mining and Rehabilitation

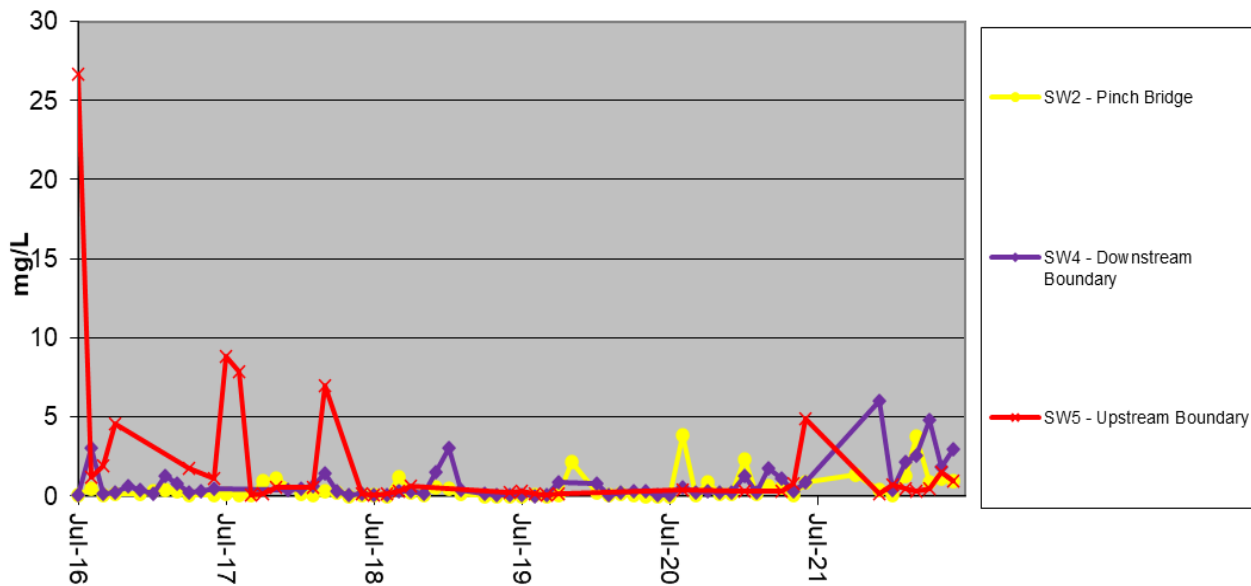
**Surface Water Sites - Iron (Total)
CHPP and Bellbird Creek
Long-Term Data**

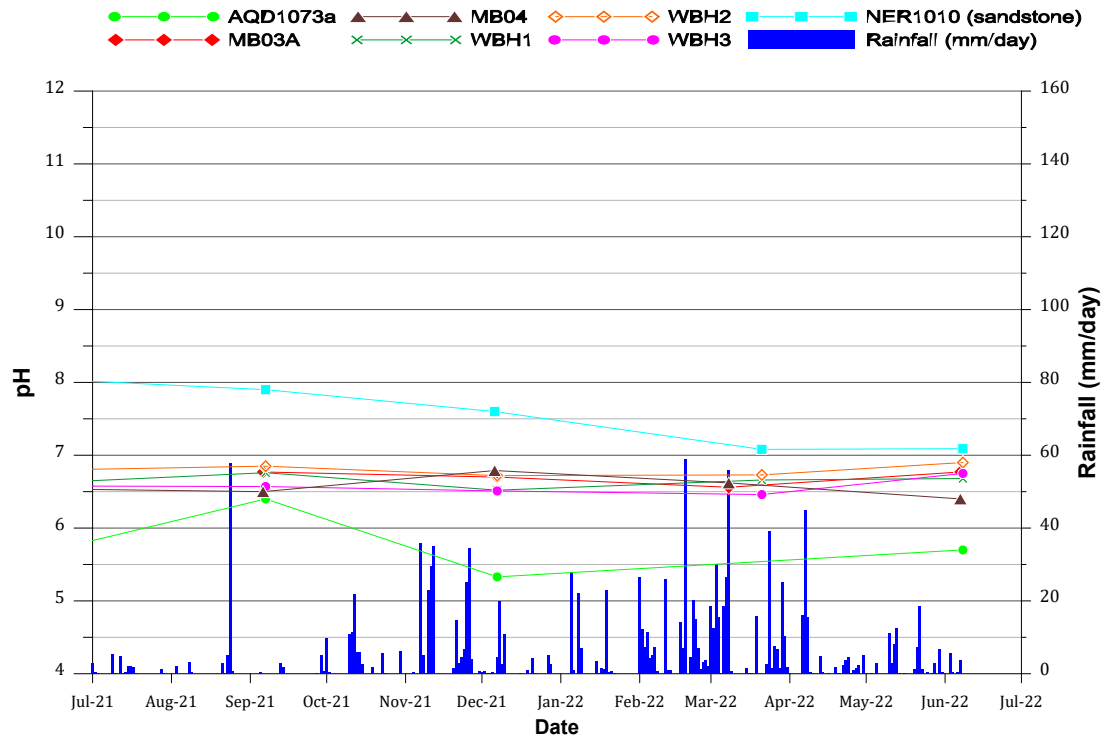
FIGURE 12.7 STAGE 2 AND BELLBIRD SOUTH ALLUVIUM AND SANDSTONE AQUIFER PH TRENDS

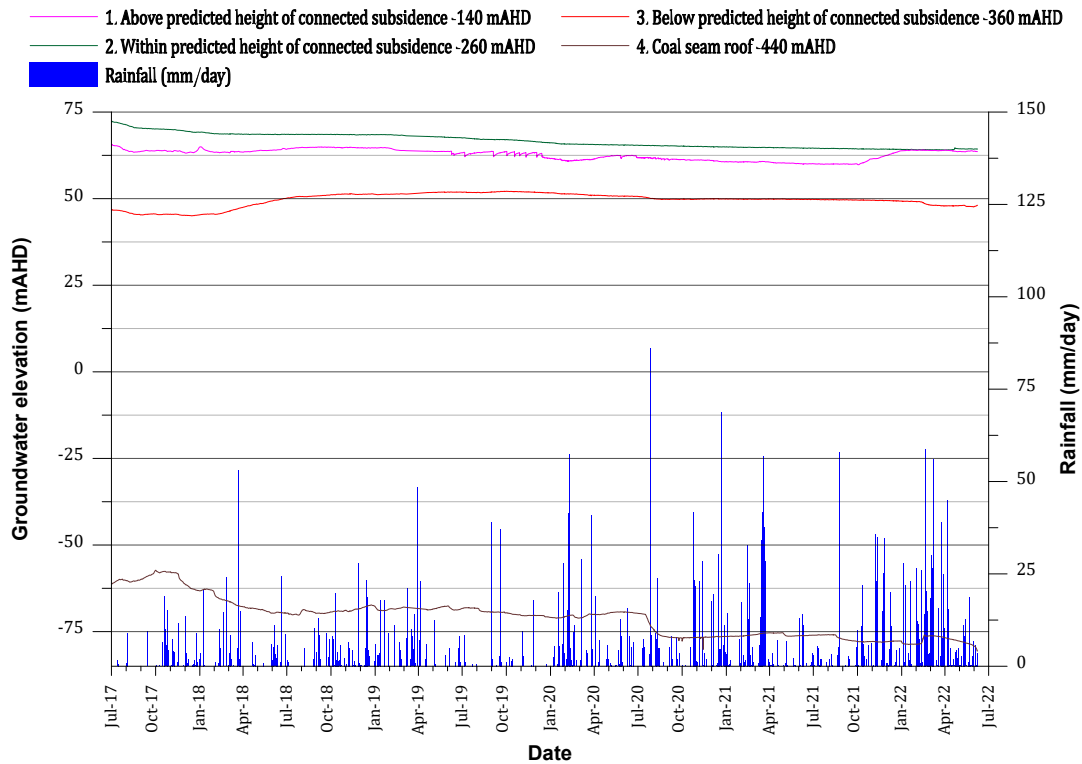
FIGURE 12.15 5-YEAR EX01H PIEZOMETRIC HEAD MEASUREMENTS: SENSORS NO.1 TO NO.4

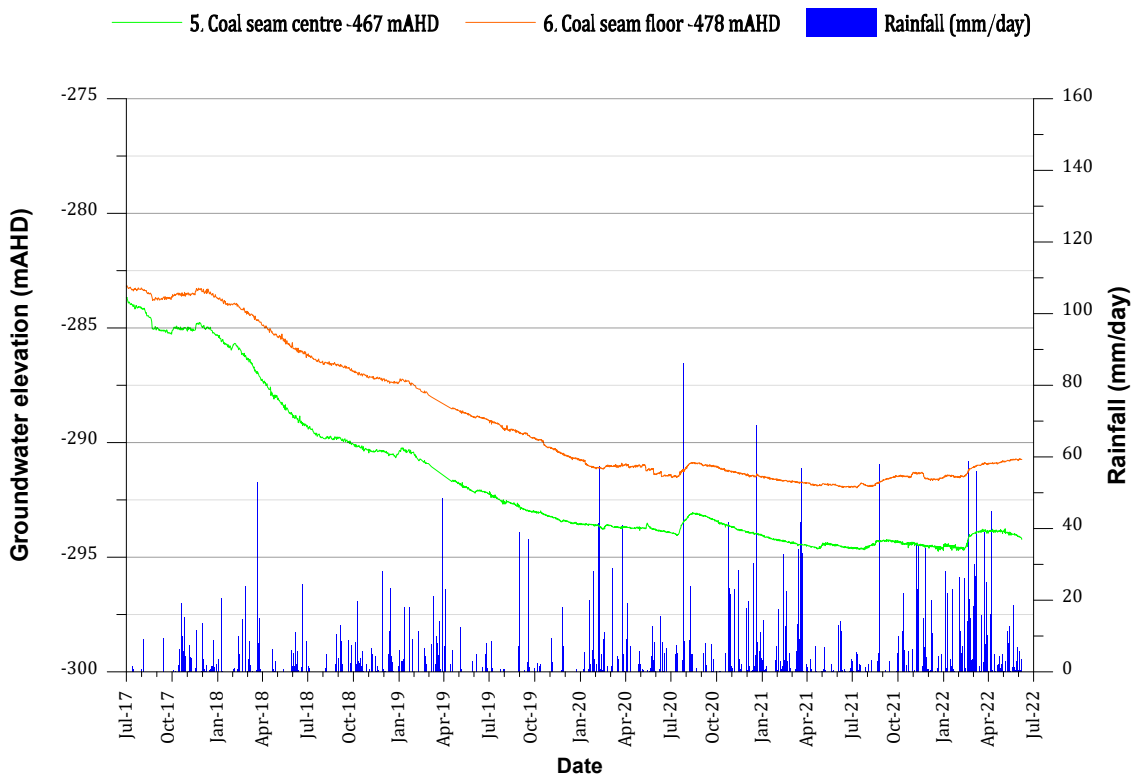
FIGURE 12.16 5-YEAR EX01H PIEZOMETRIC HEAD MEASUREMENTS: SENSORS NO.5 AND NO.6

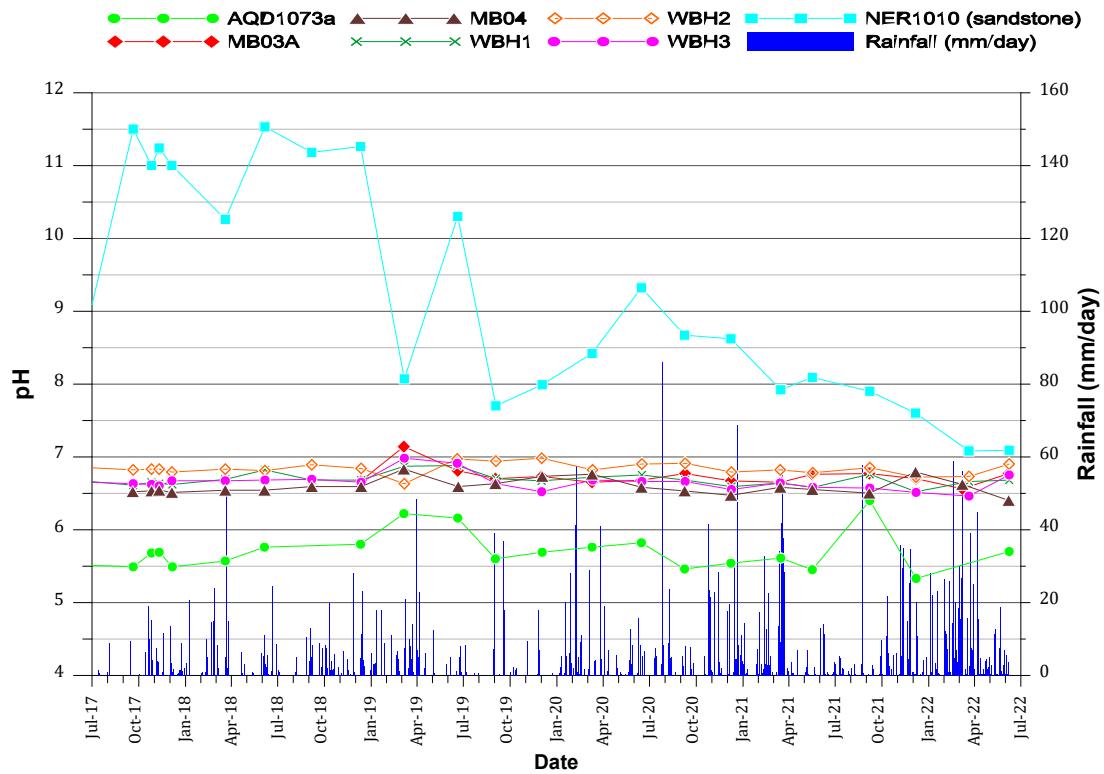
FIGURE 12.17 5-YEAR STAGE 2 AND BELLBIRD SOUTH ALLUVIUM AND SANDSTONE AQUIFER PH TRENDS

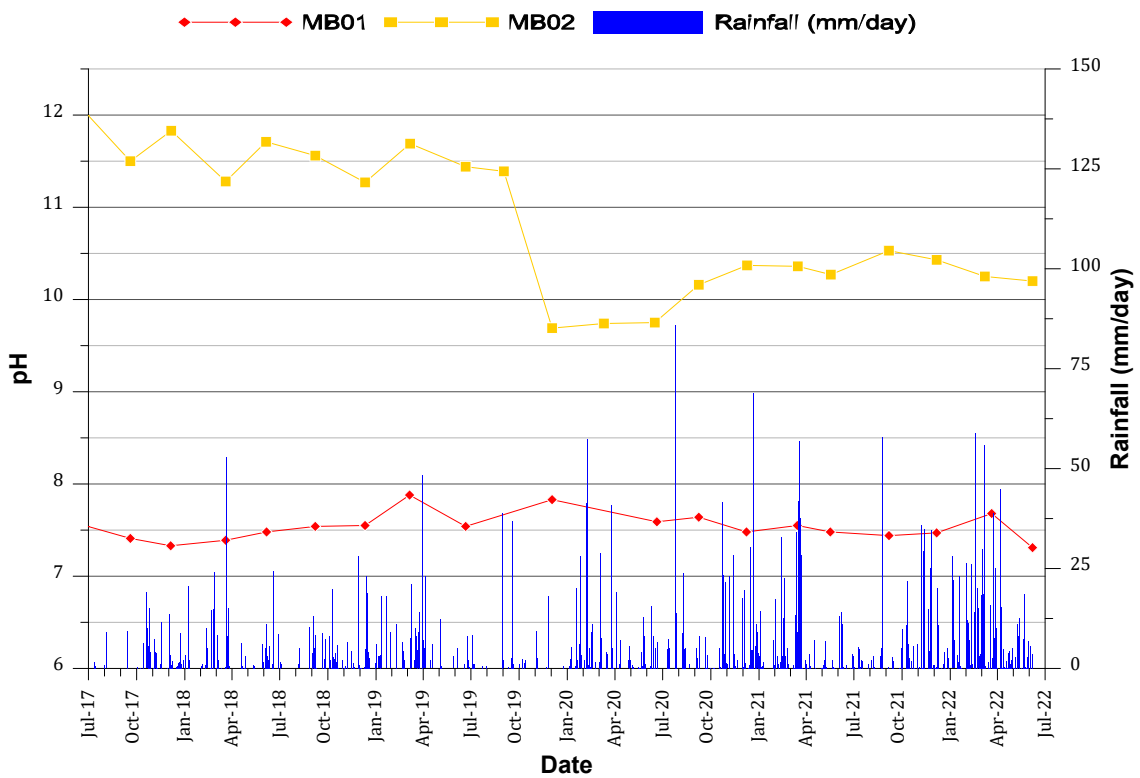
FIGURE 12.18 5-YEAR STAGE 3 SANDSTONE AQUIFER PH TRENDS
