## **Traffic Study**

**Austar Coal Mine Pty Ltd**  
Report for Austar Coal Mine  
Traffic Study

July 2008

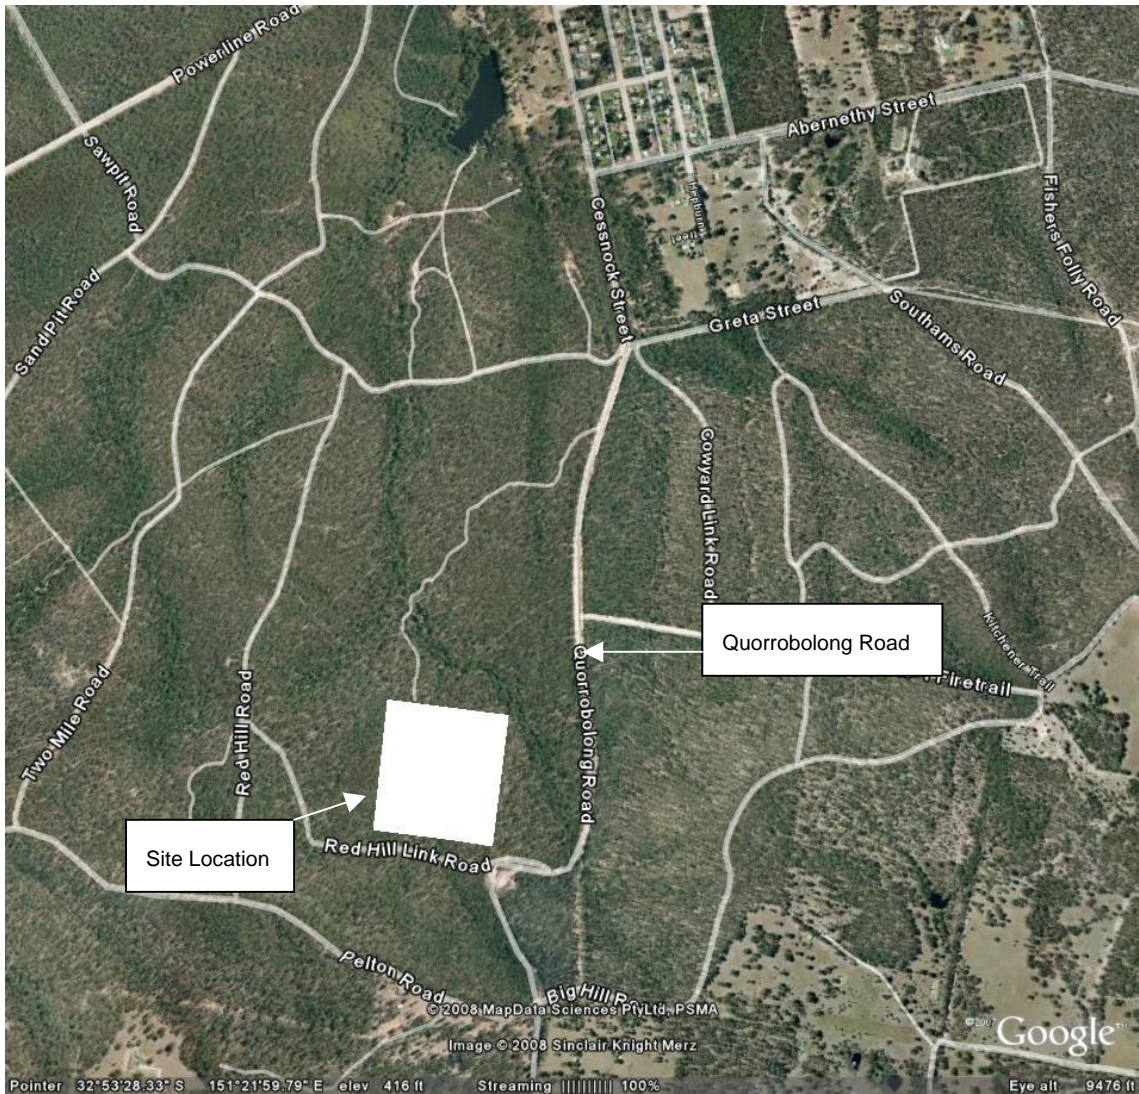
**Figure 1 Proposed Surface Infrastructure Site location**

The proposed Surface Infrastructure Site is located approximately 10 kilometres south of Cessnock and will be the access point to the mine for the majority of employees. Access to the site will be via Quorrobolong Road. The location of the site is shown in Figure 1.

The proposed development involves constructing an additional Surface Infrastructure Site to provide access to the mine for personnel, bathhouse, administration offices, car parking and other services. The location of the site on Quorrobolong Road is shown in Figure 1. The existing pit top facility will be maintained and continue to function as the main access point for mining equipment and maintenance of the mine. The Austar Coal Mine Conceptual Plan for the proposed development is shown in Appendix D. Features of the proposed development include:

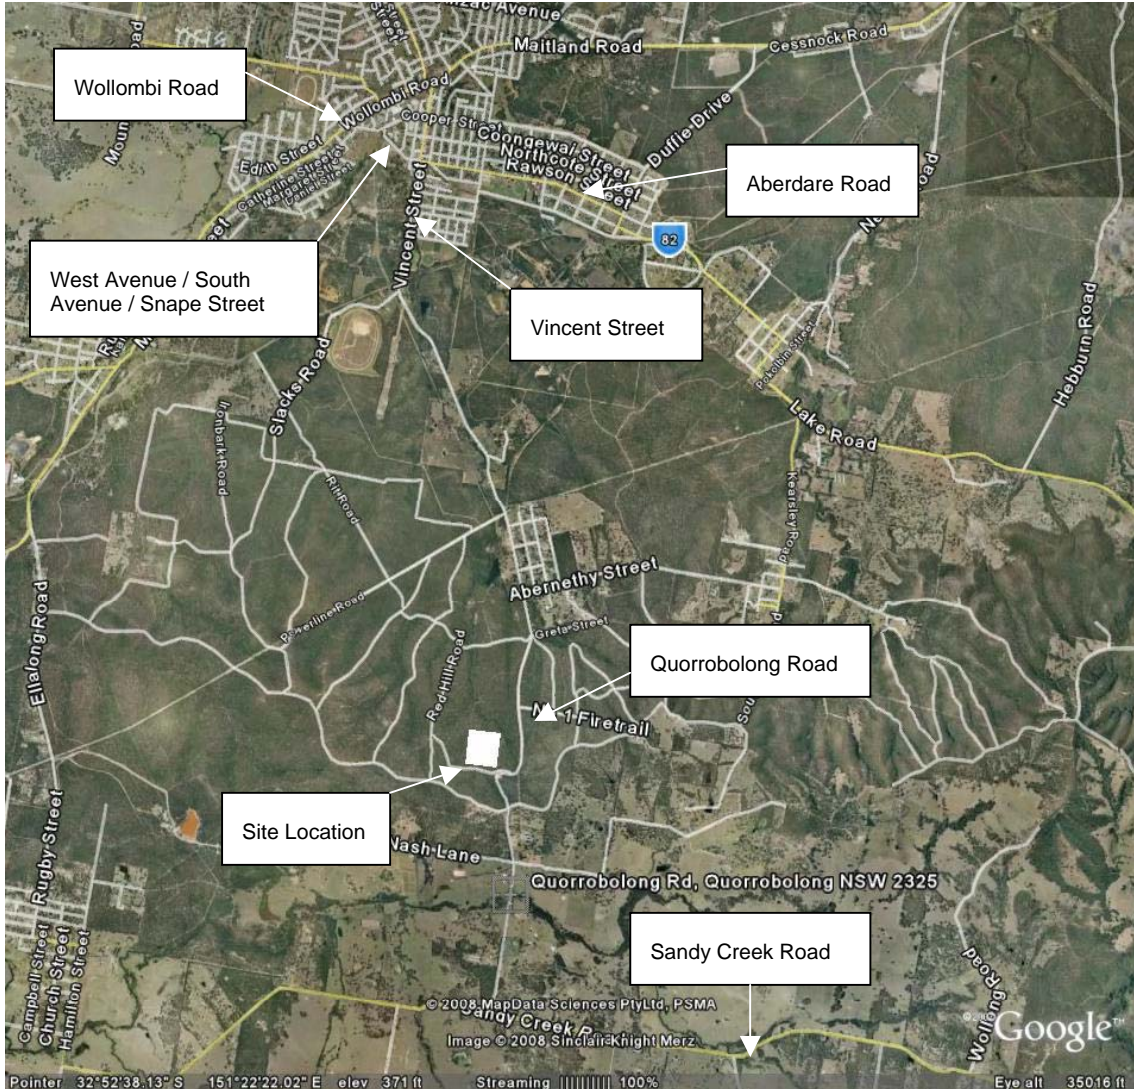
**Figure 2 Key roads and intersections surrounding the Quorrobolong Site**

The key roads surrounding the Quorrobolong Site are highlighted in **Figure 2**. These include:

- ▶ Quorrobolong Road;
- ▶ Sandy Creek Road;
- ▶ Wollombi Road;
- ▶ West Avenue / South Avenue / Snape Street;
- ▶ Aberdare Road;
- ▶ Duffy Drive;
- ▶ Maitland Drive; and
- ▶ Vincent Street.

The existing road network performance has been measured based on Australian Traffic Survey (ATS) classified turning movement surveys that were undertaken on 6 September 2007 at the three (3) key intersections within the study area as listed below (and highlighted in Figure 2).

The three (3) key intersections surrounding the Quorrobolong Site (and as highlighted in Figure 2) were modelled with the aid of Sidra Intersection 3.1 (SIDRA) traffic modelling software, based on the volumes from the surveyed turning movement counts. The main performance indicators from SIDRA include:

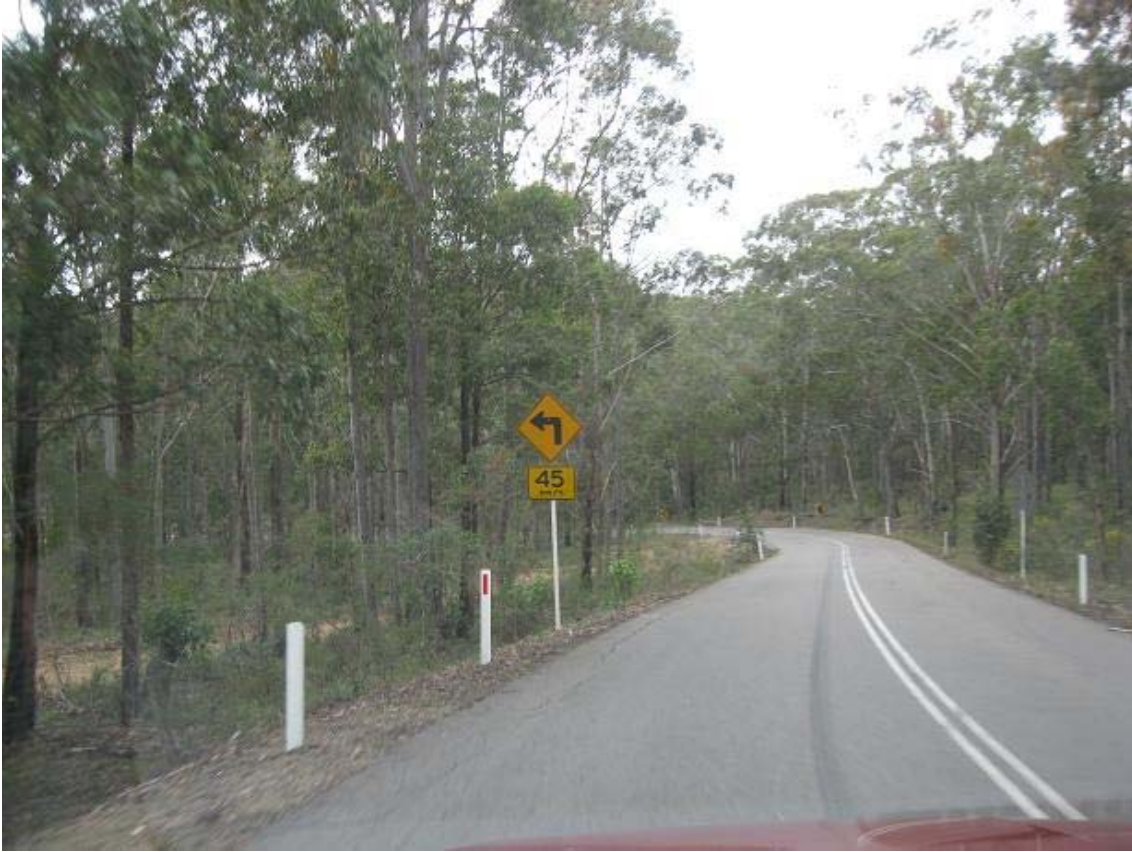
**Photo 1** Quorrobolong Road south of the proposed access

A winding section of Quorrobolong Road approximately 250m south of the of the proposed access contains speed advisory signs ranging from 45km/h to 75km/h. Line marking is present on this section of road (approximately 1km in length) and safety barriers are provided where necessary. The pavement condition on this section of road is good. Photo 1 shows the horizontal alignment south of the proposed access.

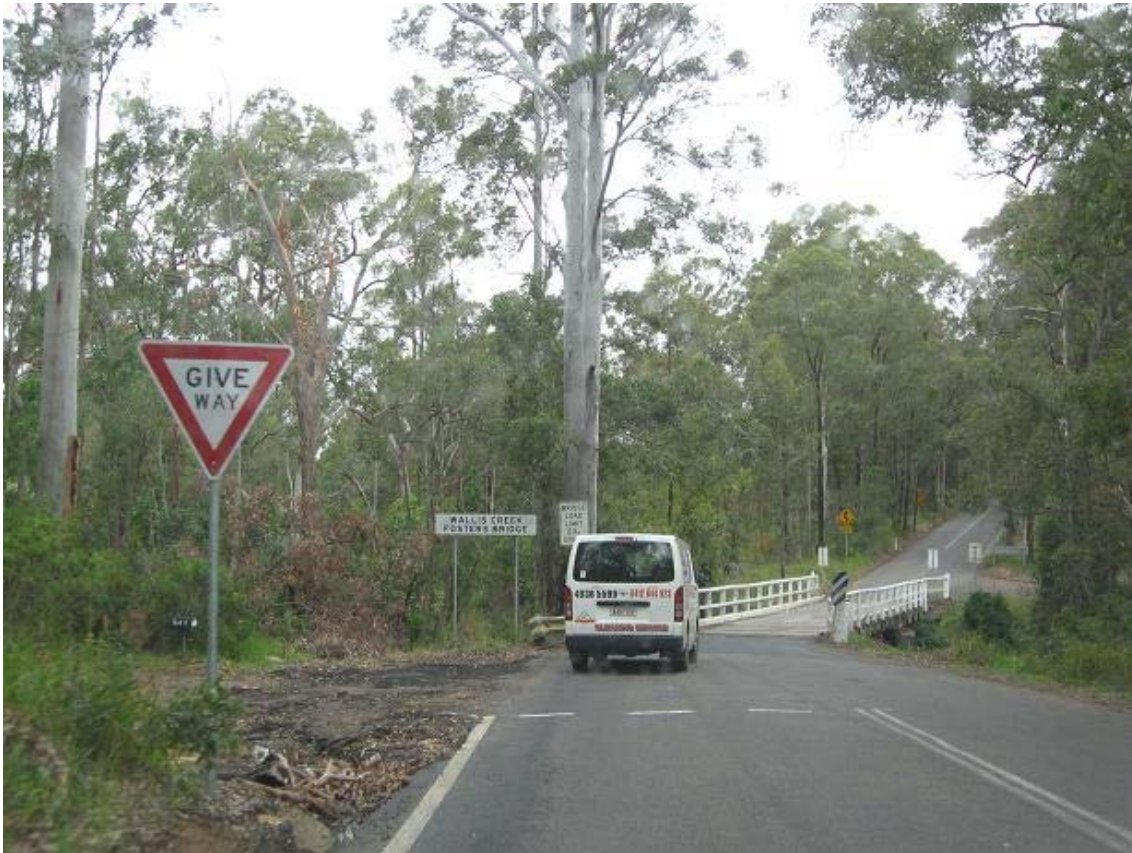
**Photo 2 Wallis Creek Fosters Bridge – Sandy Creek Road**

Sandy Creek Road is a two-lane two-way rural road that extends between Hamilton Street in the west and Lake Road in the east. The road consists of tight bends with speed advisory signs ranging from 35km/h to 75km/h for approximately 3km. For the remainder of the length of Sandy Creek Road the horizontal and vertical geometry of the road appears satisfactory for the 100km/h sign posted speed. The pavement is currently in good condition and has centre and edge line marking. A load limit of 20 tonnes applies to the one lane wooden Wallis Creek Fosters Bridge situated approximately 8km east of the intersection of Sandy Creek Road and Quorrobolong Road (shown in Photo 2).

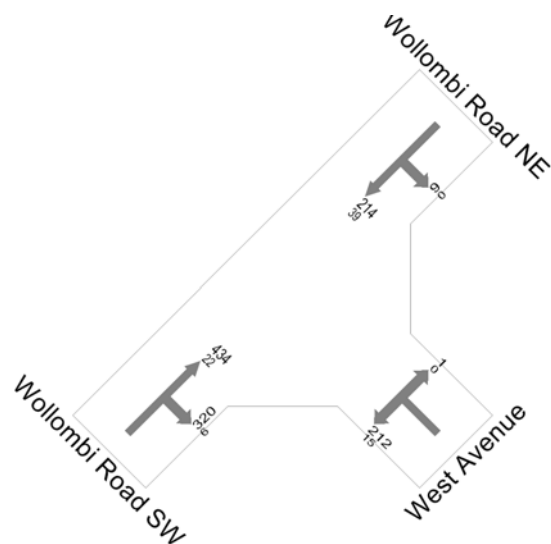
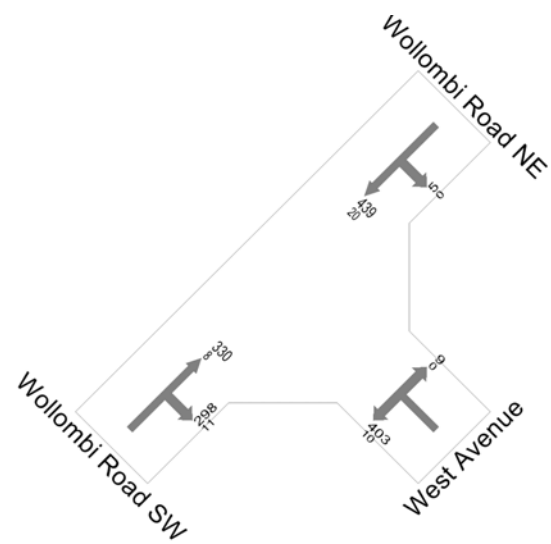
**Figure 4 Wollombi Road / West Avenue AM and PM peak classified turn counts**

- ▶ The speed limit along Wollombi Road and West Avenue has been modelled to be 60 km/h and 50 km/h respectively; and
- ▶ The classified turn counts during the morning and evening peak periods are as shown in Figure 4.

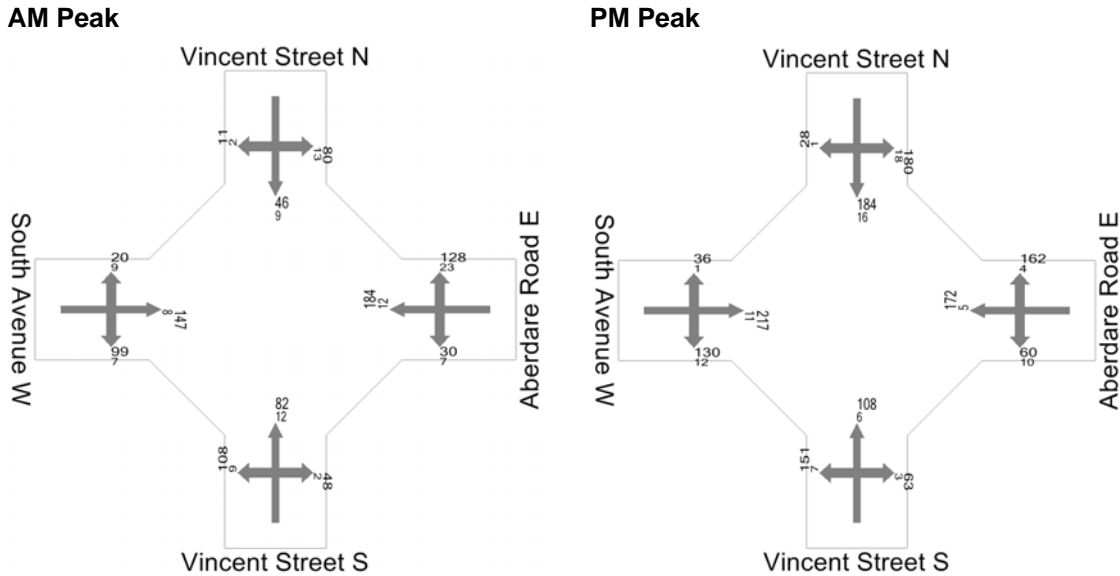
**Figure 6 Aberdare Road / Vincent Street AM and PM peak classified turn counts**

- ▶ The speed limit along Vincent Street and Aberdare Road has been modelled to be 60 kph and Snape Street/South Avenue has been modelled to be 50 kph; and
- ▶ The classified turn counts during the morning and evening peak periods are as shown in Figure 6.

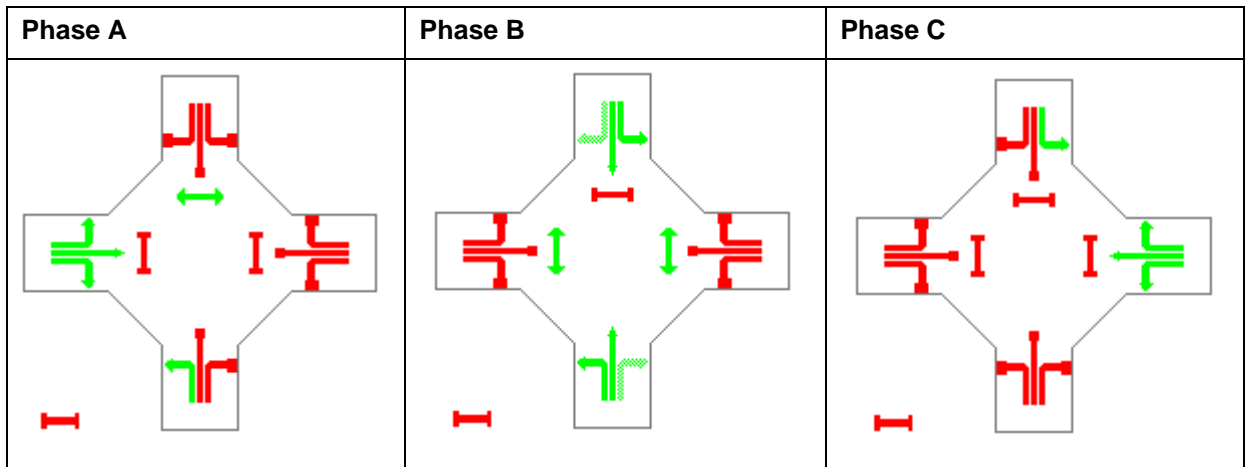
**Figure 7 Phase arrangement employed for Aberdare Road / Vincent Street signalised intersection for the morning and evening peak periods.**

- ▶ The phase arrangement employed in the SIDRA analysis has been based from the Traffic Signal Plan for the intersection (reference number TCS VV2356) provided by RTA and an on-site survey of signal operations conducted by Australian Traffic Survey (ATS) on 6 September 2007 for a ten (10) minute period during the evening peak. The phase arrangement employed for the morning and evening peak periods is highlighted in Figure 7.

- ▶ A fixed cycle time of 90 seconds was employed for both the morning and evening peak periods. This cycle time was determined from the average cycle time calculated from the on-site survey undertaken by ATS and the practical cycle time calculated by SIDRA. The phase times were optimised in SIDRA; and
- ▶ The default pedestrian volume of 50 pedestrians / hour on the North, East and West approach has been employed.

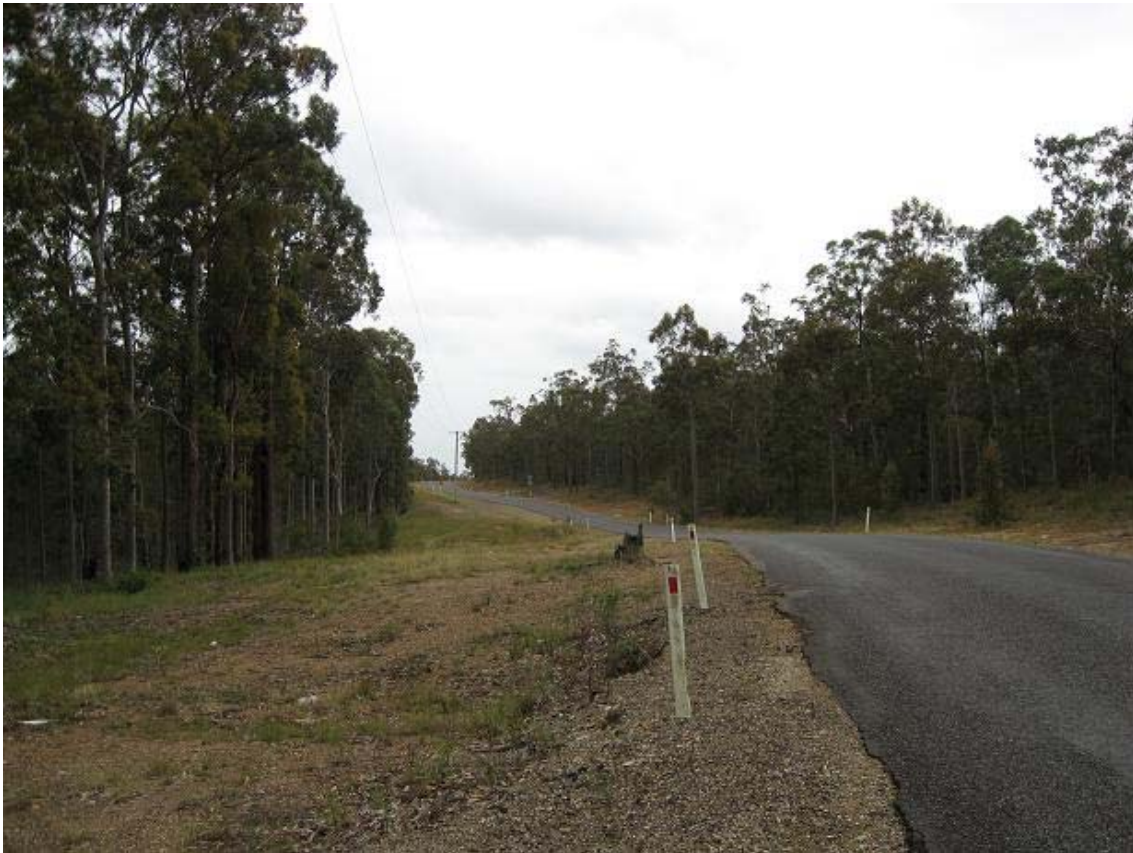
**Photo 3** View north from the proposed access

Table 8 demonstrates that sight distance at the proposed access meets the minimum requirement in both directions, but is less than the desirable for northbound traffic. The erection of a left side road junction (W2-4) warning sign for northbound traffic will provide an early warning of the upcoming intersection. Lighting the intersection at night would further assist drivers to recognise the intersection location. Photo 3 and Photo 4 show the line of sight from the proposed access in the north and south direction respectively.

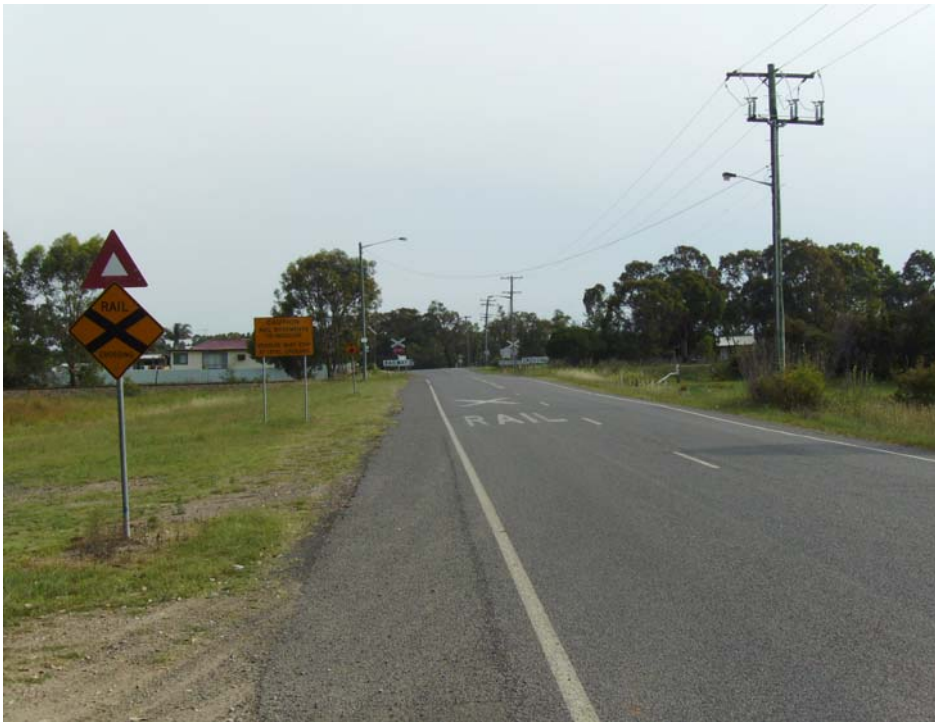
**Photo 1-1 Northern Approach to Level Crossing**

- ▶ Straight road alignment and level grading (approx) on approaches and through the level crossing. Intersection with Racecourse Road approximately 100 m to the south;
- ▶ Straight rail alignment on approaches and through the level crossing;
- ▶ Rail alignment angled to road (60 degrees approx);
- ▶ 'Stop sign' level crossing control;

- ▶ 60 km/hr sign posted speed limit for Vincent Street and part of Quorrobolong Road to the south;
- ▶ 30 km/hr speed limit for South Maitland rail line through level crossing;
- ▶ Existing residences adjacent to the level crossing – NE and NW corners;
- ▶ School bus route;
- ▶ No pedestrian facilities;
- ▶ Street lighting each side of the level crossing (diagonal);
- ▶ Existing power poles and overhead cables on westside of roadway; and
- ▶ Signage and line-marking generally appropriate for a level crossing with 'stop sign' control for a straight road.

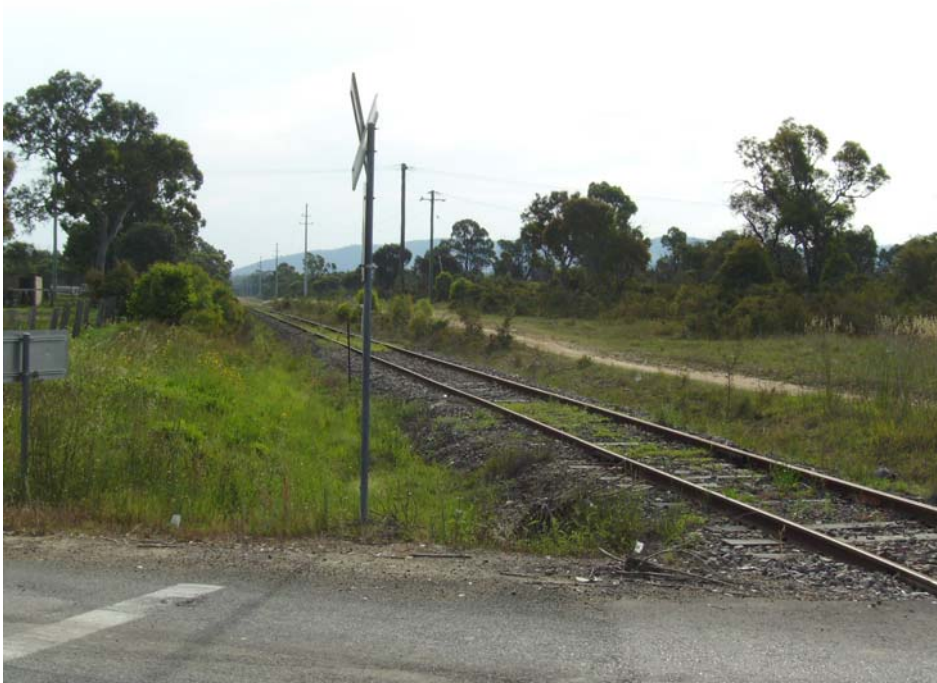
**Photo 1-3 View to The West Along Rail Line From Level Crossing**

It was noted that the level crossing and approaches remained the same as found on Thursday 15 February 2007, except for some additional tree/shrub growth to the west of the level crossing adjacent to the rail line. See Photo 1-3 above.

It is recommended that the overgrown shrubs be removed from the sight line corridor.
