Managed by Rio Tinto Coal Australia

Mount Thorley Warkworth
Monthly Environmental Report
August 2017

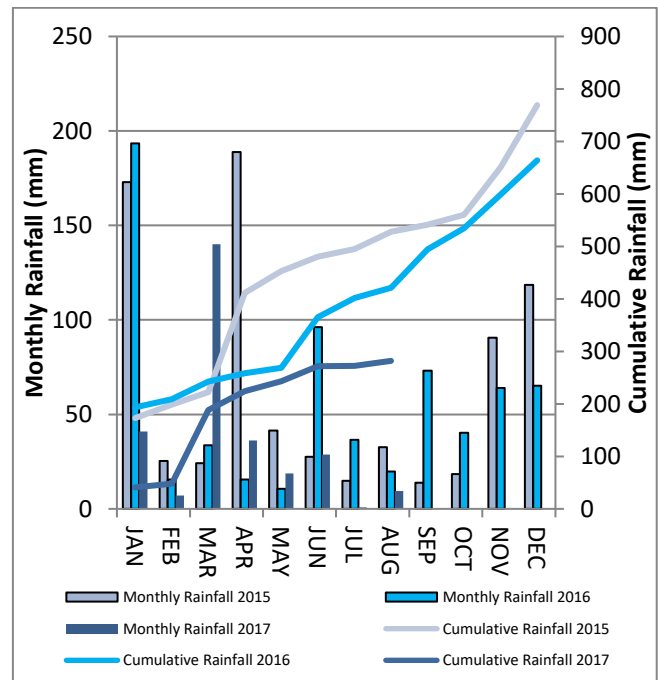
Figure 1: Rainfall Trend YTD

2017	Monthly Rainfall (mm)	Cumulative Rainfall (mm)
August	9.4	282.0

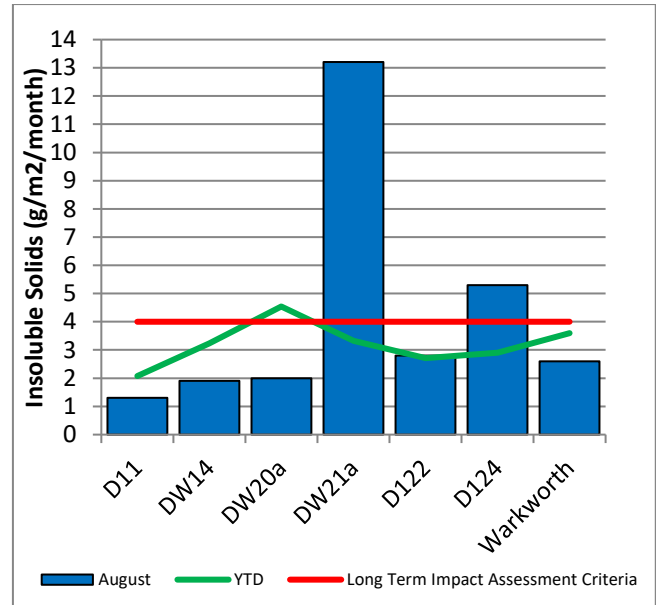
Figure 4: Depositional Dust – August 2017

Figure 4 displays insoluble solids results from depositional dust gauges during the reporting period compared against the year-to-date average and the annual impact assessment criteria.

During the reporting period the DW21a and D124 monitors recorded a monthly result above the long term impact assessment criteria of 4.0 g/m² per month. Field notes associated with DW21a and D124 confirm the presence of insects and bird droppings. As such the results are considered contaminated and will be excluded from calculation of the annual average.

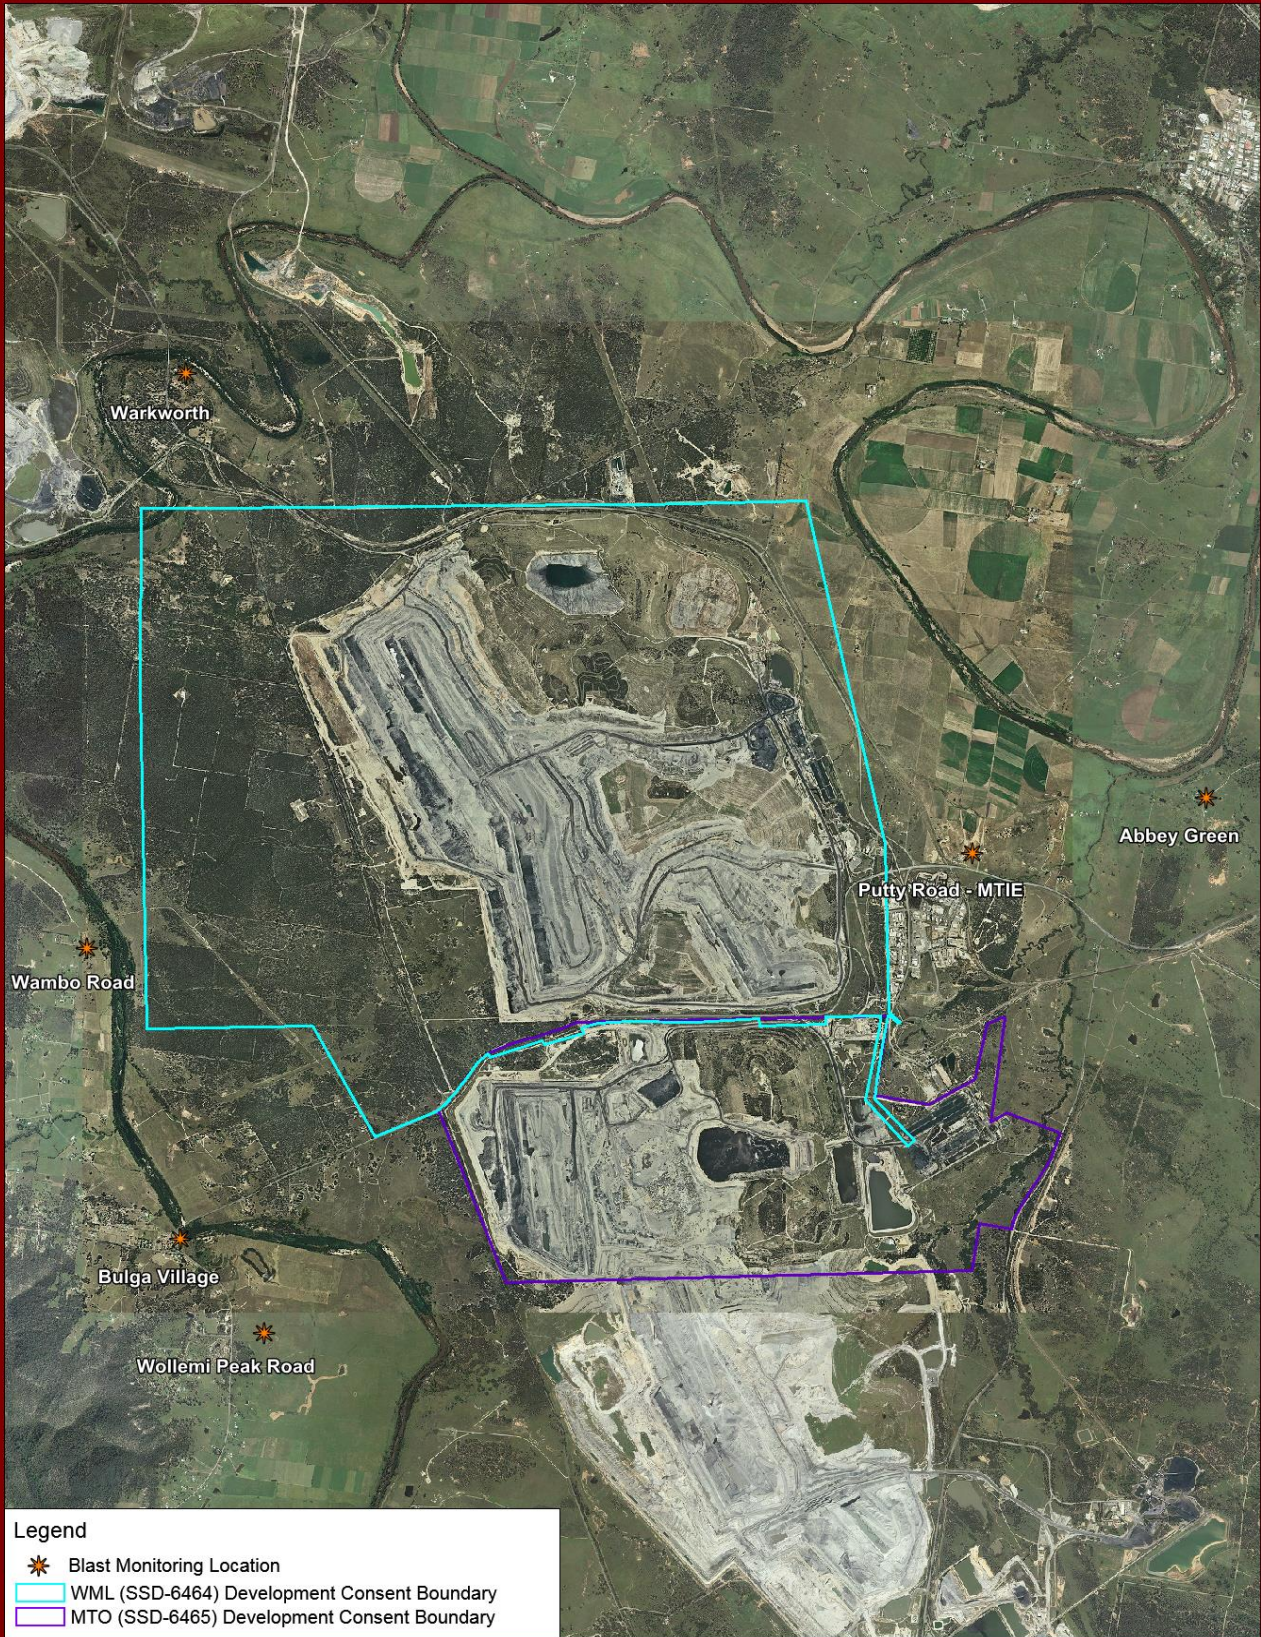
Figure 15: MTW Blast Monitoring Location Plan

MTW have a network of six blast monitoring units. These are located at nearby privately owned residences and function as regulatory compliance monitors.

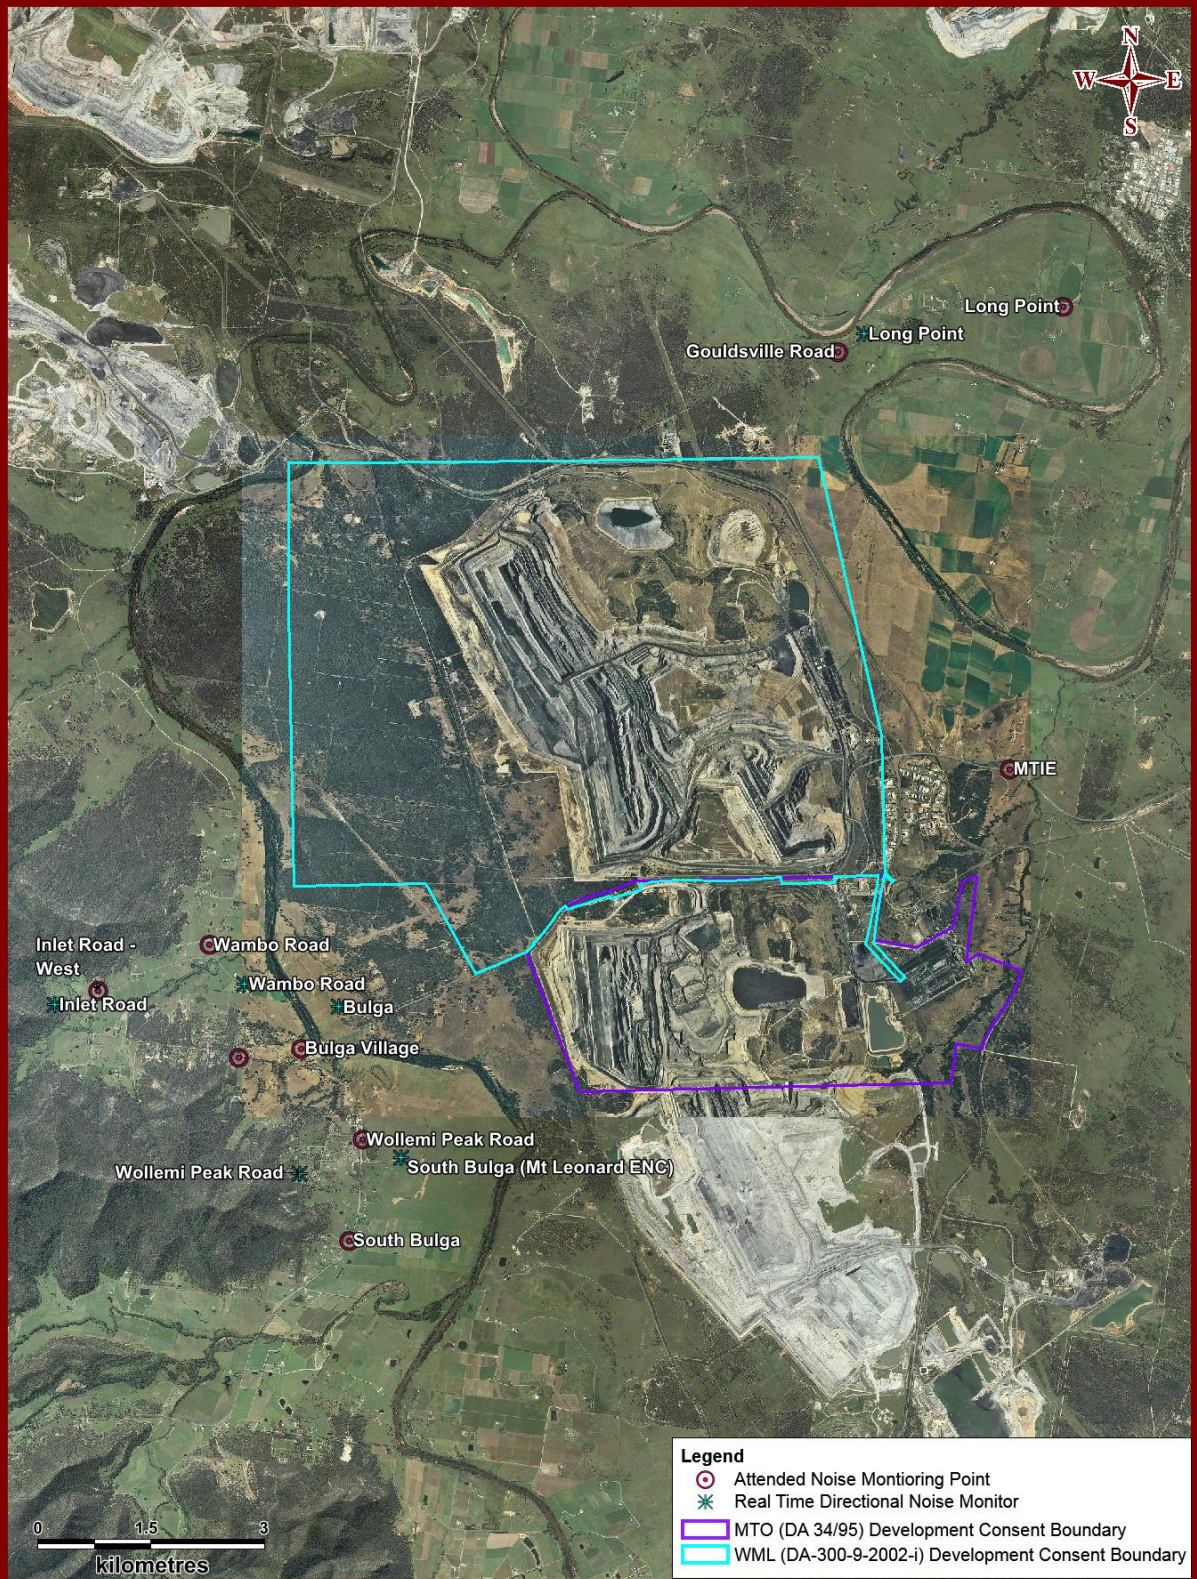
Figure 16: Noise Monitoring Location Plan

Routine attended noise monitoring is carried out in accordance with the MTW Noise Management Plan. A review against EIS predictions will be reported in the Annual Review. The purpose of the noise surveys is to quantify and describe the acoustic environment around the site and compare results with specified limits. Real time noise monitoring also occurs at nine sites surrounding MTW. Noise monitoring locations are displayed in Figure 16.

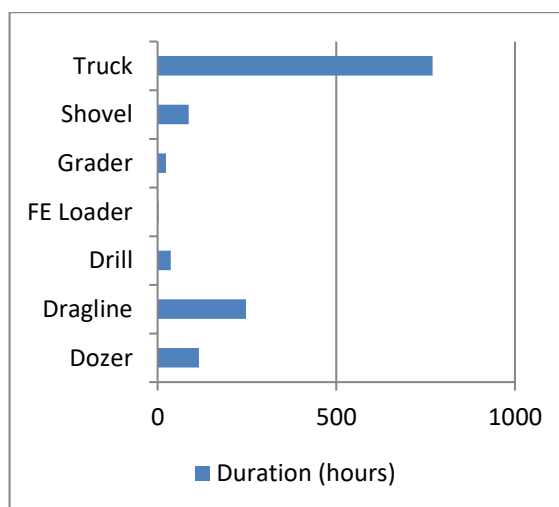
Figure 17: Operational Downtime by Equipment Type – August 2017

During August, a total of 1283.2 hours of equipment downtime was logged in response to environmental events such as dust, noise and adverse meteorological conditions. Operational downtime by equipment type is shown in Figure 17.

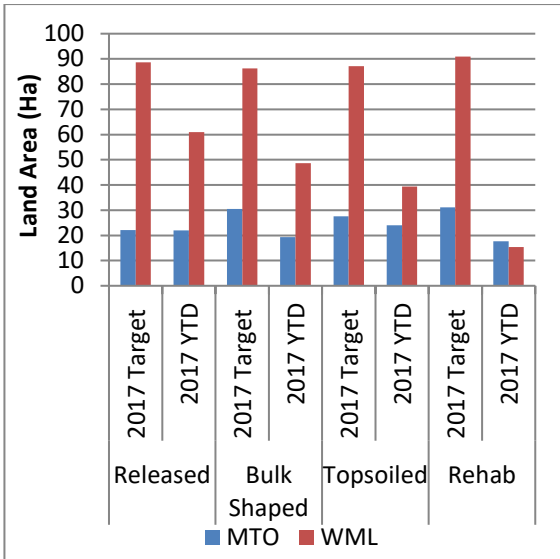
Figure 18: Rehabilitation YTD - August 2017

During August, 21.04 Ha of land was released, 8.20 Ha of land was bulk shaped, 22.96 Ha of land was topsoiled, 9.51 Ha of land was composted and 5.23 Ha of land was rehabilitated.
