Austar Coal Mine

Community Consultative Committee Meeting Minutes

COMMUNITY CONSULTATIVE MEETING

Q1 2019
20 February 2019

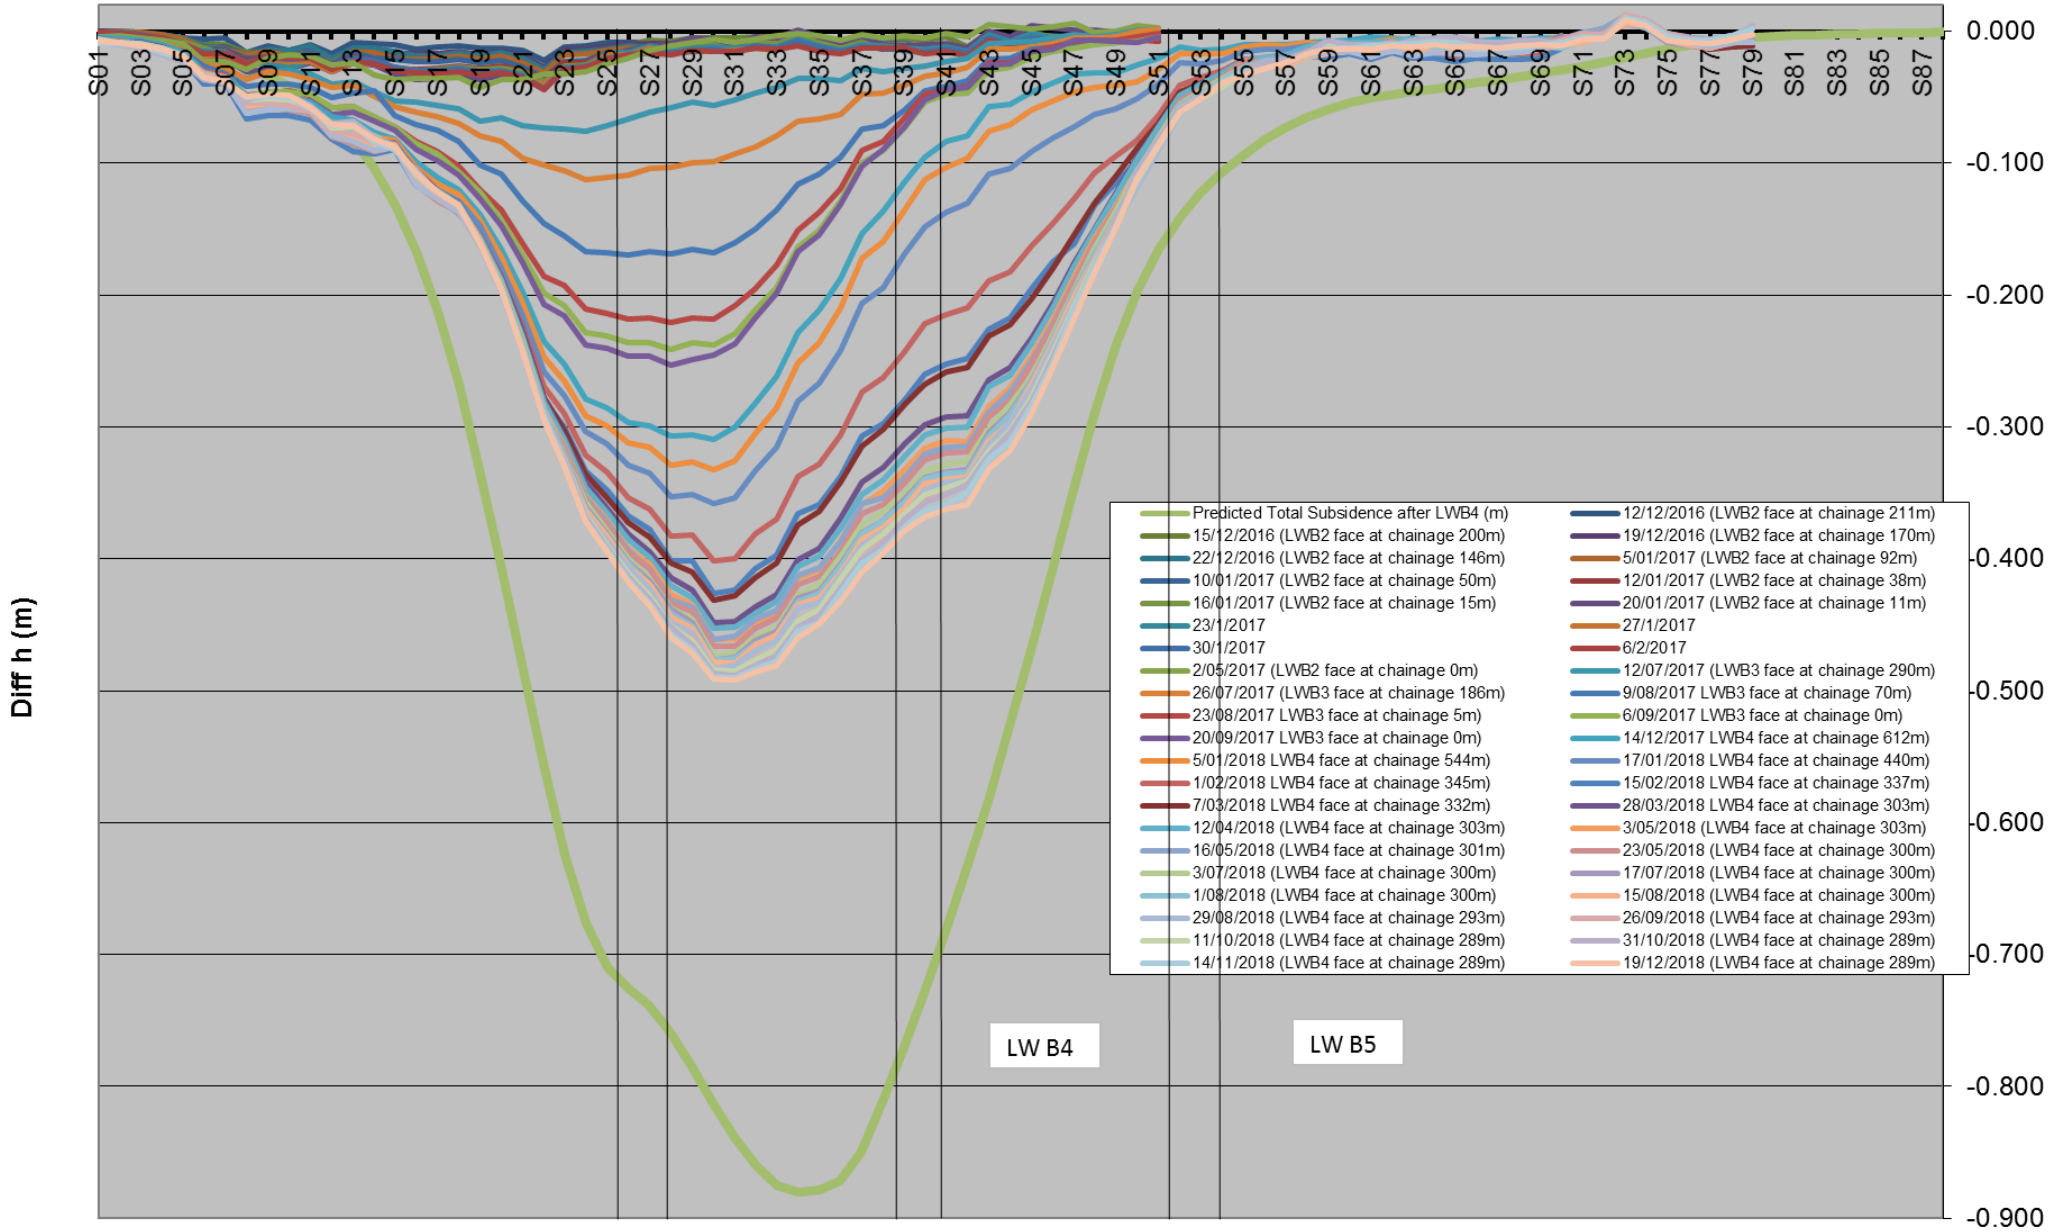
Subsidence- LINE "SCR1"

- Subsidence surveys are ongoing along the Sandy Creek Road monitoring line
- Maximum recorded surface level movement on Sandy Creek Road is approximately 492 mm as surveyed 19 December 2018

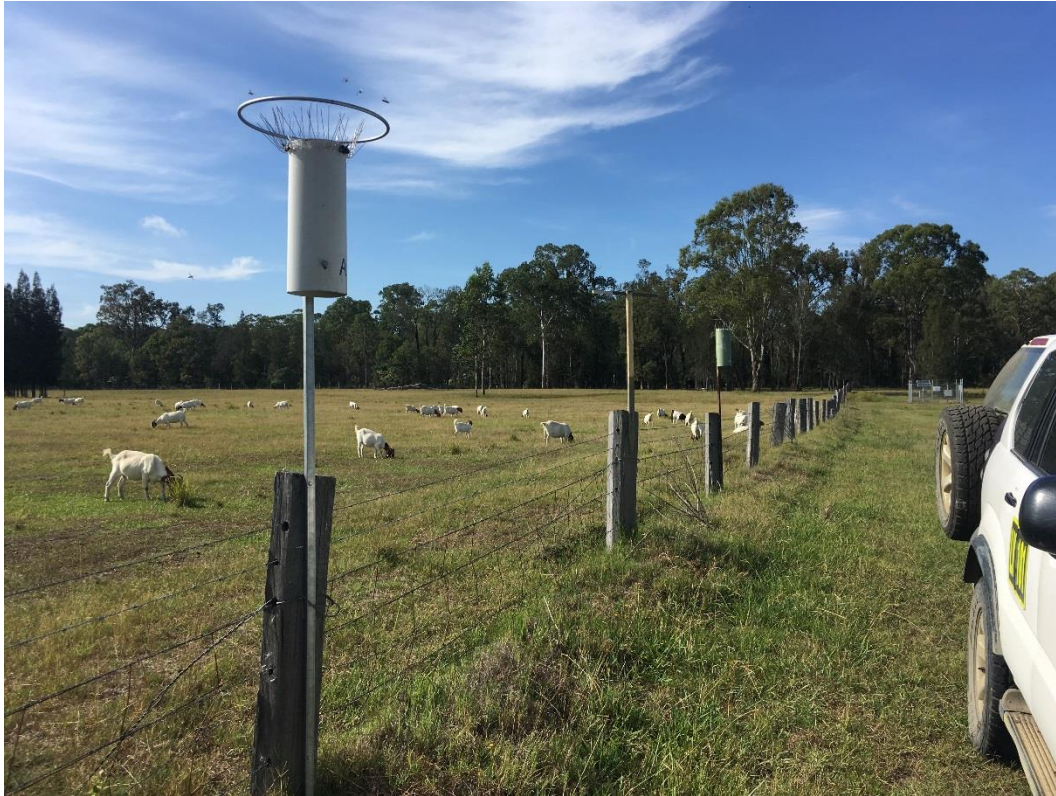
Dust Deposition Gauge 5A (D5A)

- A second dust deposition gauge was installed adjacent to D5 (near 3 Shaft)
- Increased potential for result if D5 contaminated
- Alternate type of bird spikes/ring to D5

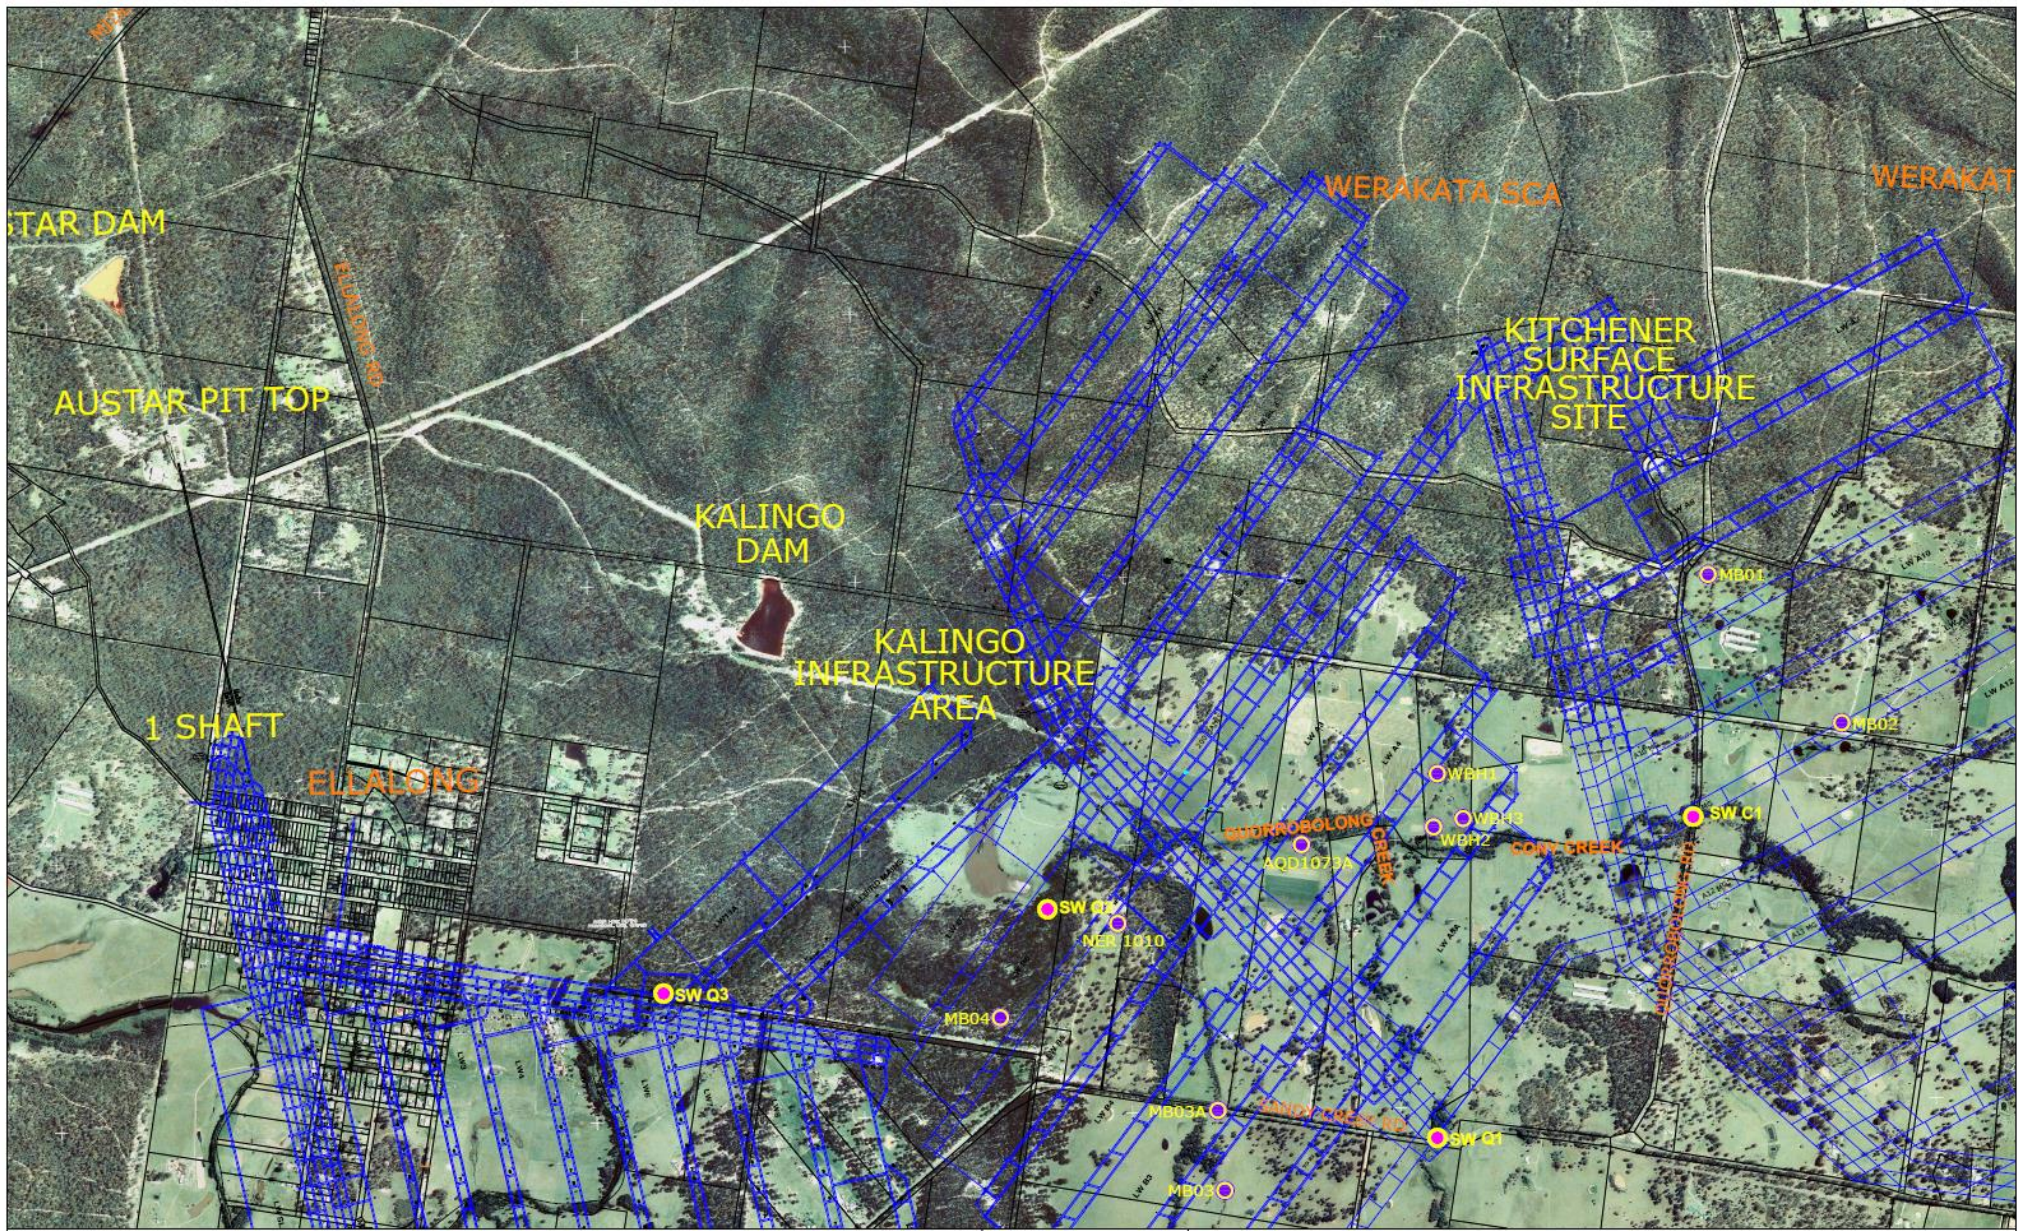
Austar Surface & Groundwater Monitoring Locations

- NER1010 Ground Water Monitor
- SW 2 Surface Water EPL Sample Points
- SW C1 Coney Creek Sample Points
- SW Q1 Quorrobolong Creek Sample Points

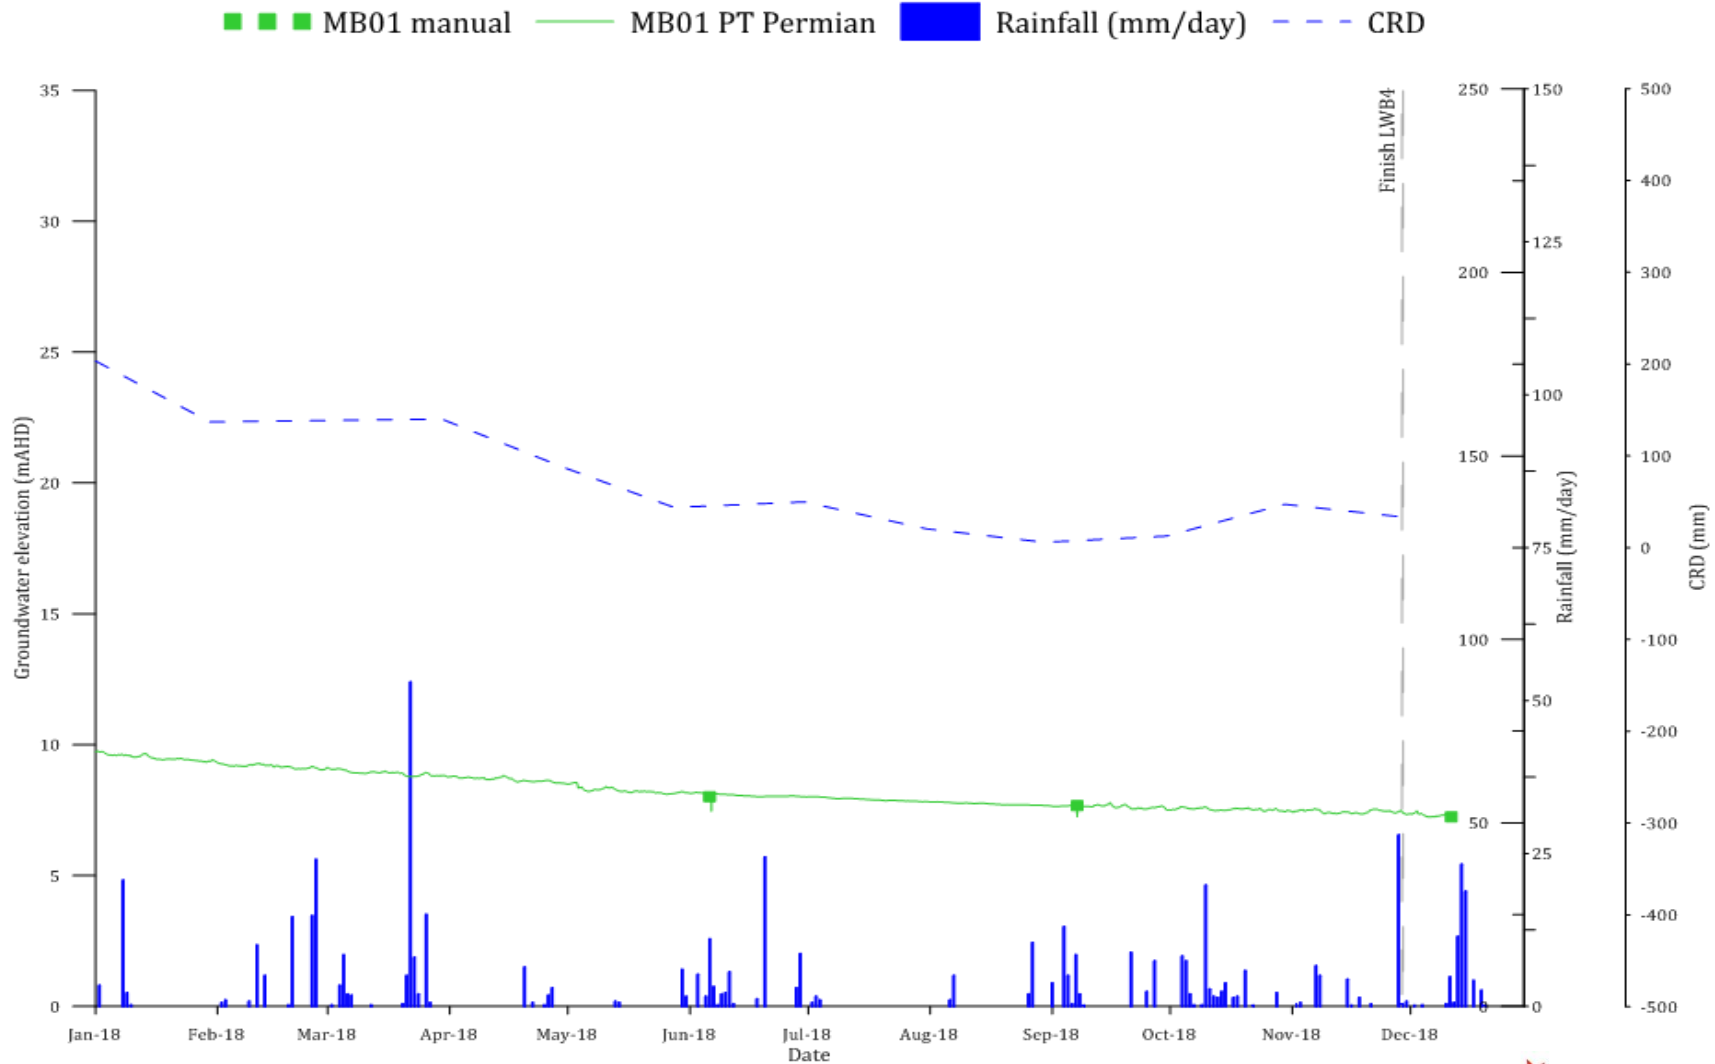
**Stage 3 MB01 sandstone aquifer
groundwater level hydrograph**

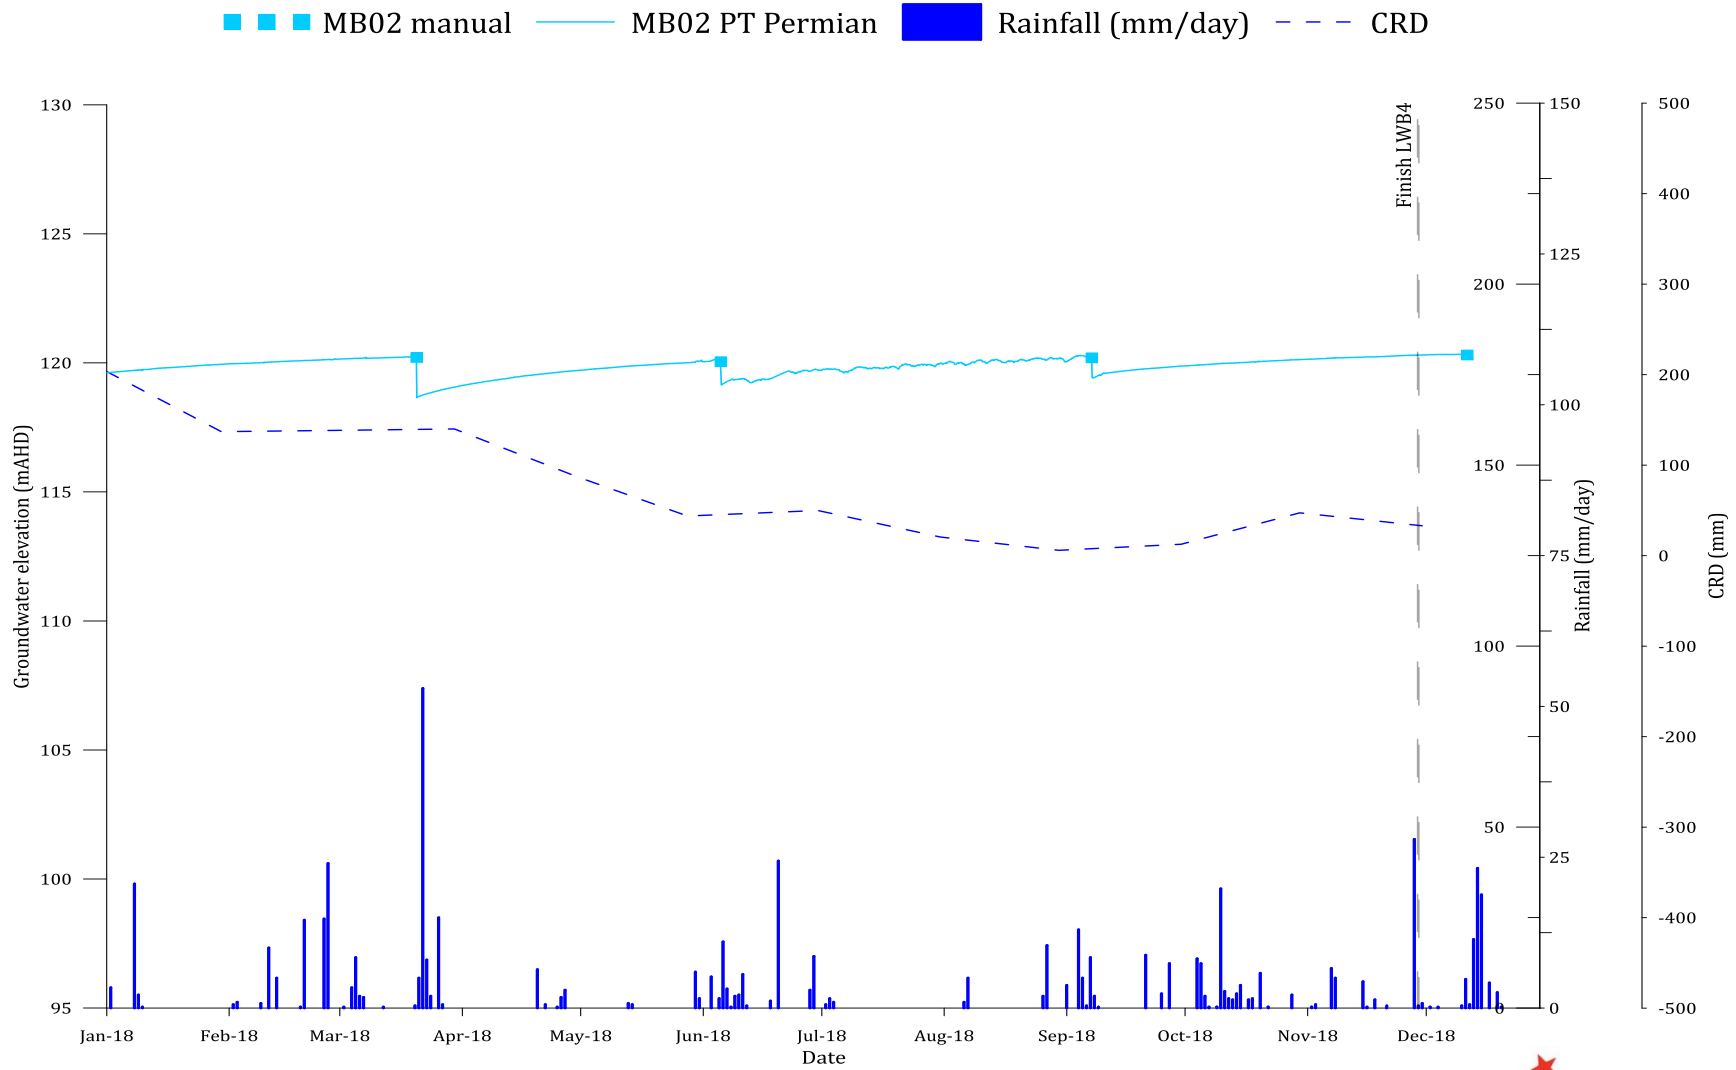
**Stage 3 MB02 sandstone aquifer
groundwater level hydrograph**

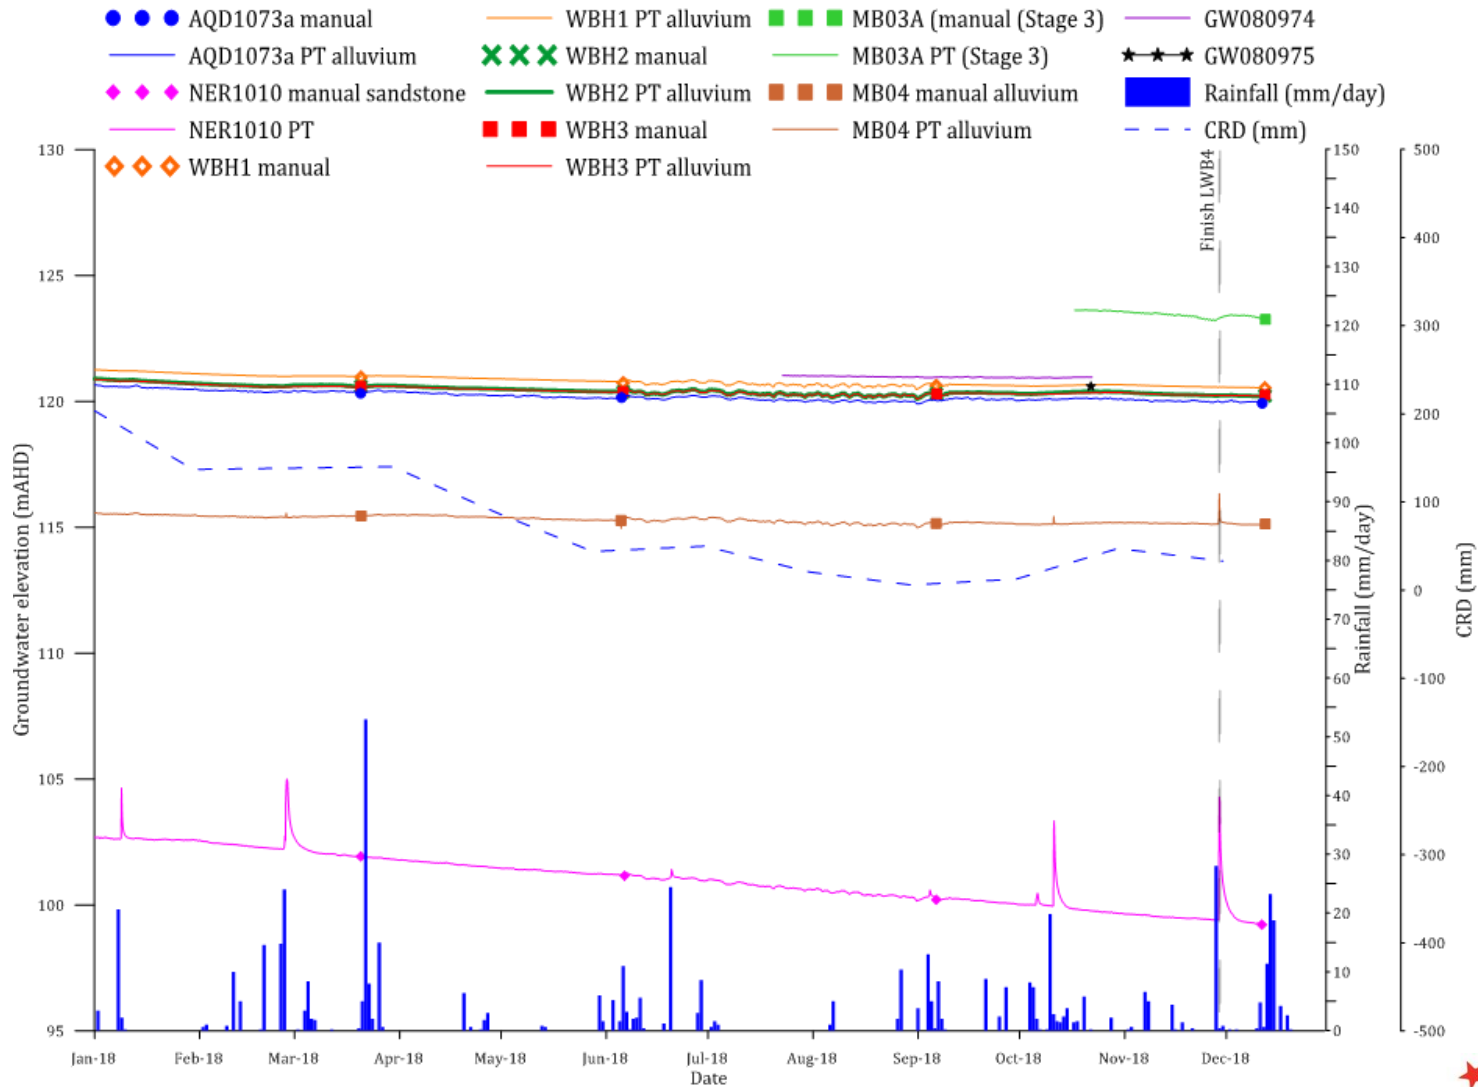
**Stage 2 & Bellbird South alluvium and sandstone aquifer,
and NOW groundwater level hydrographs**

- First monitoring results MB03A recorded December 2018
- Overall groundwater level decline and minor increases in alluvial monitoring bores are considered to be due to naturally occurring climatic conditions
- NER1010 and MB01 groundwater levels continue a slow decline
- There are no new trends in groundwater quality or water levels since previously reported

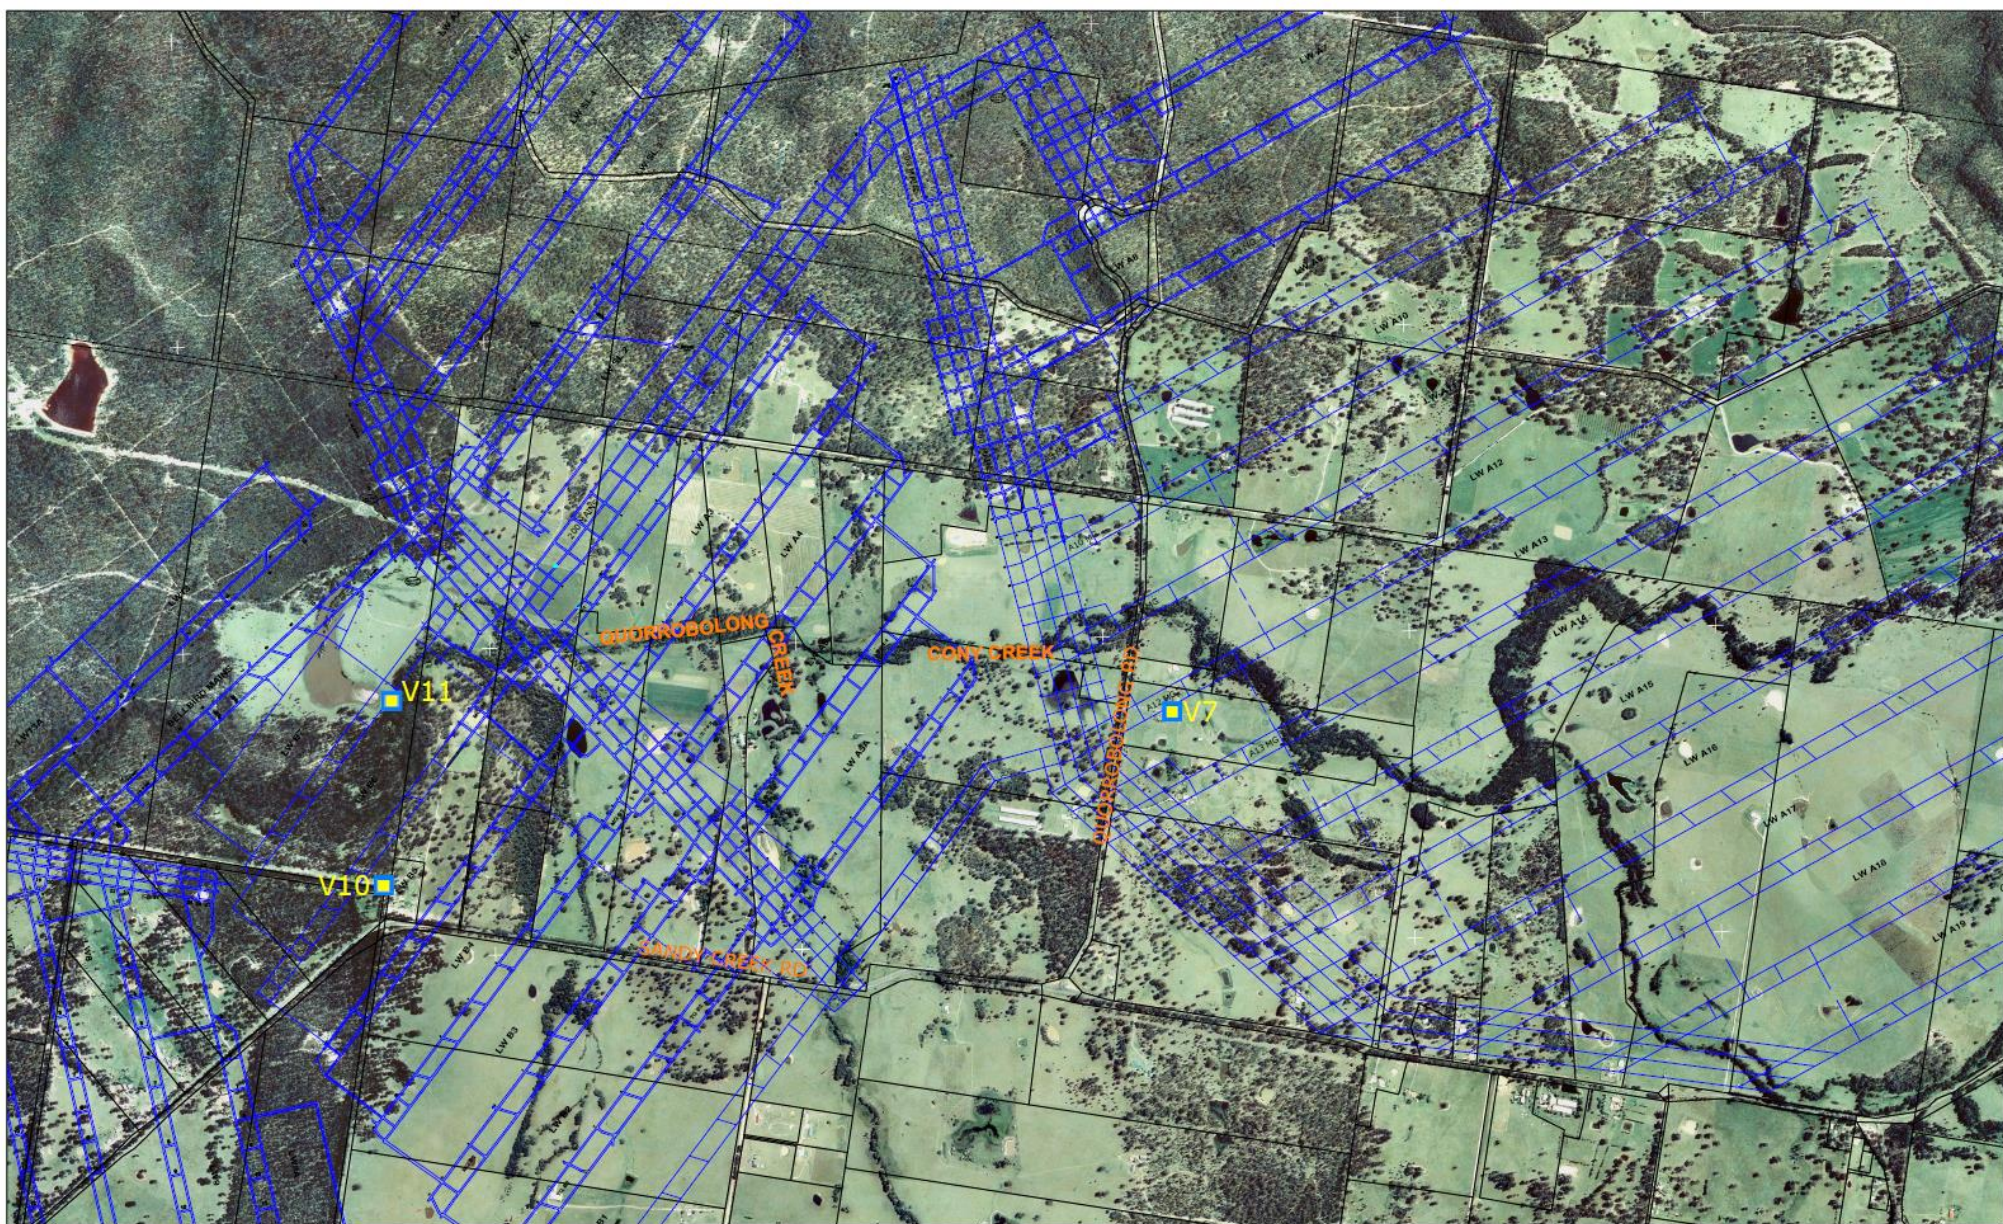
TITLE
Figure 11: Vibration Monitoring Locations

- **Monitor V7 – 345 Quorrobolong Road**
 - Monitoring commenced 11 June 2013
 - No new vibration events recorded greater than 1mm/s on any axis

- **Monitor V11 (Previously V9c) – above LWB6**
 - Monitoring commenced 19 July 2017
 - No new vibration events recorded greater than 1mm/s on any axis
 - Monitor name change in-line with updated Noise and Vibration Management Plan 2018

- **Monitor V10 – above LWB5**
 - Monitoring commenced 28 August 2017
 - No new vibration events recorded greater than 1mm/s on any axis

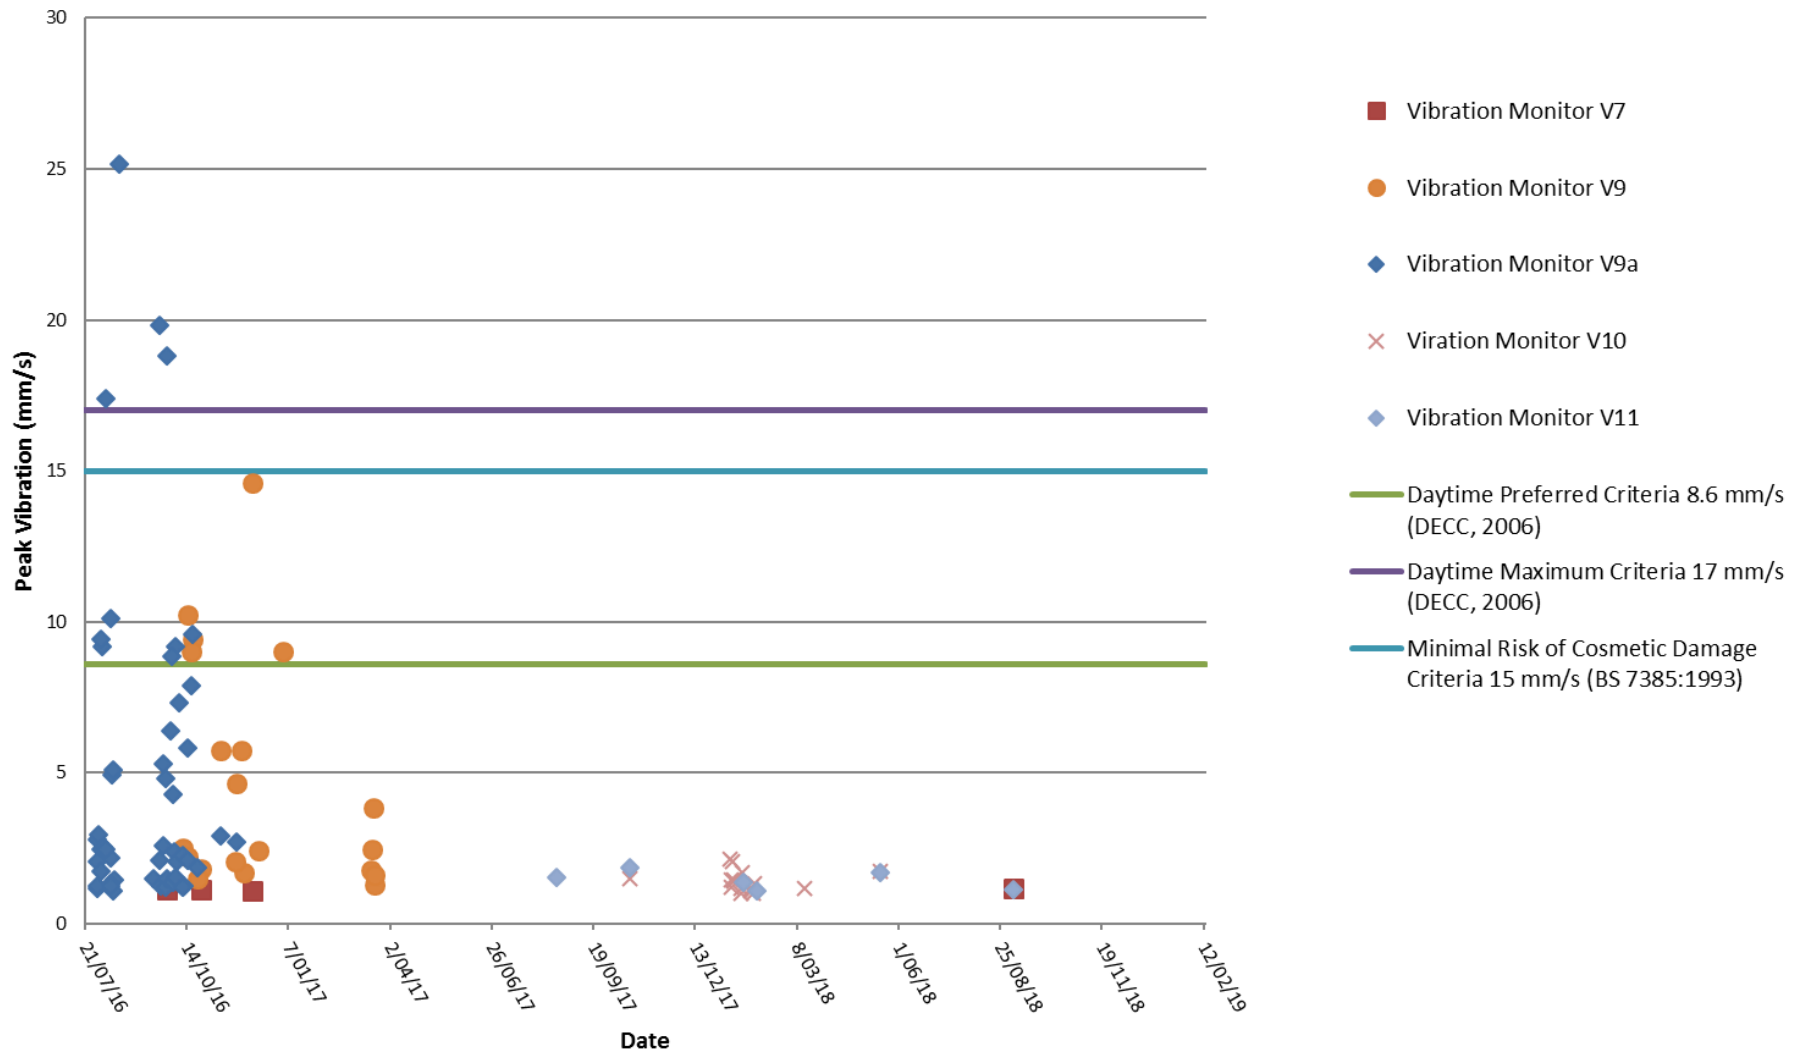
Austar Peak Ground Vibration - Night and Day Combined (Events > 1mm/sec)
