## Austar Coal Mine

### Community Consultative Committee Meeting Minutes

# AUSTAR COAL MINE

## COMMUNITY CONSULTATIVE MEETING

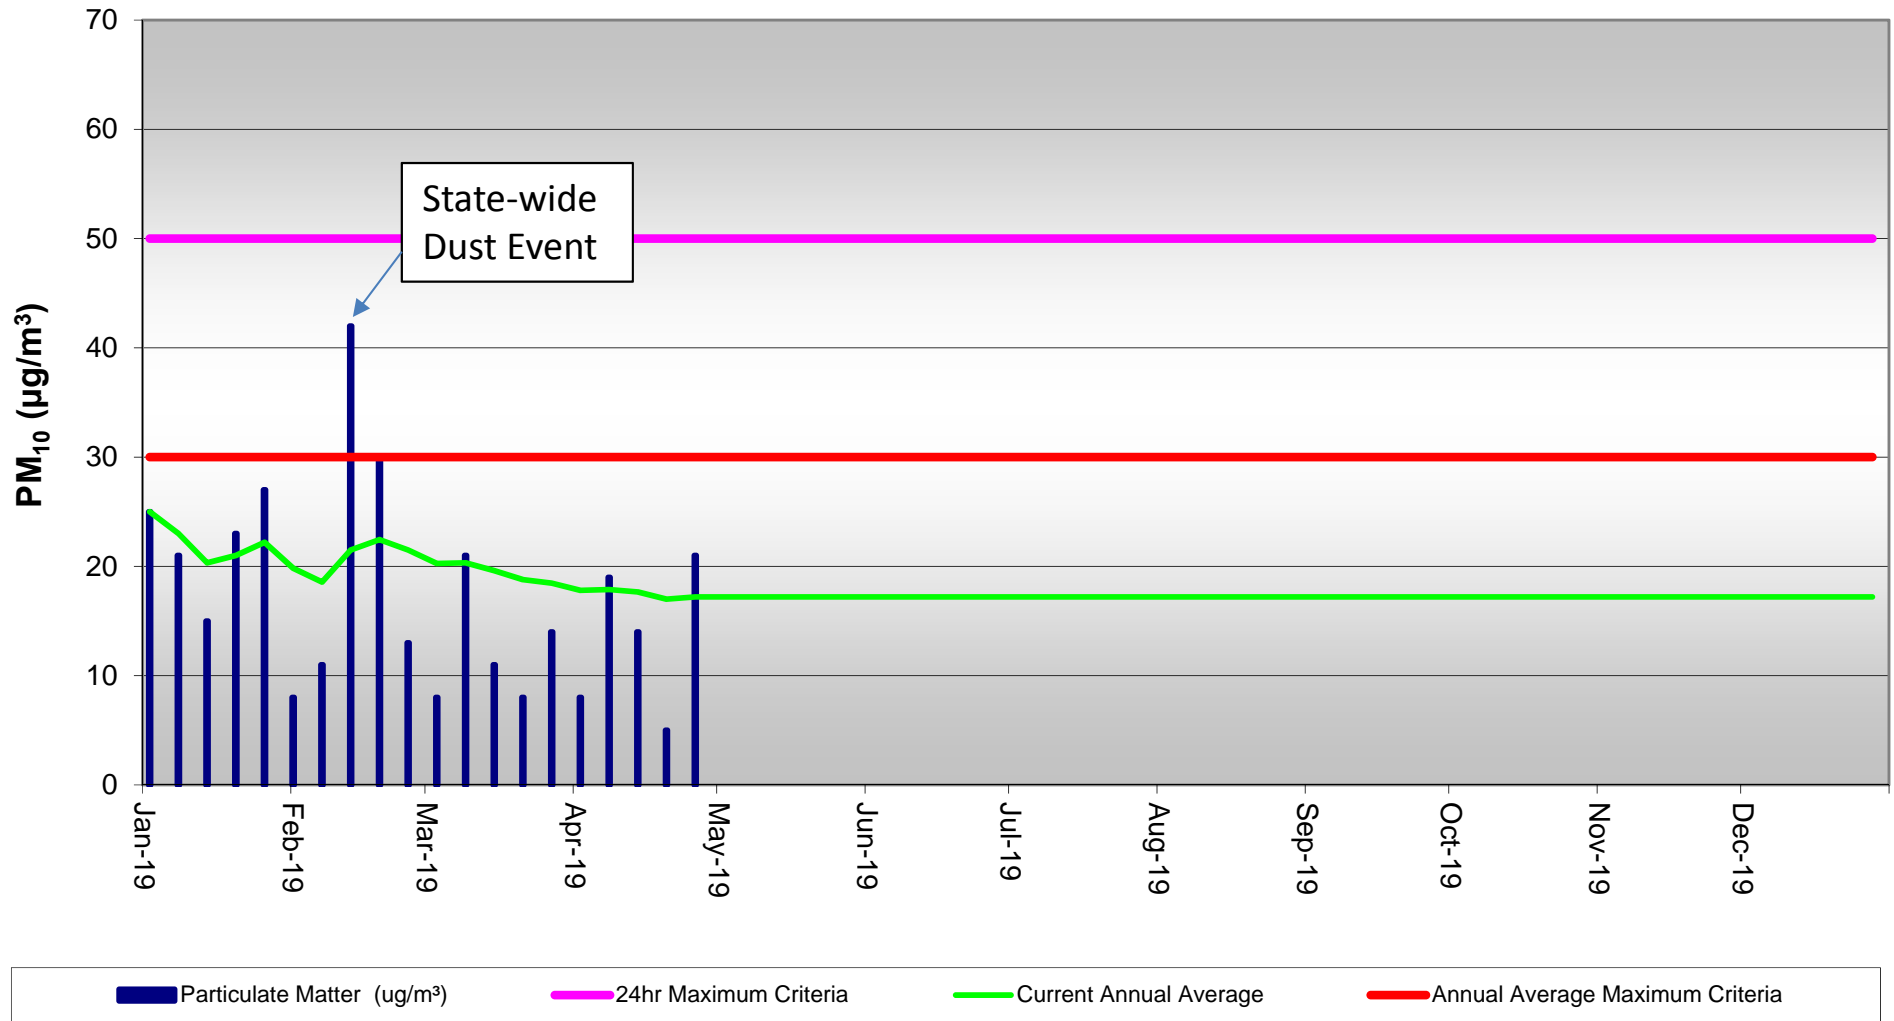
## Particulate Matter <10µm (PM<sub>10</sub>) - HVAS3 (Quorrobolong – East Kitchener SIS)

Note: Details on November 2018 high dust reading reported in previous CCC presentation

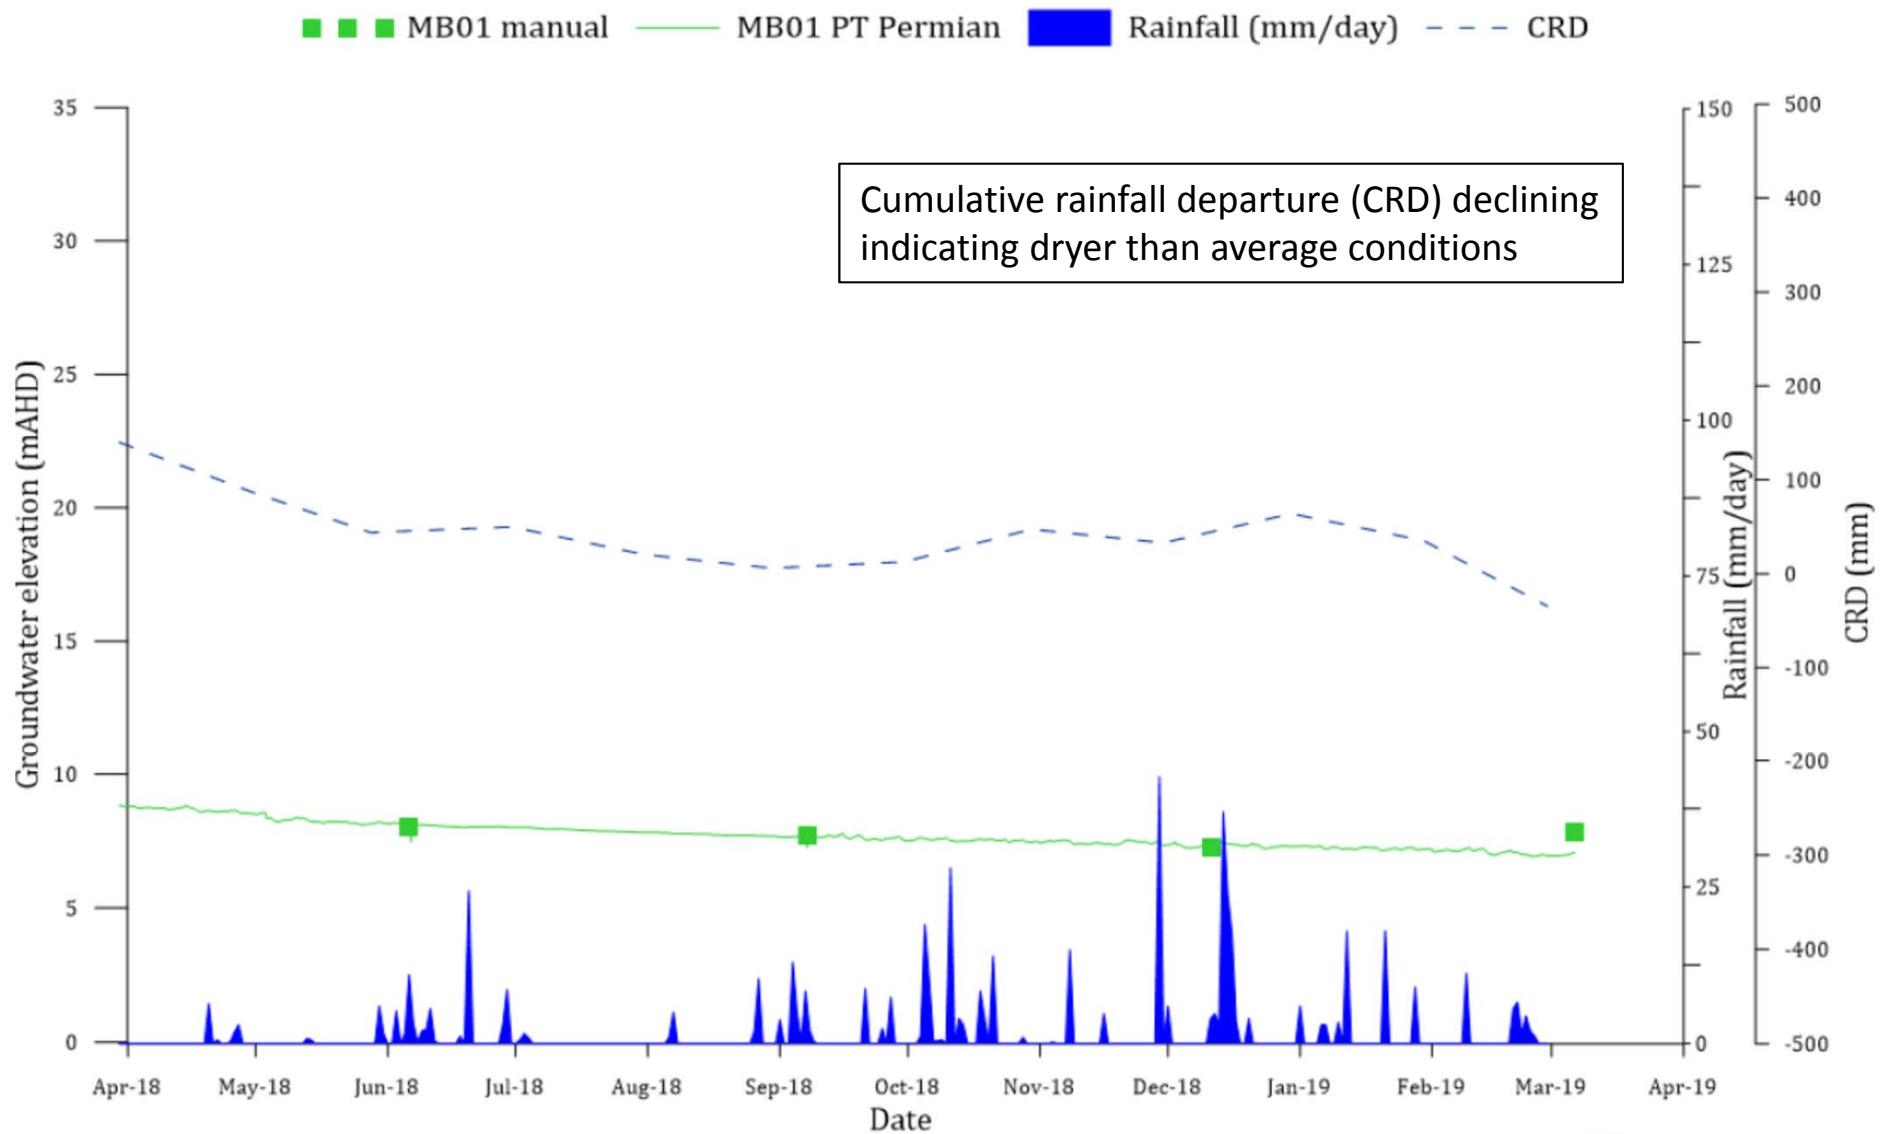
Stage 3 MB01 sandstone aquifer groundwater level hydrograph

- Overall groundwater level has remained stable or is in minor decline attributable to current prolonged dry conditions
- No changes to existing trends in groundwater quality or water levels since previously reported

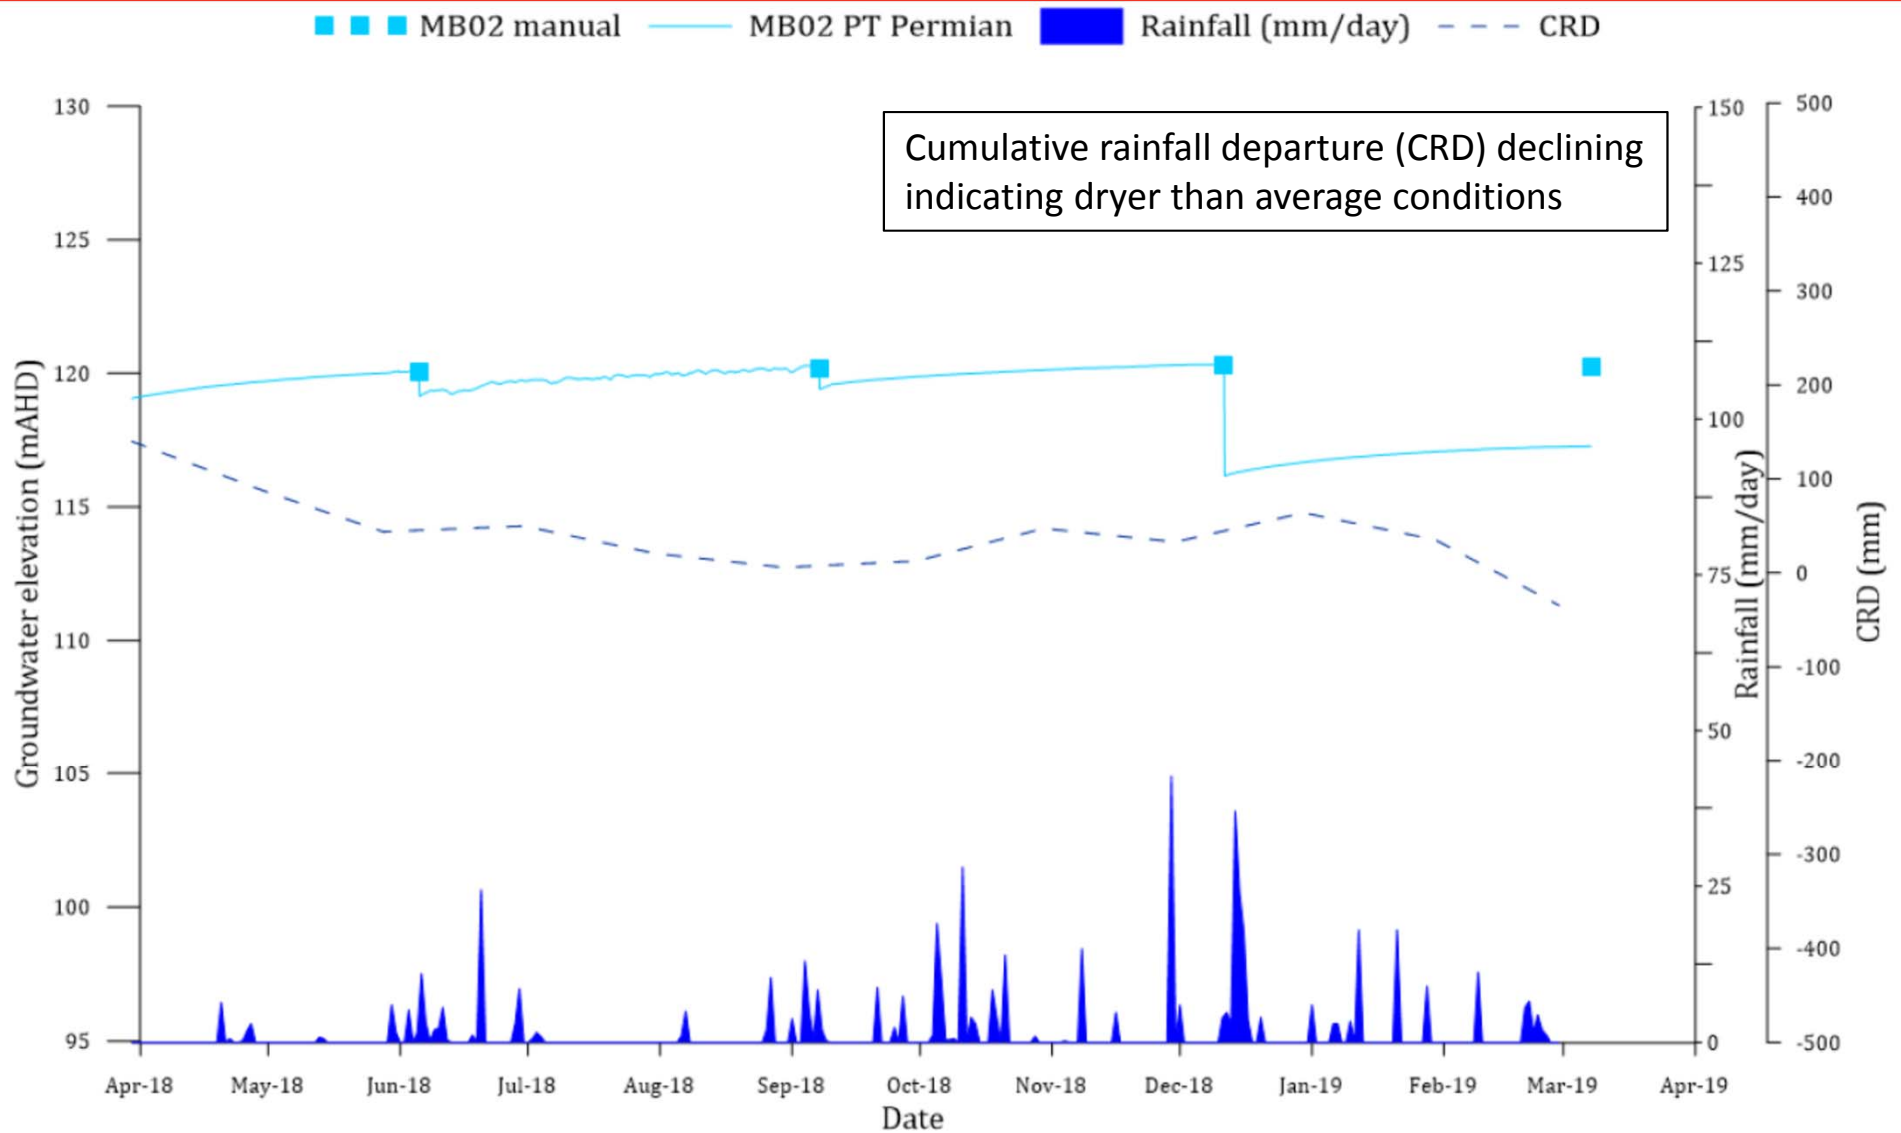
Stage 3 MB02 sandstone aquifer groundwater level hydrograph

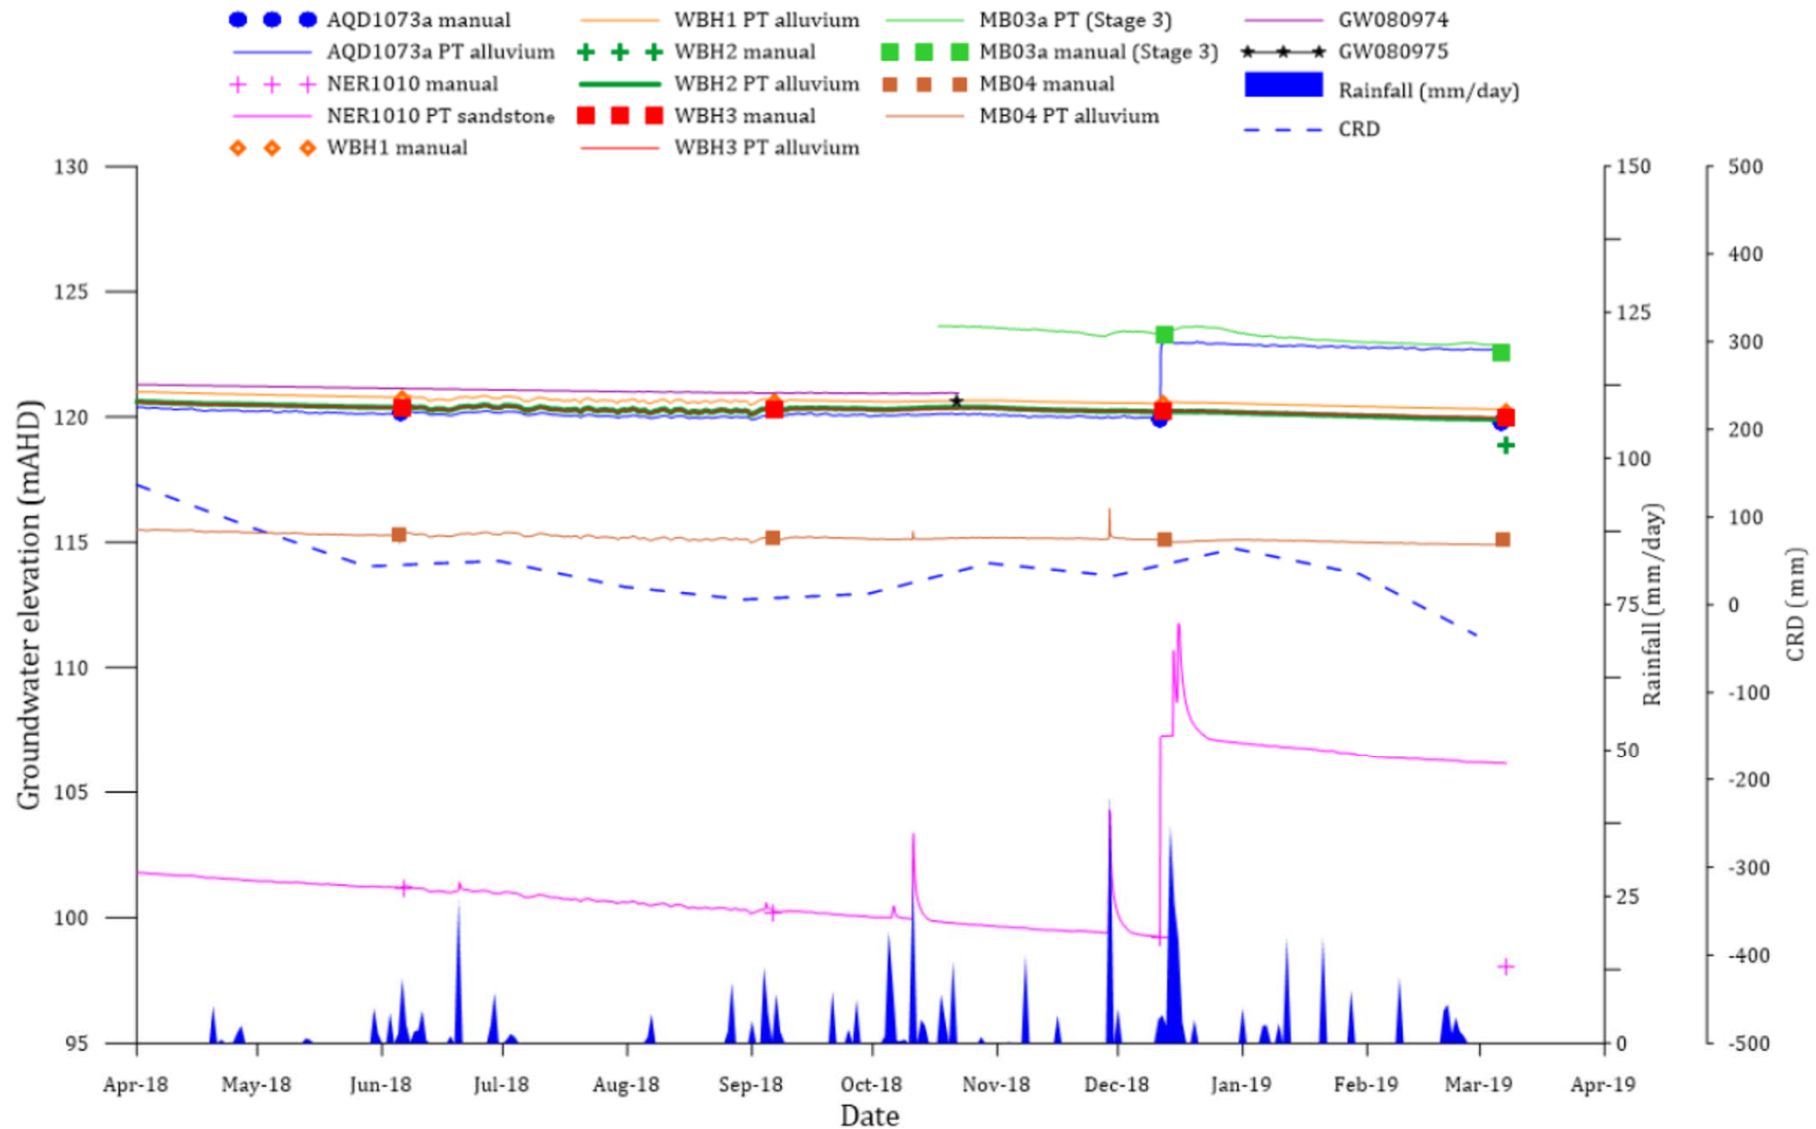
**Stage 2 & Bellbird South alluvium and sandstone aquifer, and NOW groundwater level hydrographs**
