MOOLARBEN STAGE 1 OPTIMISATION MODIFICATION - ARCHAEOLOGICAL SURVEY COVERAGE DATABASE

ABORIGINAL HERITAGE SITE DATA¹

APPENDIX 4.

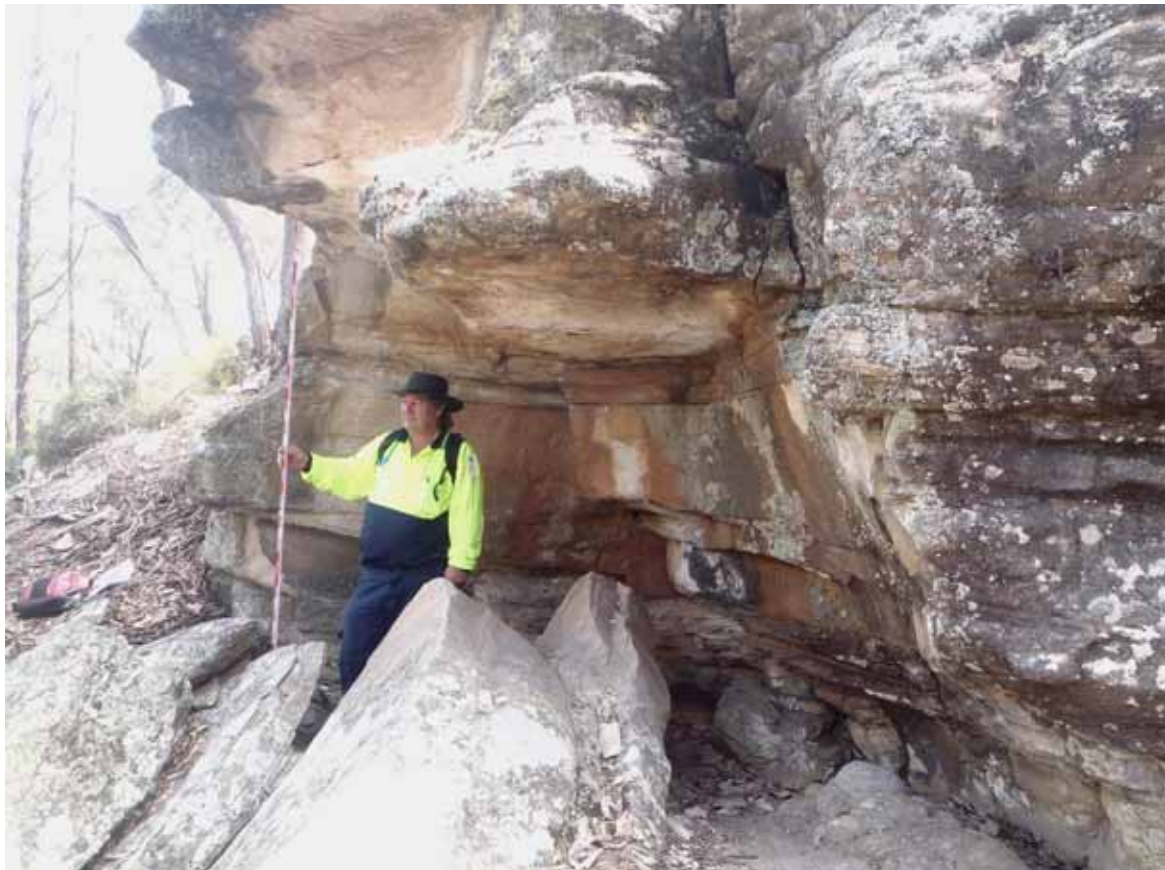
Photograph: S1MC326

Rock Outcrop Material: *Sandstone*
Outcrop Type: *Rock shelter*
Outcrop Form: *Scarp*
Aspect: *South*
Erosion: *Exfoliation*
Surface Condition: *Exfoliating, exposed/weathered*
Soil: *Silt, sand, gravel*
Disturbance to Deposit: *Moderate*
Causes of Disturbance: *Erosion, animal burrows*

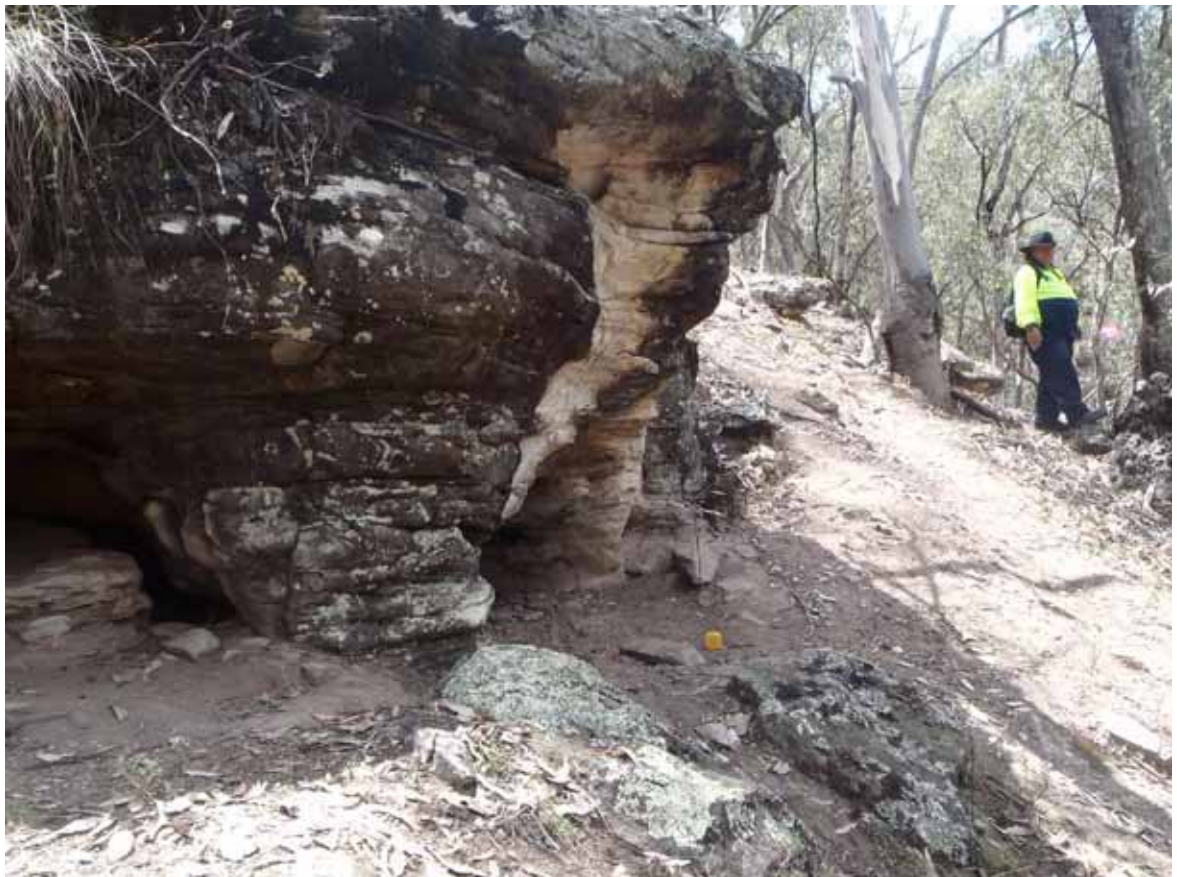
Photograph: S1MC327

Rock Outcrop Material: *Sandstone*
Outcrop Type: *Rock shelter*
Outcrop Form: *Scarp*
Aspect: *South south east*
Erosion: *Exfoliation*
Surface Condition: *Exfoliating, exposed/weathered*
Soil: *Silt, sand*
Disturbance to Deposit: *Moderate*
Causes of Disturbance: *Animal burrows*

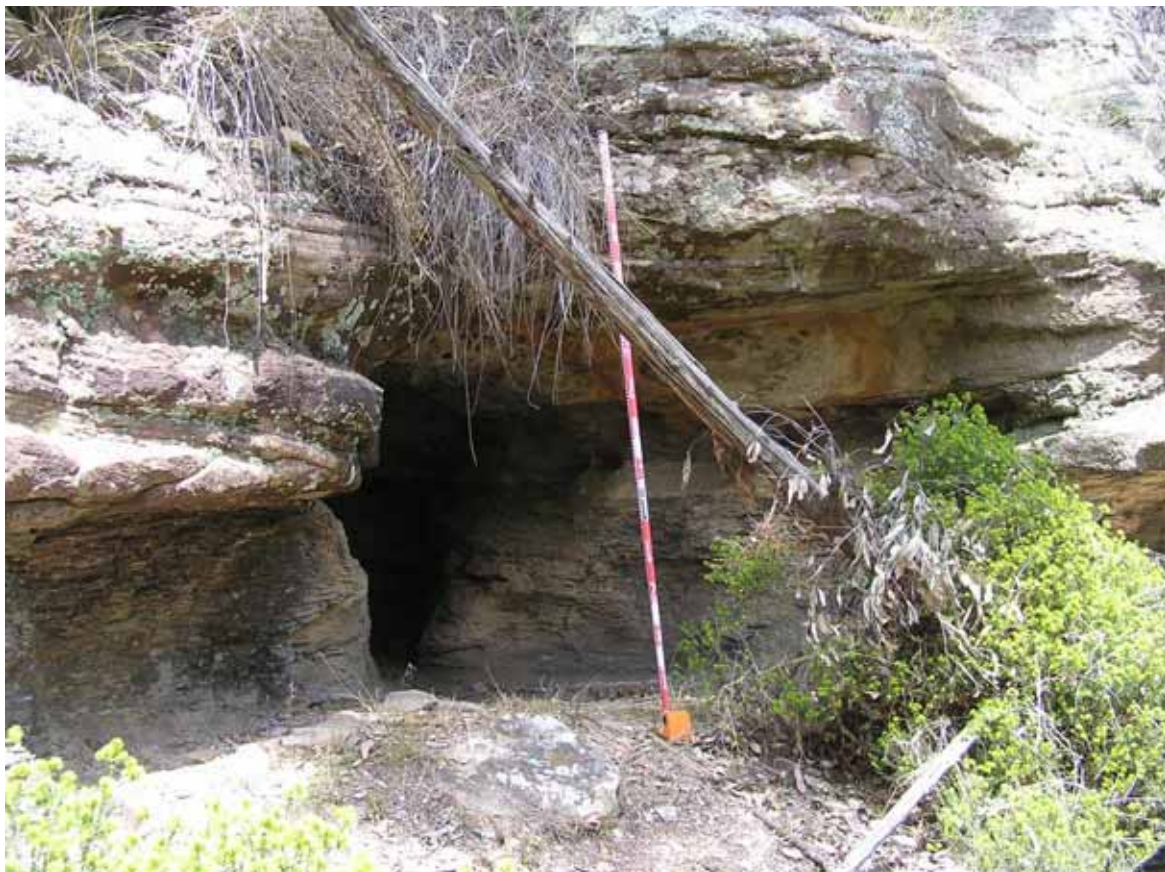
Photograph: S1MC329

Rock Outcrop Material: *Sandstone*
Outcrop Type: *Rock shelter*
Outcrop Form: *Scarp*
Aspect: *West*
Erosion: *Exfoliation*
Surface Condition: *Exfoliating, exposed/weathered*
Soil: *Silt*
Disturbance to Deposit: *Moderate*
Causes of Disturbance: *Erosion, animal burrows*

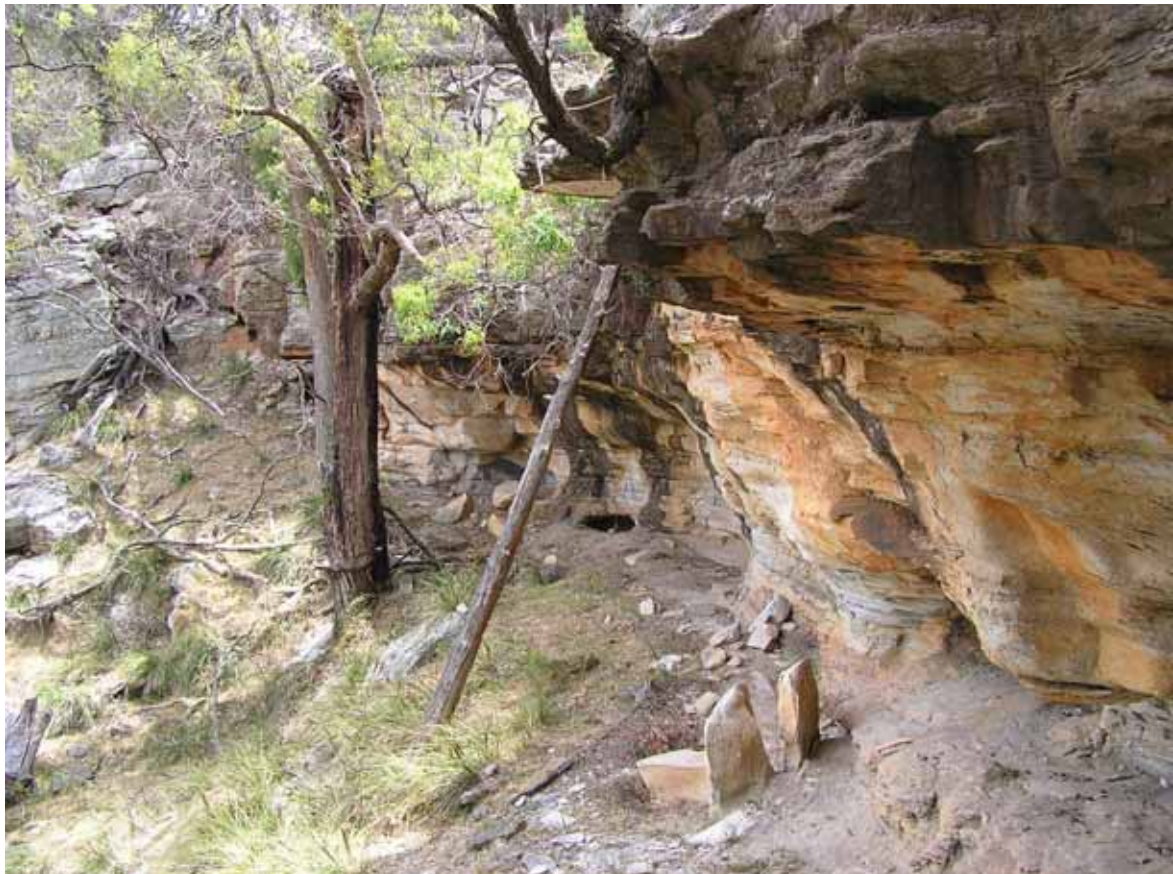
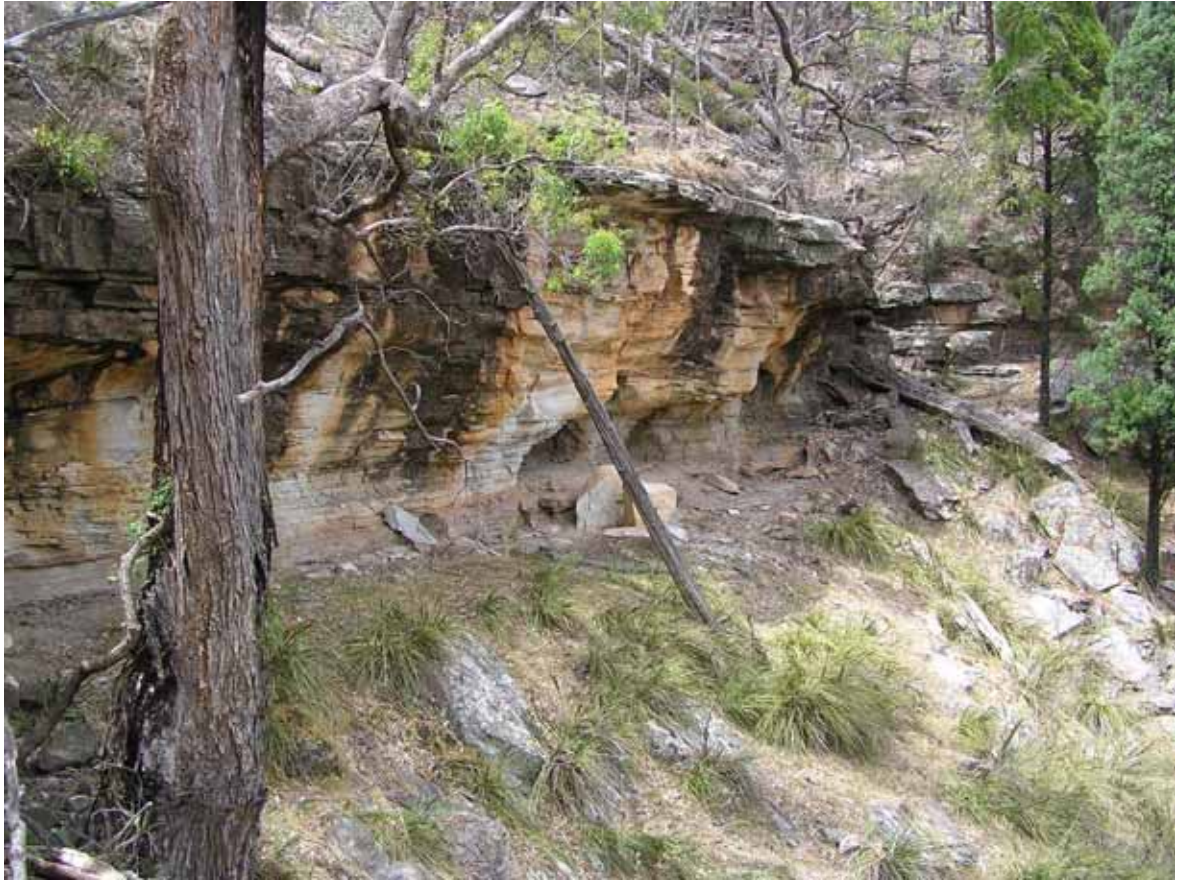
Photograph: S1MC335

Rock Outcrop Material: *Sandstone*
Outcrop Type: *Rock shelter, overhang*
Outcrop Form: *Scarp*
Aspect: *West*
Erosion: *Exfoliation, cavernous*
Surface Condition: *Exfoliating, exposed/weathered*
Soil: *Silt, sand*
Disturbance to Deposit: *Moderate*
Causes of Disturbance: *Erosion*

- Shelter 23 metres across x 1.5 metres deep x 3 metres high;
- Lower portion of moderate slope, start of drainage above;
- Run-off probably frequent into shelter;
- Black staining on walls;
- Wasps;
- Narrow, more of an overhang, but some areas 3 metres wide;
- Low to moderate potential due to erosion and narrow dimensions;
- No art, some good surfaces but weathering rates probably high;
- Abundant animal scats.

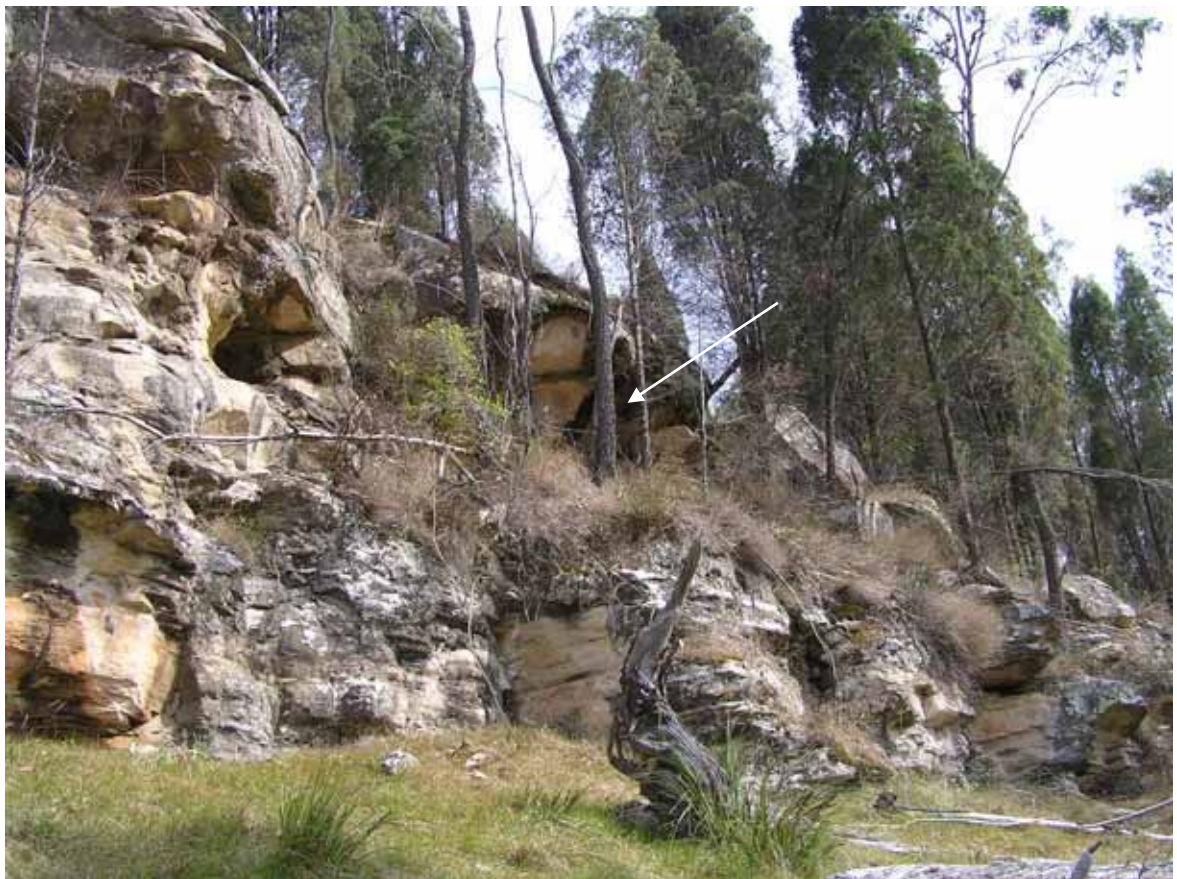
Photograph: S1MC337

Rock Outcrop Material: *Sandstone*
Outcrop Type: *Rock shelter*
Outcrop Form: *Scarp*
Aspect: *West*
Erosion: *Cavernous*
Surface Condition: *Exfoliating, exposed/weathered*
Soil: *Rocky, sand*
Disturbance to Deposit: *Moderate*
Causes of Disturbance: *Erosion*

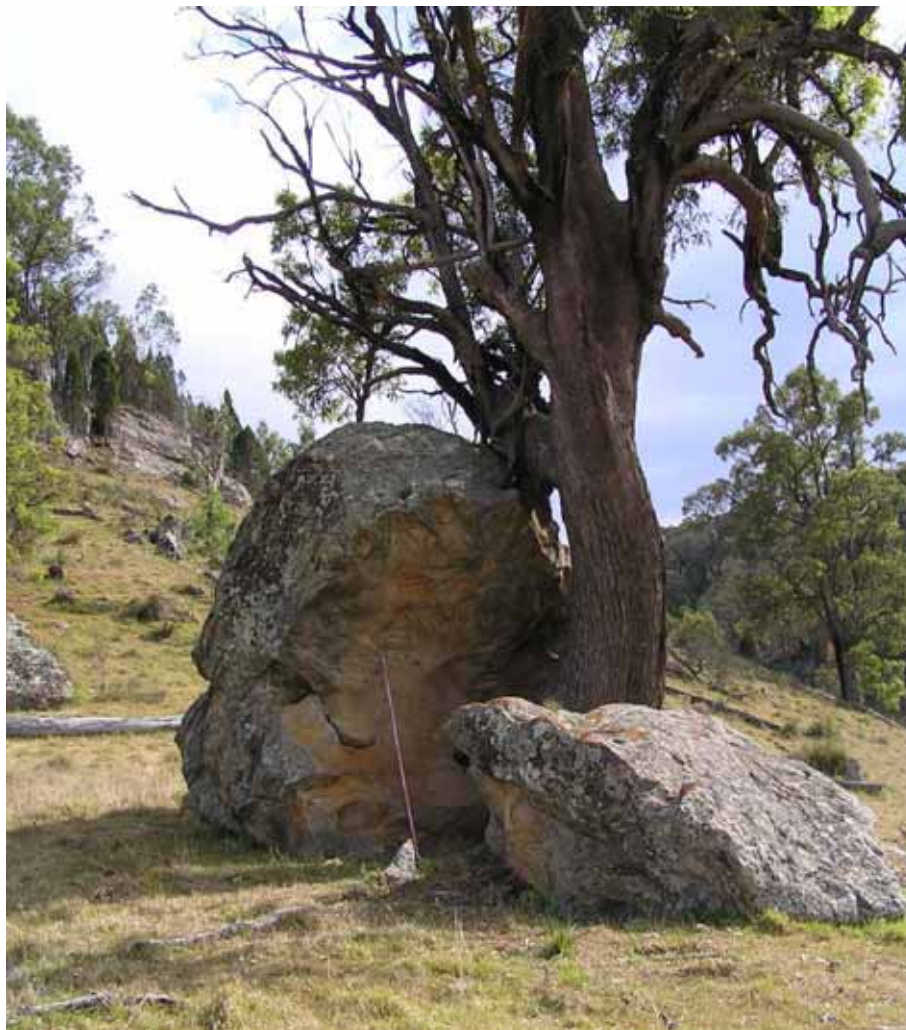
Photograph: S1MC340

Rock Outcrop Material: *Sandstone*
Outcrop Type: *Overhang*
Outcrop Form: *Boulder*
Aspect: *South*
Erosion: *Exfoliation*
Surface Condition: *Exposed/weathered*
Soil: *Rocky, sand*
Disturbance to Deposit: *Low*
Causes of Disturbance: *Erosion*

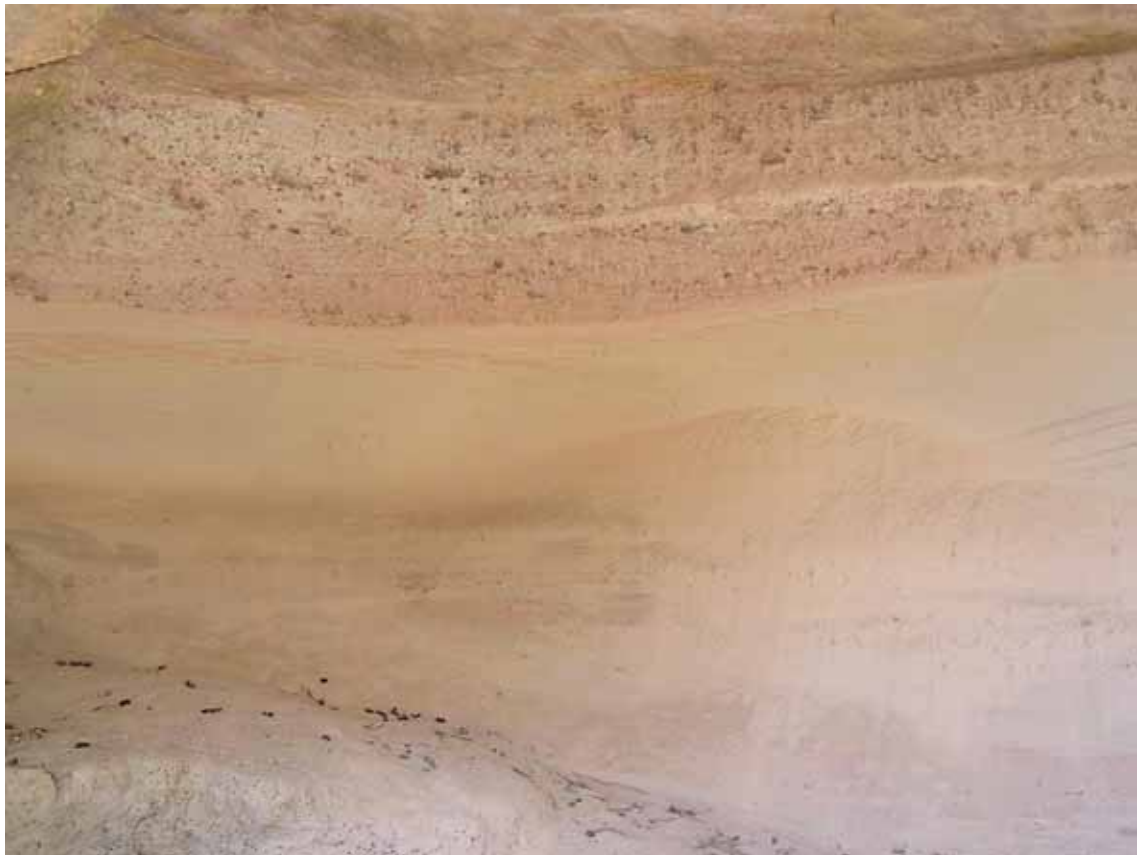
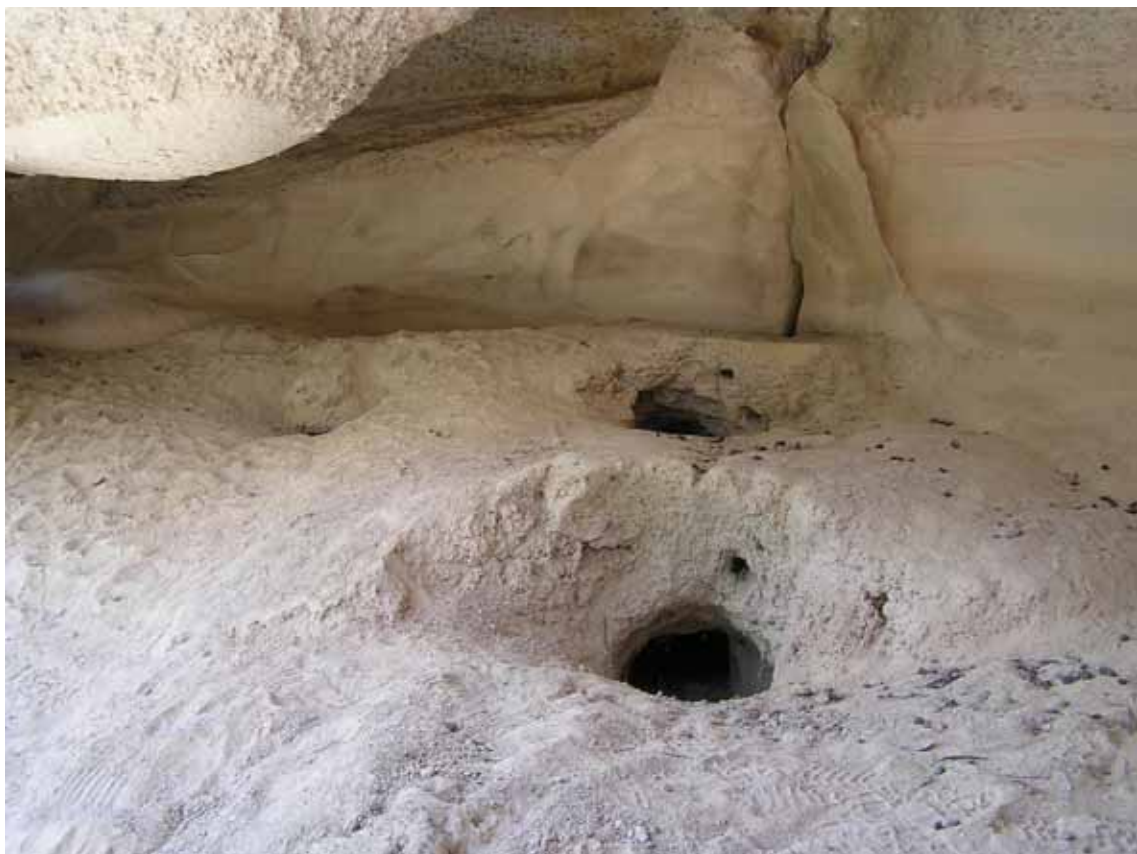
Photograph: S1MC345

Rock Outcrop Material: *Sandstone, conglomerate*
Outcrop Type: *Rock shelter*
Outcrop Form: *Scarp*
Aspect: *Southwest*
Erosion: *Exfoliation, honeycomb*
Surface Condition: *Exfoliating, exposed/weathered, accretions*
Soil: *Sand*
Disturbance to Deposit: *High*
Causes of Disturbance: *Erosion, animal burrows*

- Outside study area by about 50 metres;
- Complex of shelters in large conglomerate boulders and scarp;
- Shelter 7 metres across x 4 metres deep x 3.5 metres high;
- PAD area 7 x 4 metres.
- Large wombat burrow;
- Highly impacted deposit;
- Some great surfaces for art but none present, only natural iron oxide staining;
- Research potential reduced to low due to disturbance from wombat burrows.

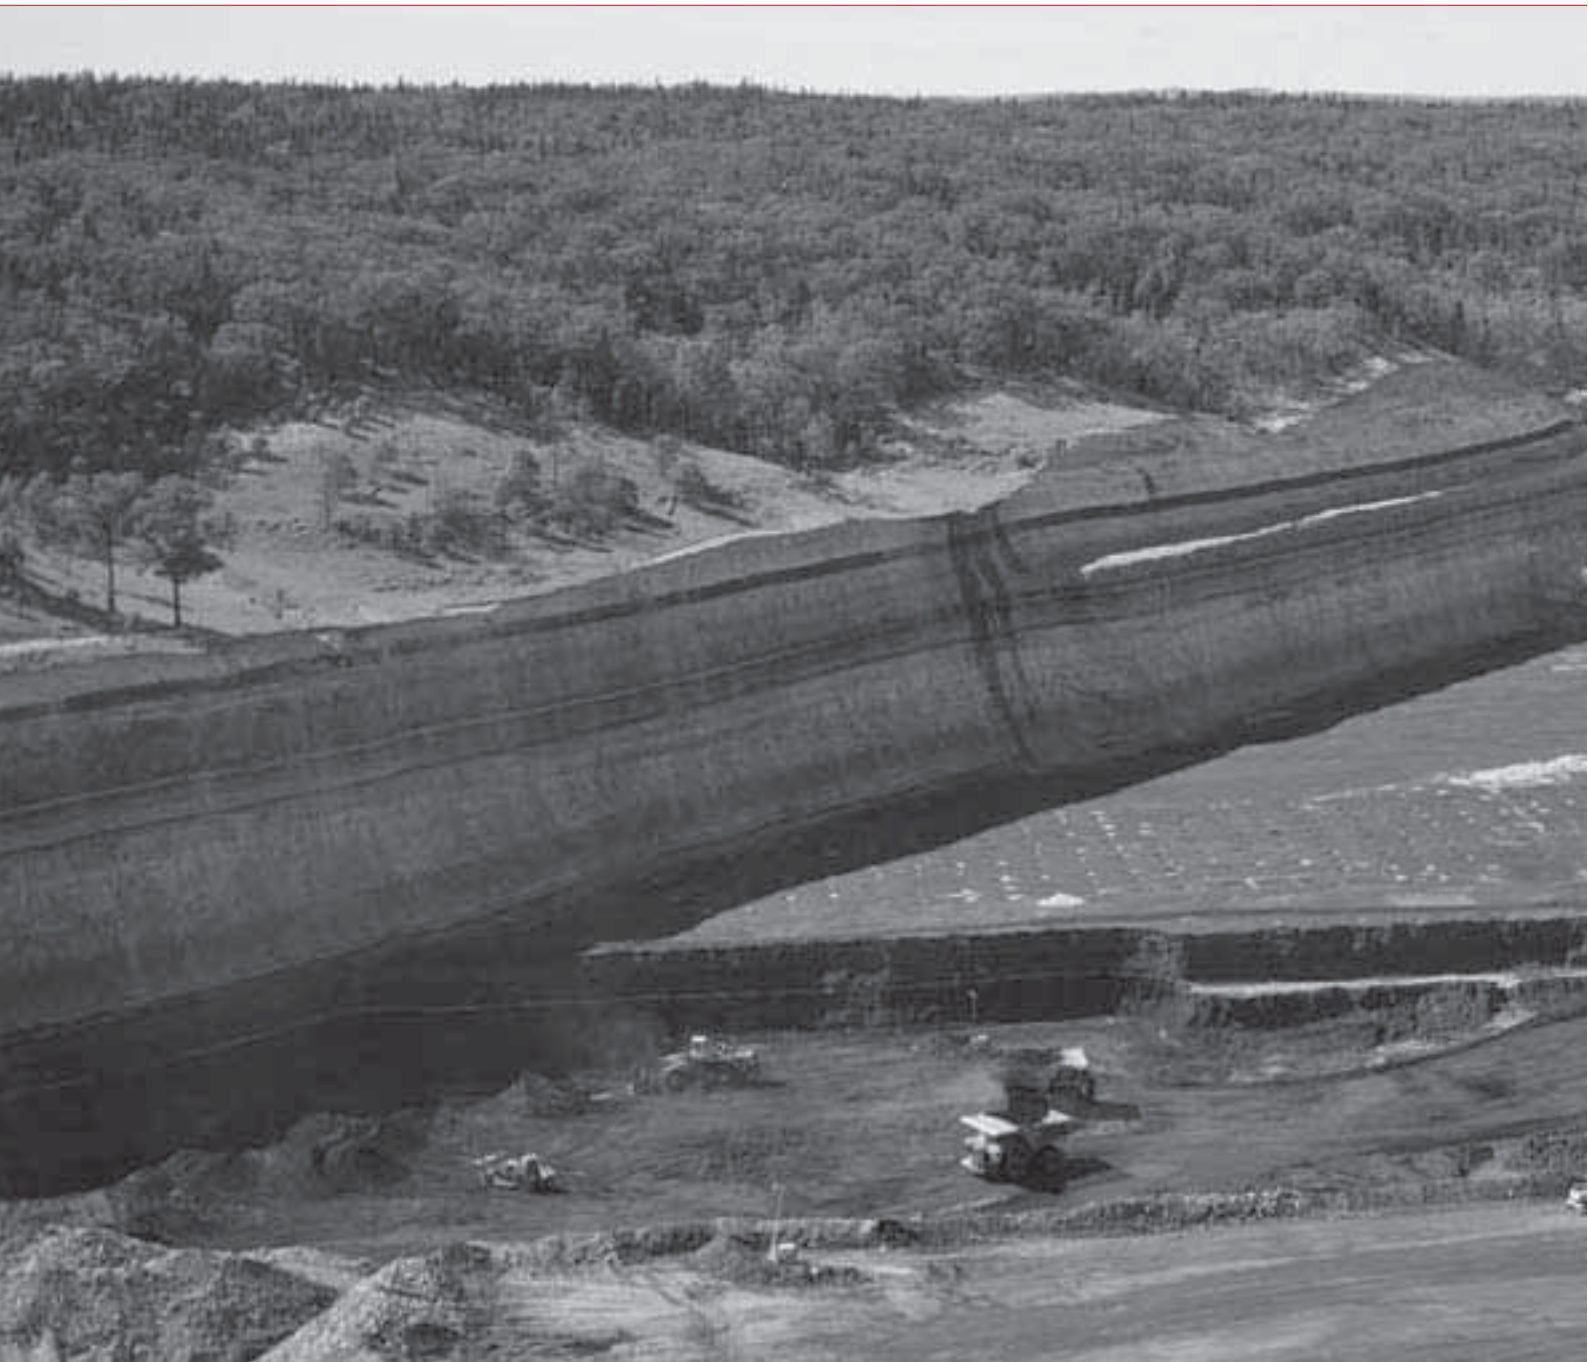
Site Plan: S1MC347

- Shelter 2.5 metres across x 1 metre deep x 1.6 metres high;
- PAD area is 1.5 x 1 metres;
- Small, low roof, runoff through shelter, low potential.

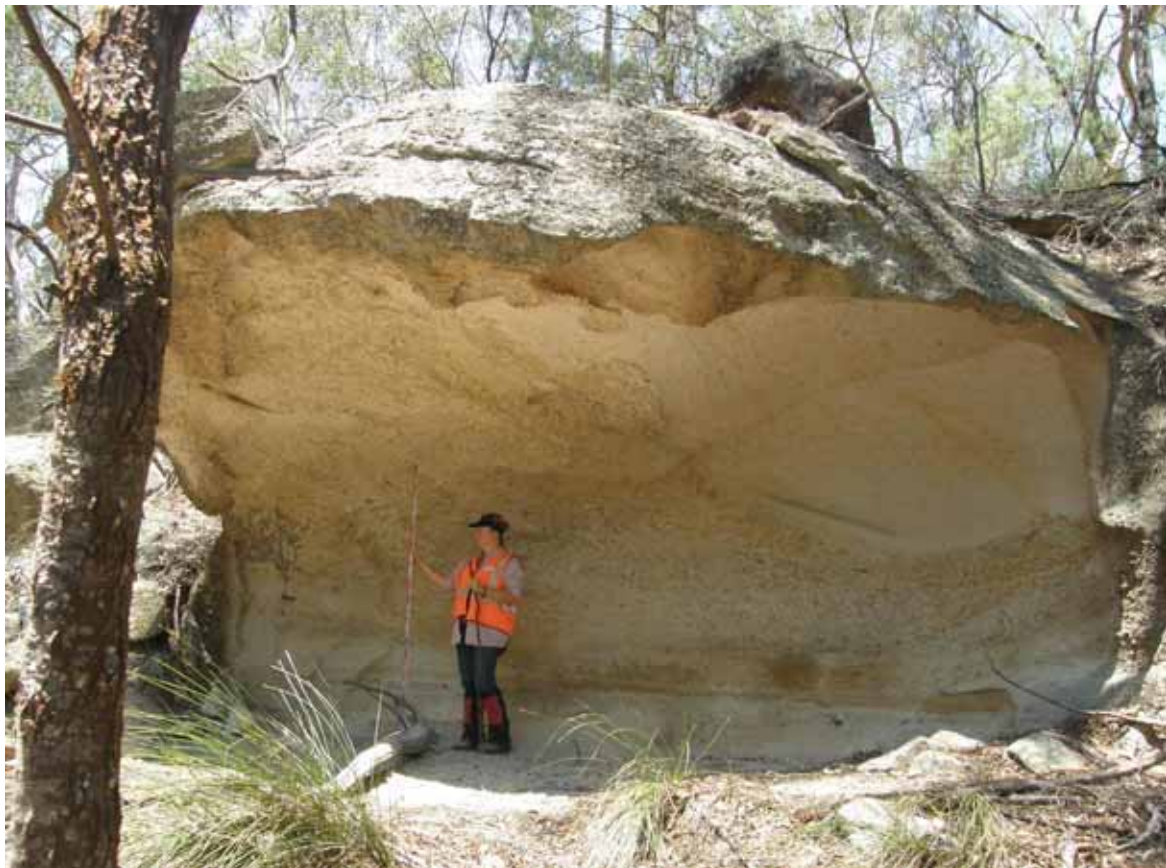
Photograph: S1MC354

Rock Outcrop Material: *Sandstone, conglomerate*
Outcrop Type: *Overhang*
Outcrop Form: *Boulder*
Aspect: *Southwest*
Erosion: *Exfoliation, cavernous*
Surface Condition: *Exfoliating, exposed/weathered*
Soil: *Sand*
Disturbance to Deposit: *Moderate*
Causes of Disturbance: *Animals, dead trees*

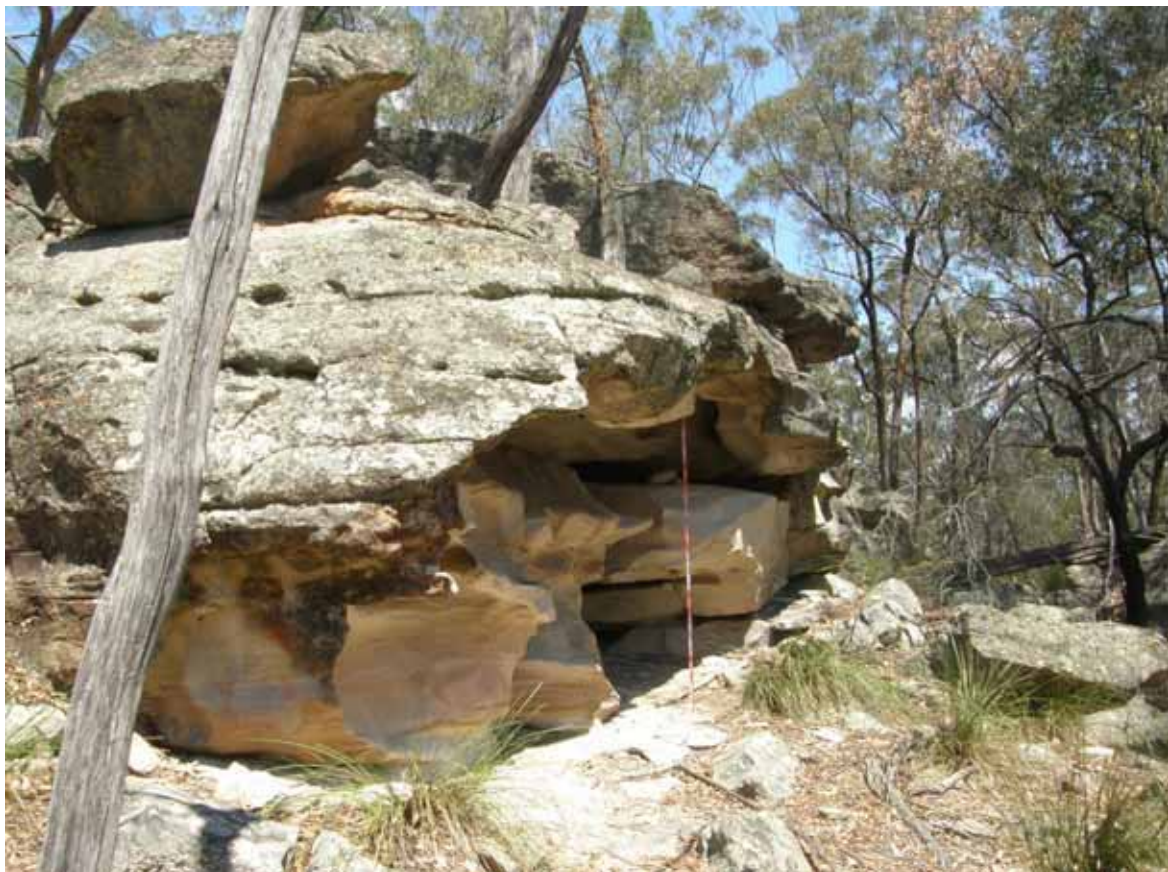
Photograph: #36-3-885

Rock Outcrop Material: *Sandstone, conglomerate*
Outcrop Type: *Rock shelter*
Outcrop Form: *Boulder, outcrop*
Aspect: *West*
Erosion: *Cavernous*
Surface Condition: *Exposed/weathered*
Soil: *Sand*
Disturbance to Deposit: *Moderate*
Causes of Disturbance: *Erosion, leaf litter, roof fall*

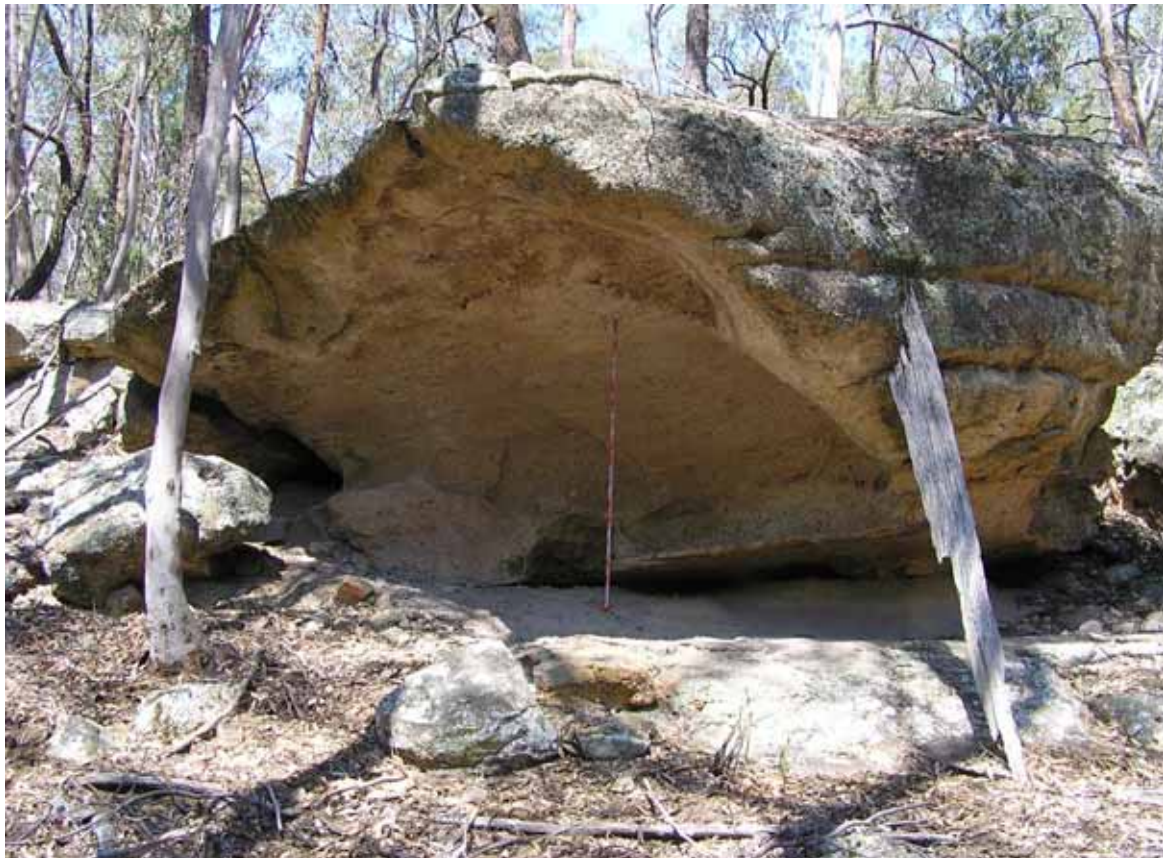
Photograph: #36-3-958

Rock Outcrop Material: *Conglomerate*
Outcrop Type: *Rock shelter*
Outcrop Form: *Scarp, boulder*
Aspect: *West*
Erosion: *Exfoliation*
Surface Condition: *Exfoliating*
Soil: *Rocky, sand*
Disturbance to Deposit: *High*
Causes of Disturbance: *Erosion, animal burrows*

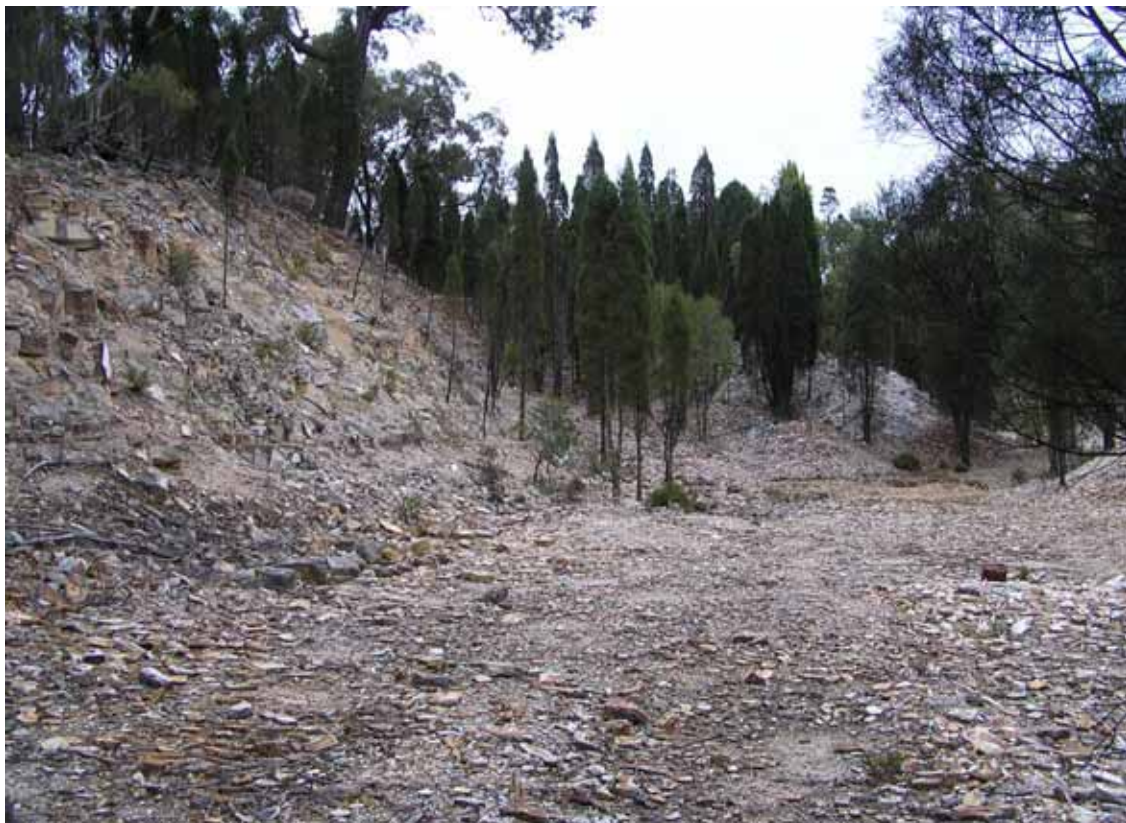
Plate 2: Example of totally modified area adjacent to Survey Area 112 in OC2 Extension Area.

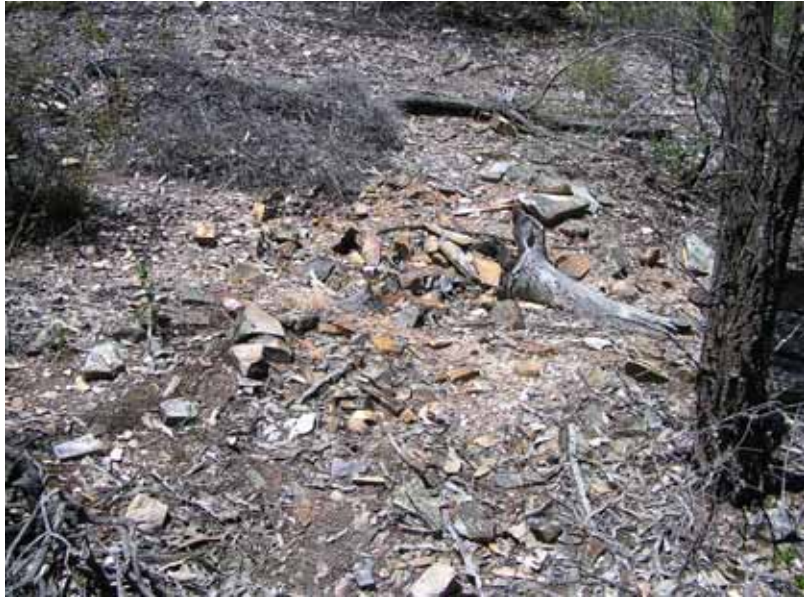
Plate 3: Example of natural occurrence of tabular tuff and tuffaceous stone (Survey Area 8).

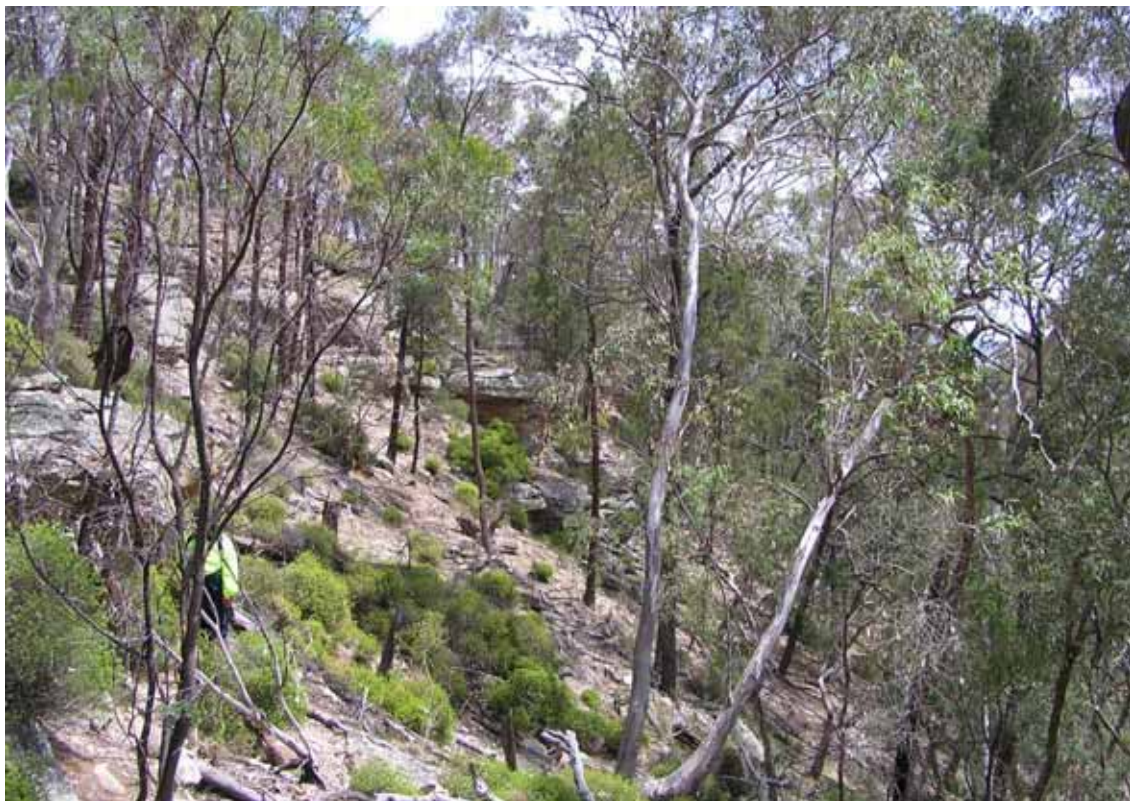
Plate 6: Survey Area 43 (moderate simple slope) in OC1 Extension Area, hosting rock formations with mostly straight walls (no rock shelters with PADs present, only hollows suitable for animals or with rocky floors and no deposit).

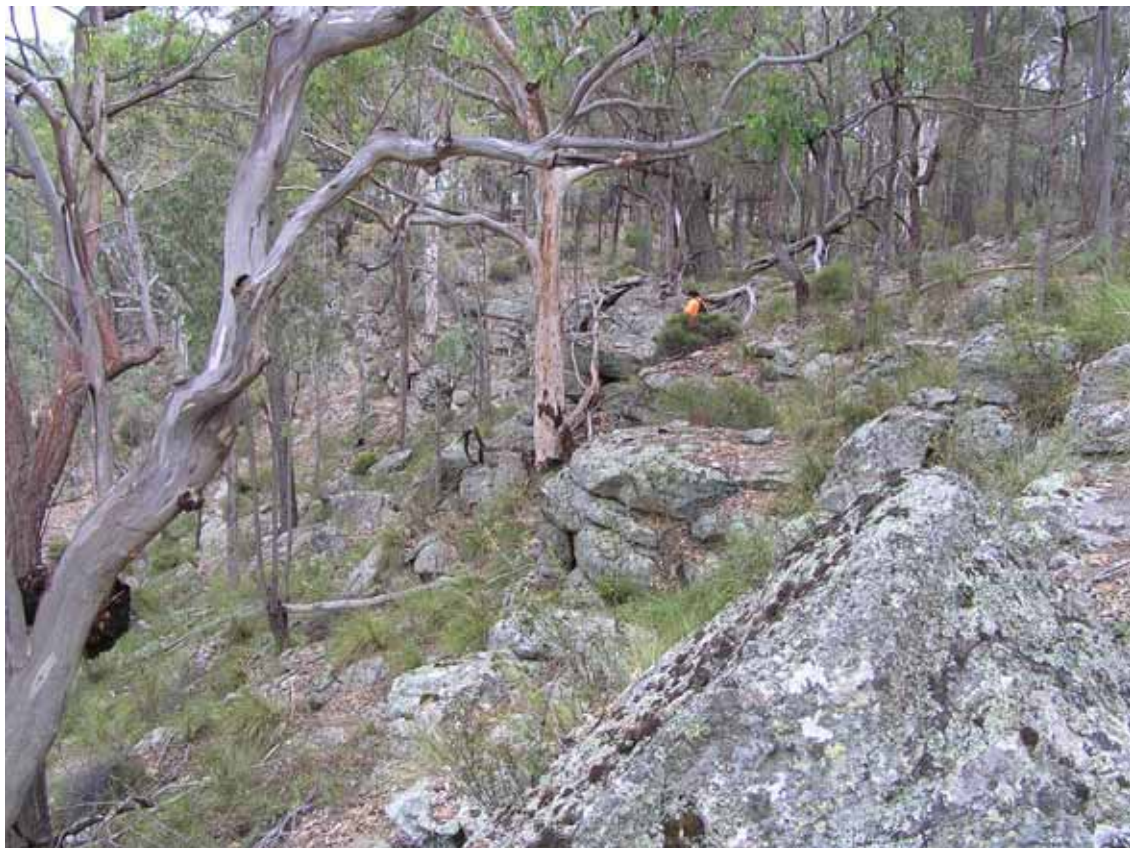
Plate 14: Survey Area 100 (steep simple slope) in OC2 Extension Area, hosting rock formations with mostly straight walls (no rock shelters with PADs present).

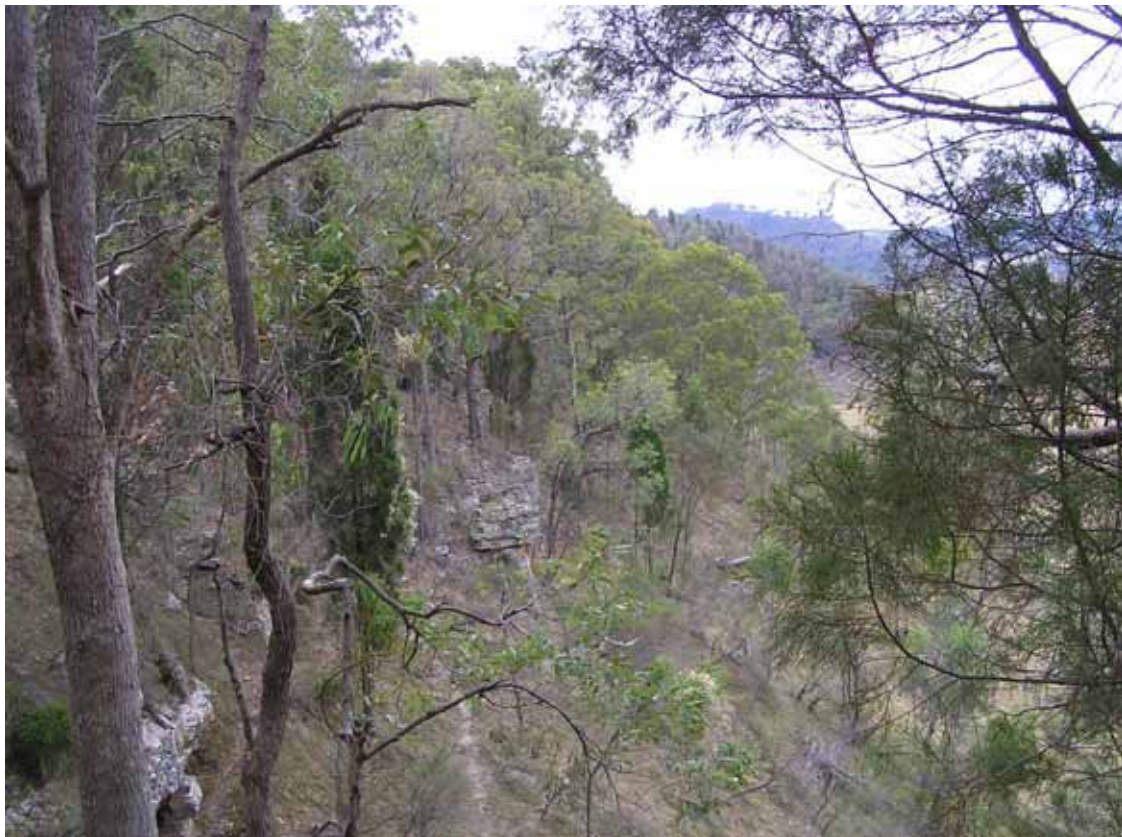
Plate 18: View south-east of Survey Area 115 (steep simple slope) in OC2 Extension Area, hosting rock formations with mostly straight walls.
