Monthly Environmental Monitoring Report

Yancoal Mount Thorley Warkworth

June 2024

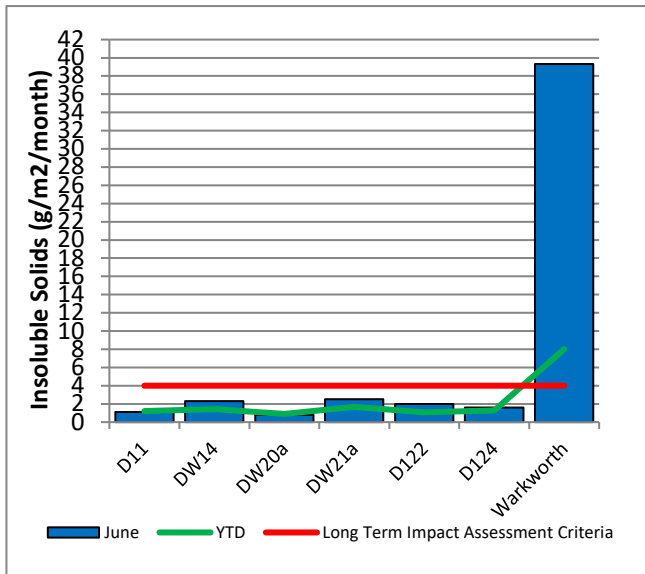
Figure 4: Depositional Dust – June 2024

During the reporting period the Warkworth monitor recorded a monthly result above the long-term impact assessment criteria of 4.0 g/m² per month. Field notes associated with Warkworth confirm the presence of sandy sediment, insects, and decomposing vegetation. As such the result (39.3 g/m²) is considered contaminated and will be excluded from calculation of the annual average.

Figure 4 displays insoluble solids results from depositional dust gauges during the reporting period compared against the year-to-date average and the annual impact assessment criteria.

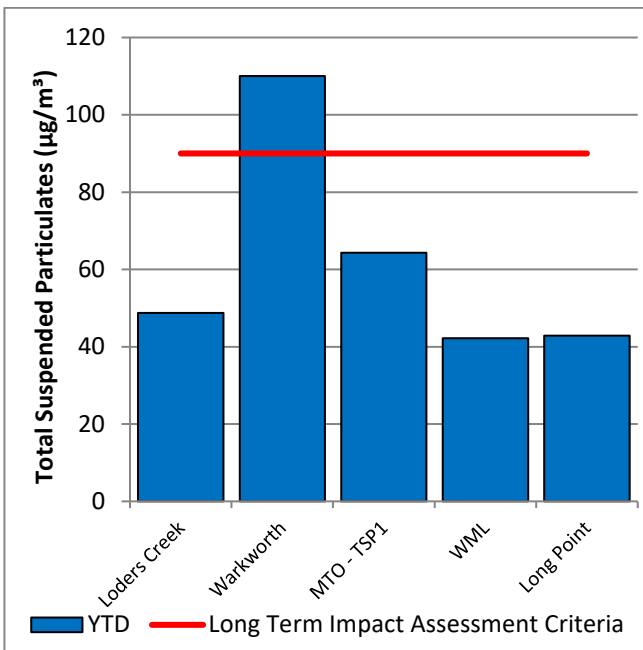
Figure 7: Annual Average Total Suspended Particulates – June 2024

Figure 7 shows the annual average TSP results compared against the long-term impact assessment criteria of 90µg/m³.
