# Annual Review

**Donaldson Coal Mine**

1 November 2023 – 31 October 2024

Ref No. 737/30a

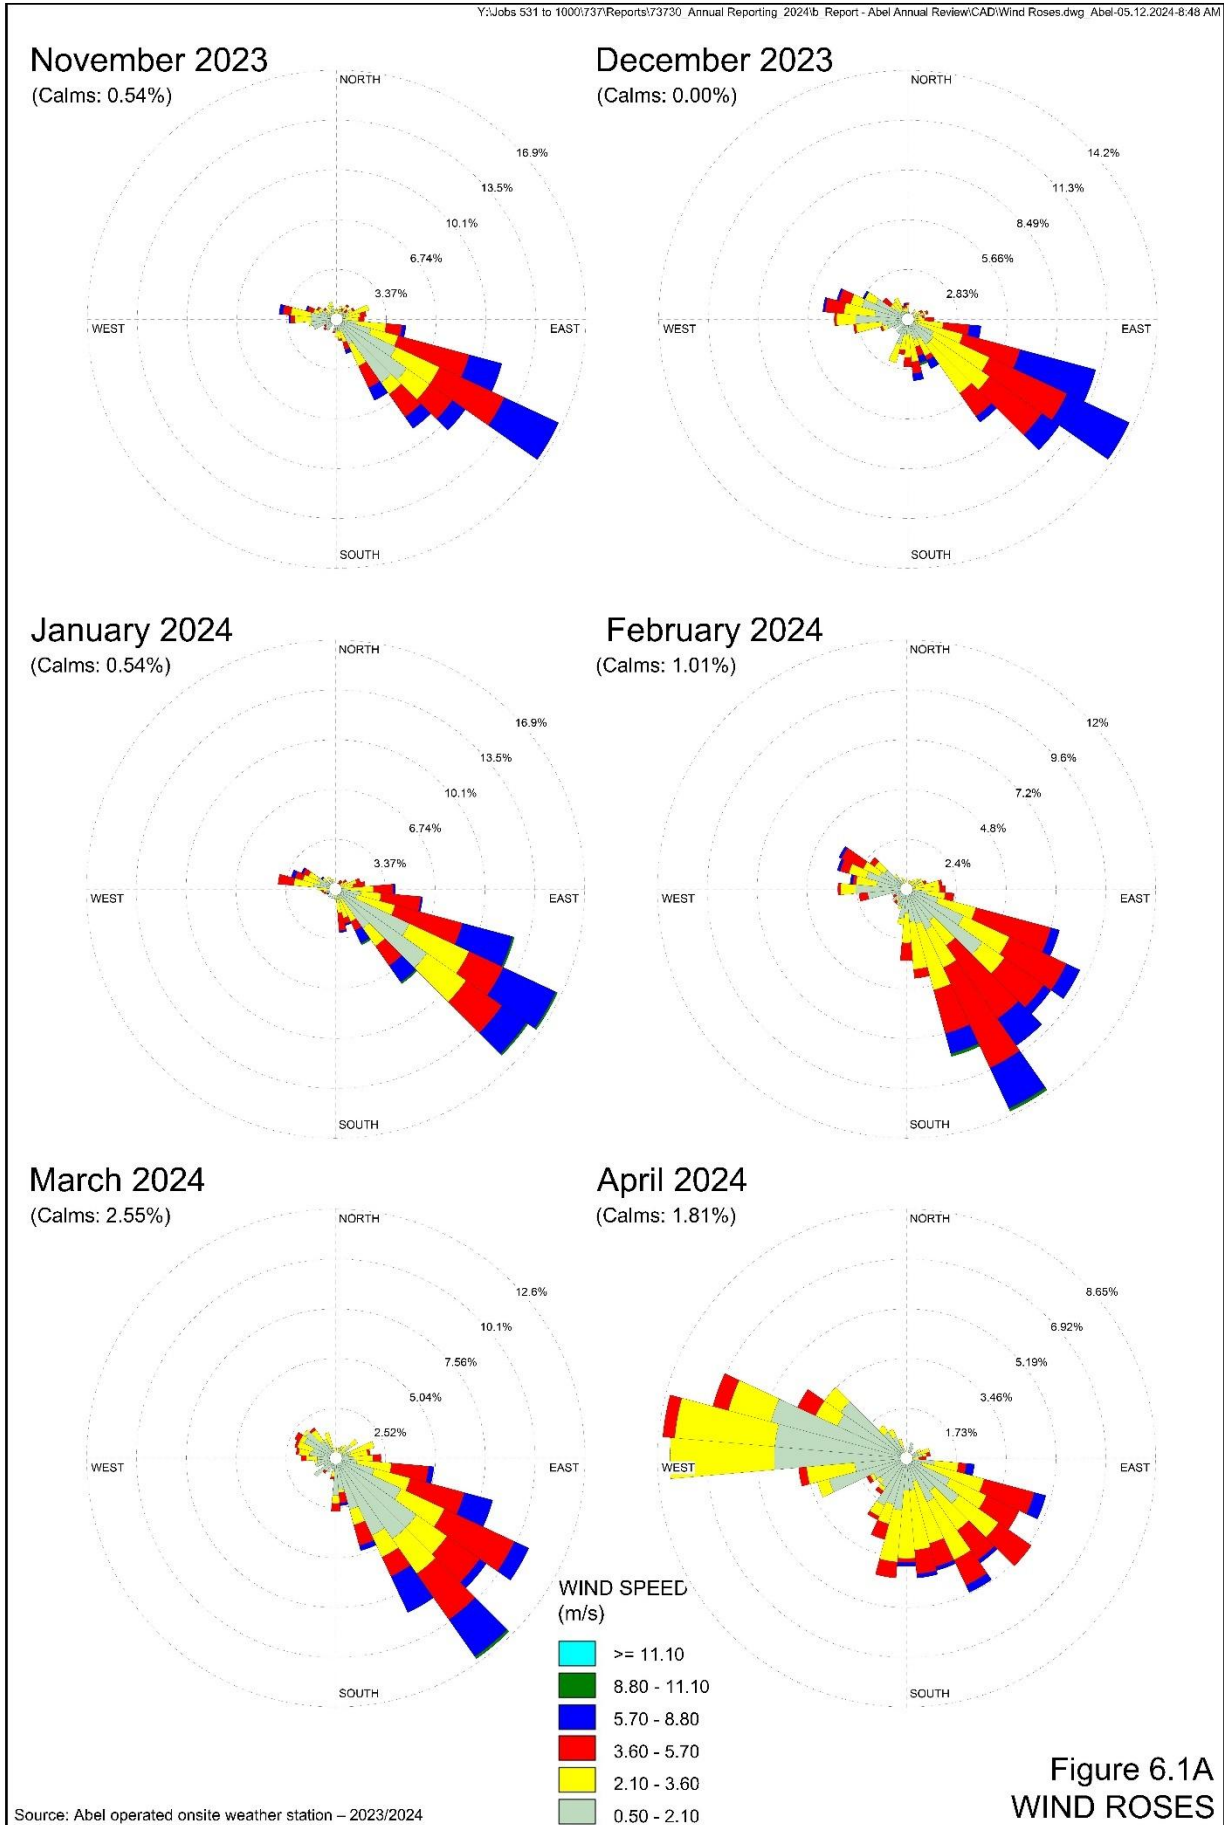
Figure 6.1A  
WIND ROSES

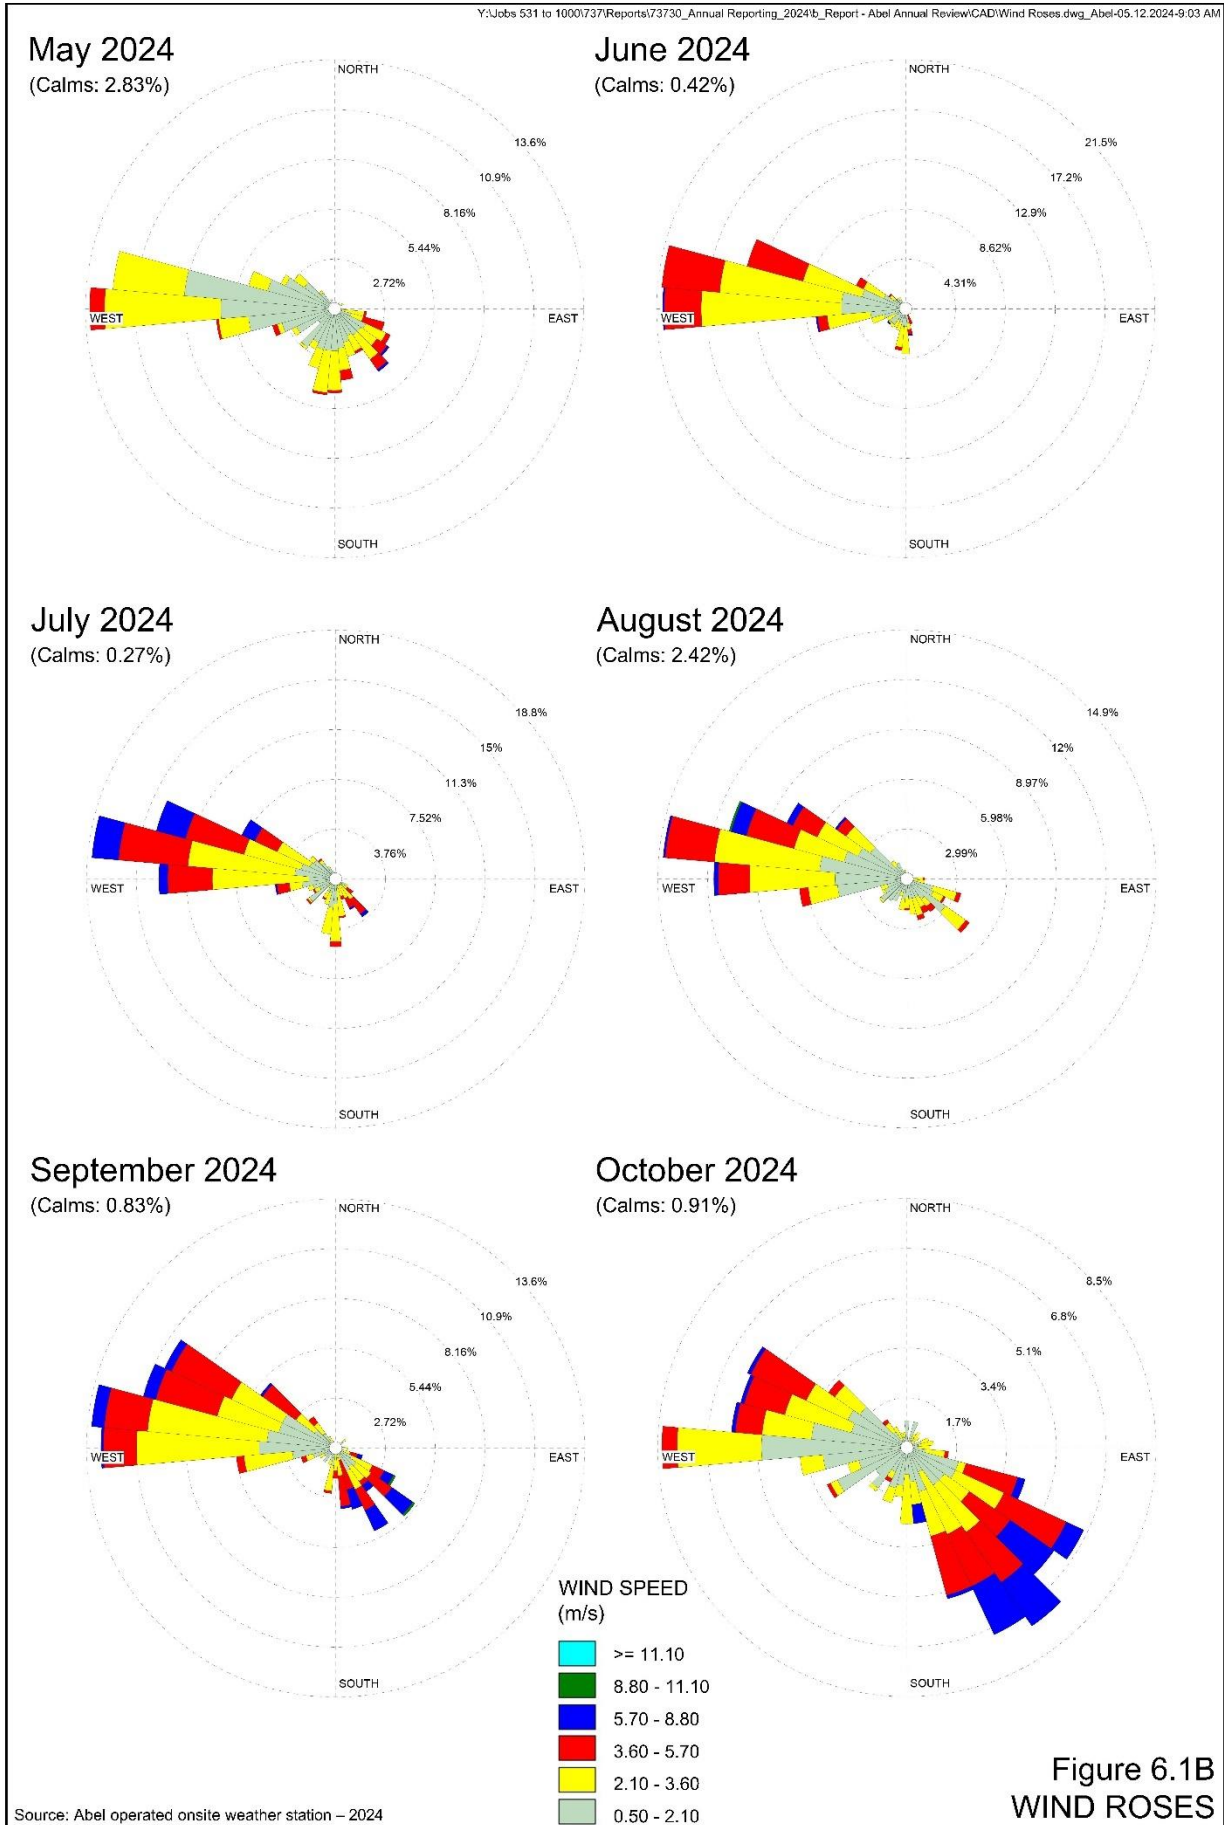
Figure 6.1B  
WIND ROSES

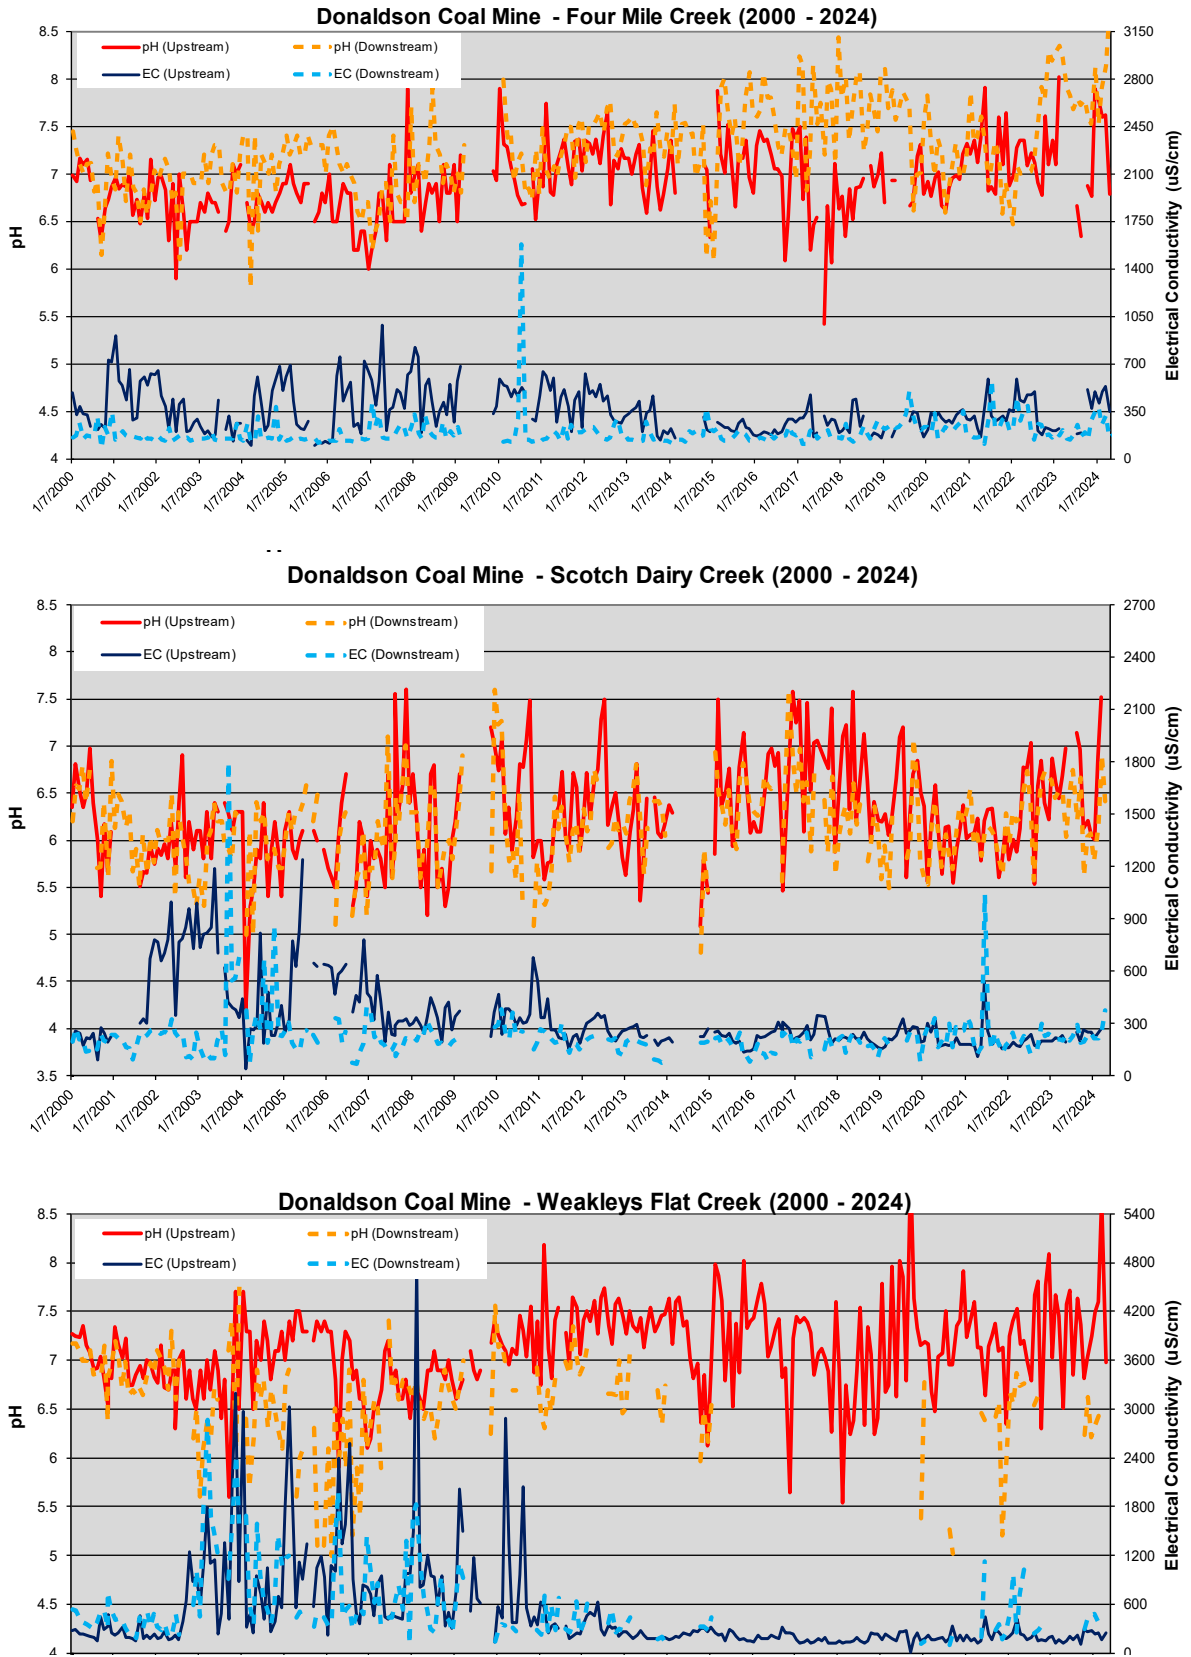
Figure 7.1 Surface Water Monitoring – 2000 to 2024

Monthly values at the remaining sites were generally consistent with pre-mining levels with only minor variations above pre-mining levels.

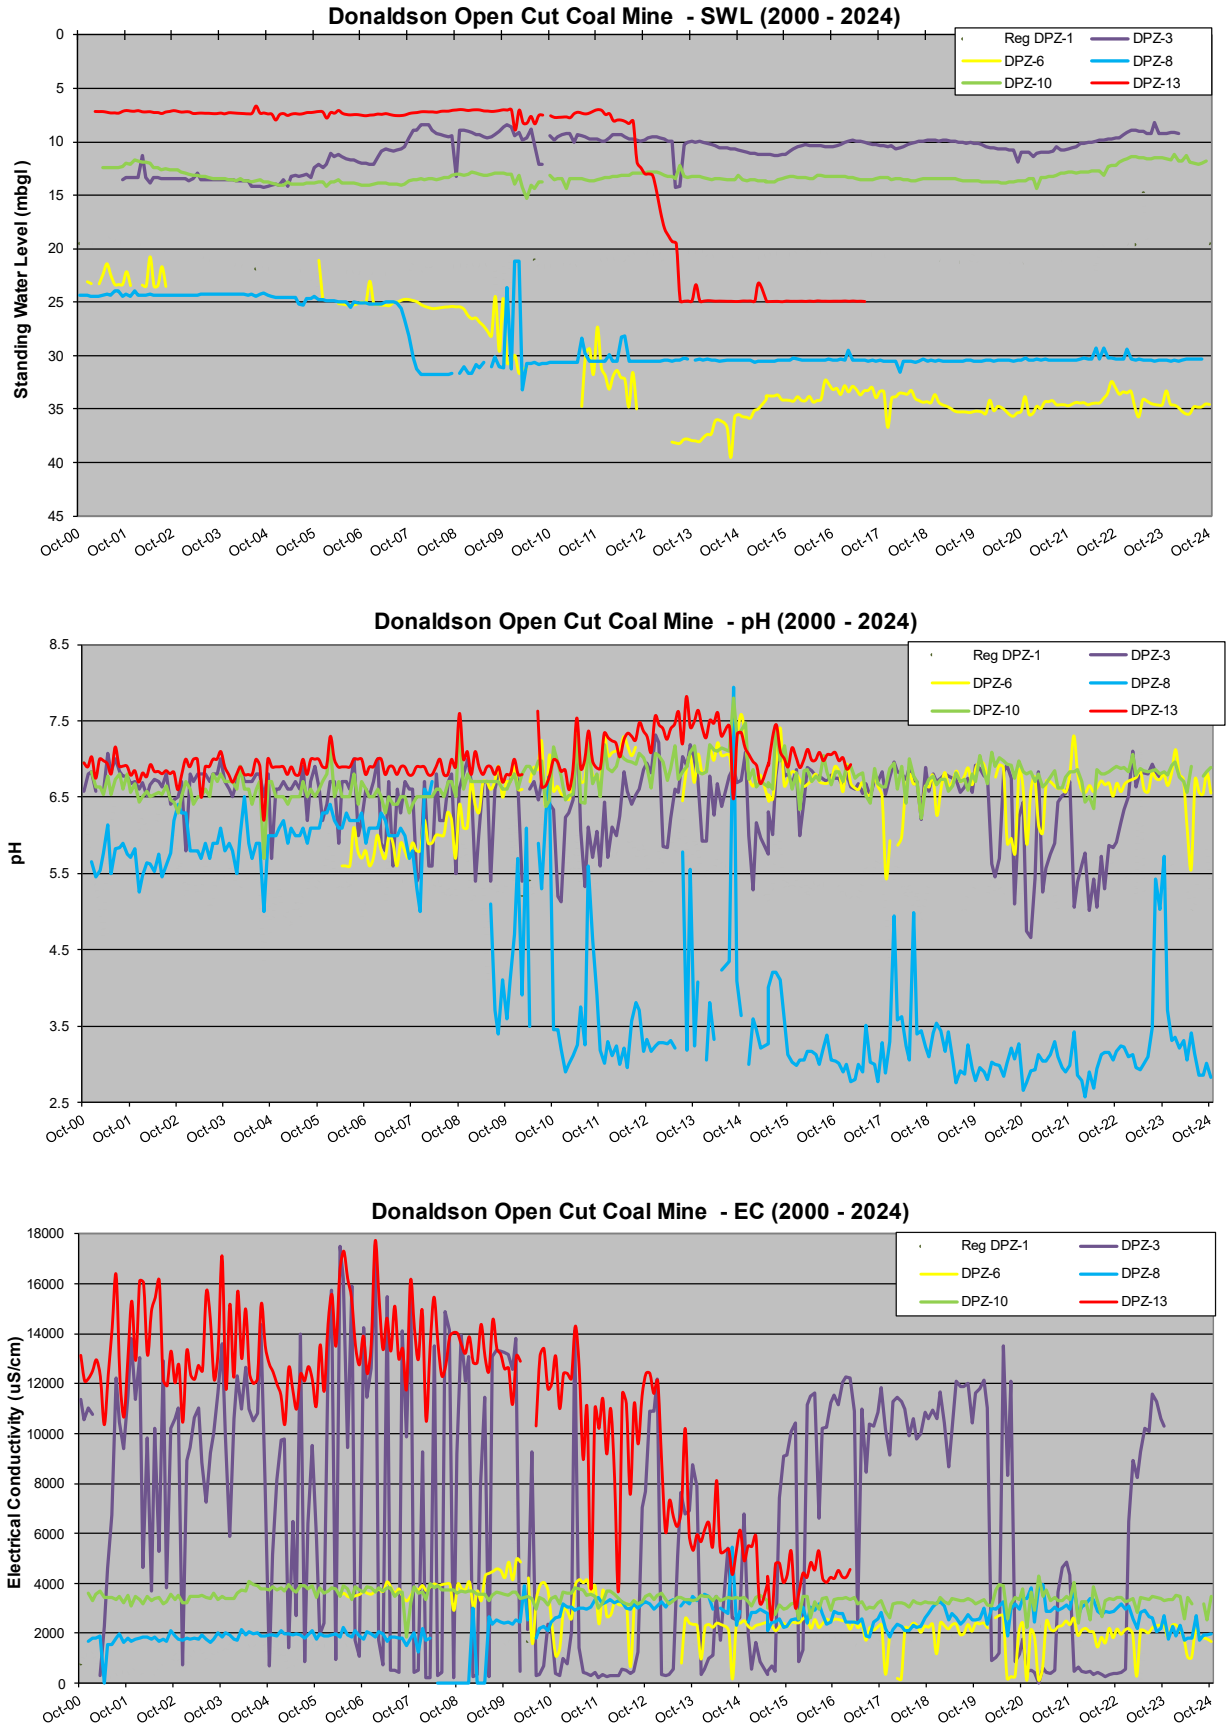
Figure 7.2 Groundwater Monitoring – 2000 to 2024

DPZ3: Located in the open cut area and screened in coal measures below Donaldson Seam. An unexplained rise in water level was recorded from 2004 to 2010 followed by a decline which was a response to mining from the Donaldson Open Cut. Between 2015 and 2018 the SWL remained relatively stable and slightly higher than pre-mining levels. During the reporting period, groundwater levels were relatively stable, ranging from 11.39 to 9.13mbgl and slightly above pre-mining levels.

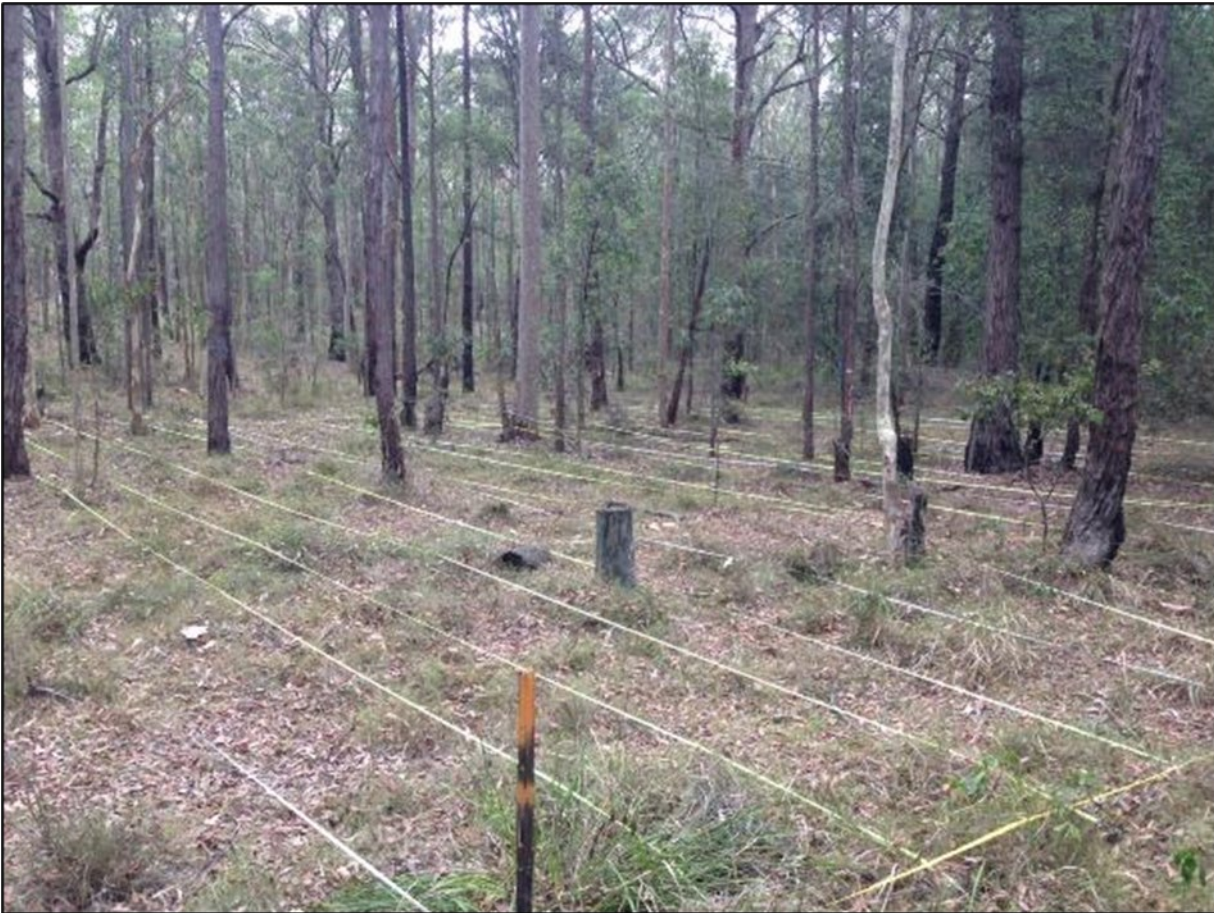
**Plate 1: Example of grid layout for collection of biomass measurements (Quadrat 5)**

Research has shown that there is a relationship between the growth of one part of an organism and another part that is known as allometric growth or allometry (where a part is a constant exponential function of the whole). The relationship between the basal area of a tree and the height can be used to monitor the development of the trees within the quadrats over time.

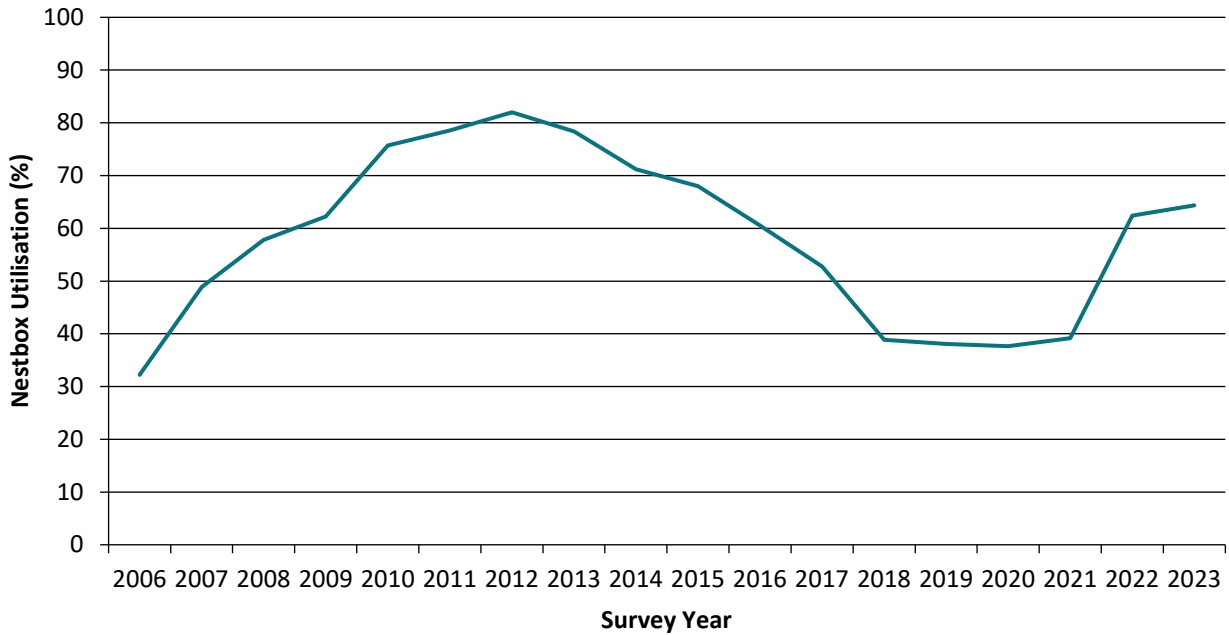
**Figure 22: Nest box usage, summer and winter combined (2006 – 2023). Usage rates are calculated based on available boxes.**

Nest box utilisation appears to be plateauing with similar usage rates to last year (**Figure 22**). Four mammal species were confirmed to have used the nest boxes, Sugar Glider (*Petaurus breviceps*), Brown Antechinus (*Antechinus stuartii*), Feather Tail Glider (*Acrobates pygmaeus*) and Common Brushtail Possum (*Trichosurus vulpecula*).

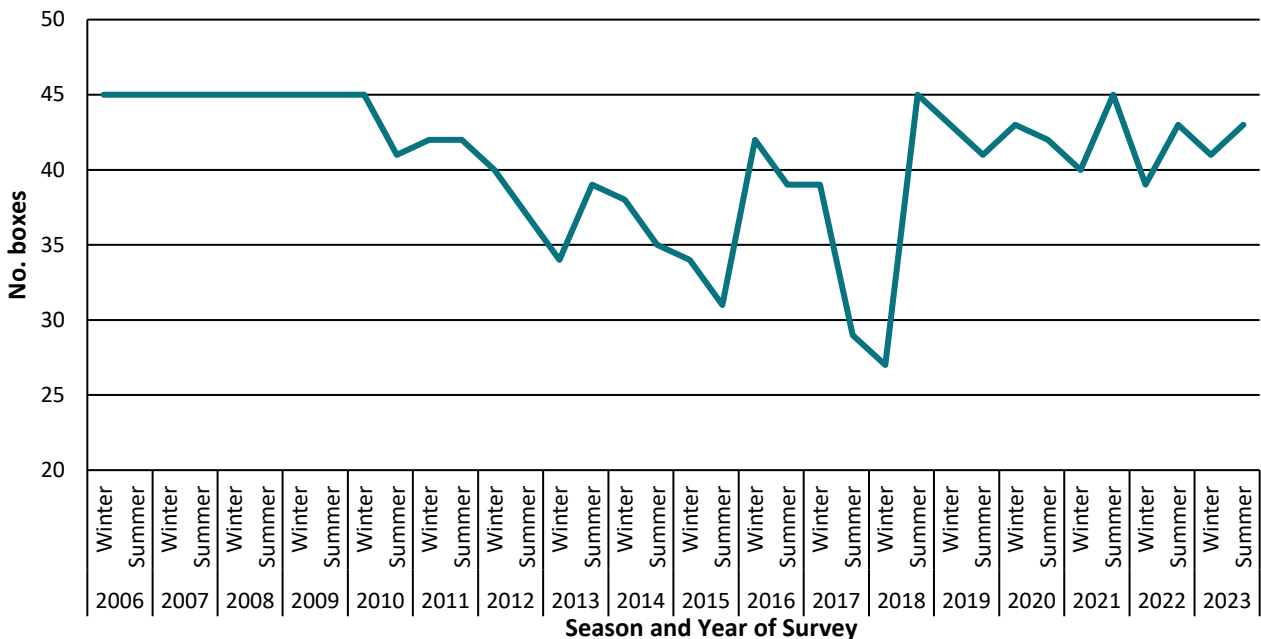
**Figure 23: Number of available nest boxes over time (2005 - 2023)**

**Figure 23** shows the number of nest boxes available for use since installation in 2005. There was no decline in nest box availability from 2006 until 2010. Since then, nest box availability has fluctuated due to weather and termite damage and the repair and installation of new nest boxes.

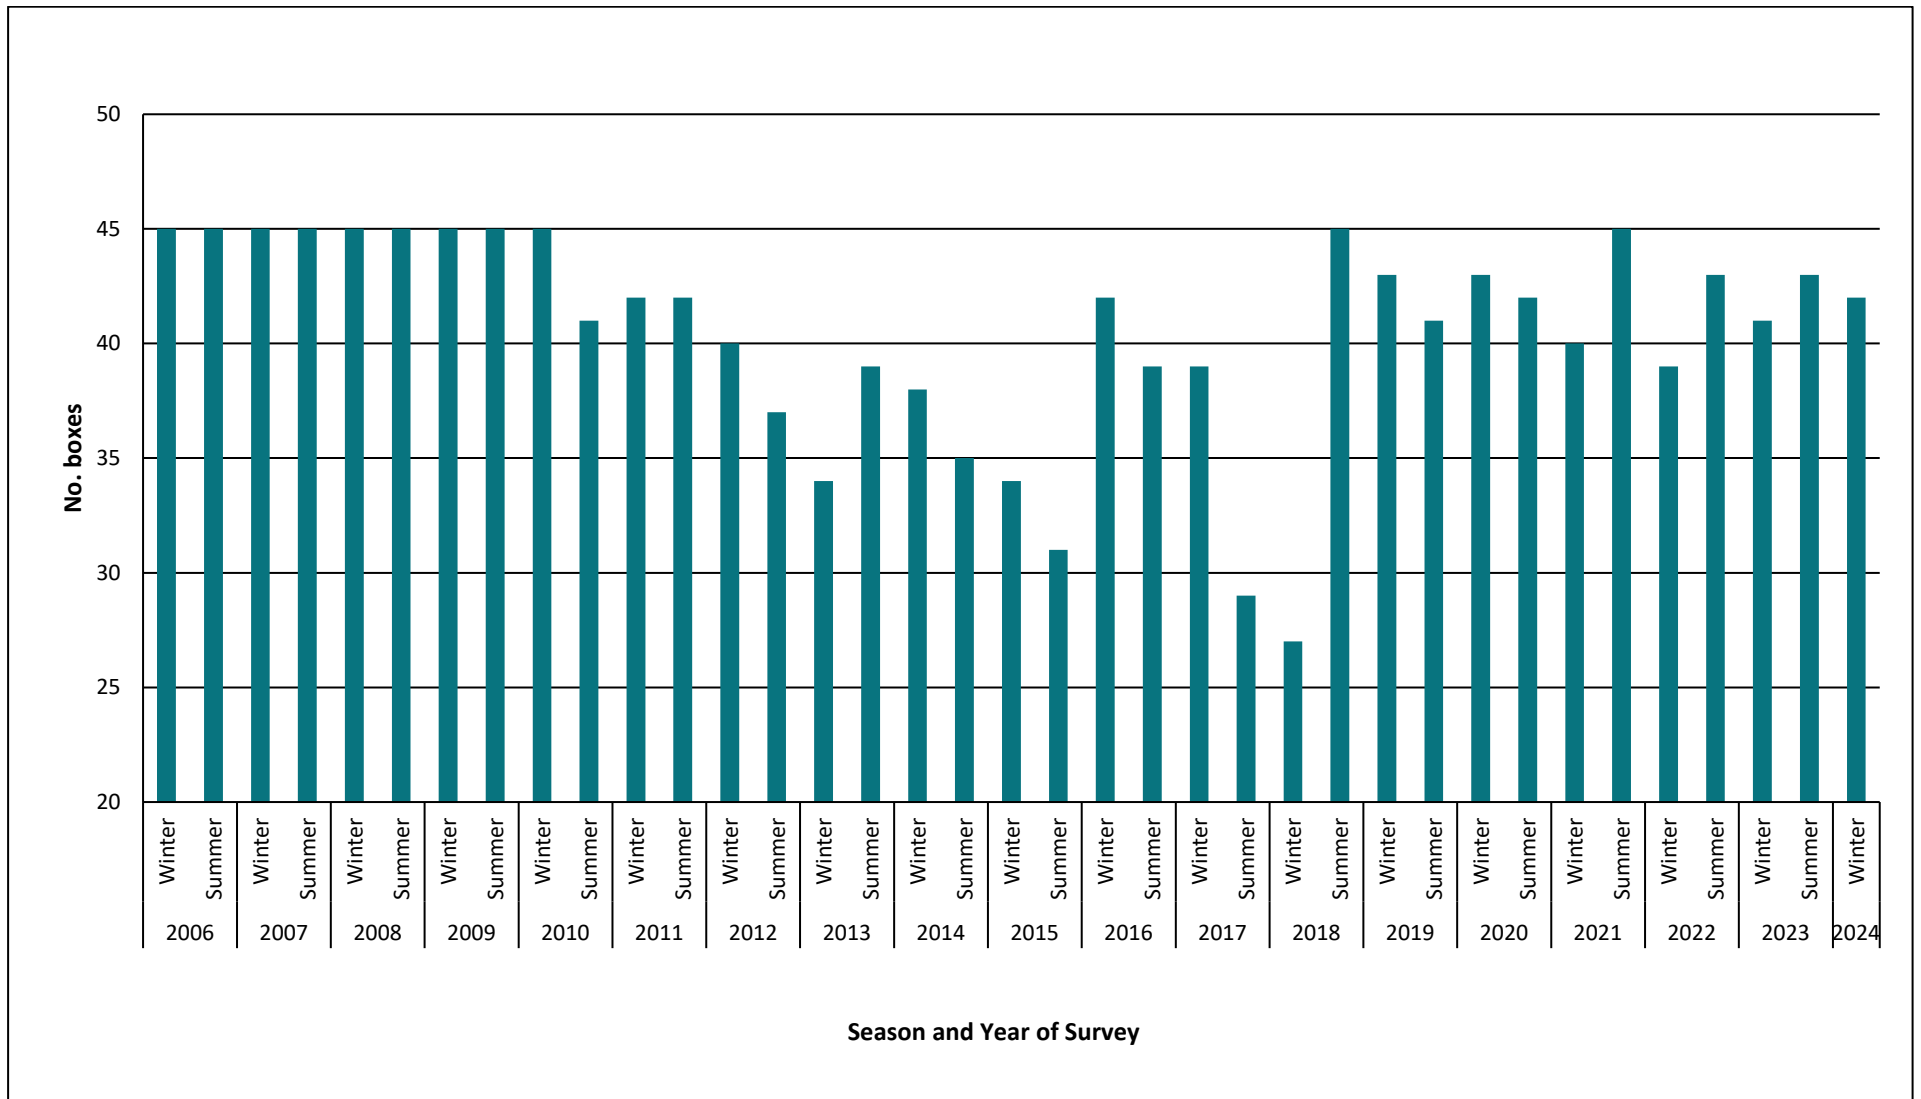
**Figure 4: Available nest boxes 2005 – 2024**

Physical evidence of fauna use was detected in 57.8% of all nest boxes in the winter 2024 surveys. Three boxes were not available for use due to deterioration of materials, with a further one nest box being utilised despite deterioration (**Figure 5**). Evidence of fauna use primarily consists of nests constructed from eucalypt leaves (indicative of glider and antechinus species). Two boxes were photographed to have sugar gliders present upon nestbox monitoring in Winter 2024. Overall, the utilisation of nest boxes has previously, and continues to, show high evidence of use within the study area.

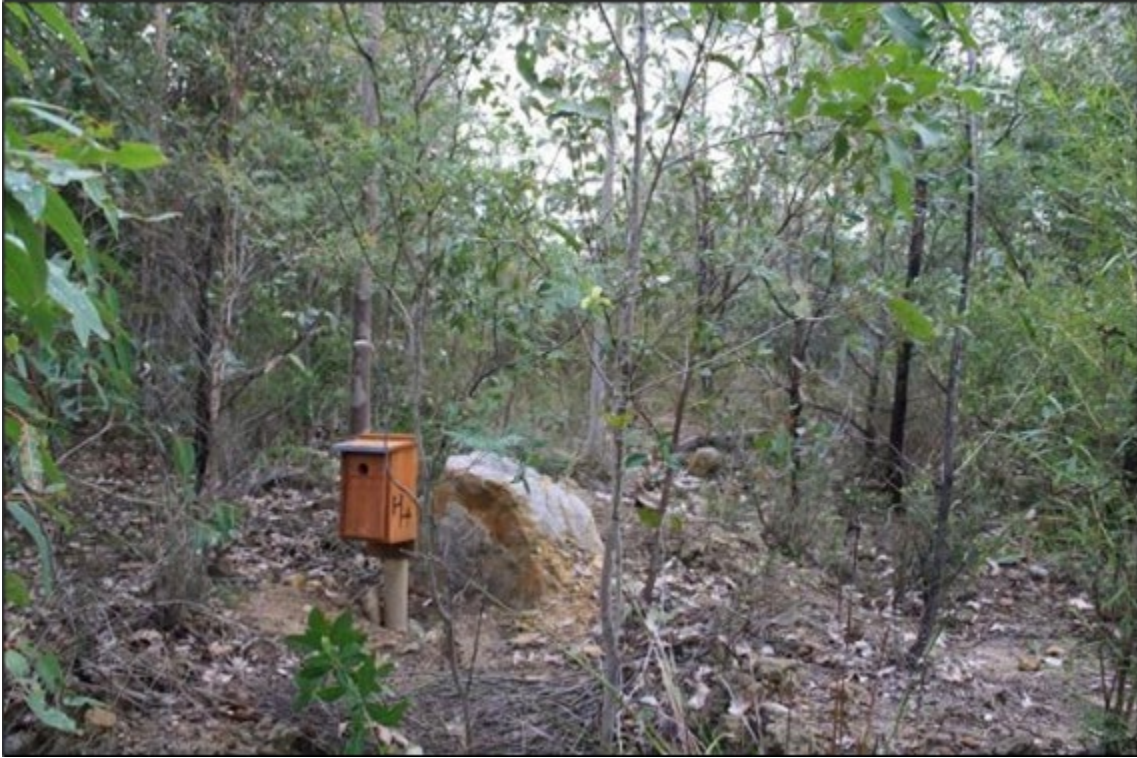
**Plate 10: Terrestrial nest box.**
