# Monthly Environmental Monitoring Report

Yancoal Mount Thorley Warkworth

September 2024

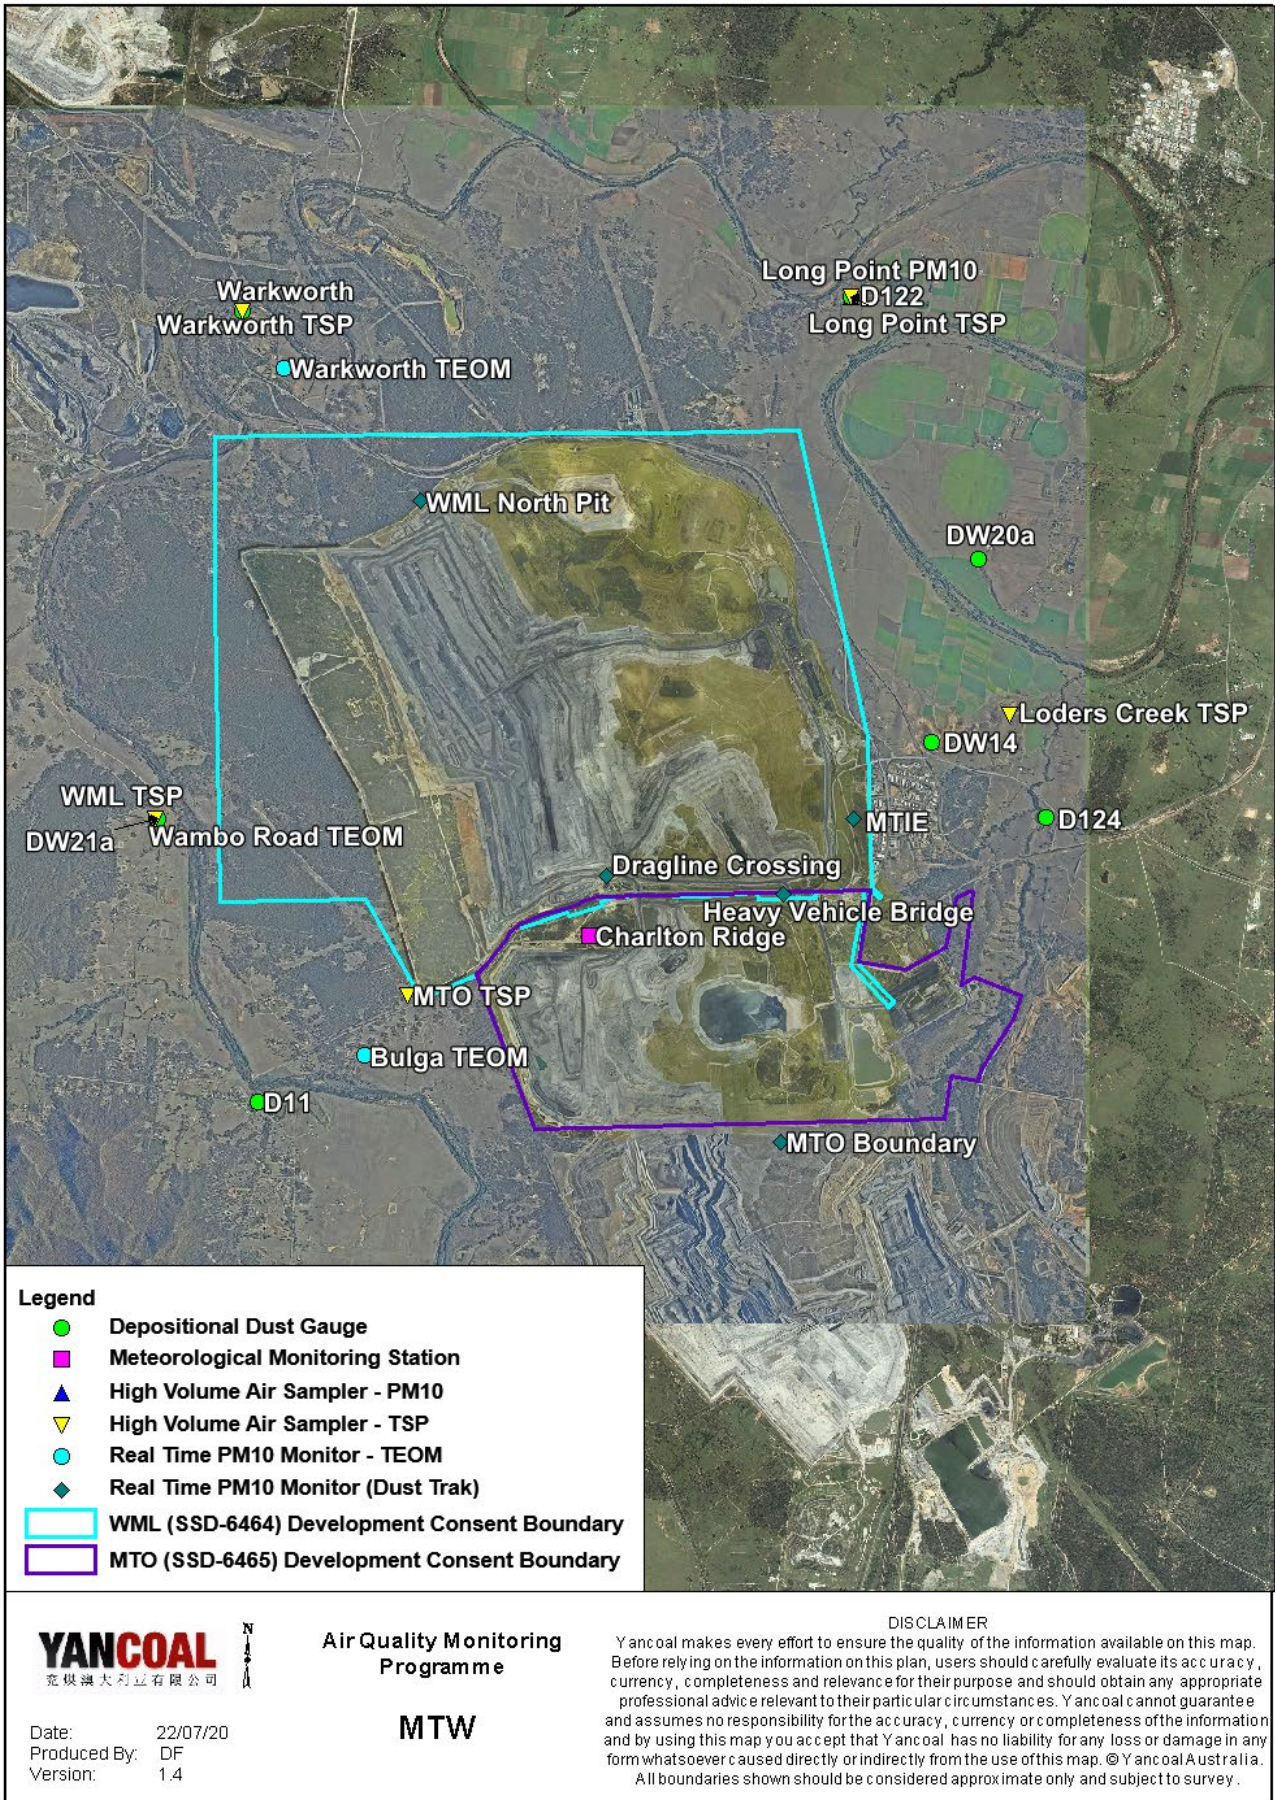
Figure 3: Air Quality Monitoring Locations

Meteorological data is collected at MTW’s ‘Charlton Ridge’ meteorological station (refer to **Figure 3**).

Suspended particulates are measured by a network of High Volume Air Samplers (HVAS) measuring Total Suspended Particulates (TSP) and Particulate Matter <10µm (PM<sub>10</sub>). The location of these monitors can be found in Figure 3. Each HVAS was run for 24 hours on a six-day cycle in accordance with EPA requirements.

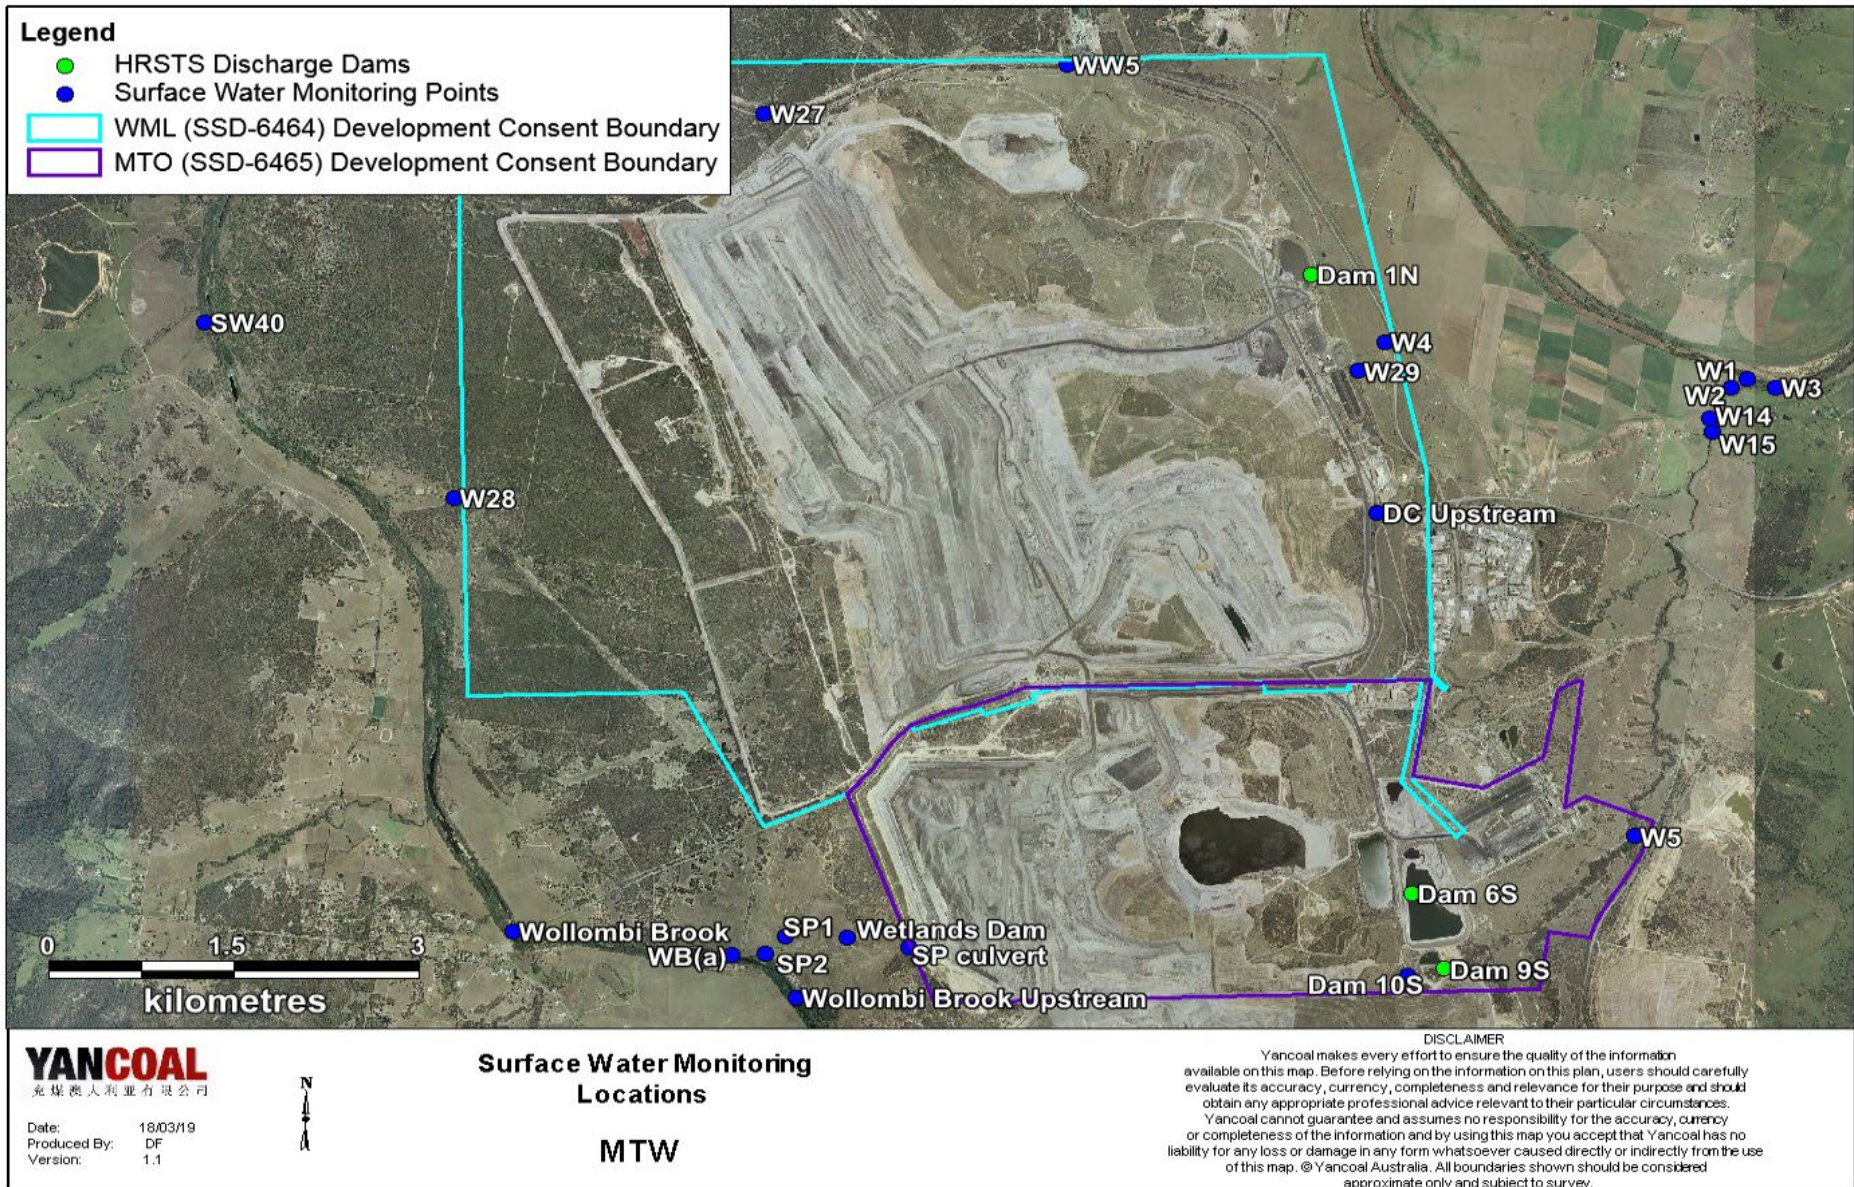
Figure 15: Surface Water Monitoring Location Plan

Monitoring is conducted at mine site dams and surrounding natural watercourses. The surface water monitoring locations are outlined in Figure 15.
