# Mount Thorley Warkworth 2020 Annual Review

Mount Thorley Warkworth (MTW) is an integrated operation of two open cut coal mines, Warkworth Mining Limited (WML) and Mount Thorley Operations (MTO). This Annual Review reports on the environmental performance of MTW for the period 1 January 2020 to 31 December 2020.

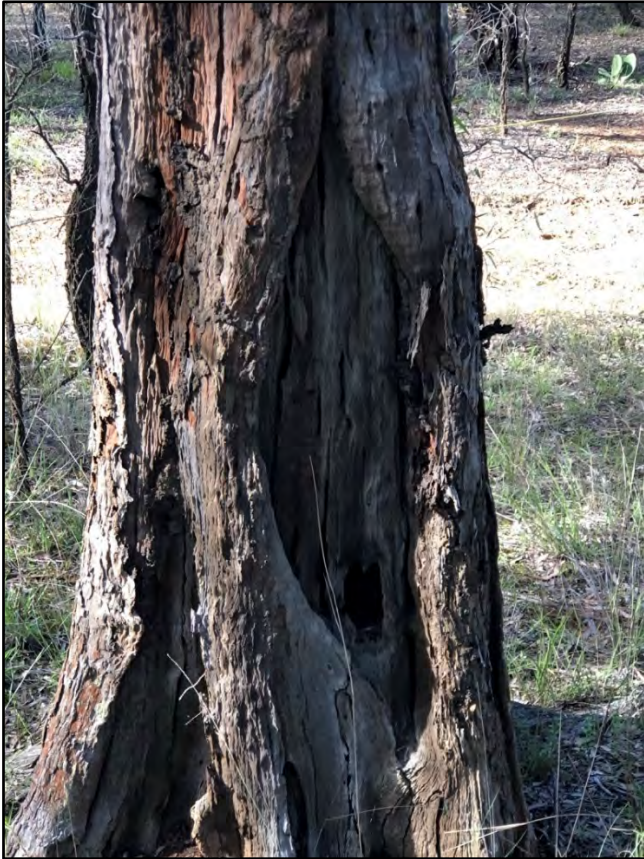
**Scarred tree MTW-8**

Four scarred trees are located within the approved future mining area at MTW. With the exception of MTW-70, these trees have been assessed by an arborist regarding the best method of removal and relocation. MTW-70 should also be assessed for removal and relocation. These scarred trees have been visited by RAPs during this compliance inspection and during other inspections and assessments. Their removal and the arborist's plans should be discussed with the CHWG, as well as the location to where they will be relocated – the WBACHCA has been suggested. The three dead trees (MTW-8, 70 and 523) are in a poor condition however and may not be able to be successfully relocated.

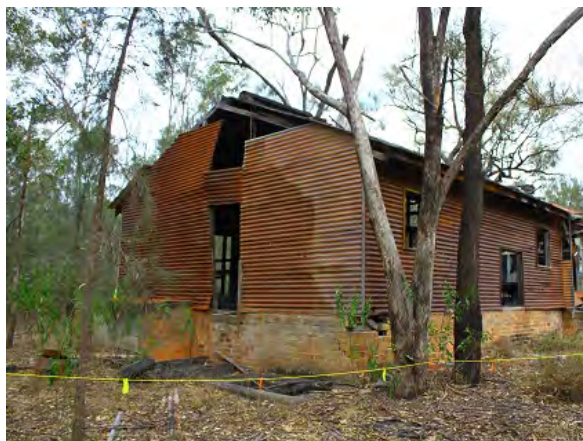
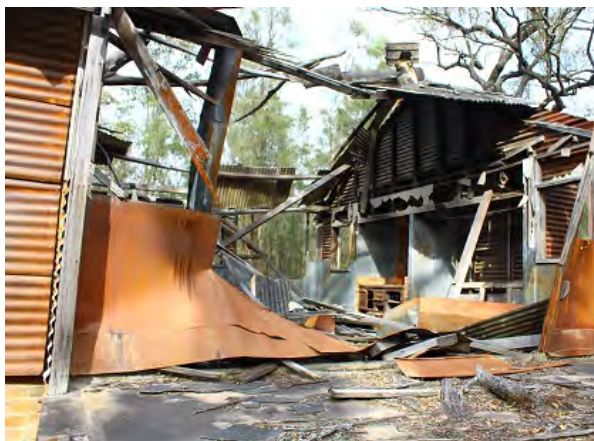
The remnant building is "L" shaped in plan with brick and concrete footings. During the original assessment conducted by ERM in November 2012 (which informed the CMP) the building was noted as being in poor condition with trees physically impacting on the building fabric, and some minor settlement issues resulting in cracking and failing brickwork. The western section of the building was the most intact part, retaining the original timber frame, corrugated asbestos cement roof sheeting and walls clad with corrugated iron sheeting.

sheeting is also missing in some places, and damaged and in poor condition where it remains. Much of the corrugated iron sheeting is corroded. Brickwork is also cracking in a number of locations resulting in significant movement outward, loss of mortar and loss of bricks along the southern and eastern elevations.

As a result, a number of structural recommendations were outlined by ERM in the CMP developed for the site in 2012. These recommendations were not intended to return the building to a serviceable state, rather they seek to do the minimum required to allow safe access to the building to prevent significant damage, and also allow safe access for asbestos removal and internal inspection of the building in the short to medium term.

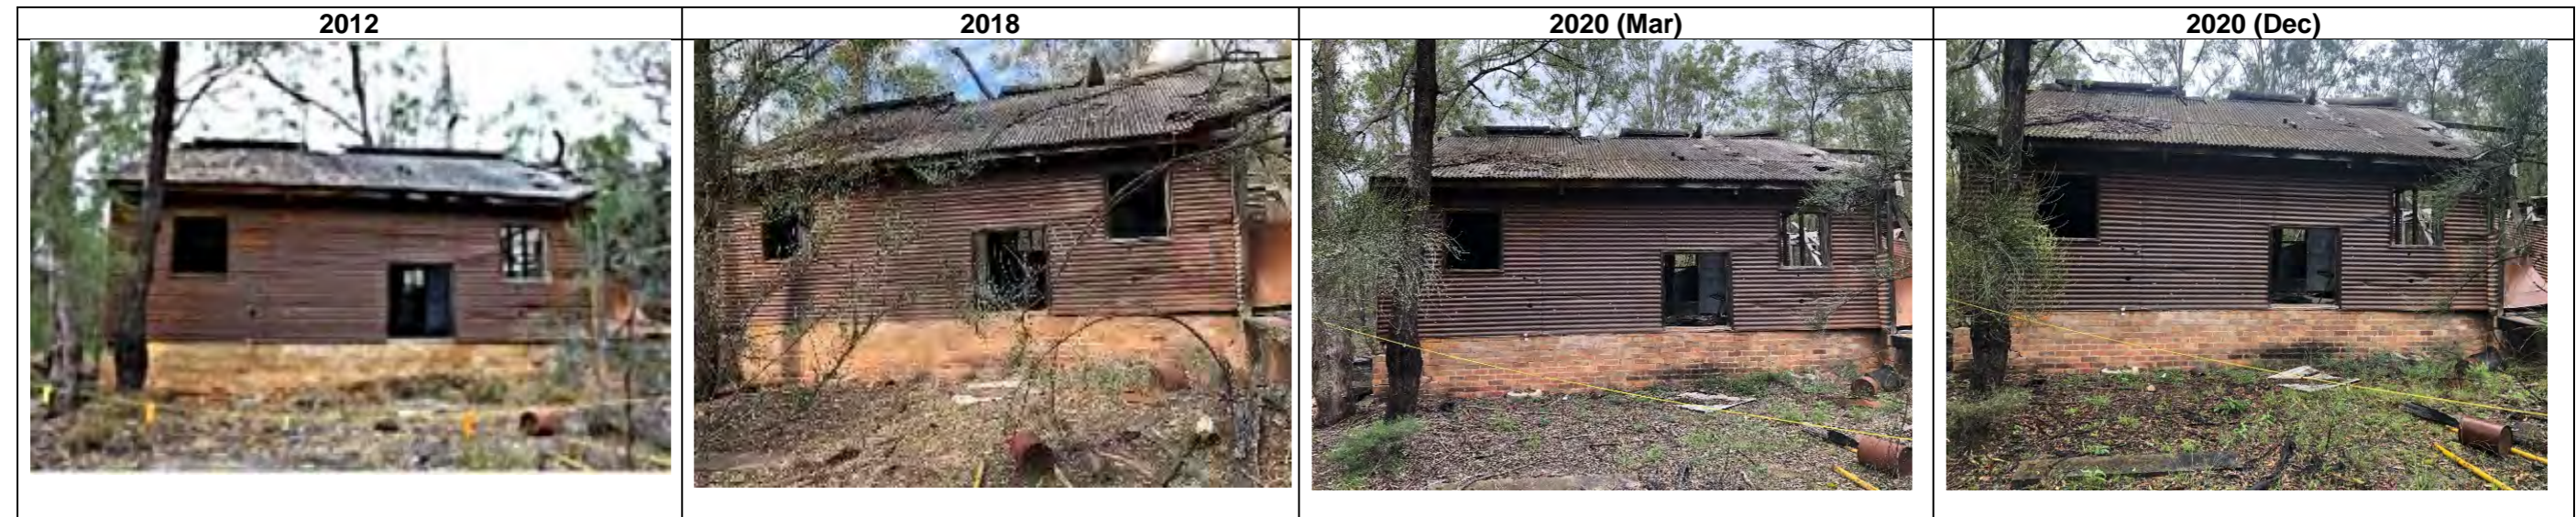
**East elevation**

**2012-18:** no discernible change – note fallen branch from tree on western side.

**2018-20 (Mar):** no discernible change – fallen branch has moved.

**Mar 2020 – Dec 2020:** no discernible change.

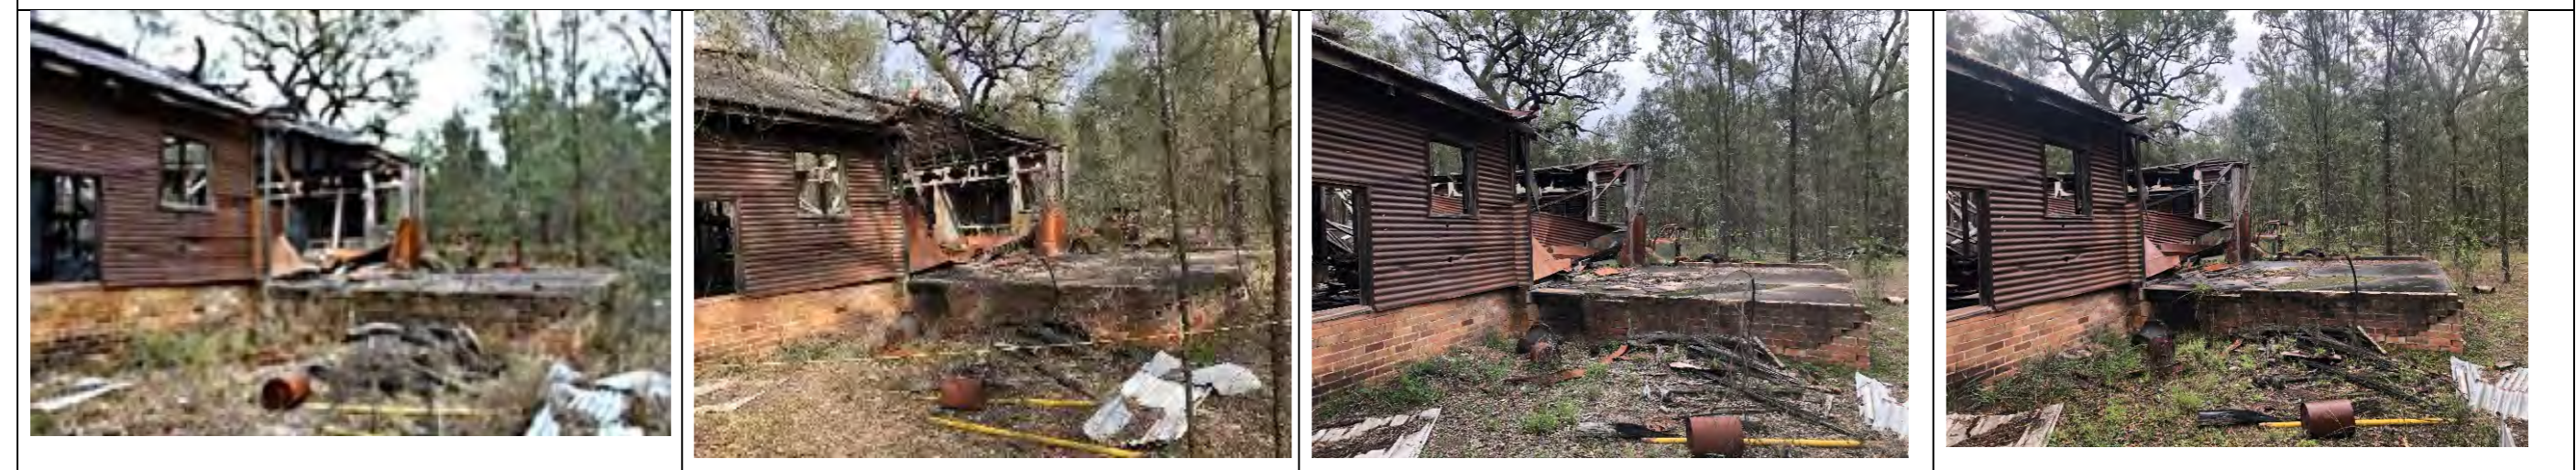
**View to north-east elevation**

**2012-18:** roof over open kitchen area has deteriorated, causing severe lean on far wall.

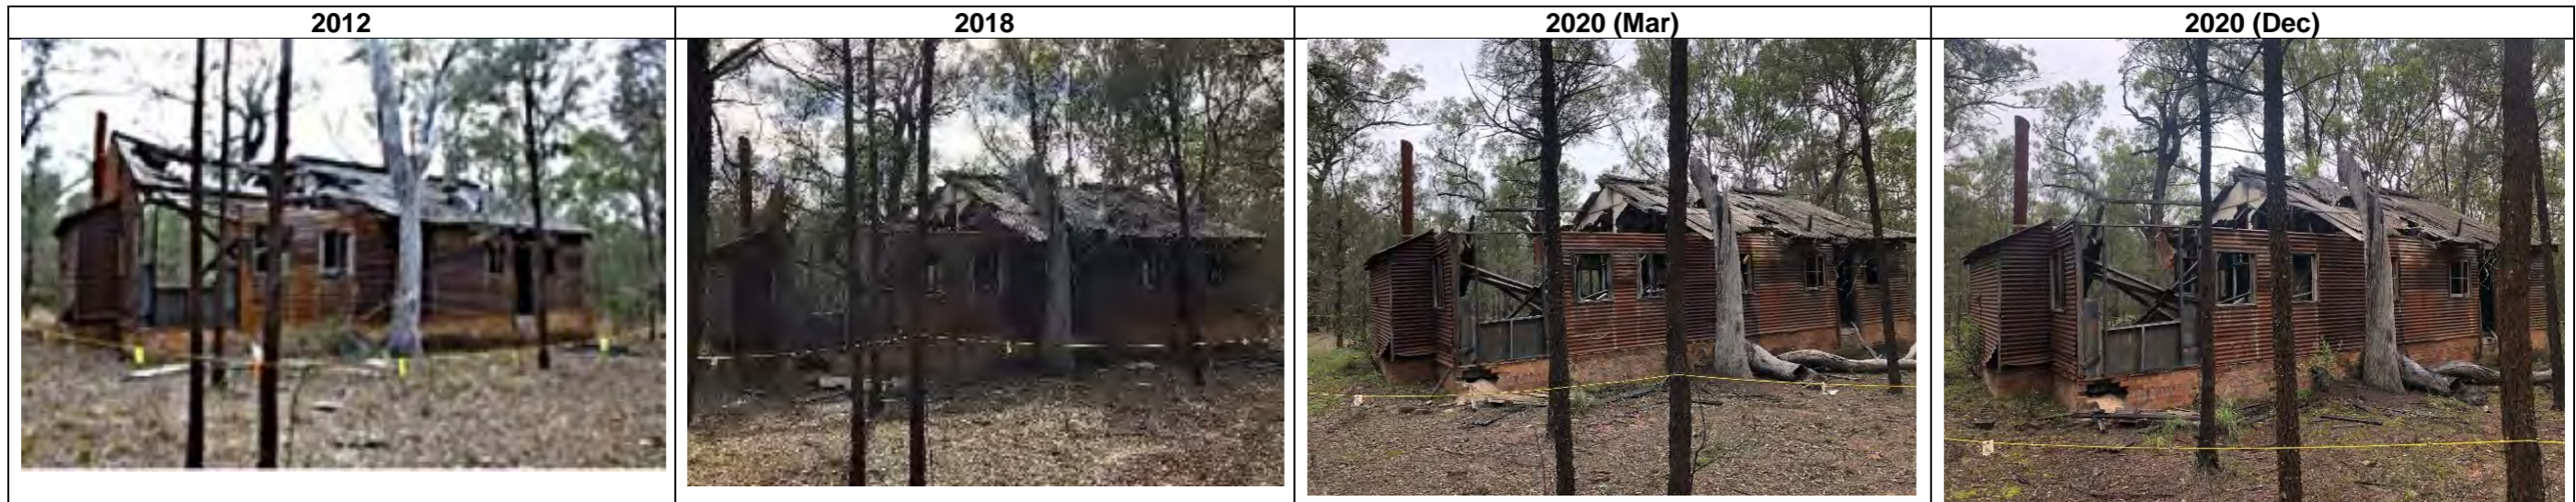
**West elevation**

**2012-18:** shows deterioration of roofing members above open kitchen area and leaning north wall, and further collapse of asbestos roof due to fallen dead tree.

**2018-20 (Mar):** top of north wall now collapsed, further damage to roof with branch now fallen to ground.

**Mar 2020 – Dec 2020:** no discernible change.

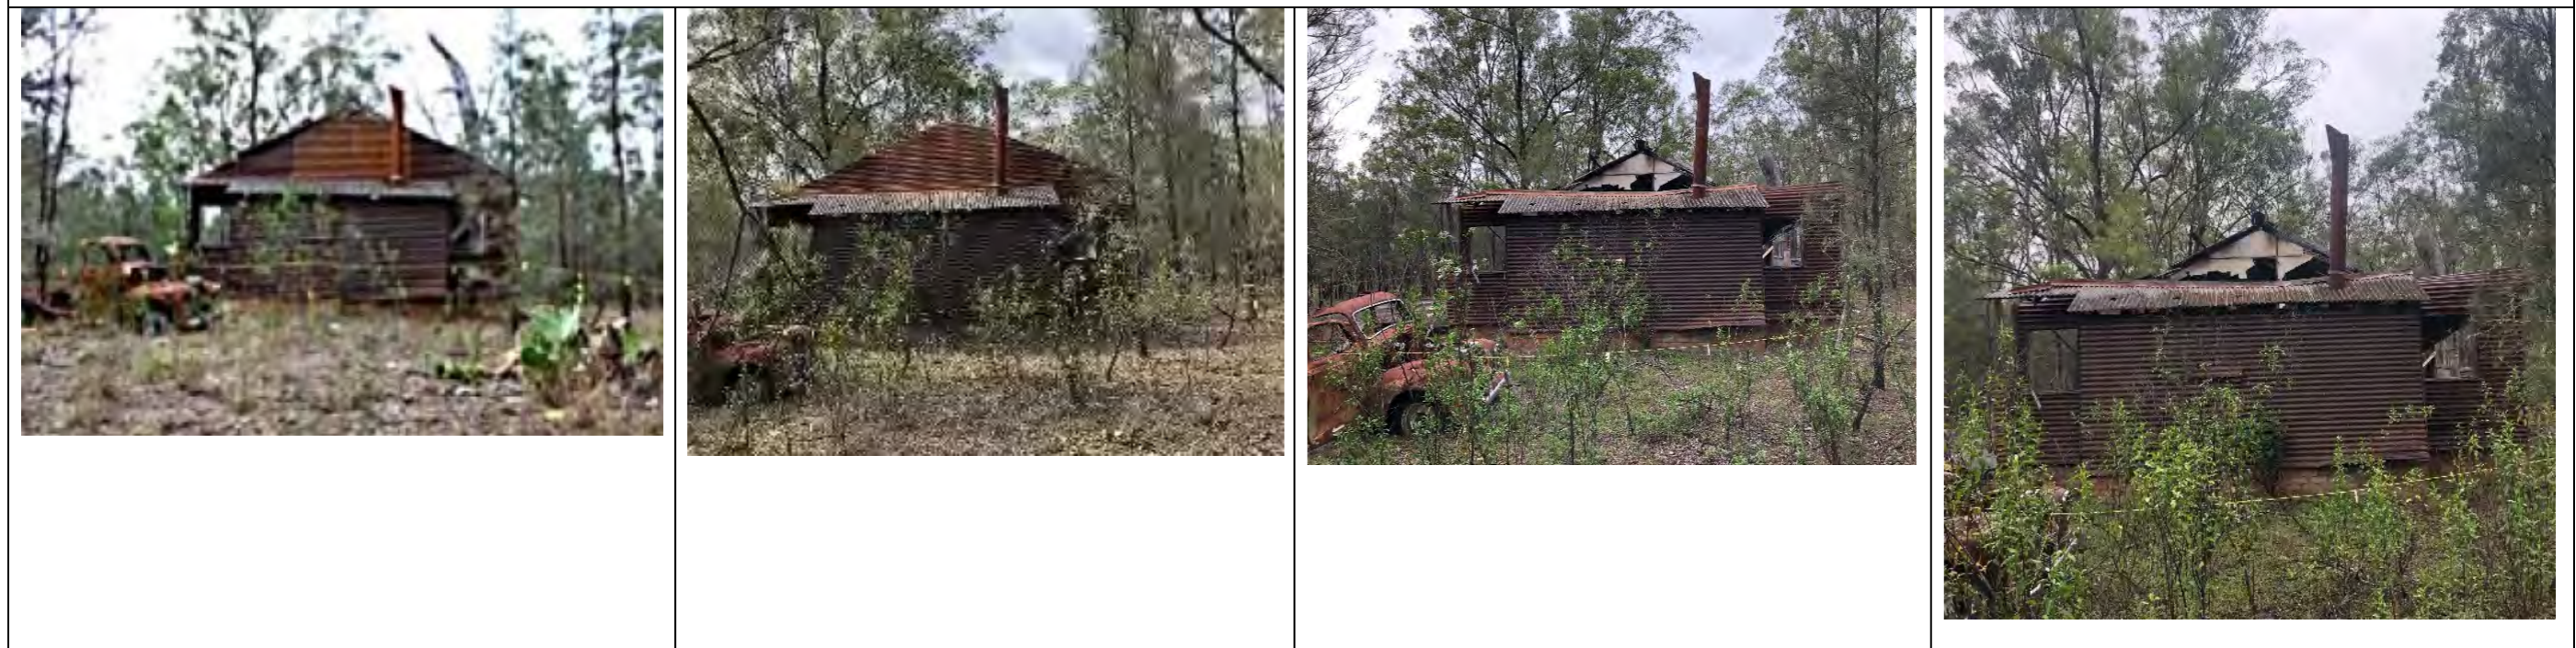
**North elevation**

**2012-18:** no discernible change.

**2018-20 (Mar):** top of north wall now collapsed.

**Mar 2020 – Dec 2020:** no discernible change.

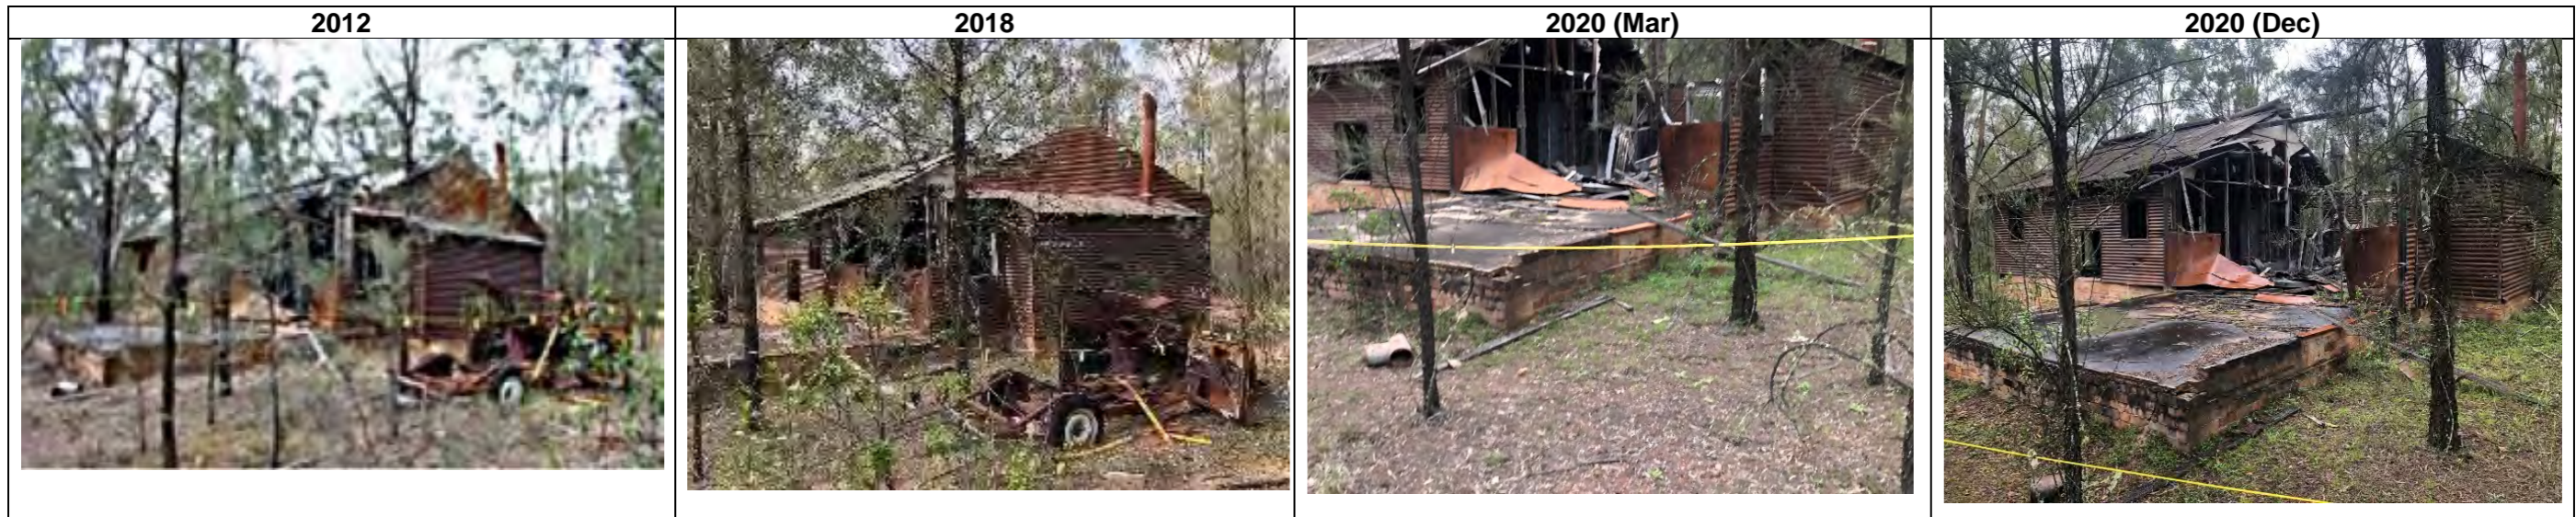
**North-east elevation**  
 2012-18: difficult to discern change.  
 2018-20 (Mar): difficult to discern change.  
 Mar 2020 – Dec 2020: no discernible change.

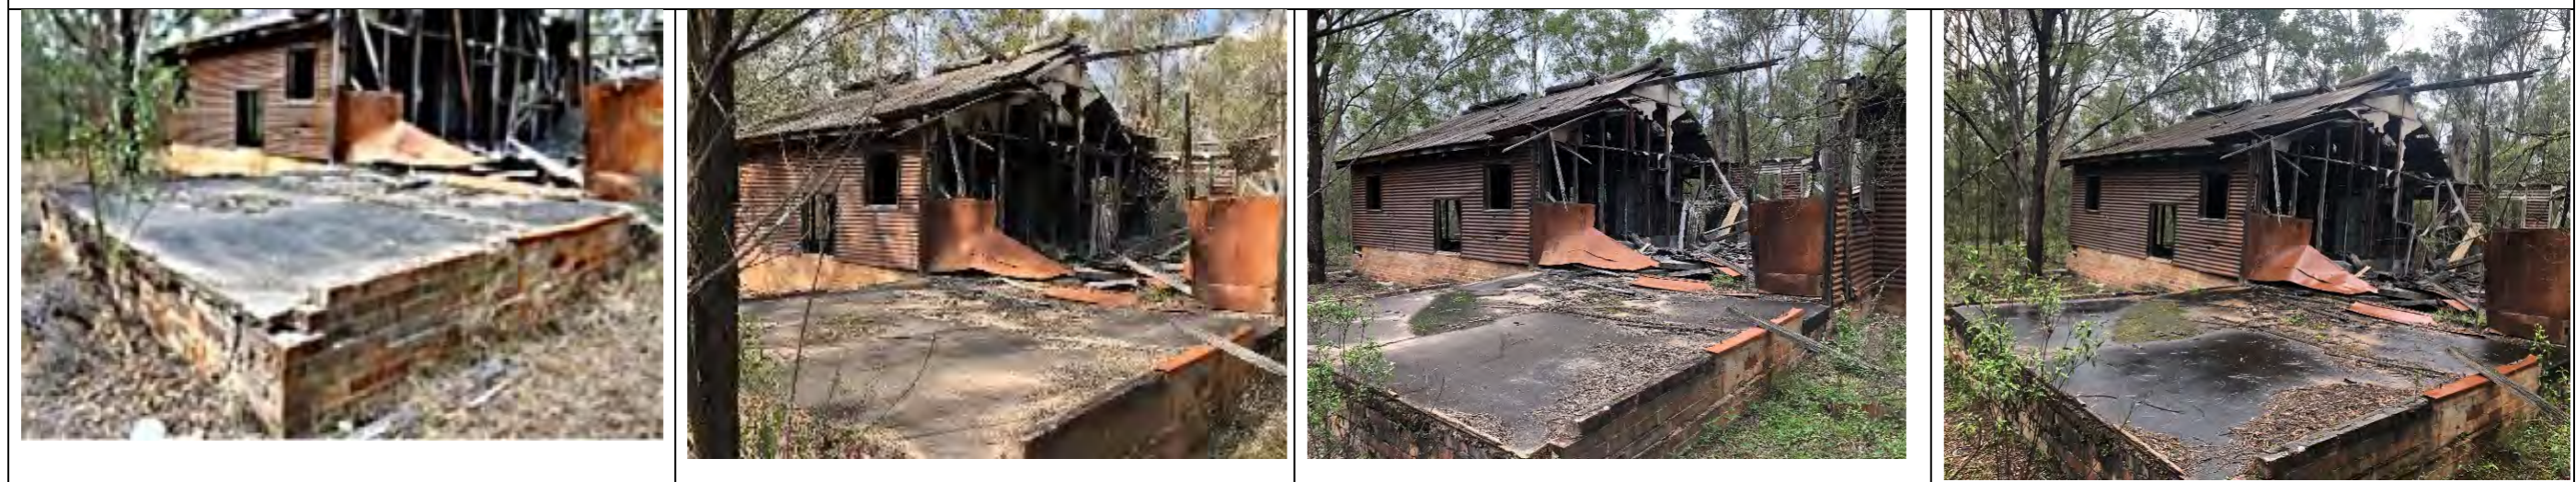
**Concrete and brick foundation at east side of building**  
 2012-18: difficult to discern change.  
 2018-20 (Mar): no discernible change.  
 Mar 2020 – Dec 2020: no discernible change.

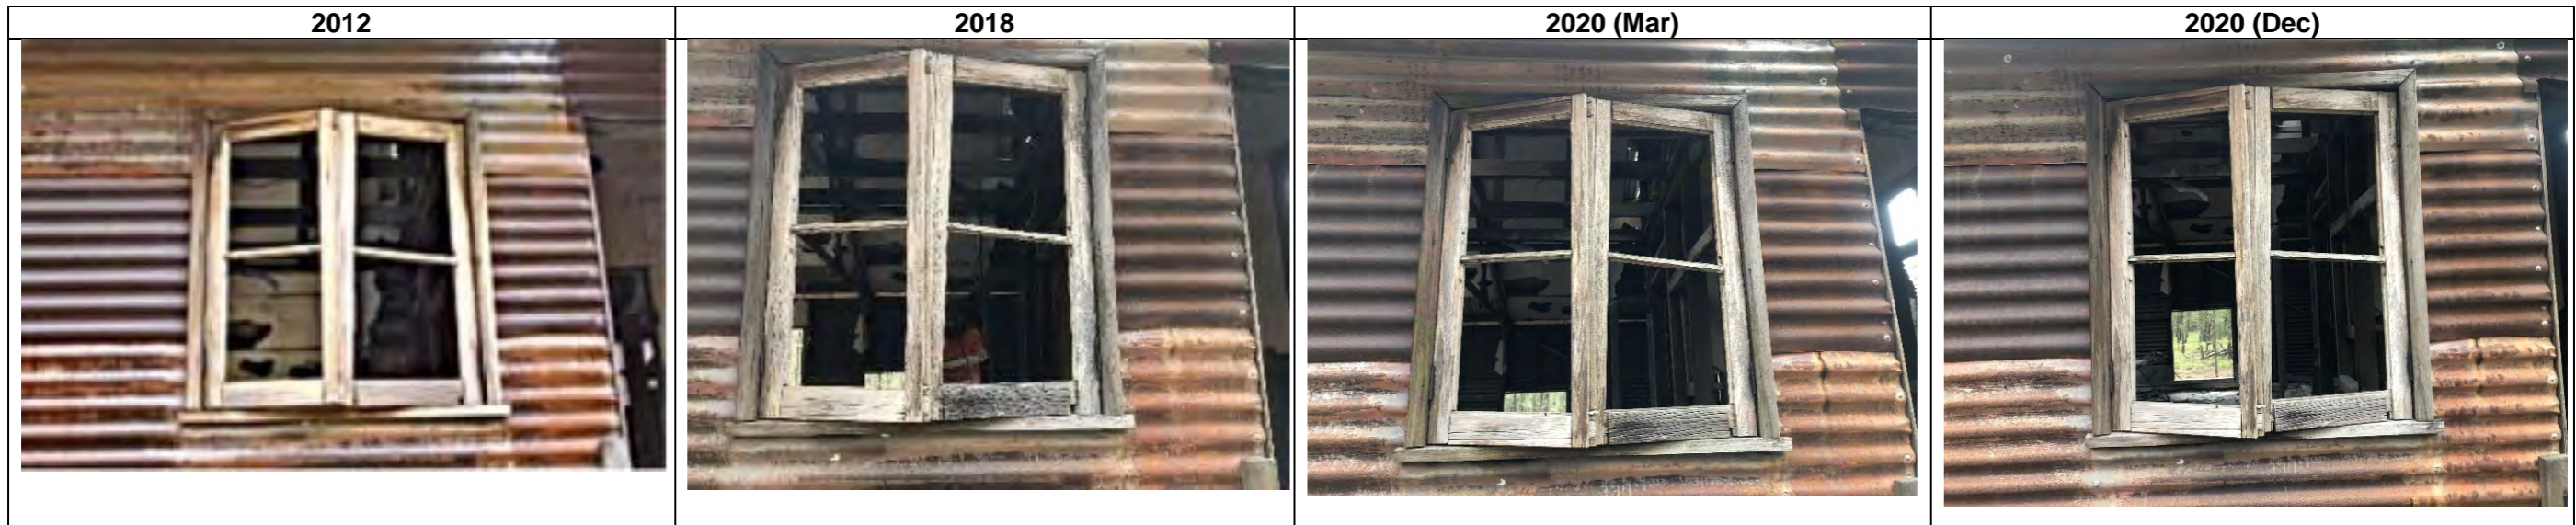
**Timber window detail, west elevation**  
**2012-18:** no discernible change.  
**2018-20 (Mar):** no discernible change.  
**Mar 2020 – Dec 2020:** no discernible change.

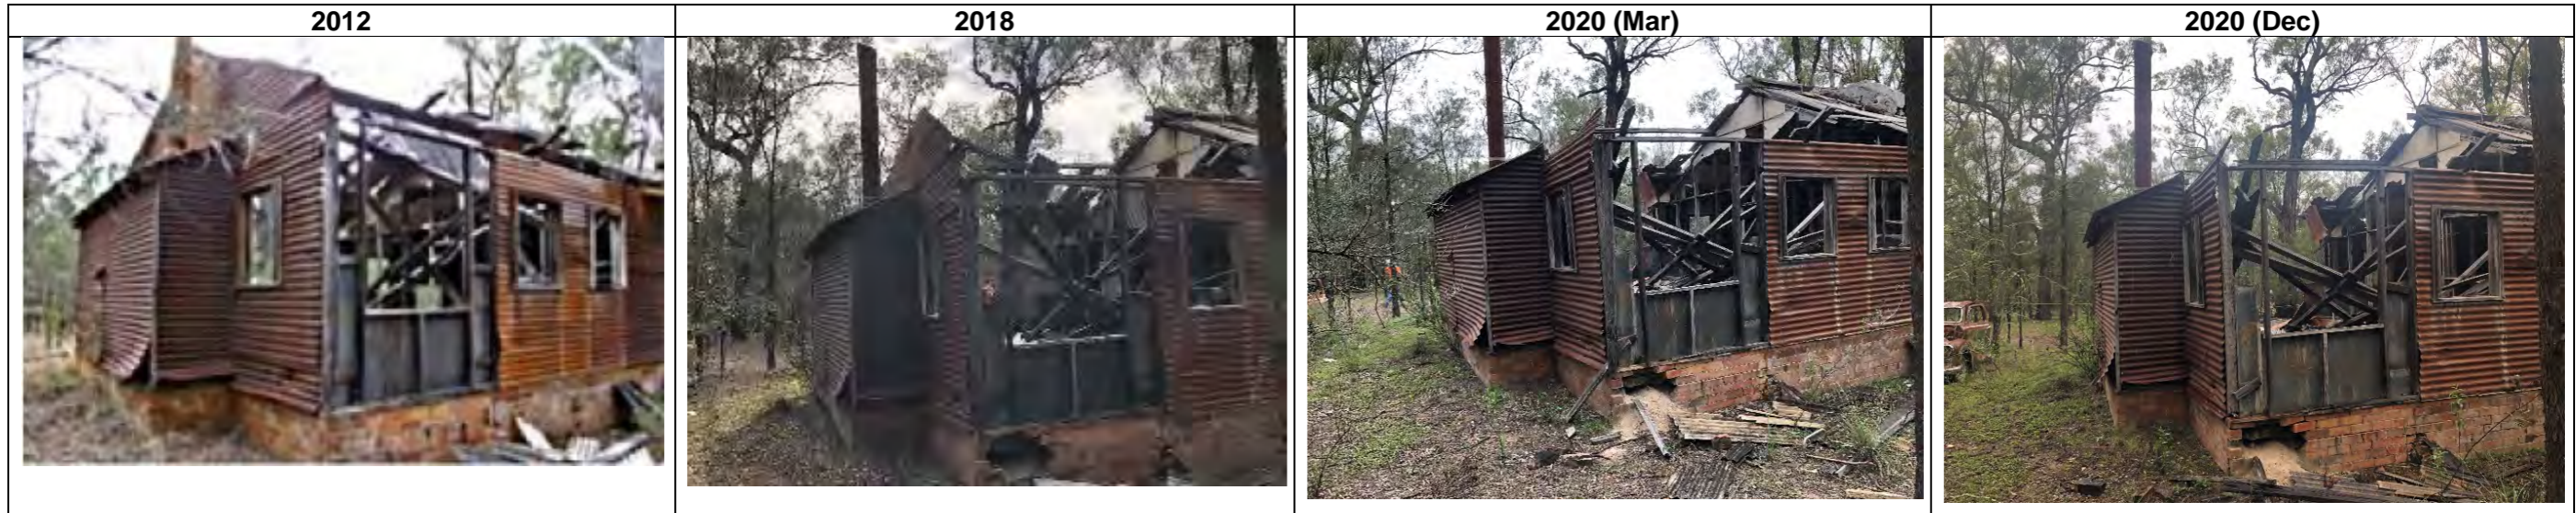
**Detail of north-west elevation**

**2012-18:** shows increased collapse over open kitchen area, as well as new damage to brick foundation at north-west corner.

**2018-20 (Mar):** shows fallen top of north wall plus increased (animal?) damage to brick foundation at north-western corner.

**Mar 2020 – Dec 2020:** no discernible change.

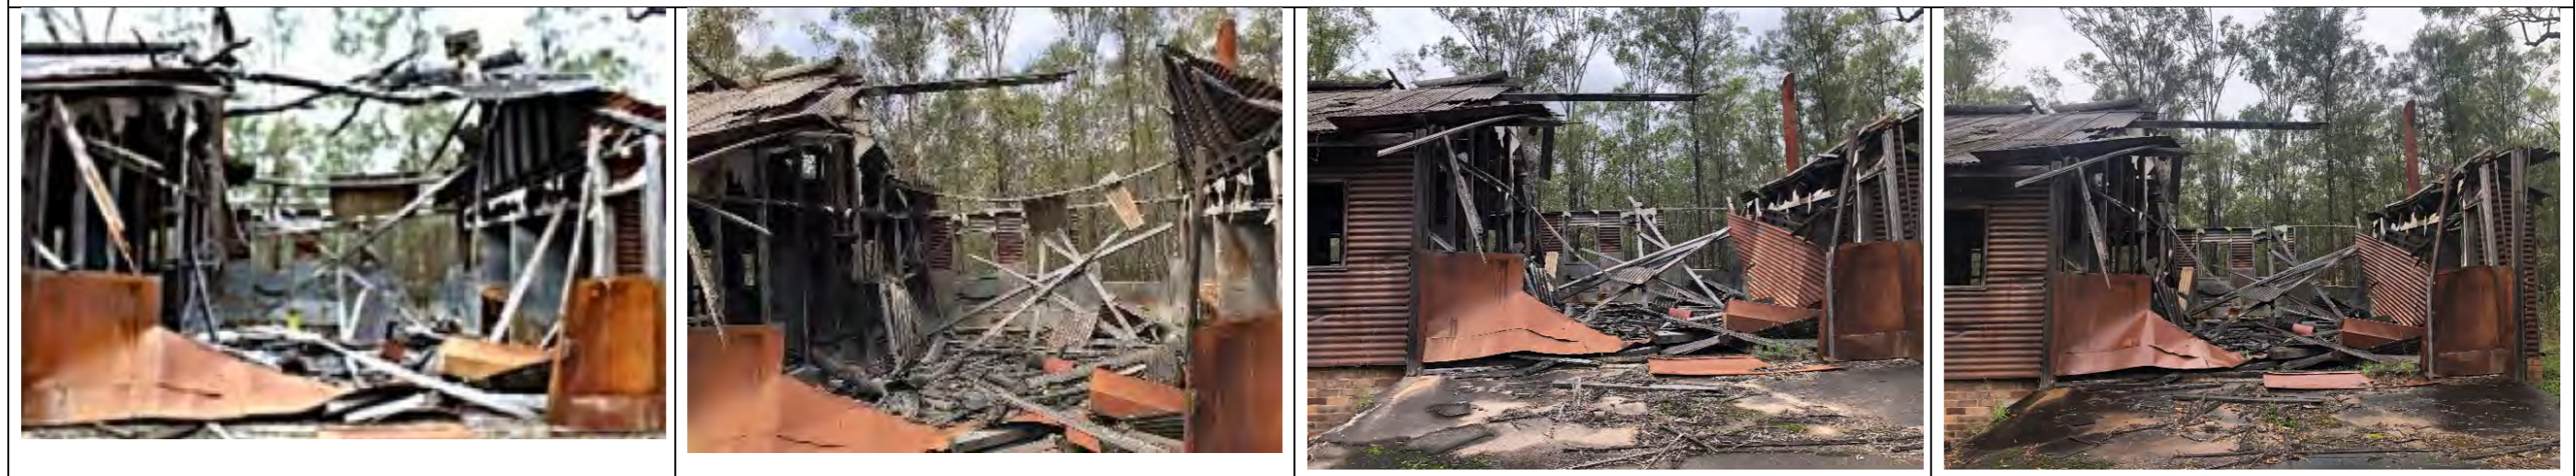
**Showing interior damage at kitchen at north end of building**

**2012-18:** shows increased collapse over and accumulation of debris within open kitchen area. Note also severe lean to north wall.

**2018-20 (Mar):** shows collapsed top of north wall and collapse of remaining full cross-beam.

**Mar 2020 – Dec 2020:** no discernible change.

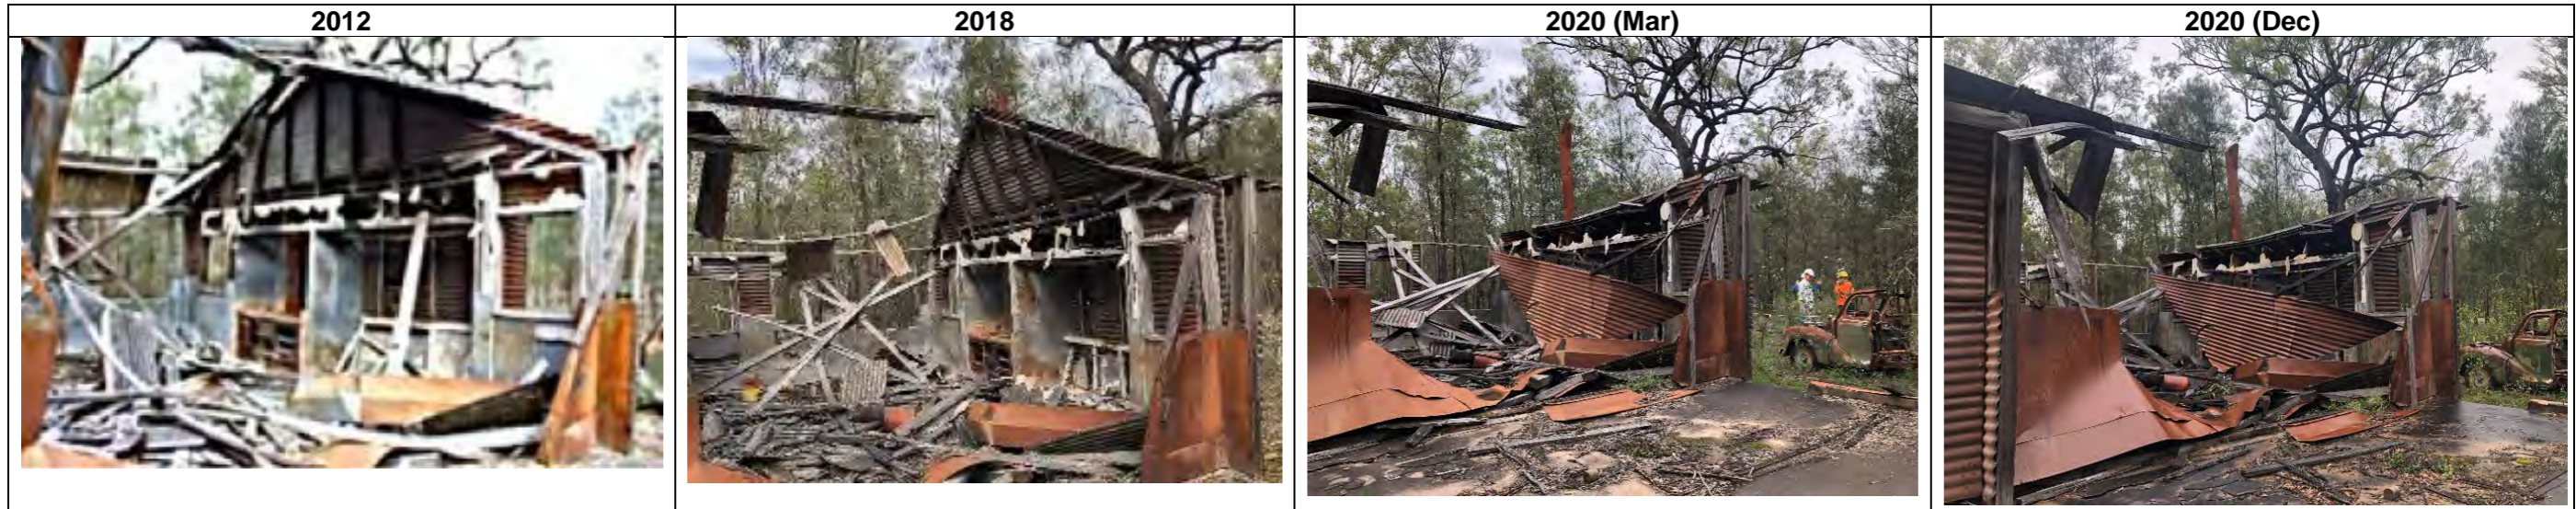
**Showing interior damage at kitchen at north end of building**

**2012-18:** shows increased collapse over and accumulation of debris within open kitchen area. Note also severe lean to north wall.

**2018-20 (Mar):** shows collapsed top of north wall and collapse of remaining full cross-beam.

**Mar 2020 – Dec 2020:** no discernible change.

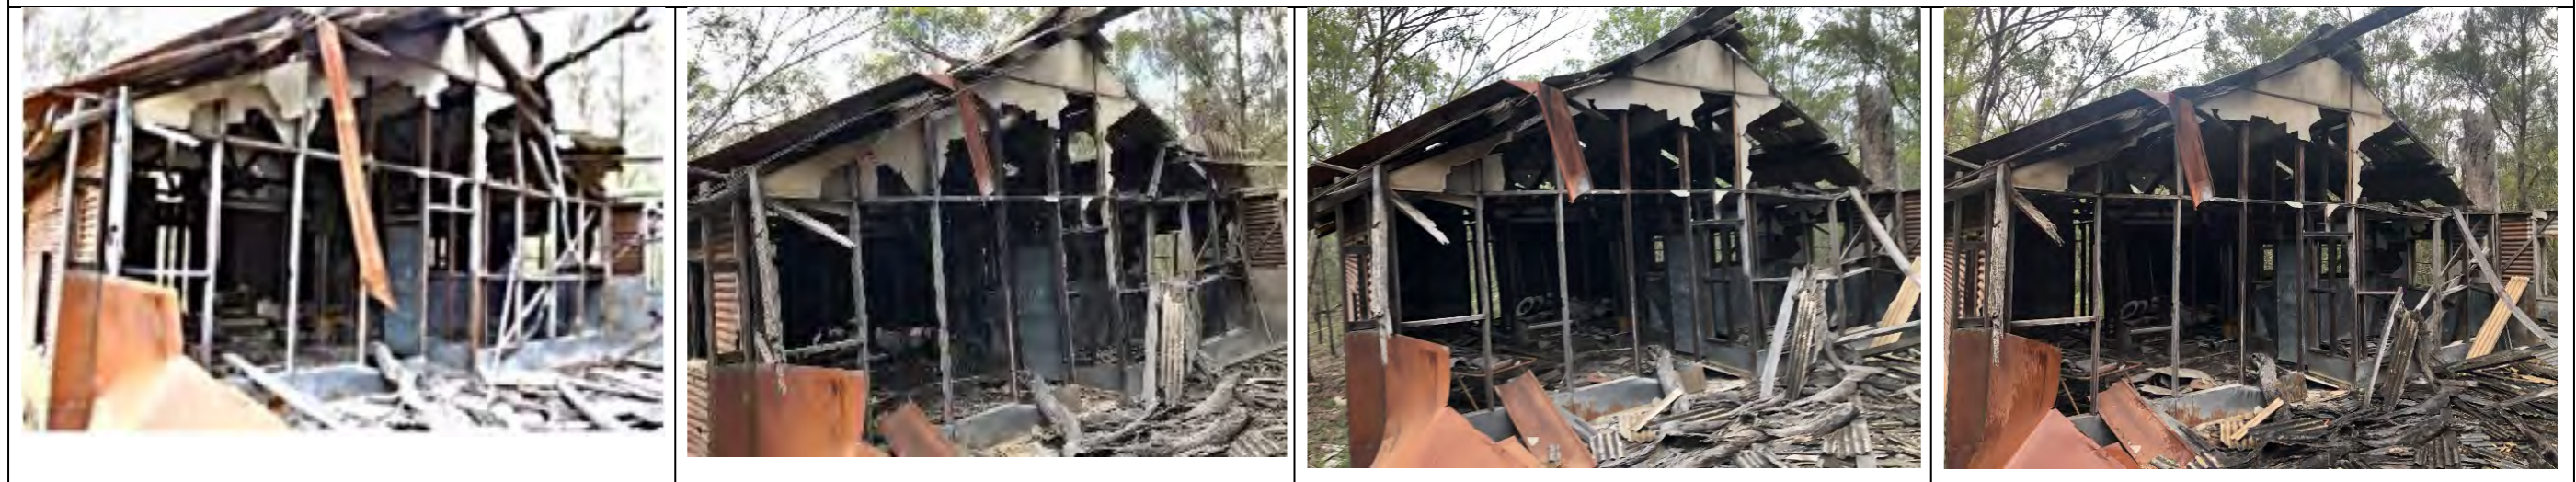
**View to interior of south end of building, view from east**

**2012-18:** shows increased collapse over open kitchen area.

**2018-20 (Mar):** shows further minor deterioration of asbestos panelling.

**Mar 2020 – Dec 2020:** no discernible change.

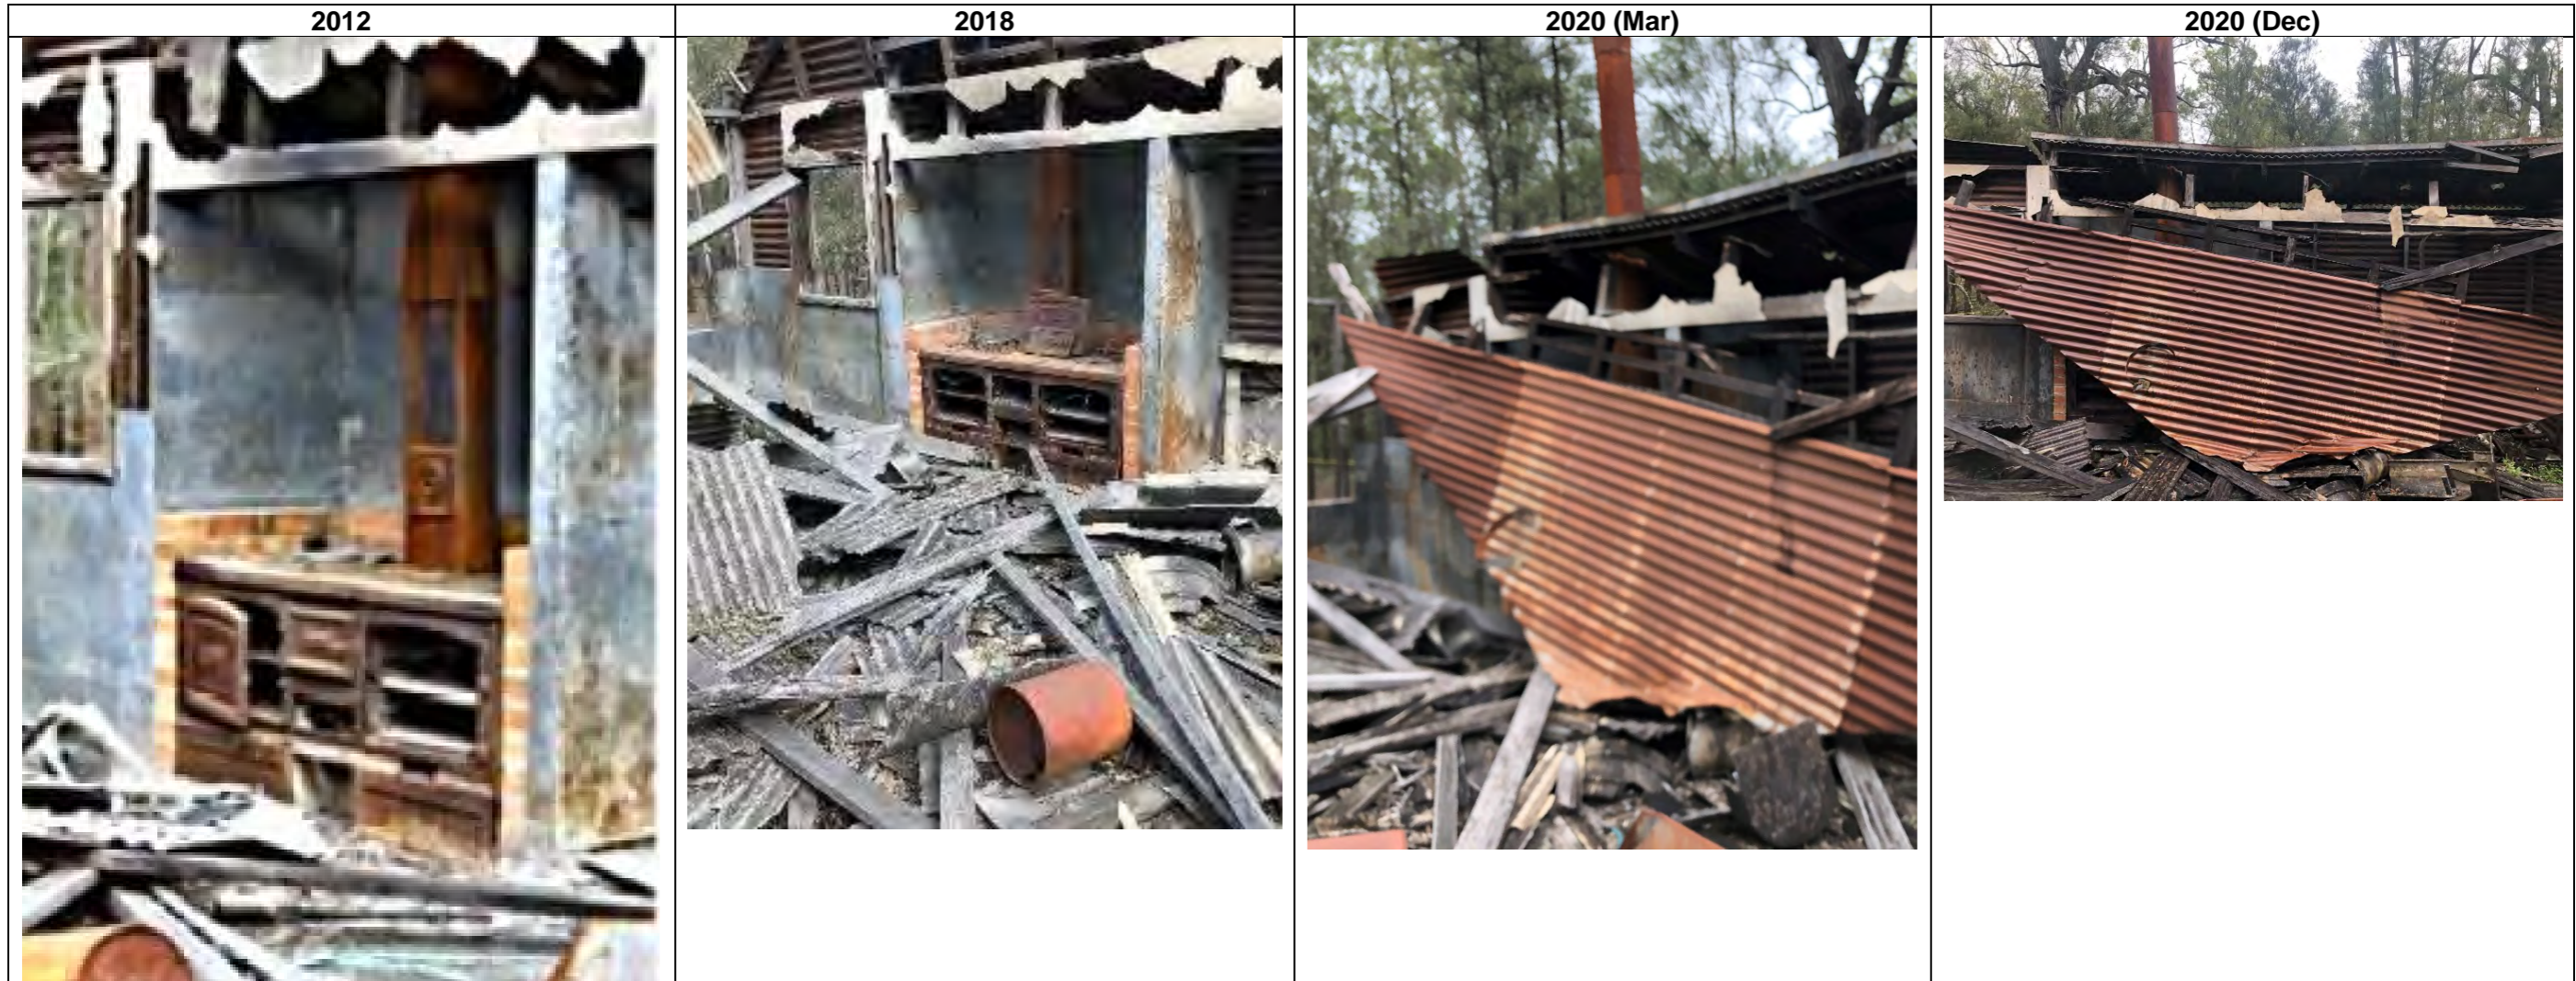
**Showing stove at kitchen at north end**

**2012-18:** note the remaining two stove doors have become unhinged and build up of debris from collapsed roof.

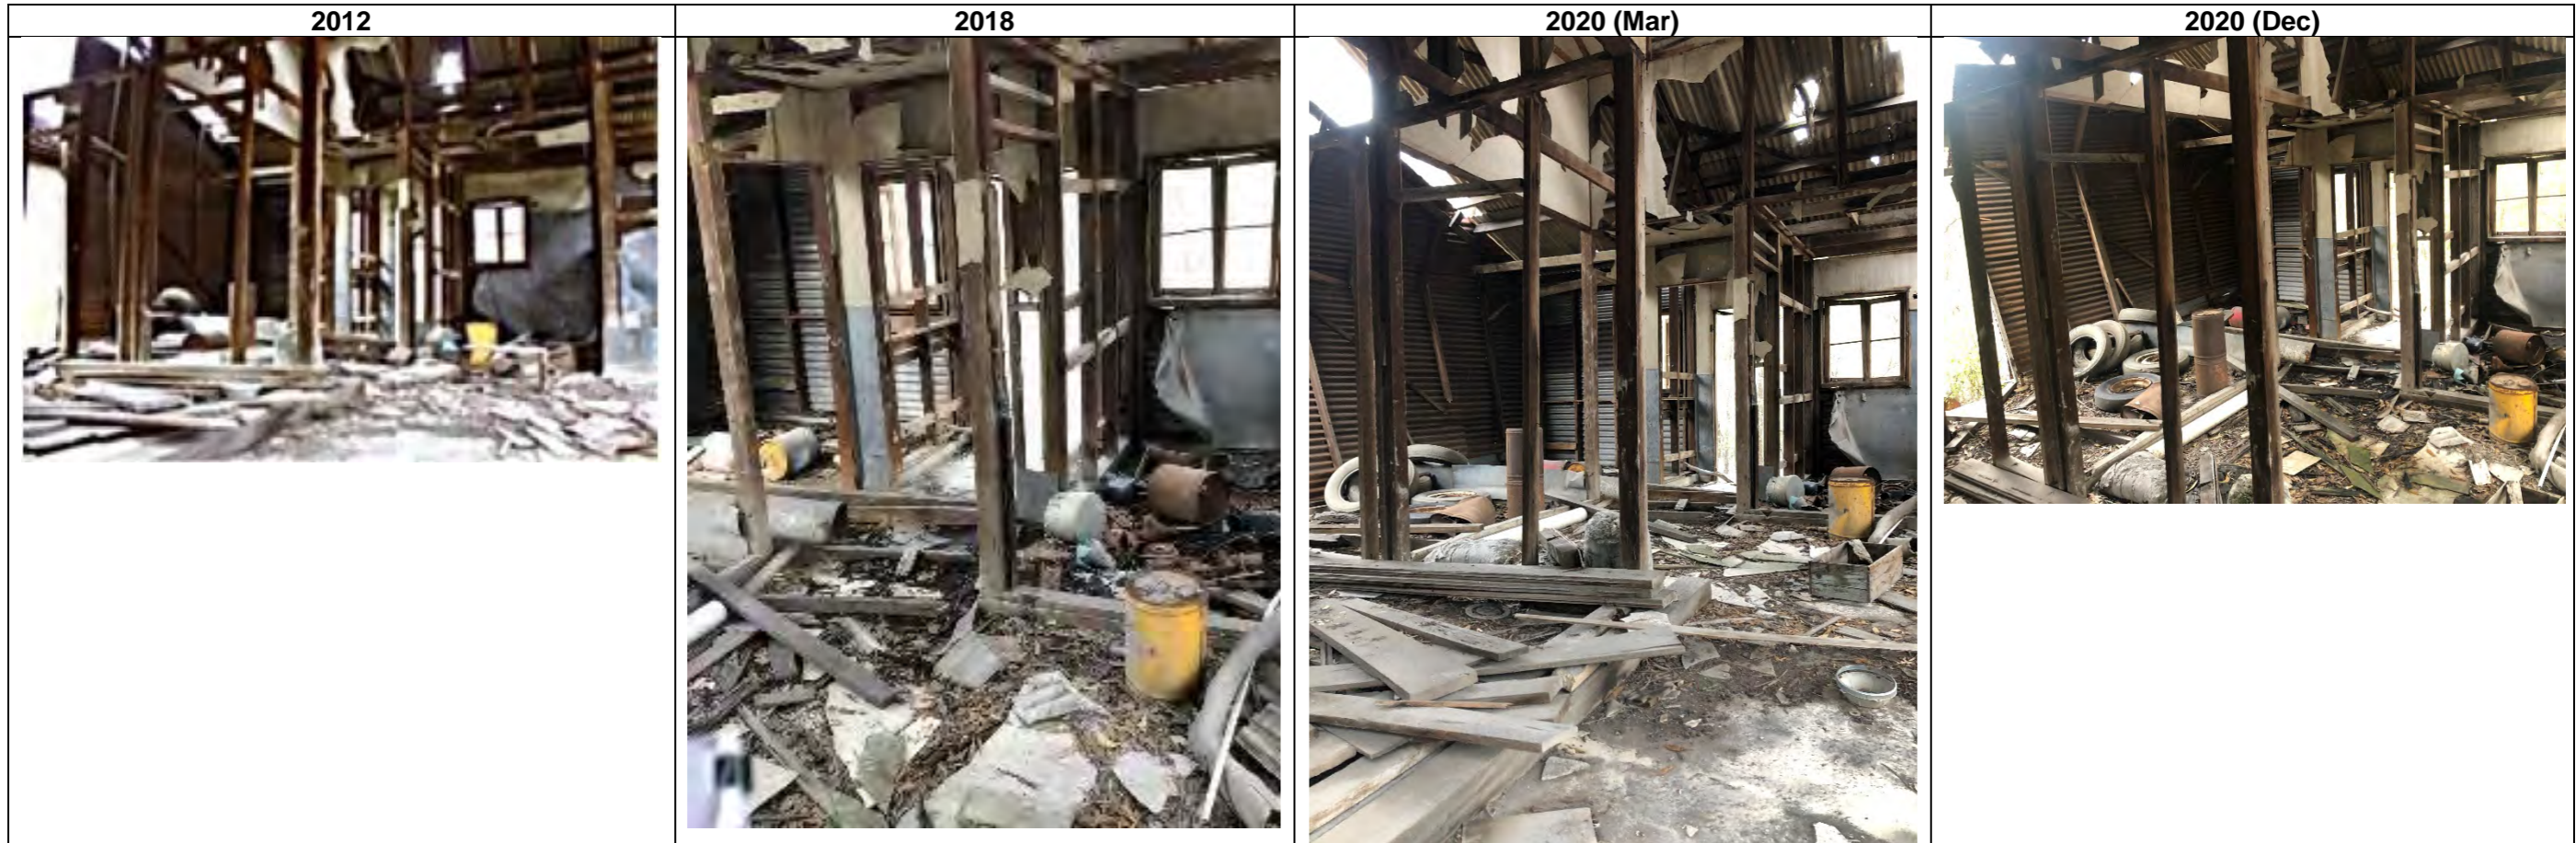
**View to interior, showing west entry to building**  
 2012-18: no discernible change.  
 2018-20 (Mar): no discernible change.  
 Mar 2020 – Dec 2020: no discernible change.

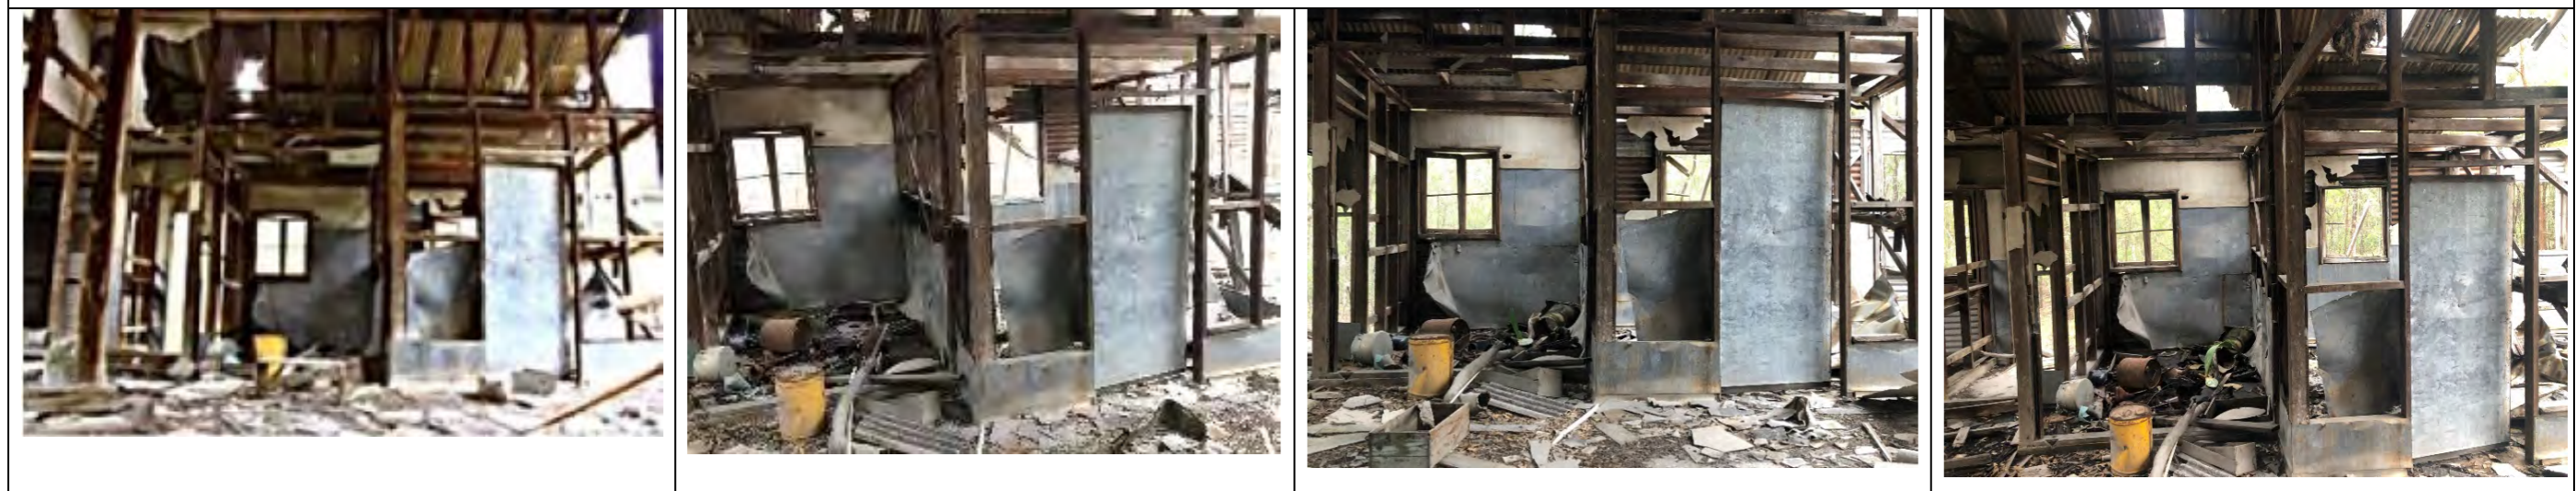
**Showing west interior space**  
 2012-18: no discernible change.  
 2018-20 (Mar): no discernible change.  
 Mar 2020 – Dec 2020: no discernible change.
