# Mount Thorley Warkworth 2020 Annual Review

Mount Thorley Warkworth (MTW) is an integrated operation of two open cut coal mines, Warkworth Mining Limited (WML) and Mount Thorley Operations (MTO). This Annual Review reports on the environmental performance of MTW for the period 1 January 2020 to 31 December 2020.

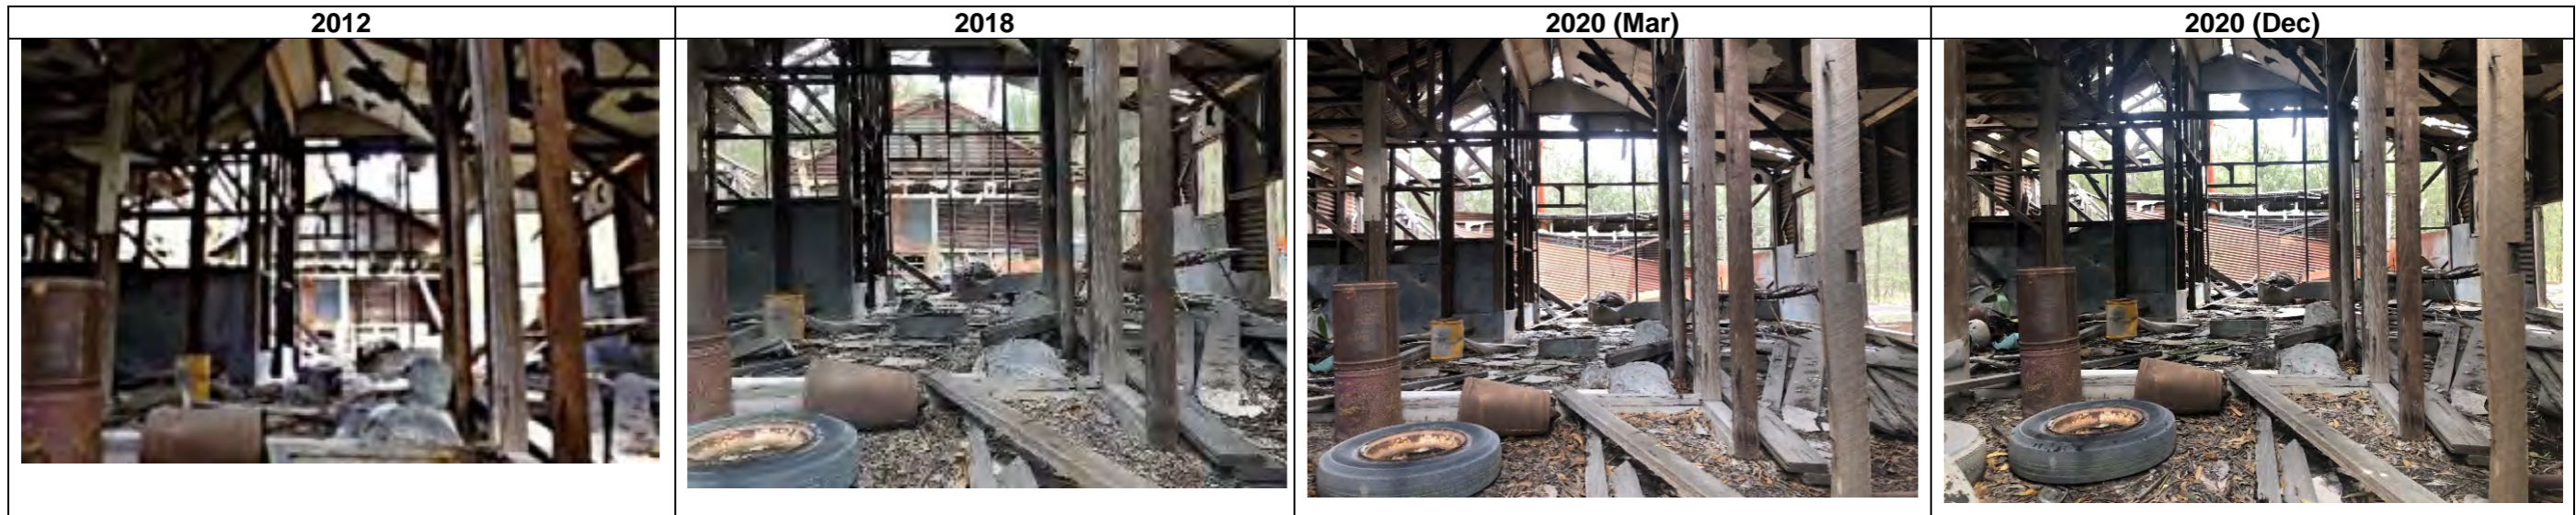
**View to interior of building, looking north from south entry**

**2012-18:** no discernible change.  
**2018-20 (Mar):** no discernible interior change, but shows collapsed north wall.  
**Mar 2020 – Dec 2020:** no discernible change.

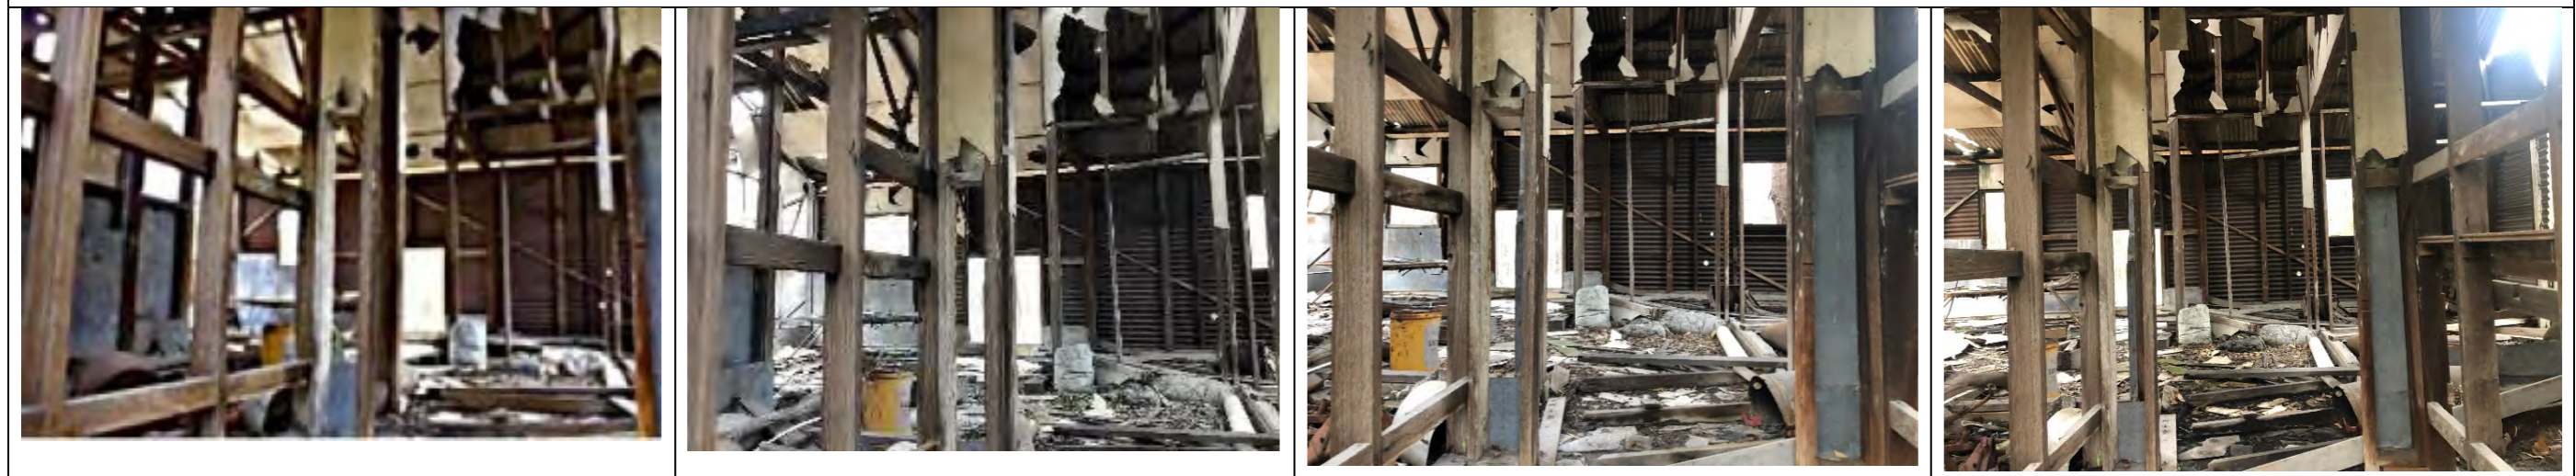
**View to interior of building from entry at west**

**2012-18:** no discernible change.  
**2018-20 (Mar):** no discernible change.  
**Mar 2020 – Dec 2020:** no discernible change.

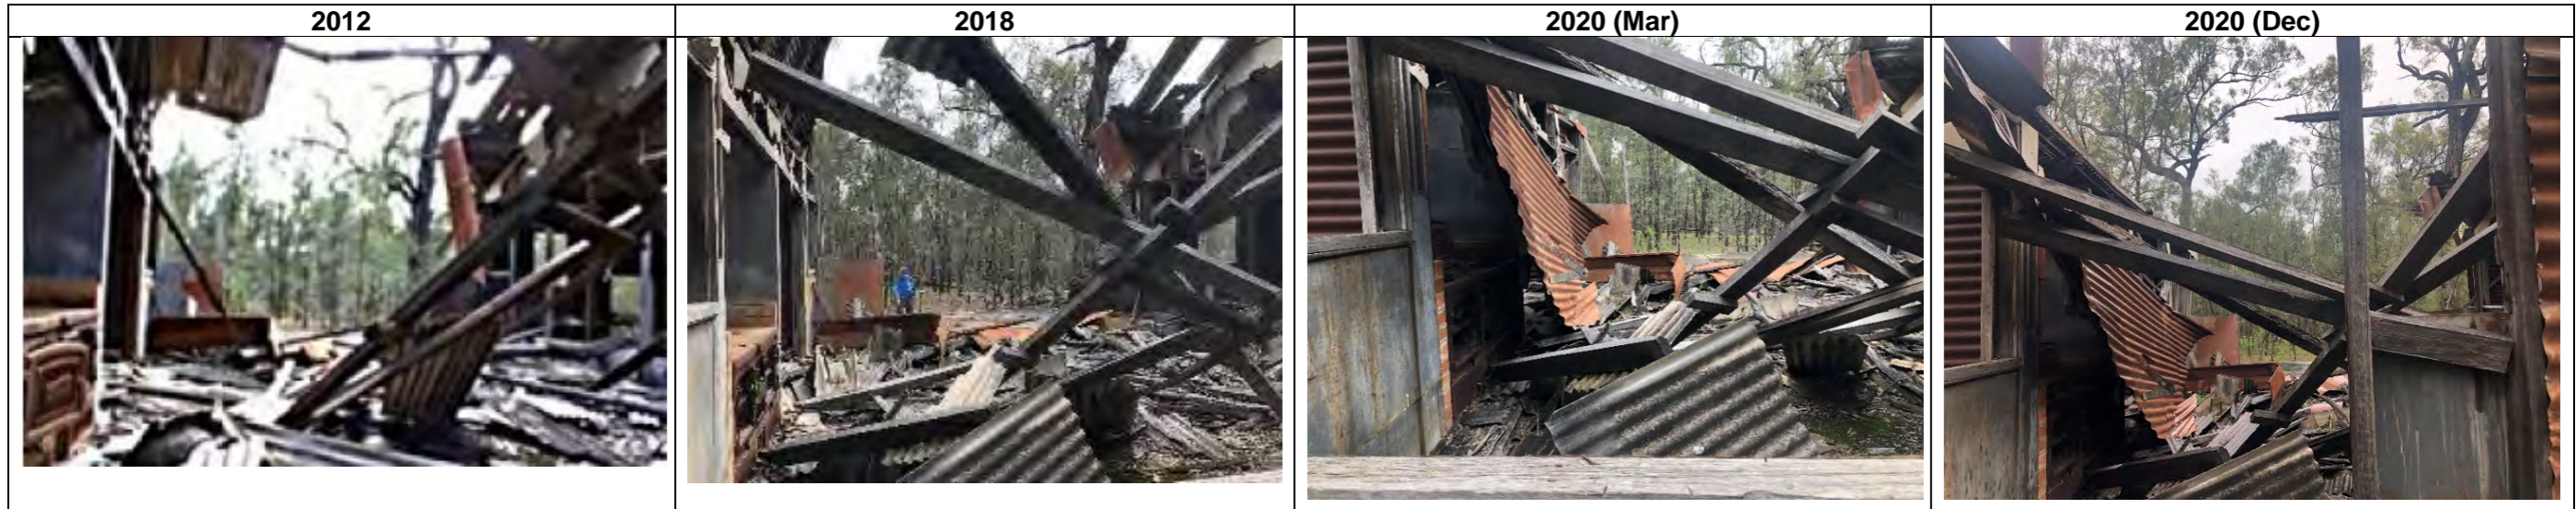
**Showing interior of building, viewed from north-west corner**  
**2012-18:** shows collapsed roofing members above open kitchen area and accumulation of debris.  
**2018-20 (Mar):** shows collapsed north wall across stove and additional fallen roof member.  
**Mar 2020 – Dec 2020:** no discernible change.

- Damaged roof sheeting and roofing members, as well as increasing structural instability of bowing southern wall;
- Due to the complete collapse of remaining roofing members over the open kitchen area the top portion of the northern wall has now failed and fallen inside the building footprint; and
- Increased damage to brick foundation in north-west corner, and new slumping of south-west foundation corner.

4. Pending the results of the asbestos assessment, any parts of the building framework, such as roofing members of walls should be stabilized and propped, using the Bligh Tanner plans as a guide;
5. A structural engineer should then inspect the building before any further works are commenced to make further recommendations on stability requirements and structural repairs. These further works should aim to reduce the likelihood and extent of any further deterioration at the site rather than seek to rebuild or renovate as it is unlikely that there would be any valid or appropriate option to re-use the site; and

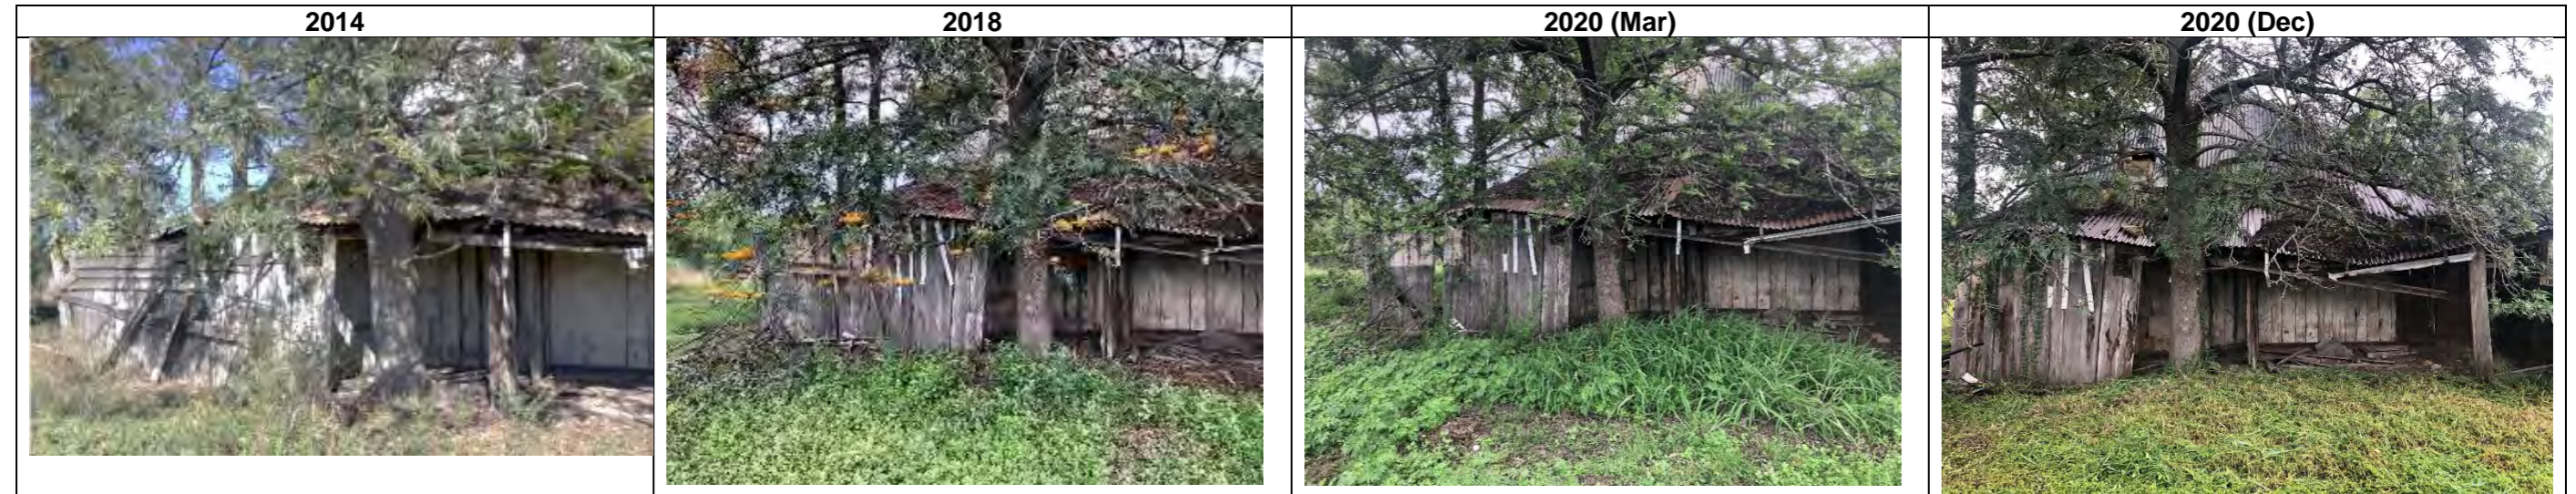
**Eastern elevation**

**2014-8:** no discernible change.

**2018-20 (Mar):** roof slumping appears to have increased.

**Mar 2020-Dec 2020:** heavy leaf litter on roof persists. Positively, vegetation surrounding the house is occurring regularly.

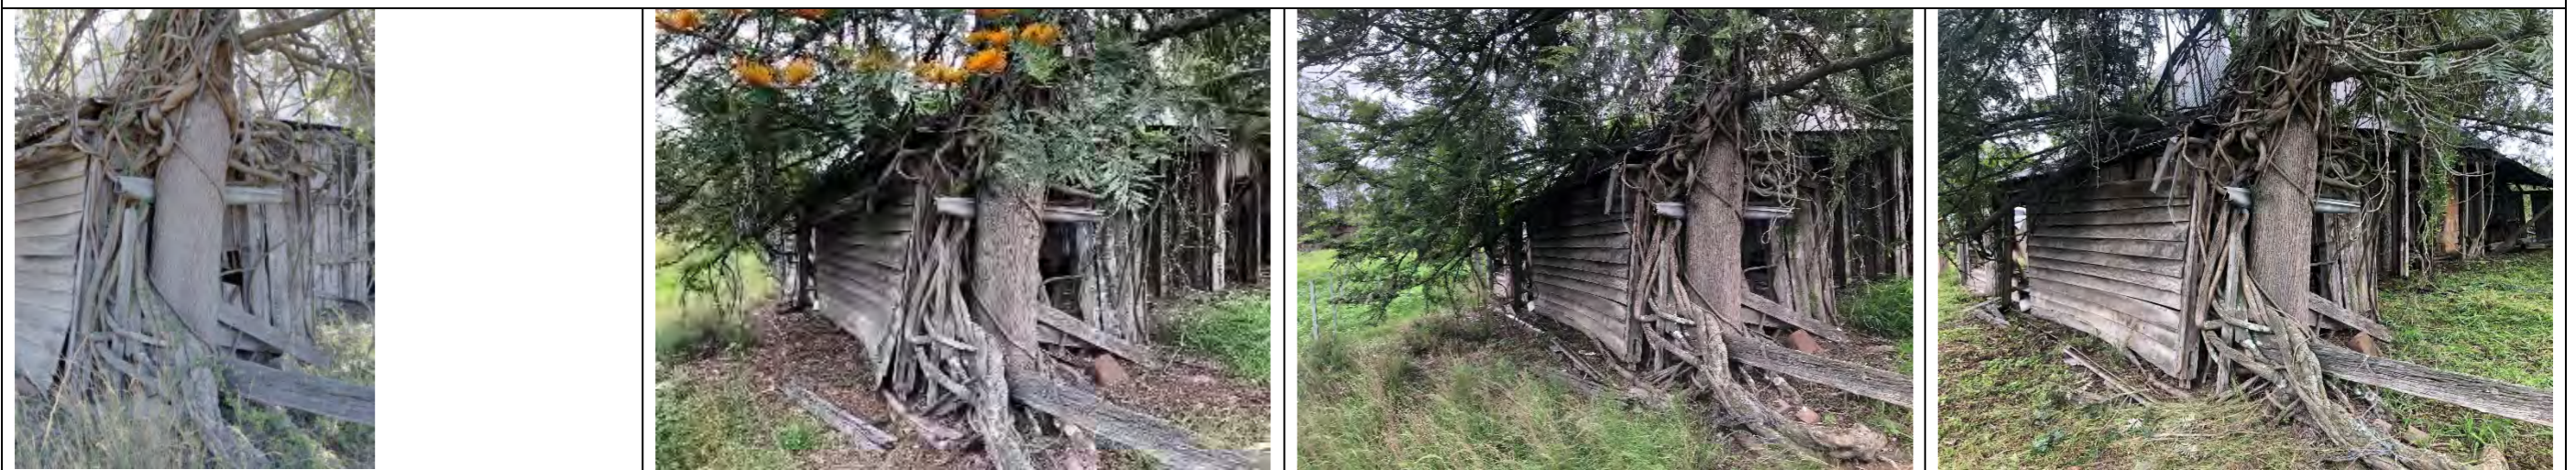
**Looking towards south-west corner from south-west**

**2014-8:** no discernible change to tree impact, but note missing vertical slabs from southern wall.

**2018-20 (Mar):** no discernible change, but vine still growing.

**Mar 2020-Dec 2020:** no discernible change.

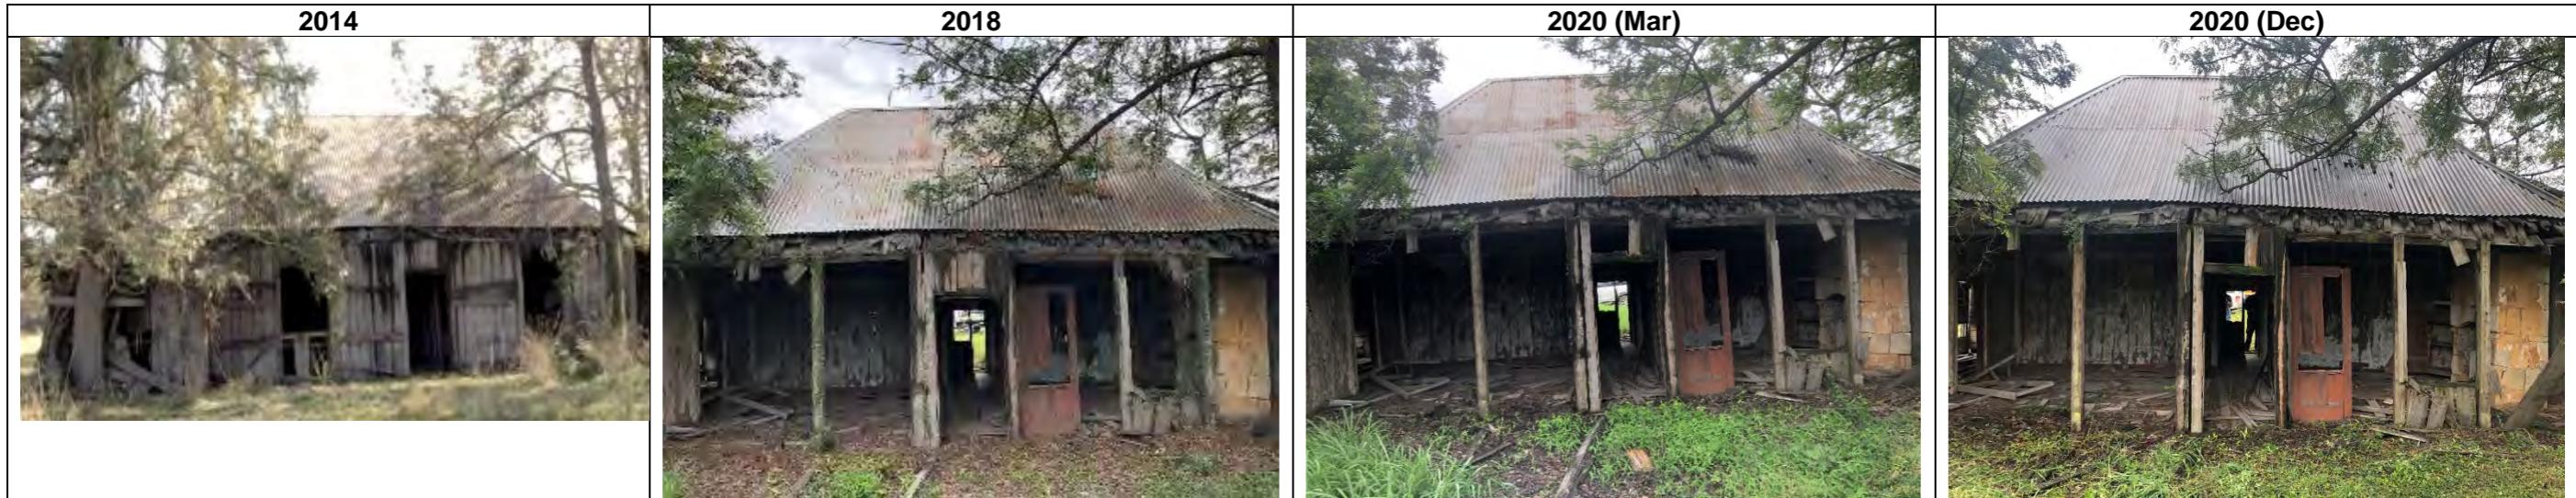
**Southern elevation**

**2014-8:** vertical timber slabs have been removed from southern wall.

**2018-20 (Mar):** possible deterioration of shingles at roof edge, and missing panels from above back door.

**Mar 2020-Dec 2020:** no discernible change.

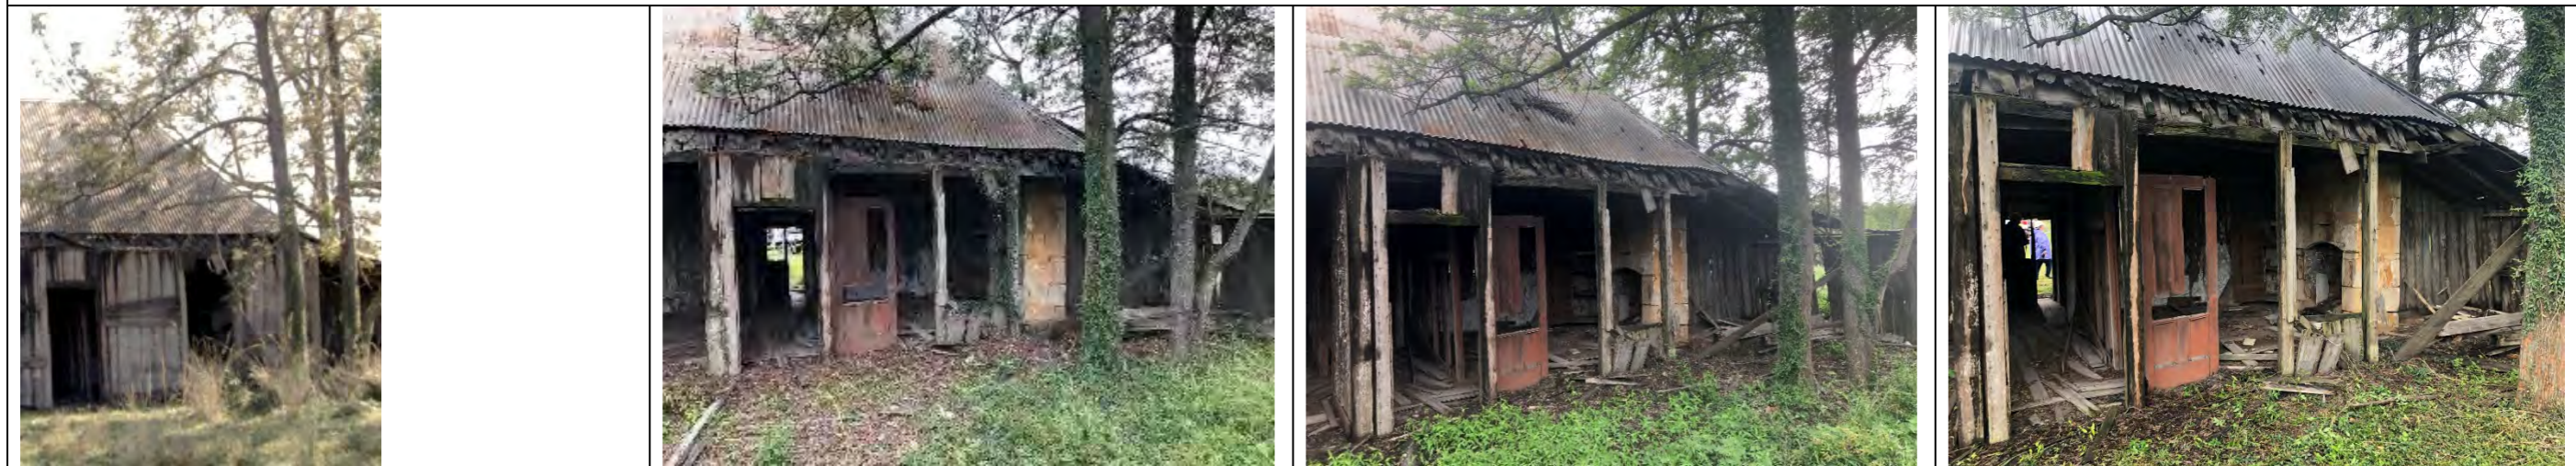
**Southern elevation**

**2014-8:** vertical timber slabs have been removed from southern wall.

**2018-20 (Mar):** possible deterioration of shingles at roof edge, and missing panels from above back door.

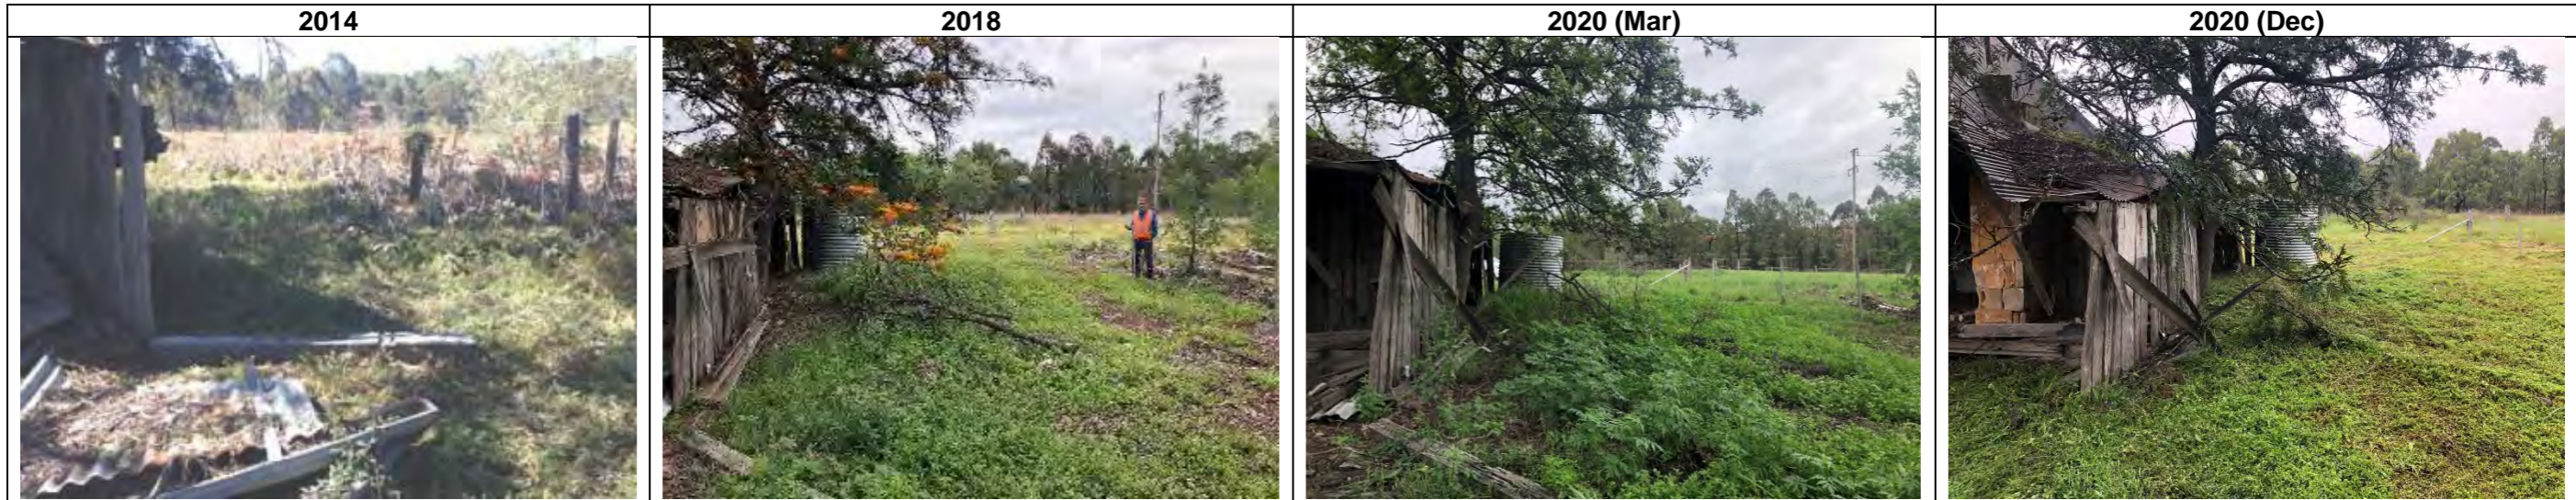
**Eastern side**

**2014-8:** debris has been cleaned and stored and a weed removal program conducted. The house area has also been fenced.

**2018-20 (Mar):** further deterioration of eastern wall and regrowth of weeds.

**Mar 2020-Dec 2020:** no discernible change.

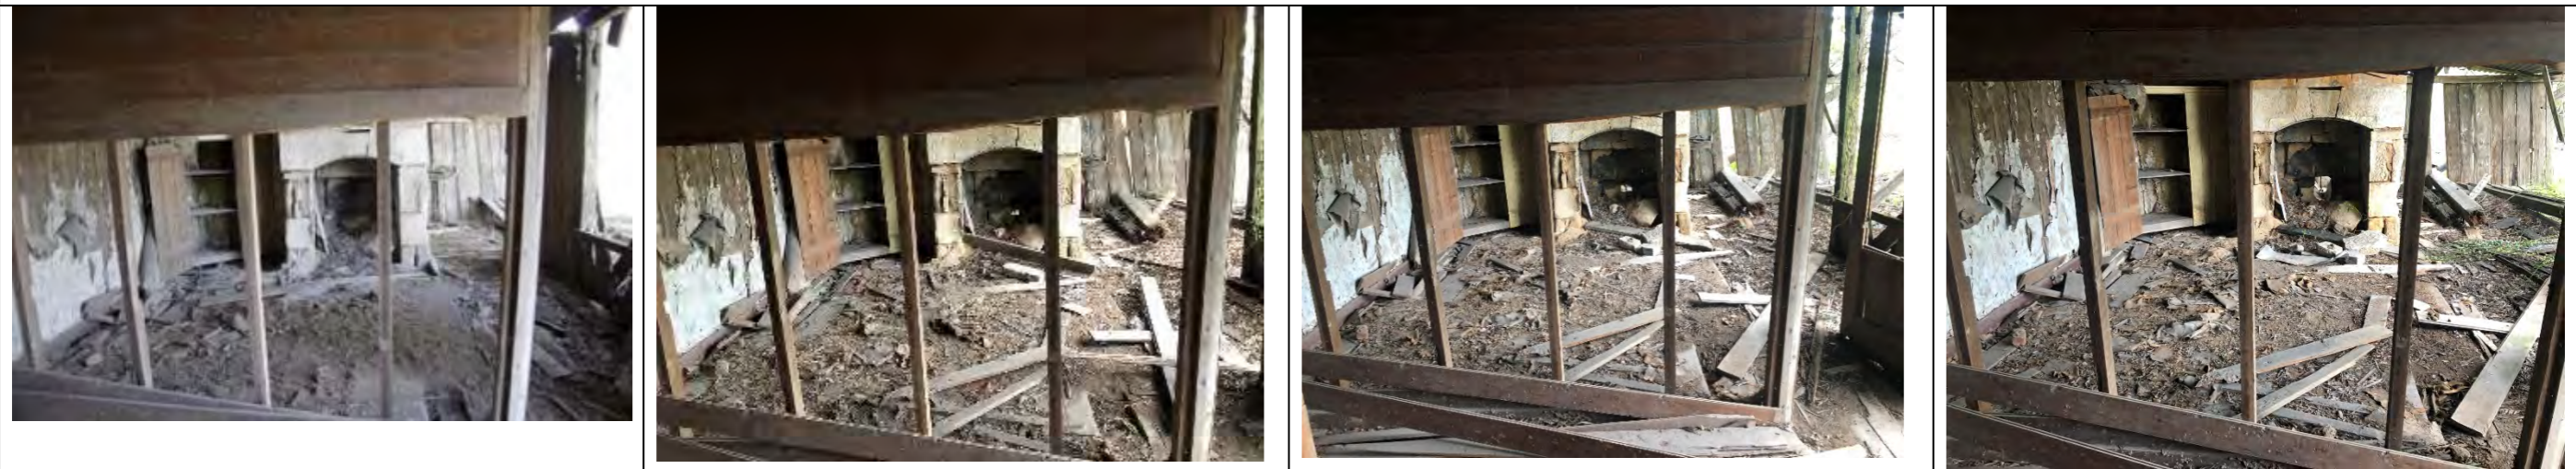
**Room 2 interior**

**2014-8:** increased debris caused by removal of southern wall.

**2018-20 (Mar):** no discernible change.

**Mar 2020-Dec 2020:** no discernible change.

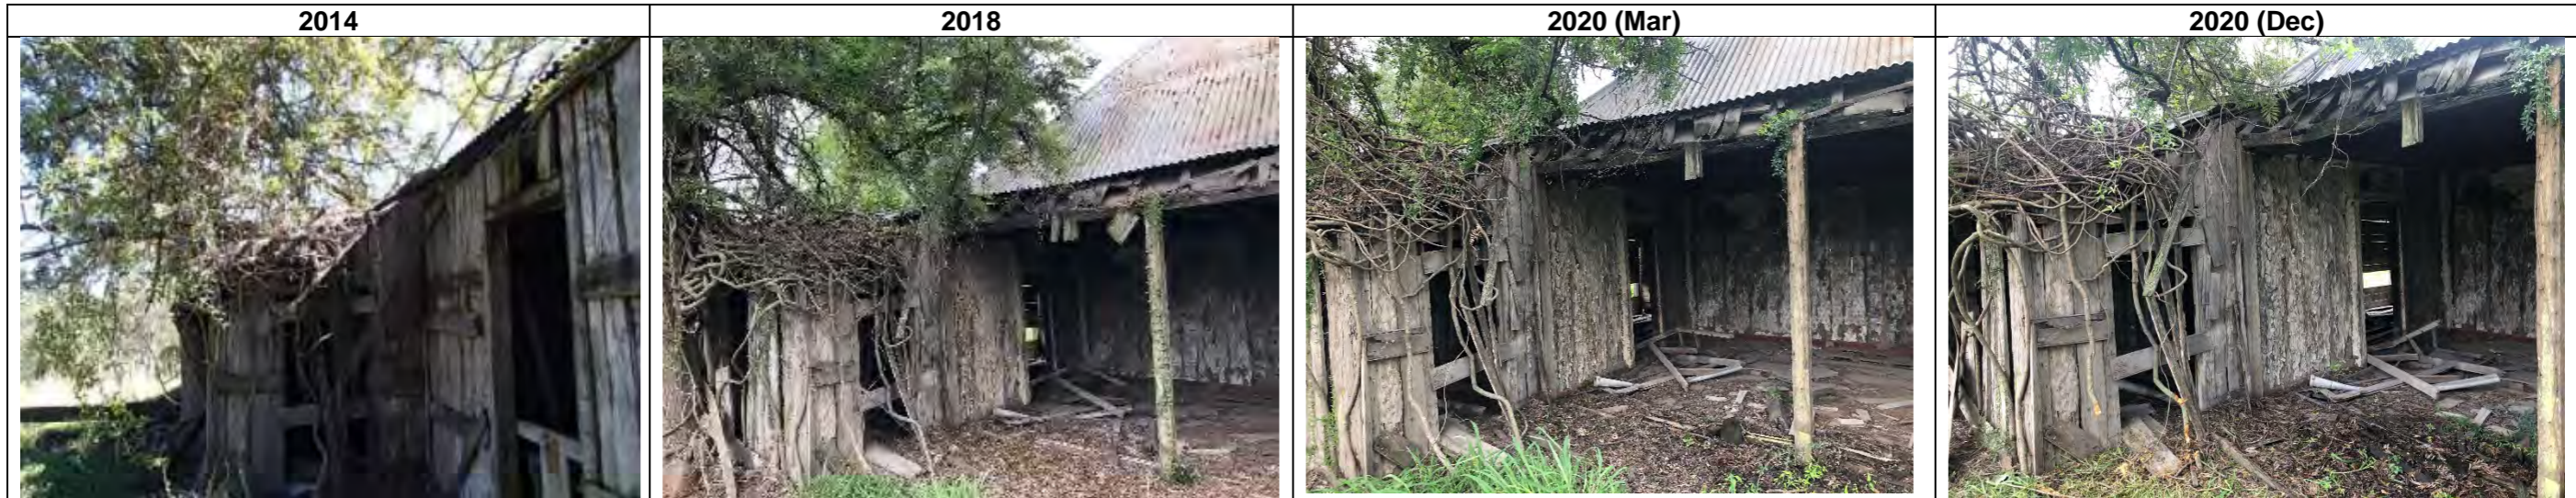
**South-west corner**

**2014-8:** shows removal of vertical slabs from southern wall.

**2018-20 (Mar):** no discernible change.

**Mar 2020-Dec 2020:** no discernible change.

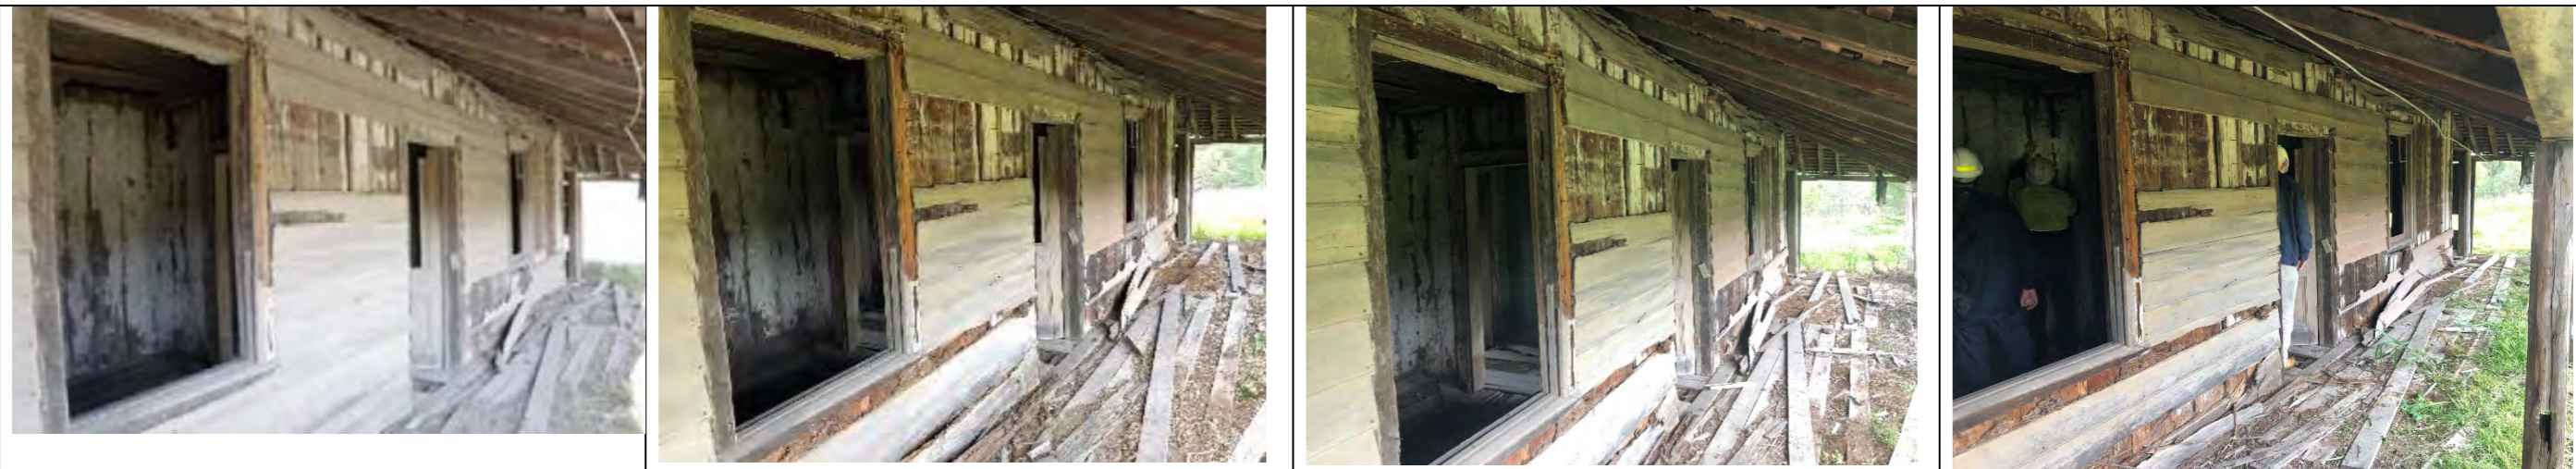
**Northern elevation**

**2014-8:** further deterioration of weatherboard panelling.

**2018-20 (Mar):** no discernible change, though termite activity present.

**Mar 2020-Dec 2020:** grass/weed growth encroaching over verandah floor.

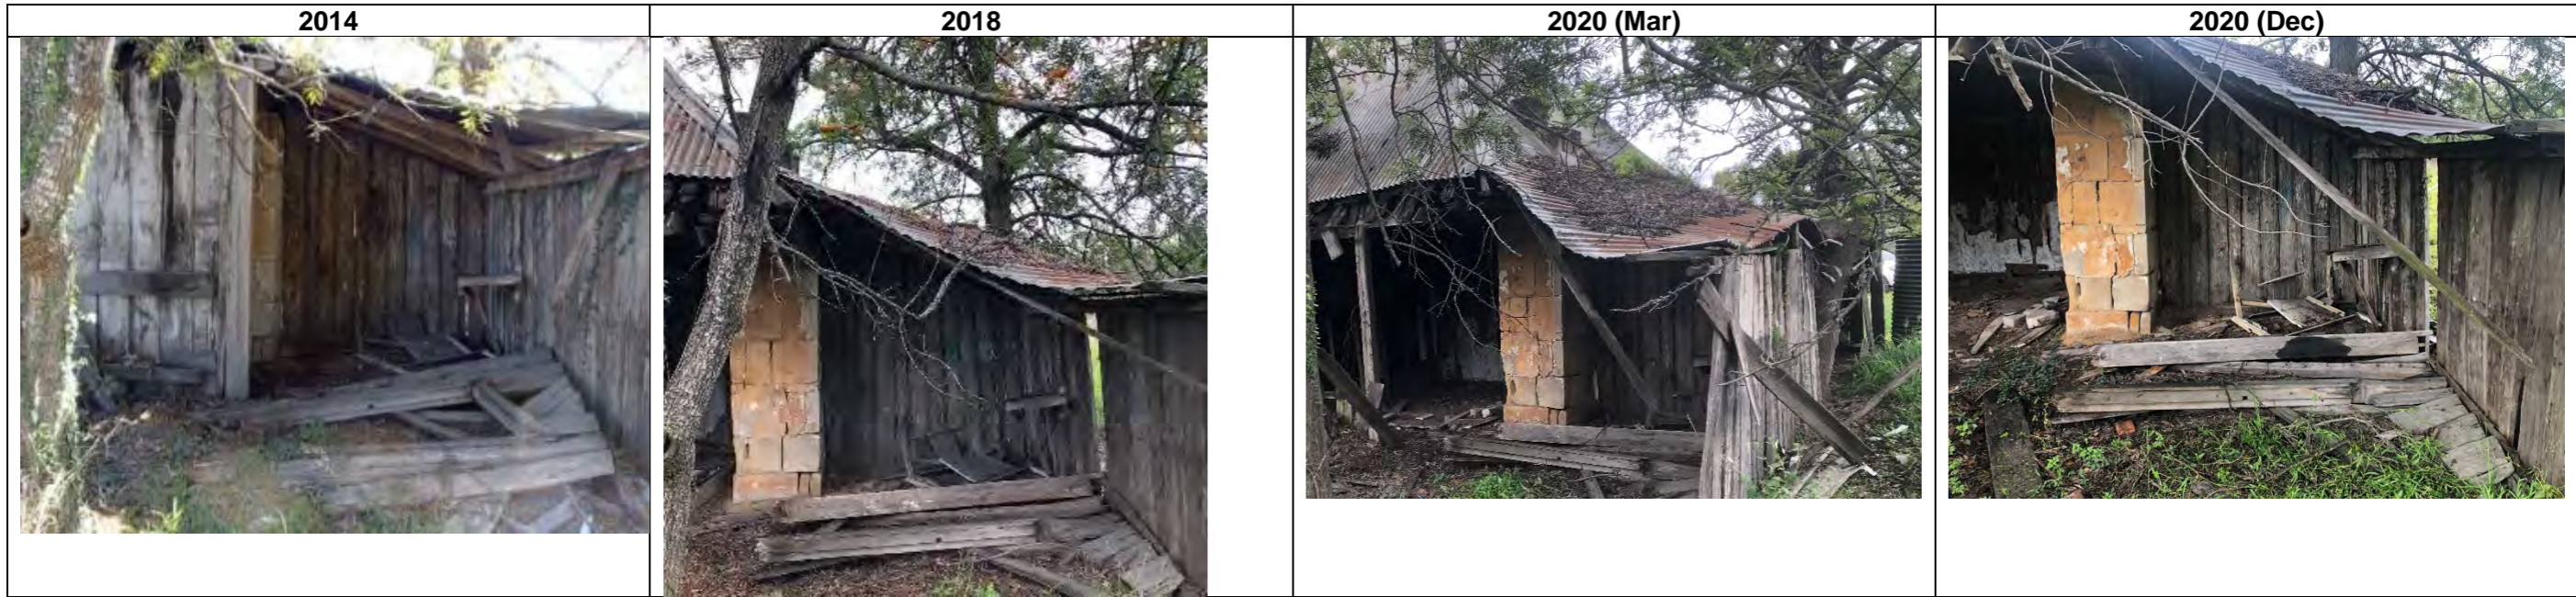
**South-east corner**

**2014-8:** shows removal of vertical slabs from southern wall, and some from eastern wall, and further collapse of roof.

**2018-20 (Mar):** further roof slumping and deterioration of eastern wall.

**Mar 2020-Dec 2020:** no discernible change.

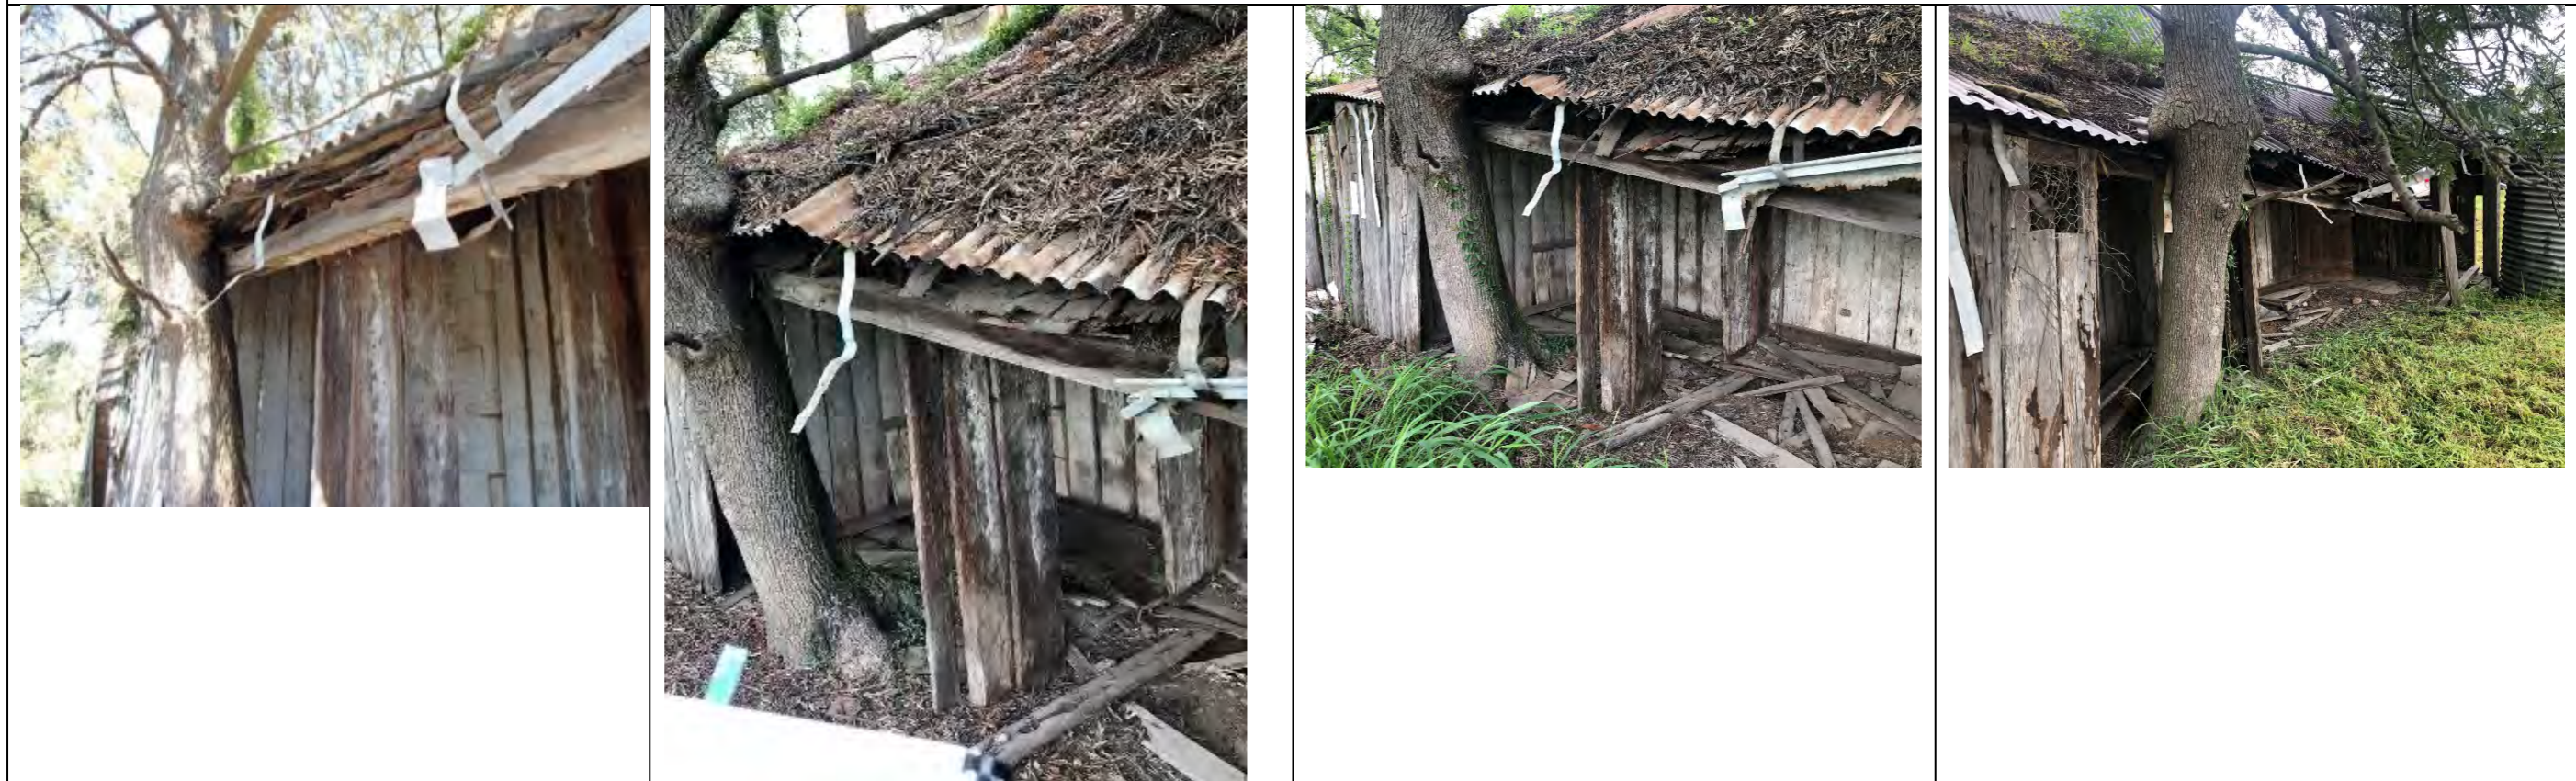
**Eastern elevation**

**2014-8:** possible further collapse of crossbeam and guttering.

**2018-20 (Mar):** tree continues to impact eastern roof line.

**Mar 2020-Dec 2020:** increased impact on roofline by tree branches.

1. Due to their propensity to harbour termites and transfer infestation to the building, remove all peppercorn trees from around the building;
2. Future condition inspections should photograph the building using the photograph views and locations presented above so that any changes to the building can be documented in subsequent inspections;

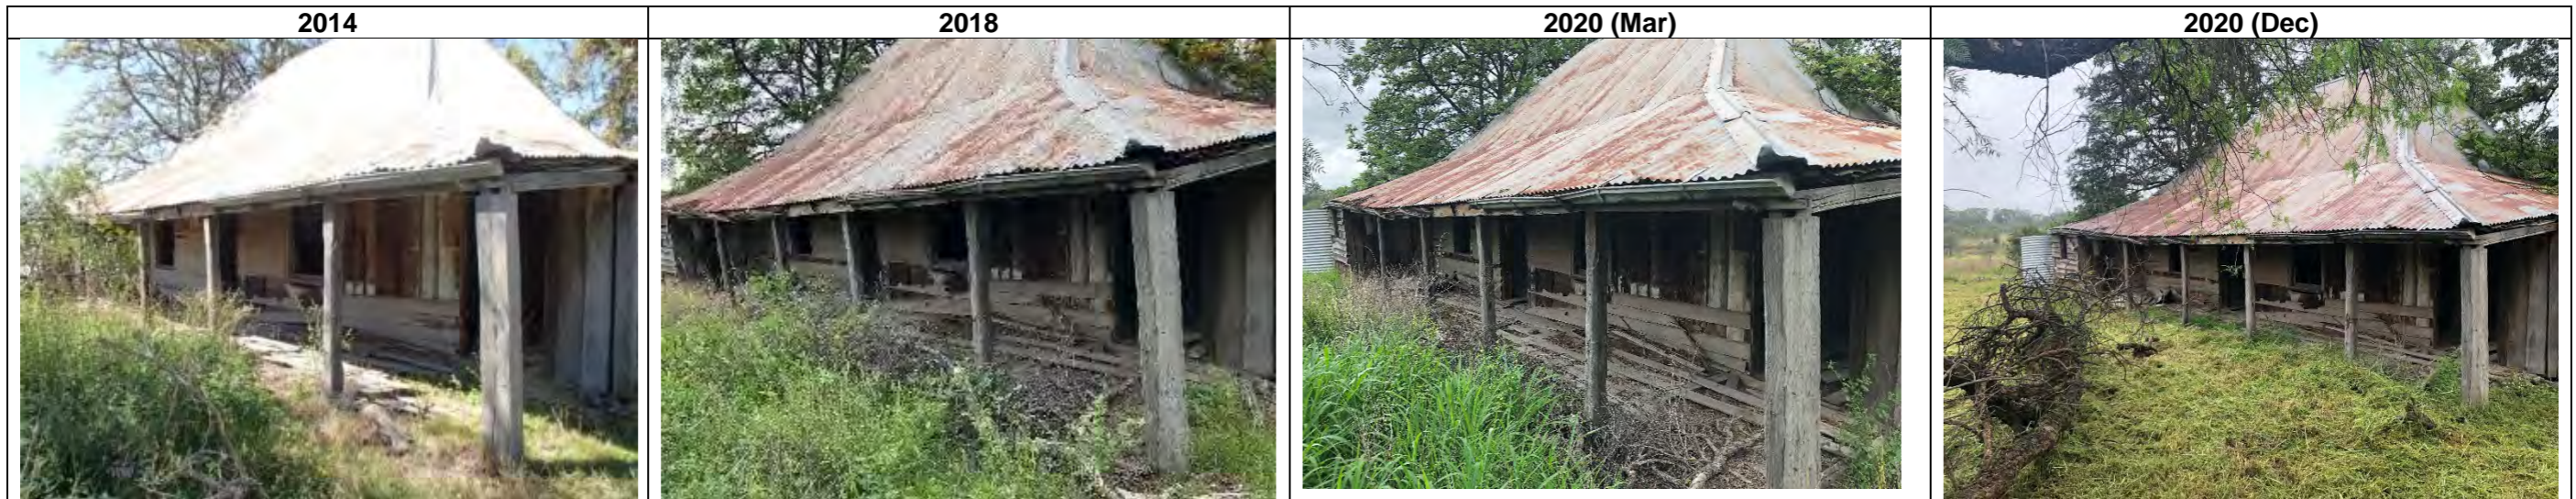
**Northern elevation**

**2014-8:** slumping of verandah along edge beam.

**2018-20 (Mar):** no discernible change.

**Mar 2020-Dec 2020:** grass/weed growth encroaching over verandah floor.

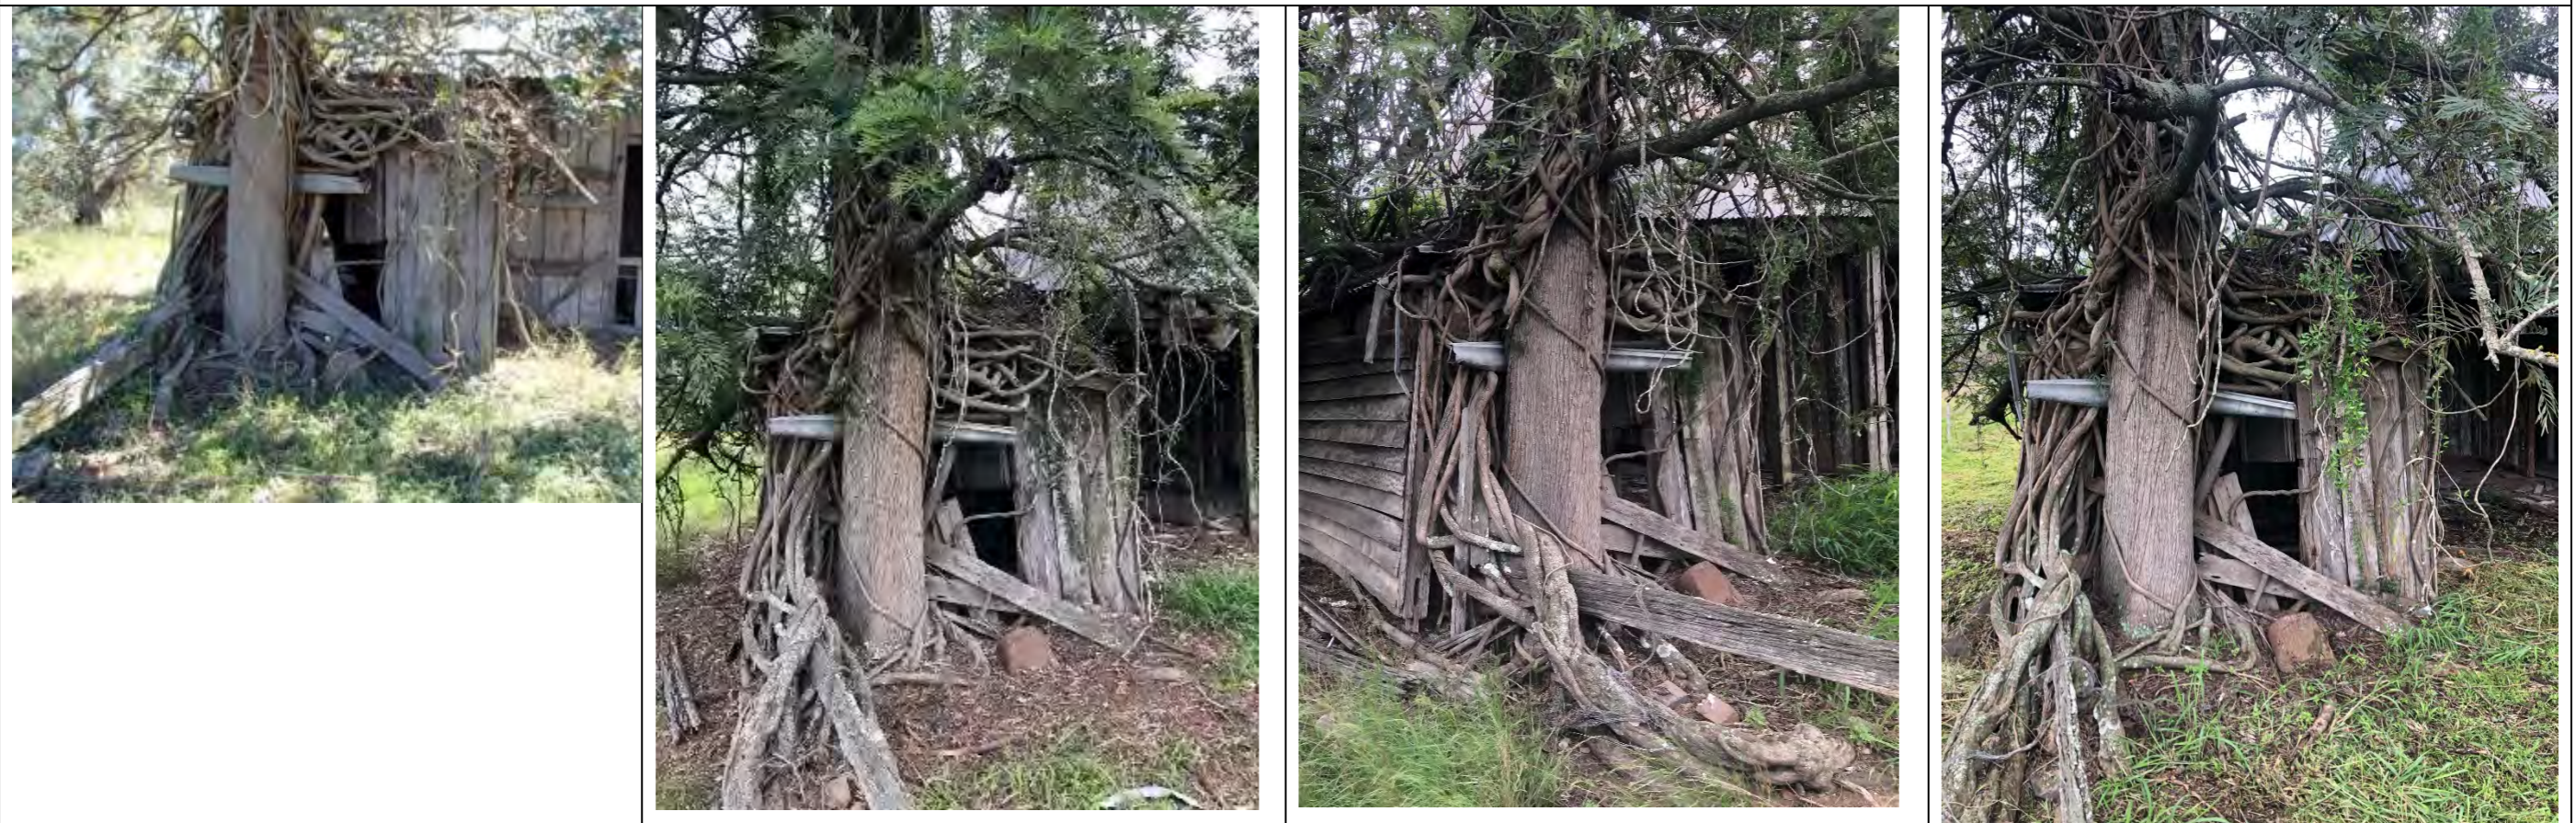
**View of south-west corner from south**

**2014-8:** shows removal of vertical slabs from southern wall as well as some increase in vegetation growth.
