# Mount Thorley Warkworth 2020 Annual Review

Mount Thorley Warkworth (MTW) is an integrated operation of two open cut coal mines, Warkworth Mining Limited (WML) and Mount Thorley Operations (MTO). This Annual Review reports on the environmental performance of MTW for the period 1 January 2020 to 31 December 2020.

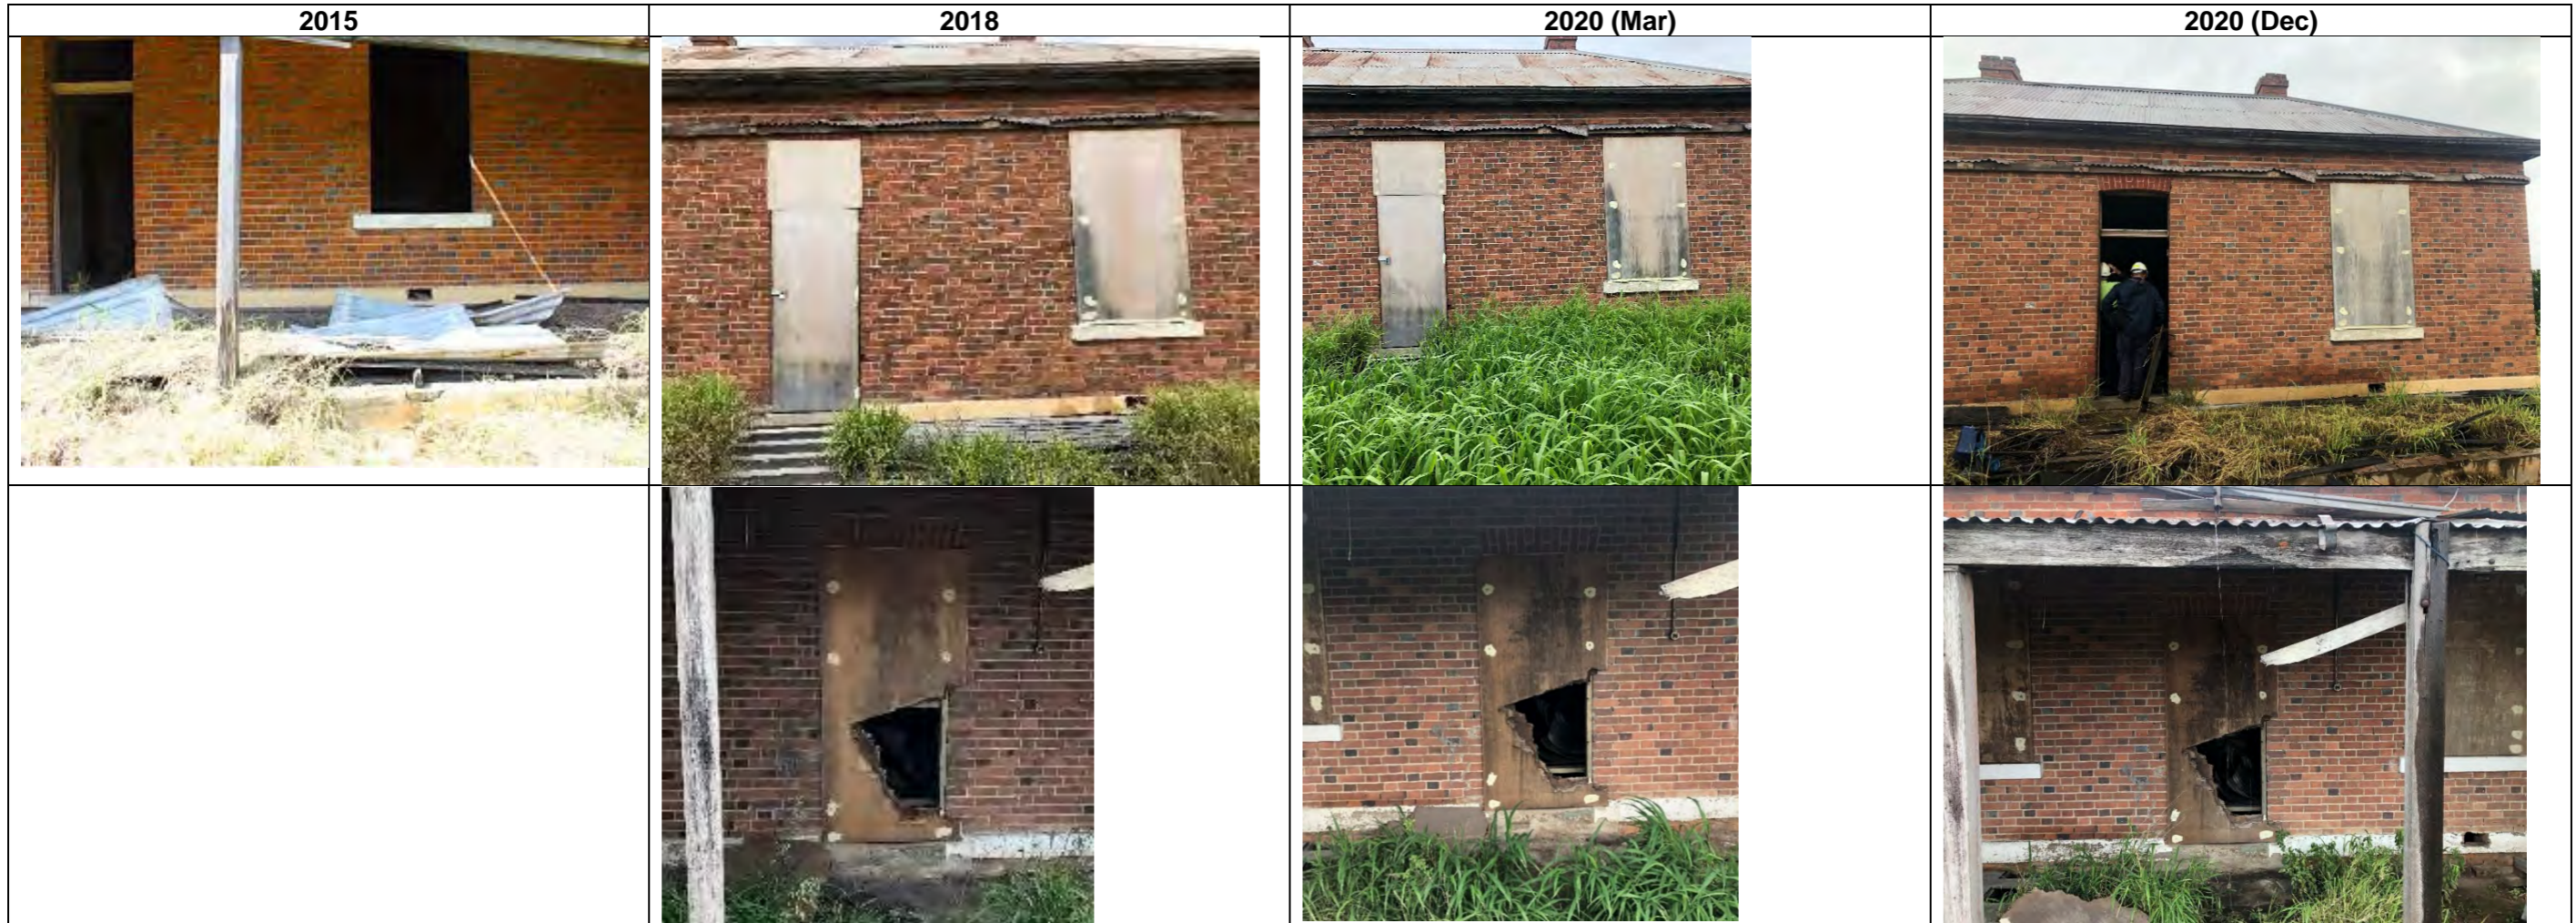
**View of door and window panelling**

2015-8: sheeting installed on all openings, however some repair required  
 2018-20 (Mar): some repair of panelling required  
 Mar 2020-Dec 2020: Front door panel requires reinstallation. Broken panel remains unrepaired

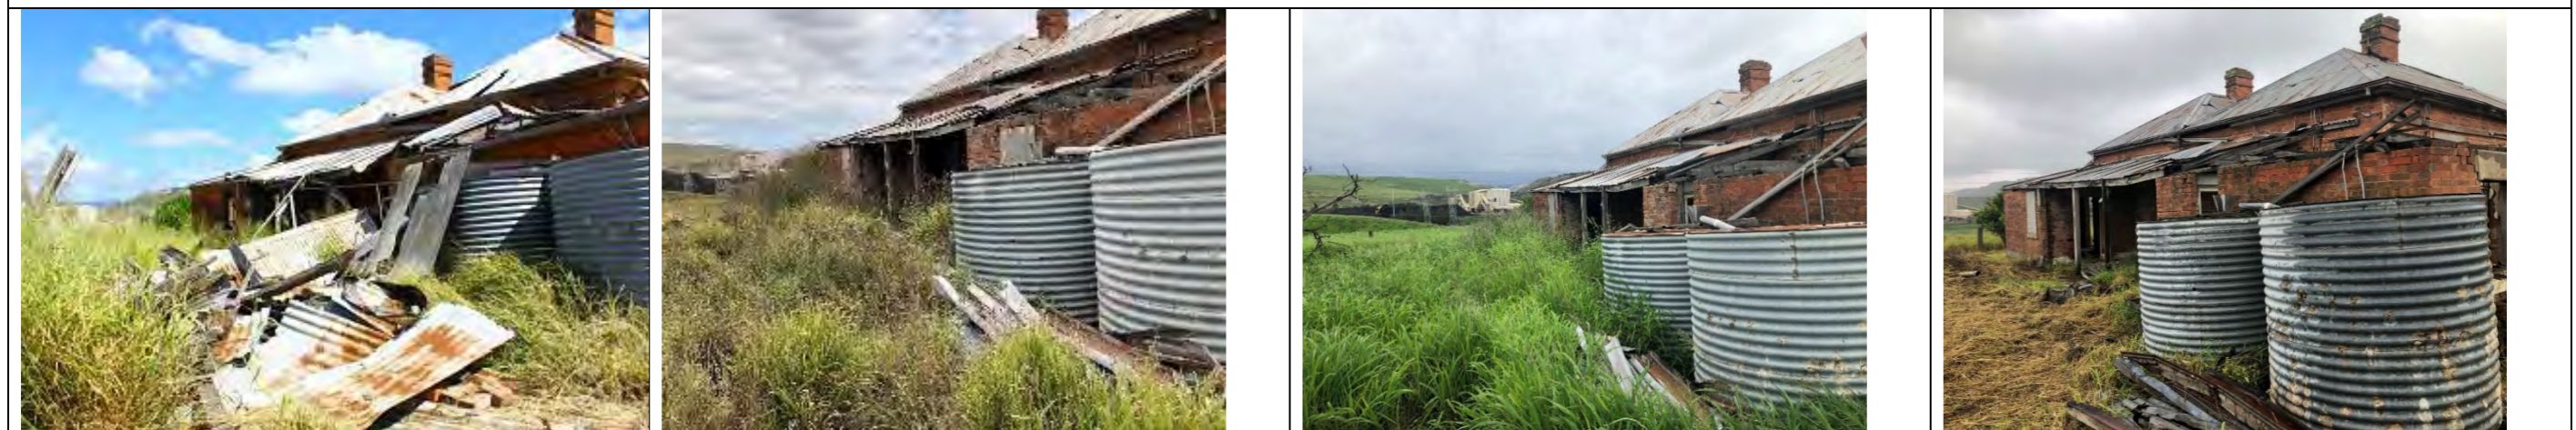
**View of rear of building (view south)**

2015-8: debris has been cleared and stacked  
 2018-20 (Mar): vegetation has regrown around building and stacked debris  
 Mar 2020-Dec 2020: vegetation cleared and debris restacked

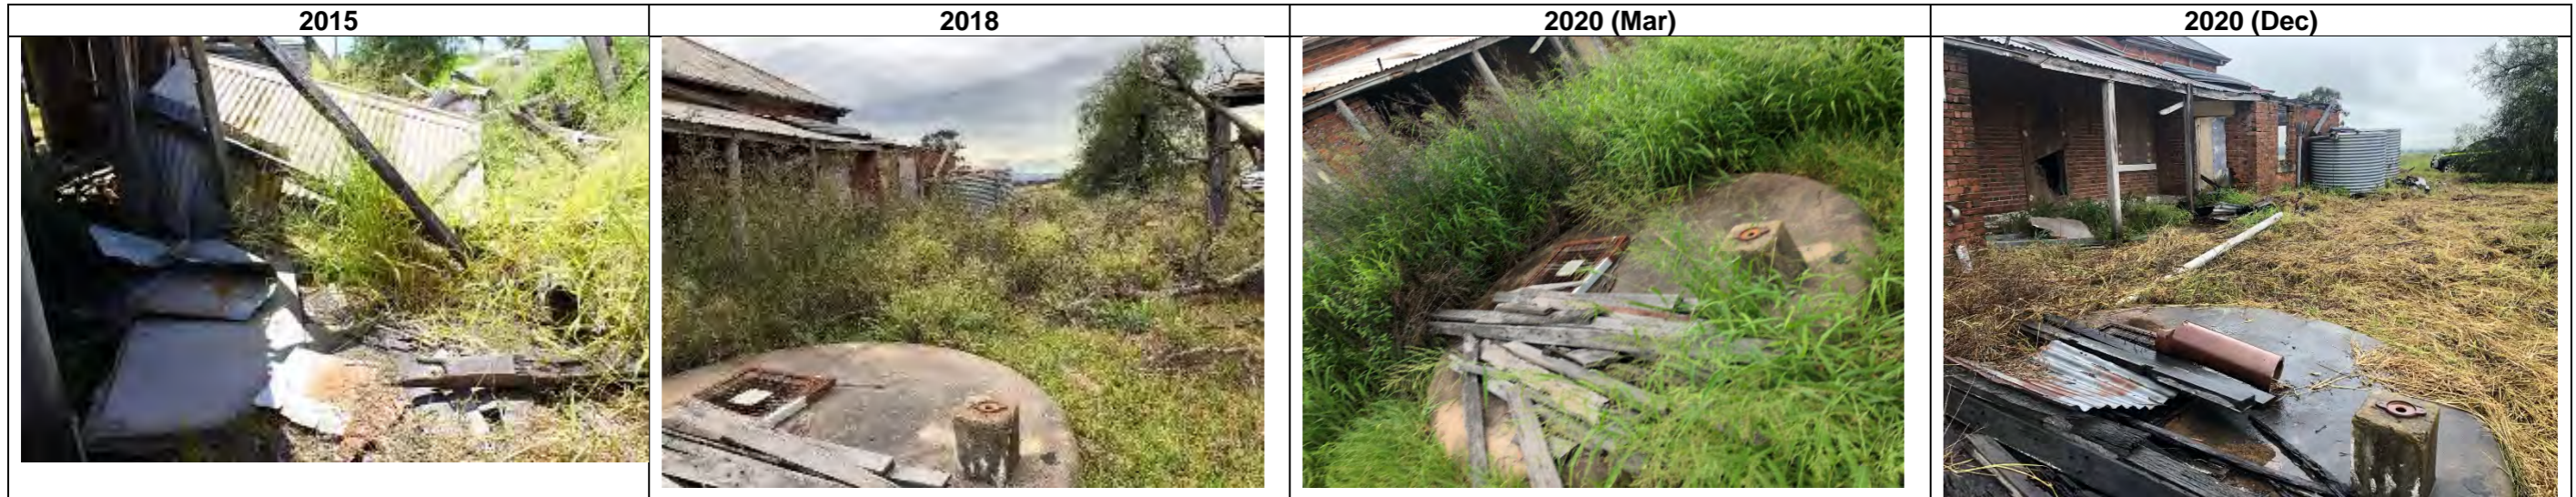
**View of rear of building (view north)**  
**2015-8:** debris has been cleared and stacked  
**2018-20 (Mar):** vegetation has regrown around building and stacked debris  
**Mar 2020-Dec 2020:** vegetation cleared and debris restacked

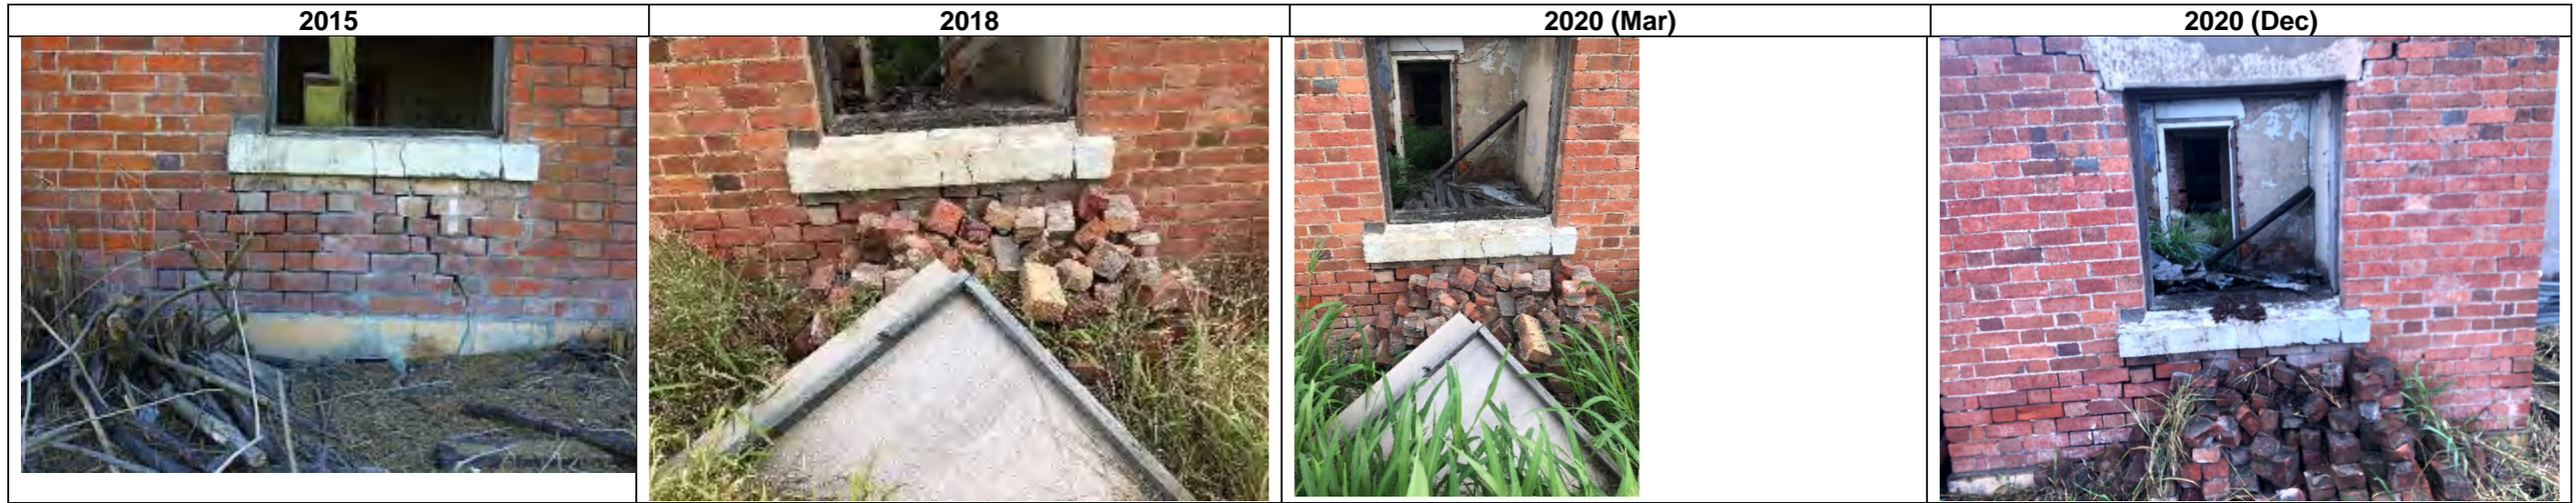
**View of north-east corner of building (focus wall below window)**  
**2015-8:** bricks from roof above stacked in front of required repointing, window sheeting removed  
**2018-20 (Mar):** no discernible change  
**Mar 2020-Dec 2020:** repointing requirements remain

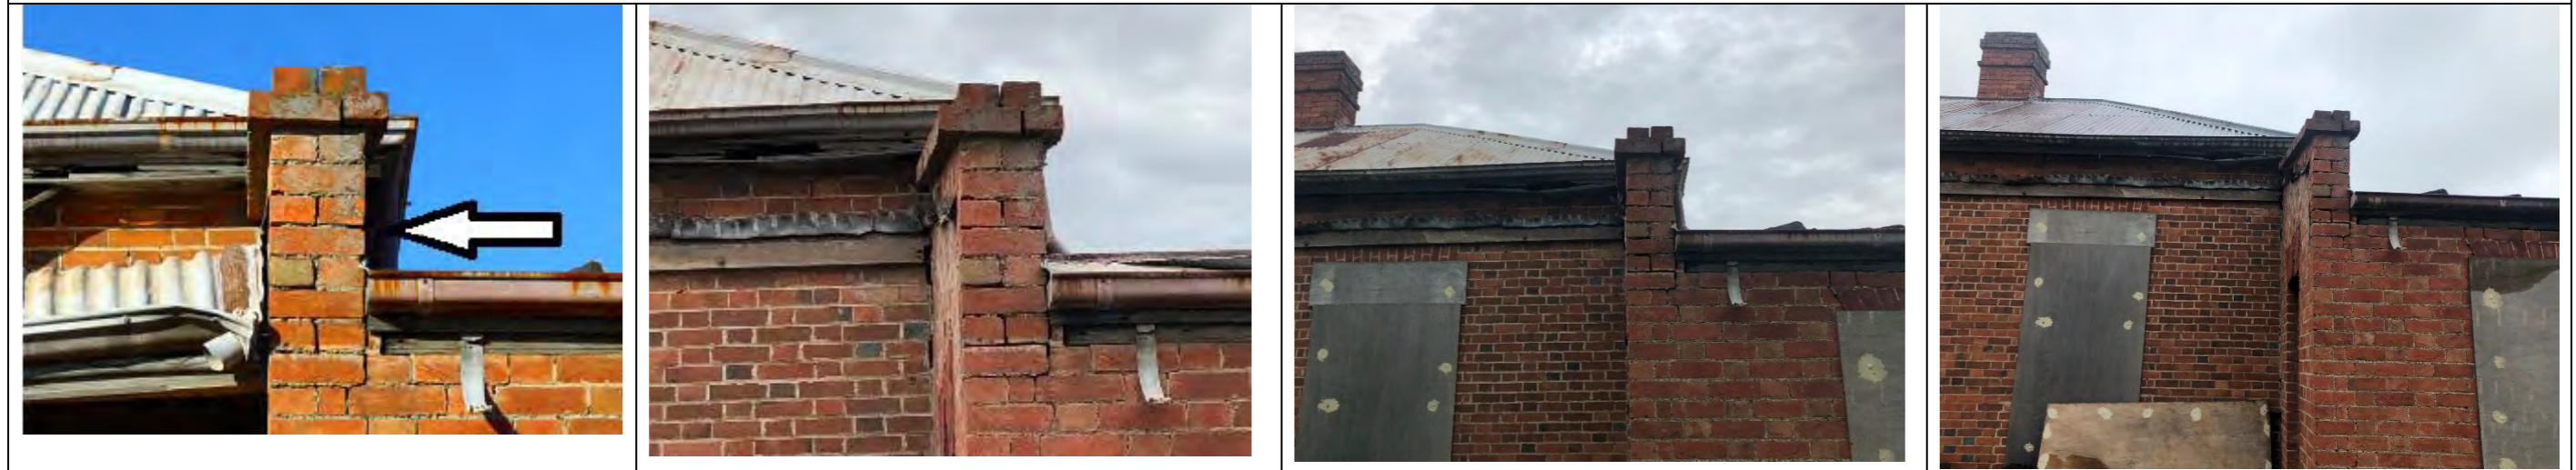
**View of south-east of building (focus on top of wall)**  
**2015-8:** no discernible change  
**2018-20 (Mar):** no discernible change  
**Mar 2020-Dec 2020:** no discernible change

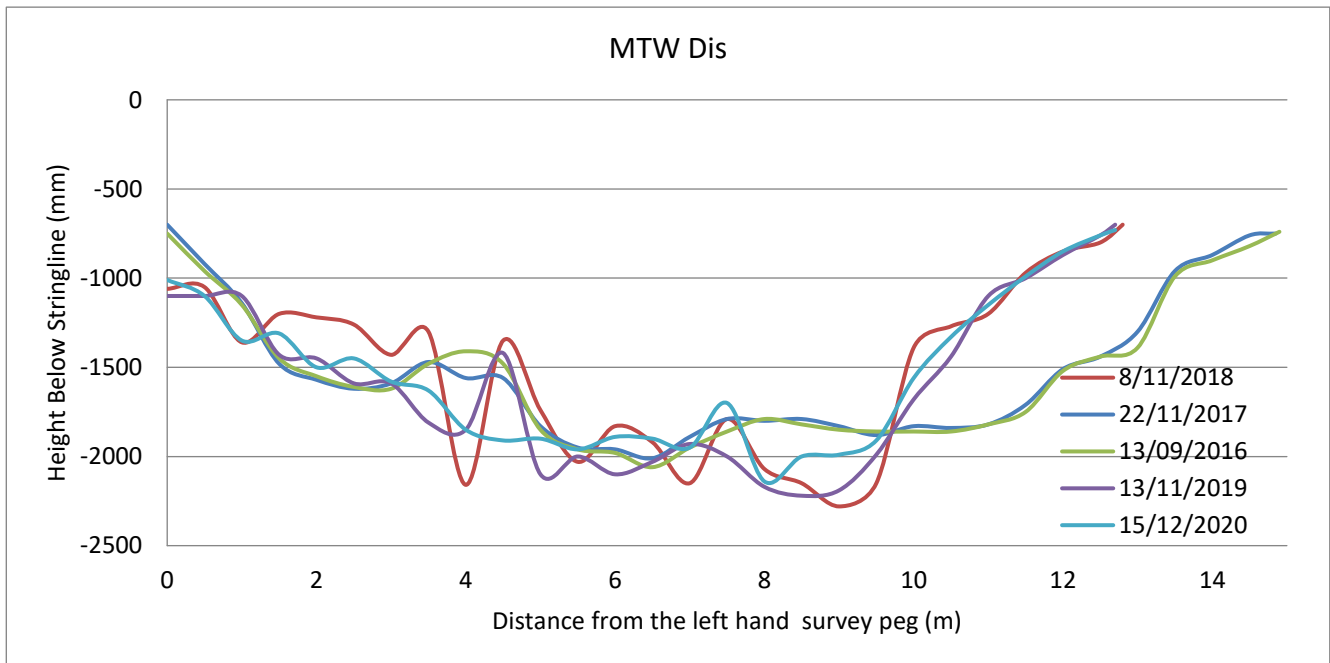
**Figure 2** MTW Dis Transect Results

For the purpose of monitoring any changes to the creek, a creek line transect was established. The transect is shown in **Figure 2** and was taken from left to right looking downstream. It can be seen from this transect that the channel hasn't changed significantly since the previous monitoring cycle. It should also be noted that as part of the upgrade works, the peg on the left bank was removed which explains why this round of monitoring shows a shorter length of transect. Difference in the data appears to be within the expected transect accuracy tolerances, it is not possible to discern if there has been bed erosion across at transect location.

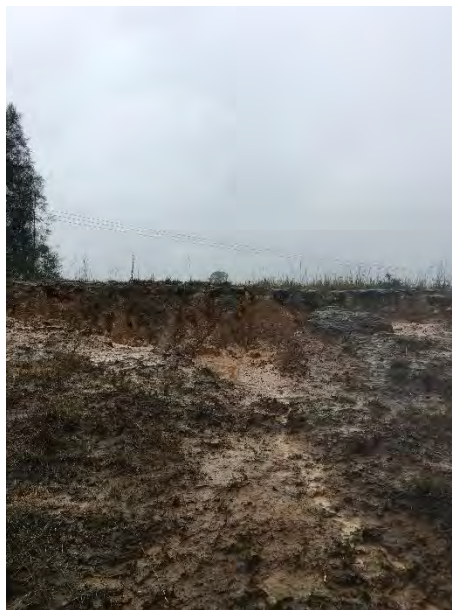
Plate 9 Erosion (top of right bank)

CSIRO Ephemeral Stream Assessment Classification – **Active**

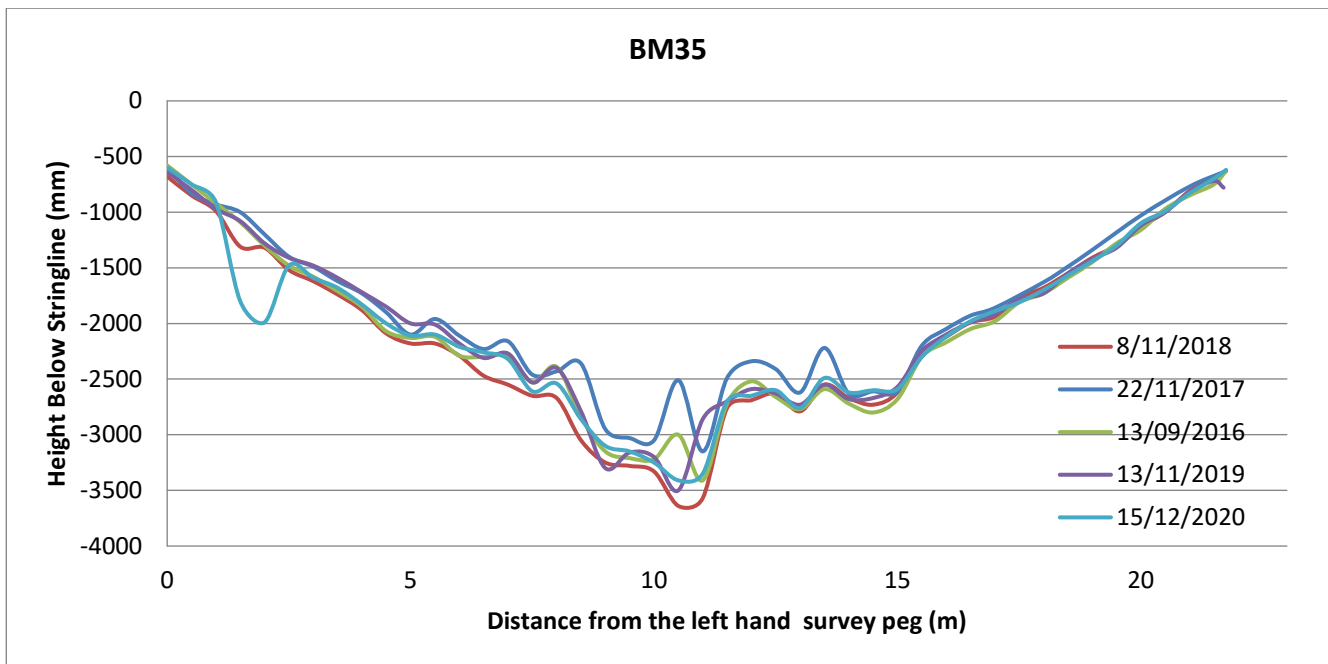
Figure 3 BM35 Transect Results

For the purpose of monitoring any changes of the creek, a creek line transect was established. The transect is shown in **Figure 3** and was taken from left to right looking downstream. It suggests that no significant scouring has occurred on the banks or creek bed since the previous monitoring cycles. A slight dip in the 2020 data at the 2m mark was caused by tussock vegetation and any other difference in the data appears to be within the expected transect accuracy tolerances.

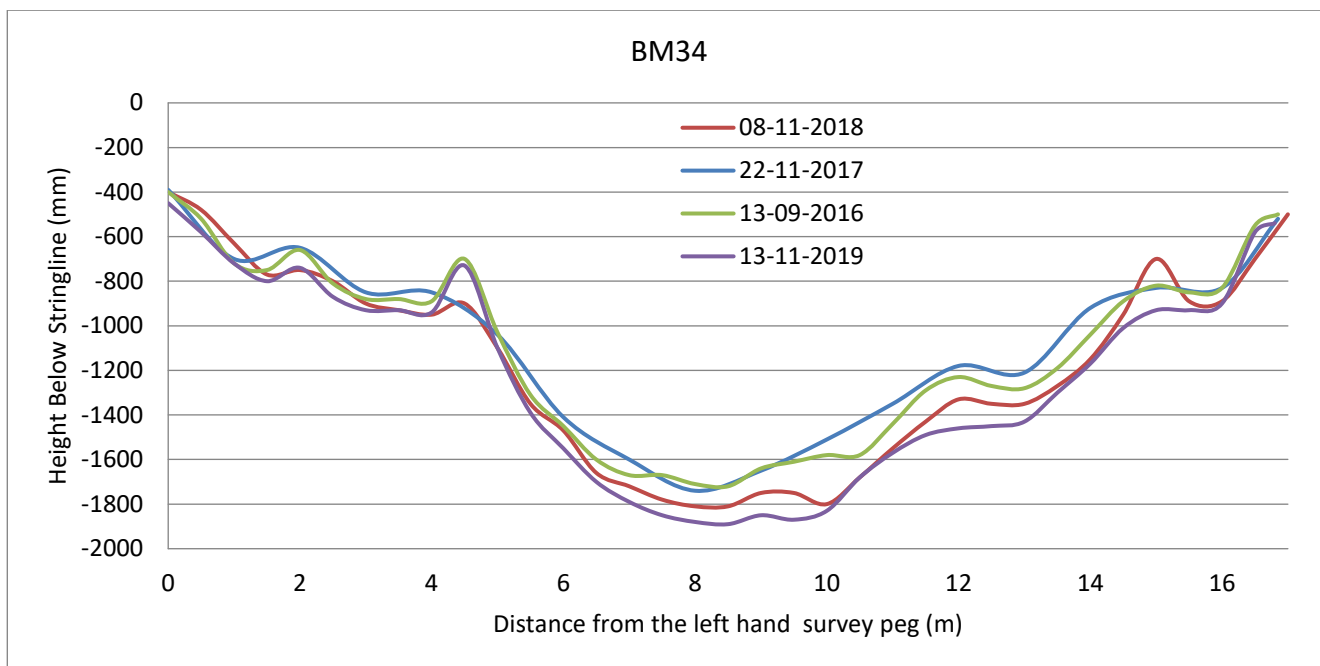
**Figure 4 BM34 Transect Results**

For the purpose of monitoring any changes of the creek, a creek line transect was established. The transect is shown in **Figure 4** and was taken from left to right looking downstream for previous rounds of monitoring. Due to flowing water in the creek, SLR was unable to undertake the 2020 transect. Visual inspection of the monitoring location suggested that the creek cross section hasn't changed since the 2019 monitoring cycle.

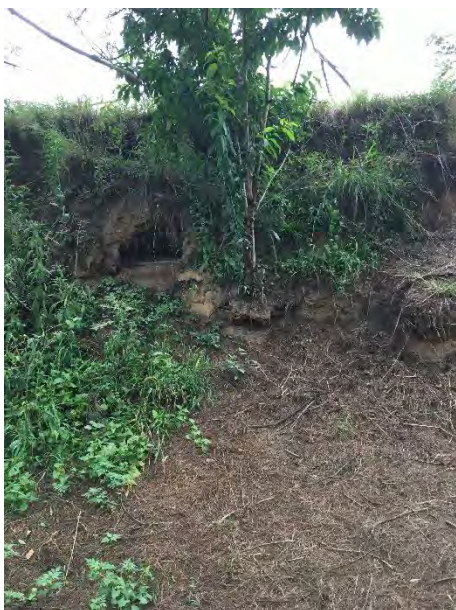
Plate 18 Erosion

CSIRO Ephemeral Stream Assessment Classification – **Potentially Stabilising**

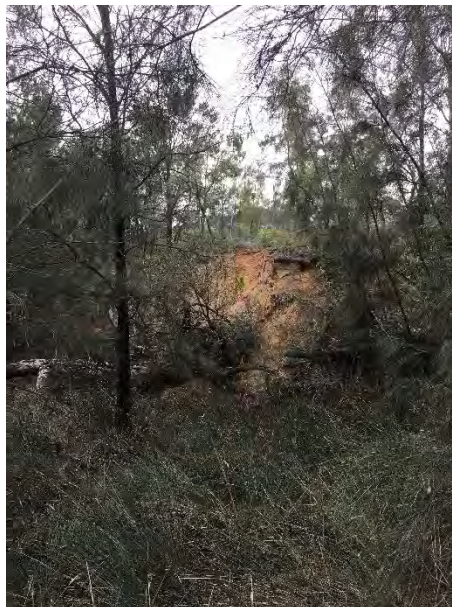
Plate 26 Erosion

### CSIRO Ephemeral Stream Assessment Classification – **Active**

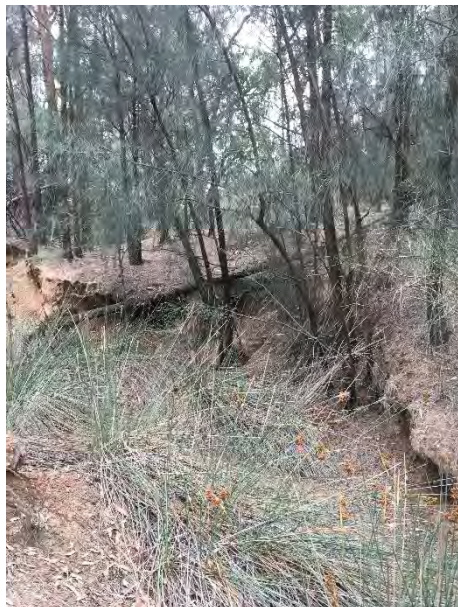
Plate 29 Erosion

CSIRO Ephemeral Stream Assessment Classification – **Very Active**

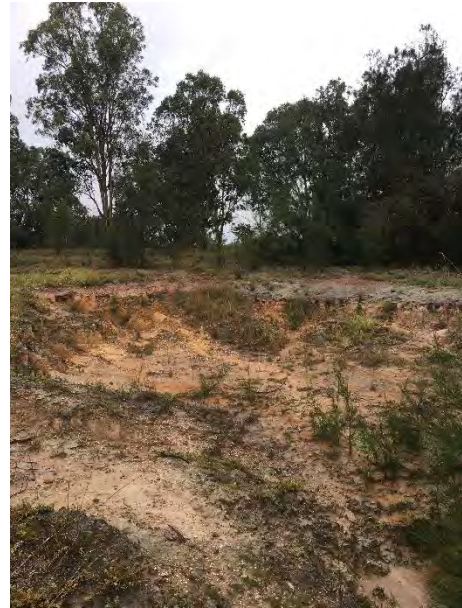
Plate 37 Erosion (top of right bank)

CSIRO Ephemeral Stream Assessment Classification – **Active**

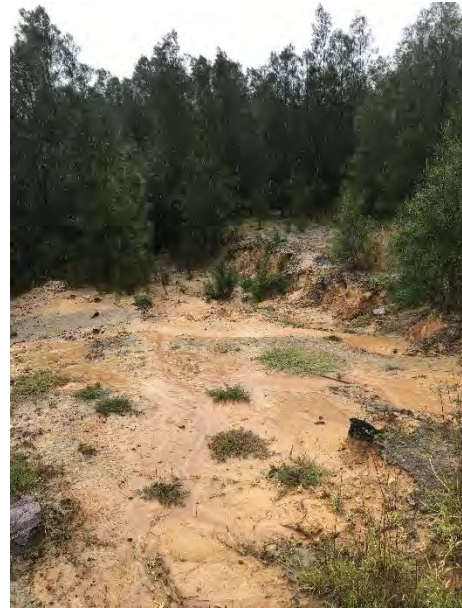
Plate 39 Erosion

CSIRO Ephemeral Stream Assessment Classification – **Active**

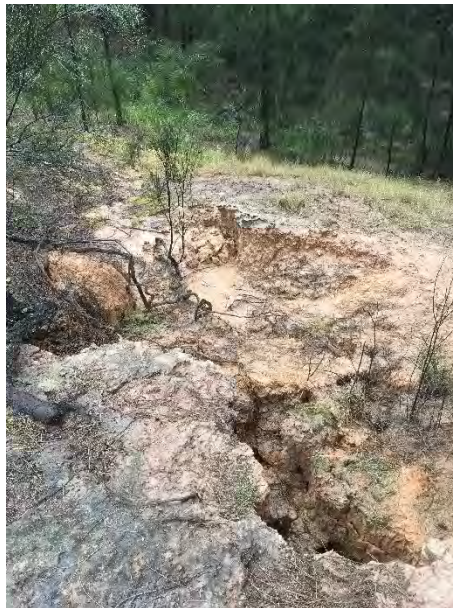
Plate 43 Erosion

CSIRO Ephemeral Stream Assessment Classification – **Active**

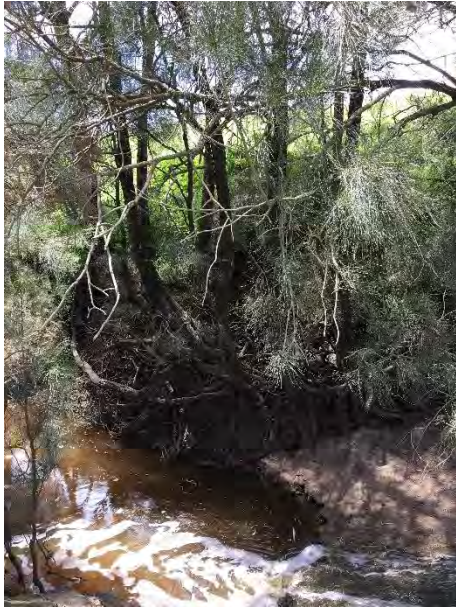
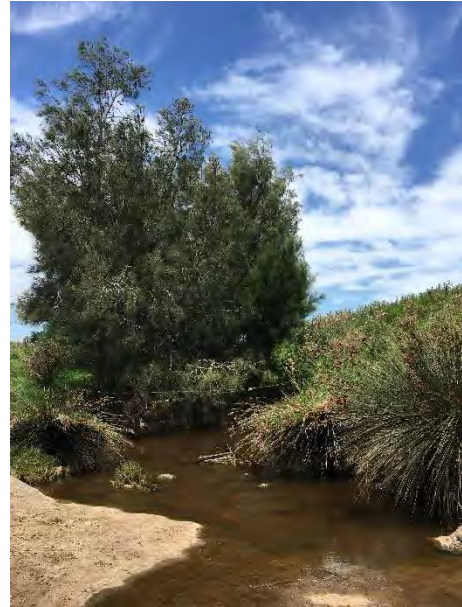
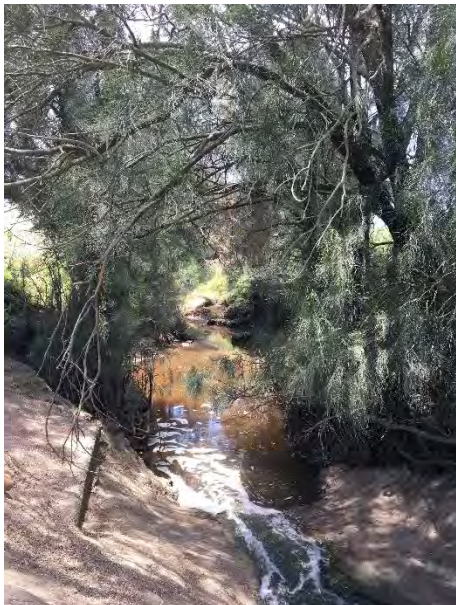
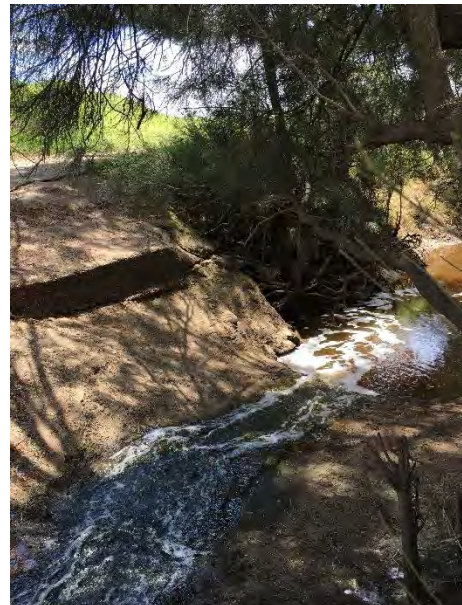
The erosion observed at LC10 is located immediately downstream of a concrete lined chute. The soil is alluvial and non-dispersive. The erosion has been created from scouring of the right bank during large flow events with the upstream chute increasing the velocity of the water to this downstream section of channel. This scouring has exposed some tree roots of some of the trees that line the creek bank. The creek has steep slopes on both banks (approximately 3m high) and was observed flowing at the time of monitoring. The creek is generally stable upstream and downstream except for some cattle tracks immediately upstream on the right bank. Overall, this monitoring location has shown similar conditions to the previous monitoring cycle.

CSIRO Ephemeral Stream Assessment Classification – **Active**

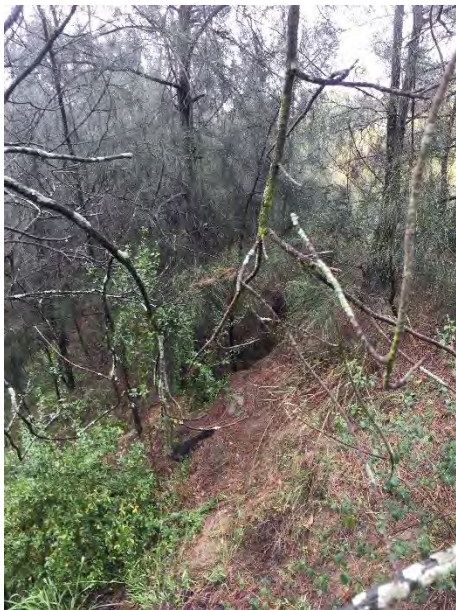
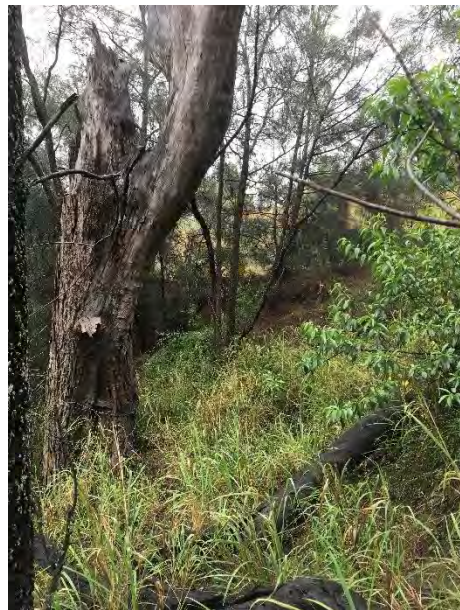
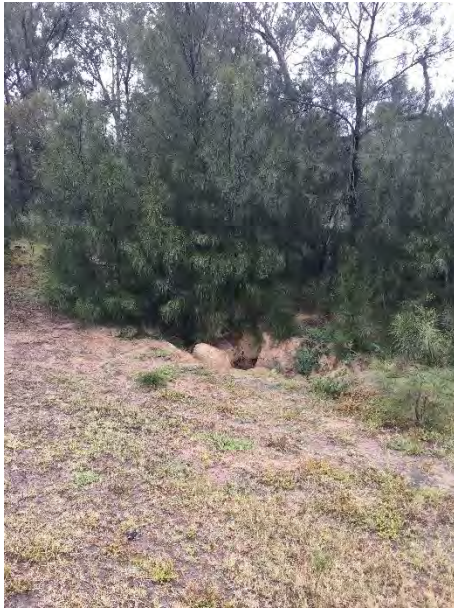
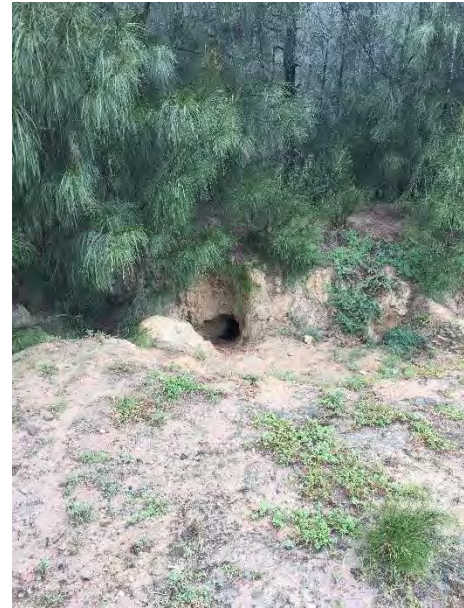
The erosion observed at LC11 includes some significant tunnelling and active erosion on the left bank with exposed vertical dispersive soil. Potential causes for this erosion include wombat holes as well as the presence of a contour bank overflow (which is located immediately upslope of the erosion). Trees were observed on both banks and creek bed. The creek bed and the right bank both show stable conditions. Overall, this monitoring location has shown similar conditions to the previous monitoring cycle.

CSIRO Ephemeral Stream Assessment Classification – **Active**

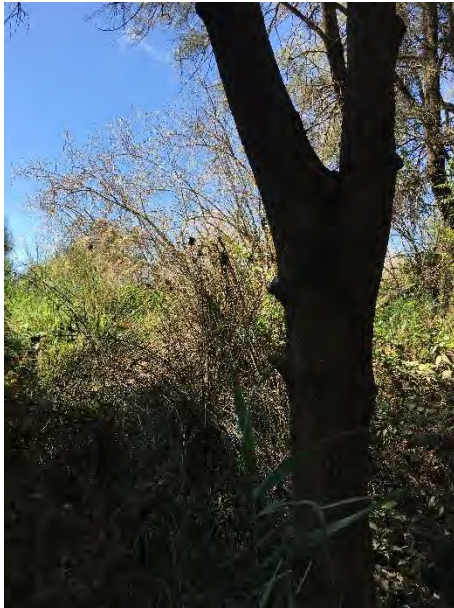
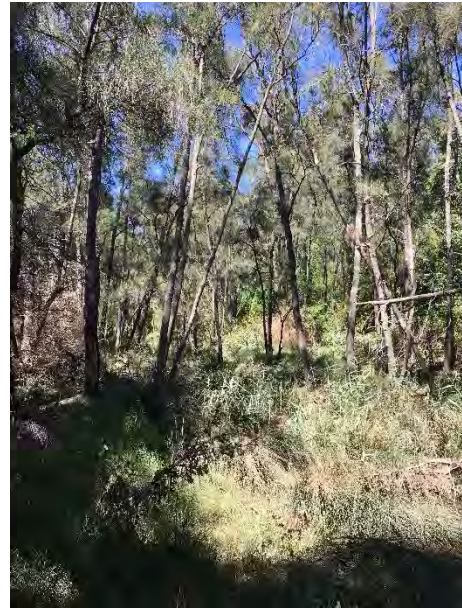
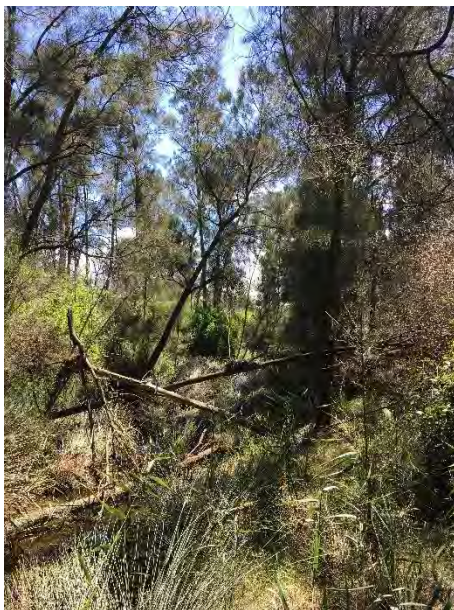
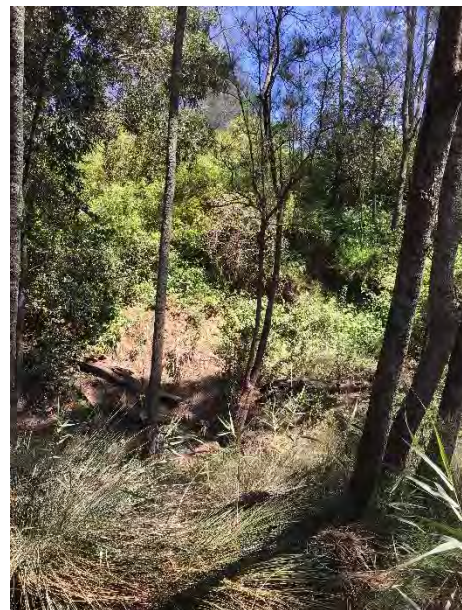
The erosion observed at LC12 includes some erosion (approximately 2m high) on the left bank. It is likely that this erosion was at least partially caused by a fallen tree at the monitoring point location. The 2020 monitoring cycle shows this erosion partially vegetated. This is most likely linked to the continuous rainfall observed in the region in the last few months. The left bank at the monitoring point is significantly higher than the right bank. The creek bed and the right bank both show stable conditions.

CSIRO Ephemeral Stream Assessment Classification – **Potentially Stabilising**

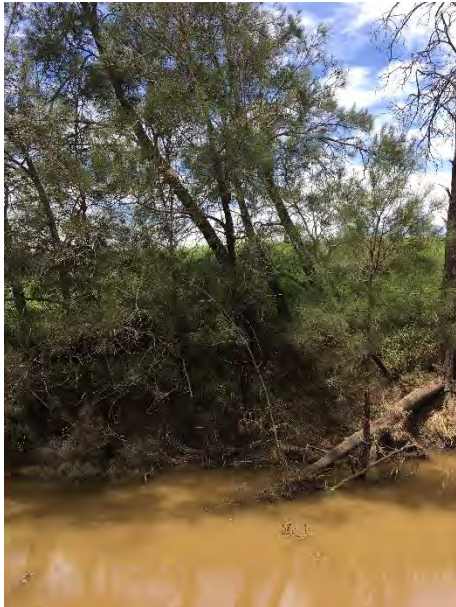
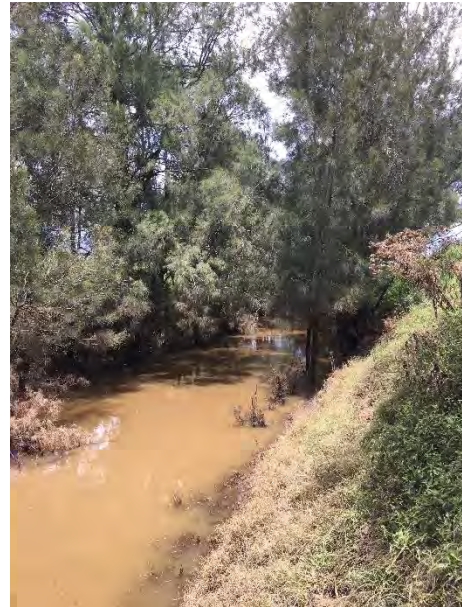
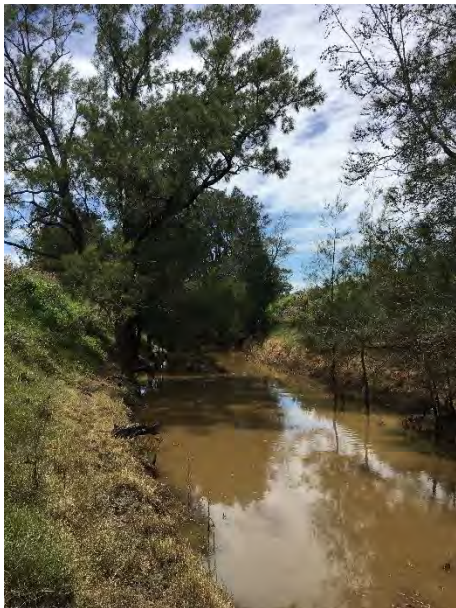
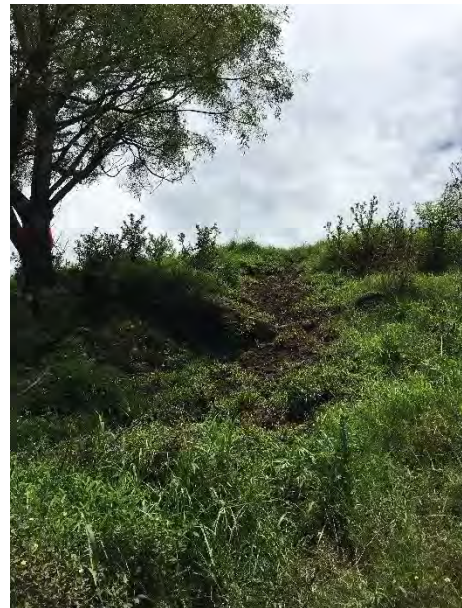
LC13 includes some erosion extending for approximately 5m on the steep left bank with exposed soil which doesn't appear to be highly dispersive. This erosion was most likely caused by livestock tracks observed upstream and downstream of the monitoring location or a localised slope failure. Other than more vegetation as a result of continuous rainfall in the region, this monitoring location has shown similar conditions to the previous monitoring cycle.

CSIRO Ephemeral Stream Assessment Classification – **Potentially Stabilising**

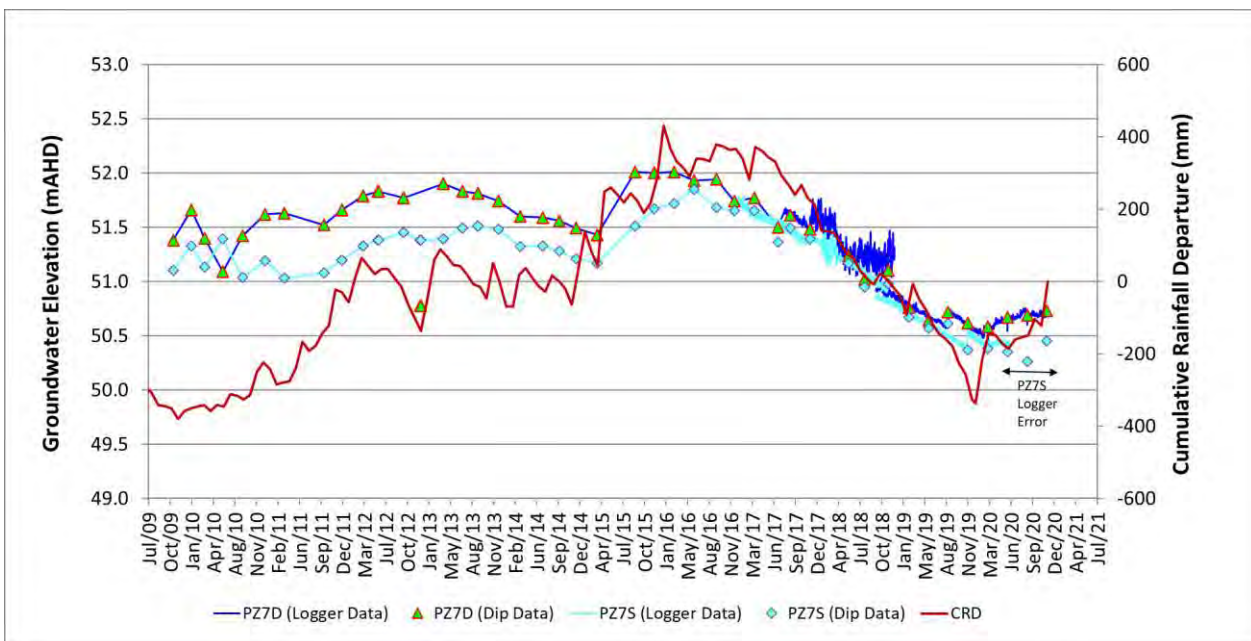
**Figure 6-2 Groundwater Levels – Warkworth Sands Bore PZ7S and PZ7D**

Bore PZ7 is a nested bore of two separate standpipes, with PZ7S constructed within the Warkworth Sands to 11.1 m depth bgl (screened interval unknown), and PZ7D constructed within the shallow overburden material to a total depth of 30.5 m bgl (screened interval unknown). Historical water level data for the bores is presented in **Figure 6-2**. **Figure 6-2** shows that groundwater elevations within the coal measures at PZ7D have historically been slightly higher than levels in the overlying Warkworth Sands, indicating a potential upward gradient. Between 2016 and 2019 this gradient has reduced, with levels within the Warkworth Sands and shallow overburden showing similar elevations and longer-term declining trends. **Figure 6-2** shows that during 2020 groundwater levels within the Warkworth Sands and shallow overburden material at PZ7S and PZ7D, respectively started to recover, likely in response to above average rainfall received in February and March 2020. A delayed recovery response is seen in the manually measured water level at PZ7S. The data collected by the logger in PZ7S was erroneous from June 2020 onwards; therefore, the short-term water level response to rainfall was not able to be examined. As recommended in the previous annual review, further investigation into the local ground conditions bore construction details and condition of the nested bore should be undertaken, to understand the interaction between the two bore depths. The logger in PZ7S should be replaced with an operating logger.

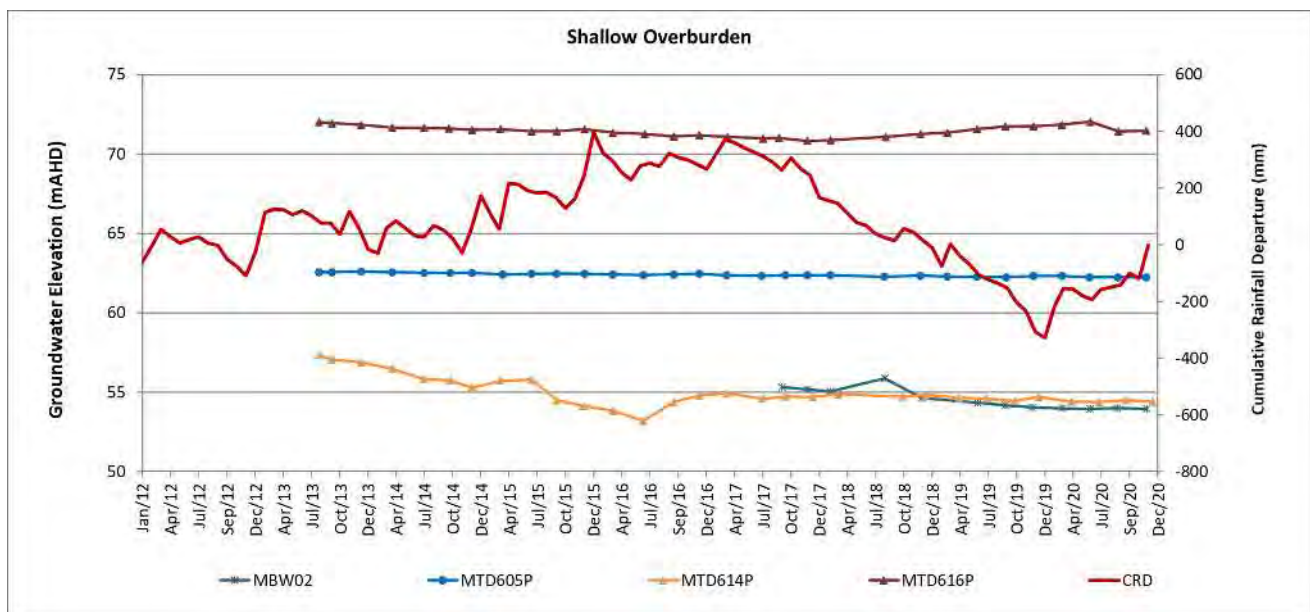
**Figure 6-6 Hydrograph of Shallow Permian Coal Measures**

Groundwater elevation trends for bores MTD605P, MTD614P, MTD616P, and MBW02 are presented in **Figure 6-6**. **Figure 6-6** shows stable to slightly declining groundwater levels within the shallow overburden material. The exception to this is bore MTD616P in which slightly increasing groundwater levels were recorded between January 2018 and May 2020. Subsequent groundwater elevations have declined and stabilised at approximately 71.4 mAHD. Given the CRD generally declined from 2017 to 2019, it would not be expected that groundwater elevations would rise. As reported in the previous annual review, no land use changes, or activities are known to have occurred near the bore that may have caused this rising trend. Further investigation into site conditions around MTD616P should be undertaken to confirm this.
