Mount Thorley Warkworth Aboriginal Heritage Management Plan 2019 Compliance Audit Inspection

Report prepared for
Yancoal Australia, Mount Thorley Warkworth

March 2020

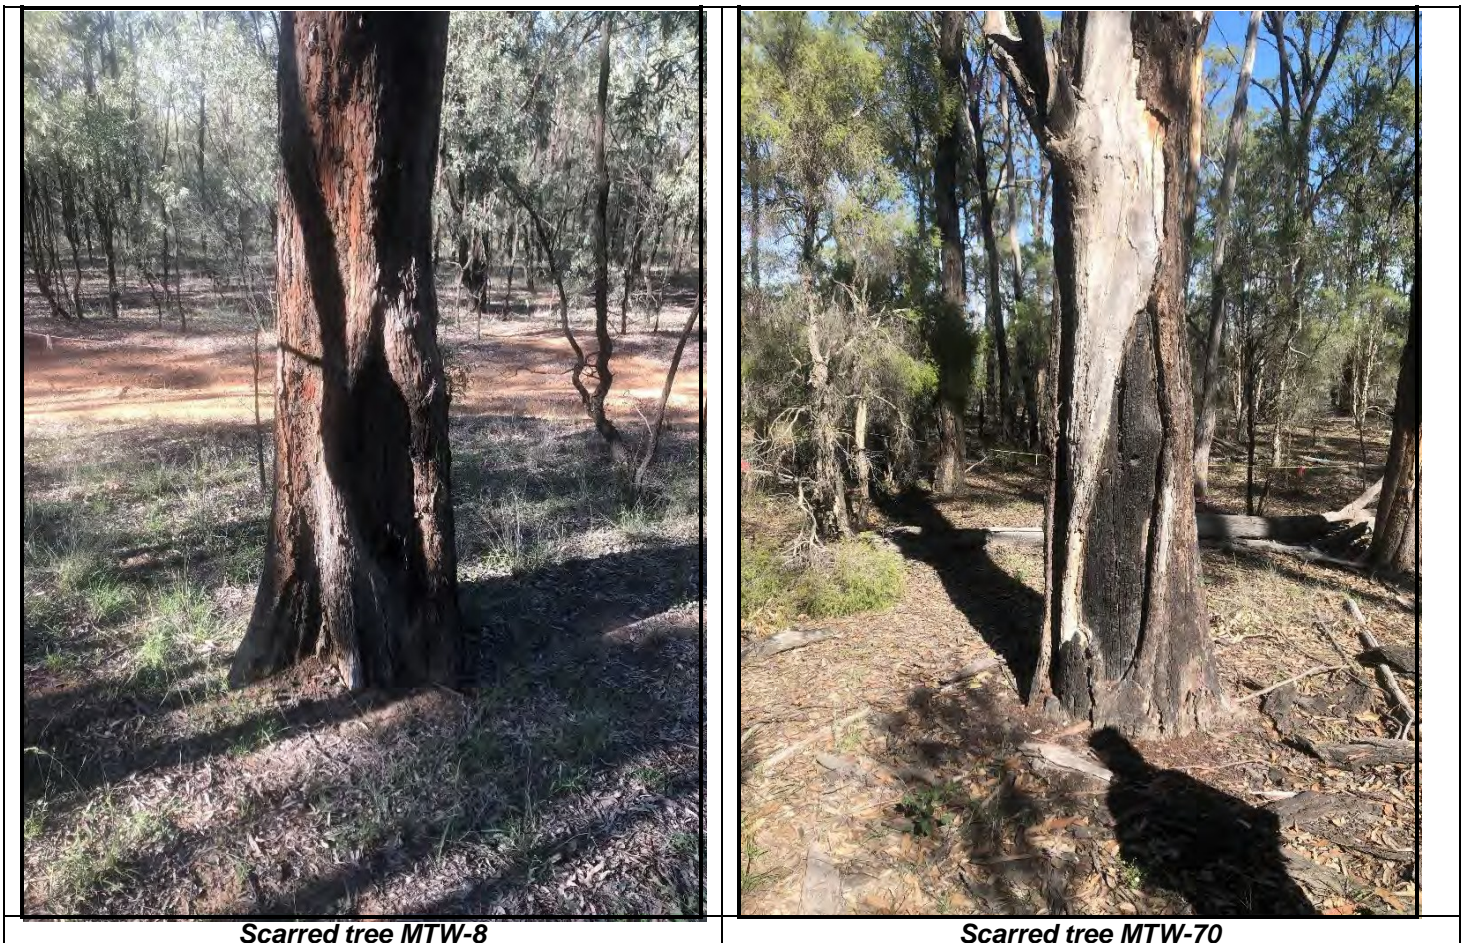
Scarred tree MTW-8

Four scarred trees are located within the approved future mining area at MTW. With the exception of MTW-70, these trees have been visited by an arborist to assess the best method of removal and relocation, and general plans developed. MTW-70 should also be assessed for removal and relocation. These scarred trees have been visited by RAPs during this compliance inspection and during other inspections and assessments. Their removal and the arborist's plans should be discussed with the CHWG, as well as the location to where they will be relocated – the Wollombi Brook ACH Conservation Area has been suggested.

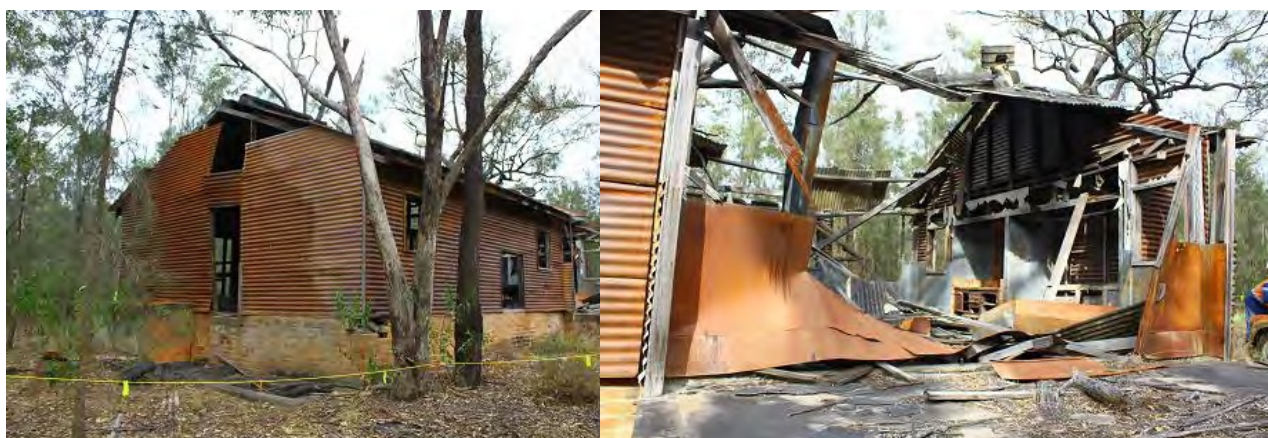
View to mess from south-east (2012)

The building is currently structurally unsound, with a large tree impacting on the roof and a number of timber elements either missing or in a deteriorated state. Corrugated asbestos roof sheeting is also missing in some places, and damaged and in poor condition where it remains. Much of the corrugated iron sheeting is corroded. Brickwork is also cracking in a number of locations resulting in significant movement outward, loss of mortar and loss of bricks along the southern and eastern elevations.

As a result, a number of structural recommendations were outlined by ERM in the CMP developed for the site in 2012. These recommendations were not intended to return the building to a serviceable state, rather they seek to do the minimum required to allow safe access to the building to prevent significant damage, and also allow safe access for asbestos removal and internal inspection of the building in the short to medium term.

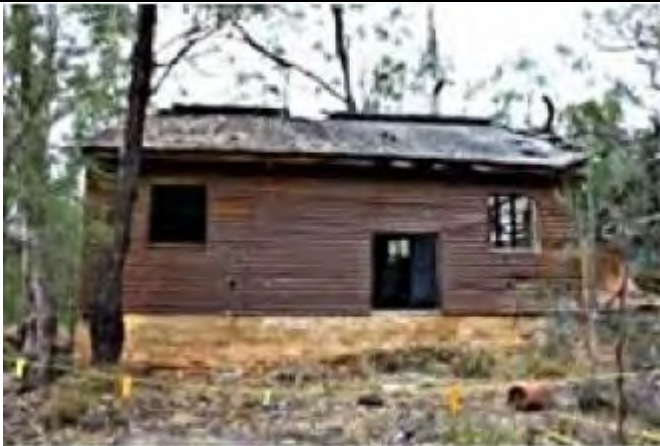
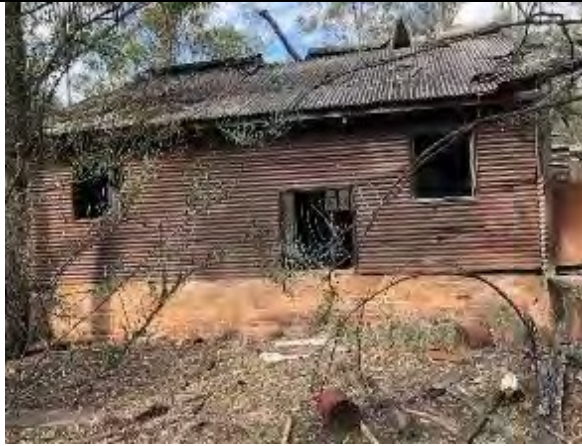
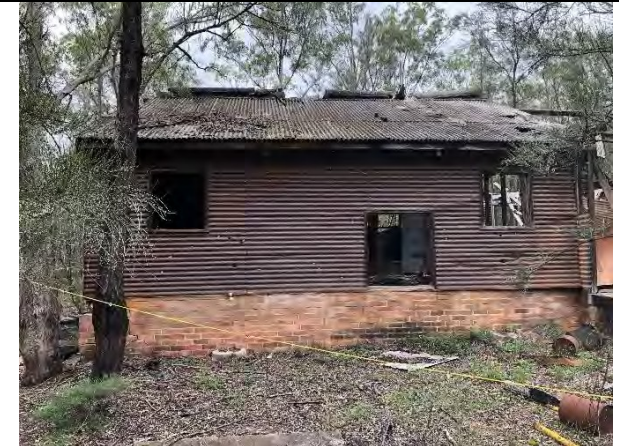
East elevation

2012-18: no discernible change – note fallen branch from tree on western side.

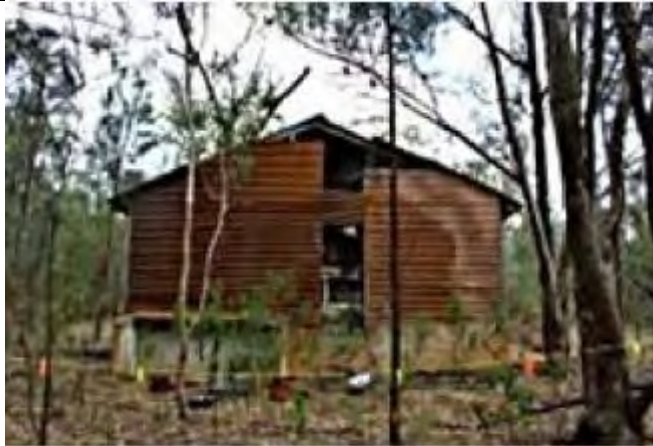
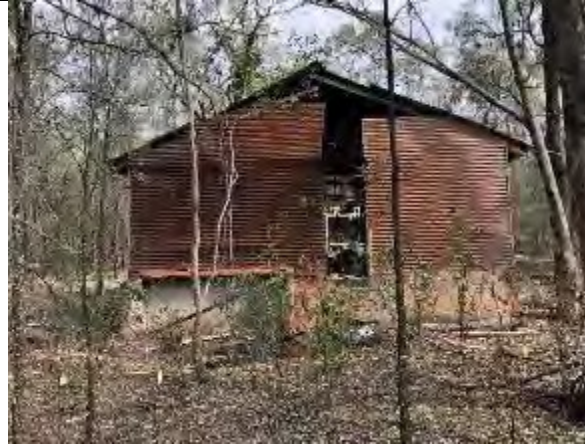
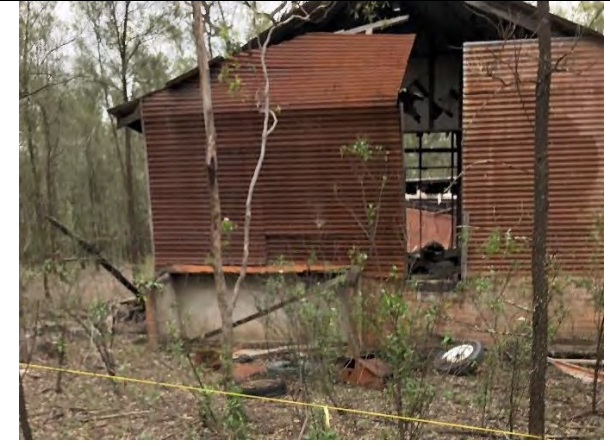
South elevation

2012-18: evidence of increased bow to southern wall and missing panel above entry.

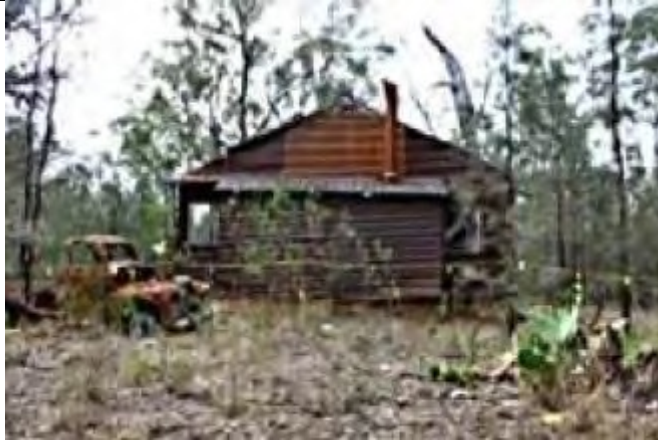
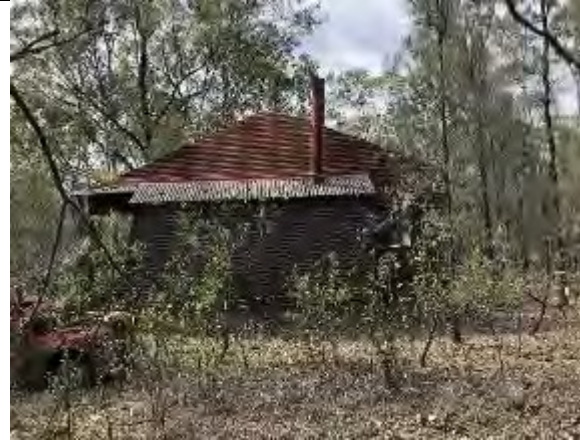
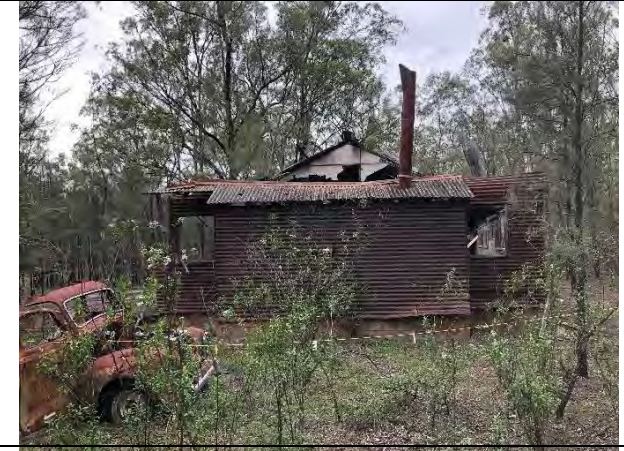
North elevation

2012-18: no discernible change.

2018-20: top of north wall now collapsed.

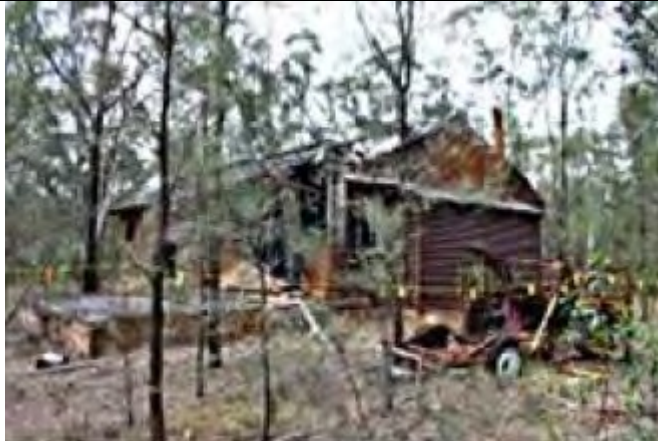
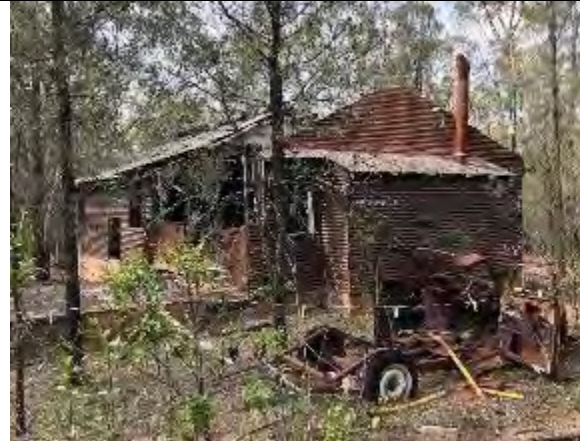
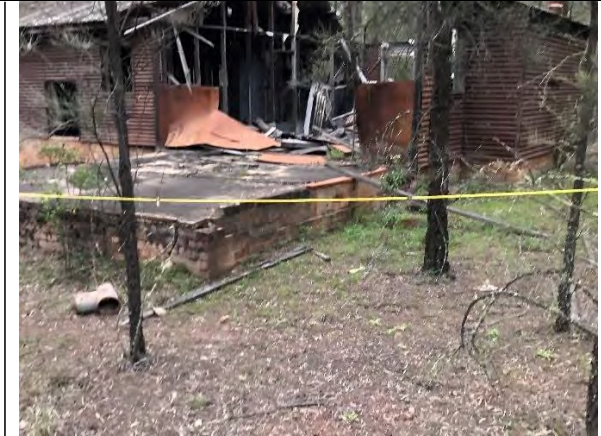
North-east elevation

2012-18: difficult to discern change.

2018-20: difficult to discern change.

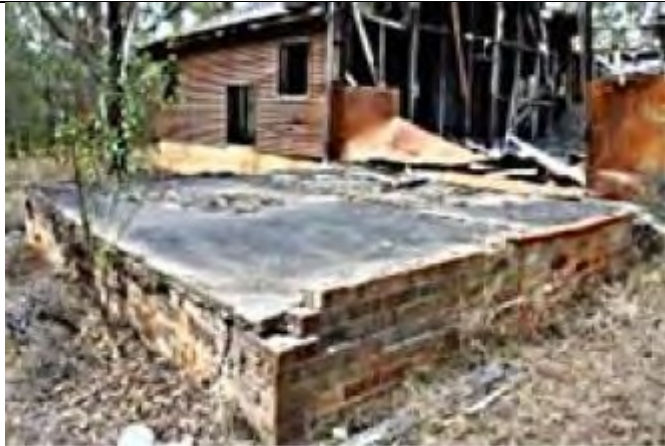
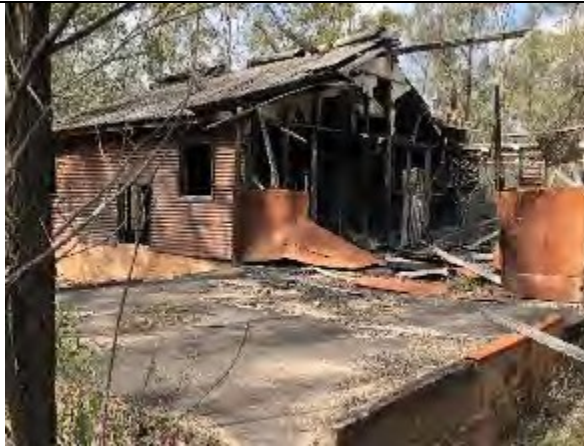
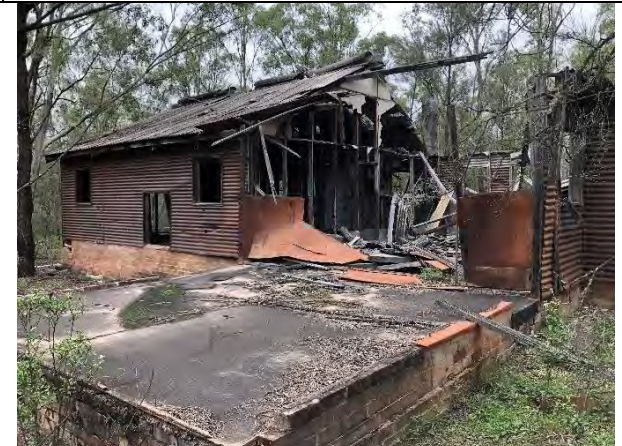
Concrete and brick foundation at east side of building

2012-18: difficult to discern change.

2018-20: no discernible change.

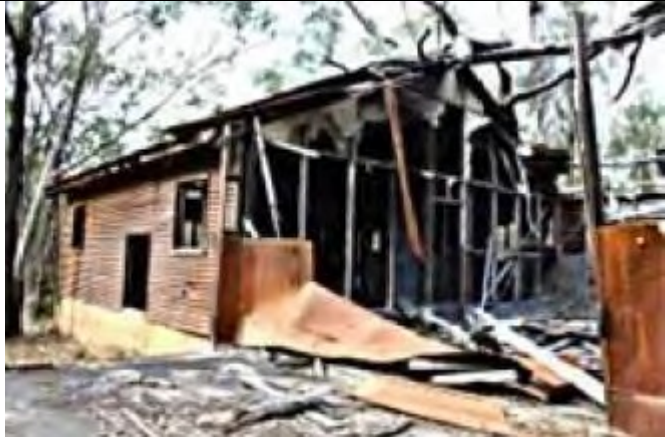
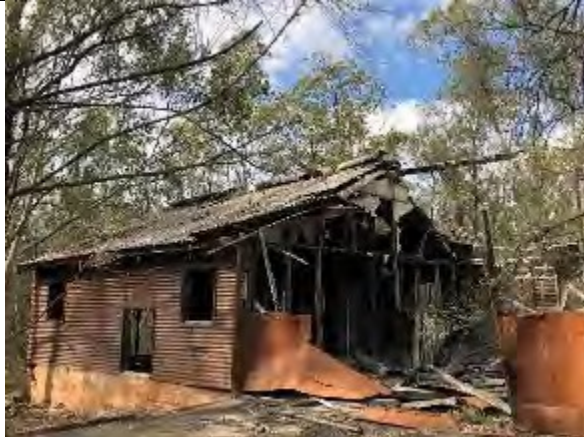
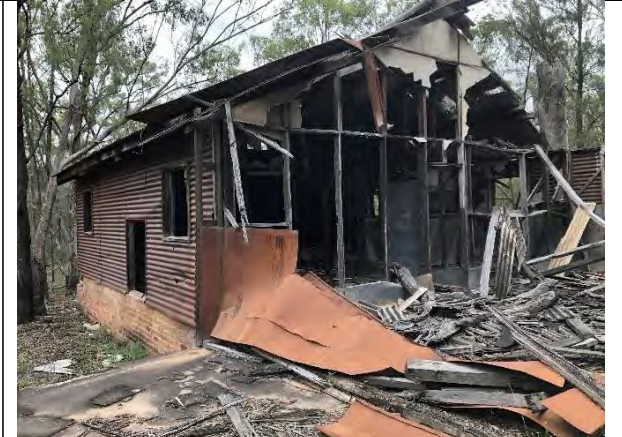
View to building interior from north-east

2012-18: shows collapse of remnant roofing members above open kitchen area.

2018-20: further minor deterioration of asbestos sheeting panelling.

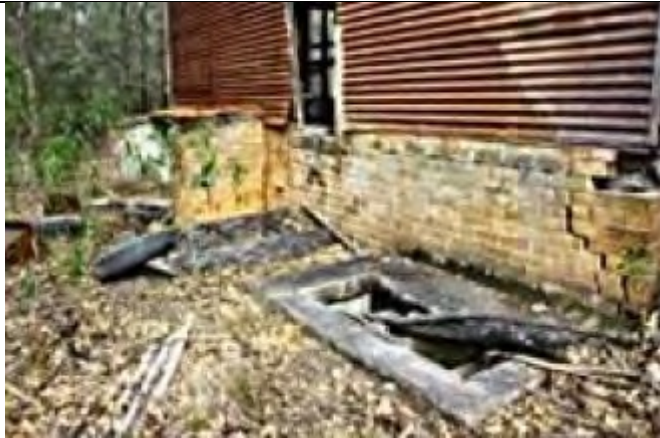
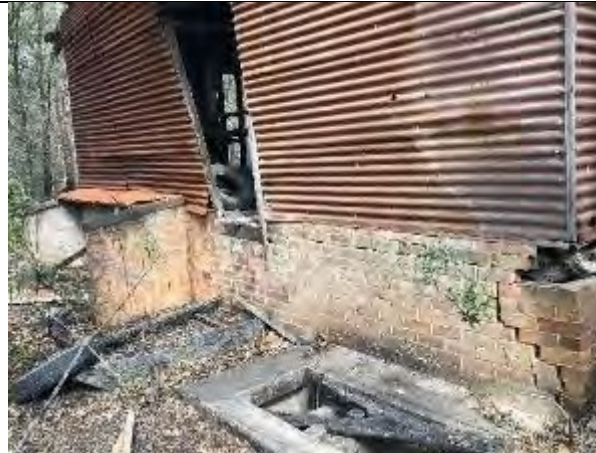
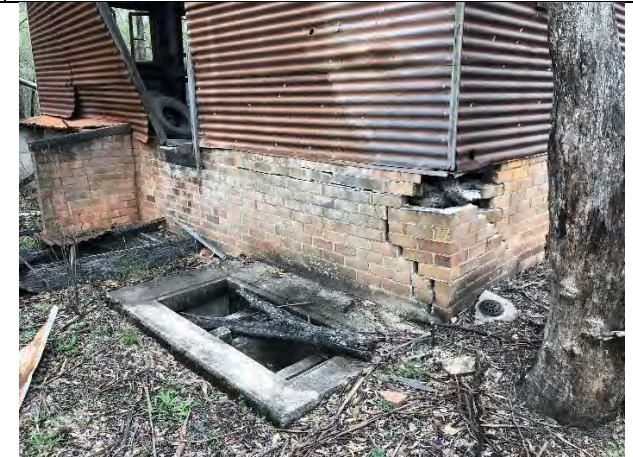
Grease trap at south end of building

2012-18: shows bow to south wall.

2018-20: shows increased bow to south wall.

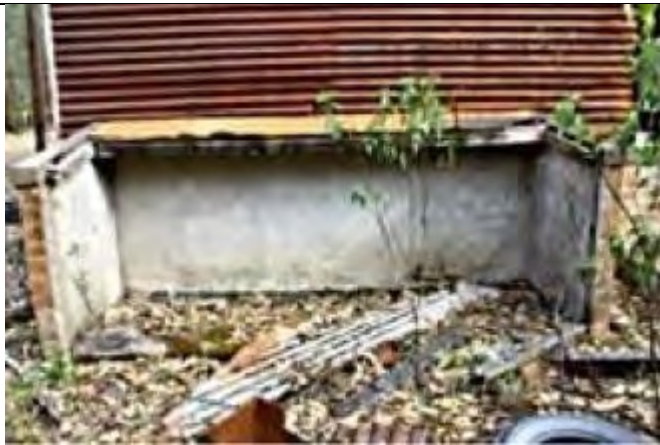
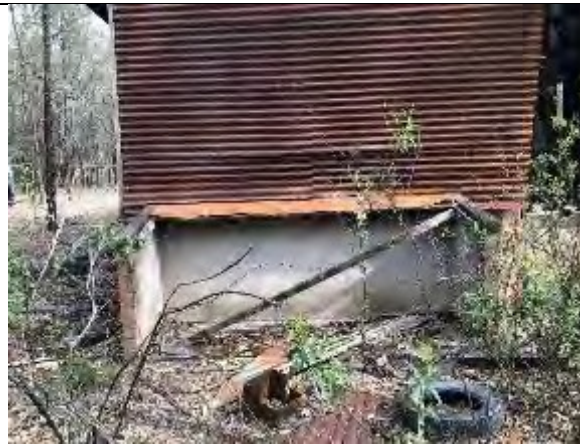
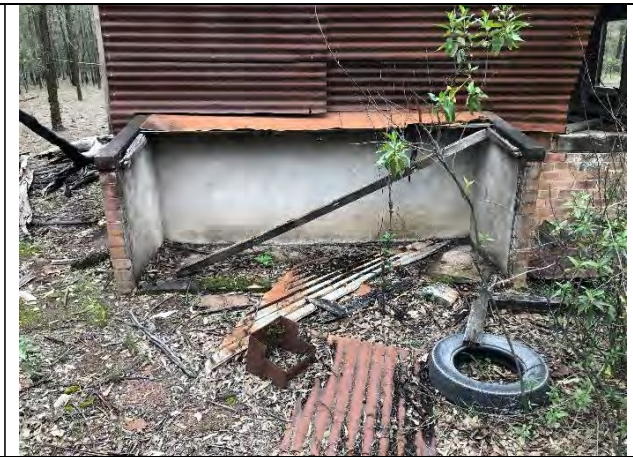
Storage area at south end of building

2012-18: further slight collapse of storage area.

2018-20: shows loosening of corrugated iron wall sheeting due to bowing in wall.

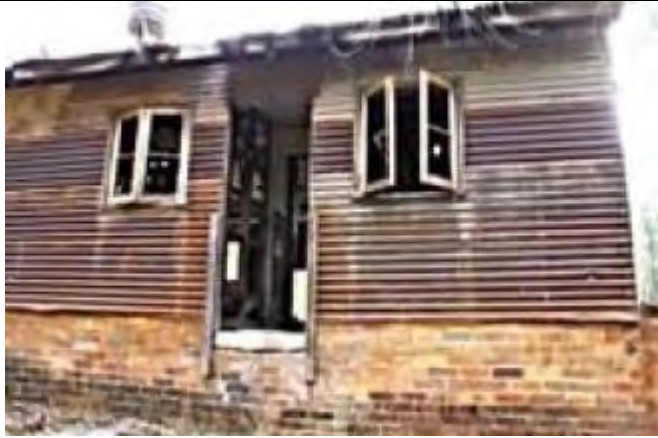
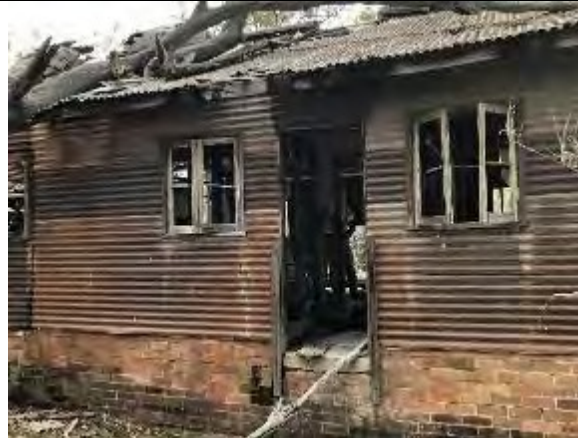
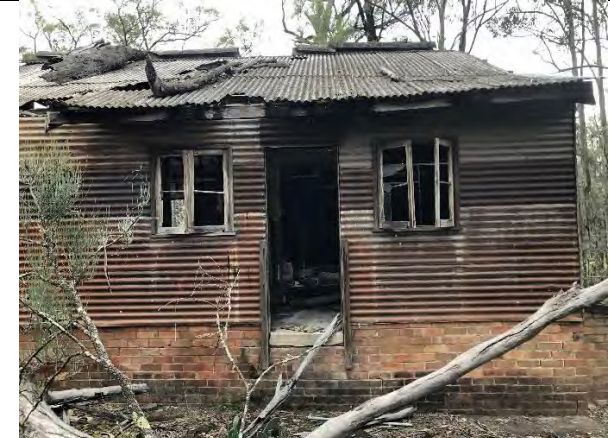
Windows and entry at west elevation

2012-18: shows large trunk/branch portions of tree collapsed on roof, which has destroyed roof ventilator.

2018-20: shows majority of branches fallen from roof, leaving increased damage to sheeting.

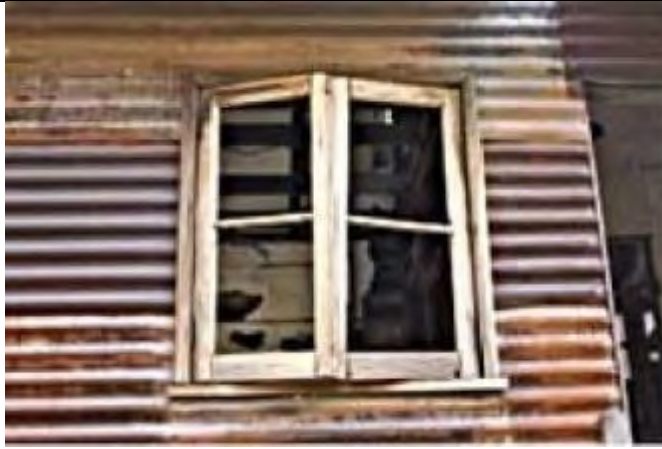
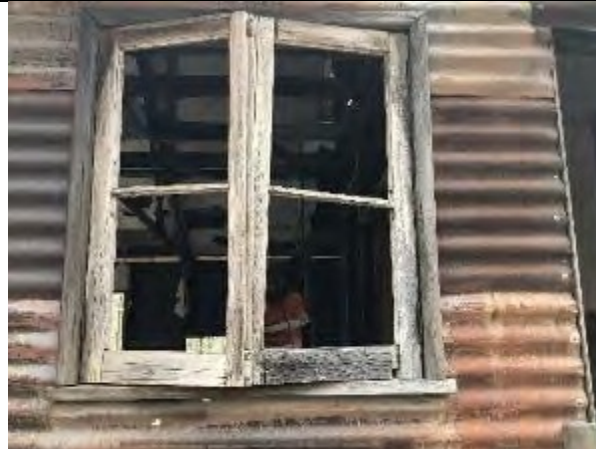
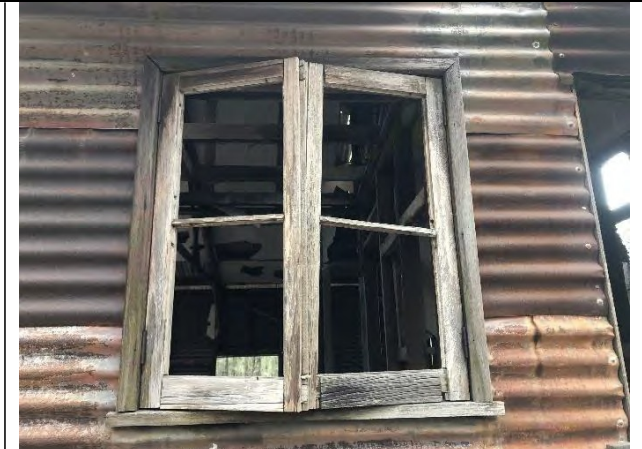
Timber window detail, west elevation

2012-18: no discernible change.

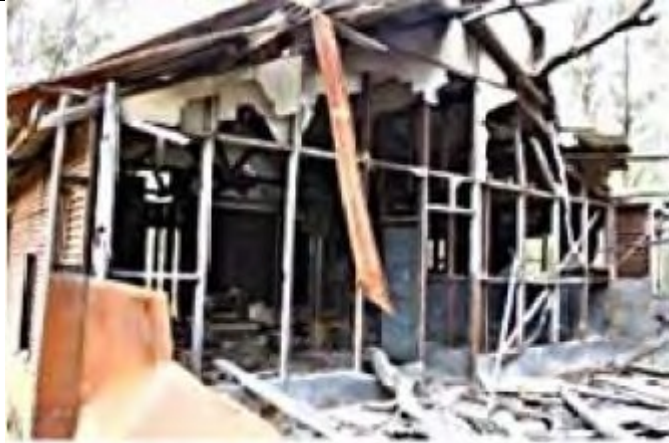
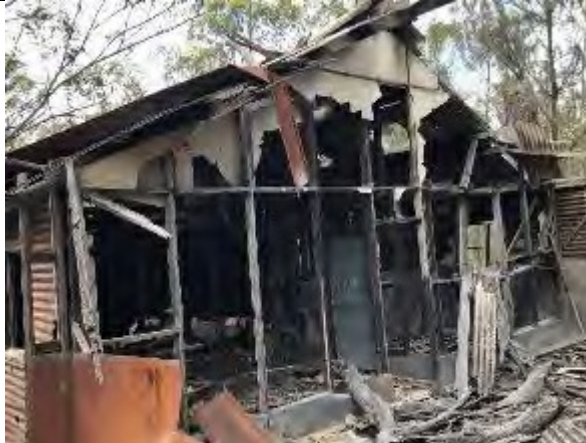
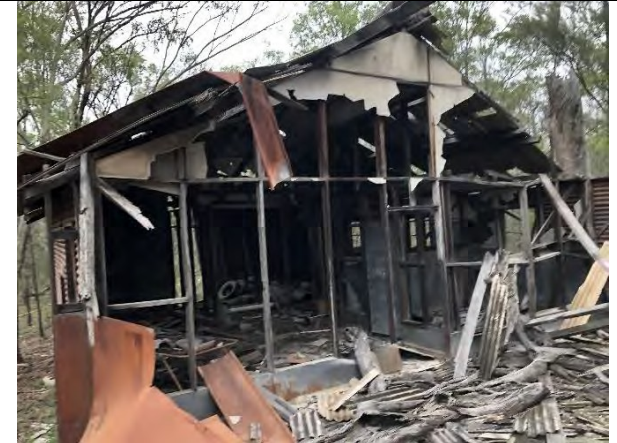
View to interior of south end of building, view from east

2012-18: shows increased collapse over open kitchen area.

2018-20: shows further minor deterioration of asbestos panelling.

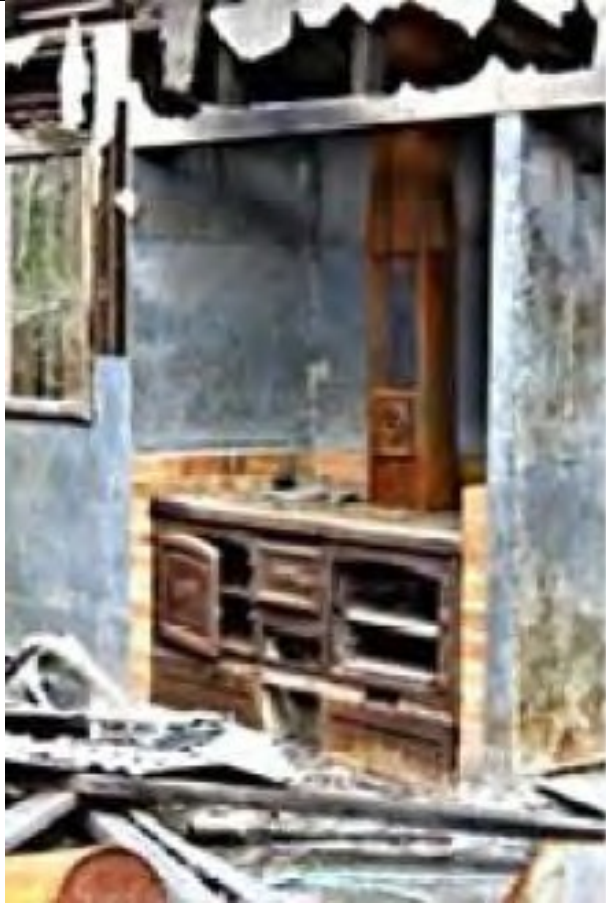
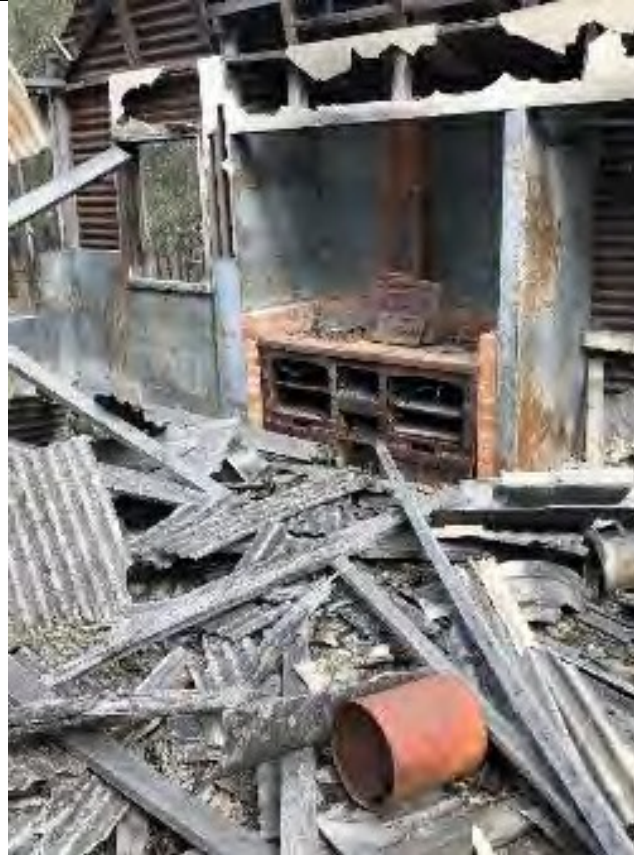
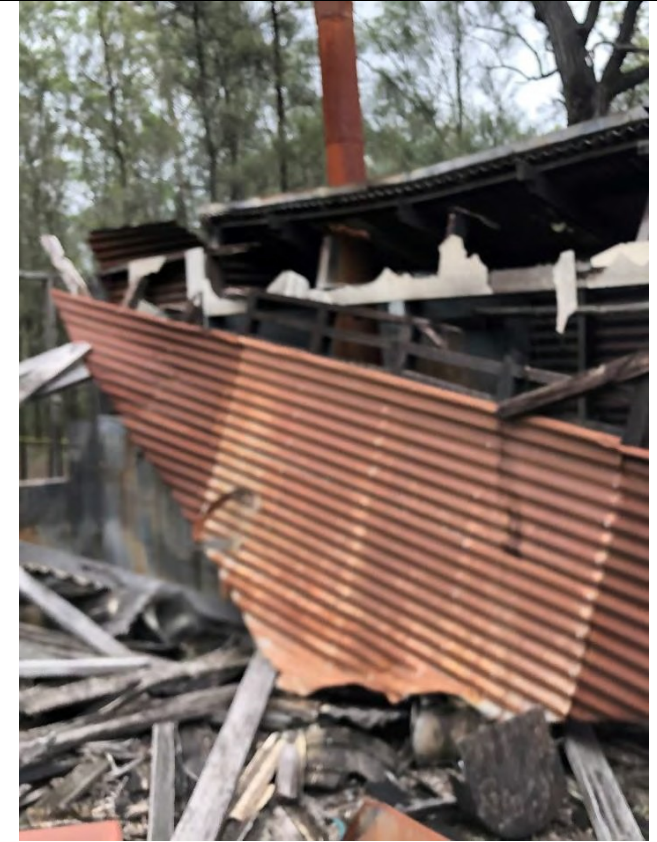
Showing stove at kitchen at north end

2012-18: note the remaining two stove doors have become unhinged and build up of debris from collapsed roof.

2018-20: stove now obscured by collapsed north wall.

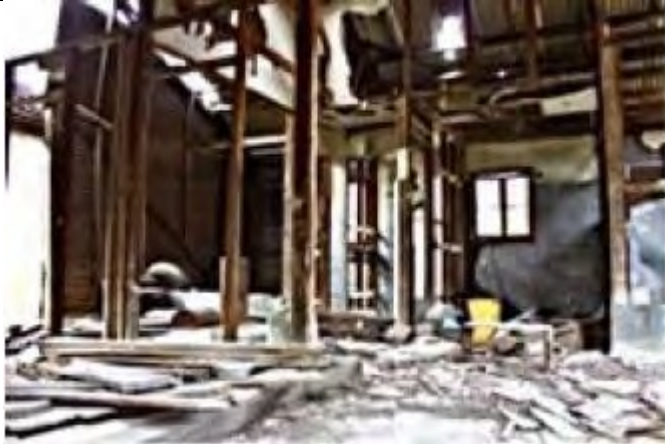
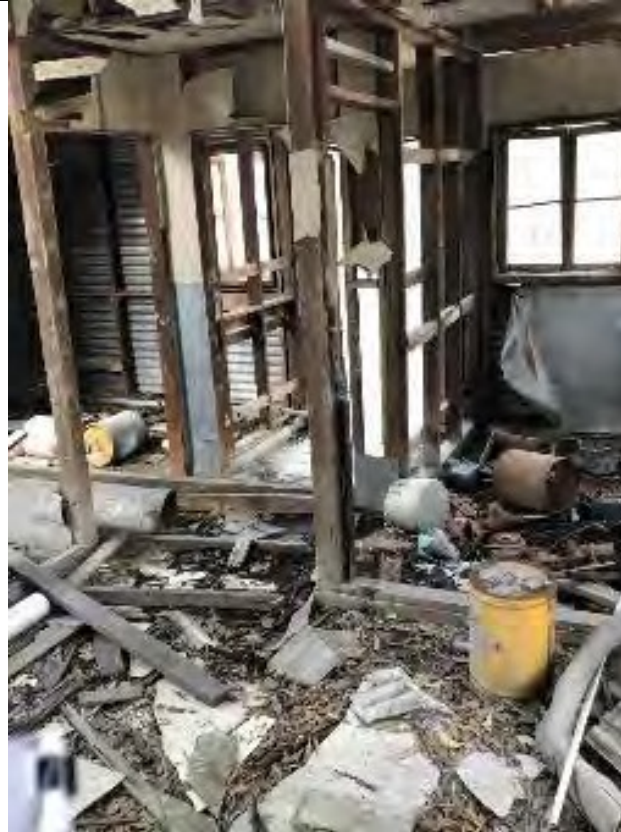
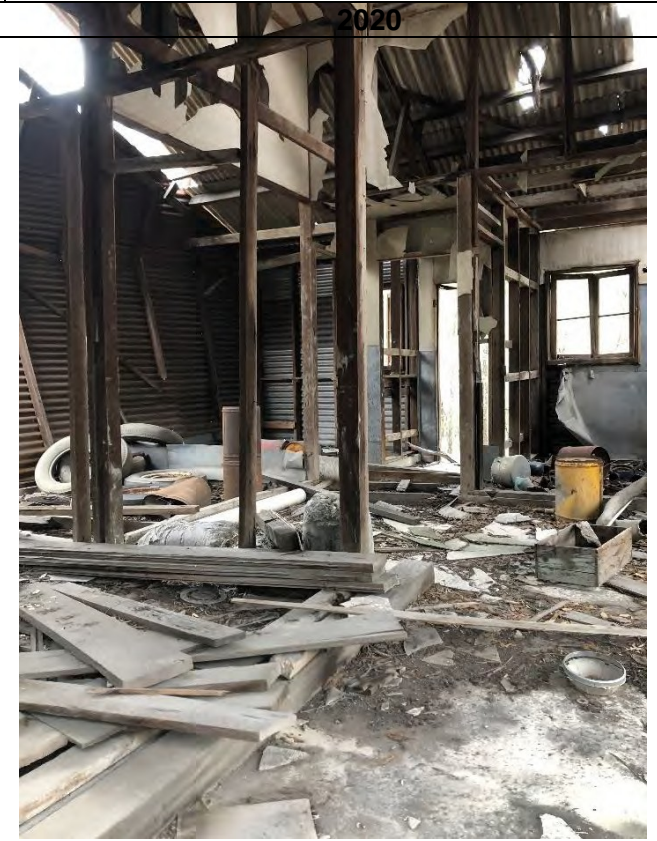
View to interior, showing west entry to building

2012-18: no discernible change.

2018-20: no discernible change.

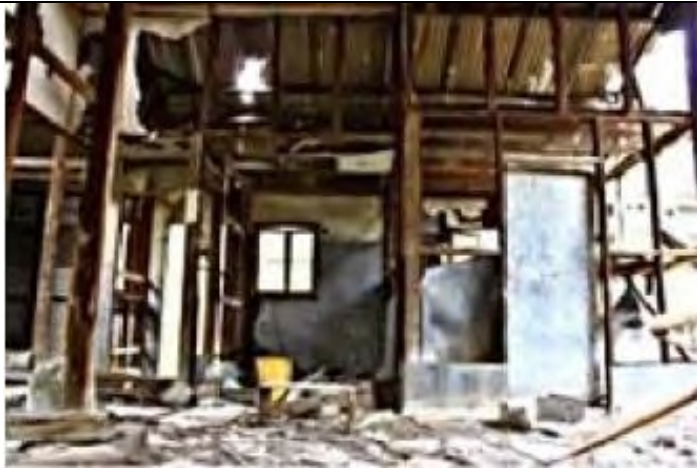
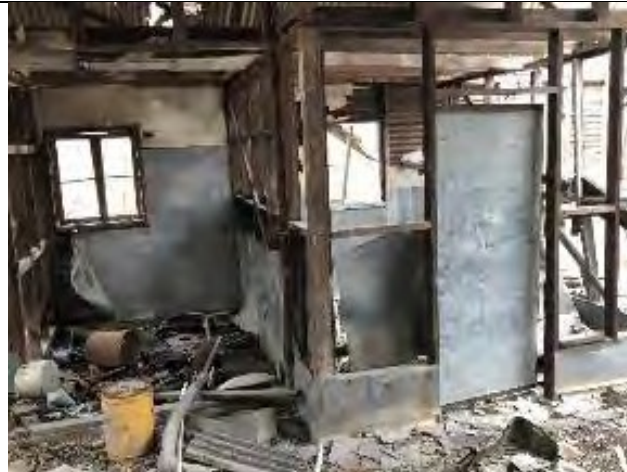
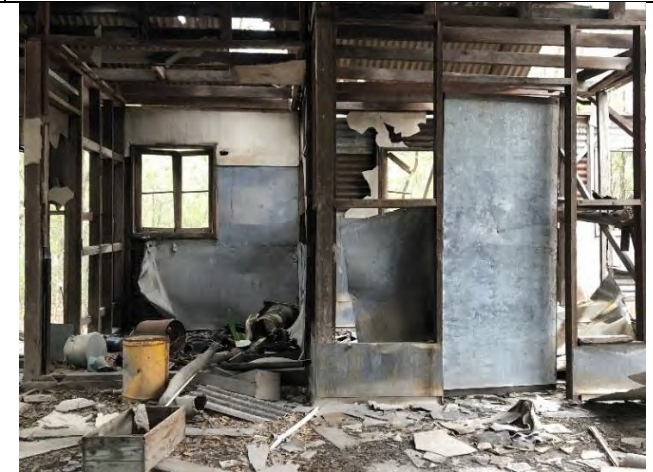
Showing west interior space
2012-18: no discernible change.
2018-20: no discernible change.

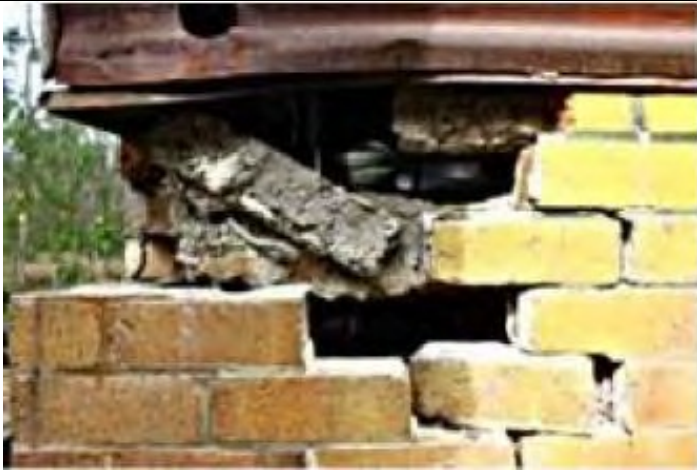
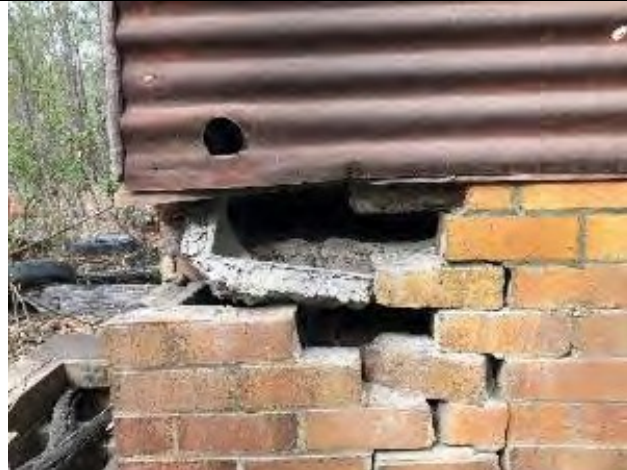
Detail of damaged brick foundation

2012-18: some further collapse of concrete/cement above brick foundation.

2018-20: some slumping outwards of corner brick foundation.

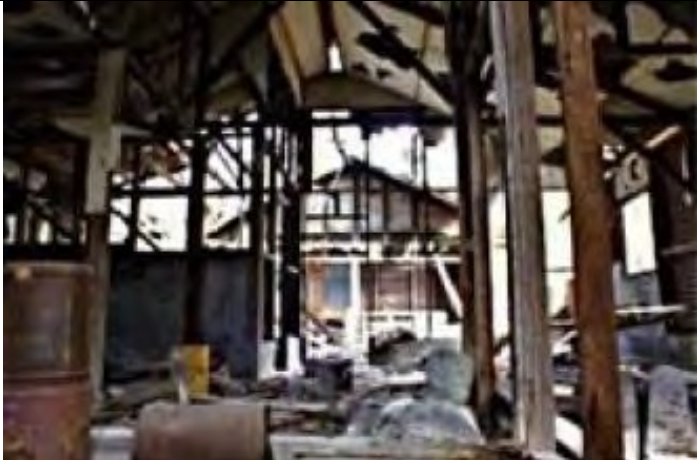
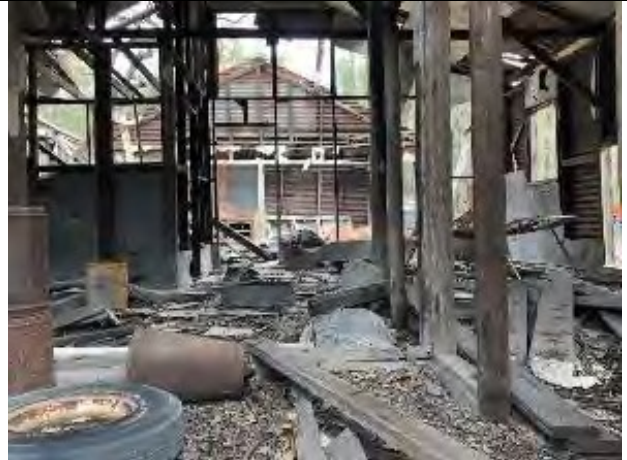
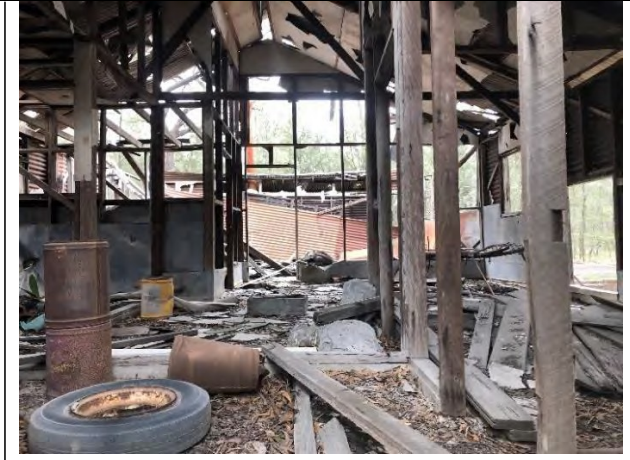
View to interior of building, looking north from south entry

2012-18: no discernible change.

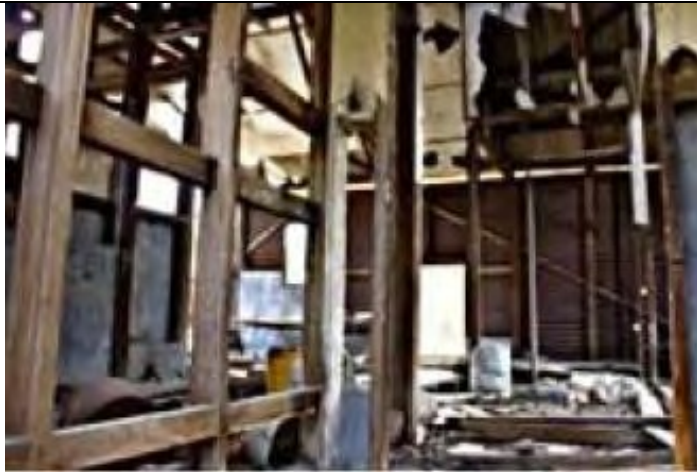
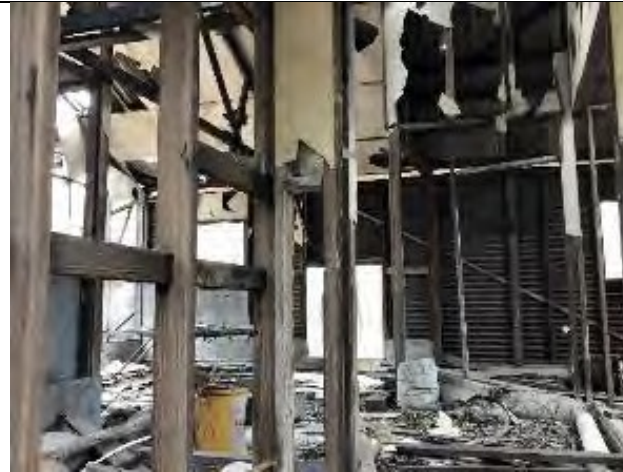
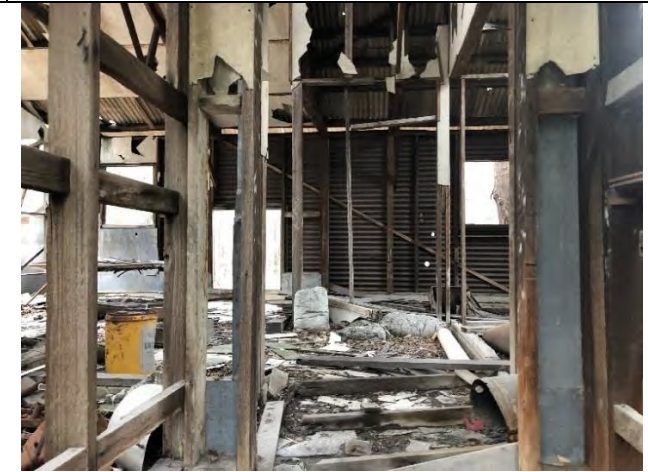
View to interior of building from entry at west

2012-18: no discernible change.

2018-20: no discernible change.

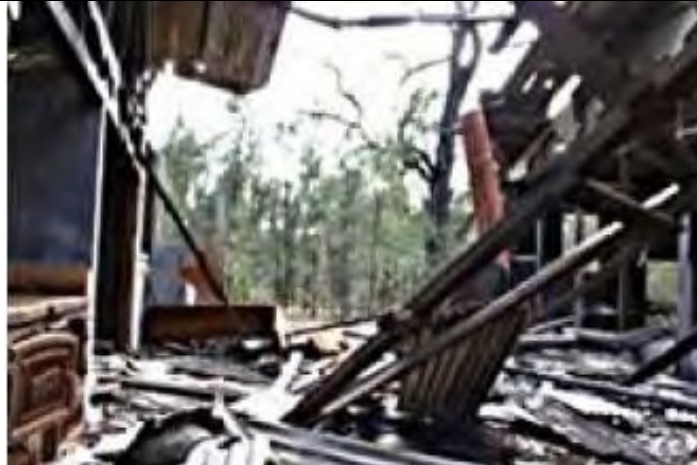
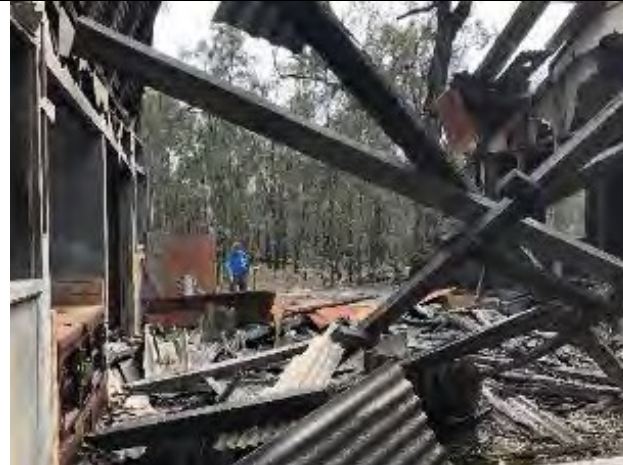
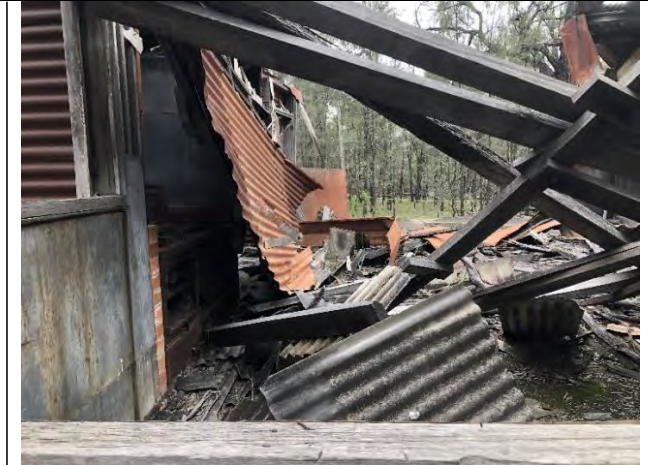
Showing interior of building, viewed from north-west corner

2012-18: shows collapsed roofing members above open kitchen area and accumulation of debris.

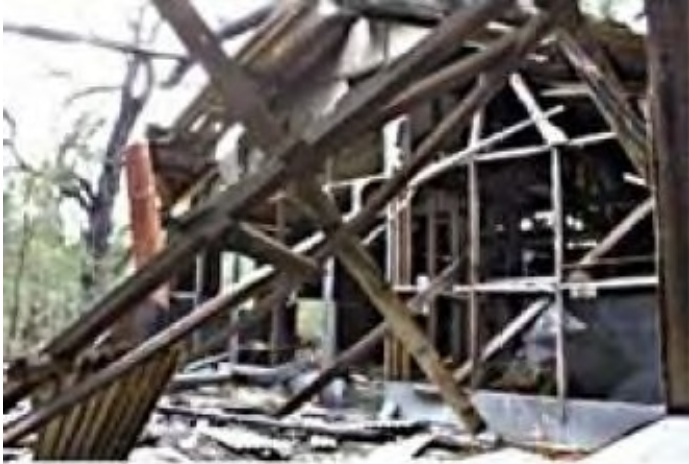
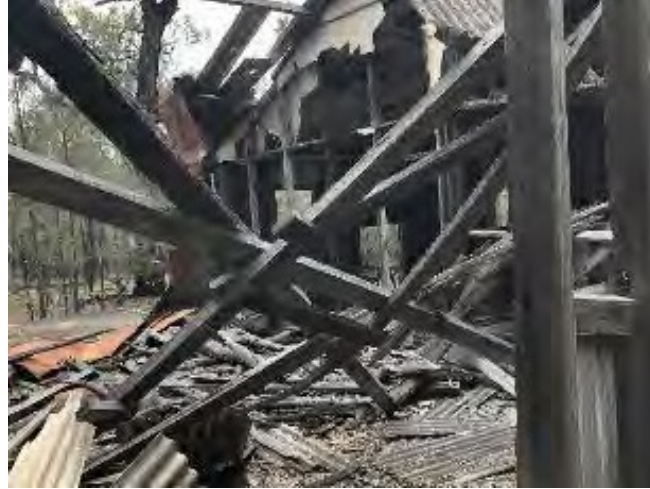
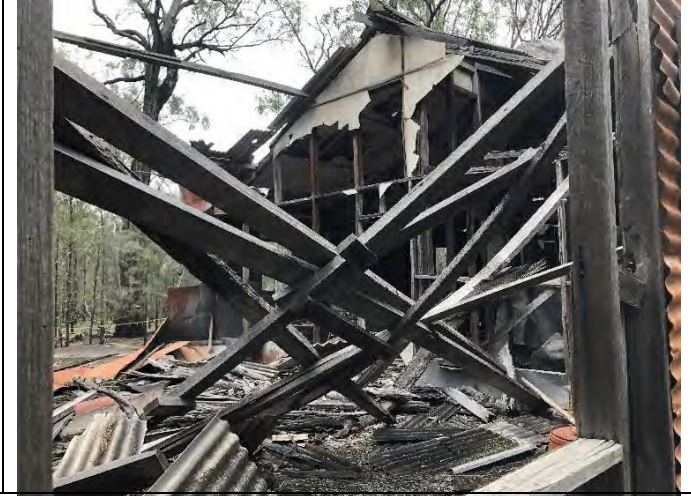
Showing interior of building, viewed from north-west corner

2012-18: shows collapsed roofing members above open kitchen area and accumulation of debris.

1. If not already conducted, have an asbestos expert assess and develop a clean up and disposal plan to deal with both the broken fragments and intact asbestos sheeting;
2. Remove any remaining tree branches from the roof. In addition, to prevent similar damage in the future, serious consideration should be given to removing or lopping those trees that are located close enough to the building that they may cause damage if they fall or drop large branches;

5. A structural engineer should then inspect the building before any further works are commenced to make further recommendations on stability requirements and structural repairs. These further works should aim to reduce the likelihood and extent of any further deterioration at the site rather than seek to rebuild or renovate as it is unlikely that there would be any valid or appropriate option to re-use the site; and

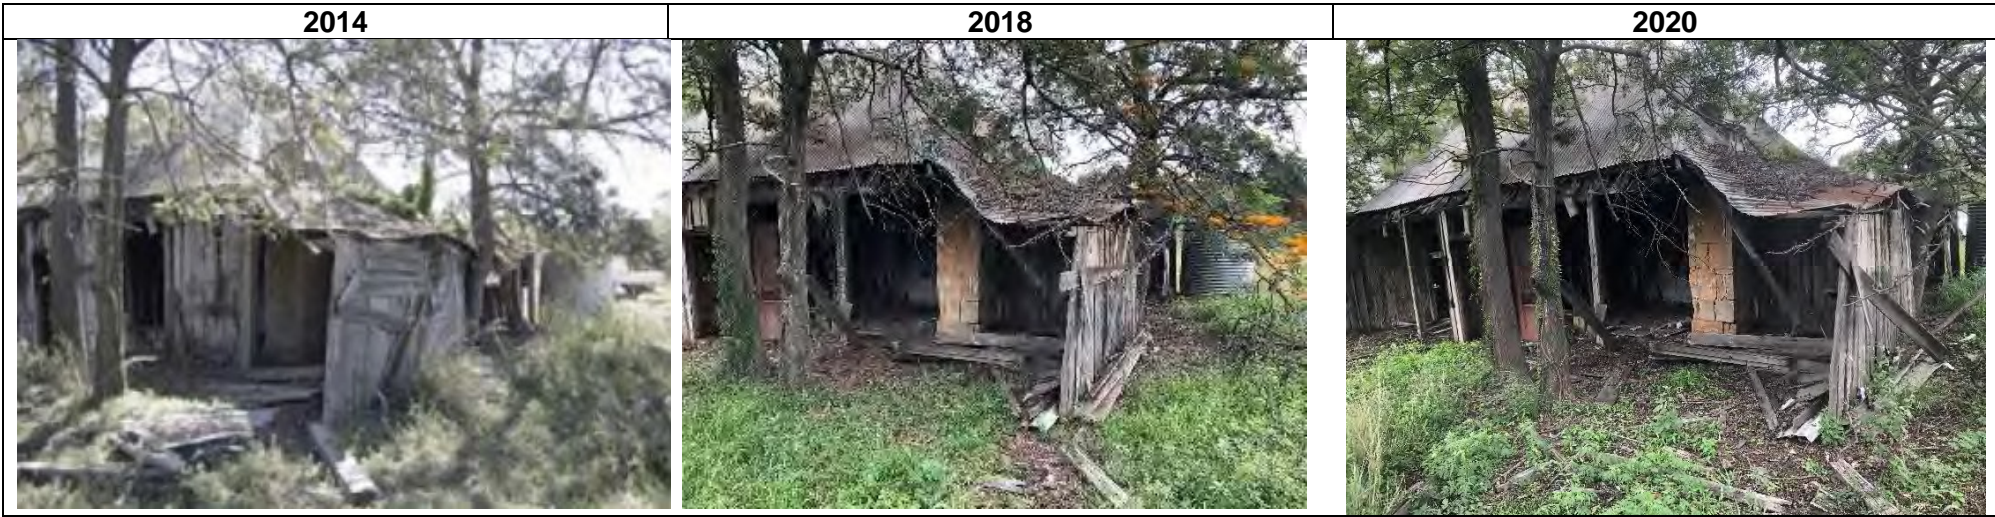
South-eastern corner

2014-8: vertical slabs have been removed causing further collapse of roof.

2018-20: further deterioration of eastern wall.

4. Due to the damage caused by the removal of the vertical slabs, once the items above are complete, a structural engineer should then re-inspect the building before any further works are commenced to make further recommendations on stability requirements and structural repairs; and

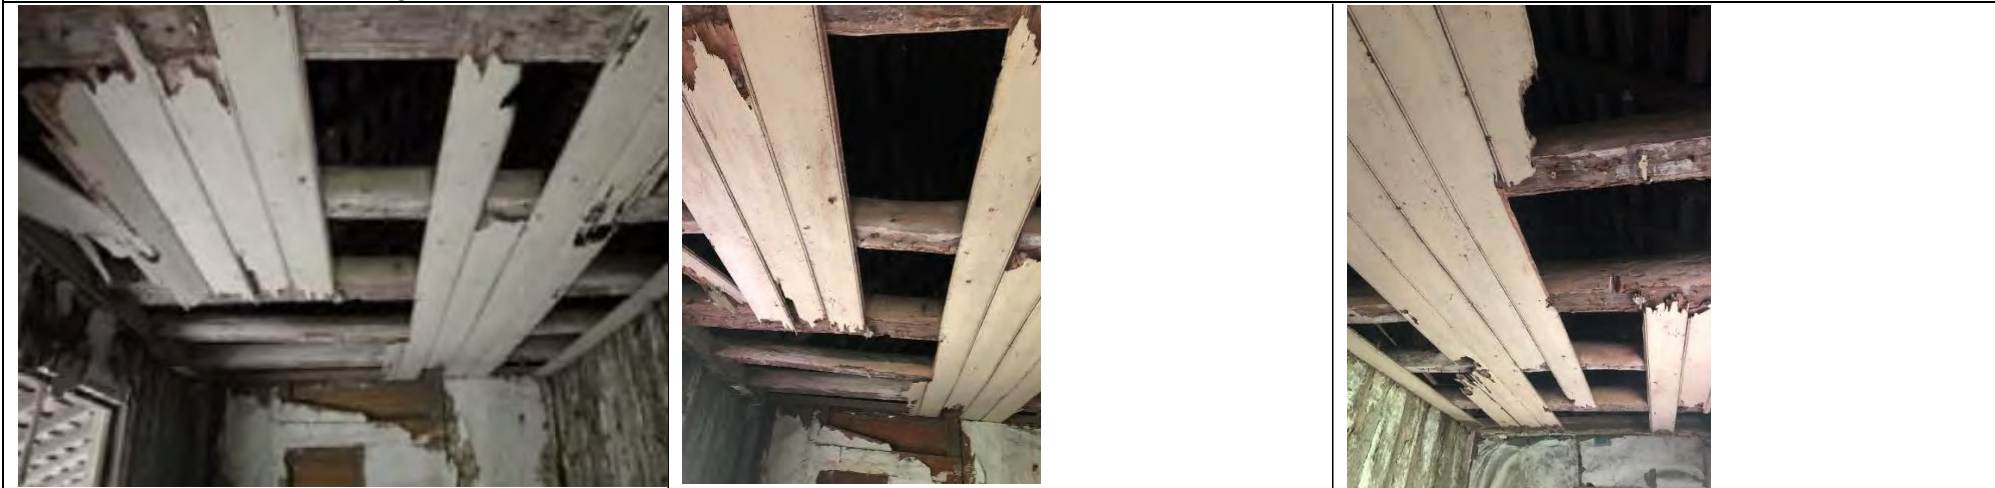
Room 4 ceiling

2014-8: no discernible change.
