Mount Thorley Warkworth Aboriginal Heritage Management Plan 2019 Compliance Audit Inspection

Report prepared for
Yancoal Australia, Mount Thorley Warkworth

March 2020

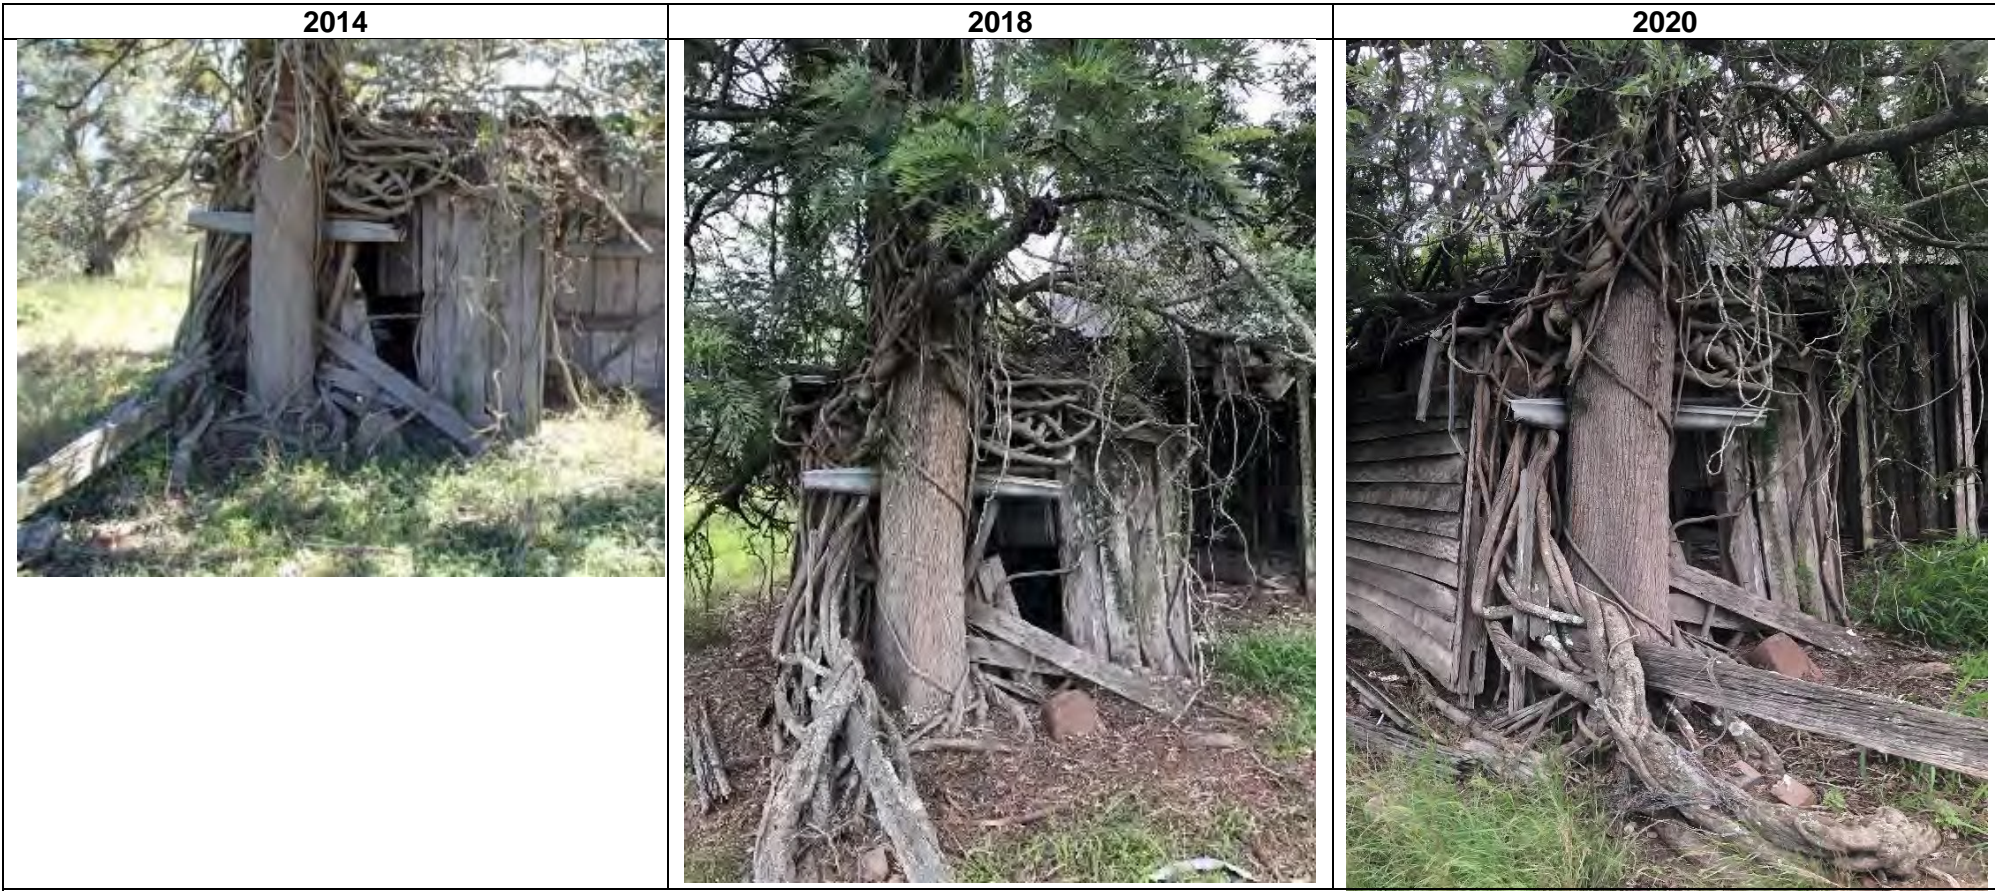
View of south-west corner from south

2014-8: shows removal of vertical slabs from southern wall as well as some increase in vegetation growth.

4. Due to the damage caused by the removal of the vertical slabs, once the items above are complete, a structural engineer should then re-inspect the building before any further works are commenced to make further recommendations on stability requirements and structural repairs; and

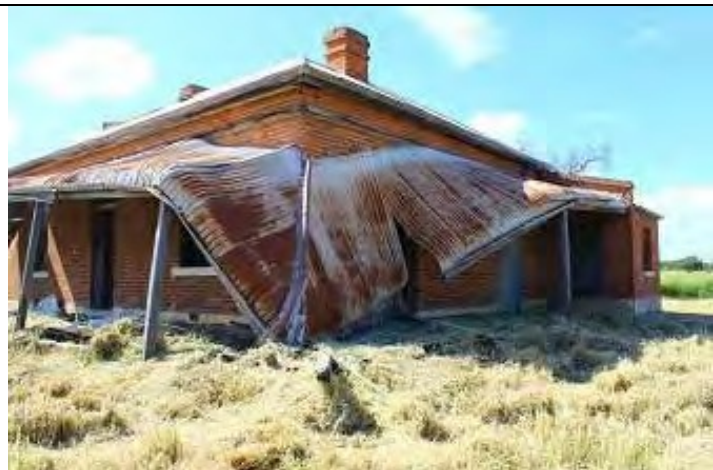
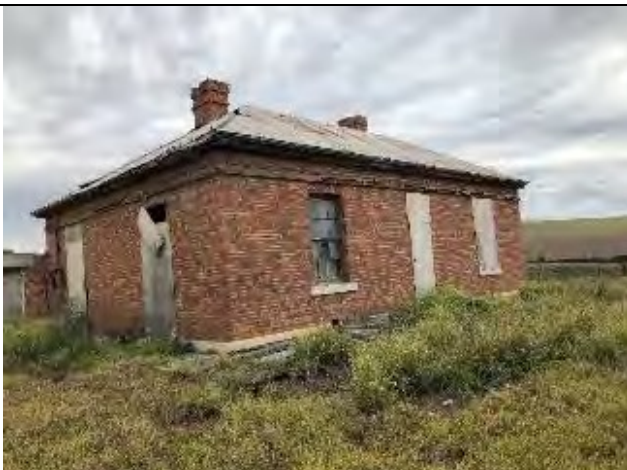
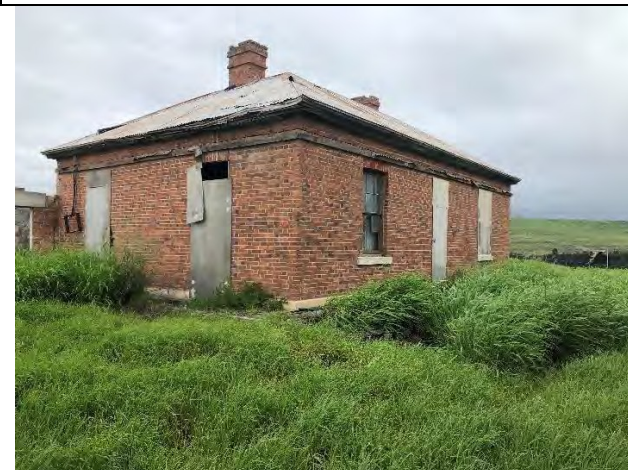
View of north-west corner (verandah focus)

2015-8: verandah removed and stored inside building

2018-20: no discernible change

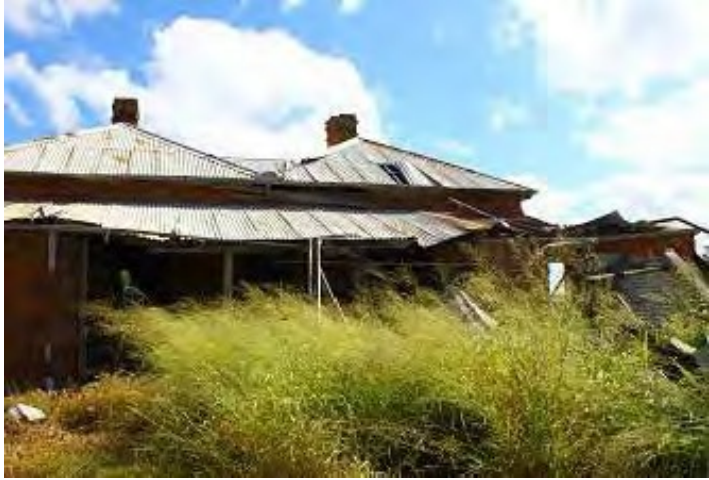
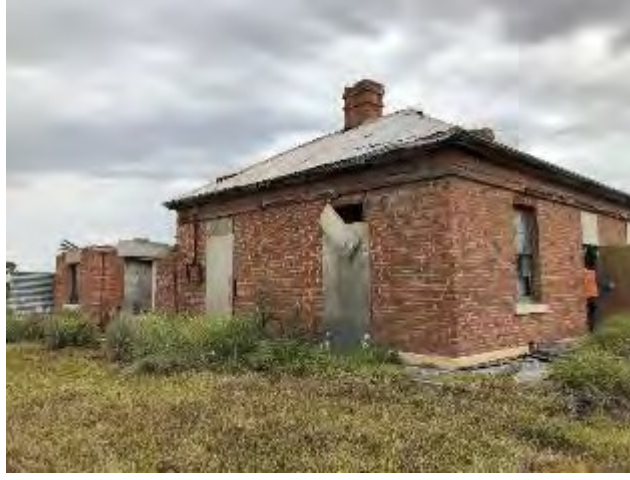
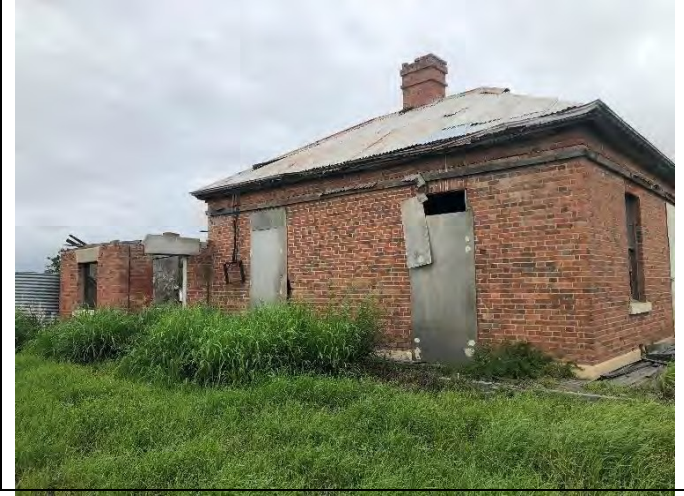
View of northern side (surrounding vegetation focus)

2015-8: grass vegetation slashed around building

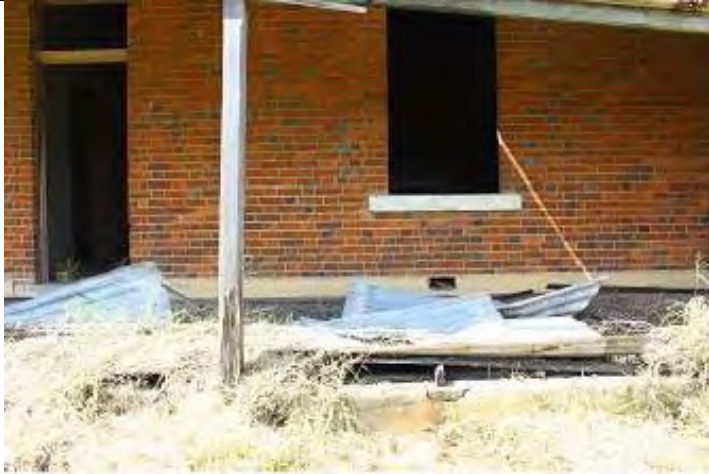
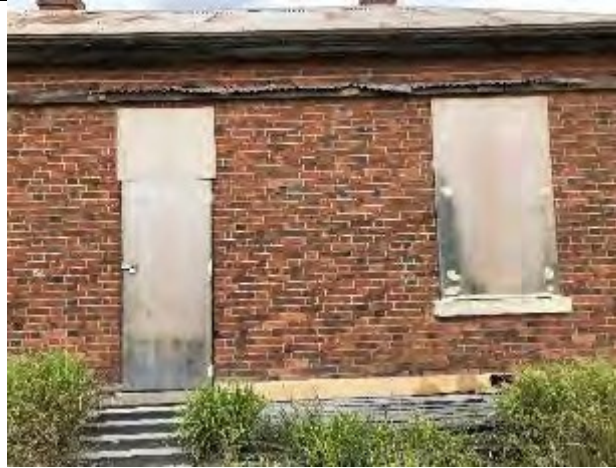
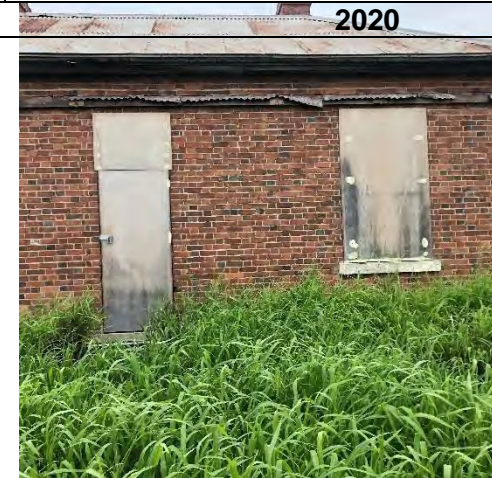
2018-20: vegetation has regrown around building

1. Implement a regular vegetation slashing and maintenance schedule for the building surrounds, ensuring all debris is clear from ground-level ventilation openings;
2. Replace any damaged plywood door/window coverings and ensure all coverings are tightly attached;
3. Patch fix any new damage to roofing sheets;
4. Implement a termite inspection regime and treat as required, giving consideration to removing the peppercorn trees surrounding the building;
5. If any asbestos or fibrous cement sheeting remains at the property, engage an asbestos removalist to remove as required;

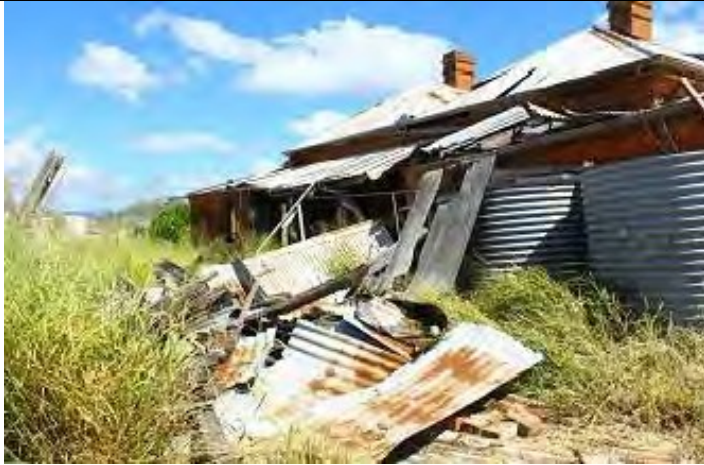
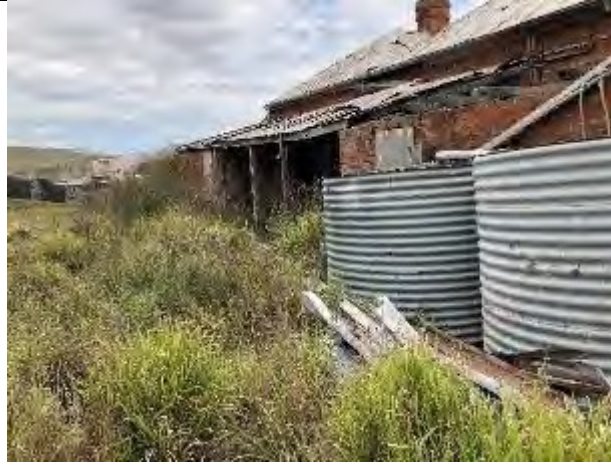
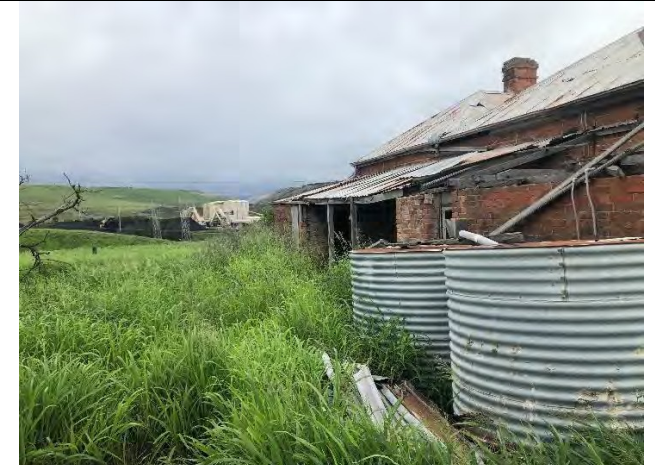
View of door and window panelling

2015-8: sheeting installed on all openings, however some repair required

2018-20: some repair of paneling required

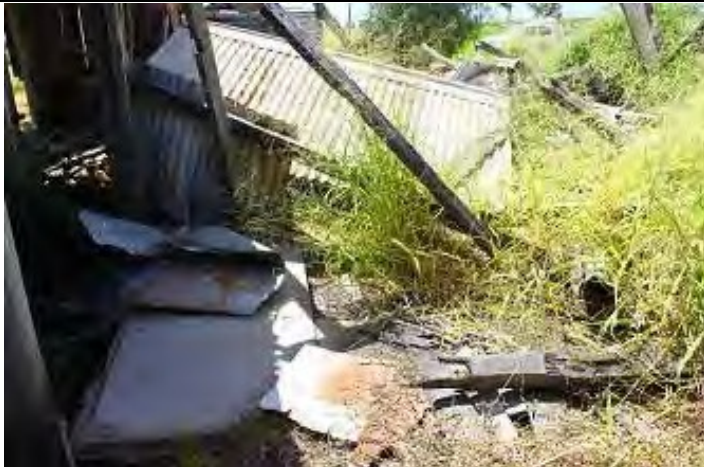
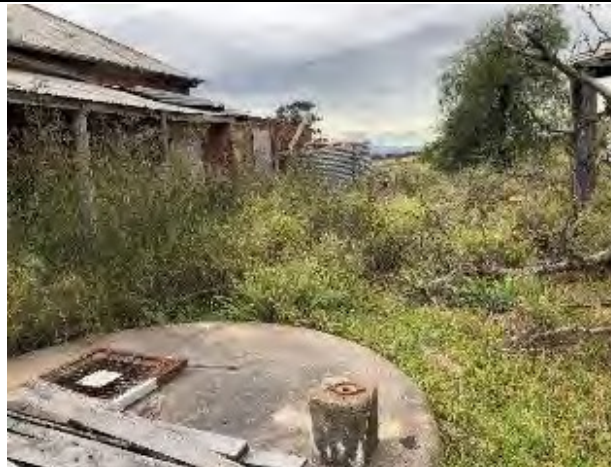
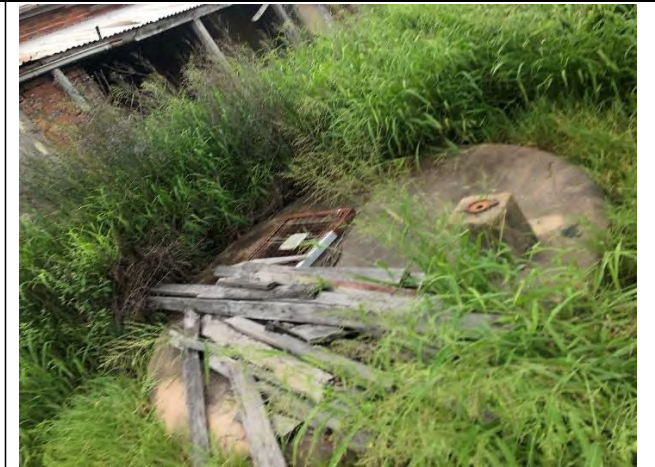
View of rear of building (focus on debris)

2015-8: debris has been cleared and stacked

2018-20: vegetation has regrown around building and stacked debris

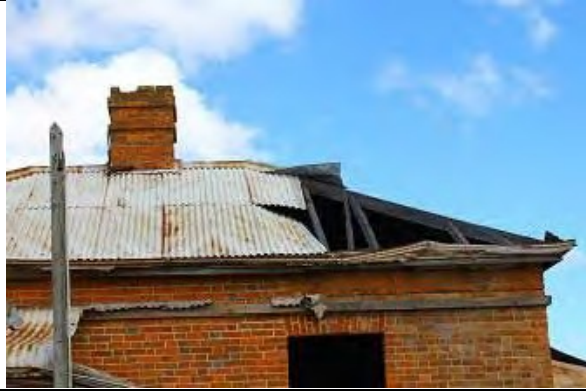
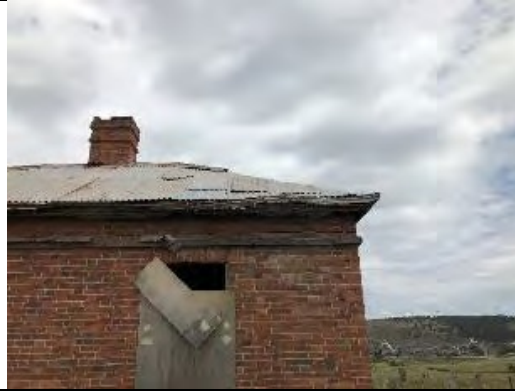
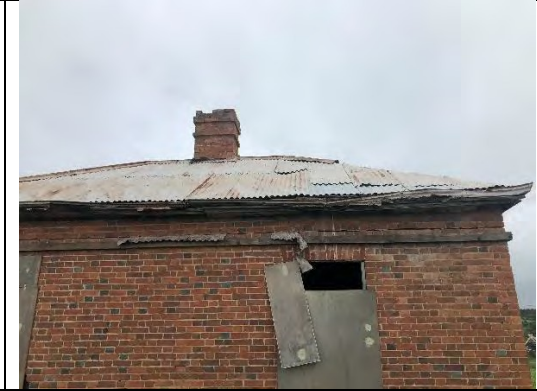
View of north-west roof corner (focus on damaged roof)

2015-8: roofing sheets have been replaced and holes patched

2018-20: some minor roof holes and lifted sheeting noted

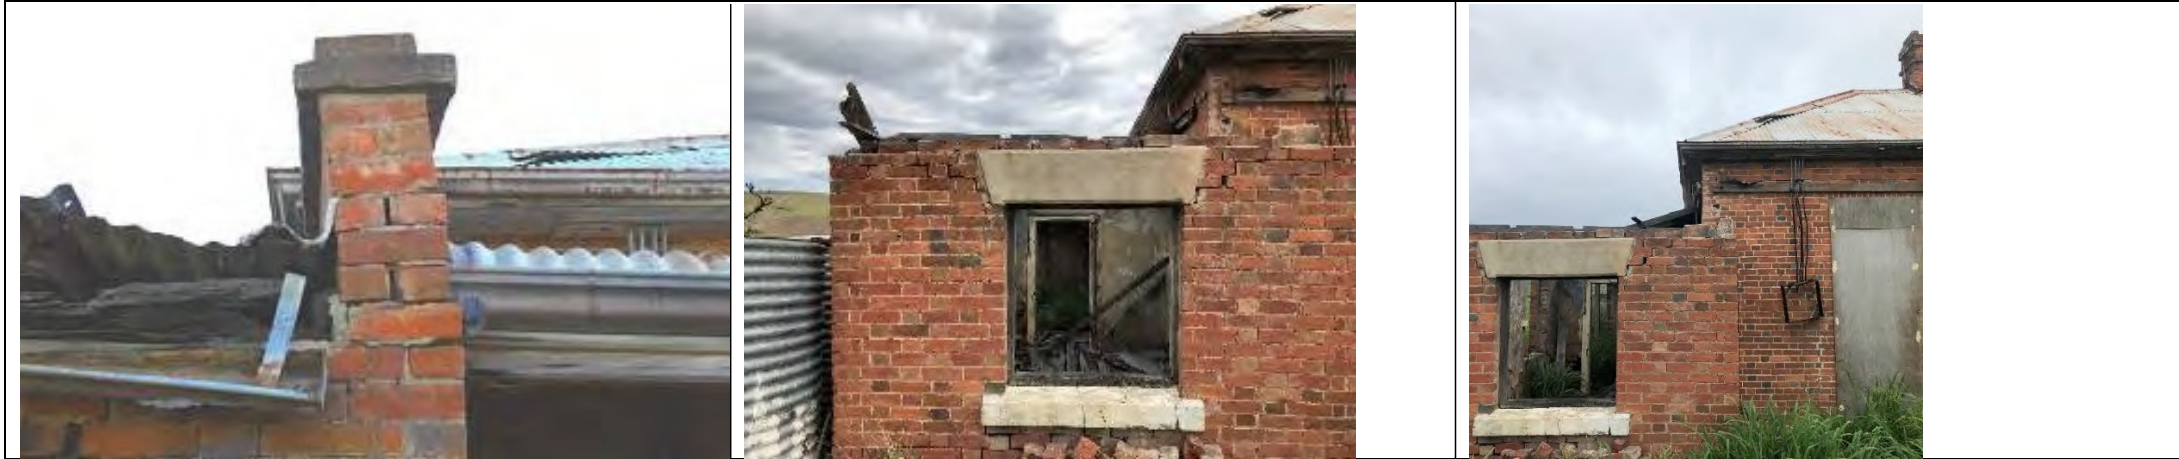
View of rear of building (focus on skillion roof)
2015-8: skillion roof and rafters have collapsed
2018-20: no discernible change

8. As the roof above Room 6 has collapsed, salvage any reusable masonry or timber and set aside within room. Engage a structural engineer to advise on feasibility of reconstructing the roof. (NB. Recommendation M9 in the CMP conservation works schedule erroneously refers to Room 5 rather than Room 6 as shown in the photograph);

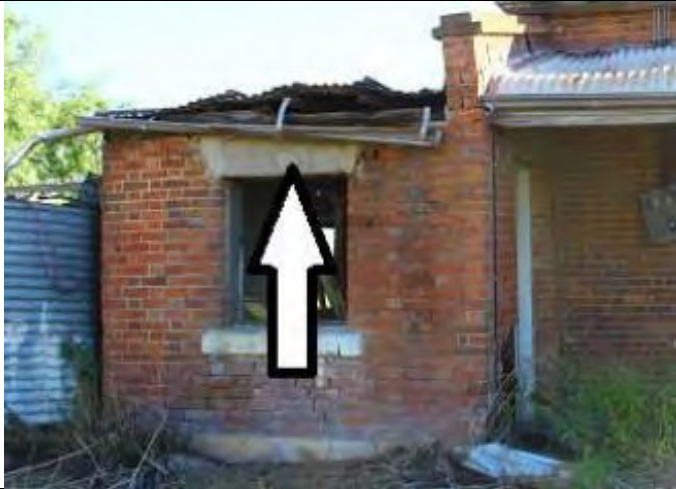
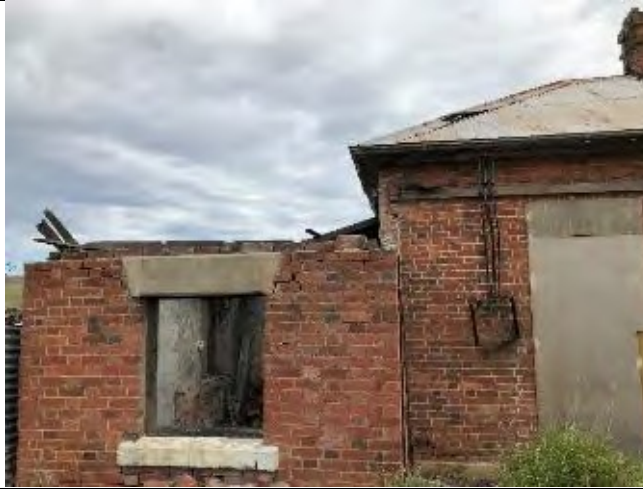
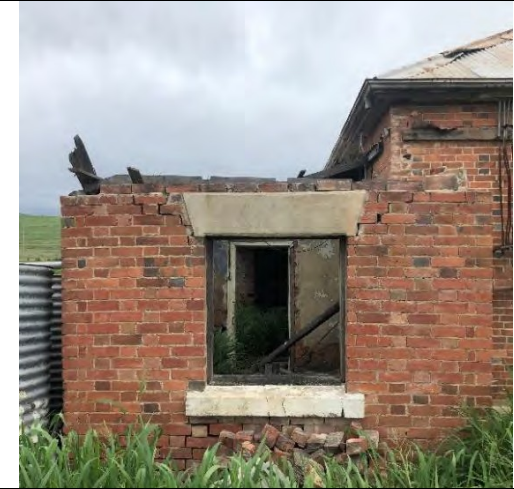
View of north-east of building (focus on skillion roof)
2015-8: roof framing, sheeting and guttering has collapsed
2018-20: no discernible change

9. Replace gutters around the house to match existing materials and ogee profile. Install new down-pipes and ensure they are discharging away from the building.

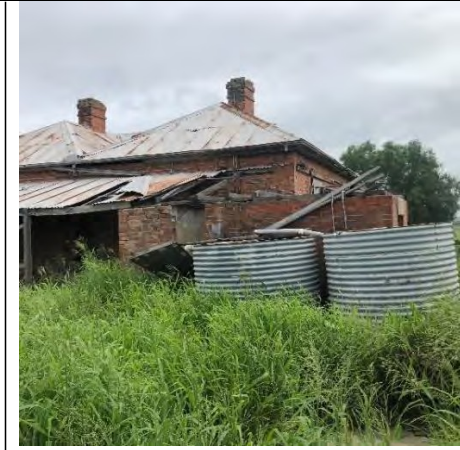
View of rear of building (focus on guttering)
2015-8: main roof holes repaired but northern section of skillion roof collapsed and guttering unchanged
2018-20: no discernible change, however vegetation regrowth evident

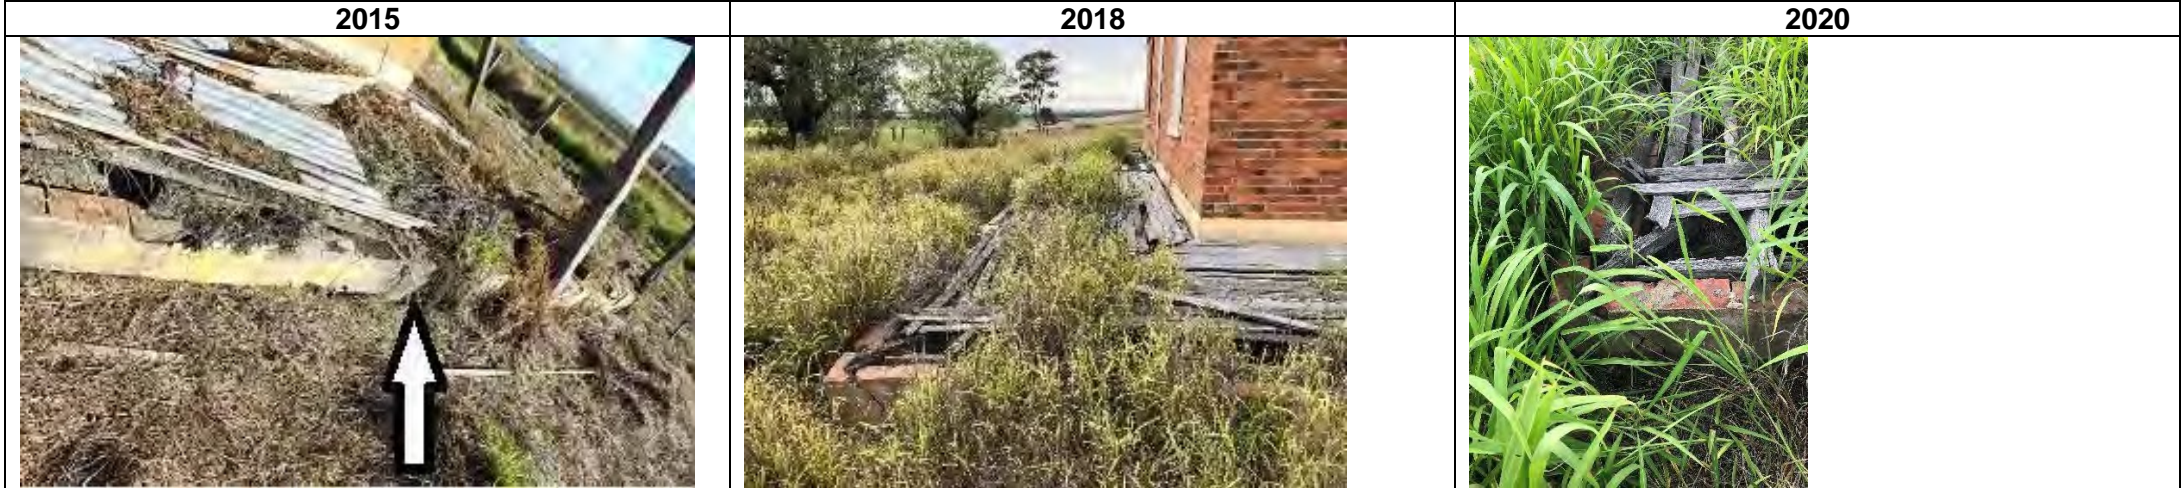
View of south-east of building (focus on top of wall)
 2015-8: no discernible change
 2018-20: no discernible change

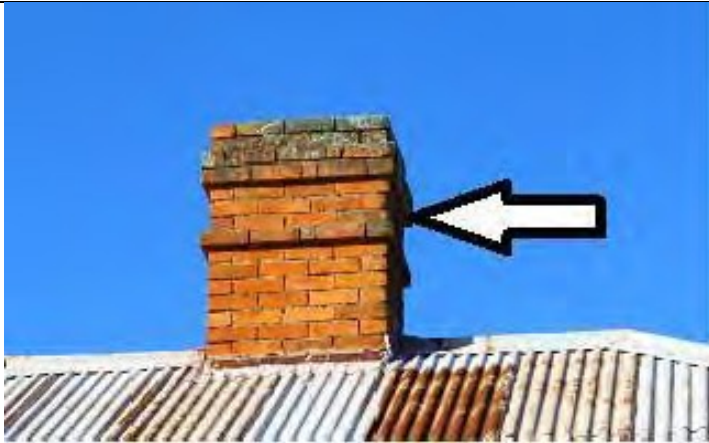
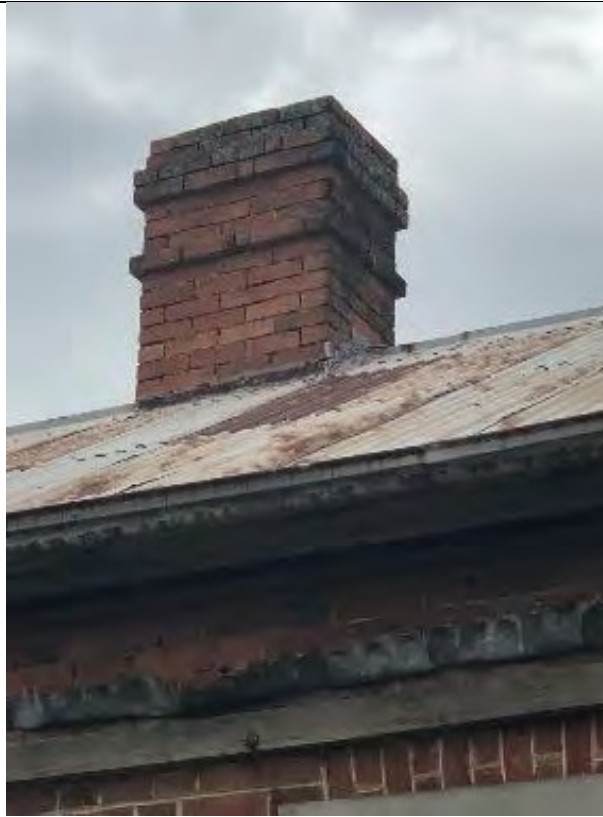
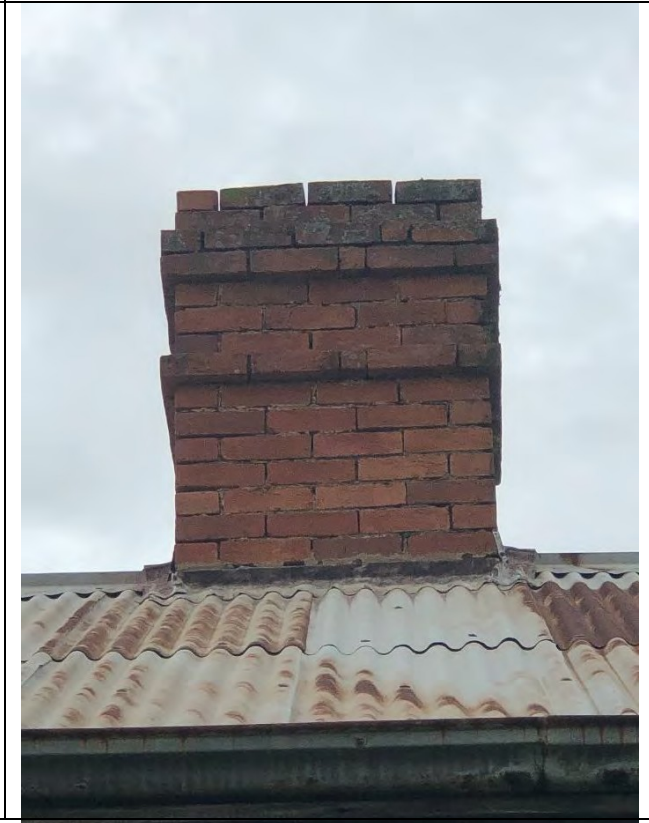
**View of southern chimney****2015-8:** no discernible change**2018-20:** no discernible change
