2019 STREAM HEALTH AND STABILITY REPORT

Mount Thorley Warkworth

SLR Ref: 630.12941-R01
Version No: -v0.2
March 2020

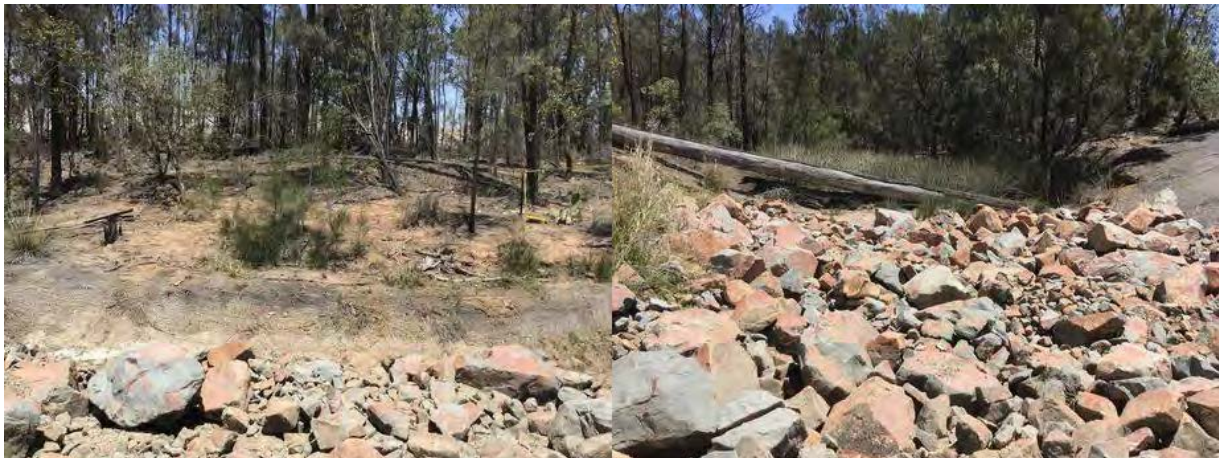
CSIRO Ephemeral Stream Assessment Classification – **Potentially Stabilising**

Plate 1 Right Bank

Plate 2 Upstream

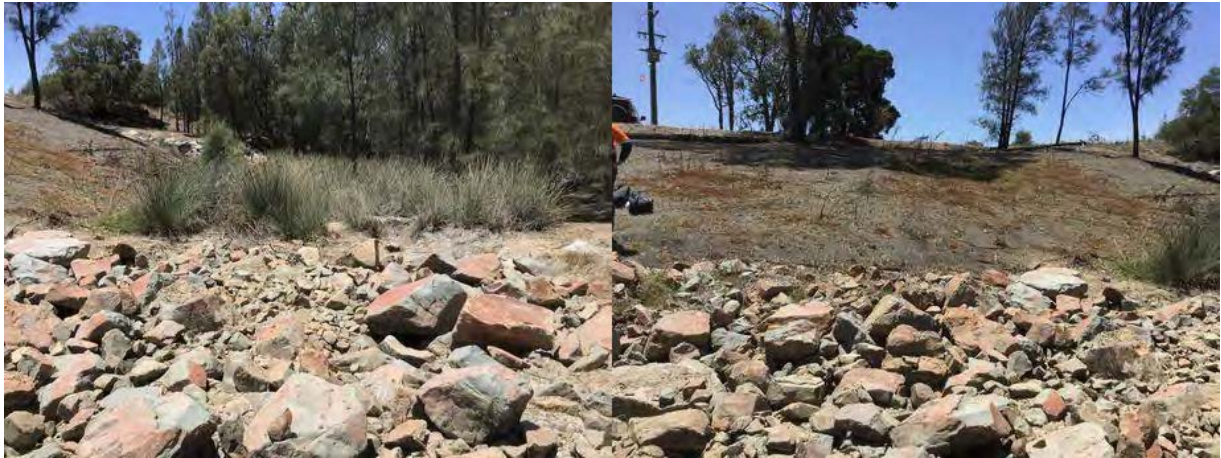
Plate 3 Downstream

Plate 4 Left Bank

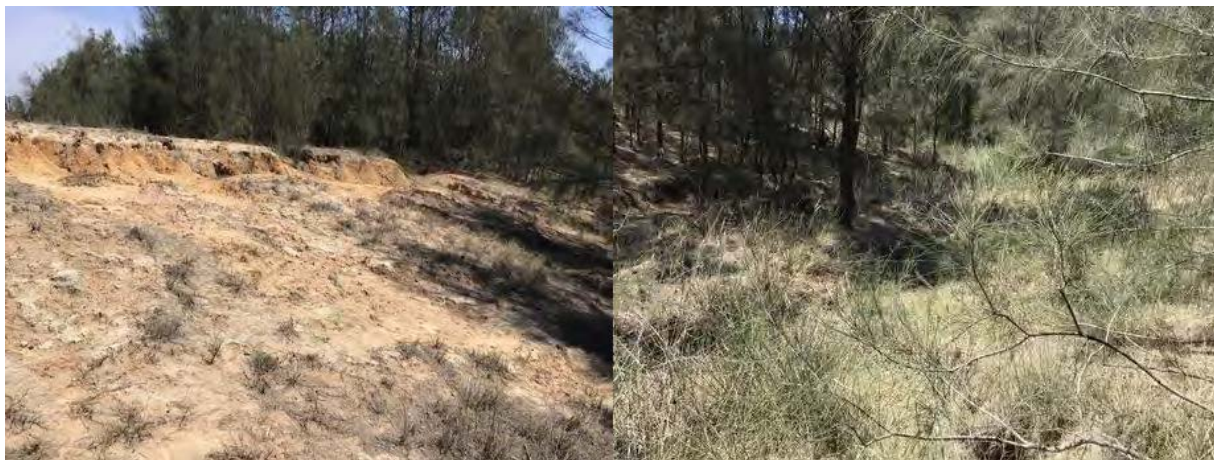
The channel at this location was observed to have a good coverage of long grass across the bed. The left bank also appears stable with good grass coverage. The right bank contains some lateral erosion (approximately 0.5m

high) at the top of the bank. The lateral erosion is forming some rill/gully erosion down this bank, however the rest of the right bank appears to be stable with good grass coverage. Overall, this location shows similar conditions to the previous monitoring cycle.

CSIRO Ephemeral Stream Assessment Classification – **Active**

Plate 5 Right Bank

Plate 6 Upstream

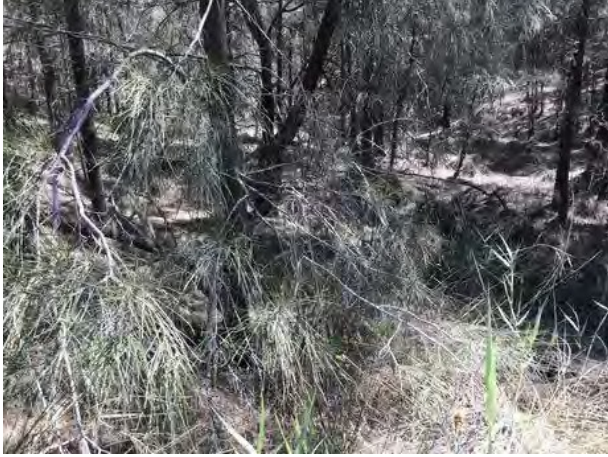
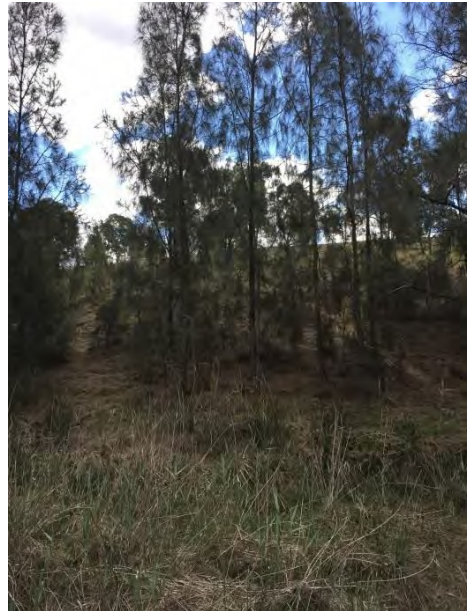
Plate 7 Downstream Plate 8 Left Bank

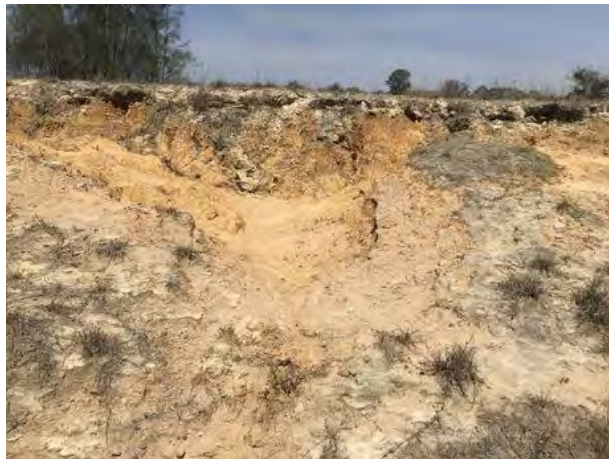
Plate 9 Erosion (top of right bank)

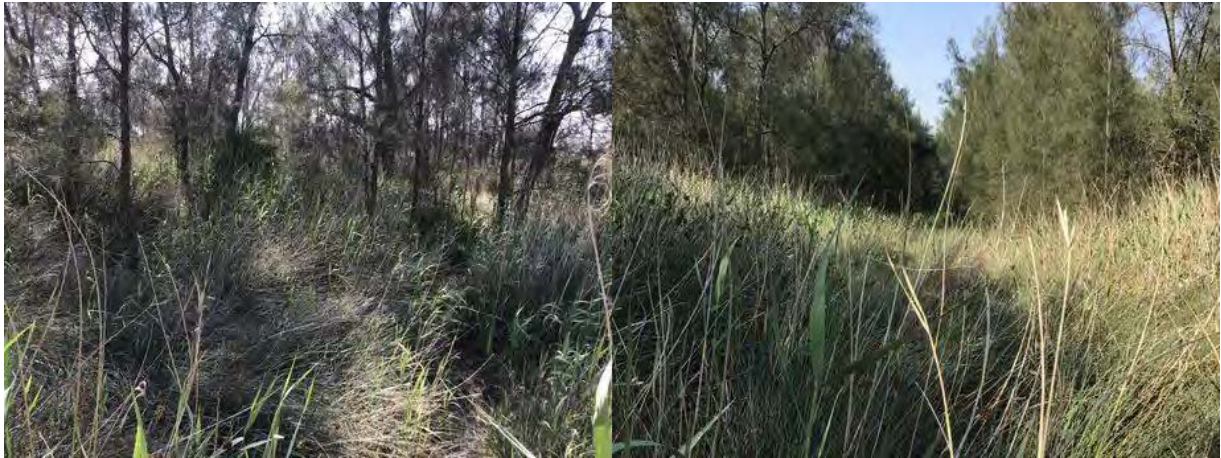
CSIRO Ephemeral Stream Assessment Classification – **Stable**

Plate 10 Right Bank

Plate 11 Upstream

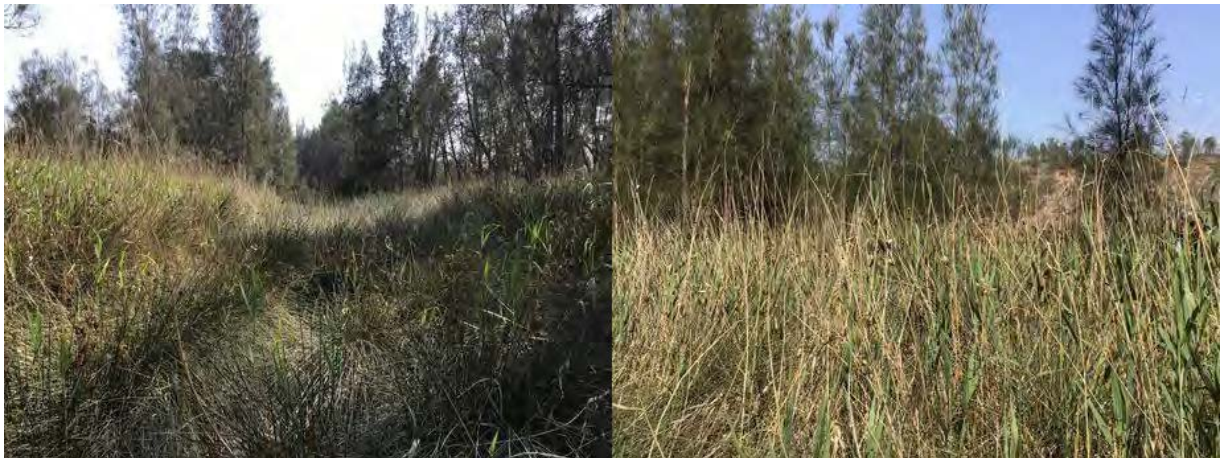
Plate 12 Downstream

Plate 13 Left Bank

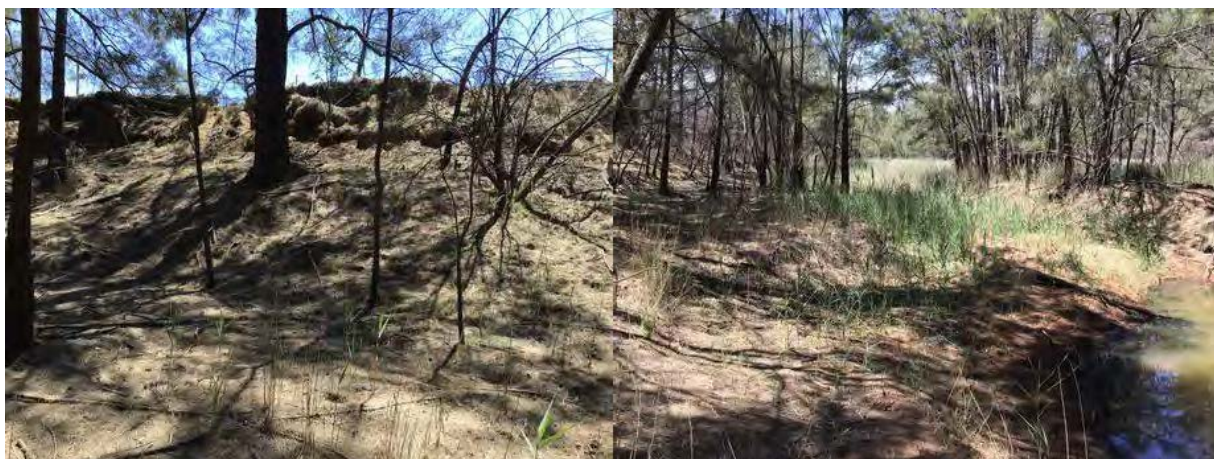
CSIRO Ephemeral Stream Assessment Classification – **Potentially Stabilising**

Plate 14 Right Bank

Plate 15 Upstream

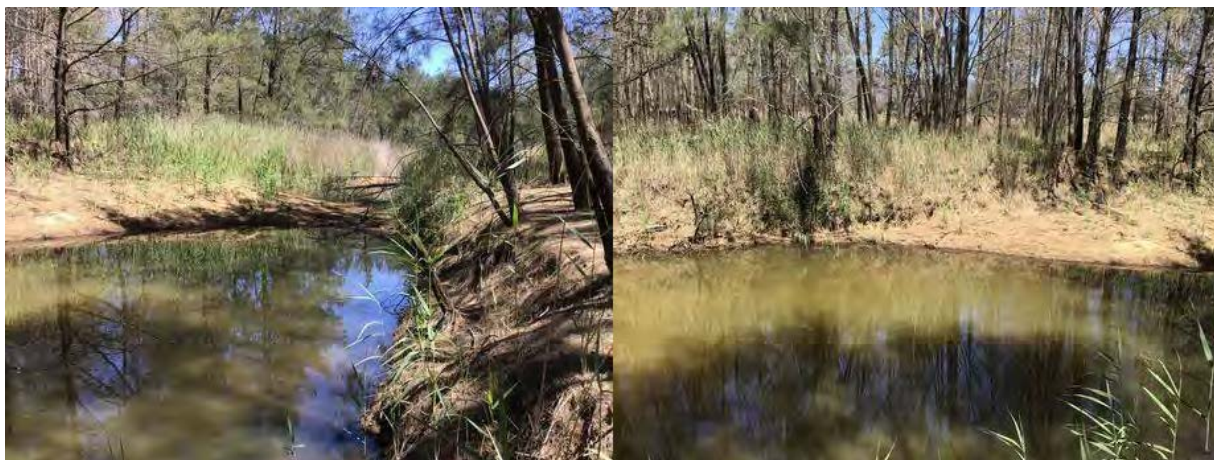
Plate 16 Downstream

Plate 17 Left Bank

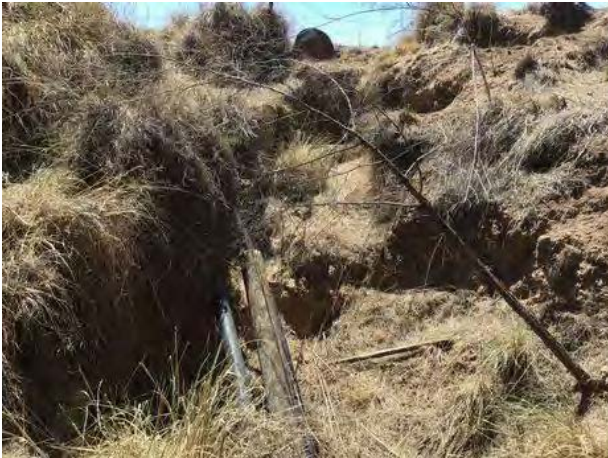
Plate 18 Erosion

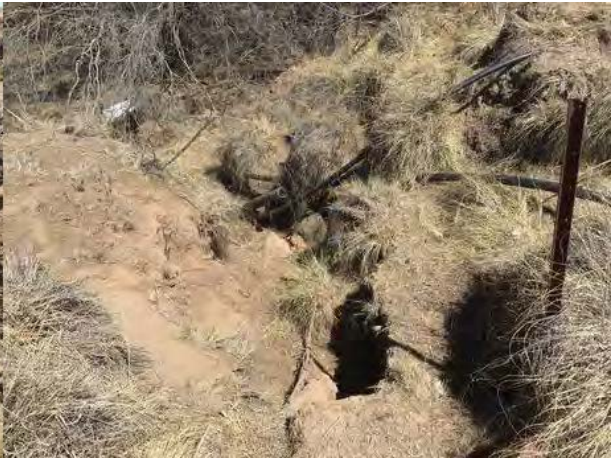
Plate 19 Erosion

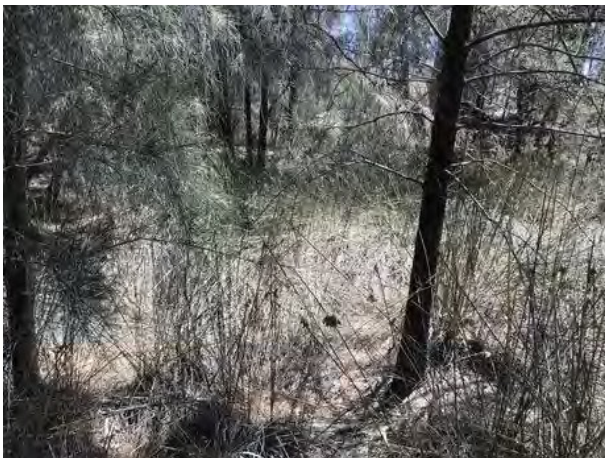
The erosion observed at LC2 included a steep near vertical section of exposed dispersive material (approximately 2m high) on the right bank. This area appeared to be actively eroding including some areas immediately downstream. However, this monitoring location appears to be similar to what was observed in the 2018 survey. A tree was observed to have fallen over at this section of the exposed creek bank. The creek bed and left bank appear to be stable at this location.

CSIRO Ephemeral Stream Assessment Classification – **Active**

Plate 24 Upstream

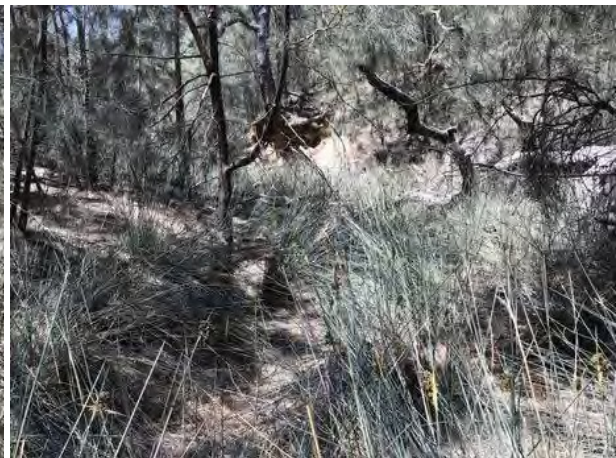
Plate 25 Downstream

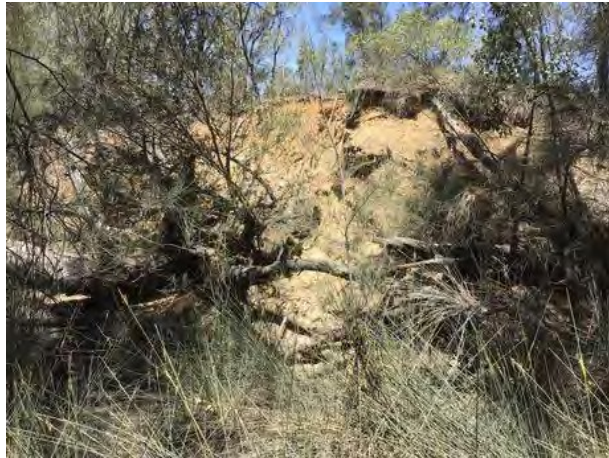
Plate 26 Erosion

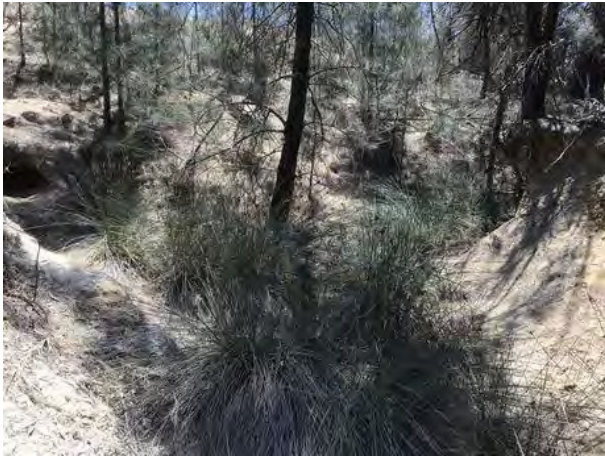
CSIRO Ephemeral Stream Assessment Classification – **Very Active**

Plate 29 Erosion

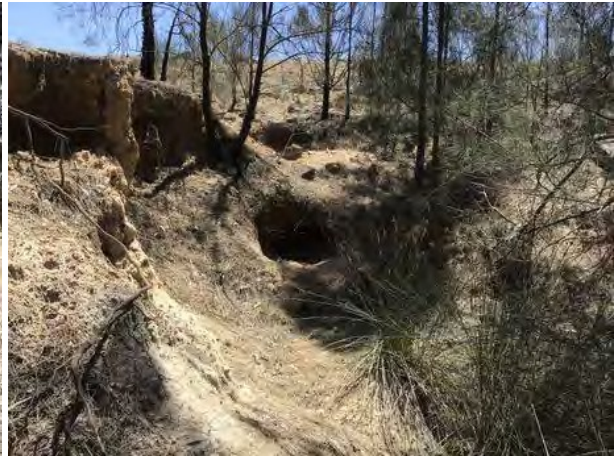
Plate 30 Tunnel Erosion

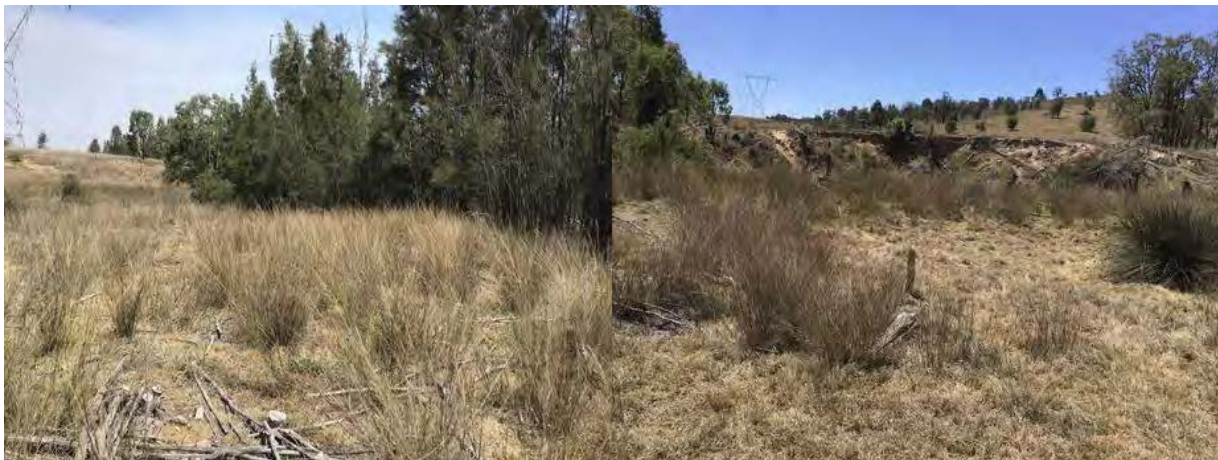
LC4 is located under a powerline in an area where it appears that vegetation has been maintained within the powerline easement. The near vertical left bank on the outside of the creek meander is about 4-5m high and has some exposed dispersive material (approximately 1m high) near the top of the bank however this erosion has shown signs of potentially stabilising. The right bank is much flatter and appears to be stable, as does the creek bed. Overall, this monitoring location has shown similar conditions to the previous monitoring cycle.

CSIRO Ephemeral Stream Assessment Classification – **Potentially Stabilising**

Plate 31 Right Bank

Plate 32 Left Bank

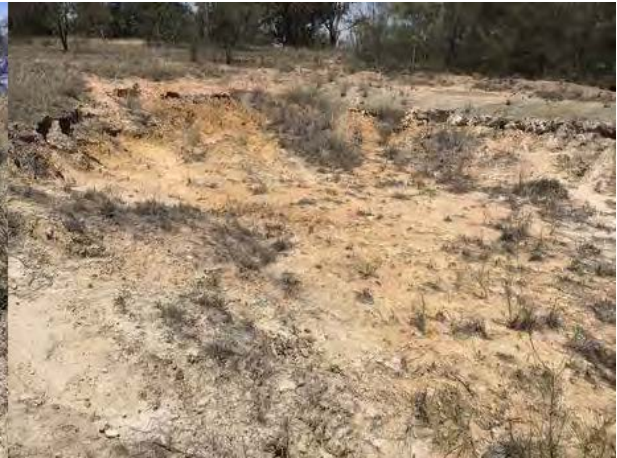
LC5 is located in a historic diversion of Loders Creek. The erosion observed at LC5 included erosion extending up the right bank approximately 20-30m. The area has 0.5-1.0m high steep exposed walls surrounding 5m of exposed soil. The creek bed and left bank appear to be stable. Overall, this monitoring location has shown similar conditions to the previous monitoring cycle.

CSIRO Ephemeral Stream Assessment Classification – **Active**

Plate 37 Erosion (top of right bank)

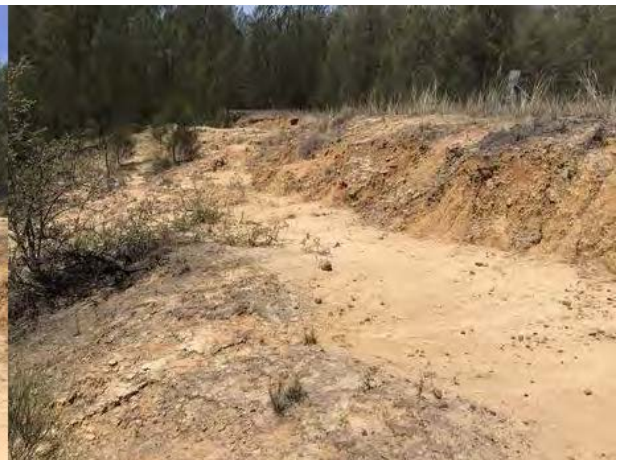
The erosion observed at LC6 included significant lateral erosion near the top of the right bank. This erosion was approximately 1m high with an alluvial fan extending approximately 2m from the near vertical bank. The rest of the right bank appears to be stable as does the creek bed and the left bank. Overall, this monitoring location appears similar to the previous monitoring cycle. The active erosion appears to be primarily the result of a historic disturbance of the top of the right bank which has exposed the highly dispersive soils at this location.

CSIRO Ephemeral Stream Assessment Classification – **Active**

Plate 39 Erosion

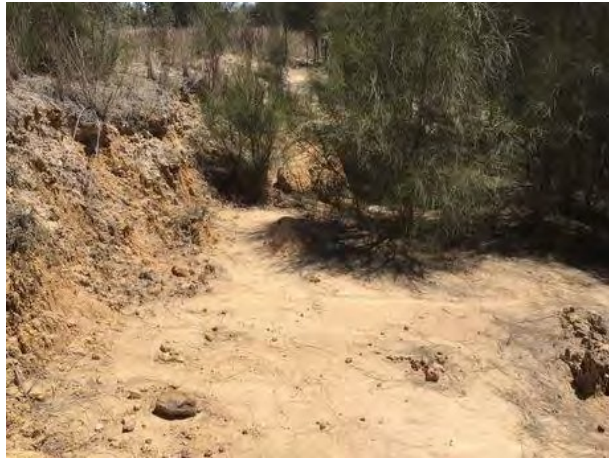
Plate 40 Erosion

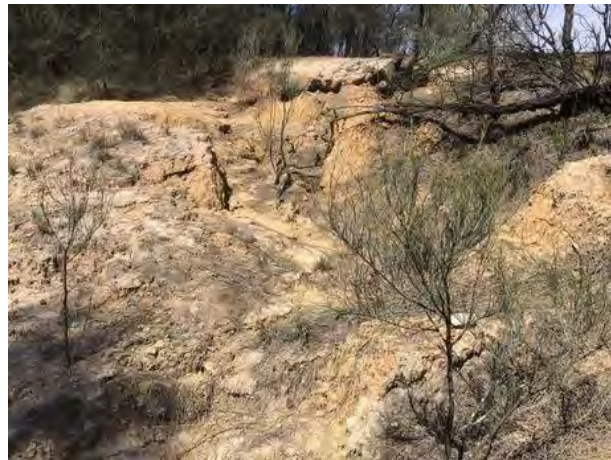
The erosion observed at LC7 included an area of active erosion of a steep comprising exposed dispersive clay material (approximately 0.8m high) on the right bank, however this erosion is not laterally extensive. The erosion appears to have been caused by lateral flow across the bare banks in the area. The right bank appears to be stable downslope of the eroded area, as does the creek bed and the left bank. Overall, this monitoring location has shown similar conditions to the previous monitoring cycle.

Plate 45 Erosion

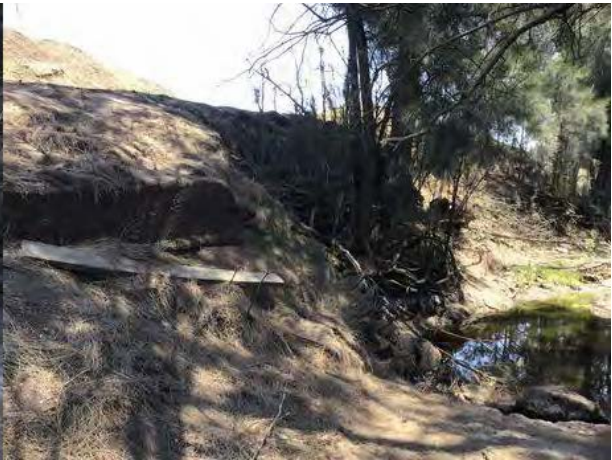
Plate 57 Left Bank

The erosion observed at LC8 included significant erosion of the left bank (approximately 0.8m high with the overall bank at approximately 2.5m high) at a location with a slight meander in the creek as shown on Plate 57. The erosion has some minor undercutting with a section of vertical banks partly stabilised by tree roots. The soil appears to be alluvial and not particularly dispersive. Trees at this location are at risk of falling over due to loss of support. The creek bed and right bank appear to be stable. Overall, this monitoring location has shown similar conditions to the previous monitoring cycle.

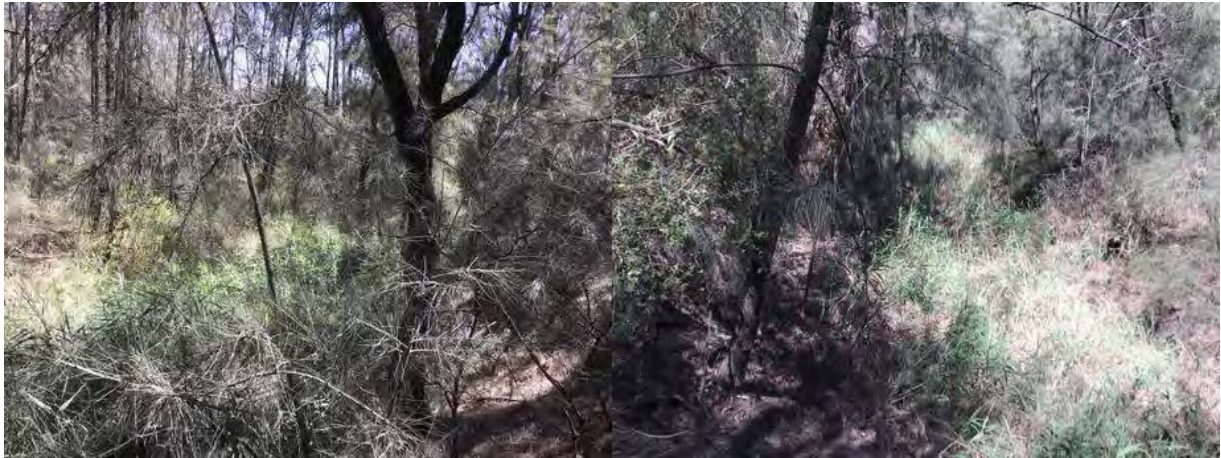
Plate 58 Upstream

The erosion observed at LC11 includes some significant tunnelling and active erosion on the left bank with exposed vertical dispersive soil. Potential causes for this erosion include wombat holes as well as the presence of a contour bank overflow (which is located immediately upslope of the erosion). Trees were observed on both banks and creek bed. The creek bed and the right bank both show stable conditions. Overall, this monitoring location has shown similar conditions to the previous monitoring cycle.

CSIRO Ephemeral Stream Assessment Classification – **Active**

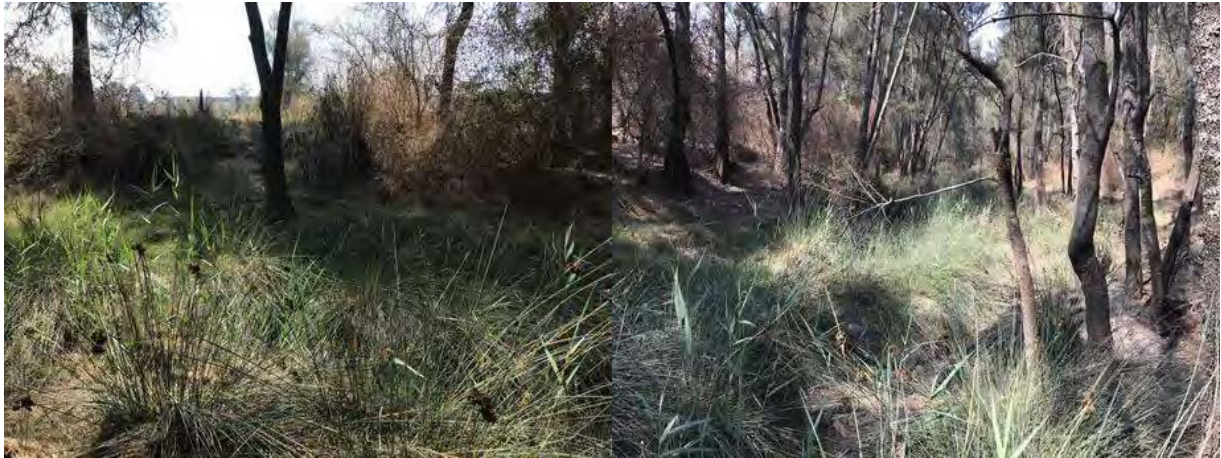
Plate 62 Right Bank

The erosion observed at LC12 includes some erosion (approximately 2m high) on the left bank with exposed vertical dispersive soil. It is likely that this erosion was at least partially caused by a fallen tree at the monitoring point location. The left bank at the monitoring point is significantly higher than the right bank. The creek bed and the right bank both show stable conditions. Overall, this monitoring location has shown similar conditions to the previous monitoring cycle.

CSIRO Ephemeral Stream Assessment Classification – **Potentially Stabilising**

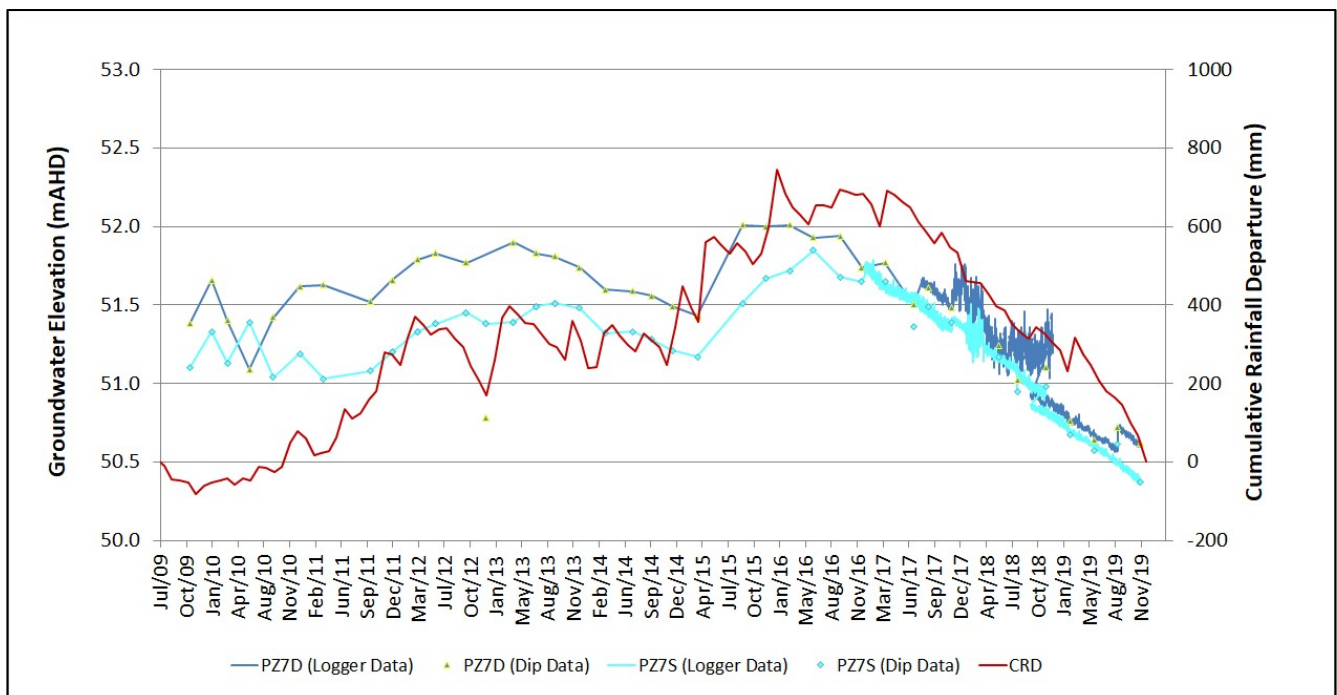
Figure 6-2 Groundwater Levels – Warkworth Sands Bore PZ7S and PZ7D

Bore PZ7 is a nested bore with screen within the Warkworth Sands to 11.1 m depth (PZ7S), and screen within the shallow overburden material at 30.5 m depth (PZ7D). Historical water level data for the bores is presented in **Figure 6-2**. **Figure 6-2** shows that groundwater elevations within the coal measures at PZ7D have historically been slightly higher than levels in the overlying Warkworth Sands, indicating a potential upward gradient. Since 2016 this gradient has reduced, with levels within the Warkworth Sands and shallow overburden showing similar elevations and trends. **Figure 6-2** shows that over 2019 groundwater levels within the Warkworth Sands and shallow overburden material at PZ7S and PZ7D generally declined. This trend appears to correspond with the general decline in rainfall over this period; however, the logger data does not show a response to the above average rainfall experienced in March 2019. Further investigation into the local ground conditions, condition of the nested bore and functionality of the bore loggers should be undertaken, to understand the interaction between the two bore depths.

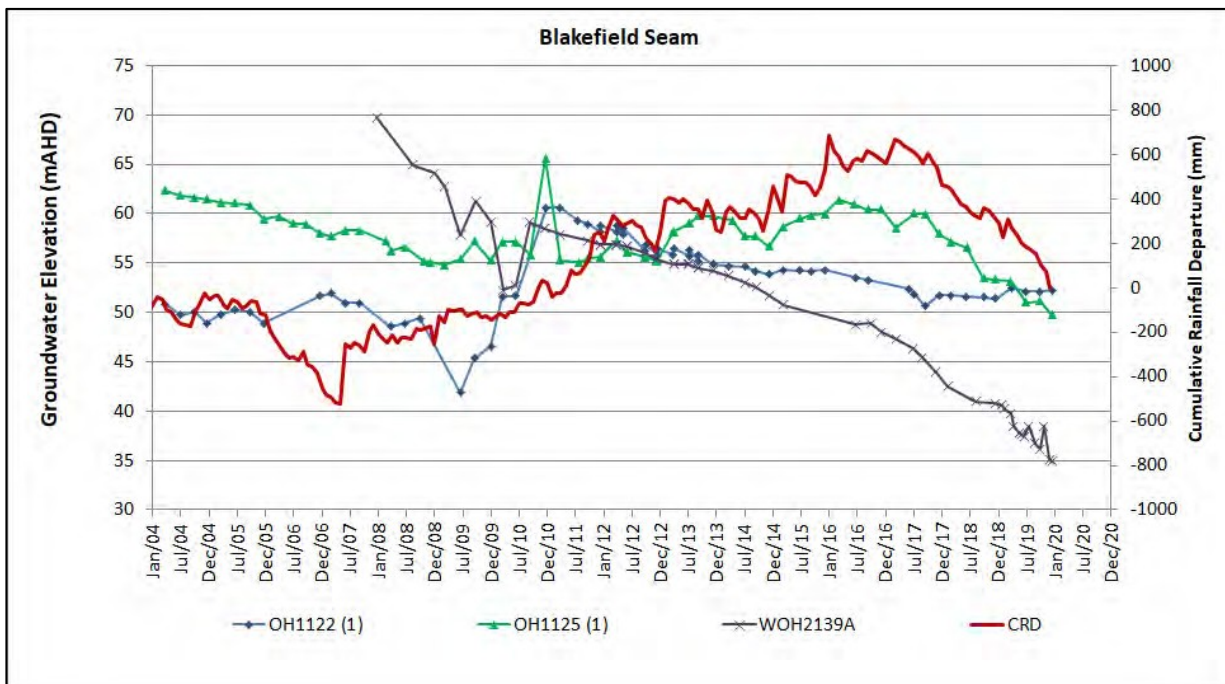
Figure 6-11 Hydrograph of Blakefield Seam

Historical groundwater level trends for bores intersecting the Blakefield Seam are presented in **Figure 6-11**. The graph shows that over 2019 groundwater elevations ranged between 34.9 mAHD and 53.16 mAHD. Over 2019 groundwater levels generally declined within the Blakefield Seam in bores OH1125 (1) and WOH2139A. Groundwater levels within OH1122 remained relatively stable throughout 2019. In response to mine progression Bore OH1125(1) recorded a 3.5 m decline, Bore WOH2139A recorded a 5.7 m decline and Bore OH1122(1) recorded a 0.2 m decline over 2019.

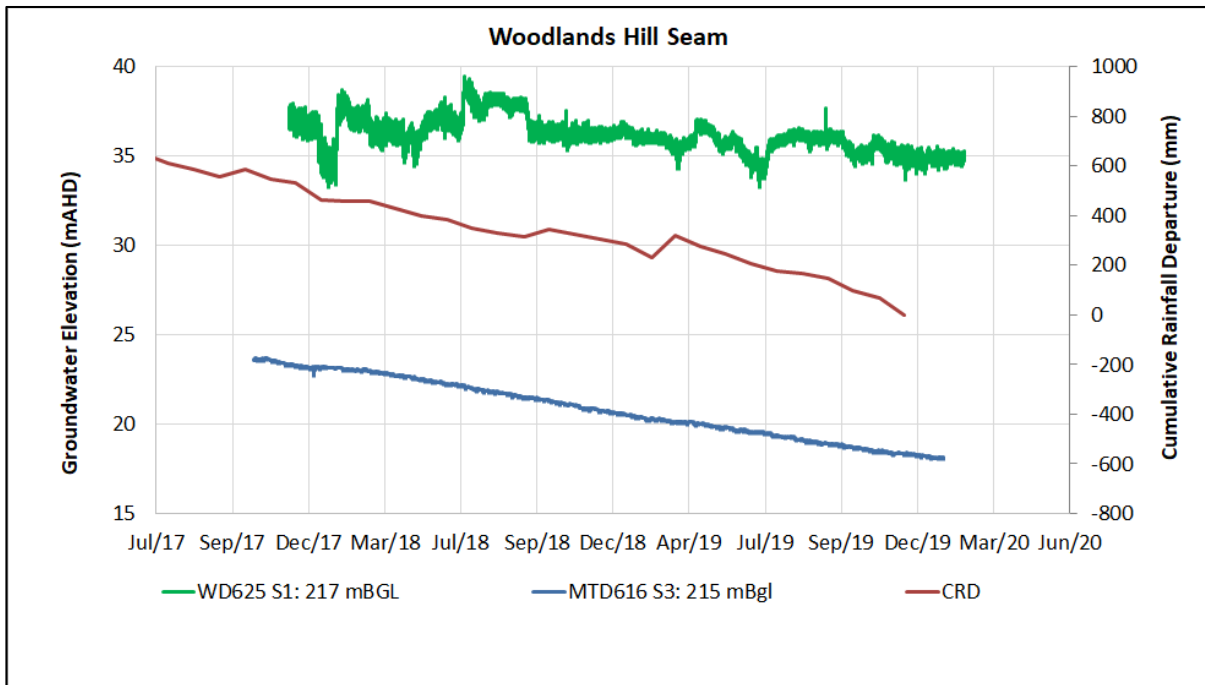
Figure 6-13 VWP Hydrograph of Woodlands Hill Seam

Groundwater level trends for VWP sensors installed within the Woodlands Hill Seam are presented in **Figure 6-13**. The graph shows that over 2019 groundwater elevations within the seam at VWP WD625 were variable, whereas at VWP MTD616 groundwater elevations slightly declined. MTD616 is located to the north west of Loders Pit and west of West Pit. The decreasing groundwater elevations are likely due to dewatering of the coal seam from mining of these pits.

WD625 is located to the west of North Pit and recorded variable but generally decreasing groundwater elevations over 2019. The cause of these fluctuations is unclear but may relate to underground mine and water storage activities at Wambo.

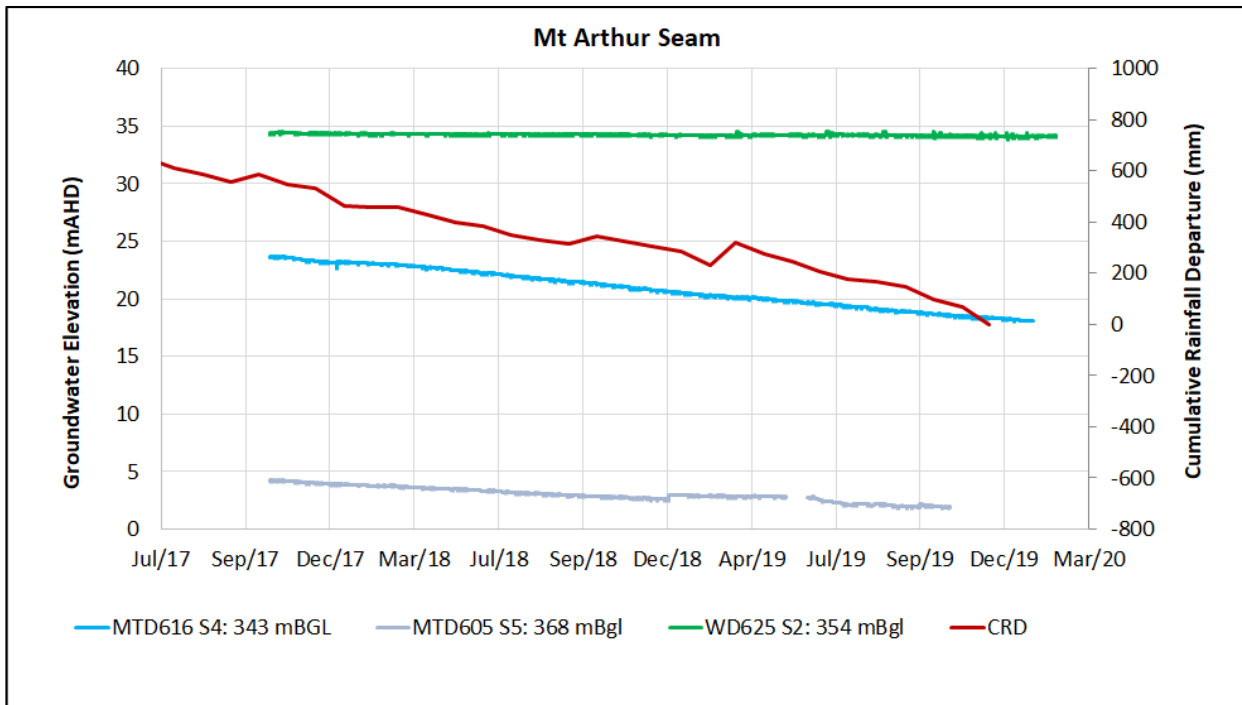
Figure 6-16 VWP hydrograph of Mt Arthur Seam

Historical groundwater level trends for VWP sensors intersecting the Mt Arthur and Piercefield coal seams are presented in **Figure 6-16** and **Figure 6-17** respectively. At MTD605 water level data is only available up to November 2019. After this period the data is erroneous, suggesting that the sensor has failed.

Figure 6-16 shows that over 2019 groundwater elevations within the Mt Arthur Seam ranged between 1.84 mAHD and 34.59 mAHD with a groundwater level decline of up to 2.48 m observed. The large difference in groundwater elevations is related to the difference in sensor elevations across the VWPs. The accuracy of the MTD605 sensor data has previously been questioned due to the low elevations recorded. The sensor calibration details and reported construction depths have been confirmed which suggests a long term issue with the sensor prior to failure. Although the accuracy of the groundwater elevations for MT605 are questionable, the decreasing trend in water level corresponds with the MTD616 readings.

The decreasing elevations within VWP MTD605 and MTD616 are likely to be due to the depressurisation of coal seams related to West Pit and Loders Pit. The stable elevations observed in WD625 suggest that depressurisation of the coal seams associated with North Pit are not influencing groundwater levels within the Mt Arthur seam at this location.

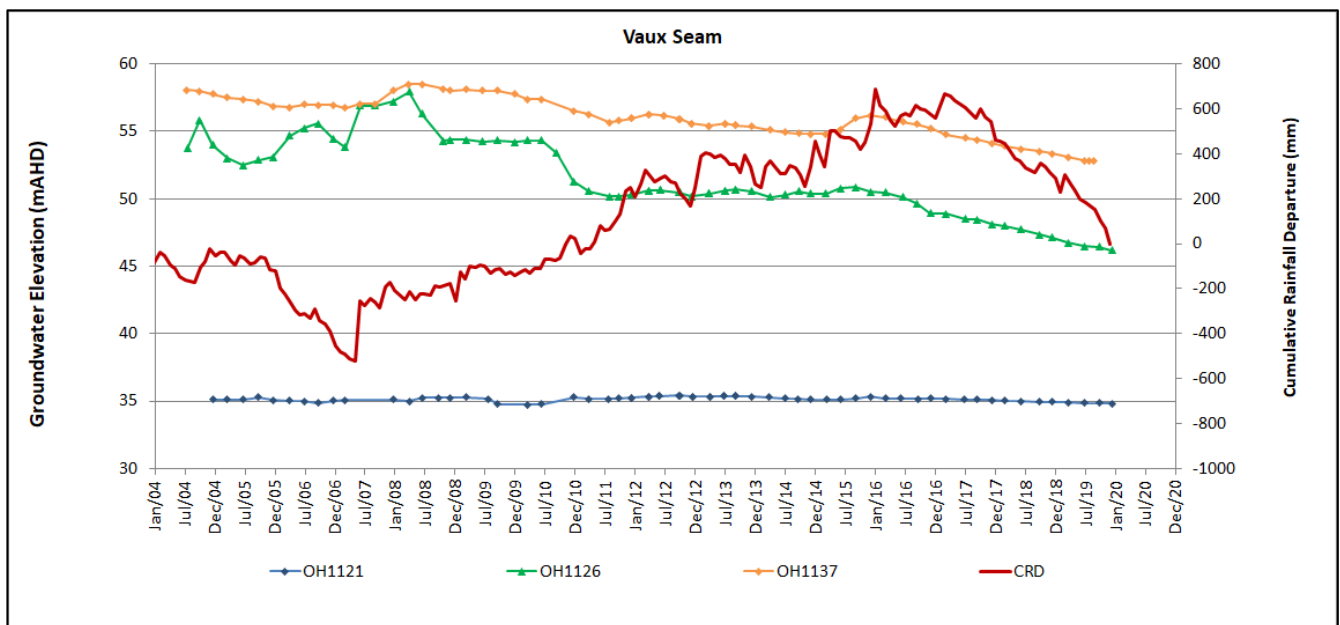
Figure 6-18 Hydrograph of Vaux Seam

Historical groundwater level trends for bores intersecting the Vaux Seam around MTW are presented in **Figure 6-18**. The graph shows that over 2019 groundwater elevations within the Vaux Seam, north of North Pit, (OH1126 and OH1137) ranged between 46.18 mAHD and 53.08 mAHD. Levels declined by up to 0.55 m with OH1137 reported as dry from September 2019. These trends are similar to trends observed within the Warkworth Seam, which may relate to depressurisation of the coal seams below the actively mined seams at MTW, or due to surrounding mine operations that target the Vaux Seam.

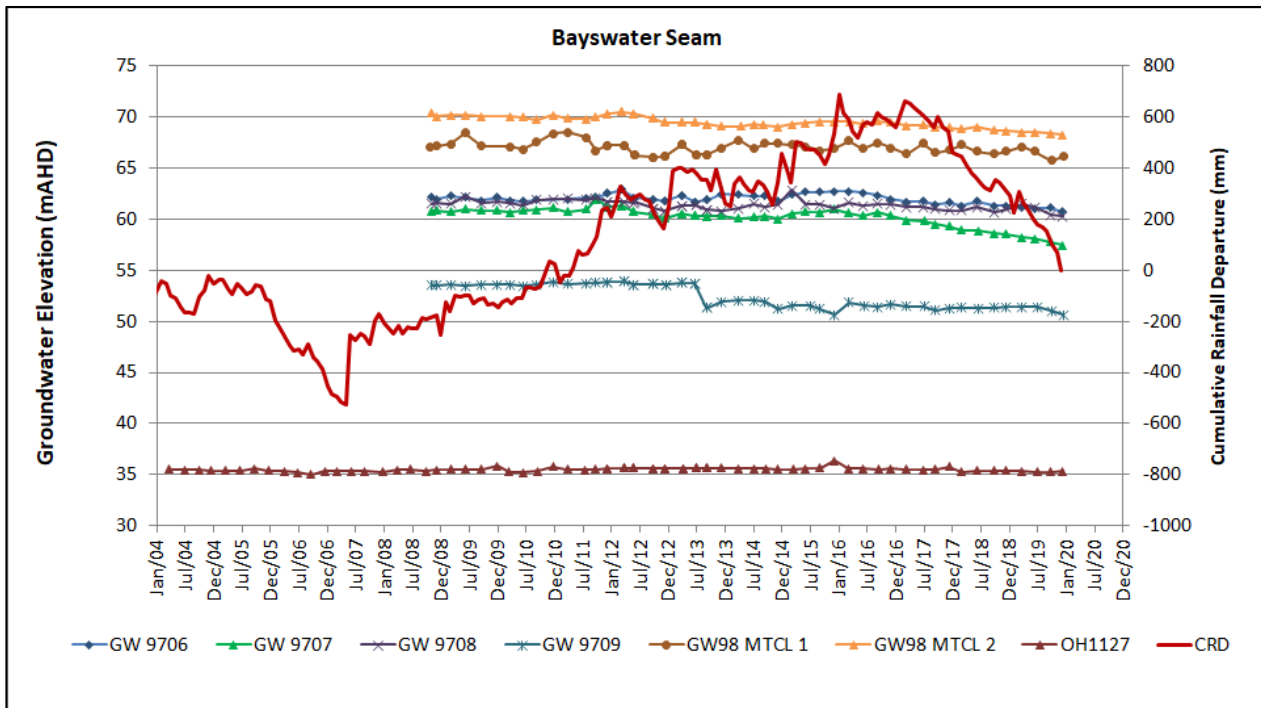
Figure 6-20 Hydrograph of Bayswater Seam

Historical groundwater level trends for bores intersecting the Bayswater Seam around MTW are presented in **Figure 6-20**. The graph shows that over 2019 groundwater levels remained relatively stable, with elevations ranging between 35.25 mAHD and 68.55 mAHD. All bores presented in **Figure 6-20** are located to the south east of South Pit.
