# Mount Thorley Warkworth 2021 Annual Review

<b>Name of Operations</b>	Mount Thorley Warkworth
<b>Name of Operator</b>	Coal & Allied (NSW) Pty Ltd (wholly owned subsidiary of Yancoal Australia Ltd)
<b>Development consent /project approval</b>	SSD-6464 & SSD-6465
<b>Name of holder of development consent/project approval</b>	Warkworth Mining Ltd Mt Thorley Operations Pty Ltd
<b>Mining Lease #</b>	Contained within Section 3.1 of this report
<b>Name of holder of mining lease</b>	Warkworth Mining Ltd Mount Thorley Operations Pty Ltd
<b>Water Licence #</b>	Contained within Section 3.1 of this report
<b>Name of holder of water licence</b>	Contained within Section 3.1 of this report
<b>MOP/RMP start date</b>	30/11/2021
<b>MOP/RMP end date</b>	02/07/2022
<b>Annual Review Start Date</b>	01/01/2021
<b>Annual Review End Date</b>	31/12/2021
<p><b>I, Gary Mulhearn, certify that this audit report is a true and accurate record of the compliance status of Mount Thorley Warkworth for the period 1 January 2021 to 31 December 2021 and that I am authorised to make this statement on behalf of Coal &amp; Allied (NSW) Pty Ltd.</b></p> <p>Note.</p> <p>a) The Annual Review is an ‘environmental audit’ for t

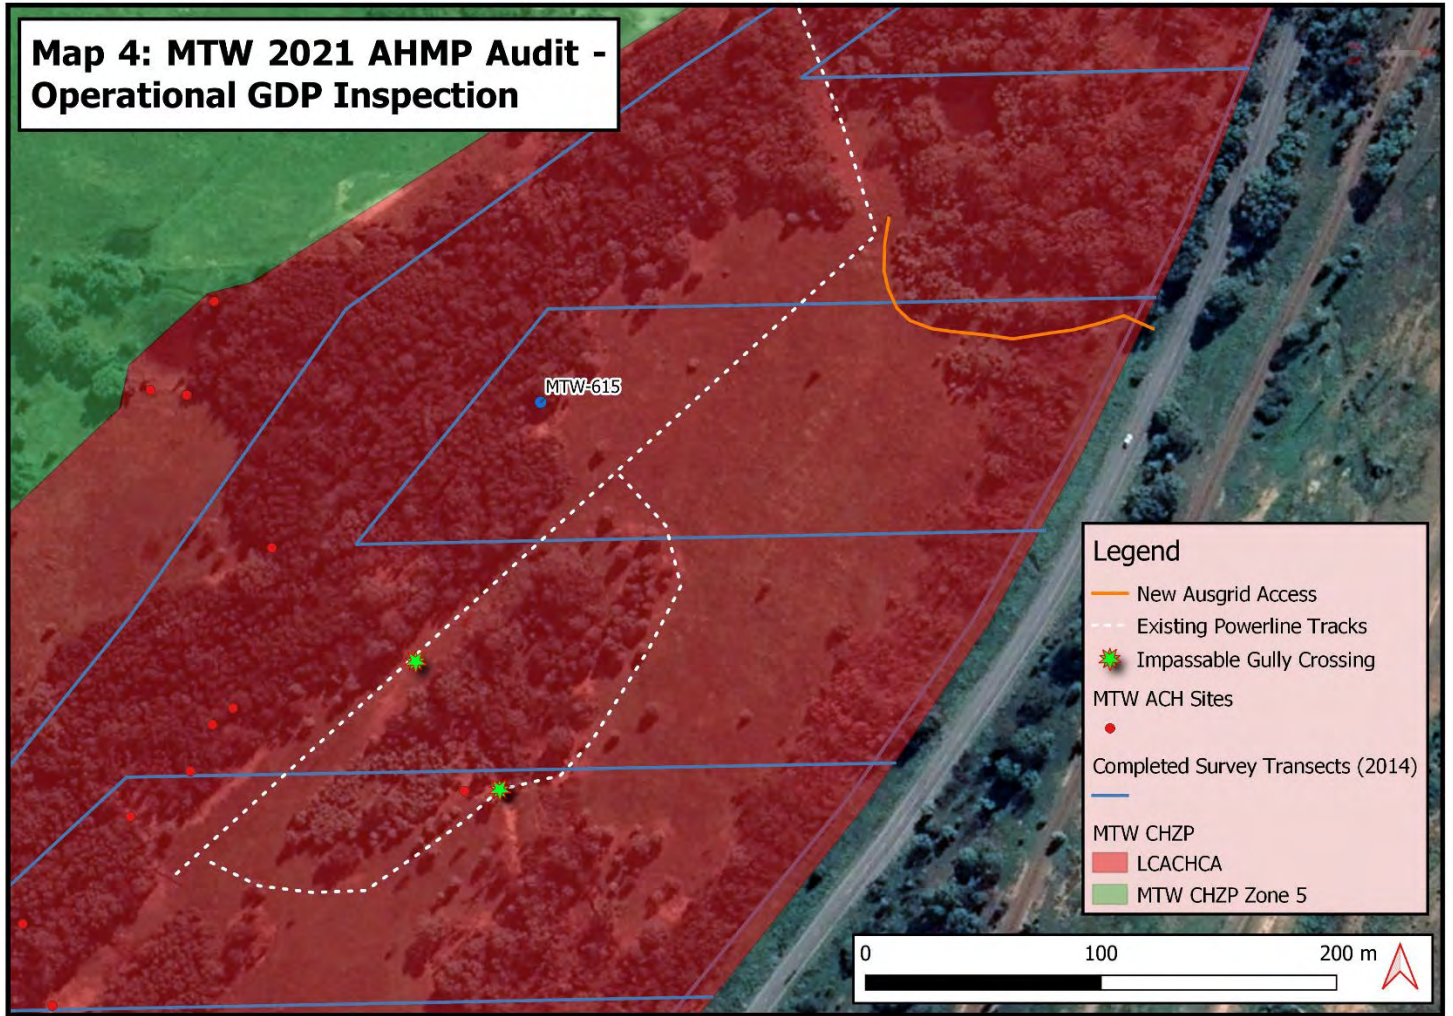
This access route measured c.150m in length and was designed to minimise vegetation disturbance and avoid impacts on any ACH sites. It runs west from Broke Rd to link up with an existing powerline track (see map below). This new access is required by Ausgrid as the former access to this part of the powerline has been closed due to erosion in a drainage gully, with remediation earthworks to the former access likely to cause impacts to previously recorded ACH sites.

The entire area has been subject to previous ACH assessments, most recently in September 2014 when comprehensive pedestrian transects were conducted by archaeologists and representatives of the CHWG. The nearest recorded ACH site (MTW-615 – an isolated mudstone flake) is located 150m to the south-west of the new access route.

The field team inspected the new access route and confirmed the results of the 2014 ACH assessment. No ACH objects or sites were located on the new access route. The nearest ACH site – MTW-615 – was inspected and successfully relocated. In terms of the overall management of ACH in this area, it was agreed that the installation of this new track, which does not disturb any ACH sites, would be preferable to the potential remediation of the existing powerline track and the subsequent disturbance of previously recorded cultural material.

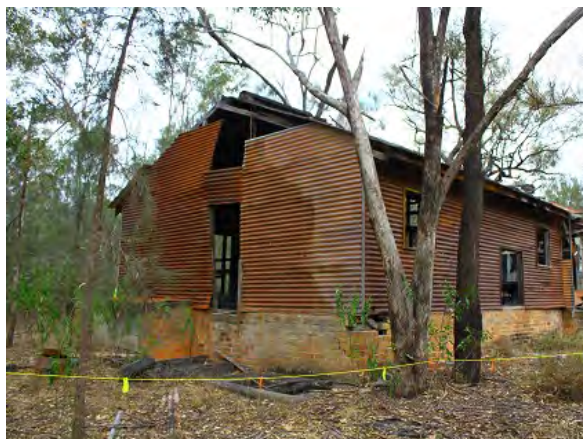
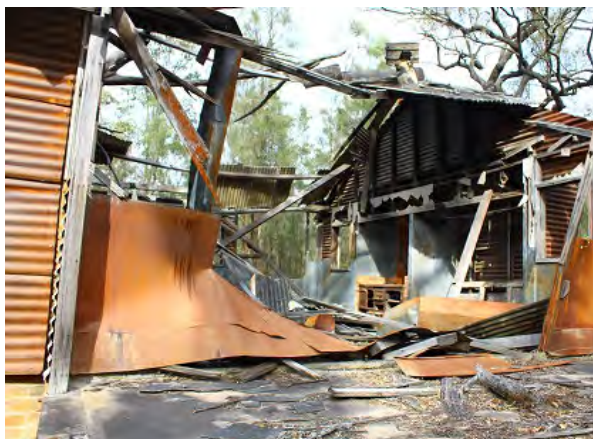
The building is currently structurally unsound, with a number of timber elements either missing or in a deteriorated state. Corrugated asbestos roof sheeting is also missing in some places, and damaged and in poor condition where it remains. Much of the corrugated iron sheeting is corroded. Brickwork is also cracking in a number of locations resulting in significant movement outward, loss of mortar and loss of bricks along the southern and eastern elevations.

*View to mess from south-east (2012)*

*Remnant kitchen area (2012)*

As a result, a number of structural recommendations were outlined by ERM in the CMP developed for the site in 2012. These recommendations were not intended to return the building to a serviceable state, rather they sought to do the minimum required to allow safe access to the building to prevent significant damage, and also allow safe access for asbestos removal and internal inspection of the building in the short to medium term.

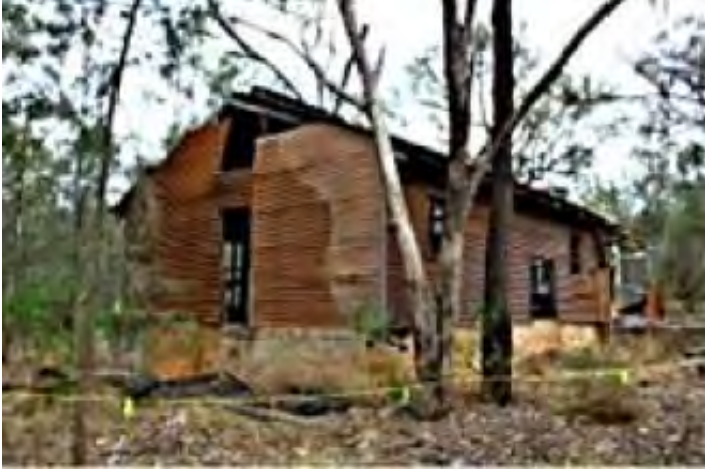
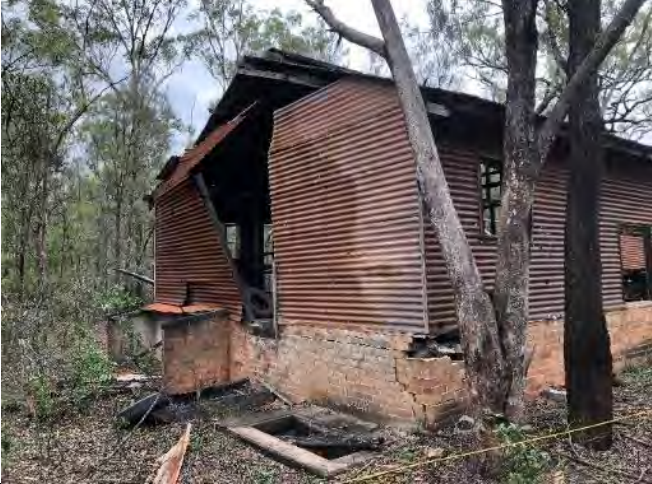
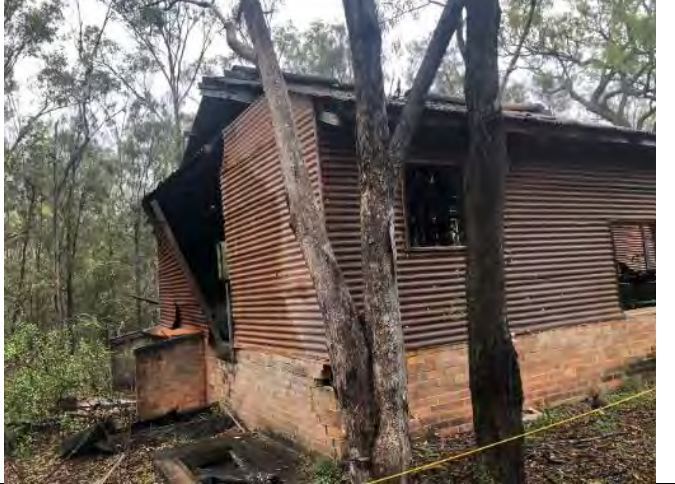
<p style="text-align: center;"><b>2012</b></p>  	<p style="text-align: center;"><b>2018</b></p>  
<p style="text-align: center;"><b>2020 (Mar)</b></p>  	<p style="text-align: center;"><b>2020 (Dec)</b></p>  
<p style="text-align: center;"><b>2021</b></p>  	<p><b><u>East elevation</u></b></p> <p><b>2012-18:</b> no discernible change – note fallen branch from tree on western side.</p> <p><b>2018-20 (Mar):</b> no discernible change – fallen branch has moved.</p> <p><b>Mar 2020 – Dec 2020:</b> no discernible change.</p> <p><b>Dec 2020 – 2021:</b> no discernible change.</p>

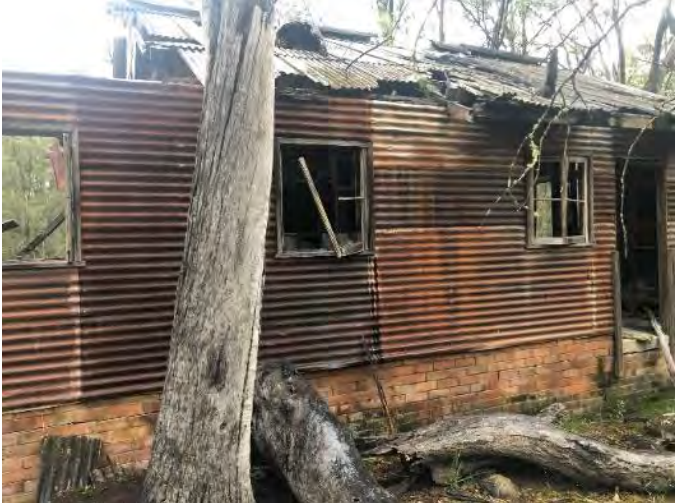
<p style="text-align: center;"><b>2012</b></p>  	<p style="text-align: center;"><b>2018</b></p>  
<p style="text-align: center;"><b>2020 (Mar)</b></p>  	<p style="text-align: center;"><b>2020 (Dec)</b></p>  
<p style="text-align: center;"><b>2021</b></p>  	<p><b><u>Timber window detail, west elevation</u></b></p> <p>2012-18: no discernible change.  2018-20 (Mar): no discernible change.  Mar 2020 – Dec 2020: no discernible change.  Dec 2020-2021: no discernible change.</p>

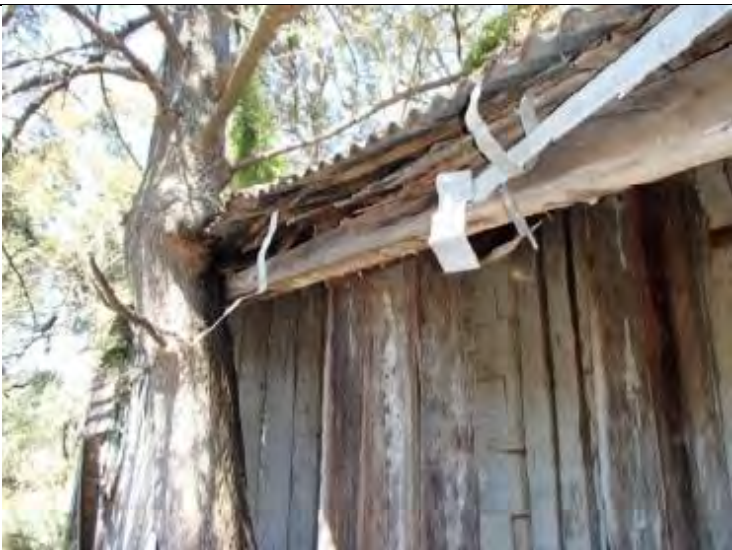
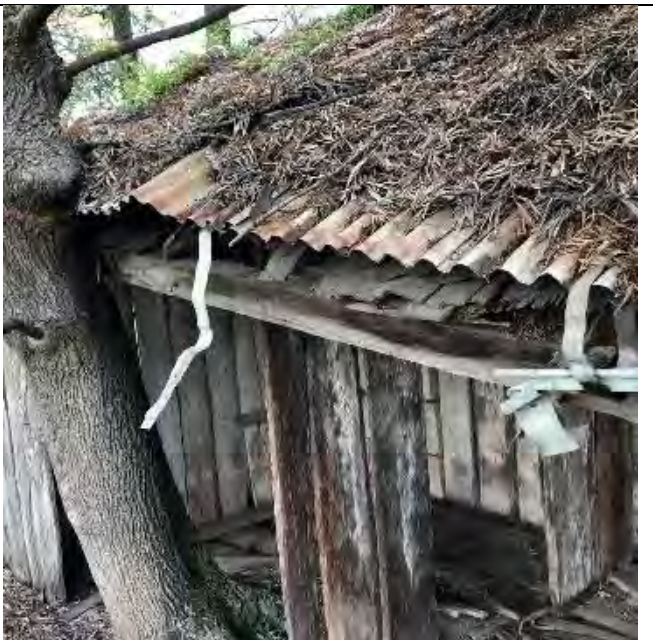
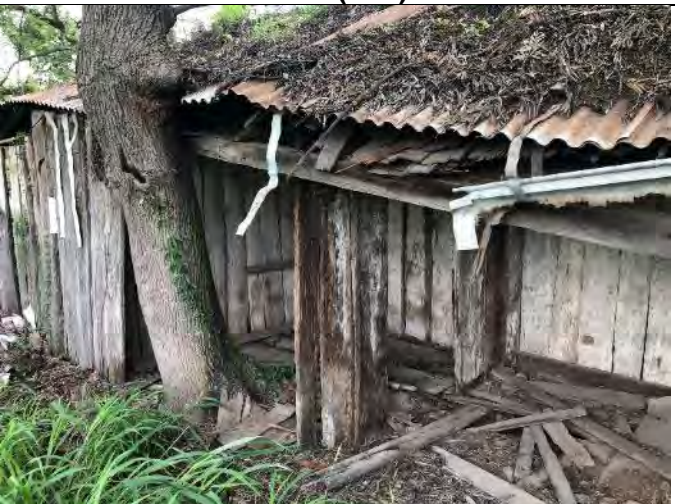
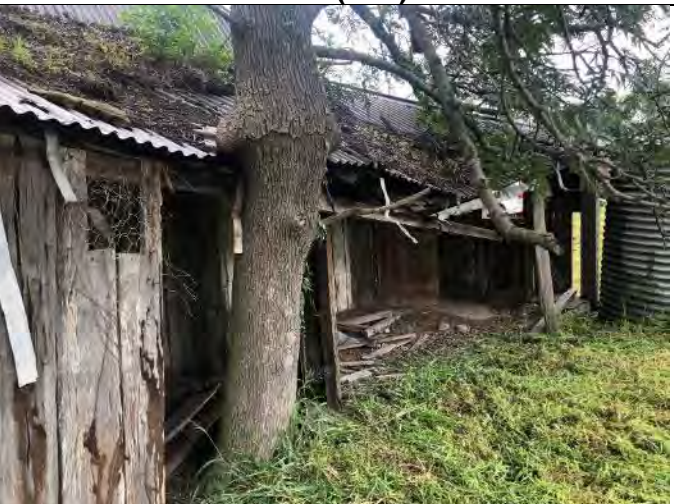
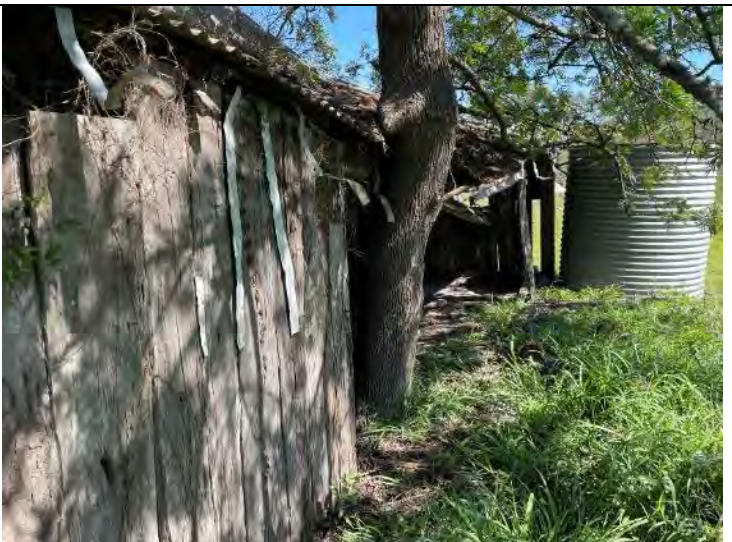
<p style="text-align: center;"><b>2014</b></p>  	<p style="text-align: center;"><b>2018</b></p>  
<p style="text-align: center;"><b>2020 (Mar)</b></p>  	<p style="text-align: center;"><b>2020 (Dec)</b></p>  
<p style="text-align: center;"><b>2021</b></p>  	<p><b><u>South-east corner</u></b></p> <p><b>2014-8:</b> shows removal of vertical slabs from southern wall, and some from eastern wall, and further collapse of roof.</p> <p><b>2018-20 (Mar):</b> further roof slumping and deterioration of eastern wall.</p> <p><b>Mar 2020-Dec 2020:</b> no discernible change.</p> <p><b>Dec 2020 – 2021:</b> further deterioration of eastern wall.</p>

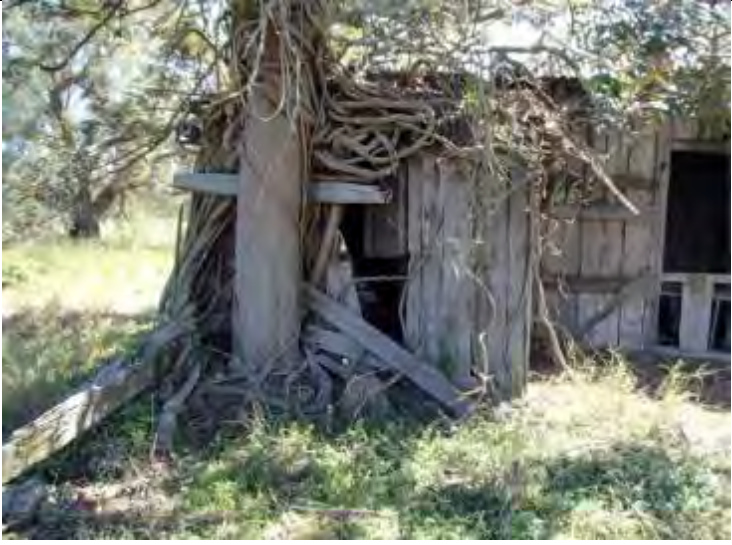
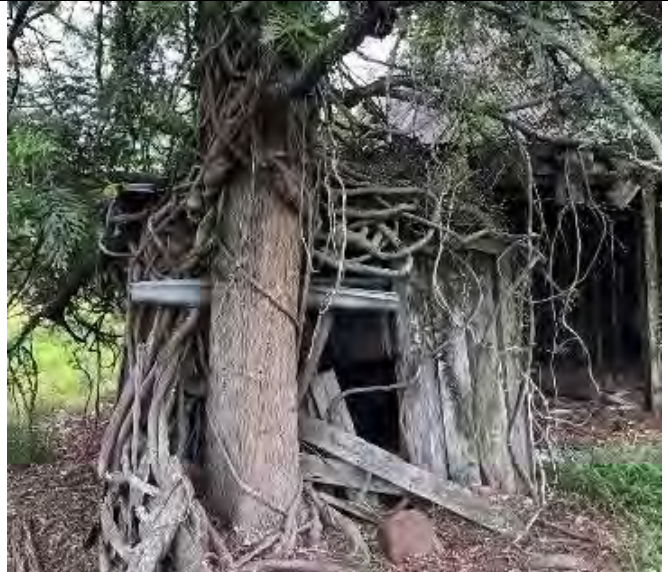
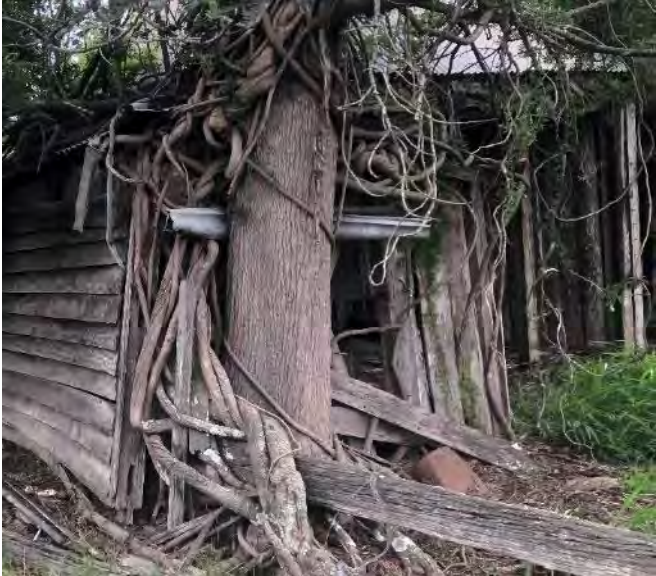
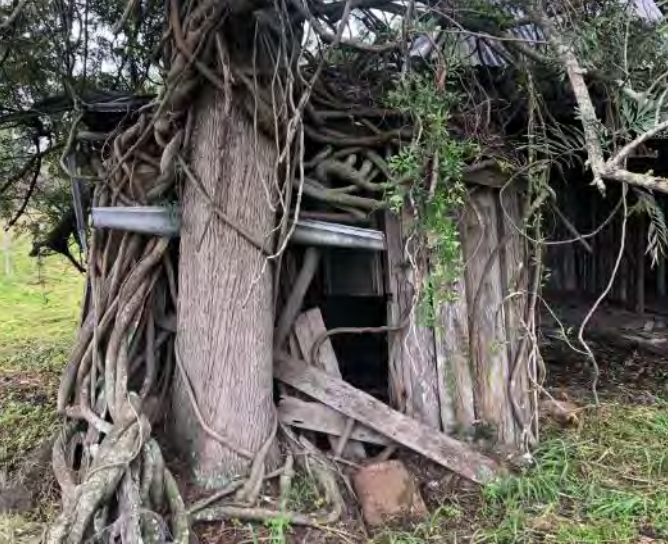
<p style="text-align: center;"><b>2014</b></p>  	<p style="text-align: center;"><b>2018</b></p>  
<p style="text-align: center;"><b>2020 (Mar)</b></p>  	<p style="text-align: center;"><b>2020 (Dec)</b></p>  
<p style="text-align: center;"><b>2021</b></p>  	<p><b><u>Northern elevation</u></b></p> <p><b>2014-8:</b> slumping of verandah along edge beam.  <b>2018-20 (Mar):</b> no discernible change.  <b>Mar 2020-Dec 2020:</b> grass/weed growth encroaching over verandah floor.  <b>Dec 2020 – 2021:</b> no discernible change.</p>

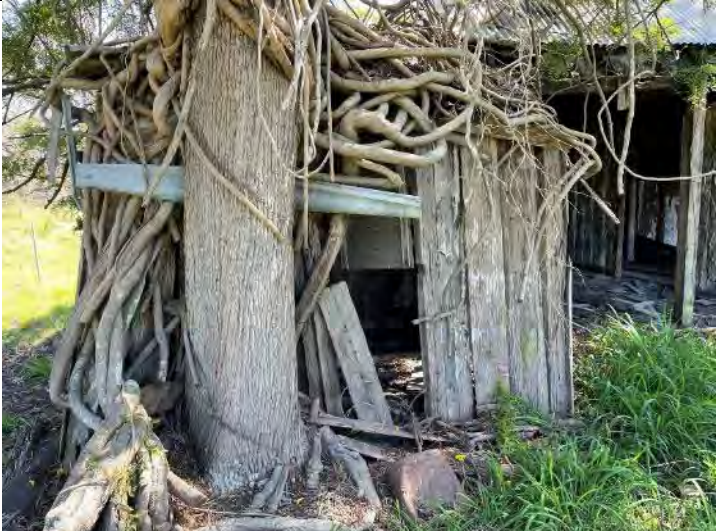
<p style="text-align: center;"><b>2021</b></p>

<p><b><u>View of south-west corner from south</u></b></p> <p><b>2014-8:</b> shows removal of vertical slabs from southern wall as well as some increase in vegetation growth.</p> <p><b>2018-20 (Mar):</b> no discernible change but continuing vegetation impacts.</p> <p><b>Mar 2020-Dec 2020:</b> Apparent increased vine growth.</p> <p><b>Dec 2020 – 2021:</b> continued impacts on south-west corner.</p>

The comparative photographs above show the changes at the building over the past eight years. Although no great change was noted between the current and the last inspection, no structural maintenance has occurred either. During this time it can be expected that the underlying causes of deterioration, such as the degeneration of wooden framework, impacts caused by adjacent trees and the effects of weather entering the unsealed building has continued. Therefore, the more significant changes and priority actions identified during the last inspection remain of importance and, if anything, their need of remediation has increased in urgency. Previous recommendations remain valid and the key issues remain:

7. Pending structural engineer's advice, refix loose ceiling boards and loose and dislodged wall slabs and plates, retaining evidence of fabric if unable to fix;

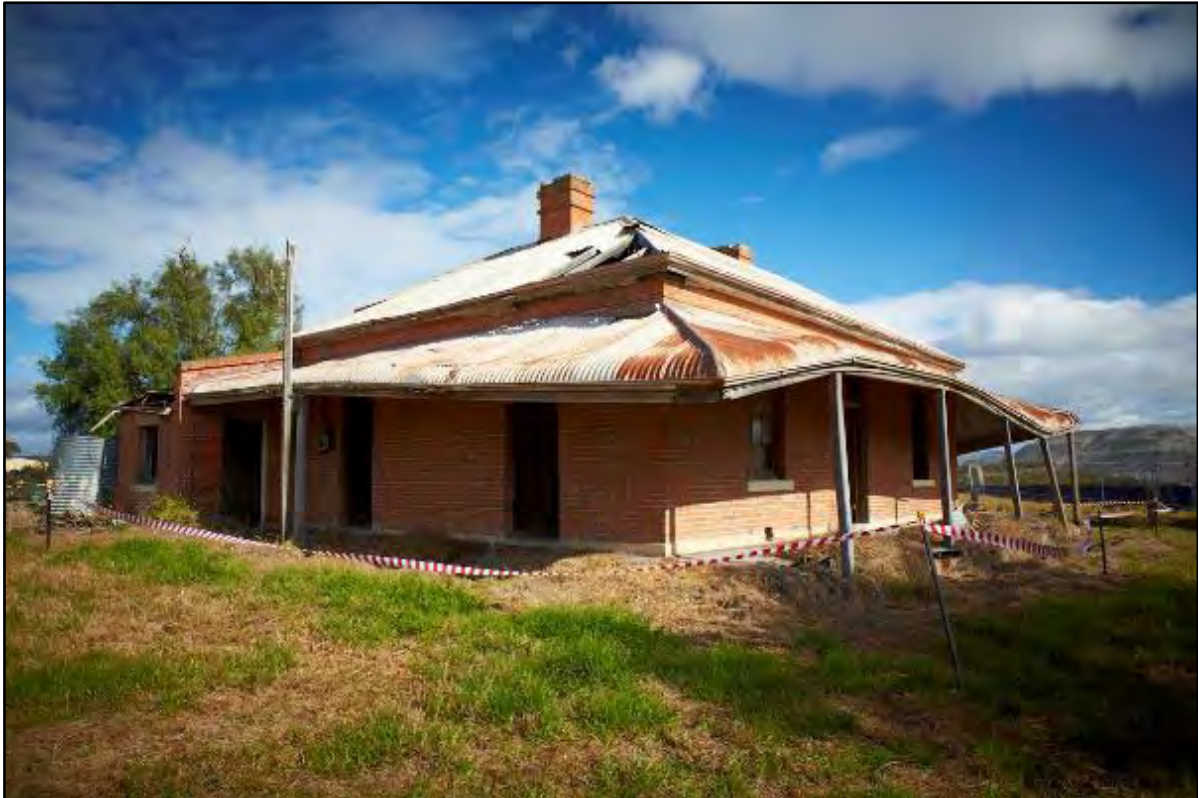
***Mount Thorley Brick Farm House (2012)***

The masonry structure of the building is sound, however, it was noted as being in poor physical condition in 2015 (when a CMP was developed for the site by ERM), with a collapsed verandah roof, missing or loose roof sheeting, missing or collapsed verandah posts, and floorboards and areas affected by termites. The conservation works schedule within the CMP considered the following issues at Mount Thorley Brick Farm House:

- Removal and safe storage of verandah;
- Initial vegetation clearing;
- Sheeting and sealing of all window and door openings;
- Clean up of scattered debris surrounding building; and
- Repair of loose roof sheeting and patching of holes.

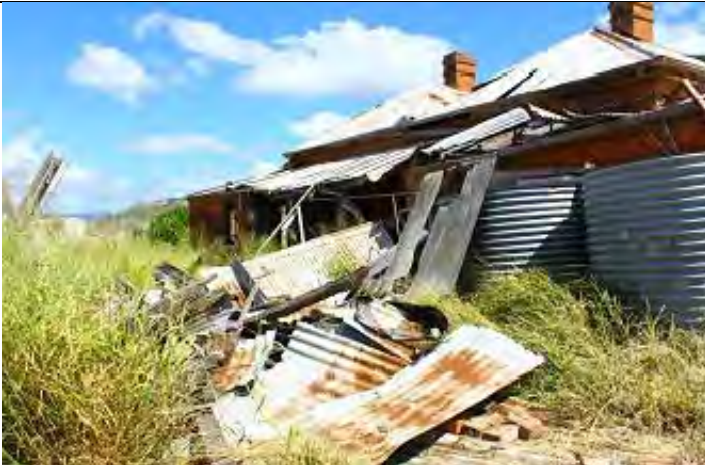
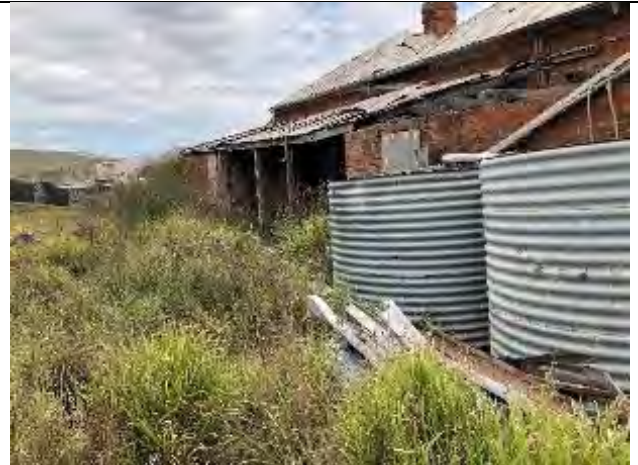
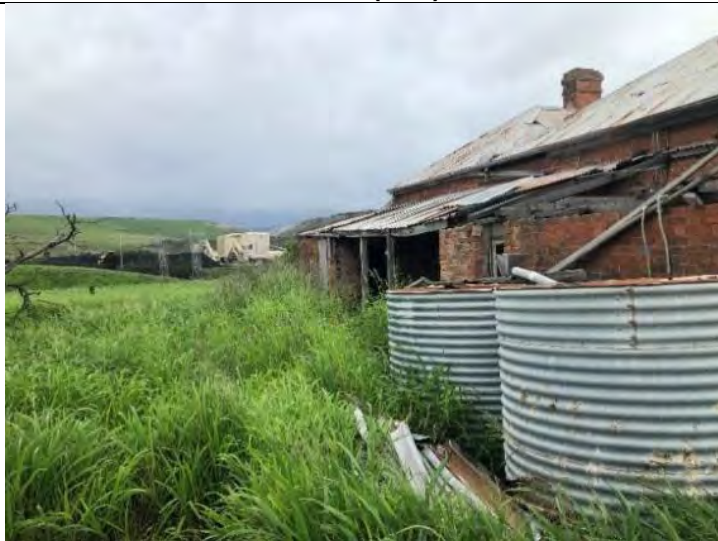
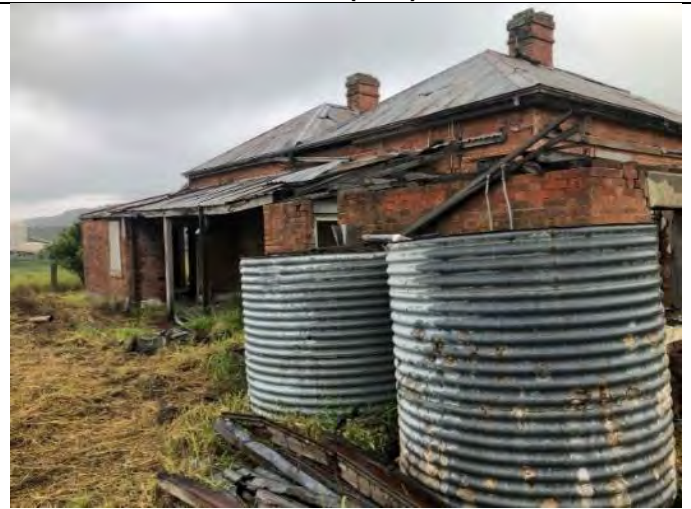
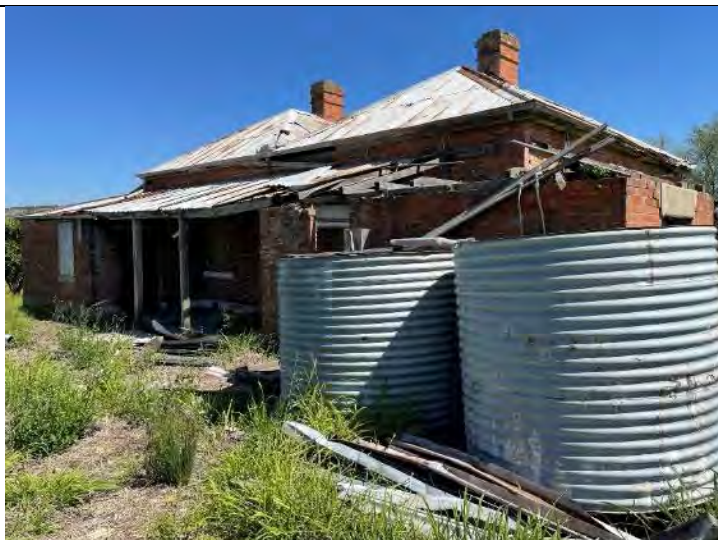
#### View of rear of building (view south)

**2015-8:** debris has been cleared and stacked  
**2018-20 (Mar):** vegetation has regrown around building and stacked debris
