Mount Thorley Warkworth 2018 Annual Review

Mount Thorley Warkworth (MTW) is an integrated operation of two open cut coal mines, Warkworth Mining Limited (WML) and Mount Thorley Operations (MTO). This Annual Review reports on the environmental performance of Mount Thorley Warkworth (MTW) for the period 1 January 2018 to 31 December 2018.

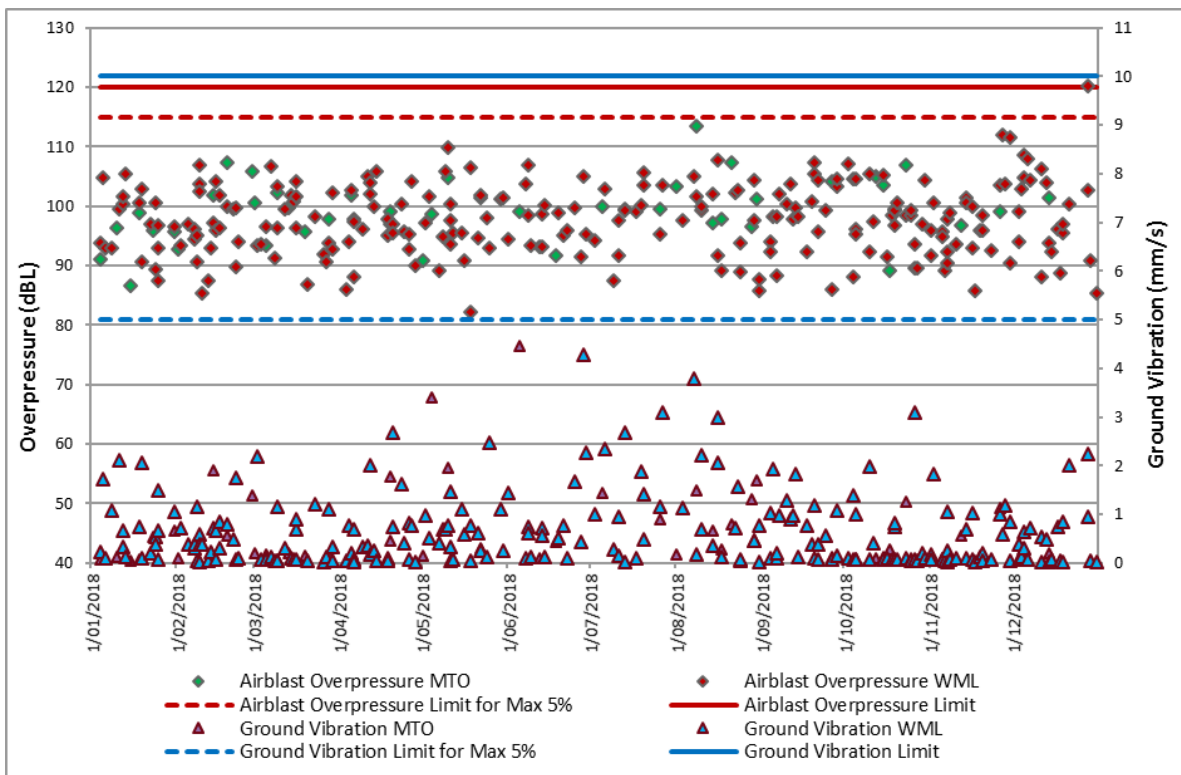
FIGURE 6: BULGA VILLAGE BLAST RESULTS

On 28 December 2018, one blast exceeded the 120dB(L) threshold for airblast overpressure at the Bulga Village blast monitor. The exceedance was reported to the Department of Planning and Environment (DP&E) and to the NSW Environment Protection Authority (EPA) on 28 December 2018. A written report was provided to the DP&E and EPA for this blast which noted that wind gusts produced substantial air pressure peaks both before and during the blast which increased air pressure levels recorded at the Bulga Village monitor. It is probable that a wind gust during the period of airblast arrival increased the air pressure level recorded by the monitor. As such, the exceedance is not considered to be a non-compliance.

The event was reported to the DP&E and to the EPA on 28 December 2018 as a precautionary measure based on the monitored results at this monitor. A written report was subsequently provided to DP&E and to the EPA for this blast which noted that wind gusts produced substantial air pressure peaks both before and during the blast. The investigation determined that it is probable that a wind gust during the period of air blast arrival increased the air pressure level recorded by the Bulga Village monitor.

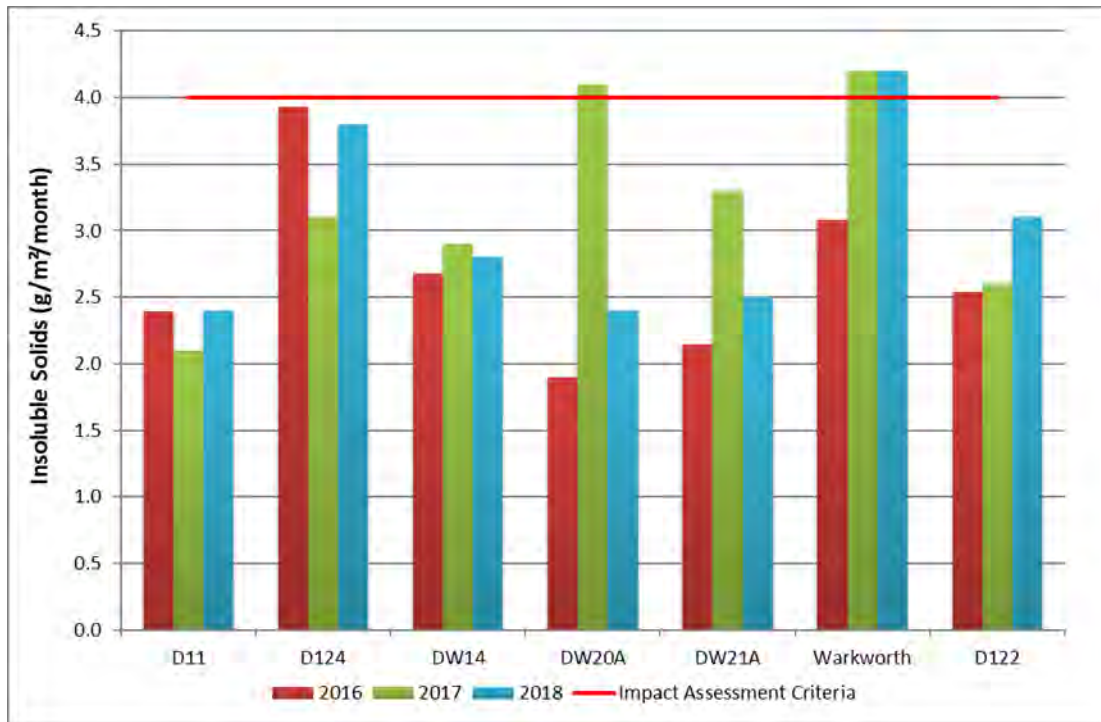
FIGURE 14: 2018 DEPOSITIONAL DUST RESULTS COMPARED AGAINST THE IMPACT ASSESSMENT CRITERIA AND PREVIOUS YEARS' RESULTS

There was one exceedance of the long-term impact assessment criteria, for maximum total deposited dust level, recorded at the Warkworth monitoring location. An external consultant was engaged to conduct an investigation which determined maximum MTW contribution to be not more than 1.6g/m²/month, or 39% of the total level of 4.1g/m²/month at Warkworth. As per MTW's approved Air Quality Management Plan, this does not constitute non-compliance and no further action is required. During 2018 monthly dust deposition rates equal to or greater than the long-term impact assessment criteria of 4g/m²/month were recorded at multiple sites. Where field observations denote a sample as contaminated (typically with insects, bird droppings or vegetation), the results are excluded from Annual Average compliance assessment. Meteorological conditions and the results of nearby monitors for the sampling period are also considered when determining MTW's level of contribution to any elevated result. Details of excluded results are presented in the relevant MTW Monthly Environmental Monitoring Report. The graphs below illustrate a general trend in increased Depositional Dust in 2017 and 2018 compared to 2016. This is consistent with well below average rainfall totals recorded in 2017 and 2018.

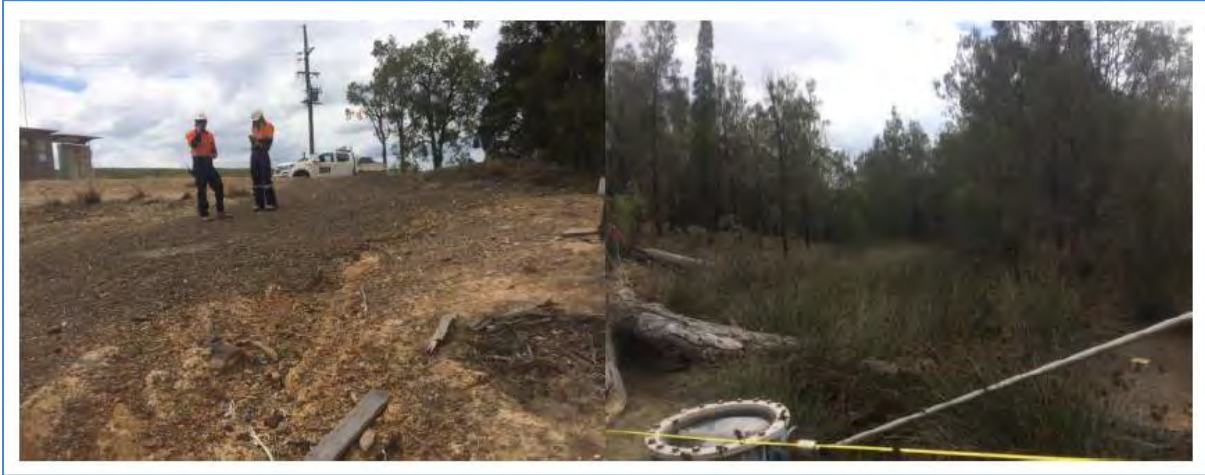
MTO HRSTS Discharge Location – Before Stability Improvement Works

During the reporting period MTW undertook creek stability improvement works at its Mount Thorley Operations HRSTS discharge location to improve the stream health and channel stability in this location. This site had a classification of poor before the remediation works were completed. During the 2018 assessment, the site was classified as stabilising. Before and after photos are provided below for reference.

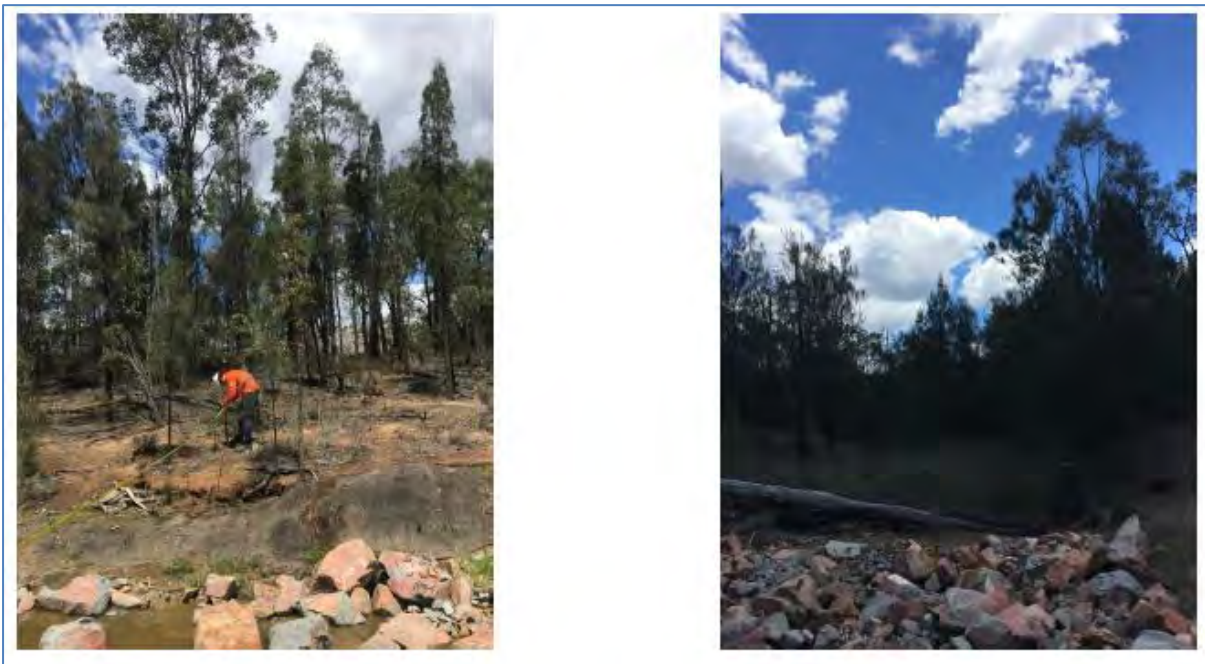
MTO HRSTS Discharge Location - After Stability Improvement Works

The 2018 stream health and stability assessment did not identify any direct impacts from MTW's current operations as contributing to a decline in stream health or channel stability. Despite this, MTW will review the LC3 stream monitoring location in the Loders Creek Cultural Heritage Conservation Area to assess whether improvement works are achievable in this zone, as this location was identified as having active erosion requiring priority attention. MTW will continue to undertake the annual stream health and stability monitoring in accordance with the requirements of its approved Water Management Plan.

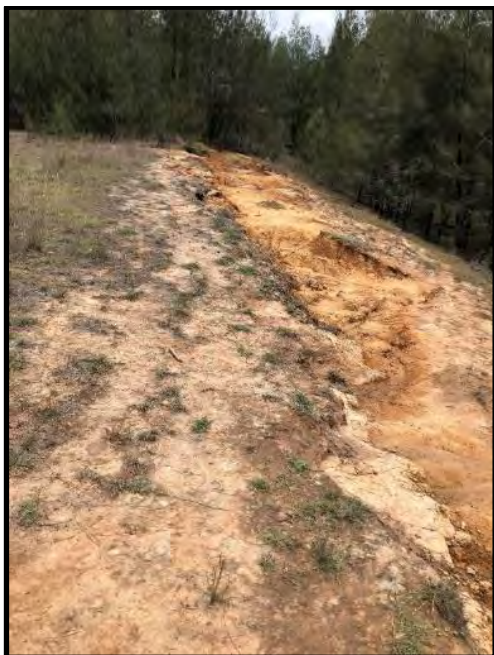
Erosion at MTW-632

There are a number of Aboriginal heritage sites located on the banks of Loder Creek, or other ephemeral watercourses leading to it, that are being impacted by erosion, which is quite severe in some areas (see photographs below). Rather than a site by site approach, it is recommended that a holistic environmental remediation plan be developed and implemented for the LCACHCA, with input from the MTW CHWG and their assistance sought in its implementation. As part of this plan, approval should be sought from the Office of Environment and Heritage (OEH) to allow the temporary removal of artefacts from remediation areas and their replacement once revegetation has been established and erosion has ceased.

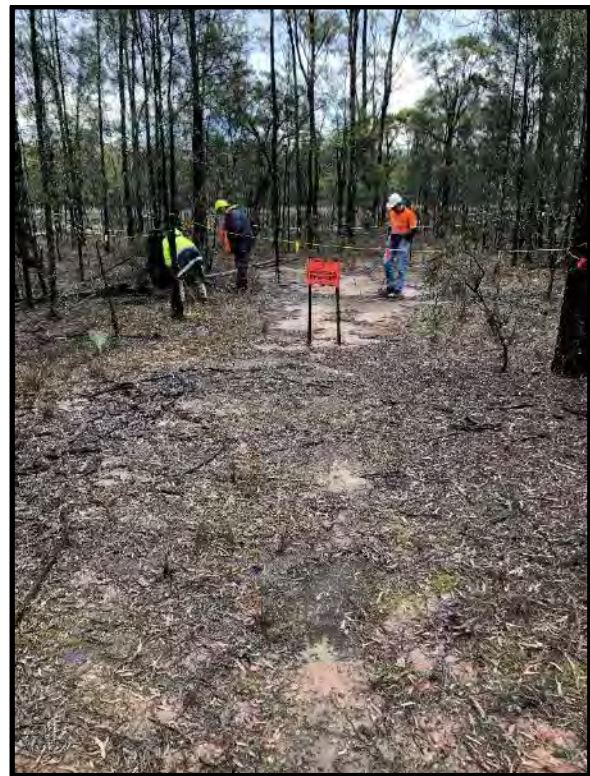
Prickly pear (centre-left) at WS7

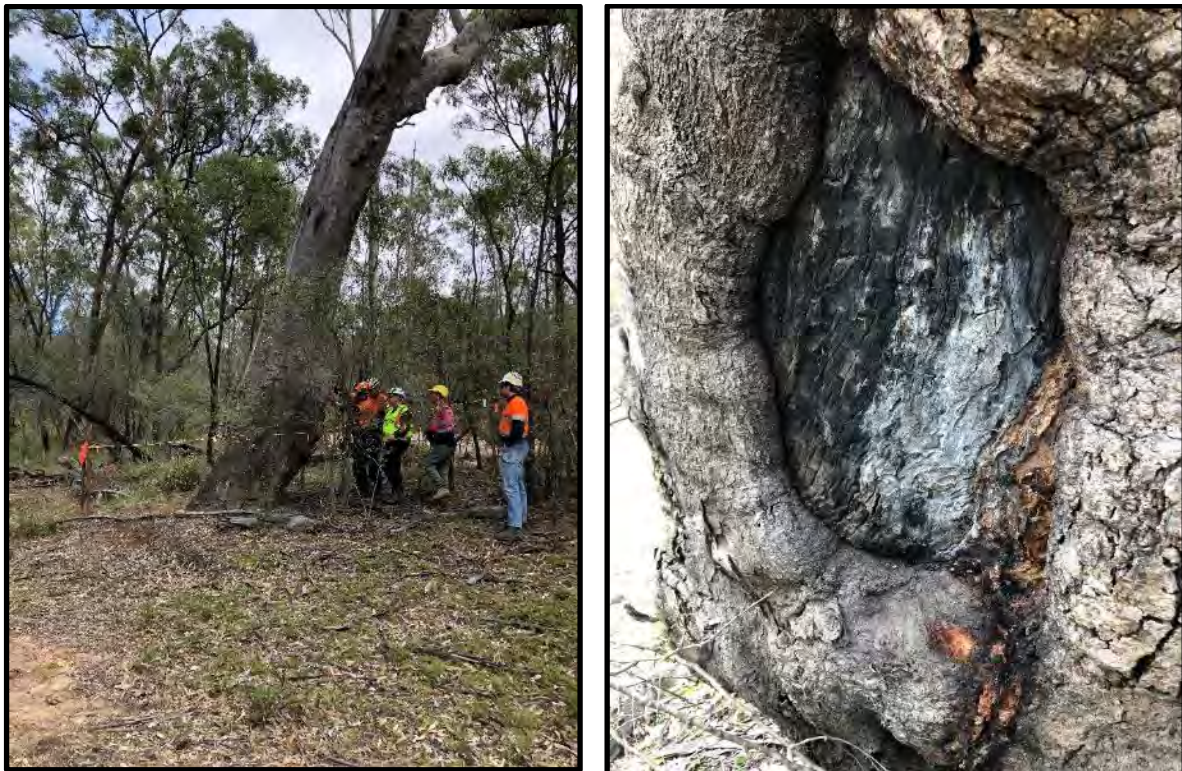
Aboriginal Scarred Tree MTW-80

The tree is in good health, with an intact (non-hollow) trunk, and advice from the arborist suggests that there is good potential to salvage the scarred portion of the trunk. It is suggested that the crown of the tree is removed and, while the scarred portion of the trunk is supported by a crane, the tree trunk then cut at the base. Consideration should be given to using dendrochronology to date the tree to add to our knowledge database. In addition, one of the RAPs has asked that the lopped wood from the crown be distributed to interested MTW CHWG members.

Once successfully removed, the tree can be transported to the WBACHCA and appropriately displayed and conserved, in consultation with the MTW CHWG. Two stone artefacts (a flake of mudstone and a flake of silcrete) were originally recorded at the site but have not been re-identified during subsequent site visits. CHWG representatives should be present to monitor the removal and remove any artefacts that may be uncovered.

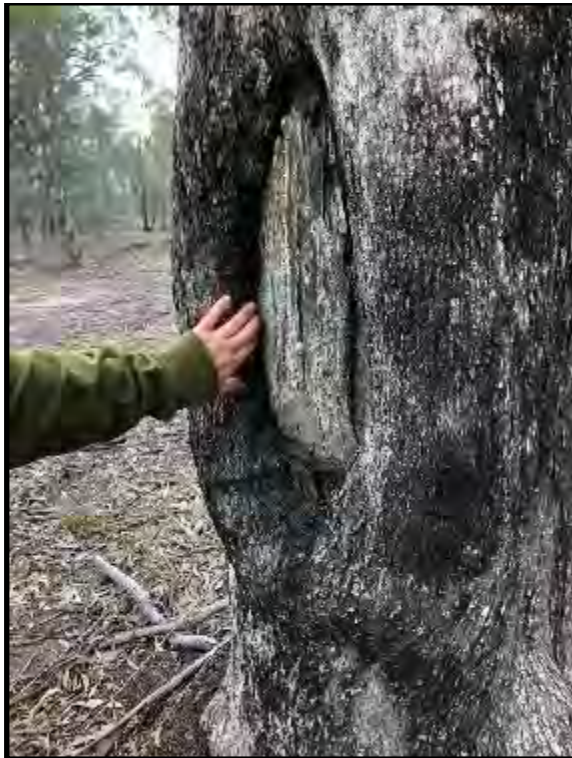
Blazed Tree GNR-005

Two historic blaze trees are located within the Wallaby Scrub Road corridor, likely associated with delineating the easement of road. GNR-005 is located on the western side of Wallaby Scrub Road, c.5m east of the current road. The scar faces east, c.90cm from the base of the tree, and measures 550 x 200mm. The scar has previously been painted white, bears an axe mark and nail, but has no other discernible numbers or arrows. MTWH-102 is also located c.5m east of Wallaby Scrub Road and the blaze is of a similar size, though closer to the base of the tree. This scar also contains a nail, but the tree, an ironbark, has been affected by fire.

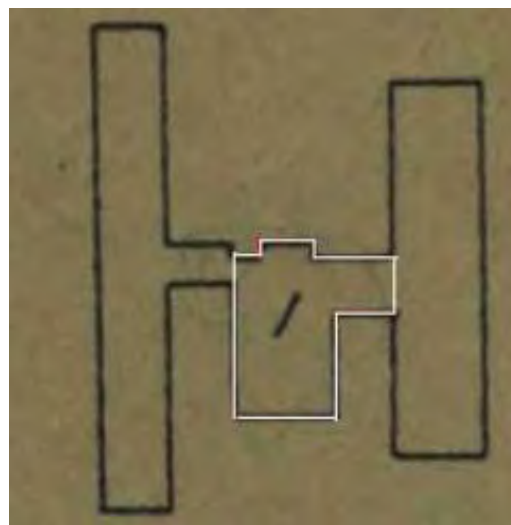
Remaining structure

The building is currently structurally unsound, with a large tree impacting on the roof and a number of timber elements either missing or in a deteriorated state. Corrugated asbestos roof sheeting is also missing in some places, and damaged and in poor condition where it remains. Much of the corrugated iron sheeting is corroded. Brickwork is also cracking in a number of locations resulting in significant movement outward, loss of mortar and loss of bricks along the southern and eastern elevations.

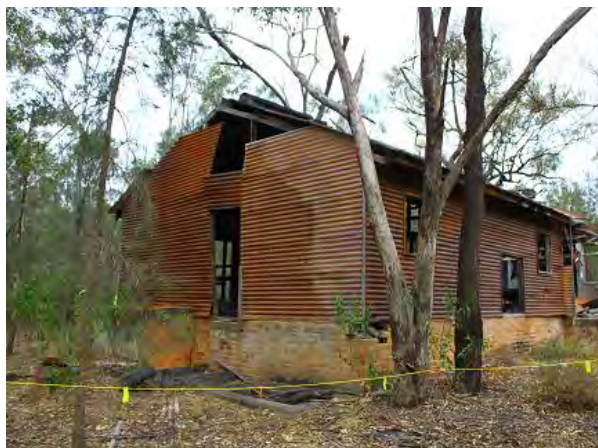
View to mess from south-east (2012)

The remnant building is “L” shaped in plan with brick and concrete footings. During the original assessment conducted by ERM in November 2012 the building was noted as being in poor condition with trees physically impacting on the building fabric, and some minor settlement issues resulting in cracking and failing brickwork. The western section of the building was the most intact part, retaining the original timber frame, corrugated asbestos cement roof sheeting and walls clad with corrugated iron sheeting.

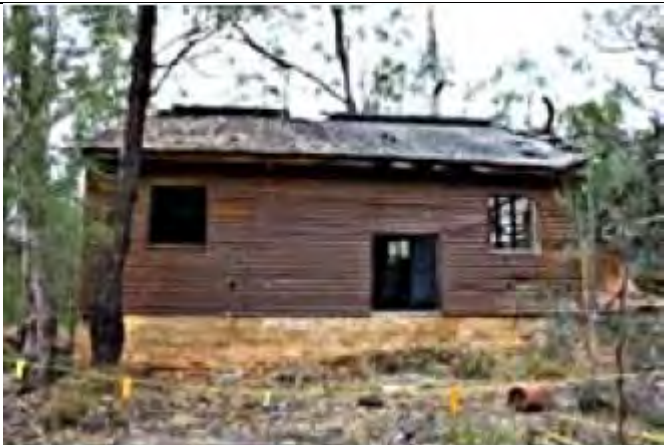
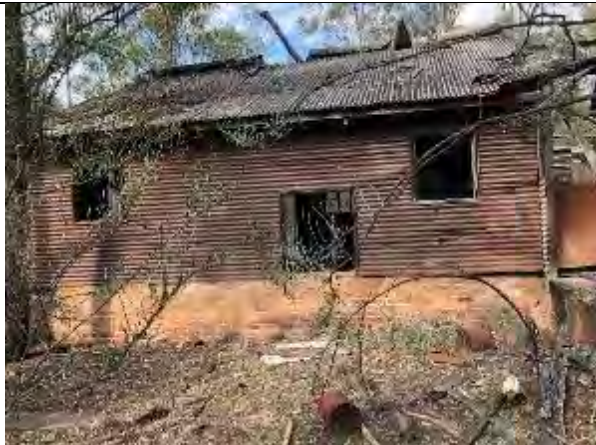
<p>East elevation: no discernible change – note fallen branch from tree on western side.</p>

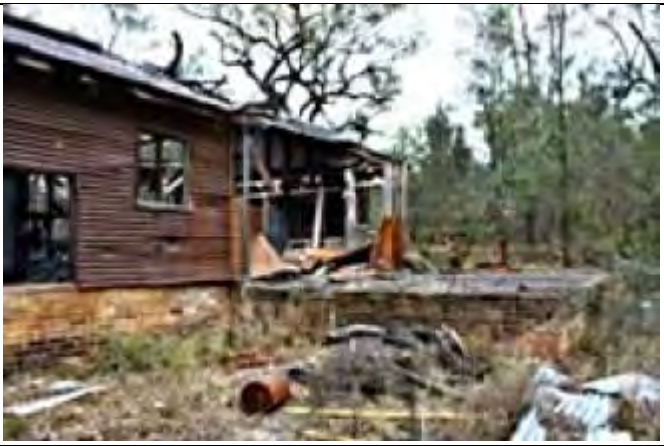
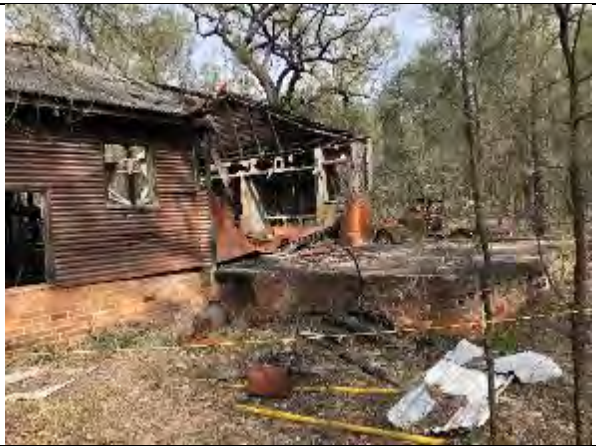
<p>View to north-east elevation: roof over open kitchen area has deteriorated, causing severe lean on far wall.</p>

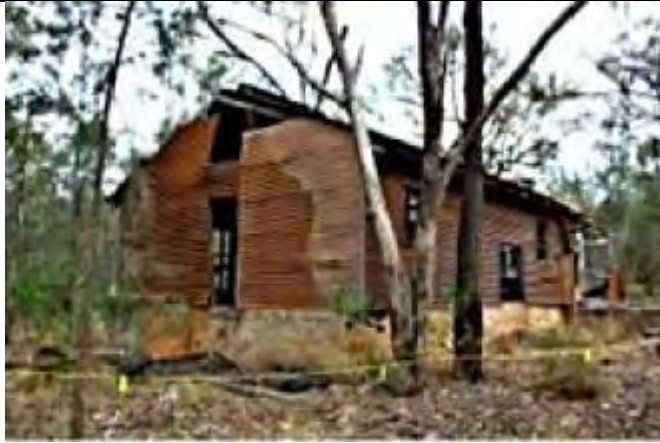
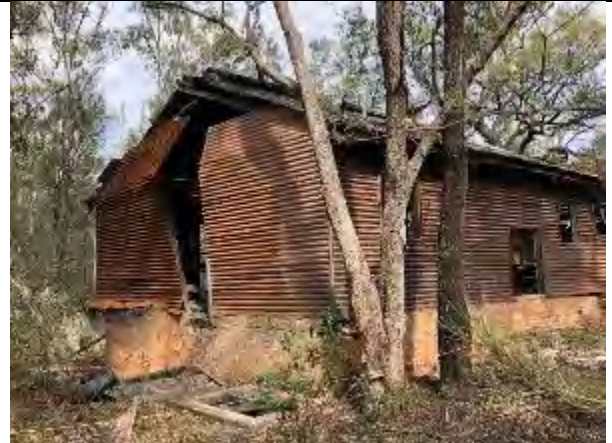
South-east elevation: evidence of increased bow to southern wall.

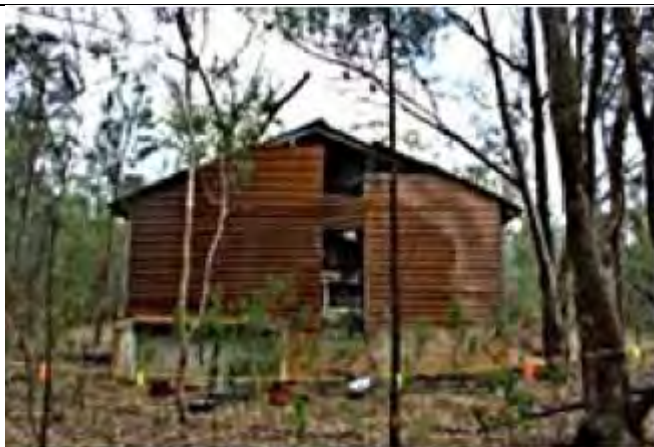
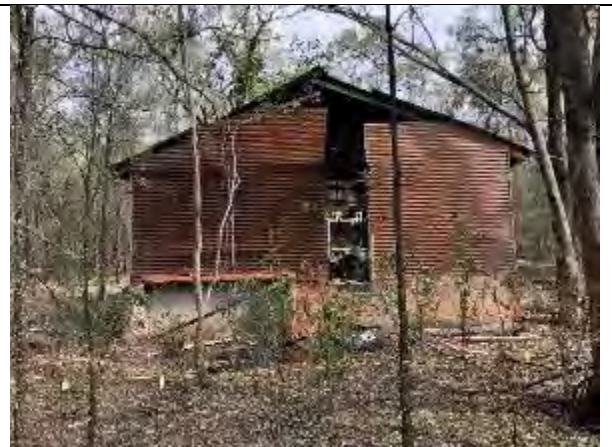
South elevation: evidence of increased bow to southern wall and missing panel above entry.

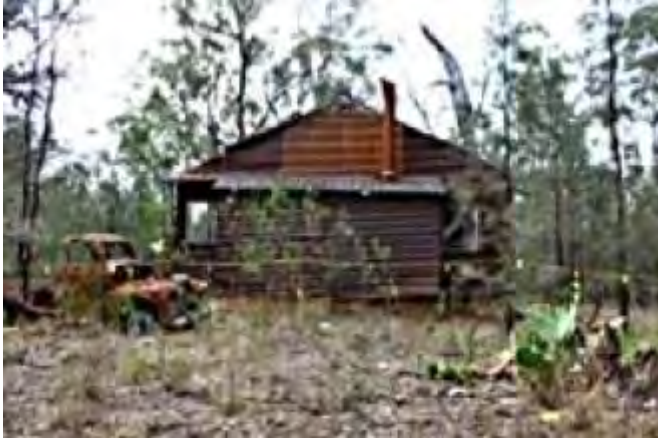
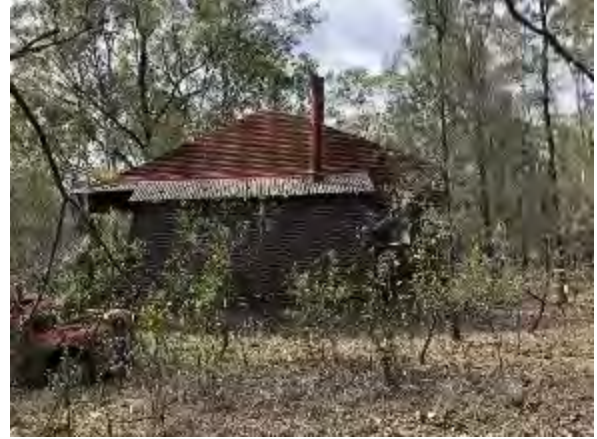
West elevation: shows deterioration of roofing members above open kitchen area and leaning north wall, and further collapse of asbestos roof due to fallen dead tree.

1. Remove the fallen dead tree from the roof. In addition, to prevent similar damage in the future, serious consideration should be given to removing or lopping those trees that are located close enough to the building that they may cause damage if they fall or drop large branches;

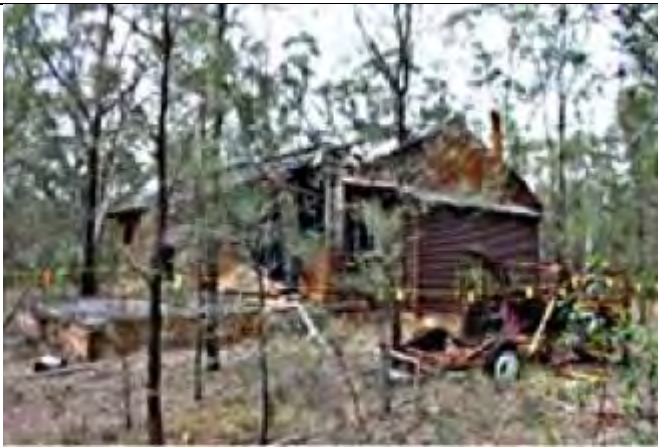
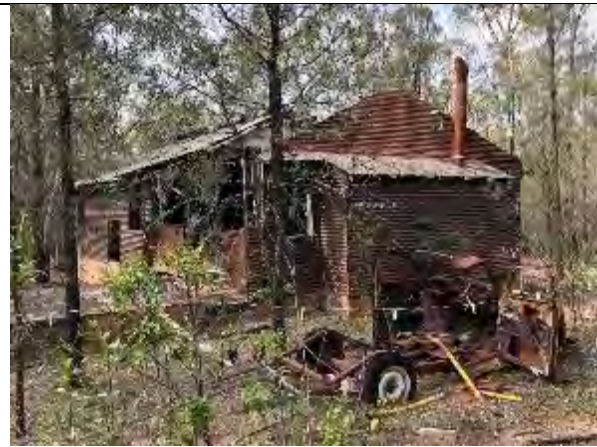
North elevation: no discernible change.

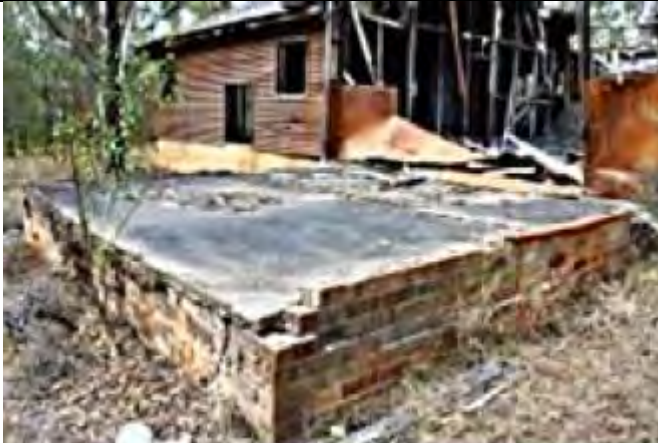
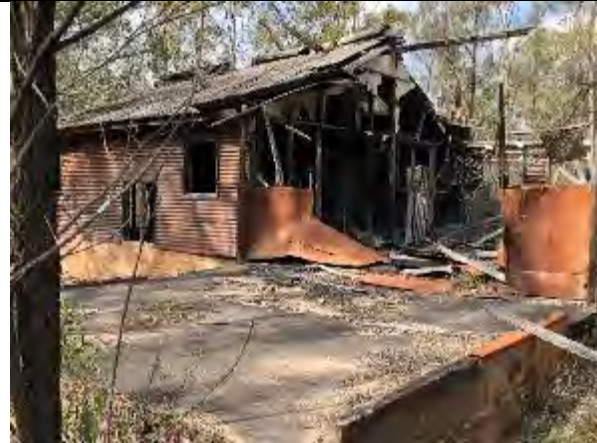
North-east elevation: difficult to discern change.

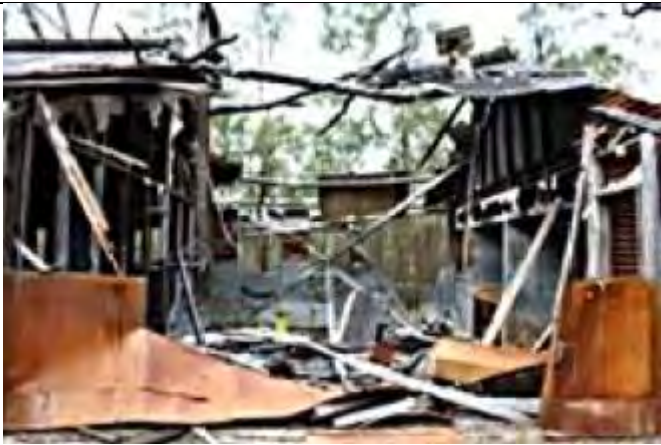
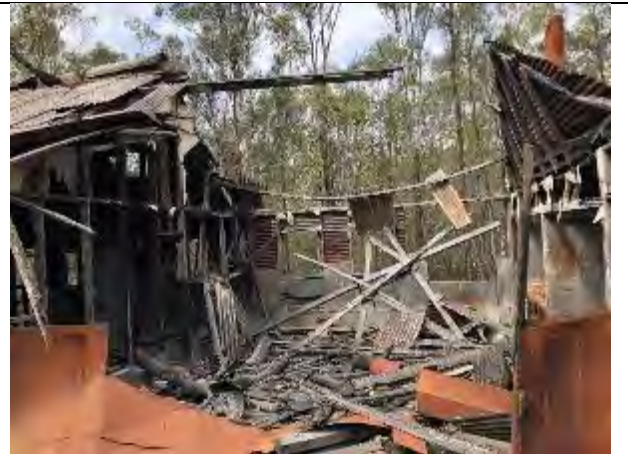
Detail of north-west elevation: shows increased collapse over open kitchen area, as well as new damage to brick foundation at north-west corner.

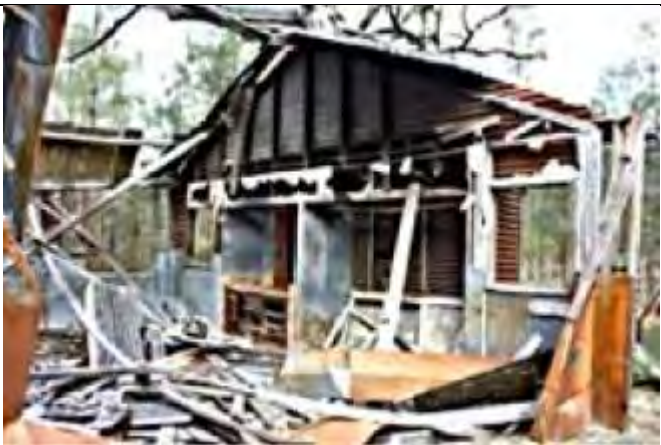
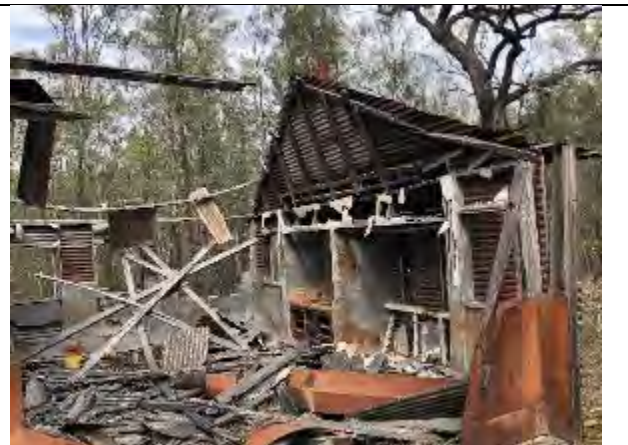
Showing interior damage at kitchen at north end of building: shows increased collapse over and accumulation of debris within open kitchen area. Note also severe lean to north wall.

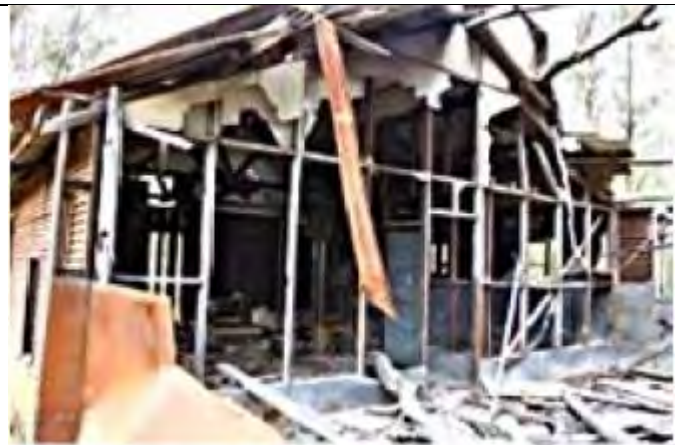
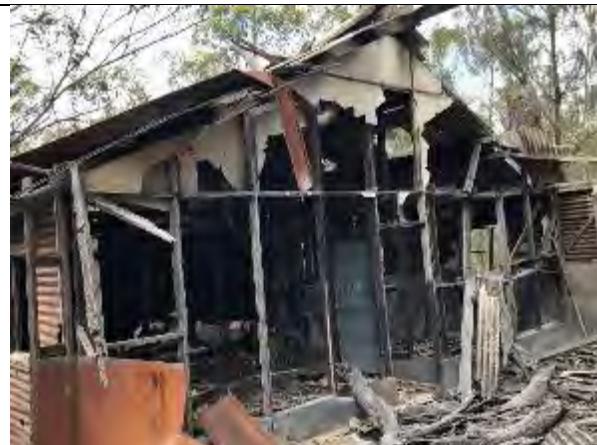
Showing interior damage at kitchen at north end of building: shows increased collapse over and accumulation of debris within open kitchen area. Note also severe lean to north wall.

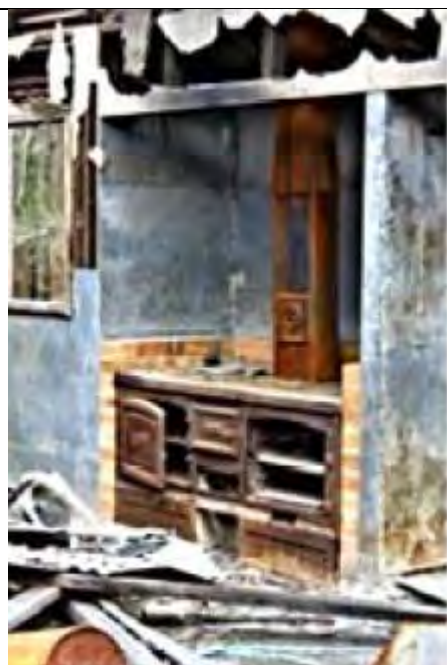
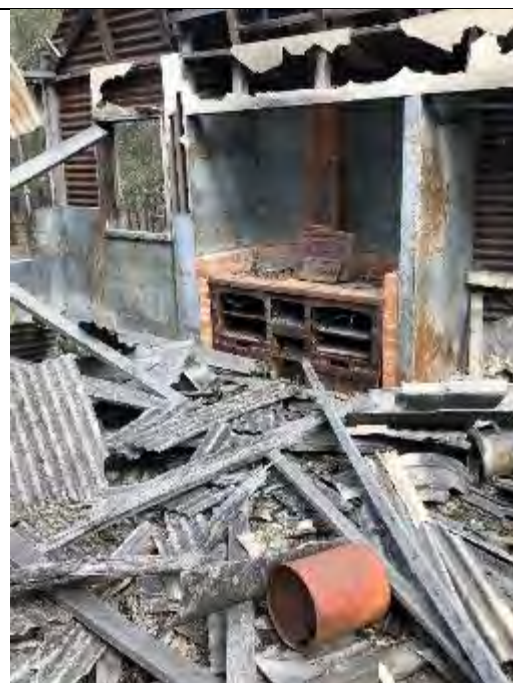
View to interior of south end of building, view from east: shows increased collapse over open kitchen area.

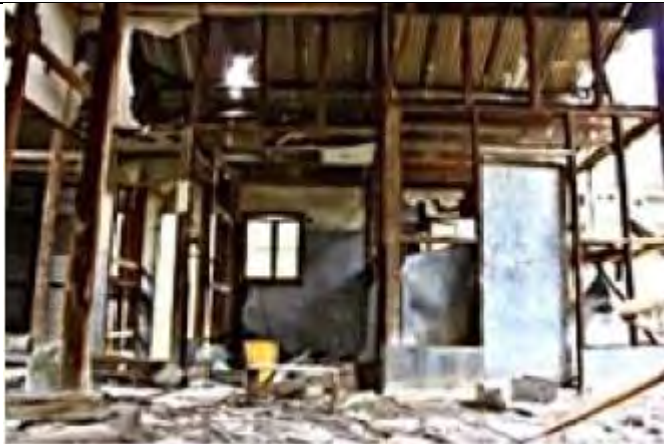
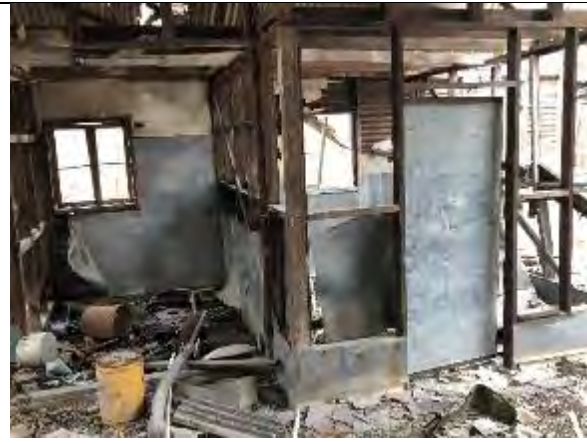
View to interior, showing west entry to building: no discernible change.

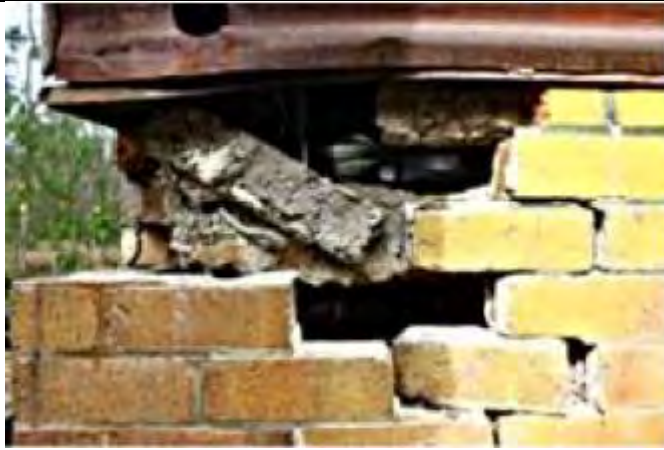
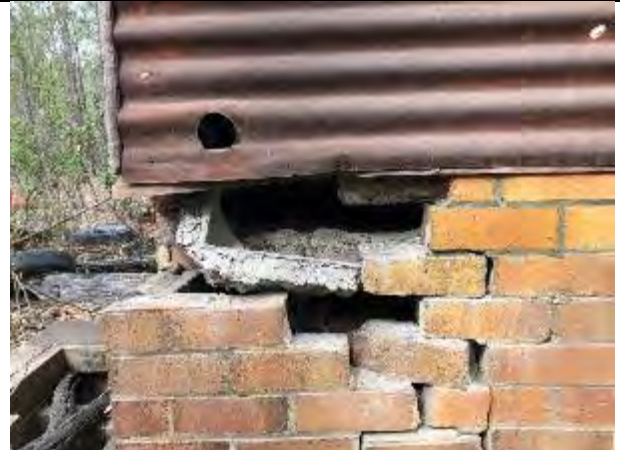
Damaged brick foundation at south-east corner: no discernible increase to cracked brick foundation.

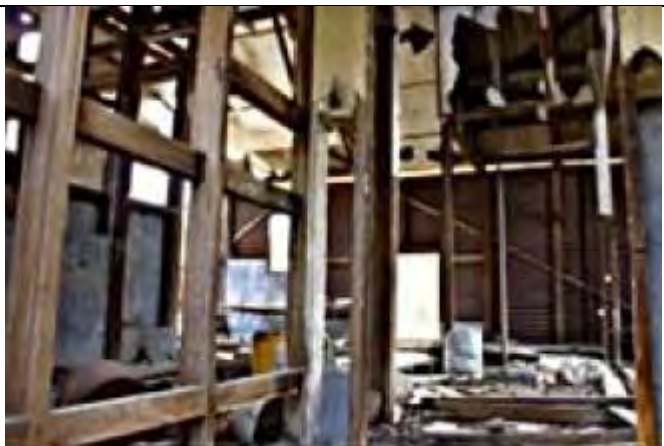
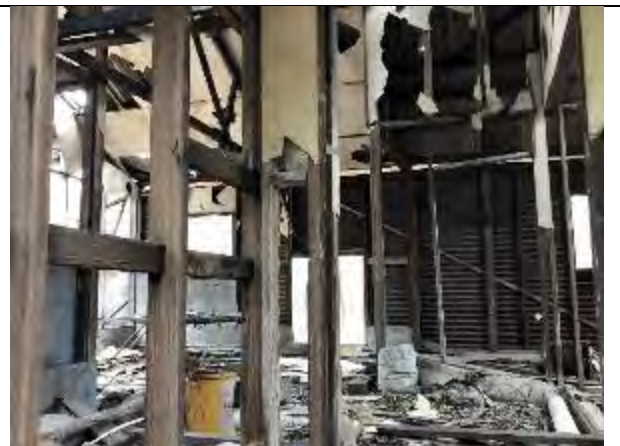
View to interior of building, looking north from south entry: no discernible change.

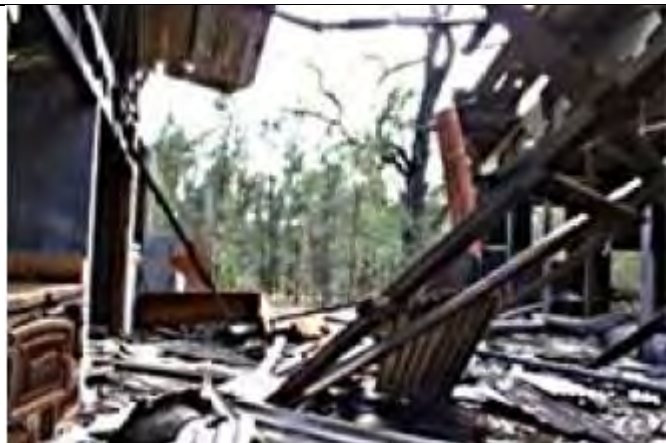
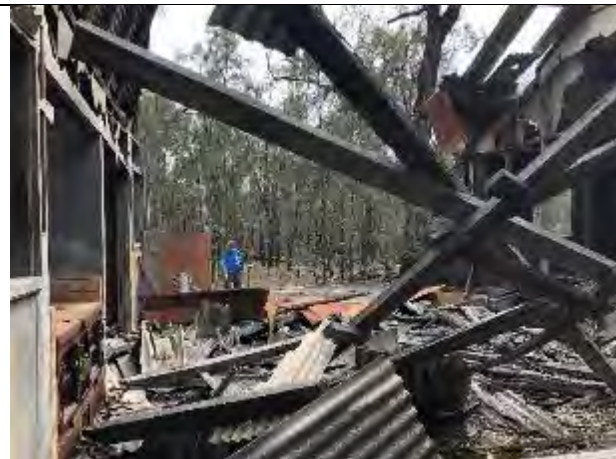
View to interior of building from entry at west: no discernible change.

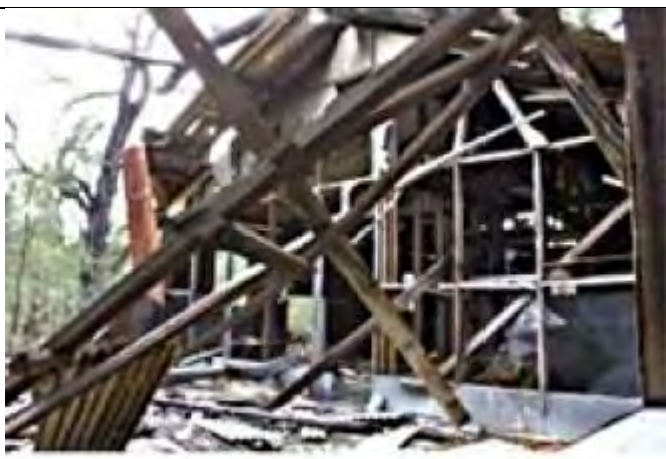
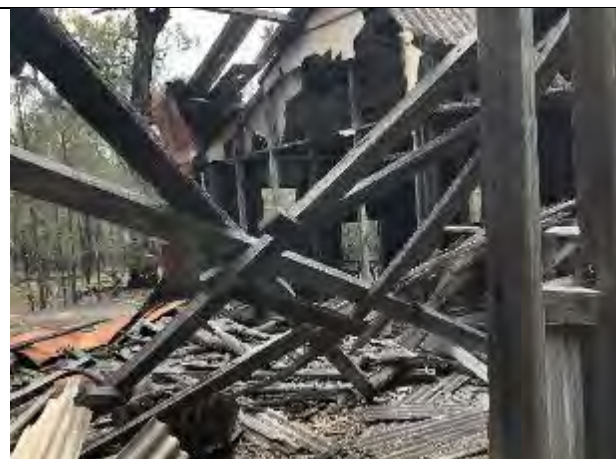
Showing interior of building, viewed from north-west corner: shows collapsed roofing members above open kitchen area and accumulation of debris.

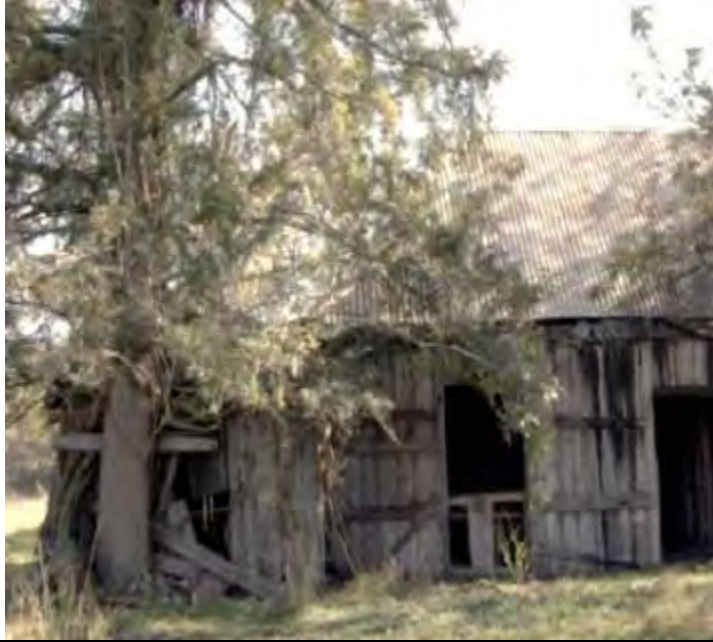
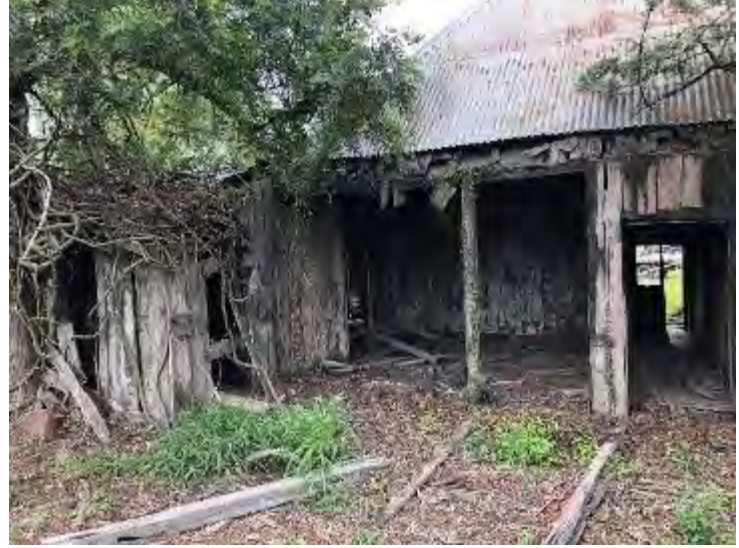
Southern elevation: vertical timber slabs have been removed from southern wall.

5. Due to the vandalism caused to the homestead by unauthorized removal of historically significant and structurally important vertical timber slabs, a security regime including the deployment of video cameras should be implemented to deter and prevent future similar episodes.

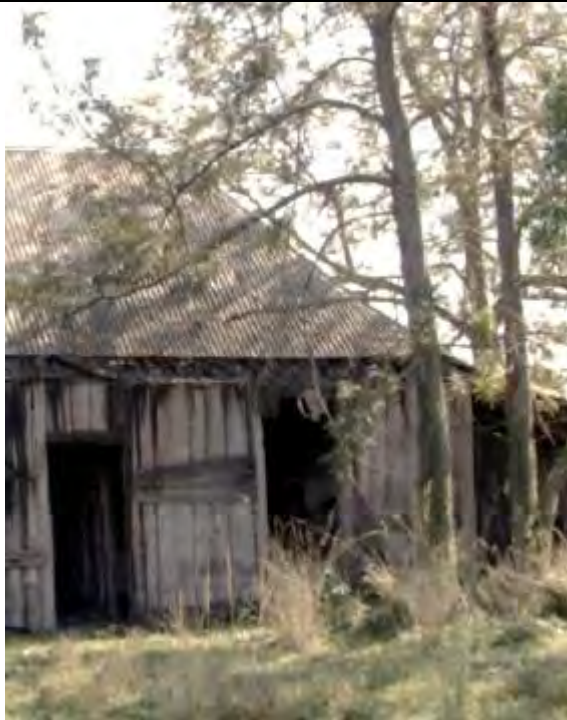
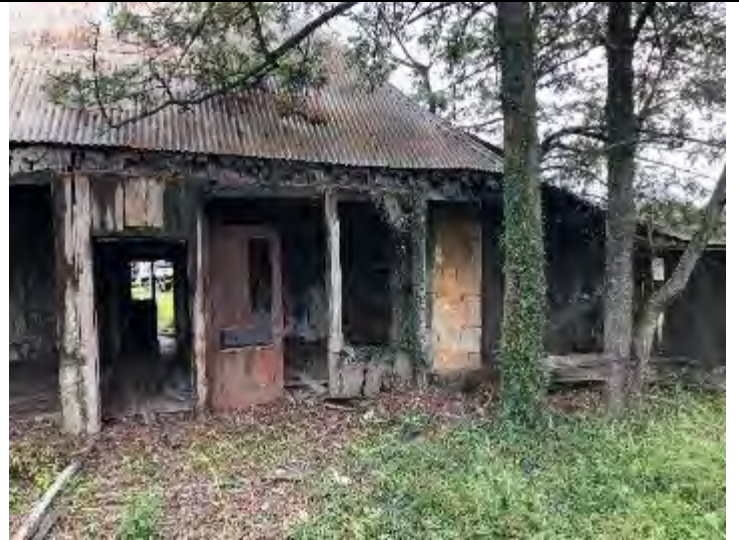
Southern elevation: vertical timber slabs have been removed from southern wall.

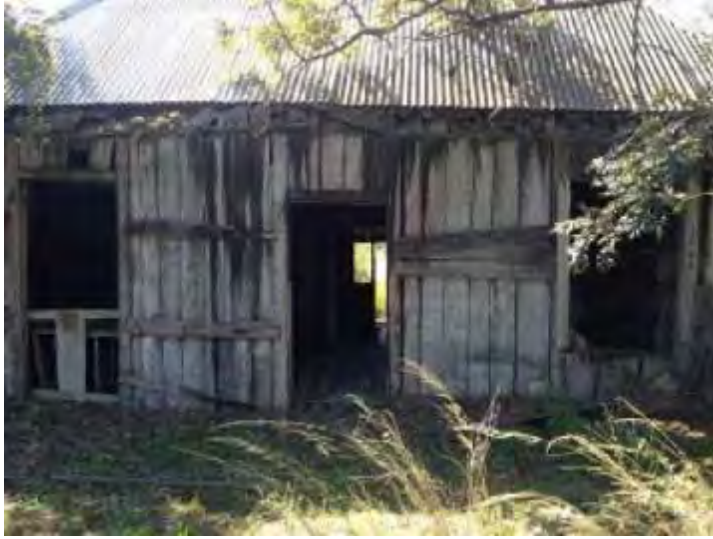
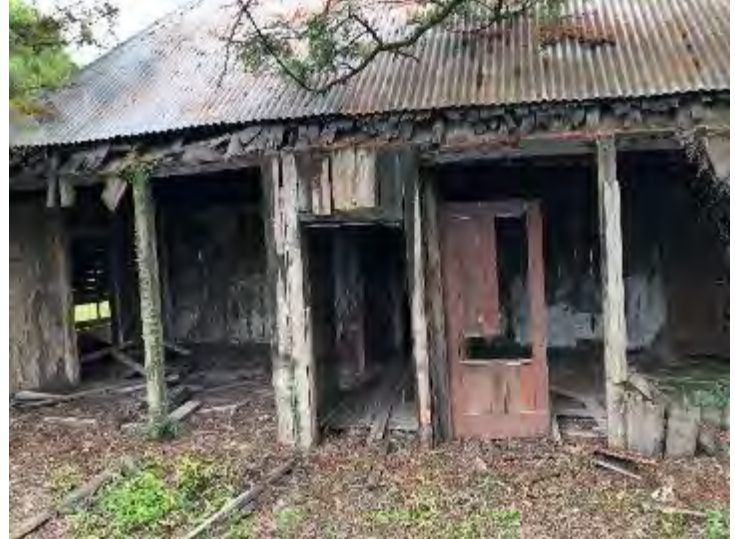
Southern elevation: vertical timber slabs have been removed from southern wall.

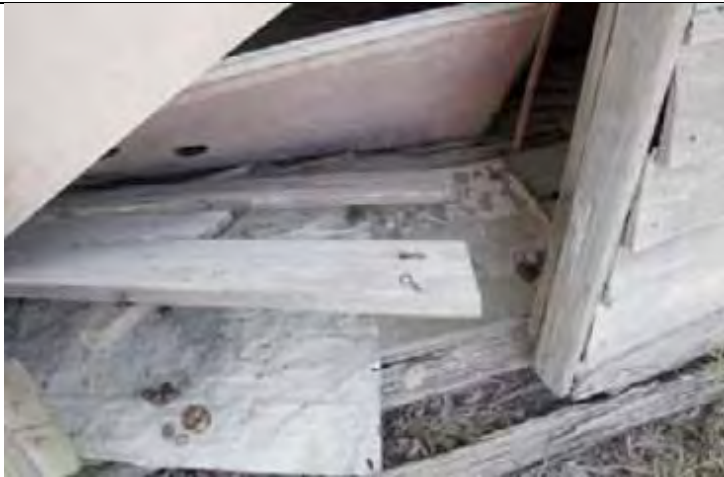
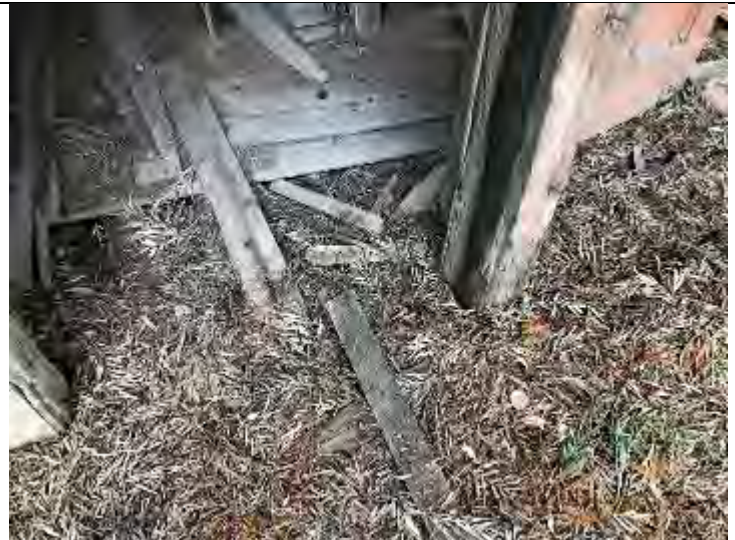
Southern elevation: vertical timber slabs have been removed from southern wall.

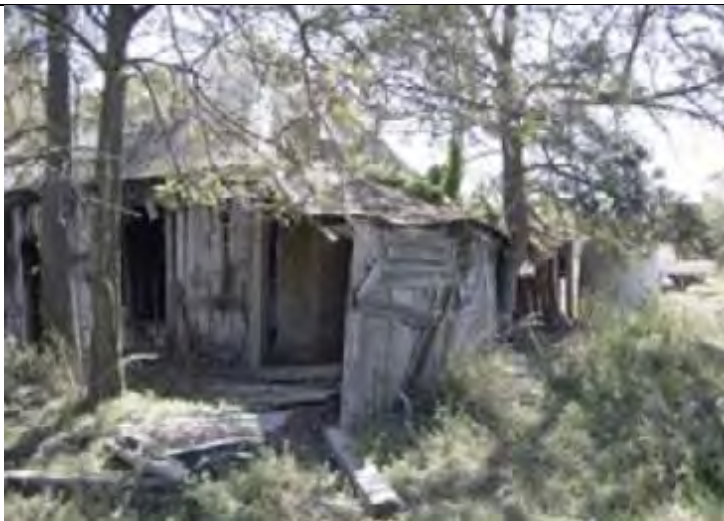
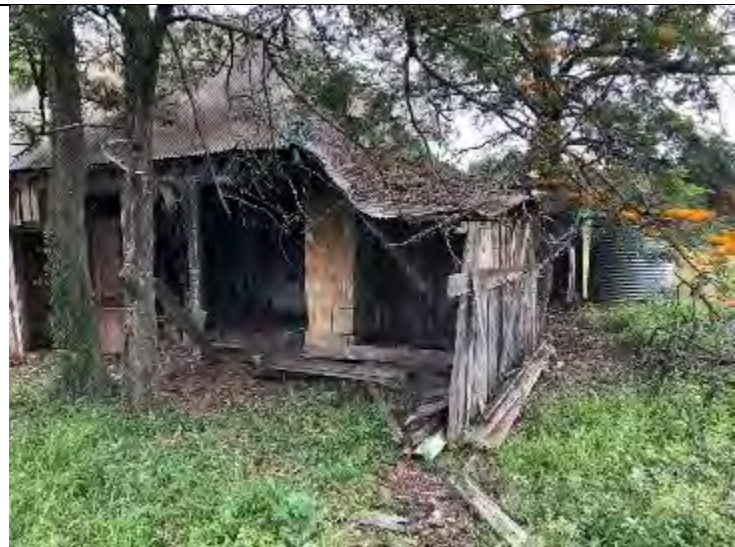
Southern elevation doorway: door has been removed.

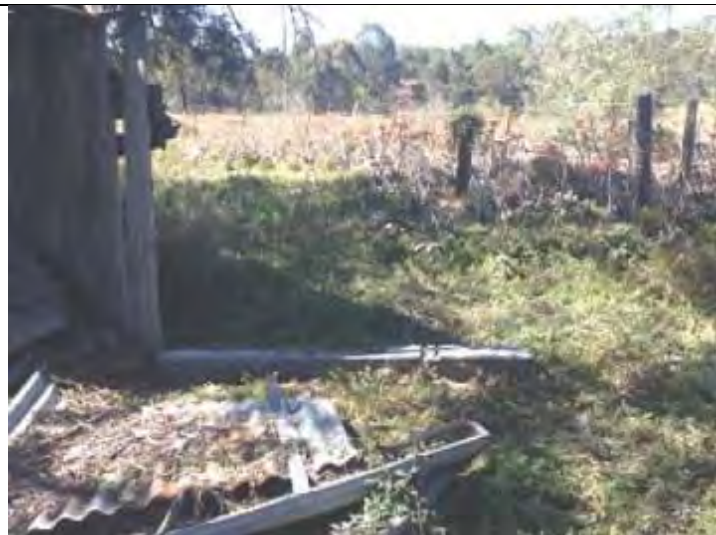
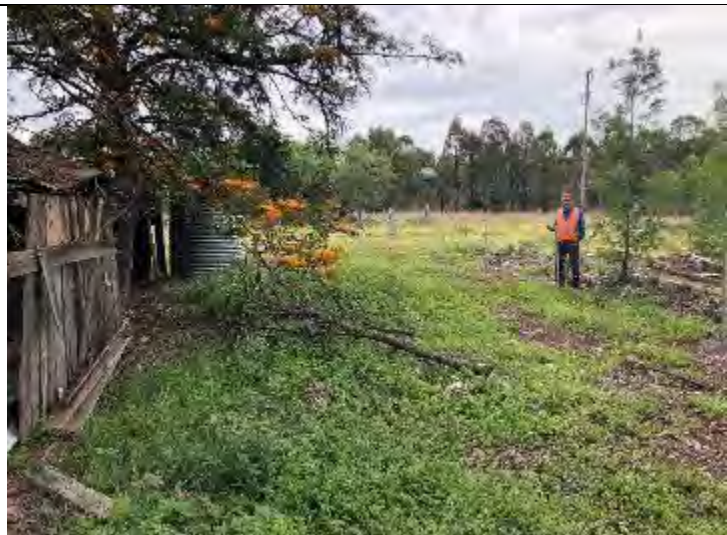
South-eastern corner: vertical slabs have been removed causing further collapse of roof.

4. Due to the damage caused by the removal of the vertical slabs, once the items above are complete, a structural engineer should then re-inspect the building before any further works are commenced to make further recommendations on stability requirements and structural repairs; and
